# The Fernery at The Acacias, University of Reading

## Structural Engineer's Report for the Fernery

**Prepared by:** Mike Wilford BEng CEng MSc MIStructE  
Conservation Accredited Structural Engineer

**Job Number:** 222

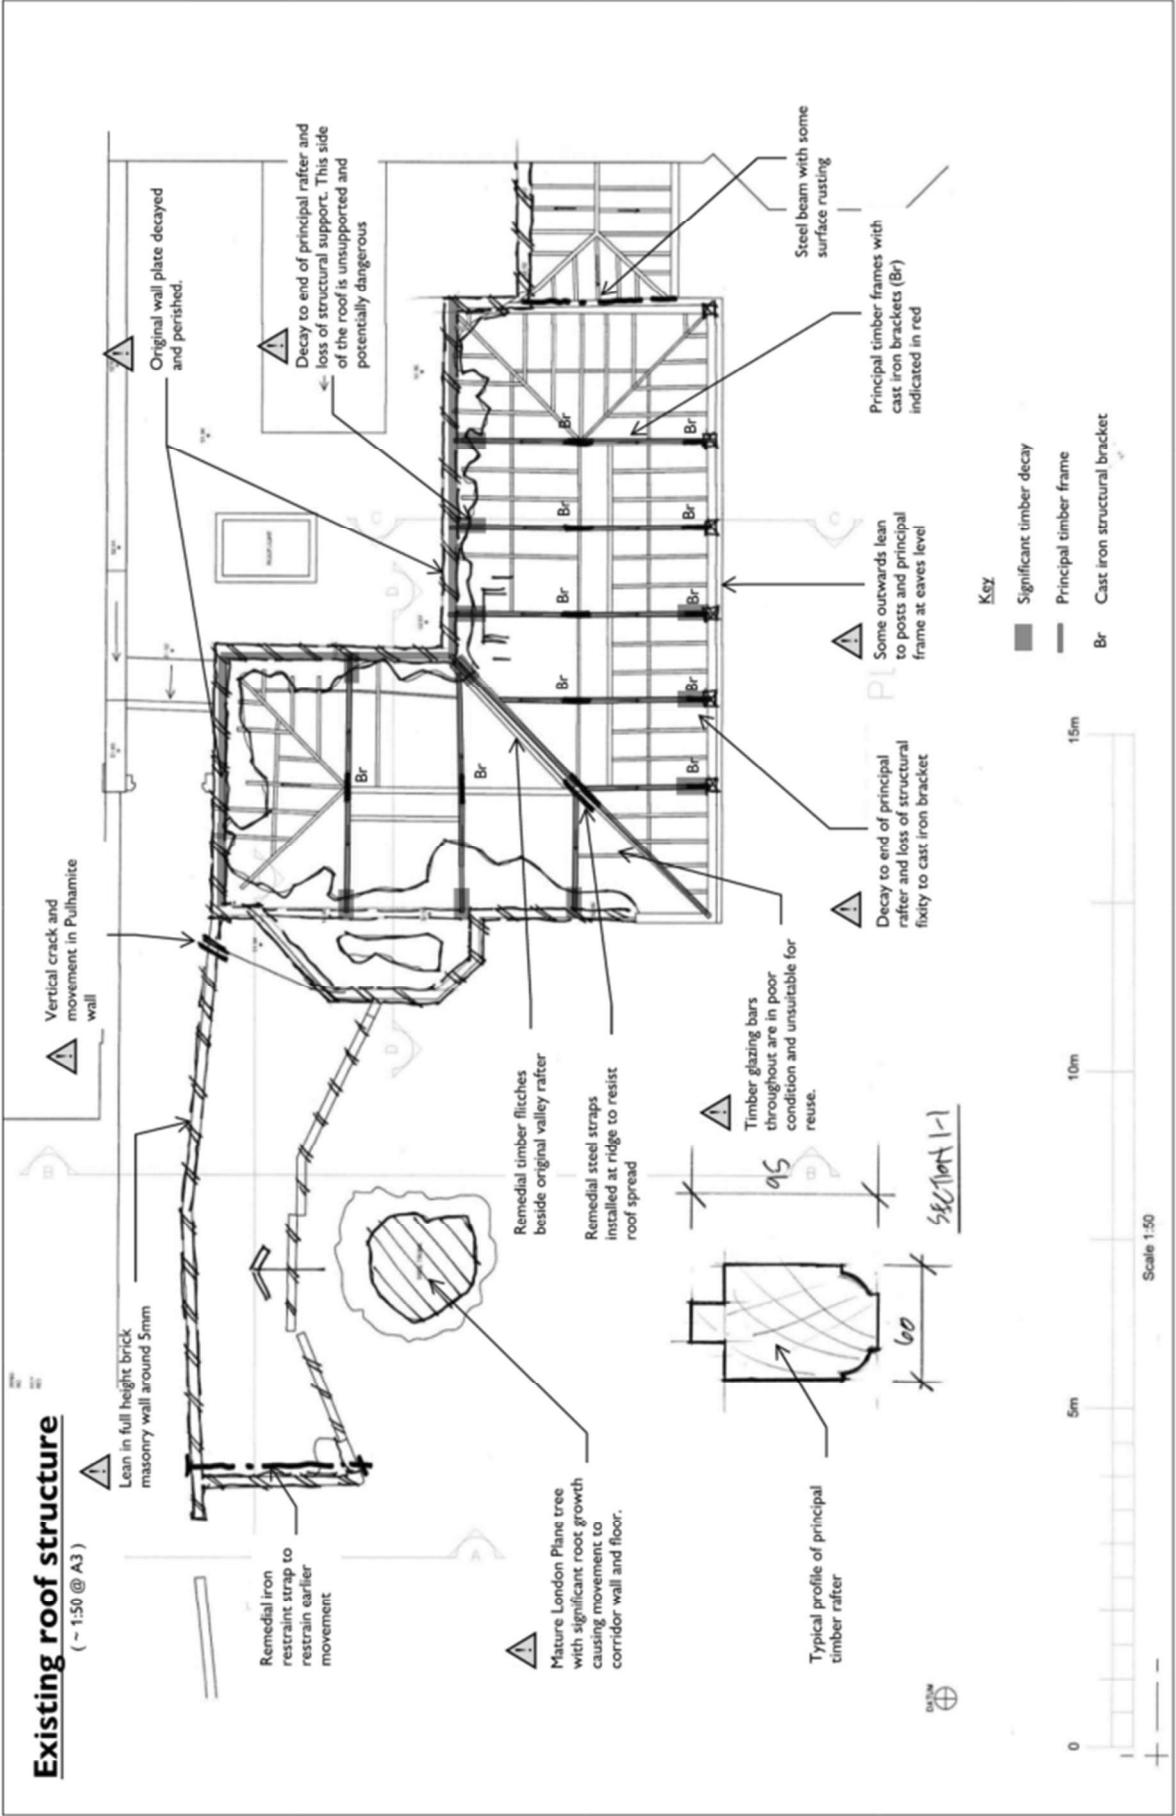
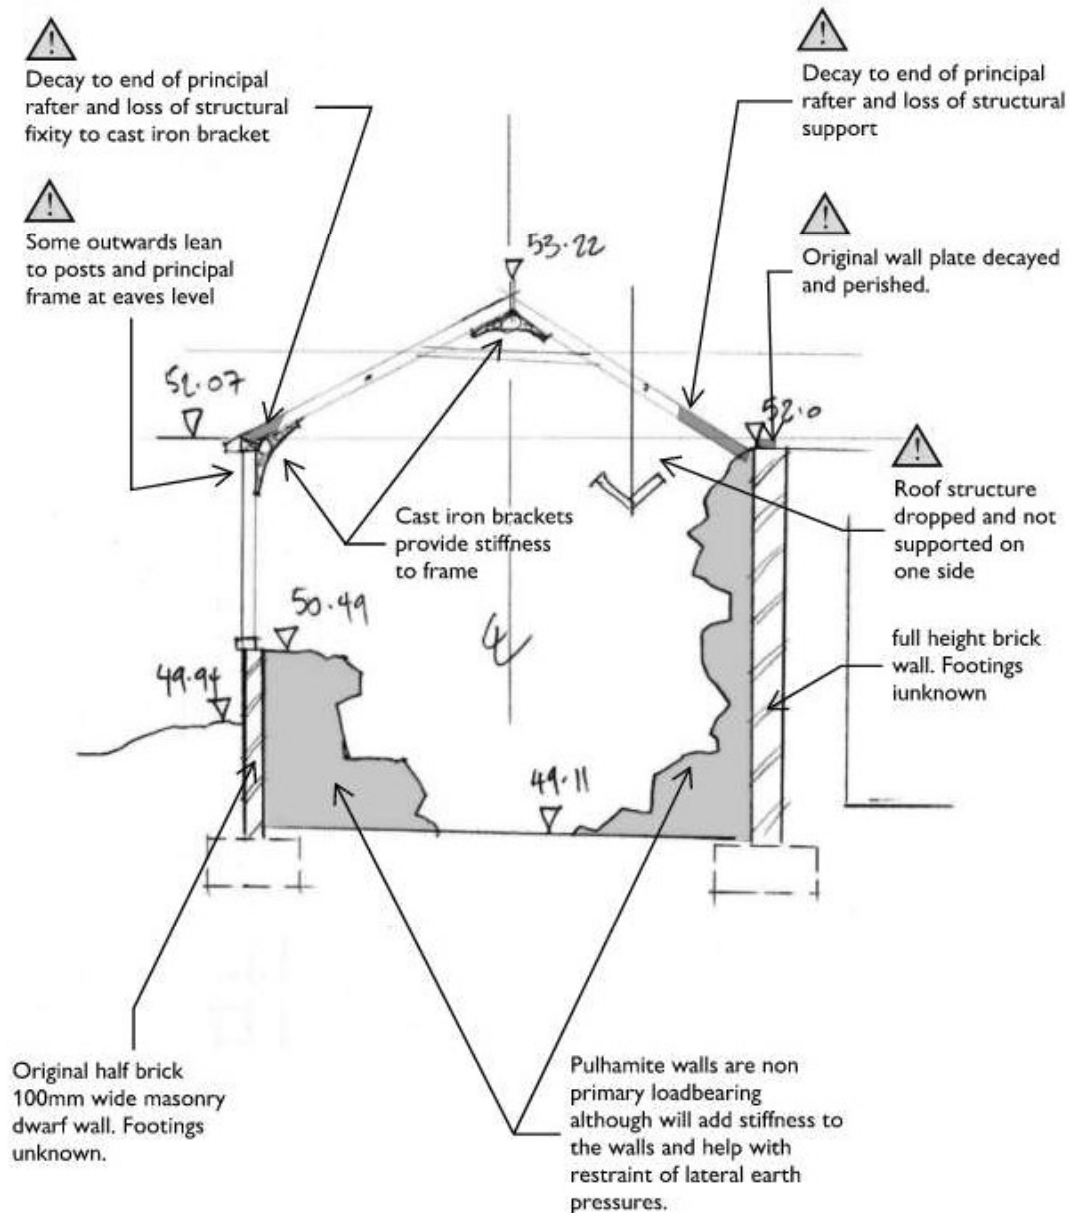
Job No. 222 Page SK 05 Rev 1

## Cross section through existing structure
