## The Fernery at The Acacias, University of Reading

### Structural Engineer's Report for the Fernery

**Prepared by:** Mike Wilford BEng CEng MSc MIStructE  
Conservation Accredited Structural Engineer

**Job Number:** 222

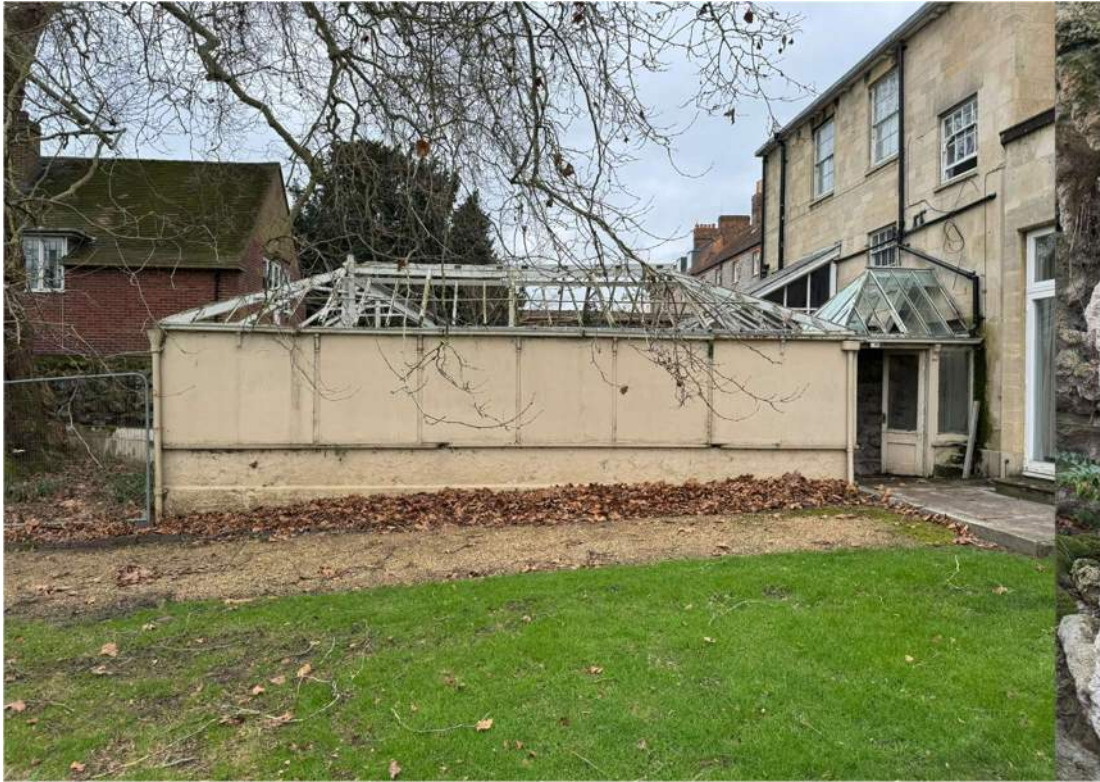
Photograph 1 – East facing wall to the Fernery. Note original glazed wall now protected with temporary boarding.

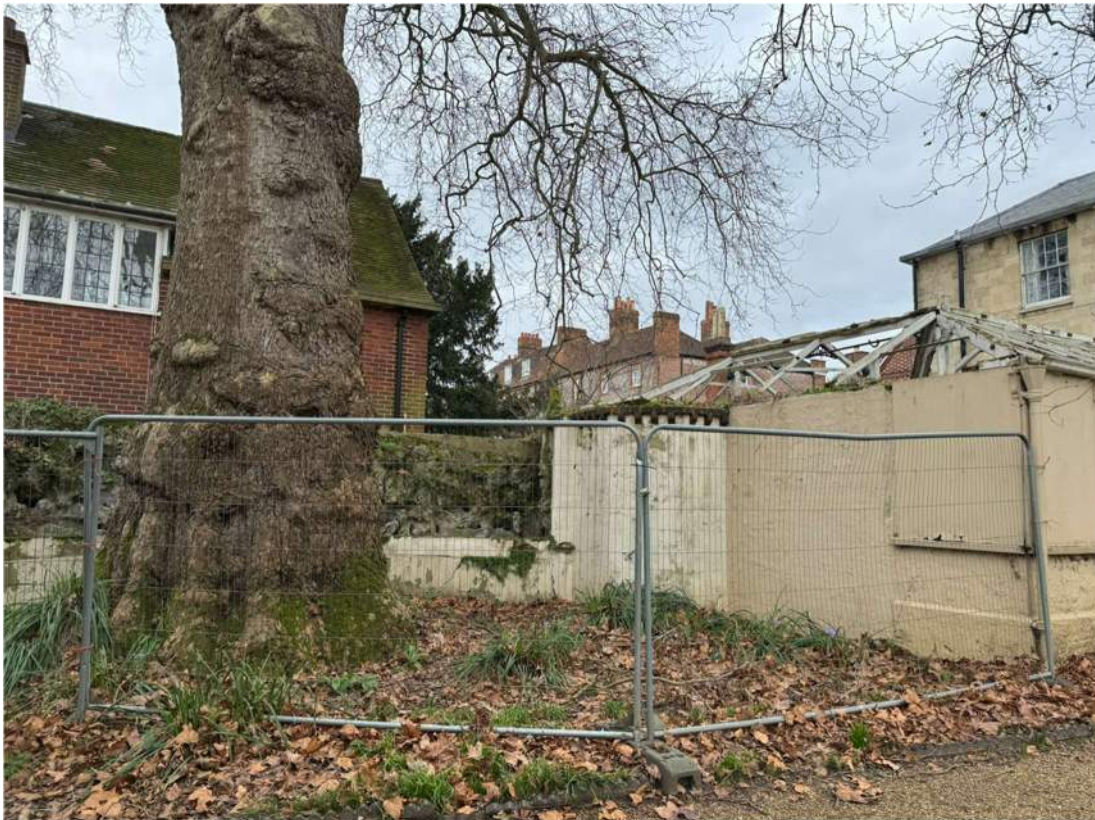
Photograph 2 – Southern wall and mature London Plane around 4.0m away.

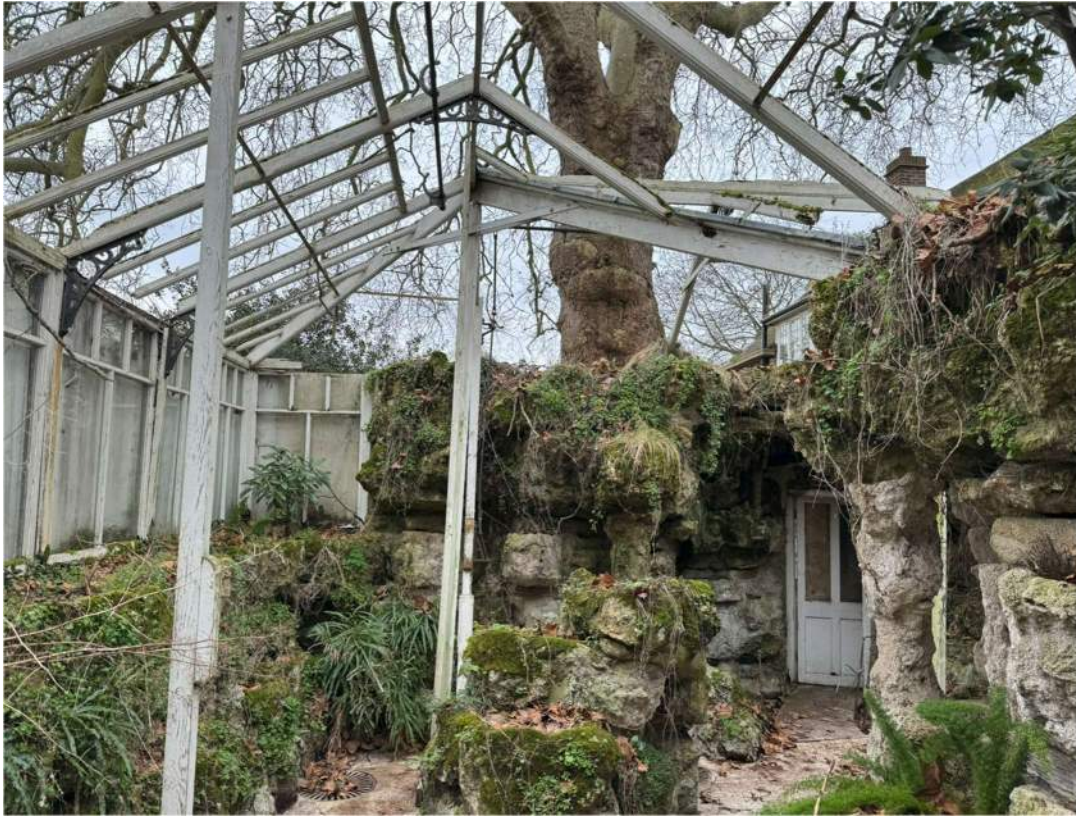
Photograph 3 – Internal view of the Fernery facing south. Note temporary central prop for hip frame.

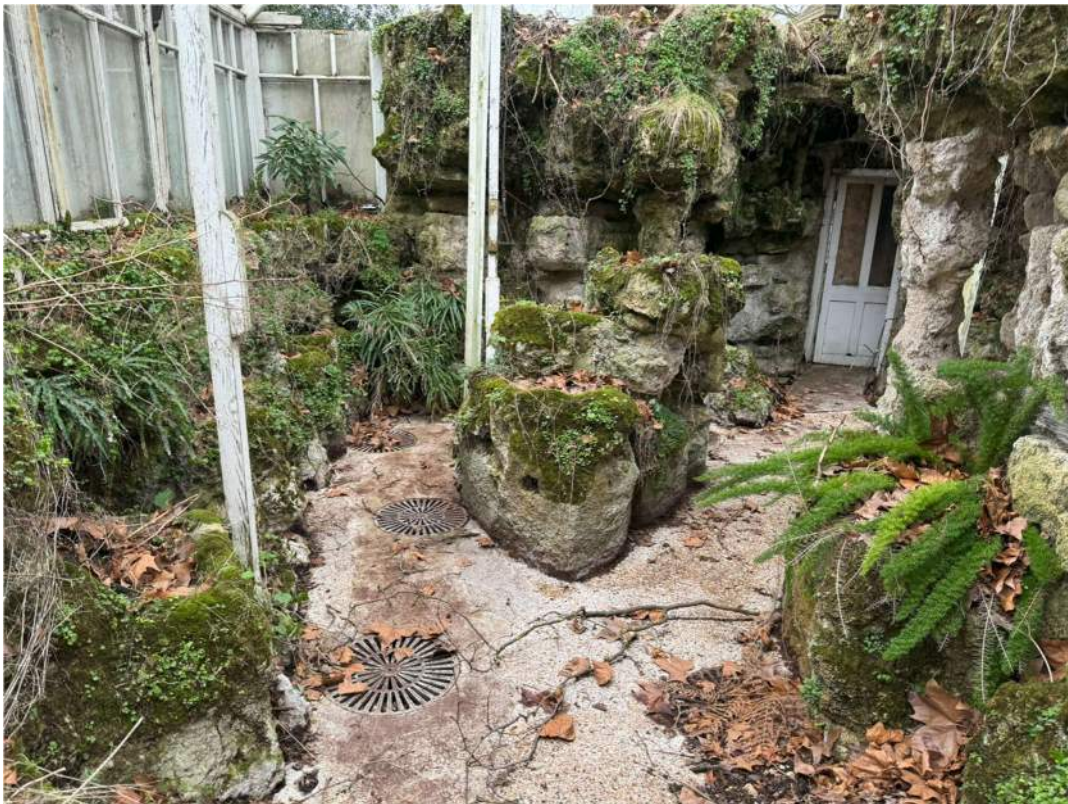
Photograph 4 – Fernery floor with cast iron duct within the terrazzo concrete slab.

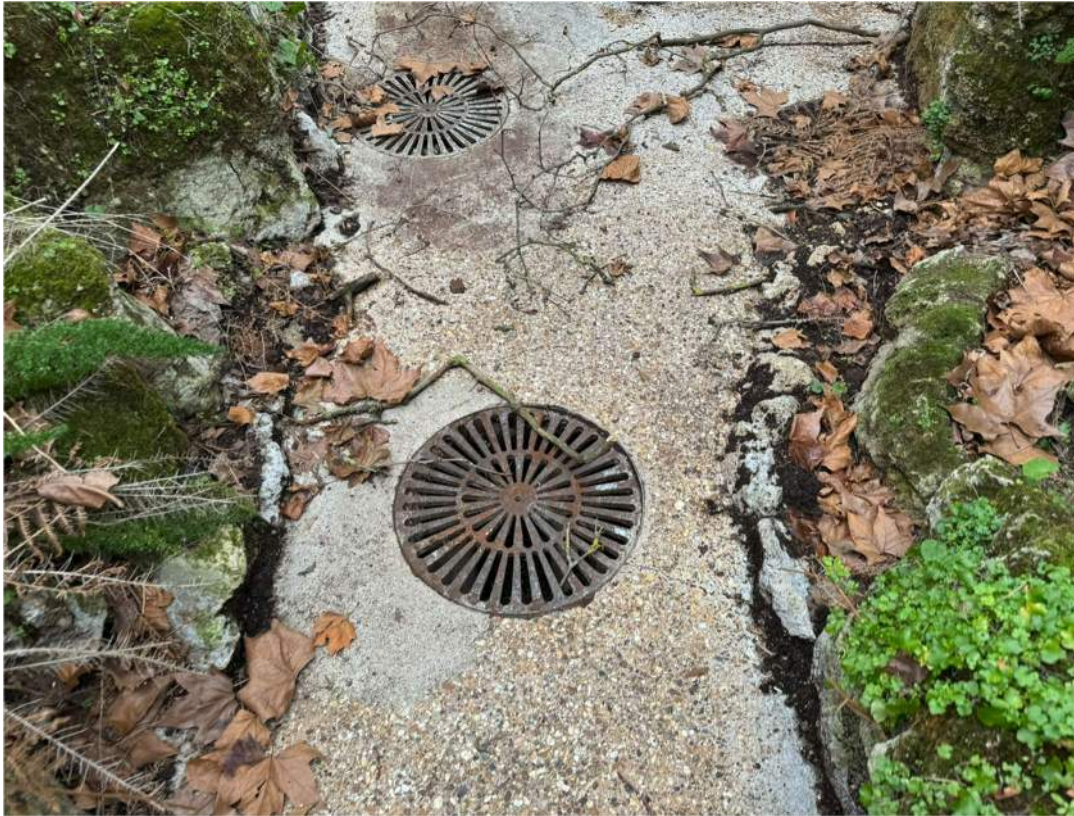
Photograph 5 – Cast iron floor duct part of the original heating and water management system.

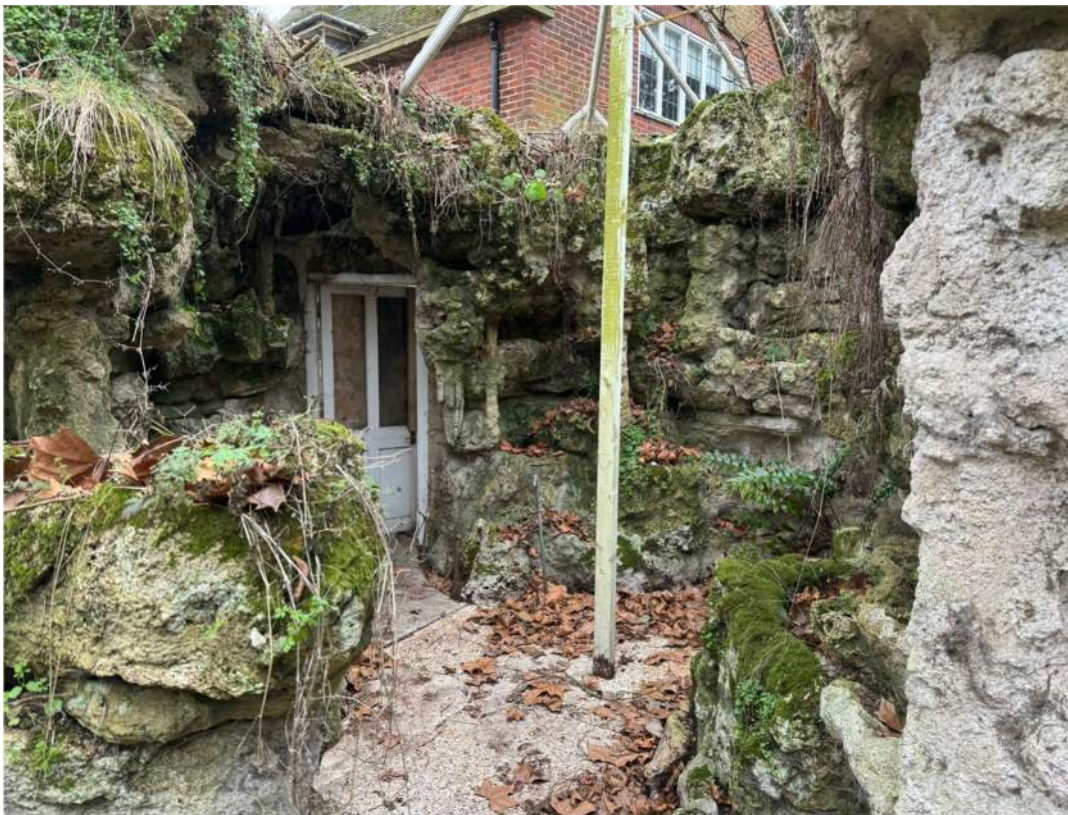
Remedial timber props have been installed to prevent collapse. Without the current props the roof structure would collapse.

Photograph 6 – Temporary timber prop

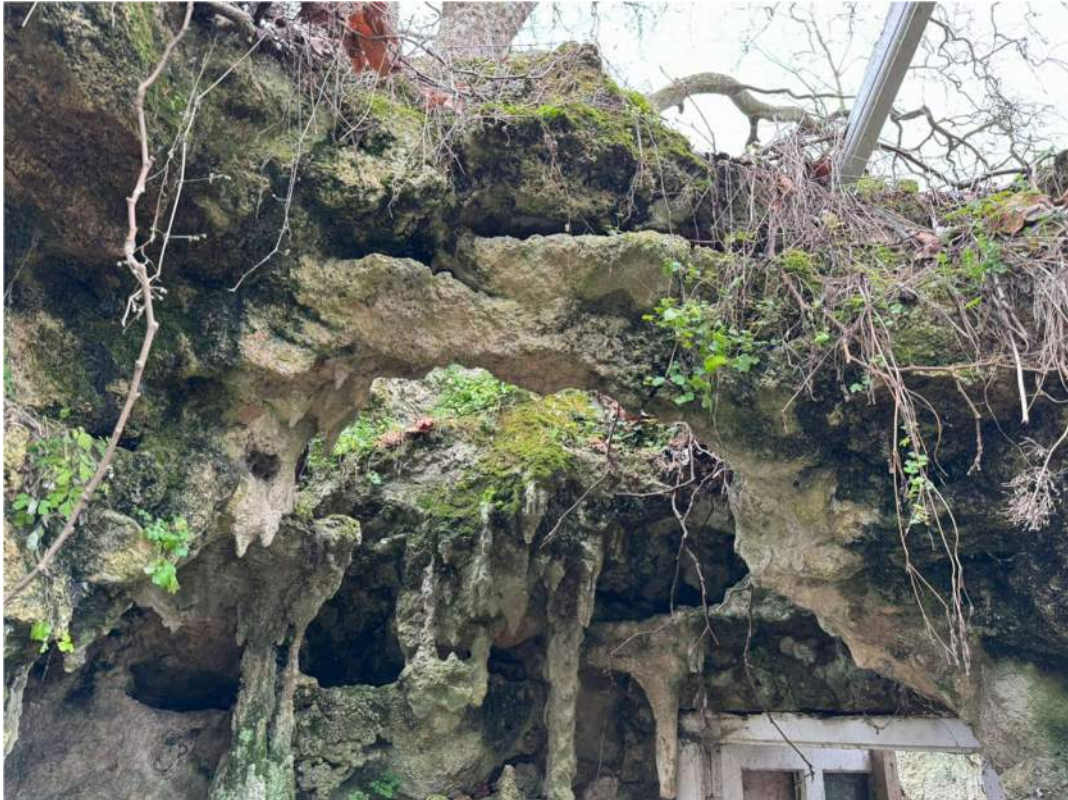
Photograph 7 – Pulhamite arch over walkway. No signs of distress.

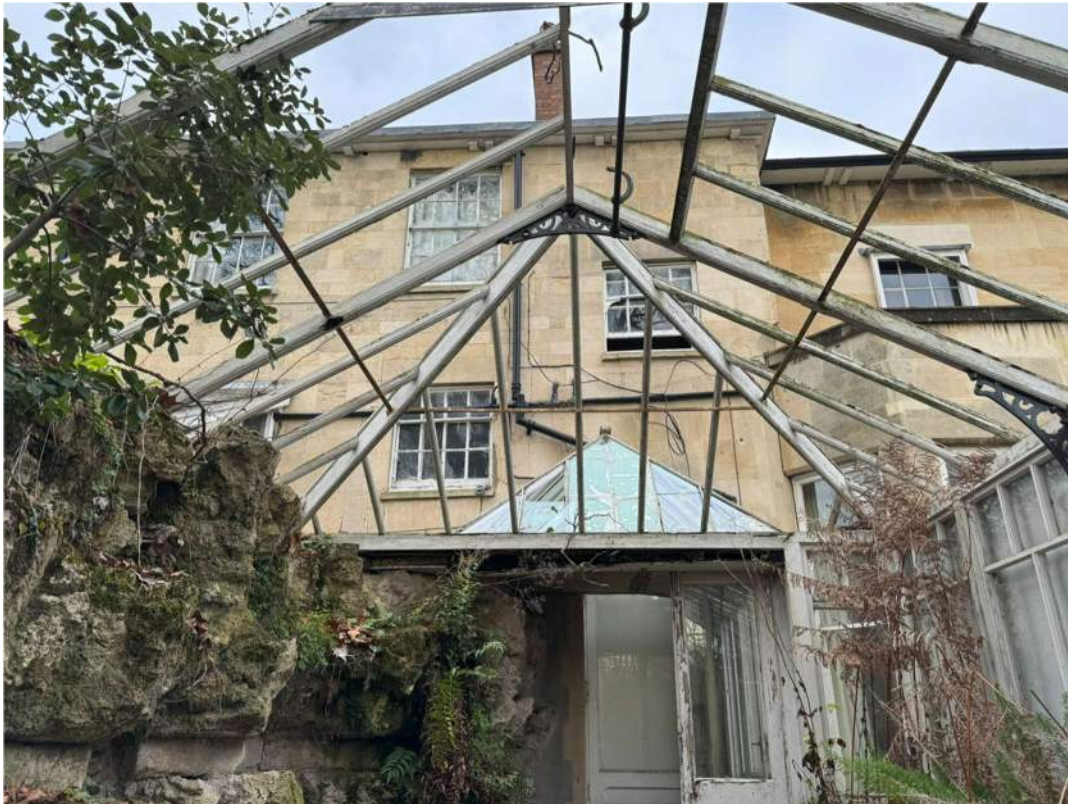
Photograph 8 – Pitched roof structure looking north towards the villa. All glazing has been removed.

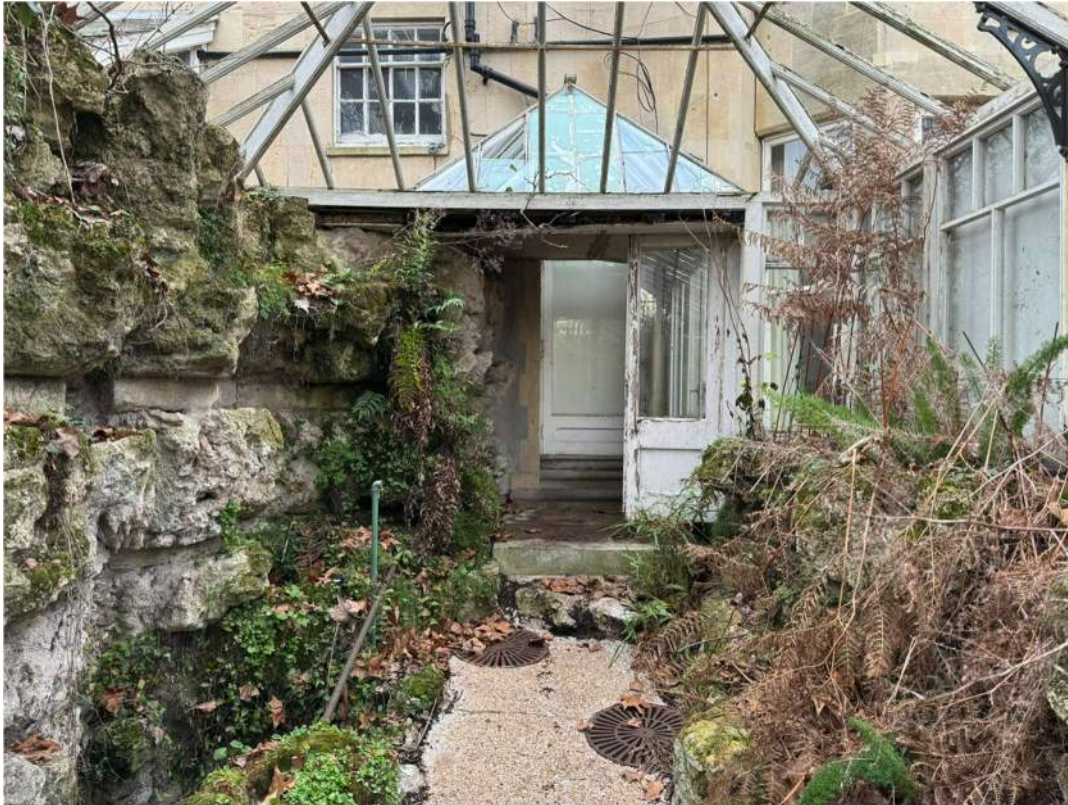
Photograph 9 – Porch structure to the north with glazing still in place but protected by plywood soffit below.

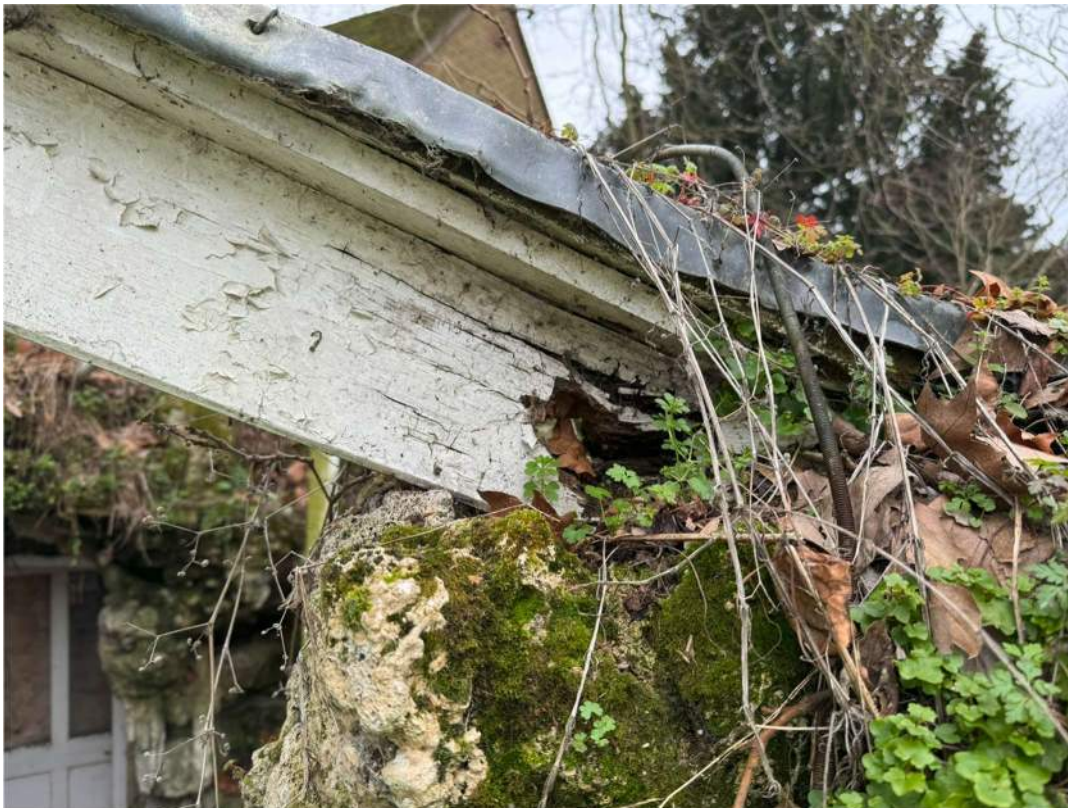
There is extensive decay to the timber structure and glazing bars. The decay is predominant at the ends of the principal rafters where they bear onto the timber wall plates. The gutters and lowest parts of the roof are difficult to access so more prone to timber decay.

Photograph 10 – Severe decay at end of principal rafter

The timber roof is in poor condition and requires very significant repair or replacement. The timber roof should be carefully dismantled and the principal frames assessed for repair. An allowance for replacement of at least 50% of the principal timber structure should be allowed for. This may include scarfing of decayed ends or full element replacement with similar materials to the original profile.

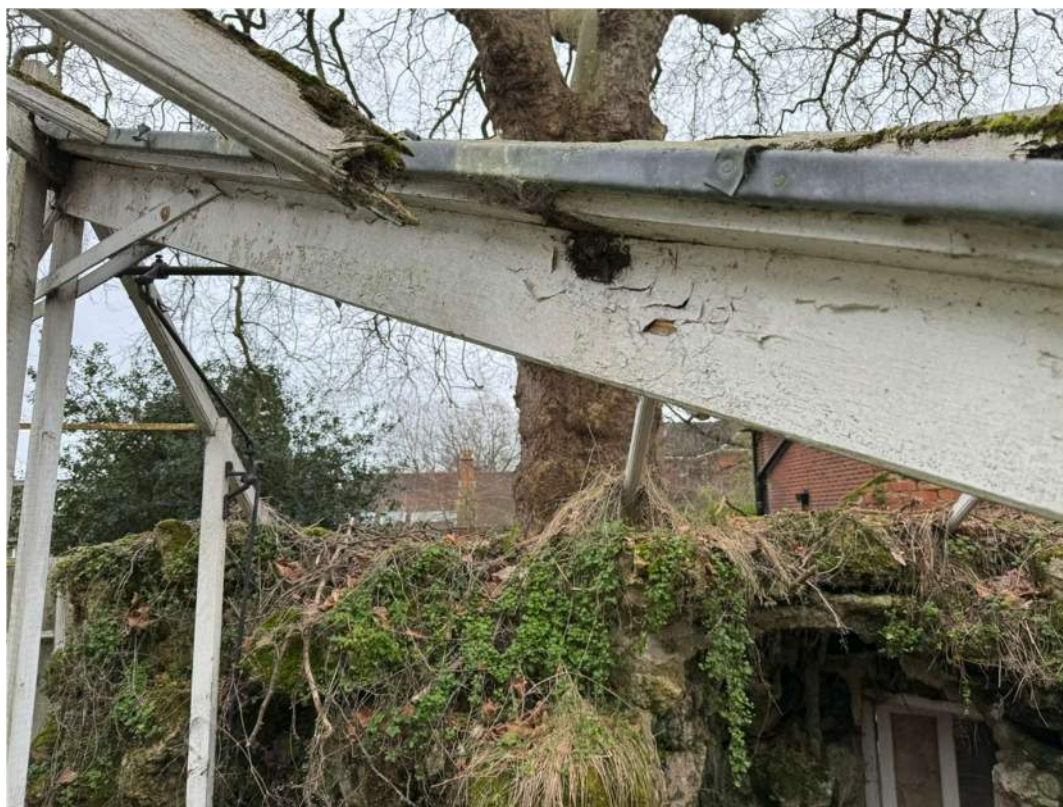
Photograph 11 – Severe decay to glazing bar and loss of support.

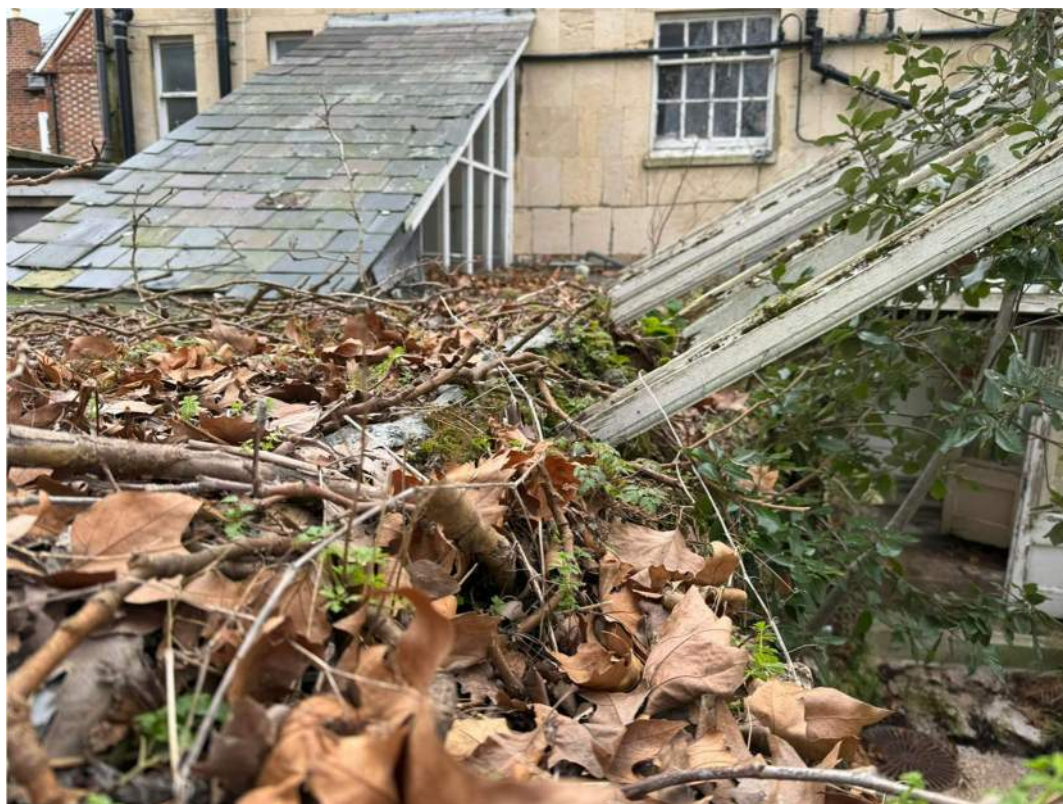
Photograph 12 – Timber wall plate above the west wall has limited access and traps water easily.

Allow for the full replacement of all timber wall plates throughout supported onto a new brick masonry upstand to raise the roof by around 150mm.

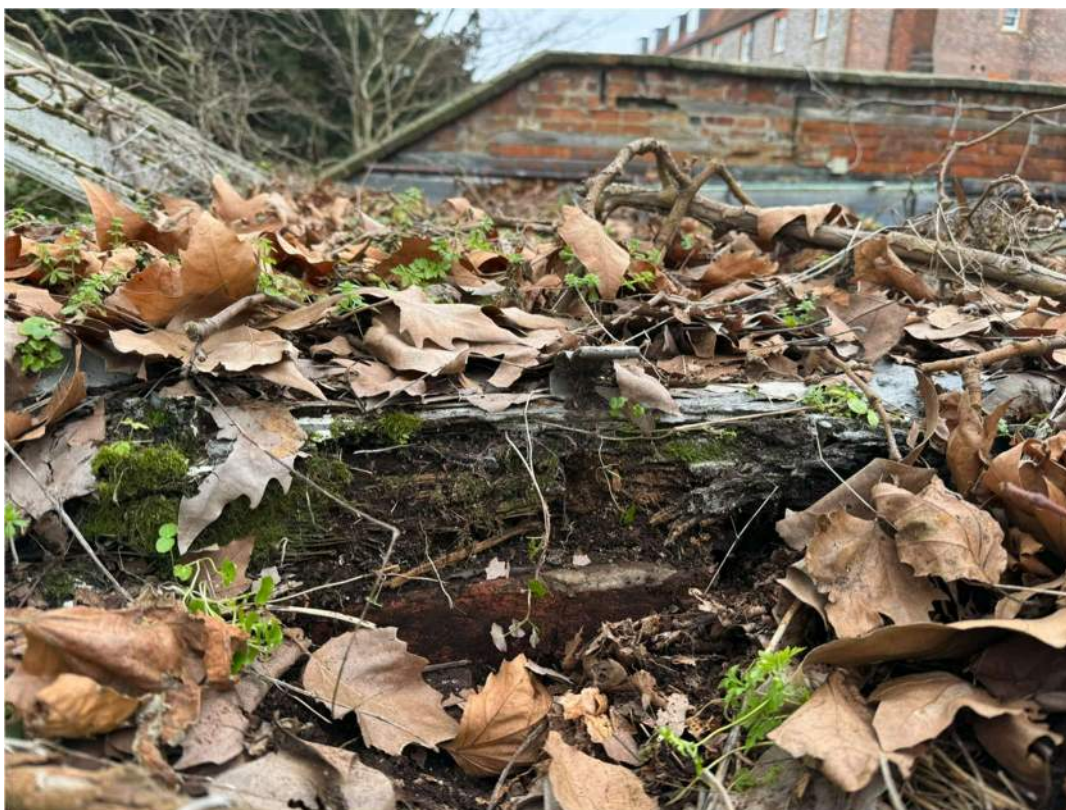
Wall plates along the top of the high level western wall have entirely perished from decay. The wall plates still remain along this high level wall can be crumbled by hand and have no structural strength.

Photograph 13 – Wall plate above west wall is perished.

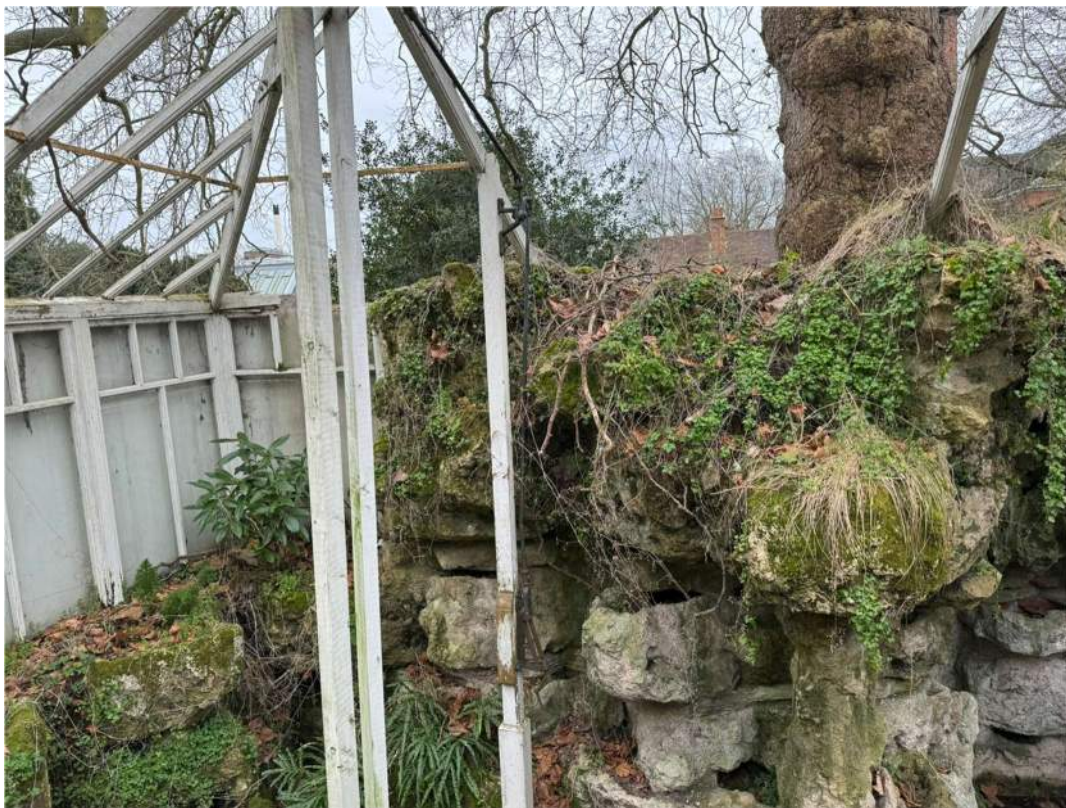
Photograph 14 – High level wall plates hidden behind Pulhamite walls.

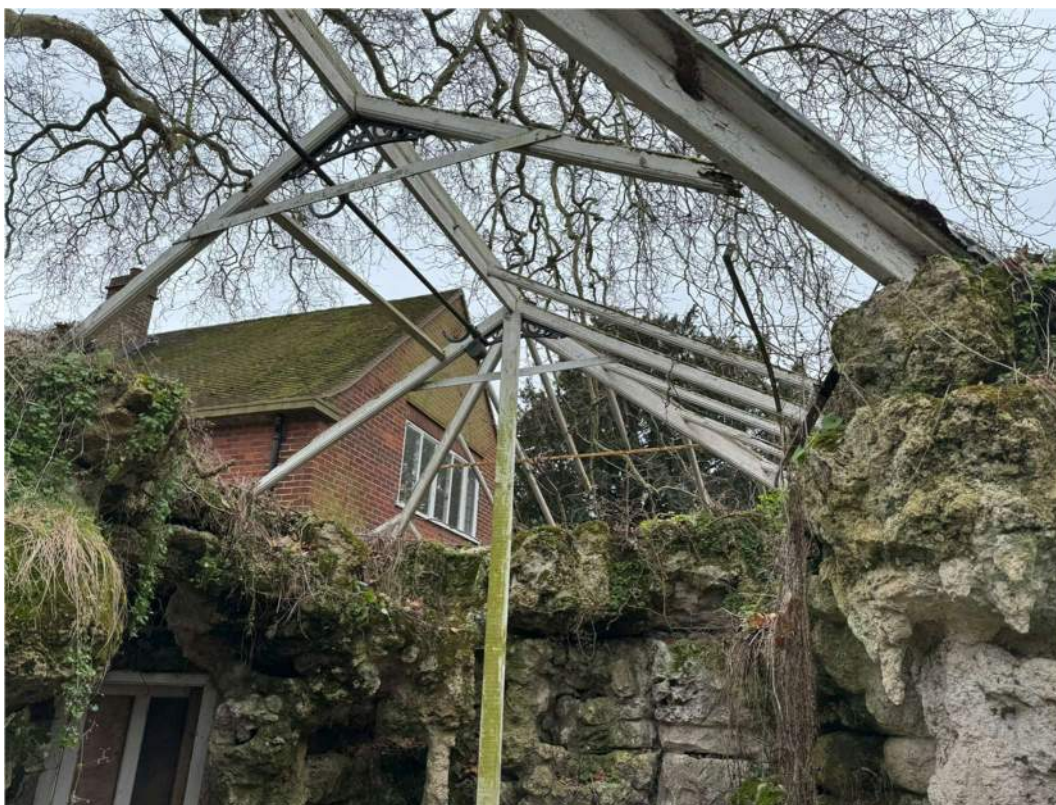
Photograph 15 – Temporary timber prop supporting end principal frame.

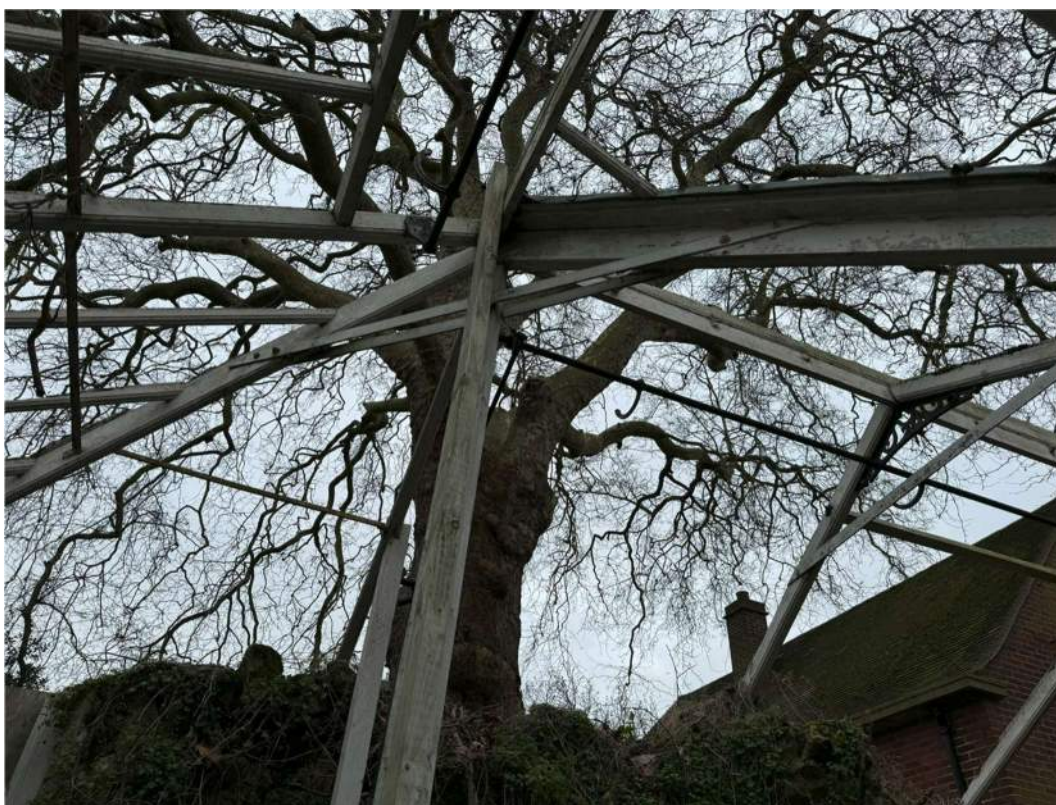
Photograph 16 – Temporary timber prop and face fixed steel straps each side of principal rafter.

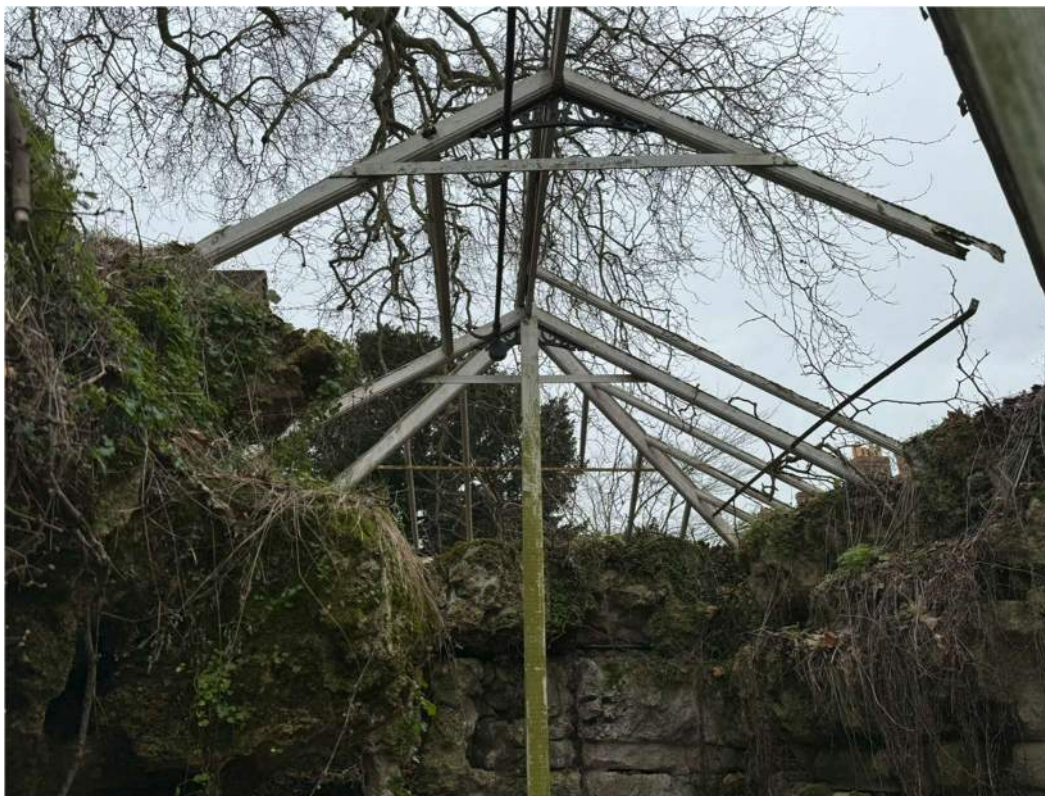
Photograph 17 - Decayed ends to principal rafters and lack of support.

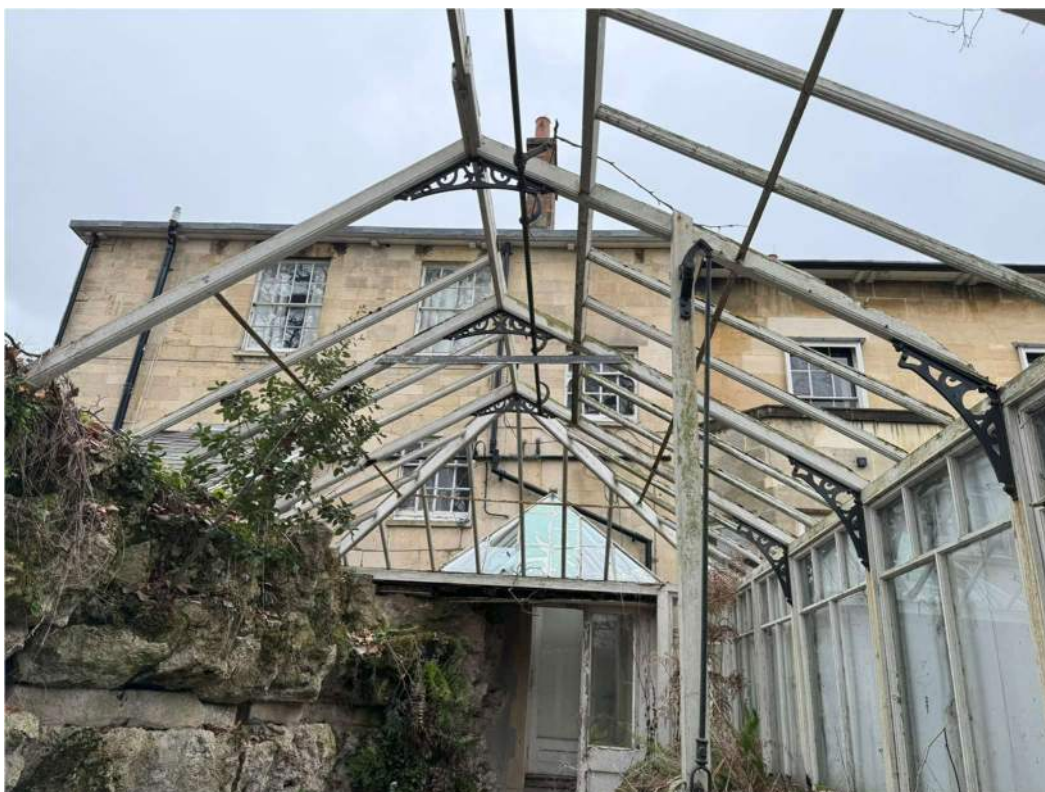
Photograph 18 – Decayed ends to principal above cast iron eaves brackets.

The original cast iron brackets should be cleaned, repainted and reused.

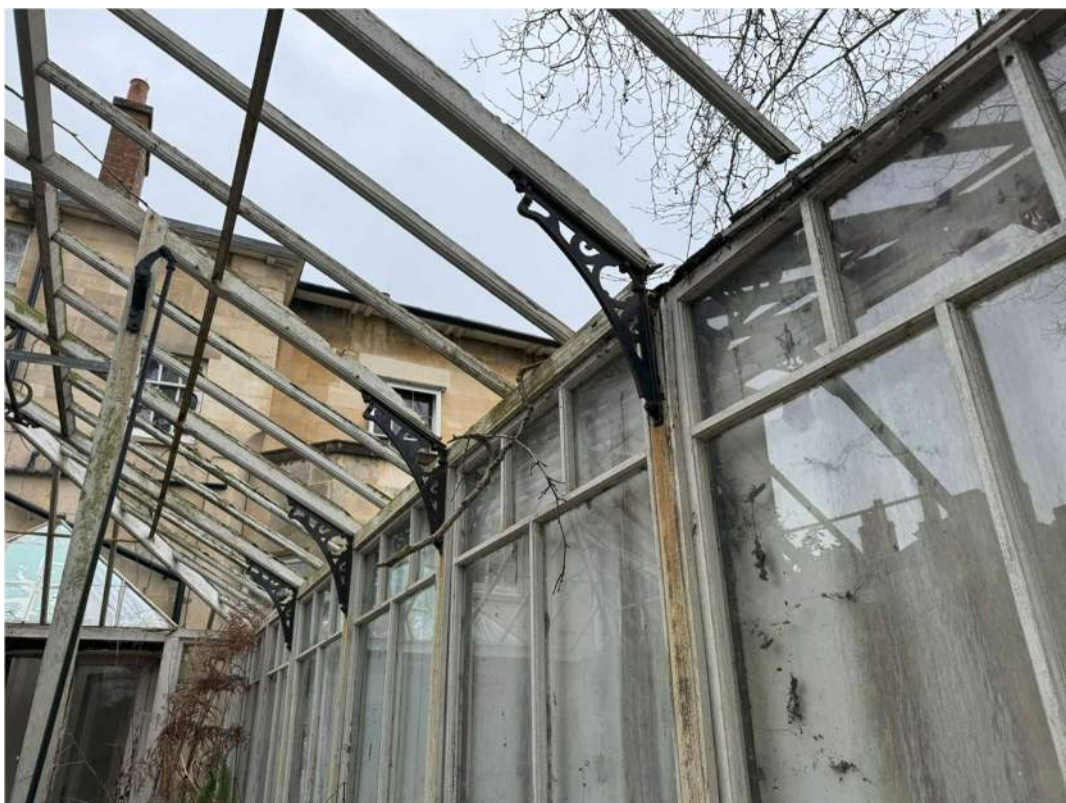
Photograph 19 – Several decayed ends to principal rafters at junction with cast iron brackets. Note glass protected by plywood.

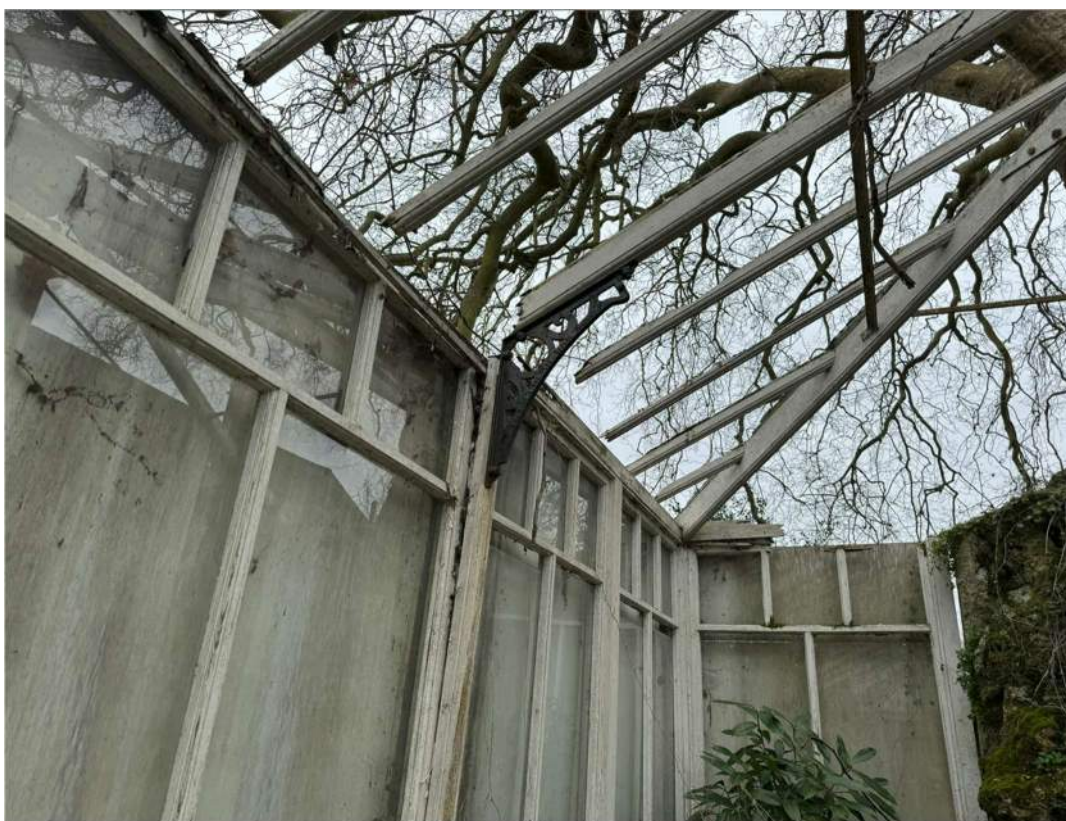
Photograph 20 – Several decayed ends to principal rafters and decayed glazing bars

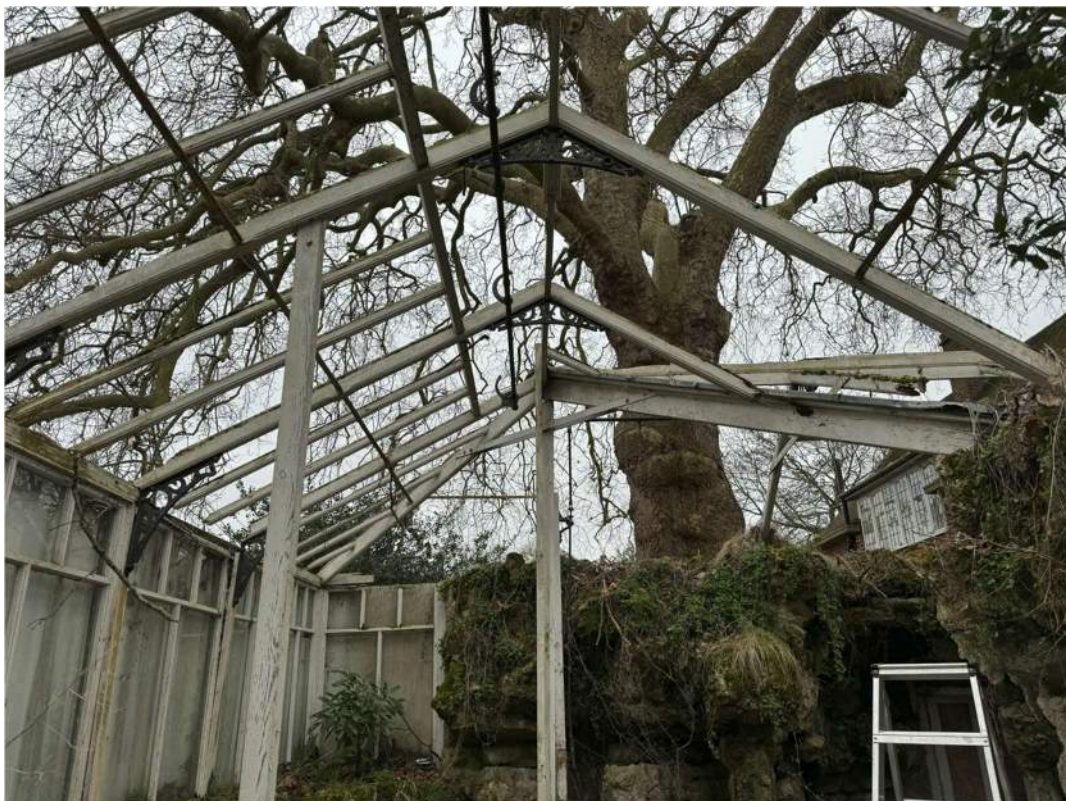
Photograph 21 – Glazing bars previously removed from western pitch

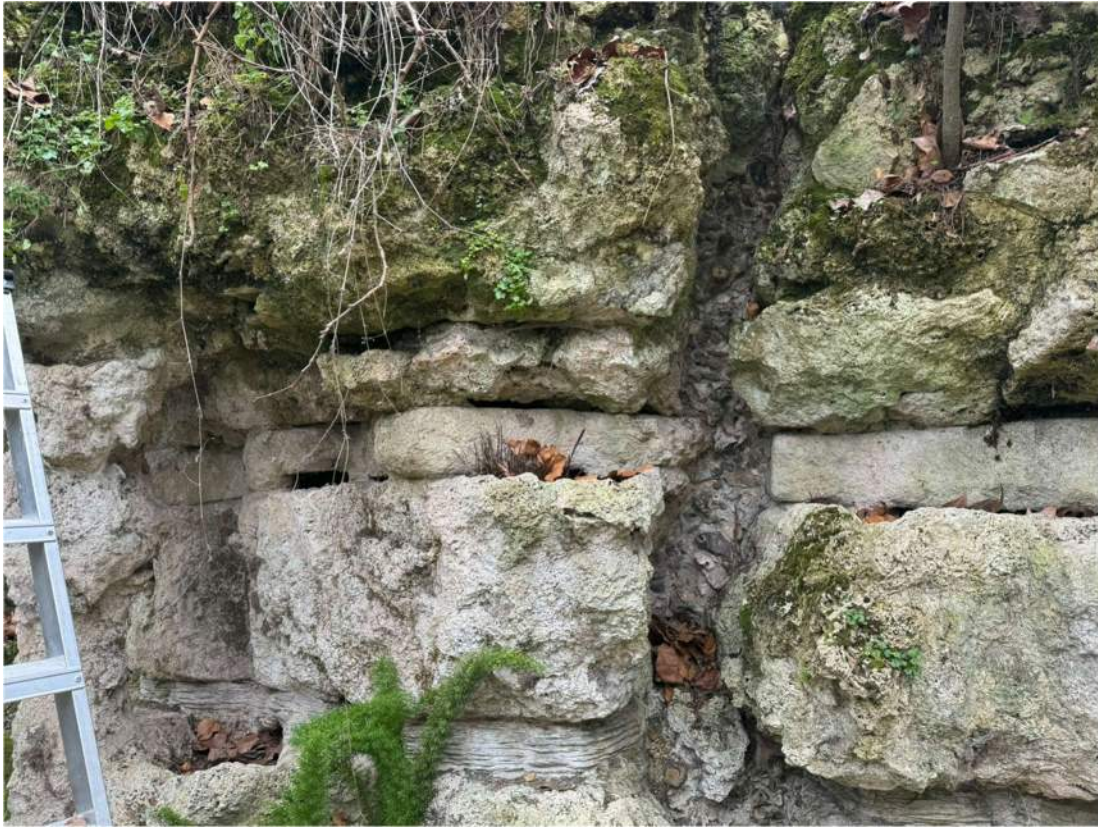
Photograph 23 – Vertical channel formed in Pulhamite wall. Potential location of high level water supply.

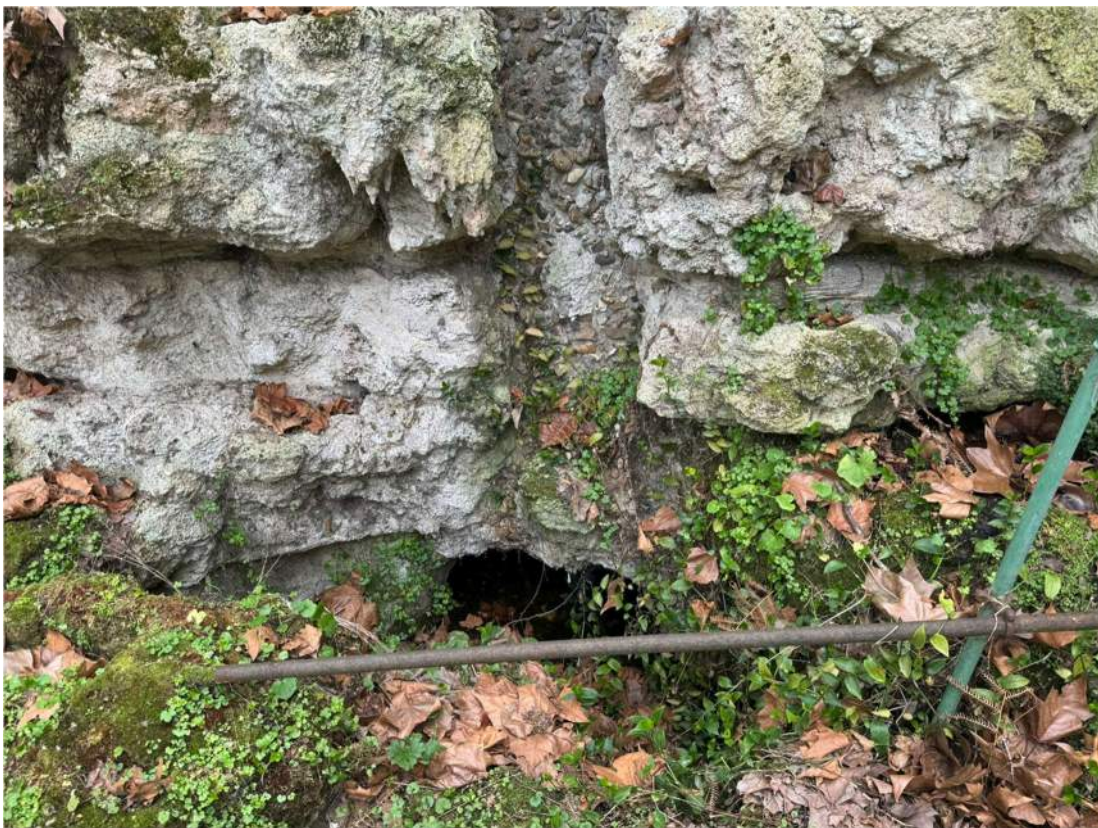
Photograph 24 – Base of vertical channel leading to water pool, part of original recirculation system.

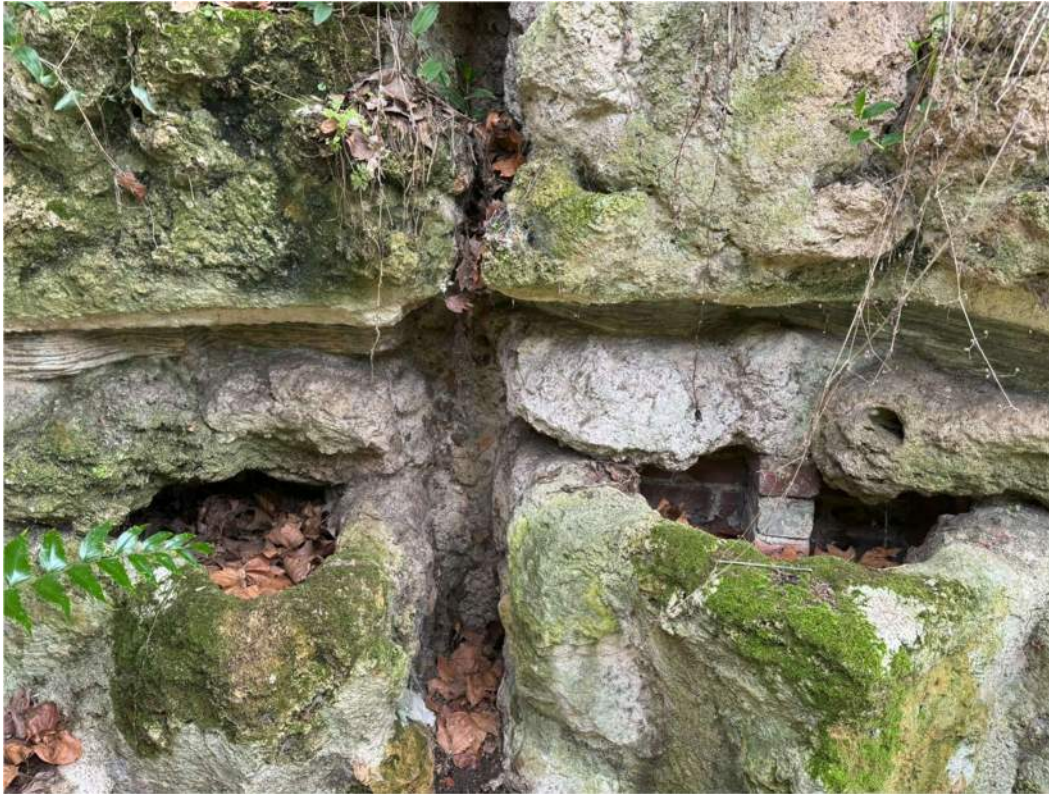
Photograph 27 – Channel for water distribution within Pulhamite and brick wall and supporting structure beyond/

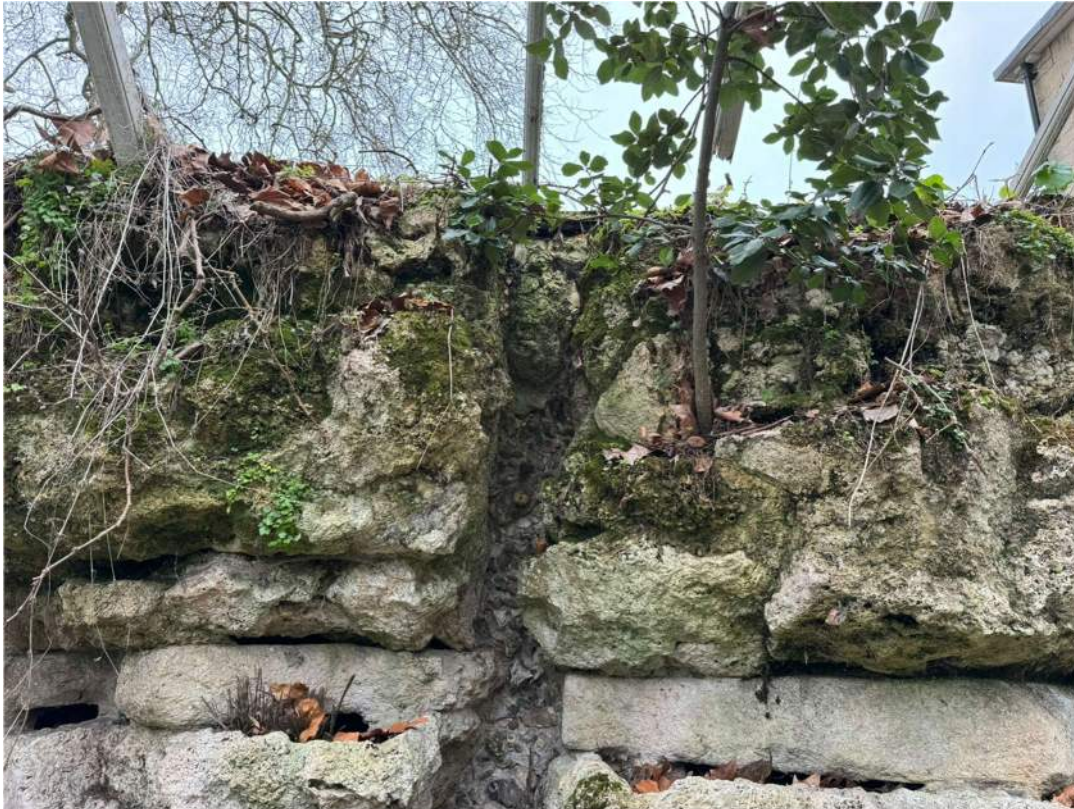
Photograph 29 – Channell in Pulhamite from high level
