## The Fernery at The Acacias, University of Reading

### Structural Engineer's Report for the Fernery

**Prepared by:** Mike Wilford BEng CEng MSc MIStructE  
Conservation Accredited Structural Engineer

**Job Number:** 222

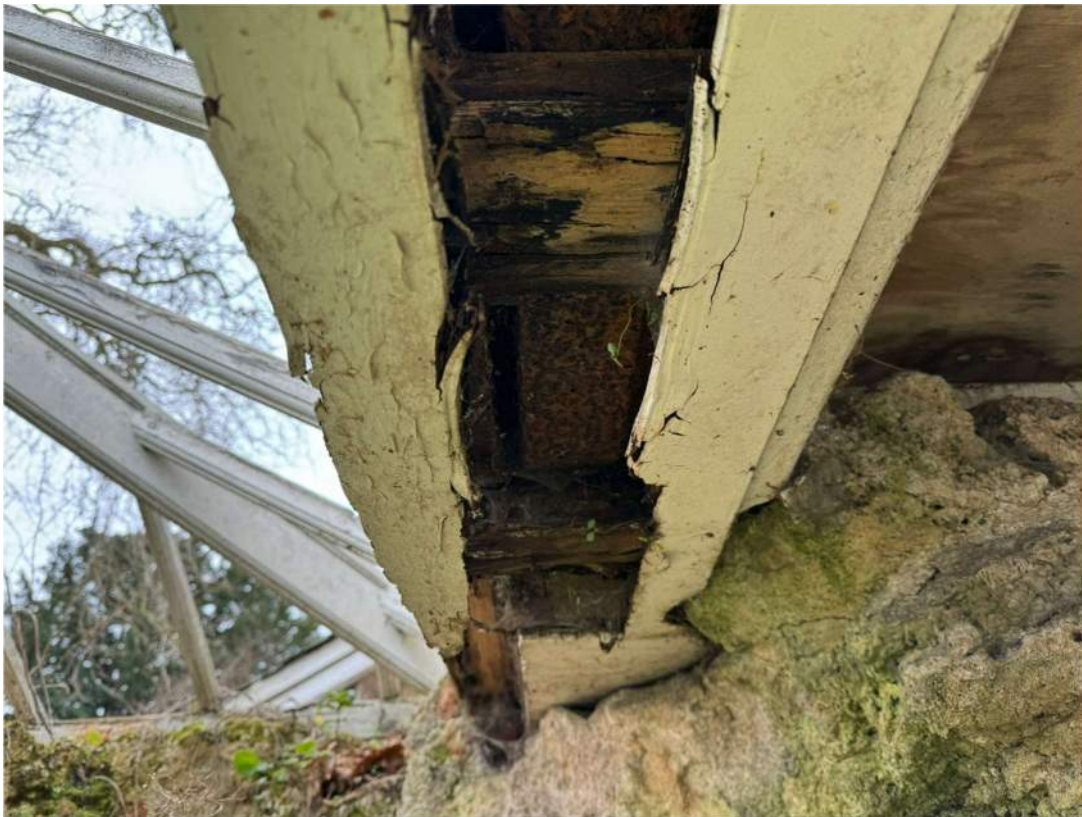
Photograph 32 – Some surface rusting to steel valley beam

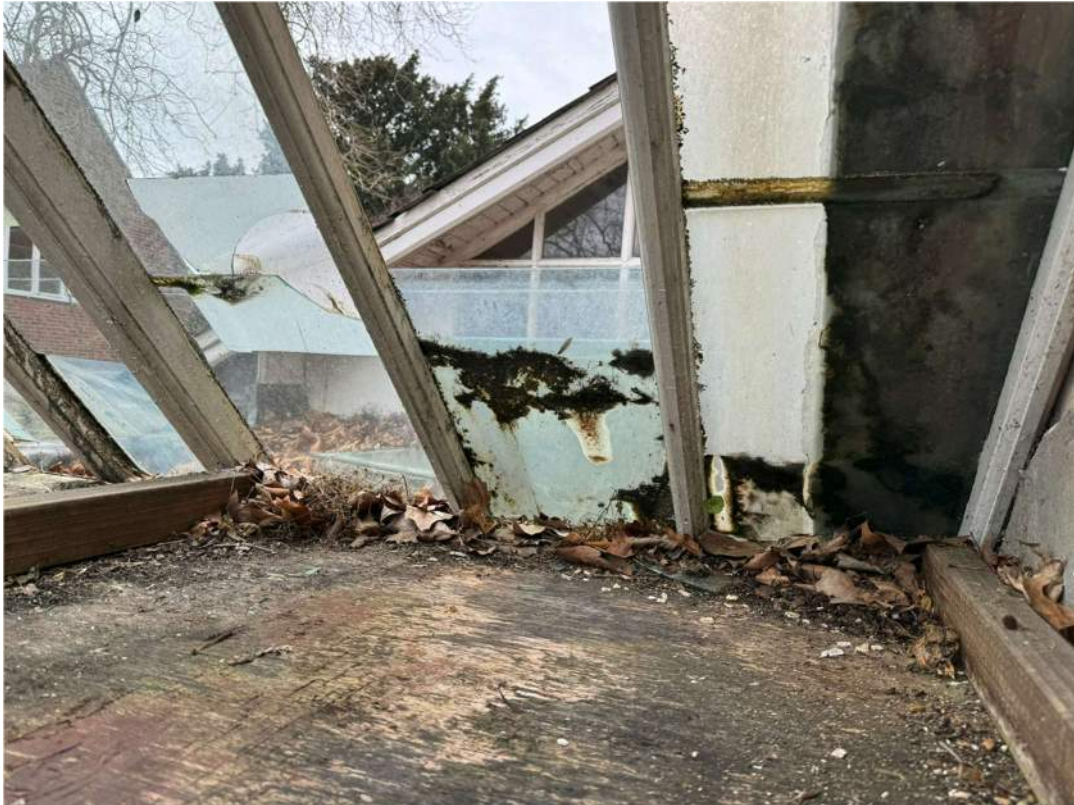
Photograph 33 – Ply crash deck with glazing and glazing bars above. Some glass panels missing.

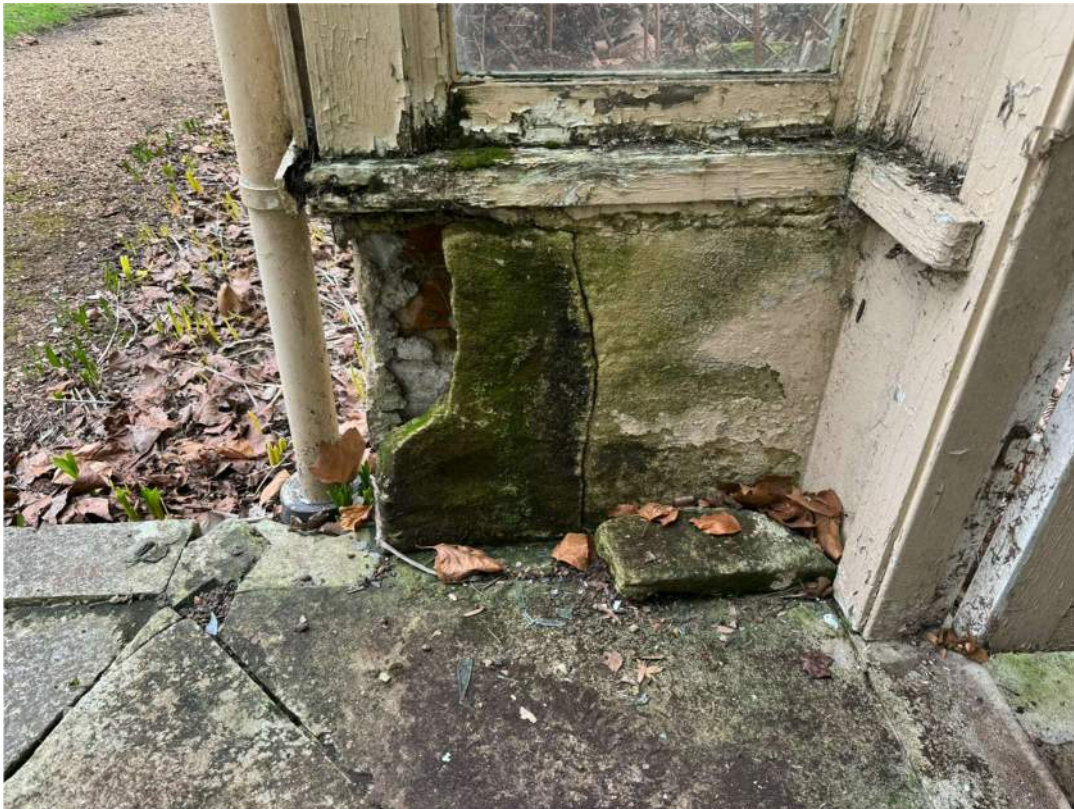
Photograph 34 – Damp and fractured render to plinth wall.

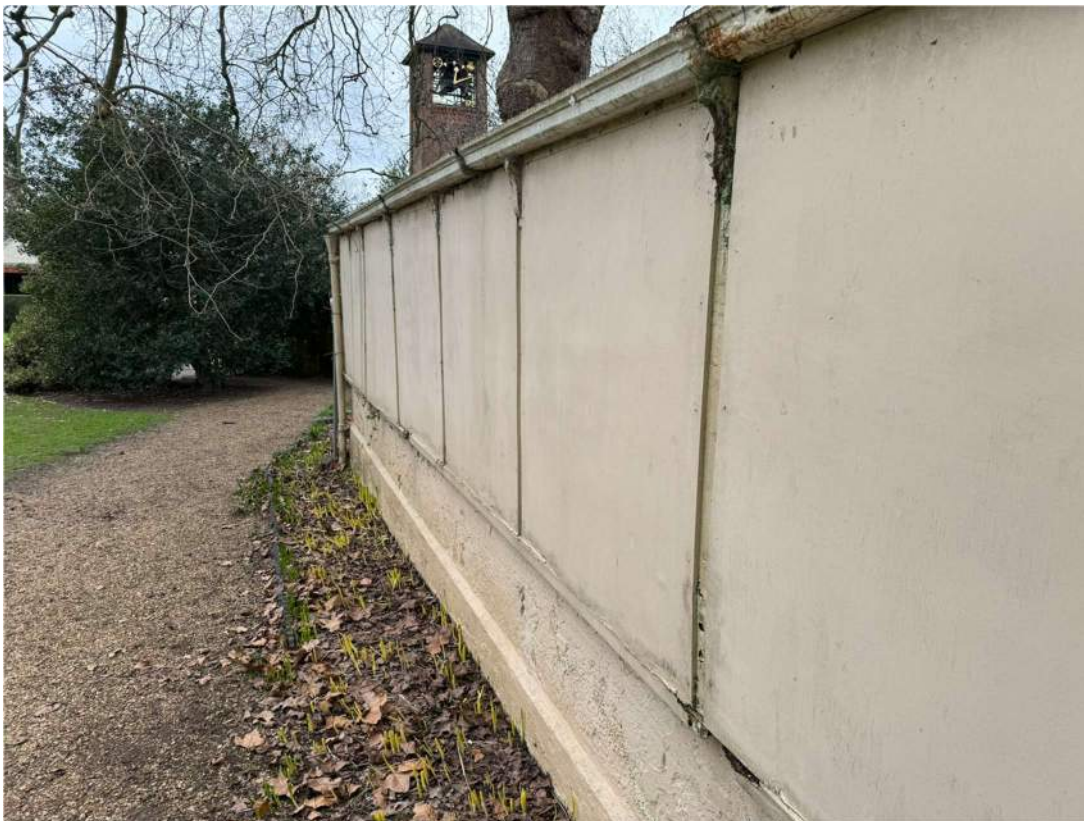
There is some outwards lean to the tops of the timber posts along the wall at eaves level due to the movement in the roof rafters and the loss of support.

This decay and loss of support to the roof frames has resulted in some sway and lean to the glazed wall along the east.

Photograph 36 – Outwards lean to timber posts and frame.

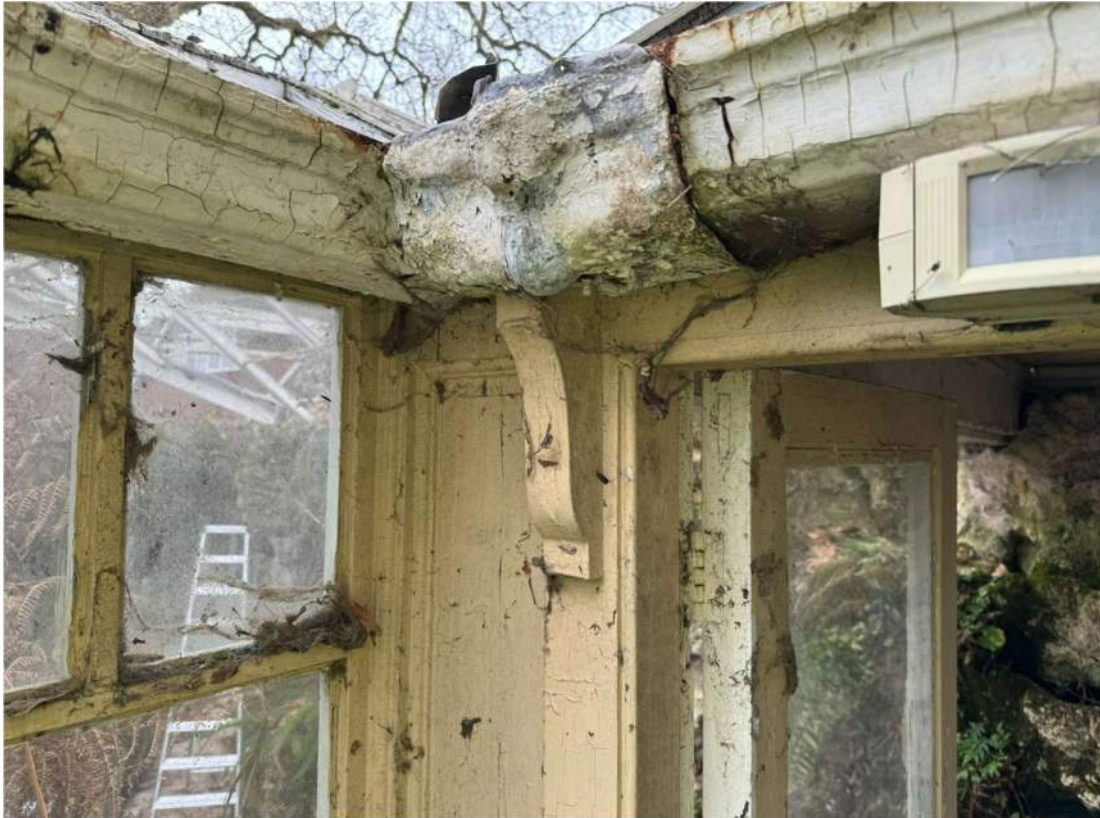
Photograph 37 – Perished cast iron gutters.

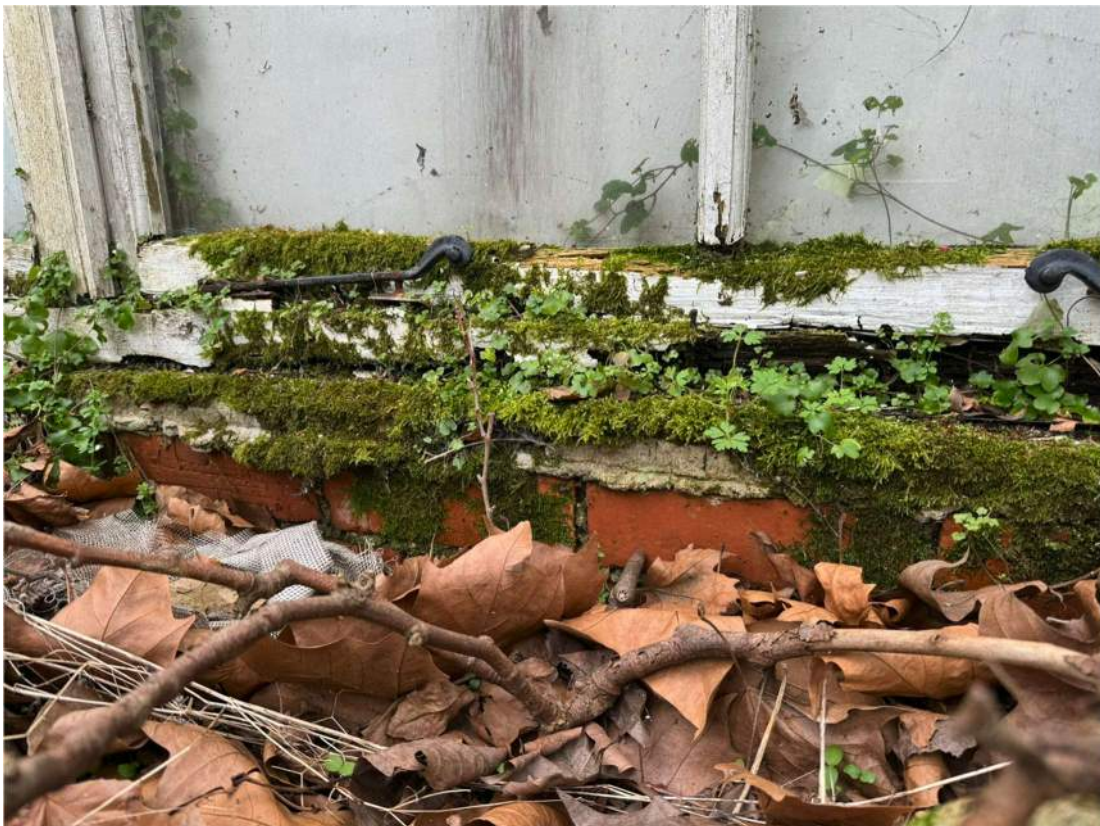
The timber wall plate along the plinth wall supporting the timber posts within the glazed wall are also in poor condition and have some areas of significant timber decay.

Photograph 38 – Perished timber wall plate along brick plinth wall

Allow for the full replacement of all timber wall plates throughout supported onto a new brick masonry upstand to raise the roof by around 150mm.

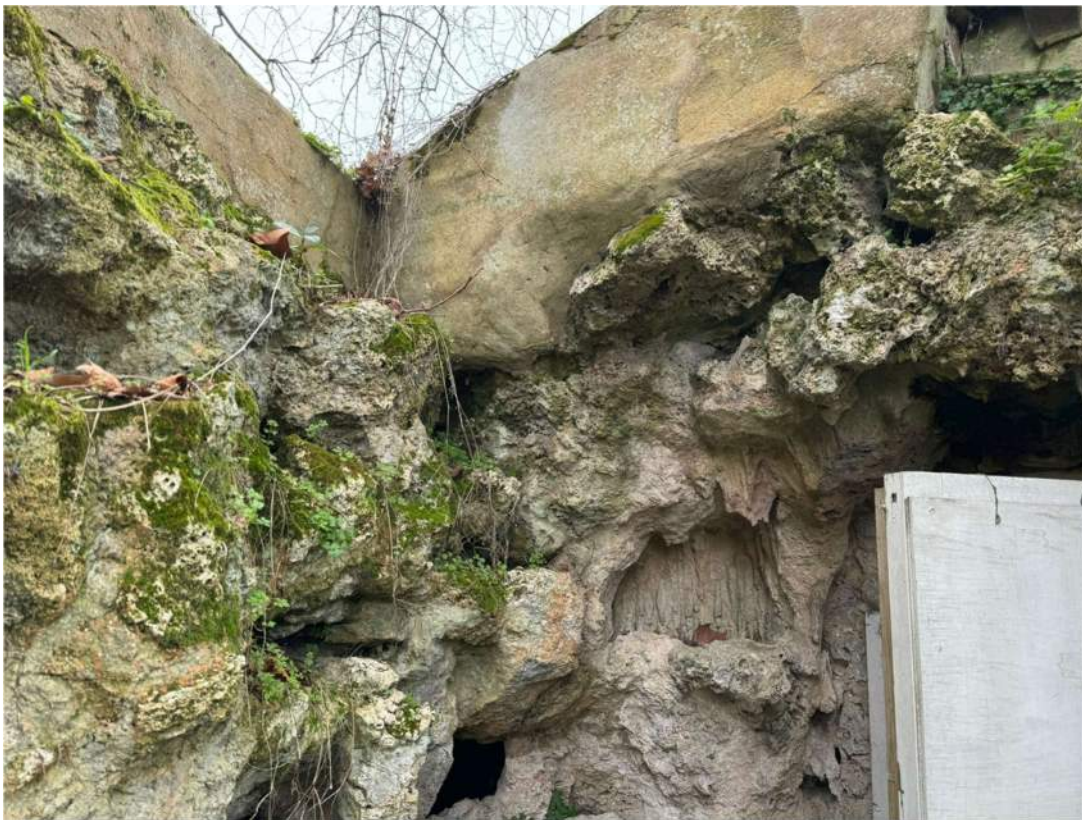
There is similar westwards movement to the full height wall or around 5mm and a 5mm vertical crack in the corner where the corridor wall meets the southern wall of the Fernery.

Photograph 40 – Pulhamite wall in corner of corridor and location of 5mm vertical crack

The crack in the western corridor wall should be stitched with a debonded tie to allow for future thermal movements. Stitch cracks with stainless steel debonded ties at 300mm vertical centres. Fill crack with lime mortar.

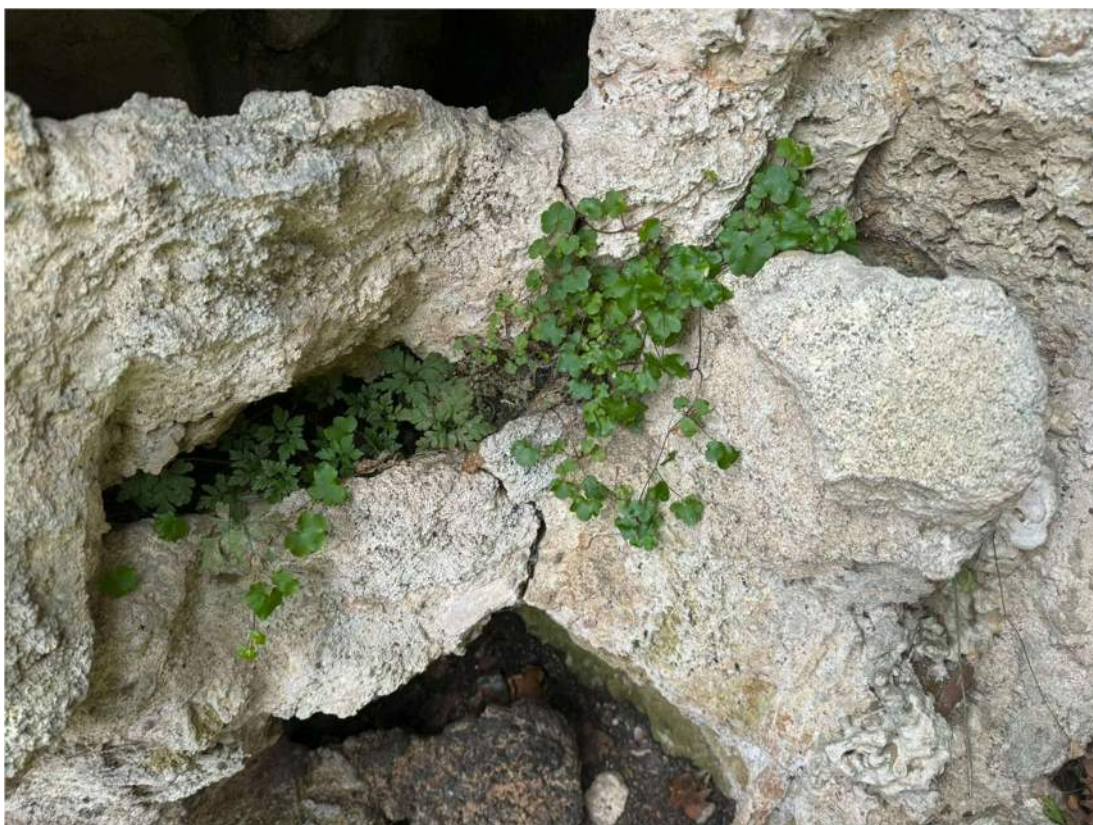
Photograph 41 – Detail of 5mm vertical crack in Pulhamite wall.

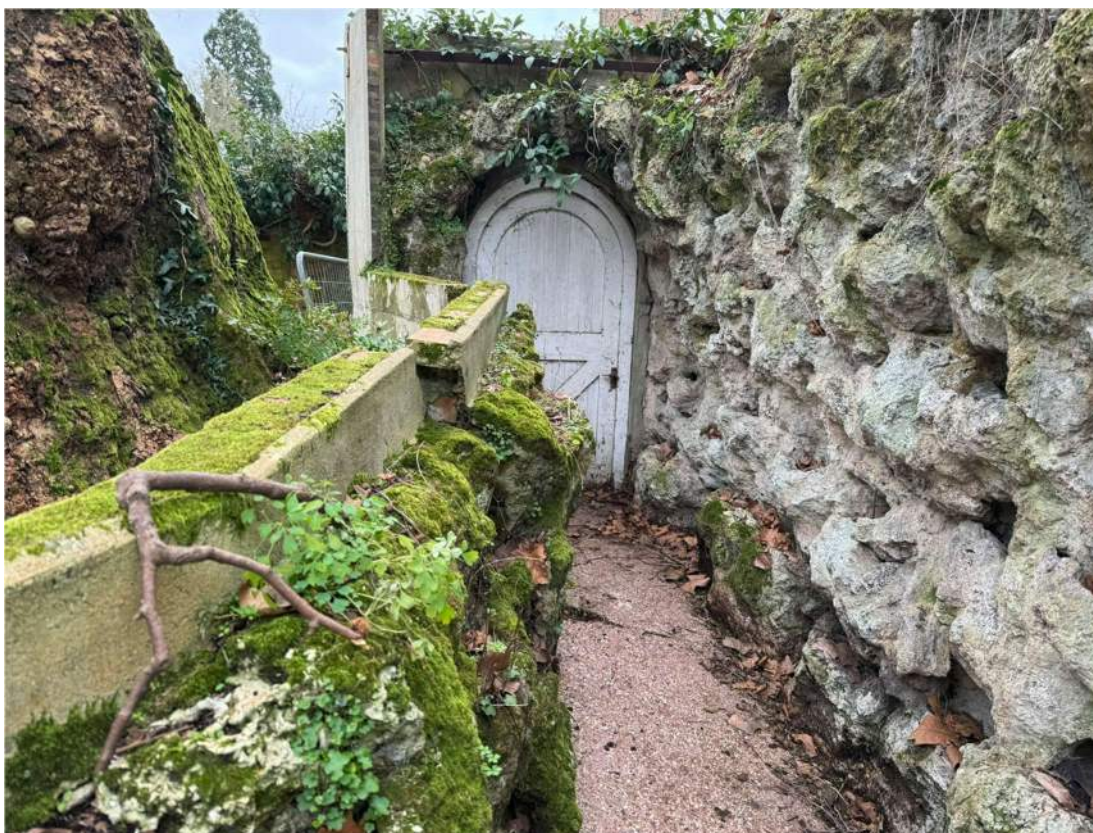
There is severe movement to the half height brick masonry wall beside the London Plane. The lean over the 1400m height of the wall is between 90-150mm.

The masonry plinth wall nearest the tree has suffered very severe movement due to the London Plane tree and has probably been leaning for many years due to the growth of the tree. The plinth wall is beyond the usual allowable limits of lean.

The wall displacement is due to the growth of the tree and possibly tree roots along the sides of the wall. It is understood that radial trunk growth can be anything up to 10mm per year and that the tree is at least 120 years old.

Photograph 42 – 90 – 150mm displacement in wall over 1400mm height.

The brick plinth wall beside the London Plane has suffered some very severe movement from the actions of the tree roots. Various options have been considered and these are included in the appendix. The Essential Works option will be implemented at this stage.

Existing cracks should be stitched with remedial stainless steel ties such as Helibar by Helifix and the fracture infilled with new masonry in a suitable mortar to match the existing.

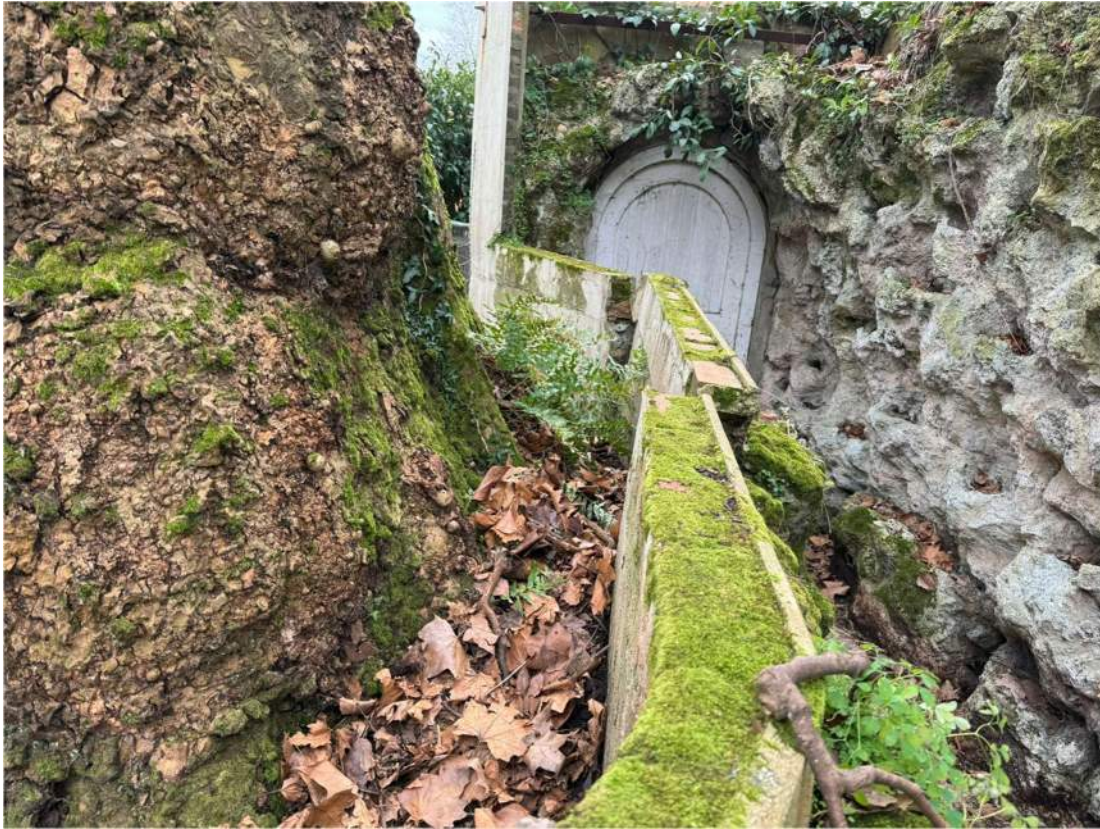
Photograph 43 – Proximity of London Plane tree and severe displacement of plinth wall.

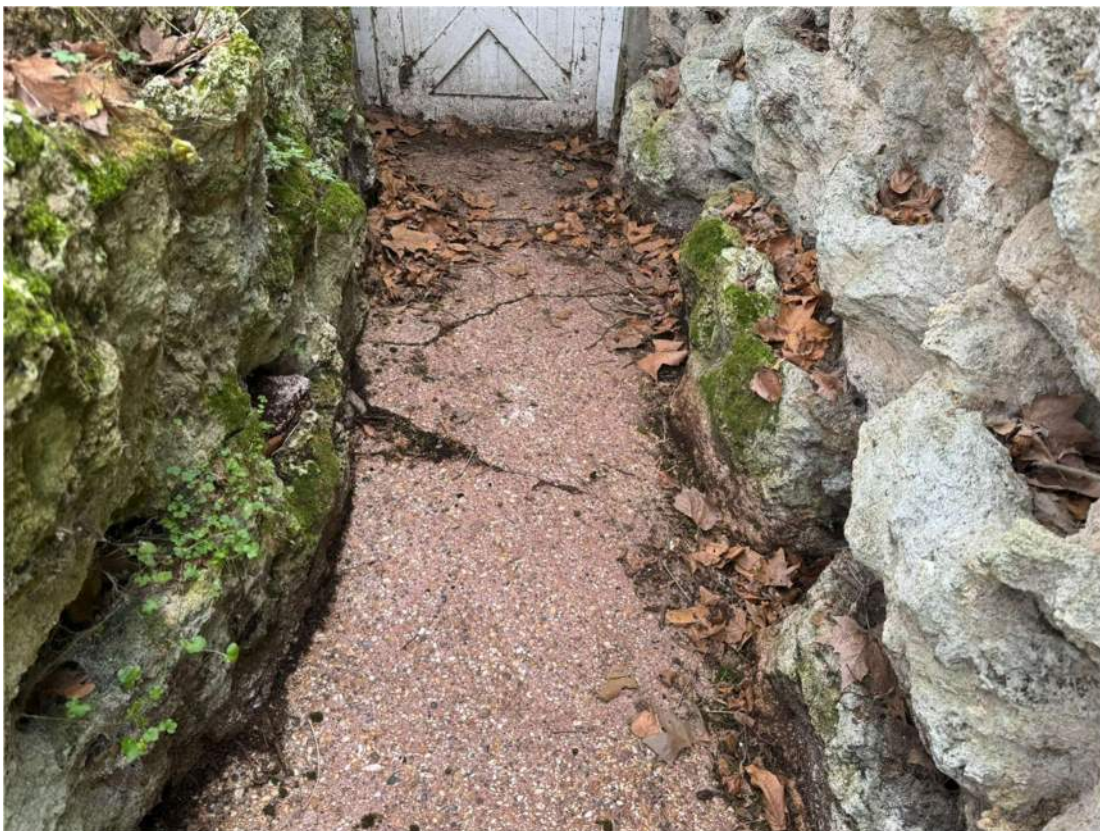
The floor of the corridor has cracked and shows significant upwards movement around the tree roots.

Photograph 44 – Cracking and movement in ground bearing concrete slab beside London Plane.

The cracks in the uneven corridor floor should be filled with repair mortar to prevent future rainwater ingress through the slab.

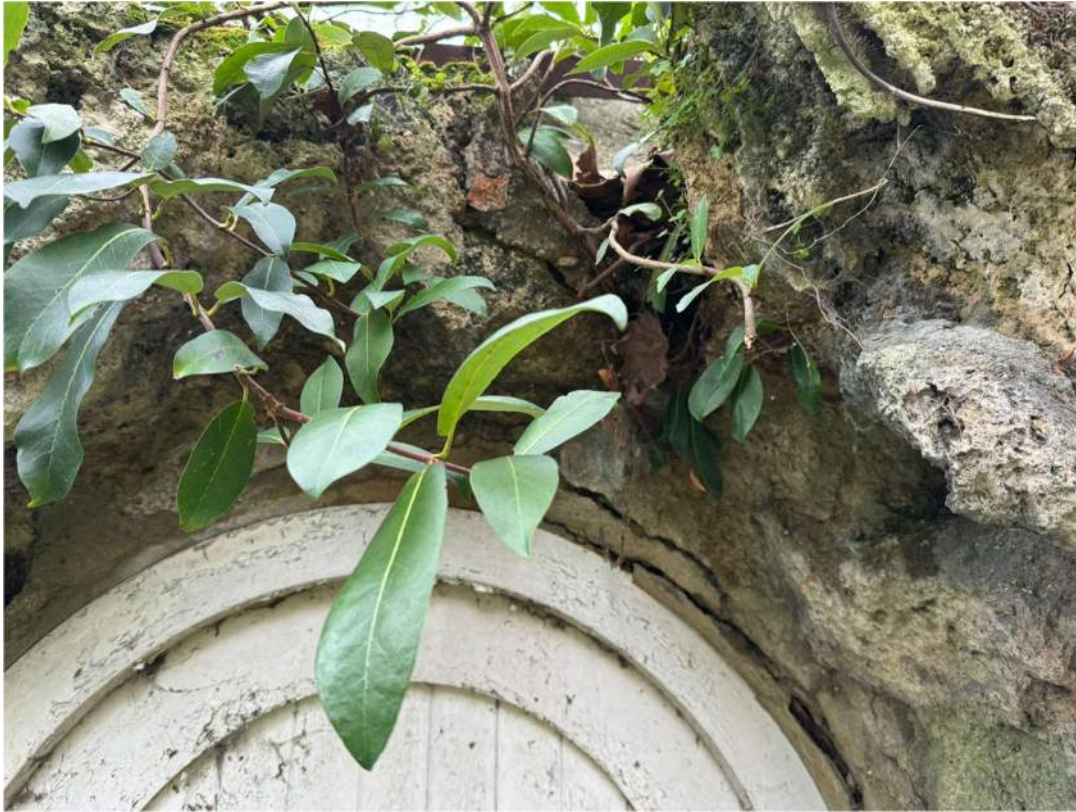
The wall at the south end of the corridor has also moved significantly in the past and an iron tie bar has been previously installed above the doorway. The tie bar has been partly successful although ground movement continues due to the tree.

Photograph 45 – Cracking above entrance arch to corridor.

The southern wall and doorway to the corridor has similarly suffered movement due to tree roots. Cracking should be stitched and repaired and the iron tie should remain.

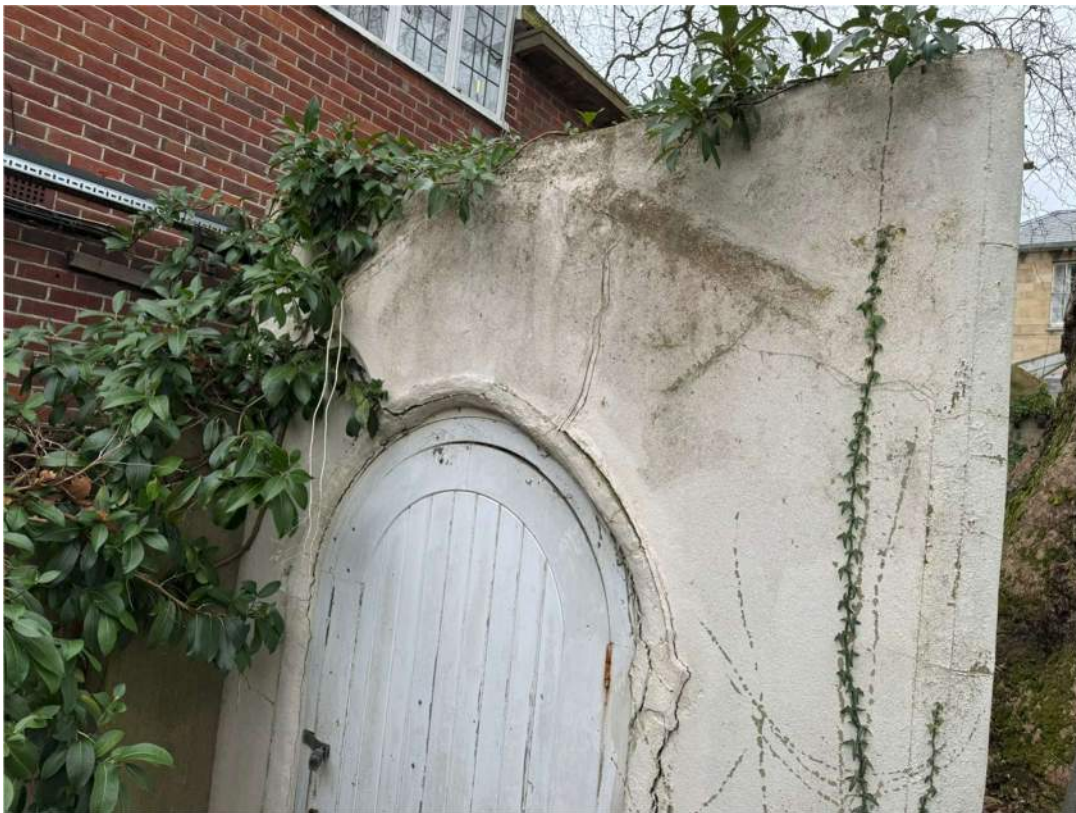
A remedial iron tie bar has been installed at the southern end of the corridor to try to restrain earlier movement. There is some historic cracking to the masonry arch here with evidence of previous repair.

Photograph 46 – Historic and repaired cracking above entrance arch.

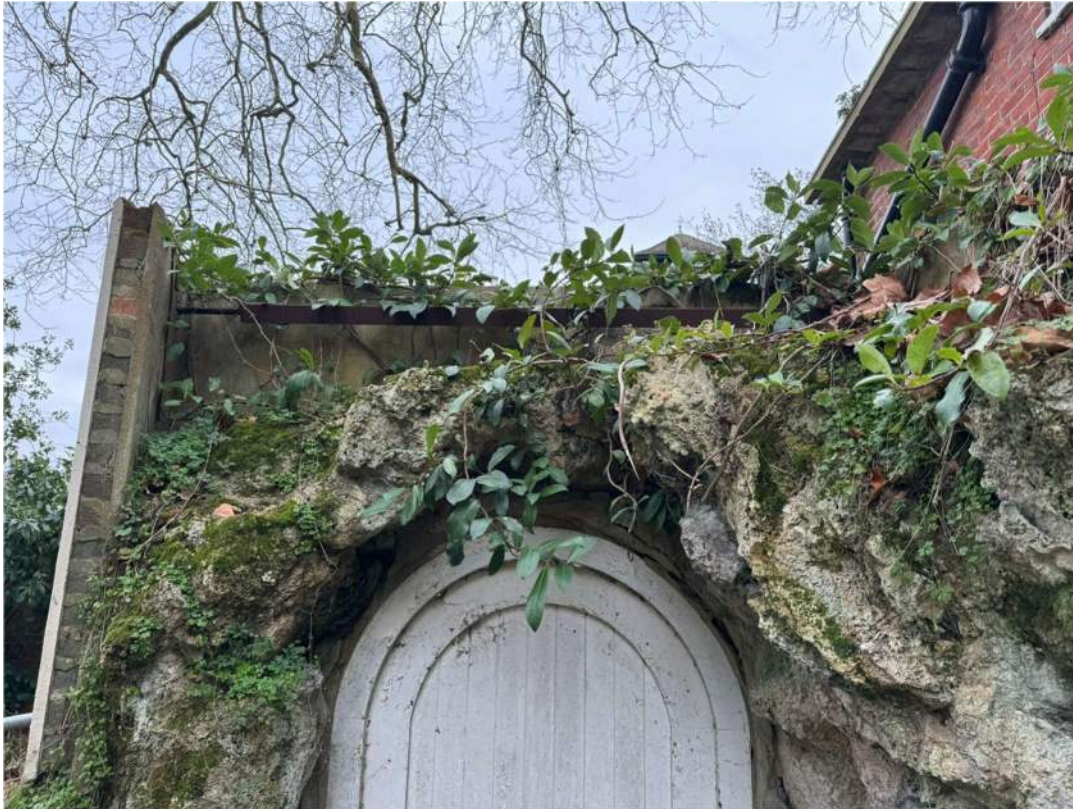
Photograph 47 – Earlier remedial tie bar above entrance arch.

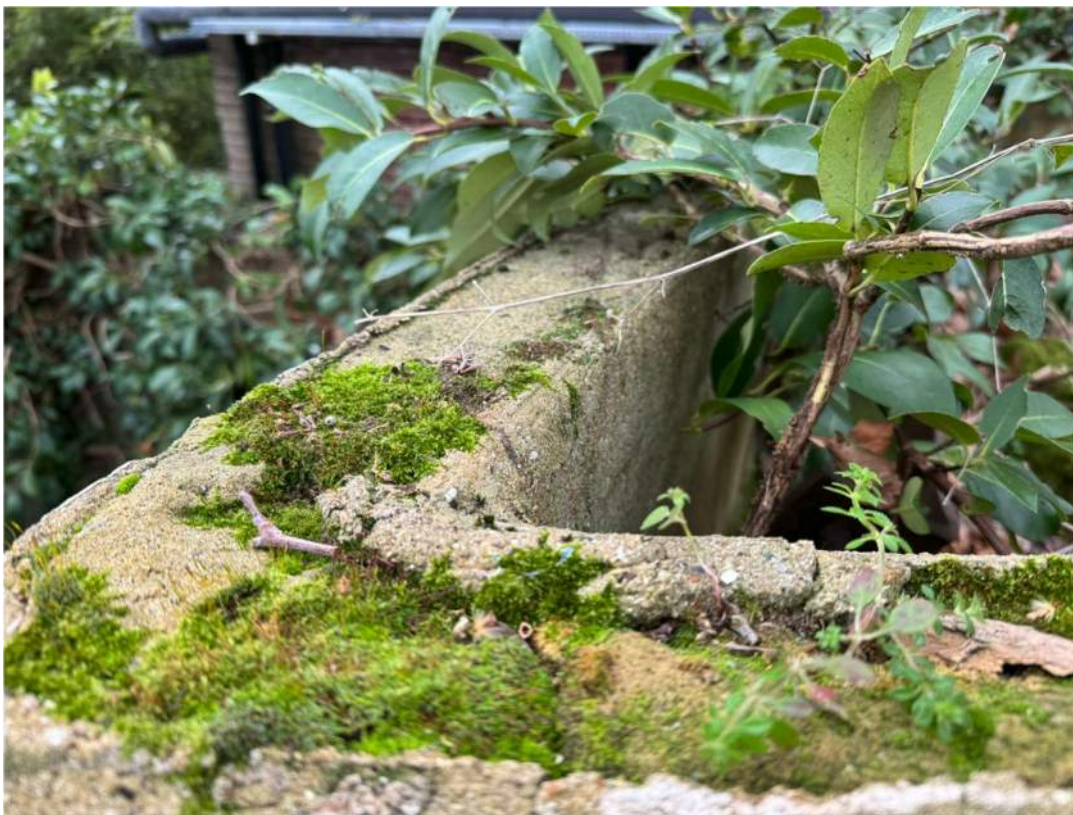
Photograph 48 – Channel for missing timber wall plate above entrance arch. Remnant of earlier glazed roof.

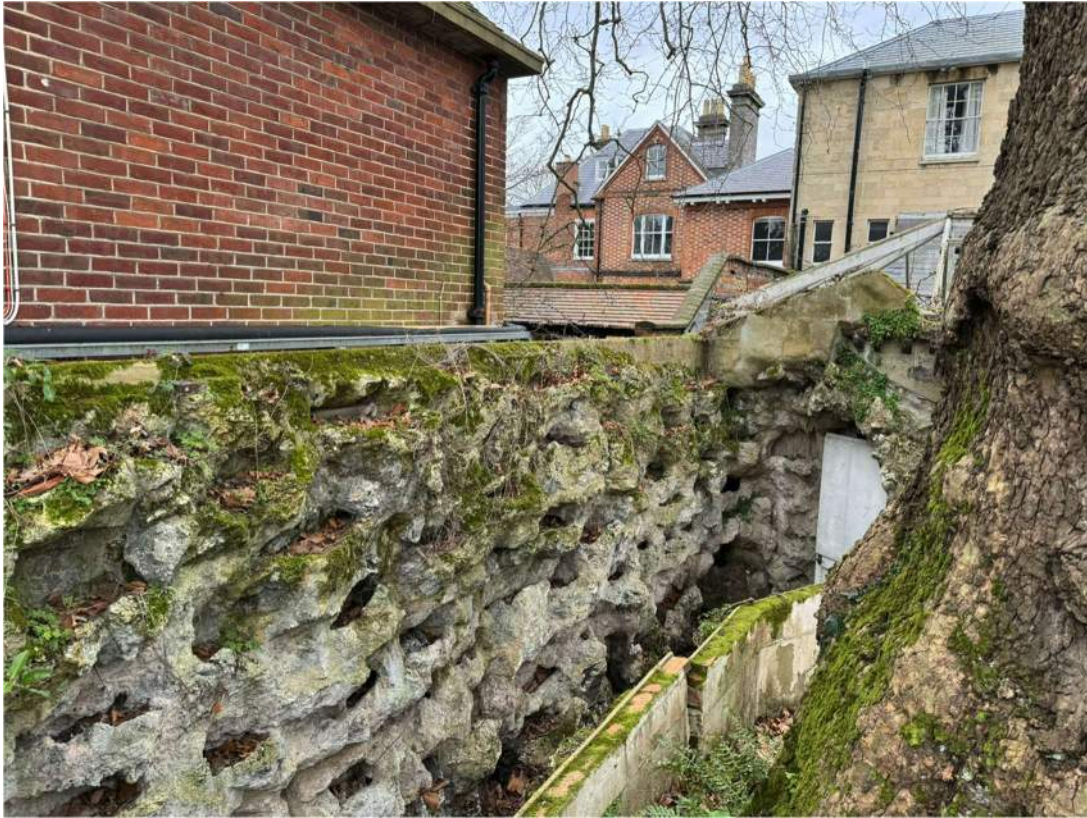
Photograph 49 – Rear corridor wall has some minor lean of around 5mm.

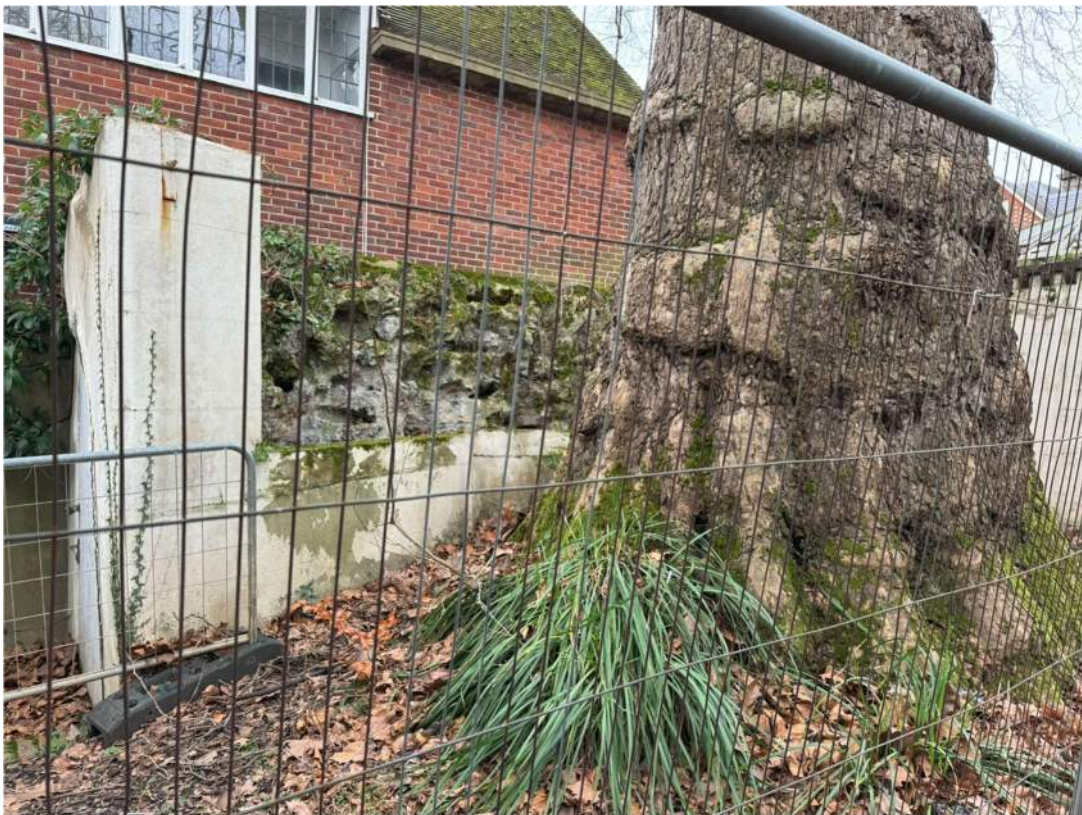
There are various trees around the building including a very large and mature London Plane to the south beside the corridor. The tree trunk diameter is around 2.3m and is only 500mm from the corridor wall.

Photograph 50 – Large and mature London Plane tree very close to the corridor wall.

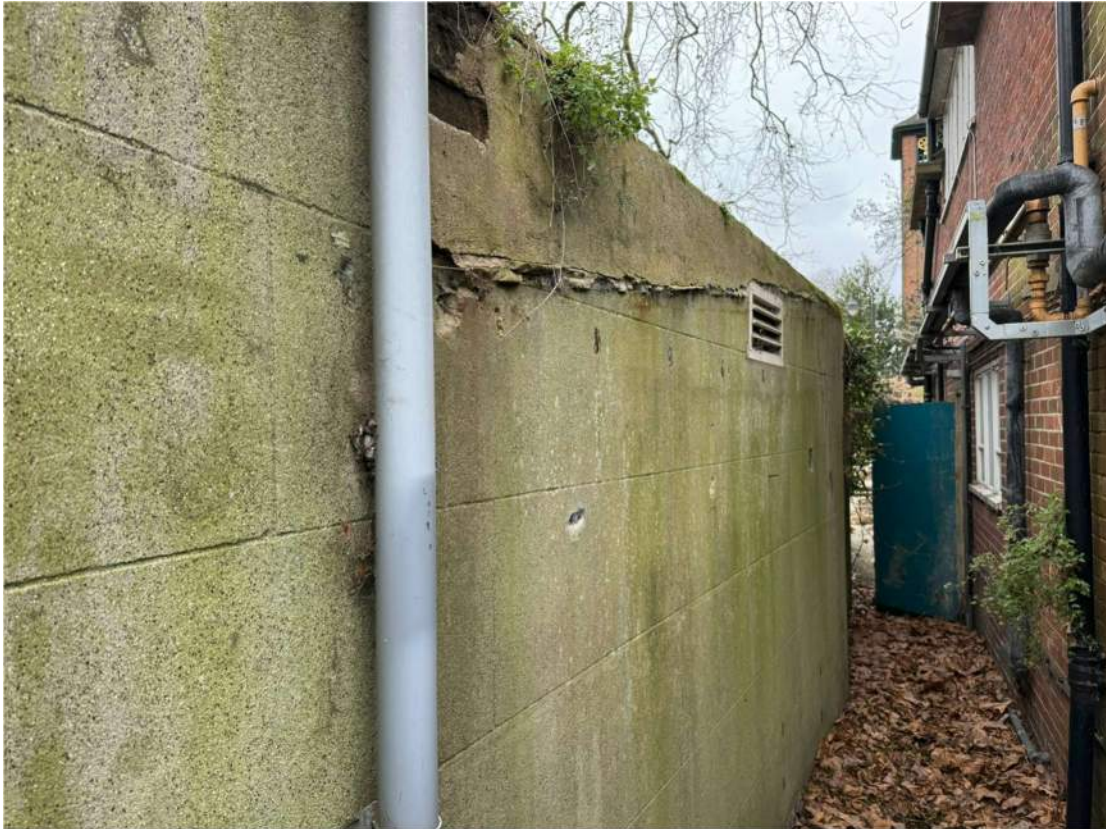
Photograph 51 – Render rear to the corridor wall and some hairline cracking.
