# Remediation Verification Report

45 Caversham Road, Reading

Project/File:  
333800180-STN-XX-XX-RP-GE-5001

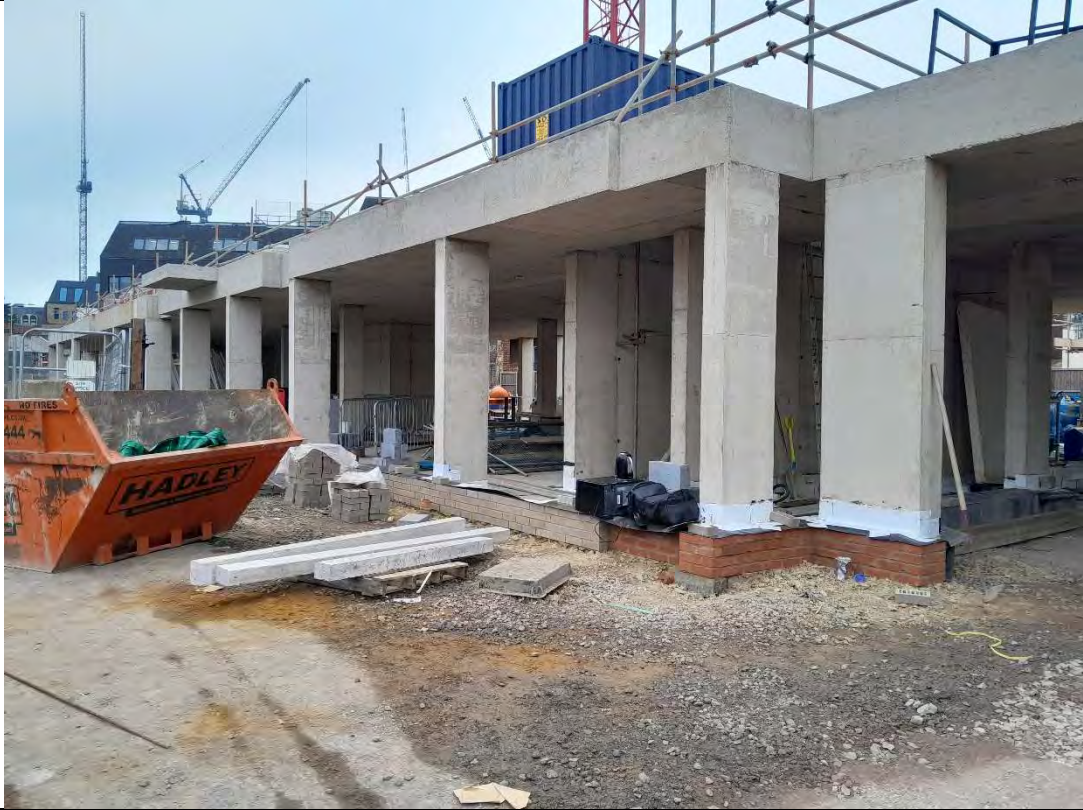
Photograph 1: General site condition

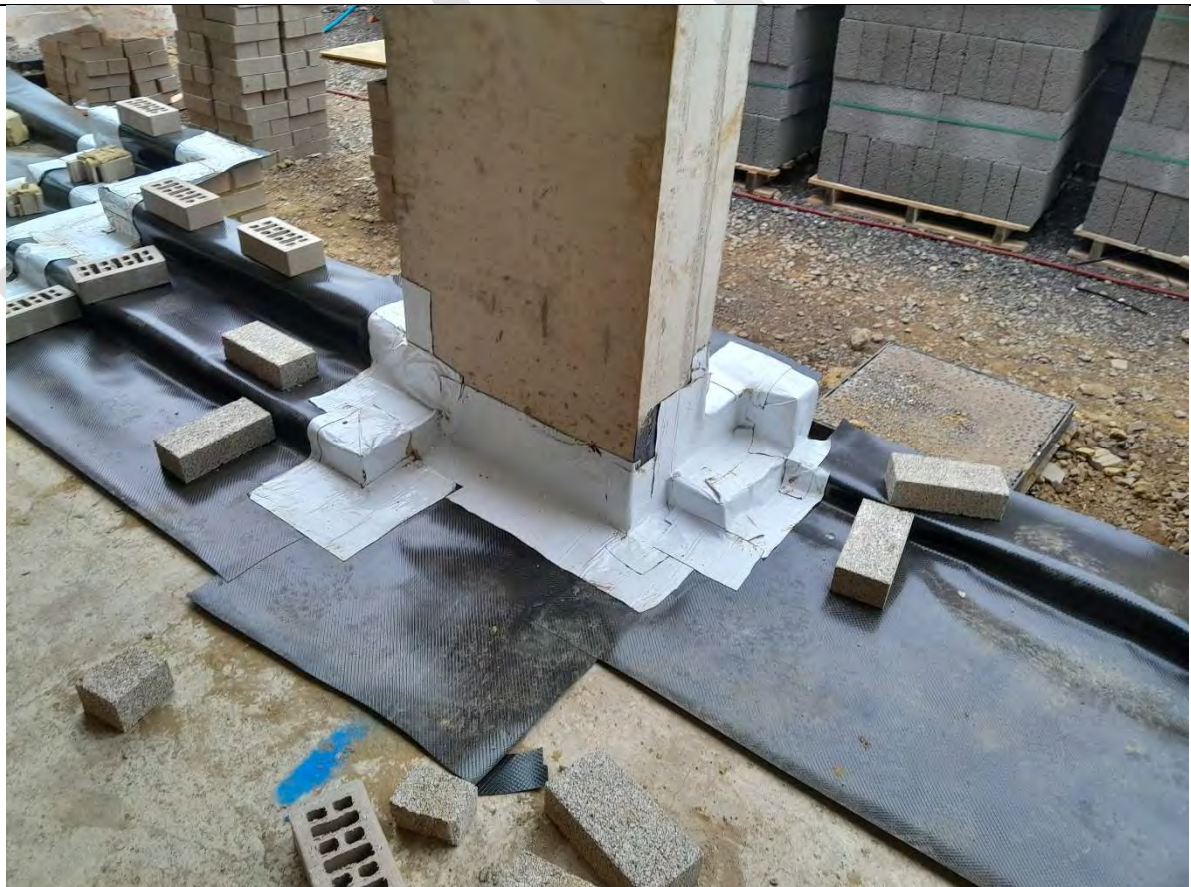
Photograph 2: DPC and detailing around external walls

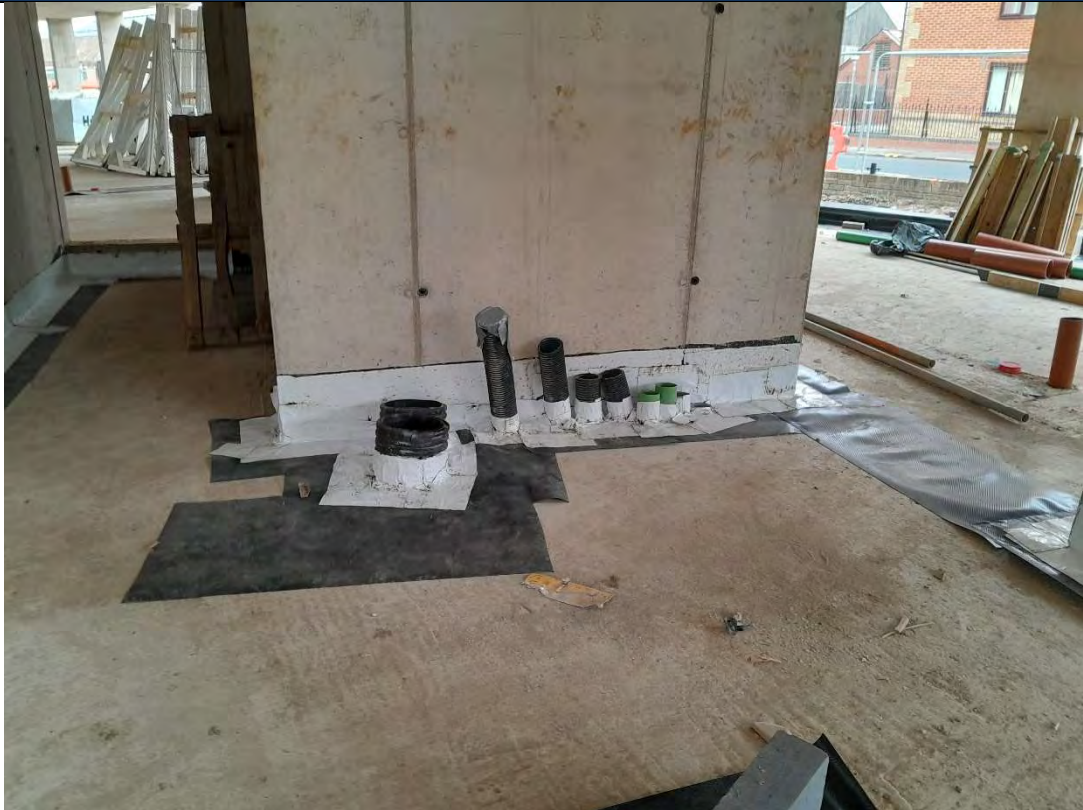
Photograph 3: DPC and detailing around internal walls and nearby services

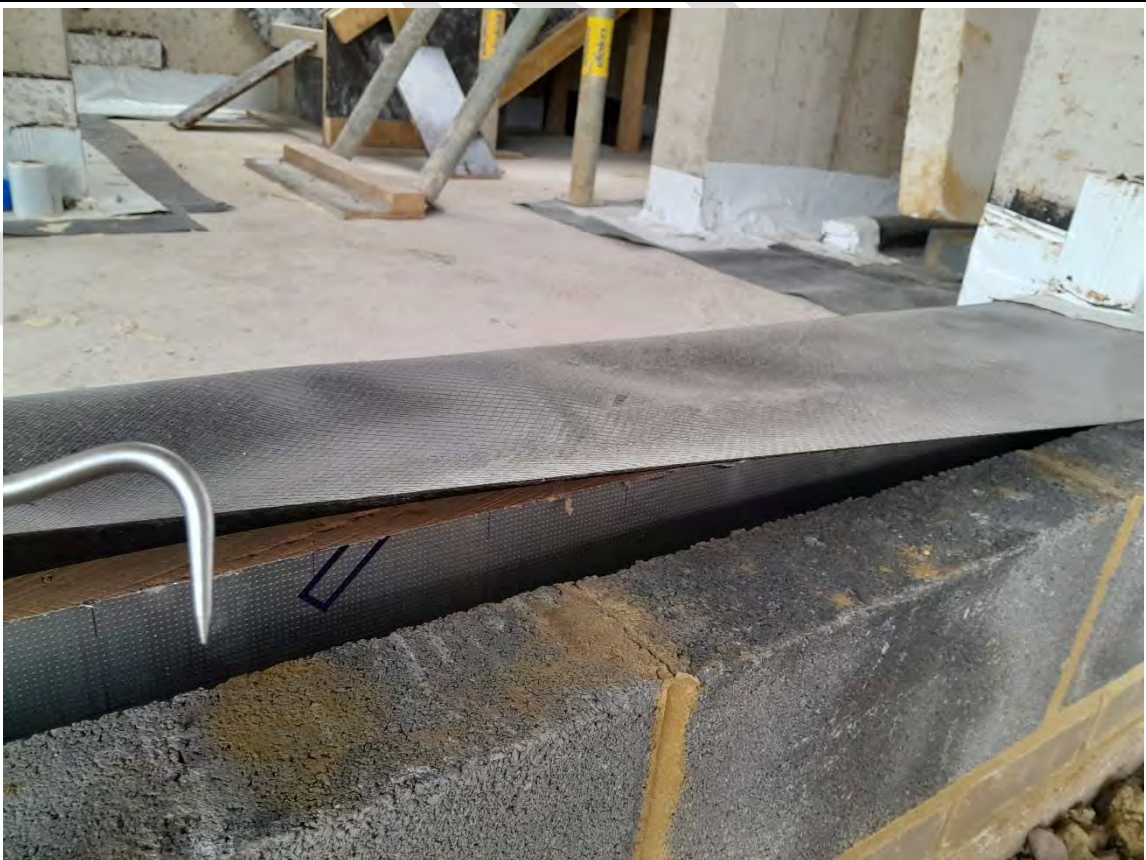
Photograph 4: Cavity

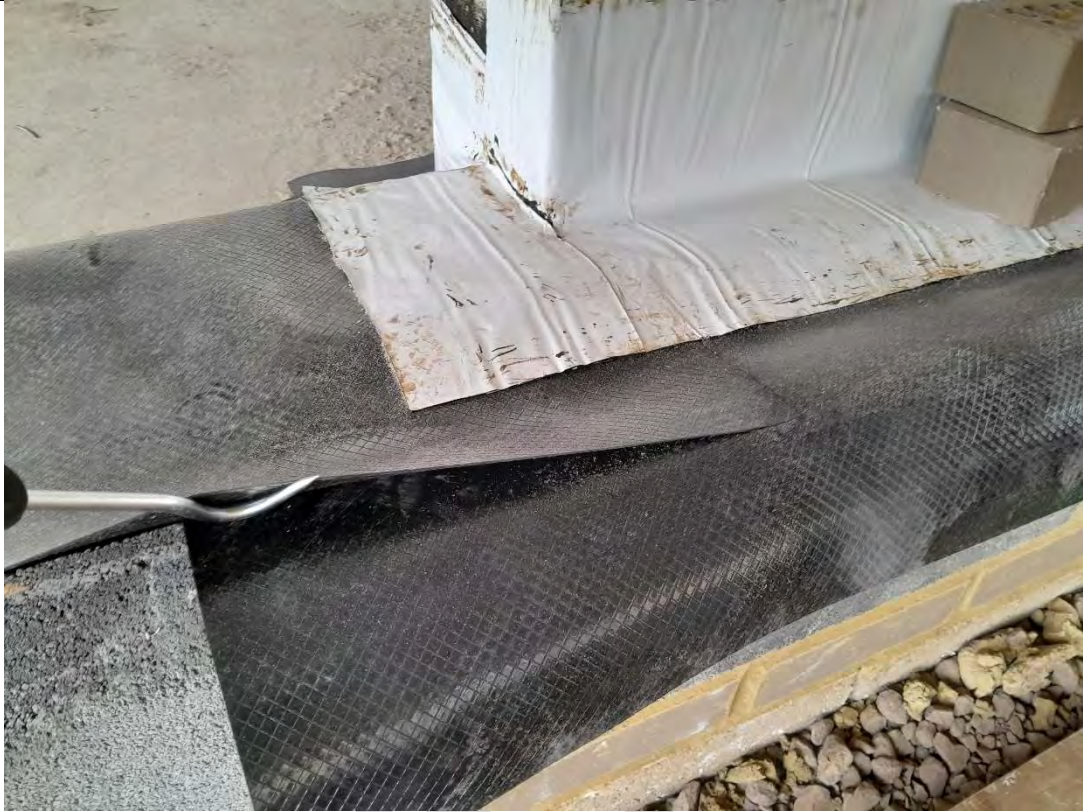
Photograph 5: sufficient overlap

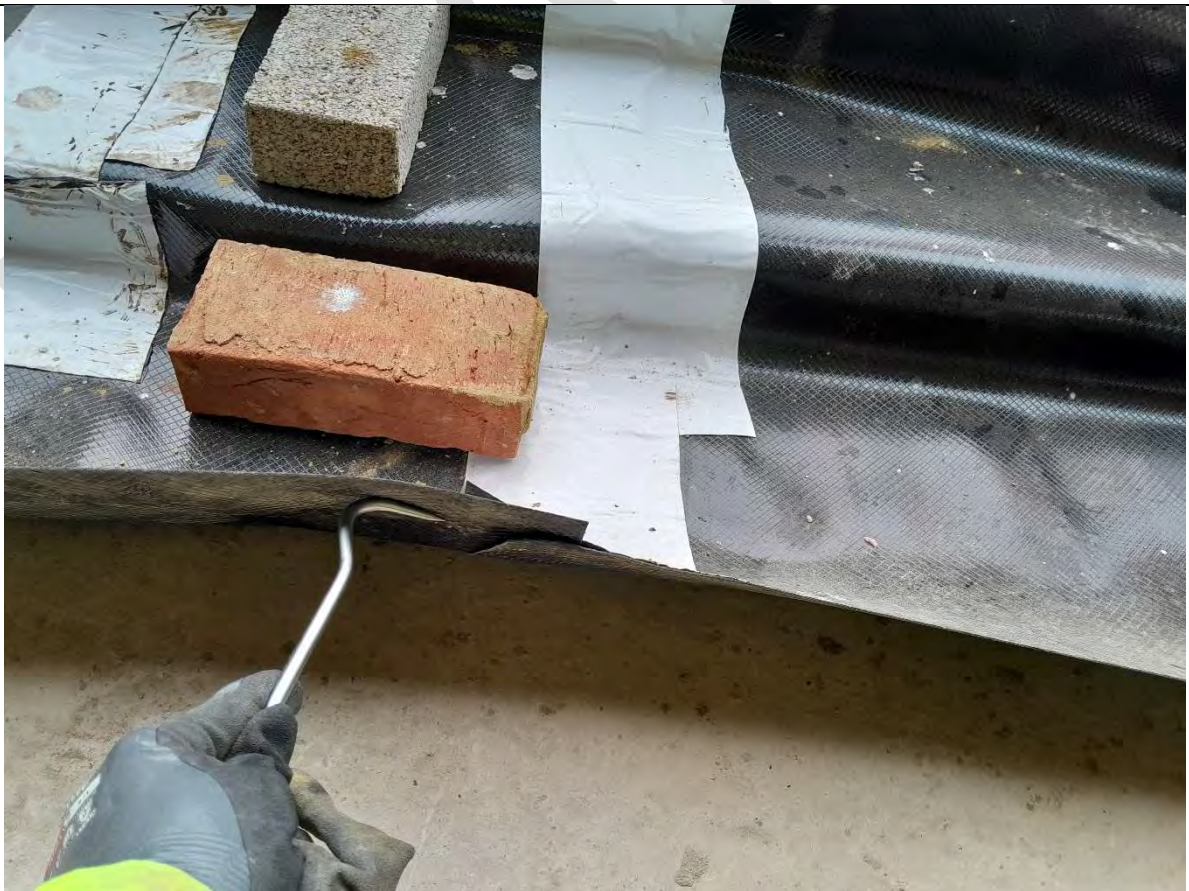
Photograph 6: Overlap <150mm with additional tape

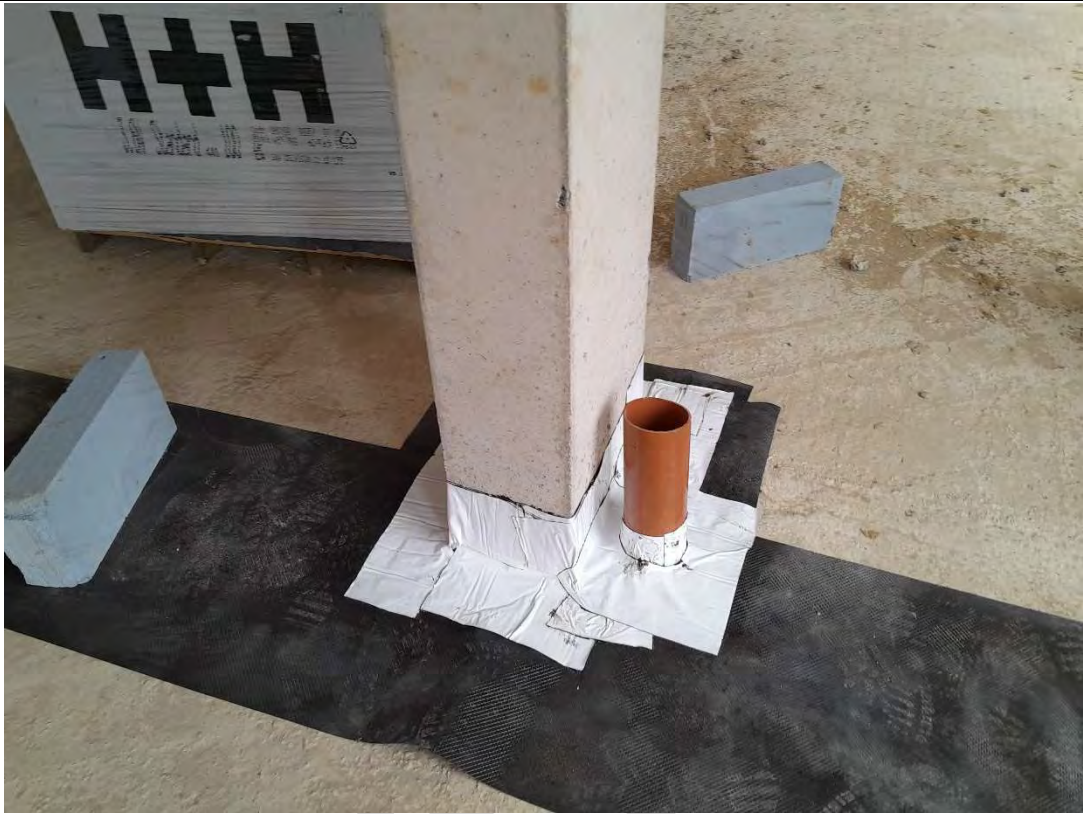
Photograph 7: Non-proprietary top hat service detailing

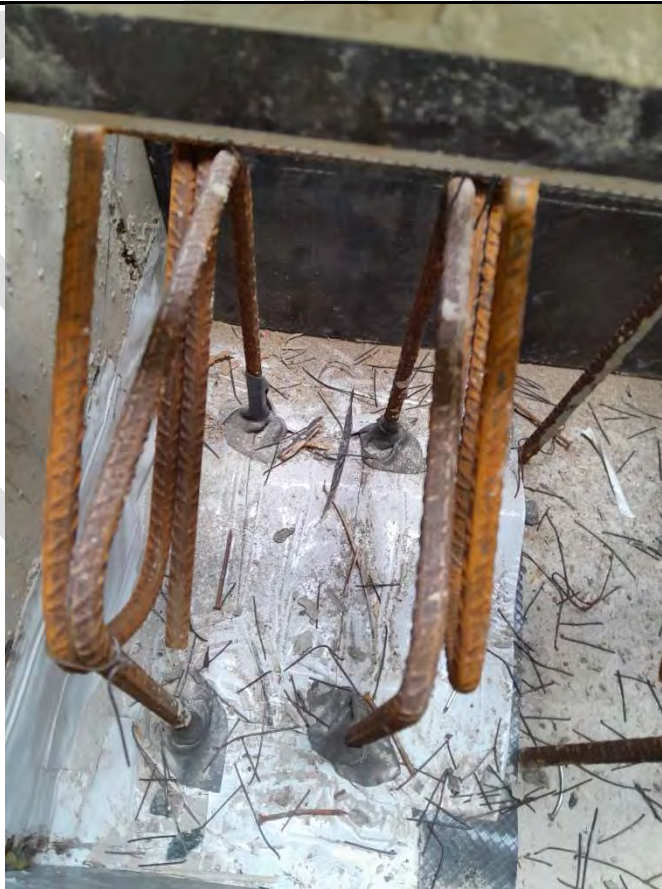
Photograph 8: Detailing around reinforcement bar penetrating DPC

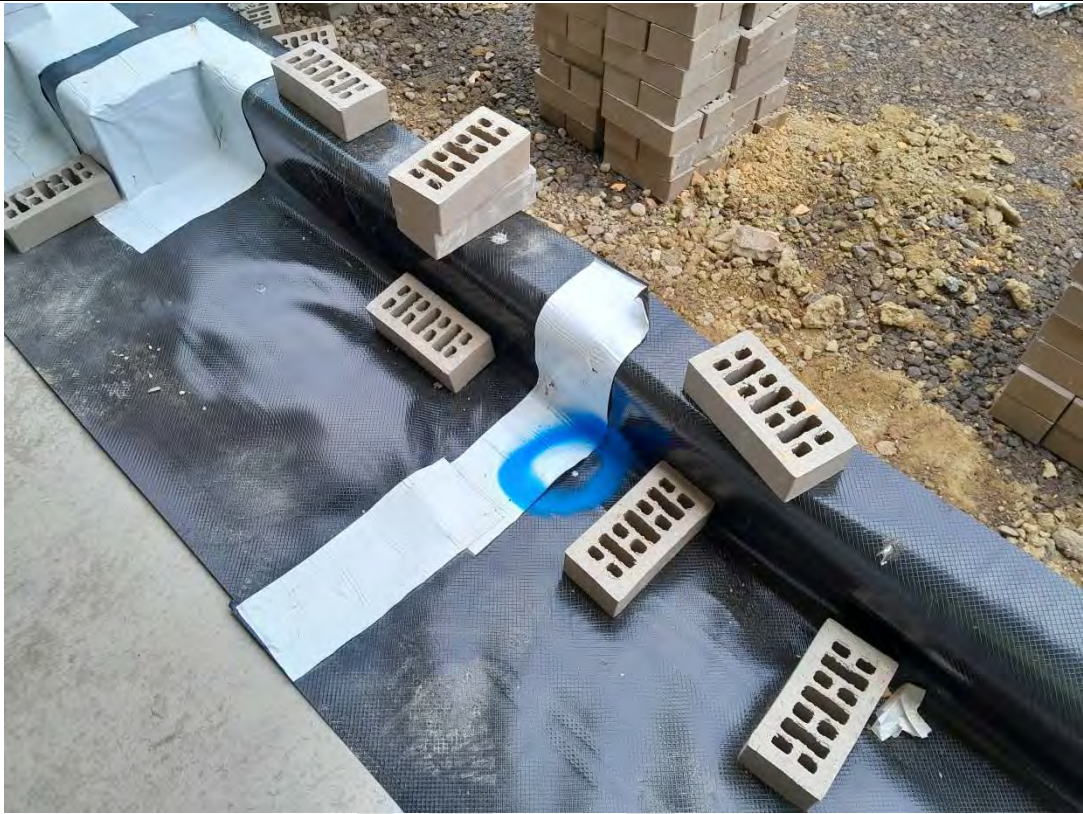
Photograph 9: possible defect in join lapping seal

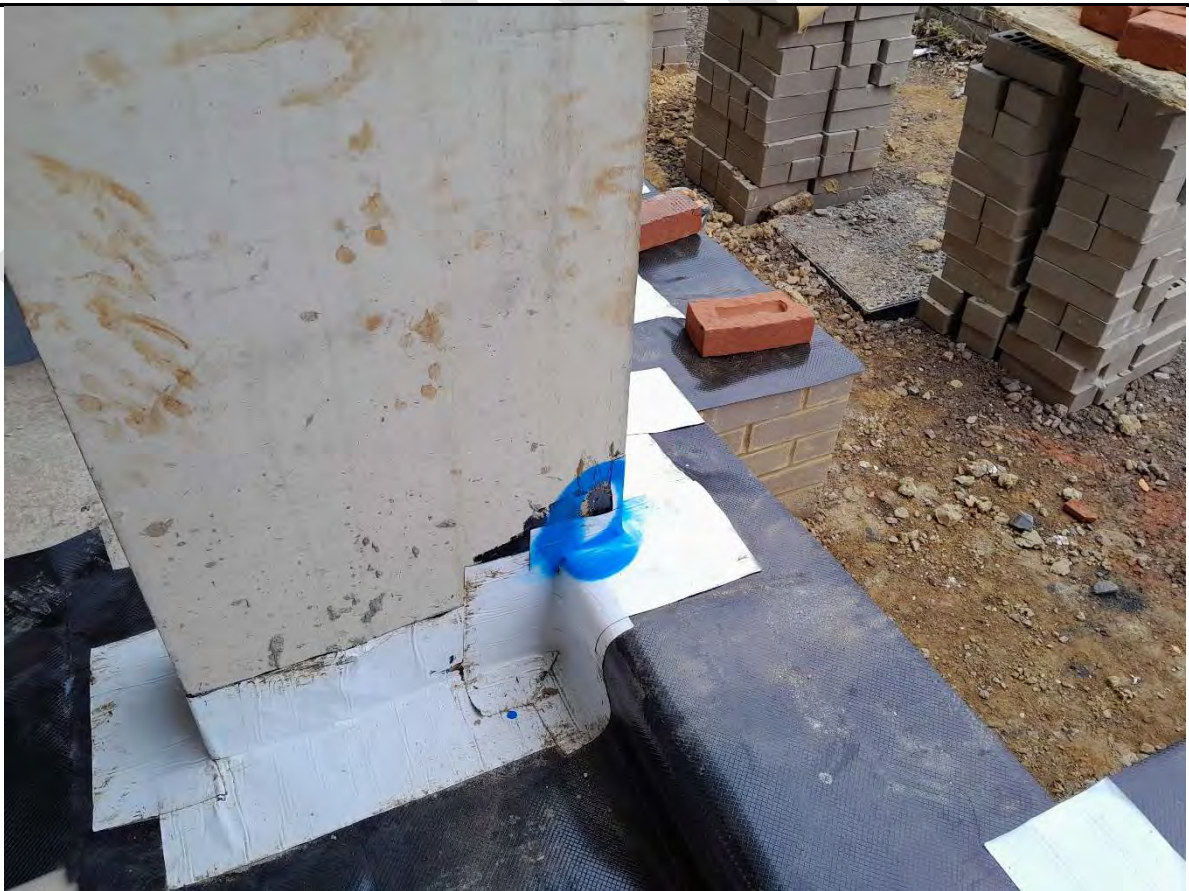
Photograph 10: possible defect in adhesion to pillar

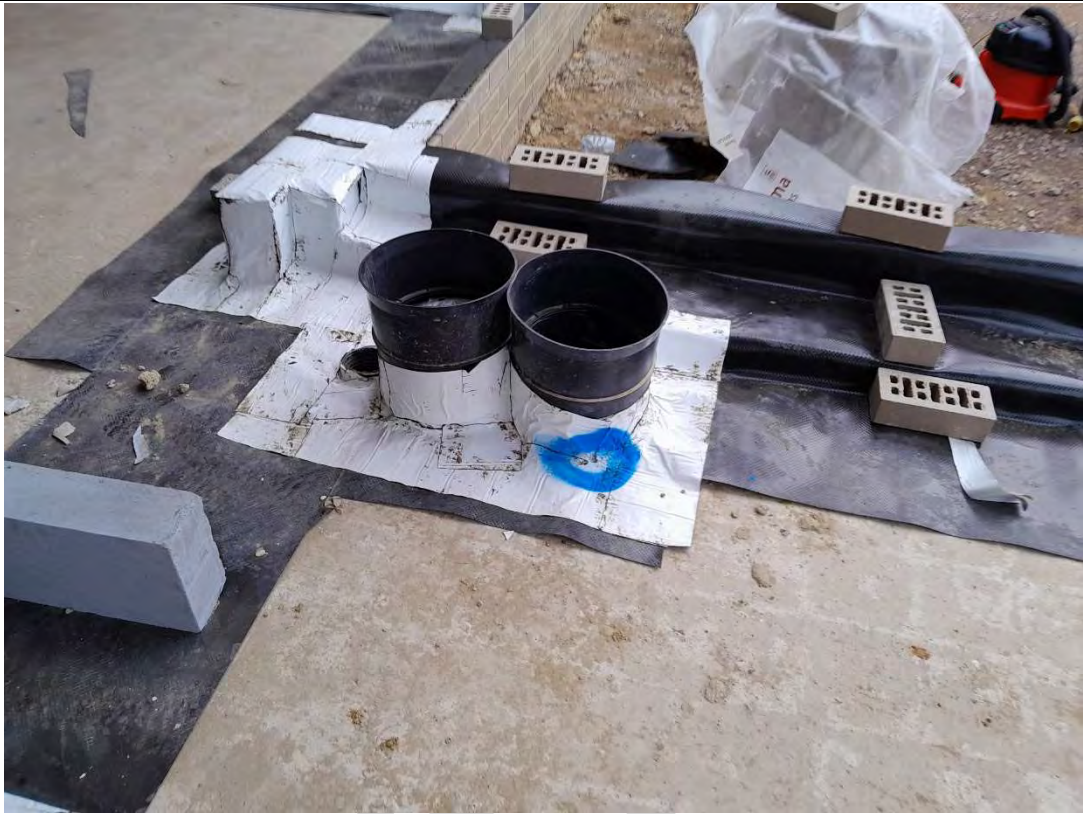
Photograph 11: possible defect in service entrance seal

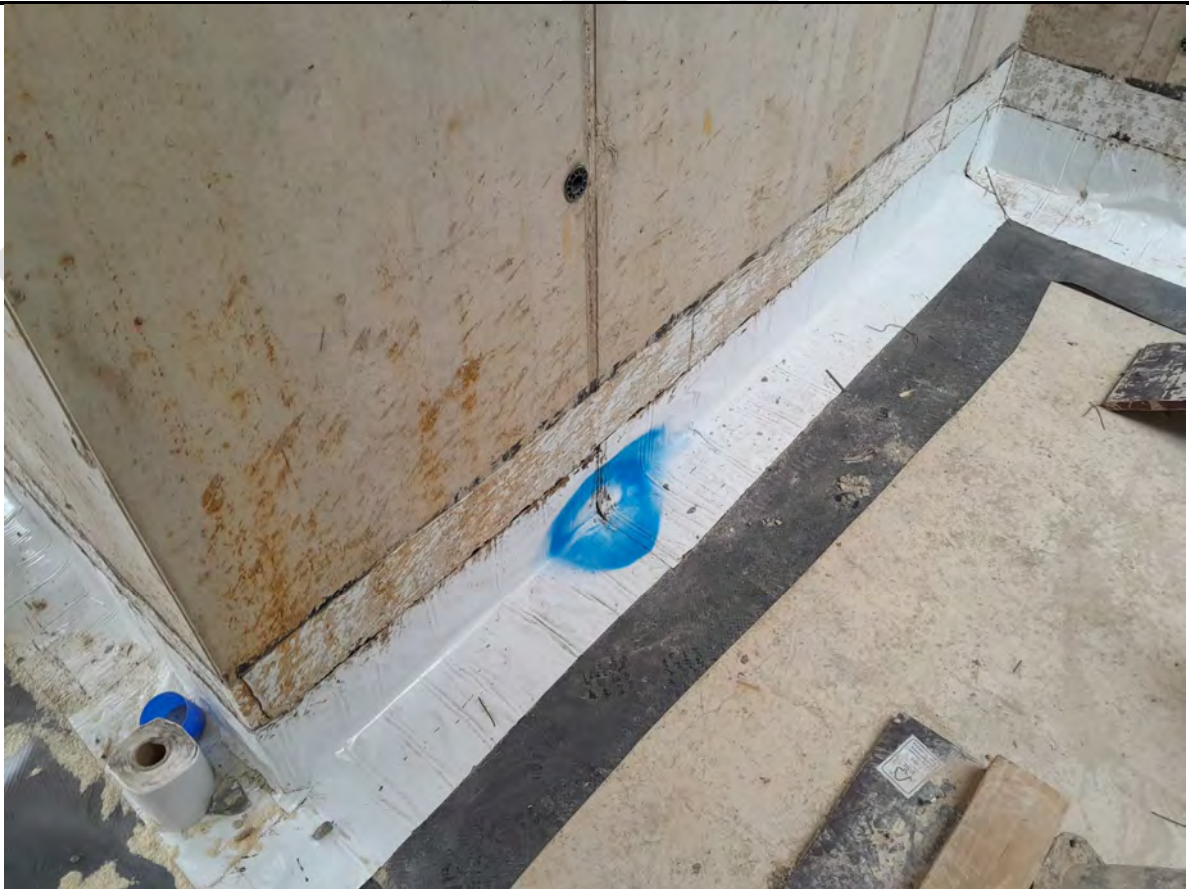
Photograph 12: possible defect in detail tape joint

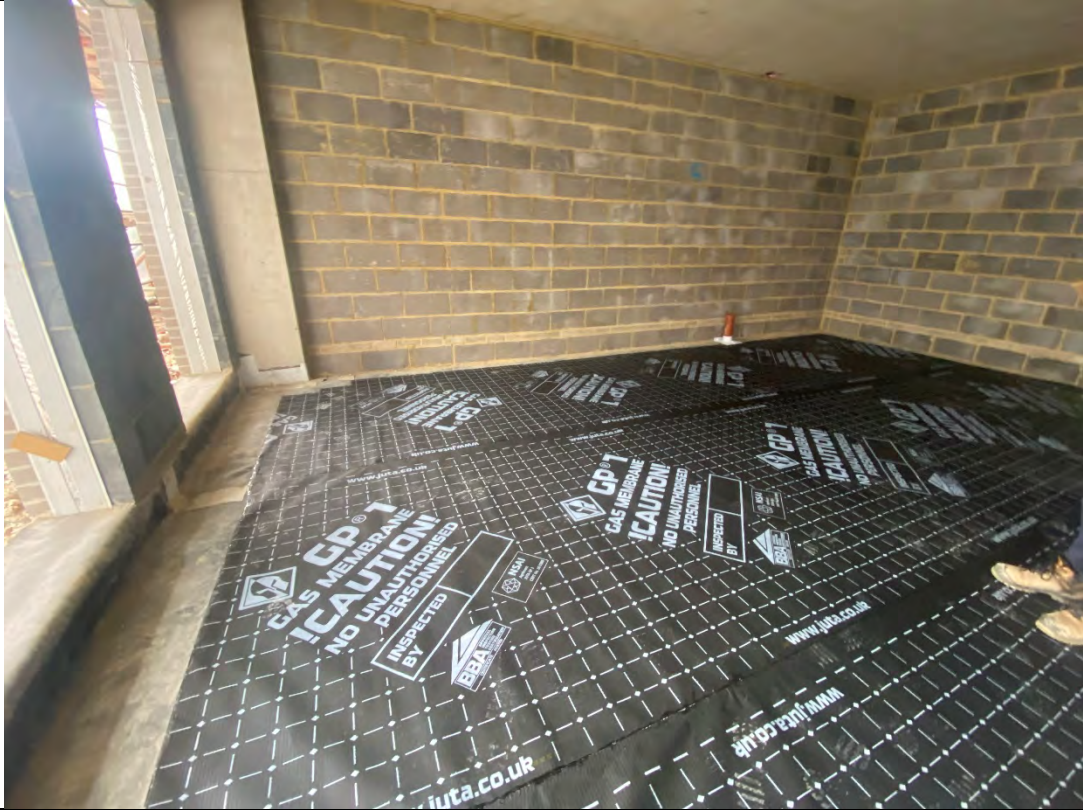
Photograph 1: General condition of membrane.

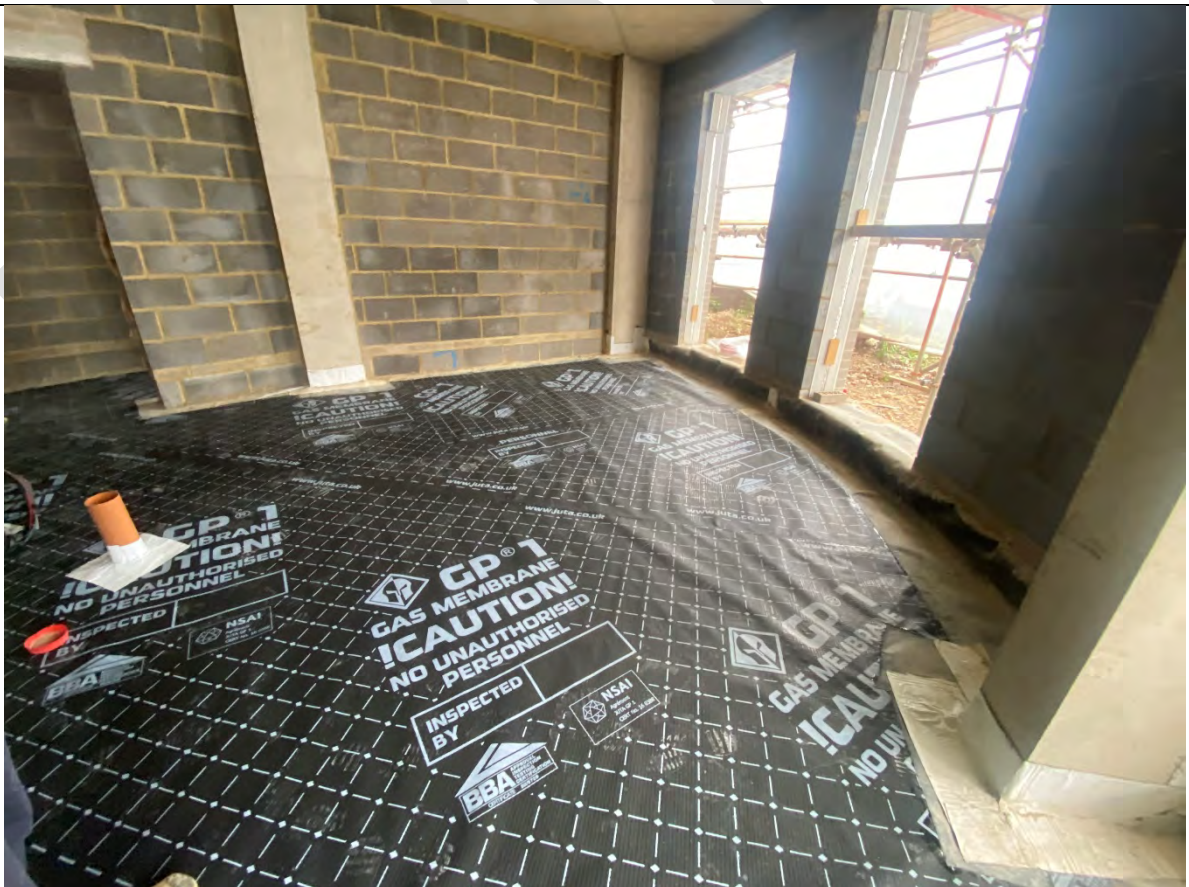
Photograph 2: General condition of membrane.

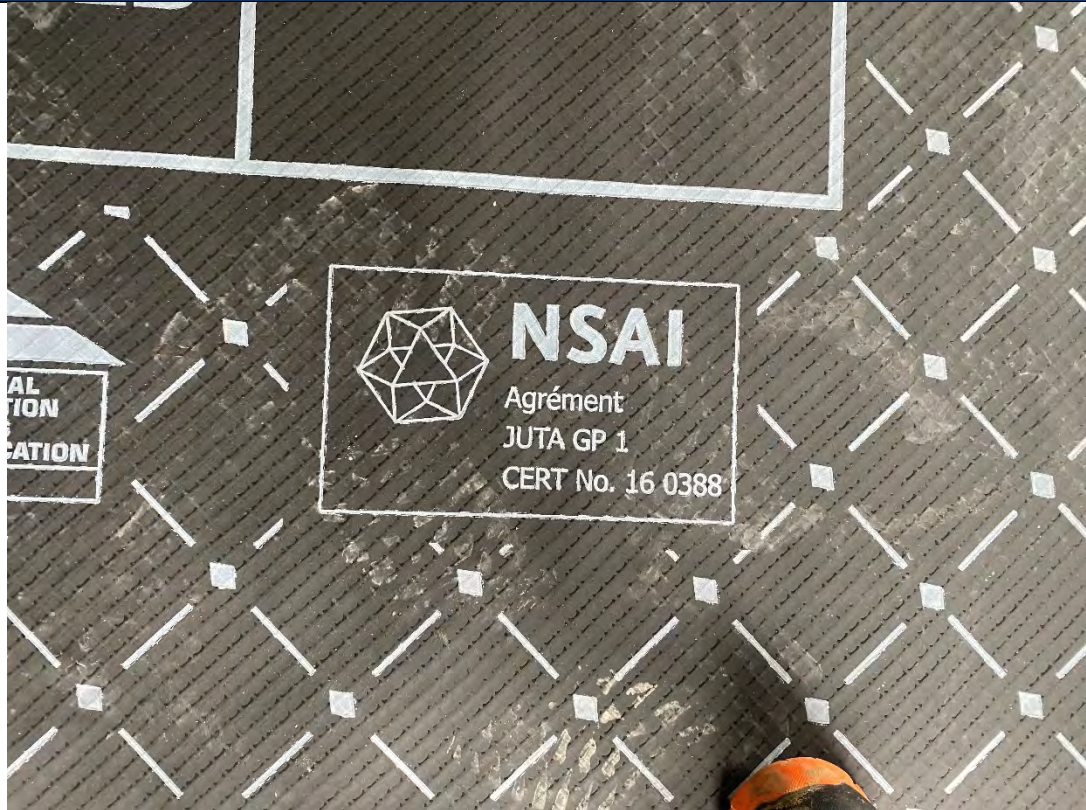
Photograph 3: Type of membrane used shown.

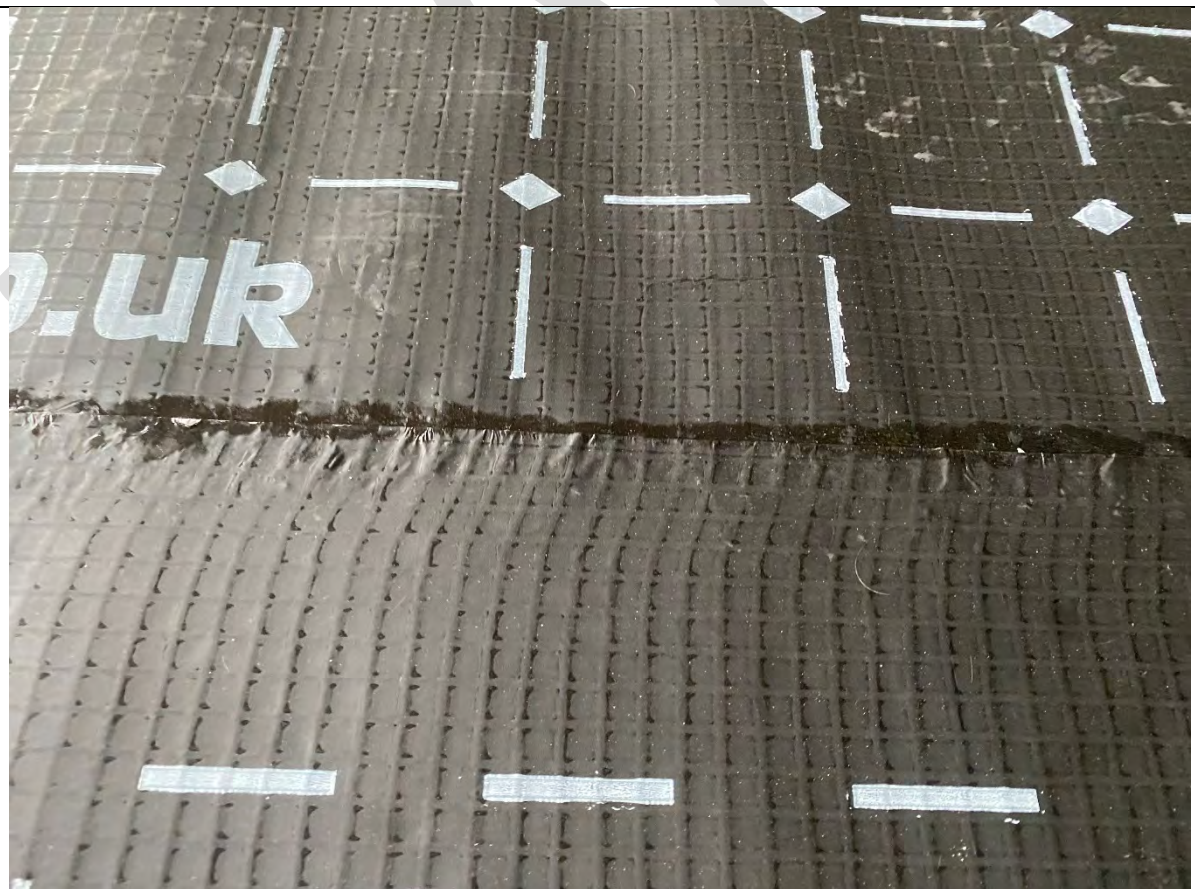
Photograph 4: Seals noted with &lt;100mm overlapping.

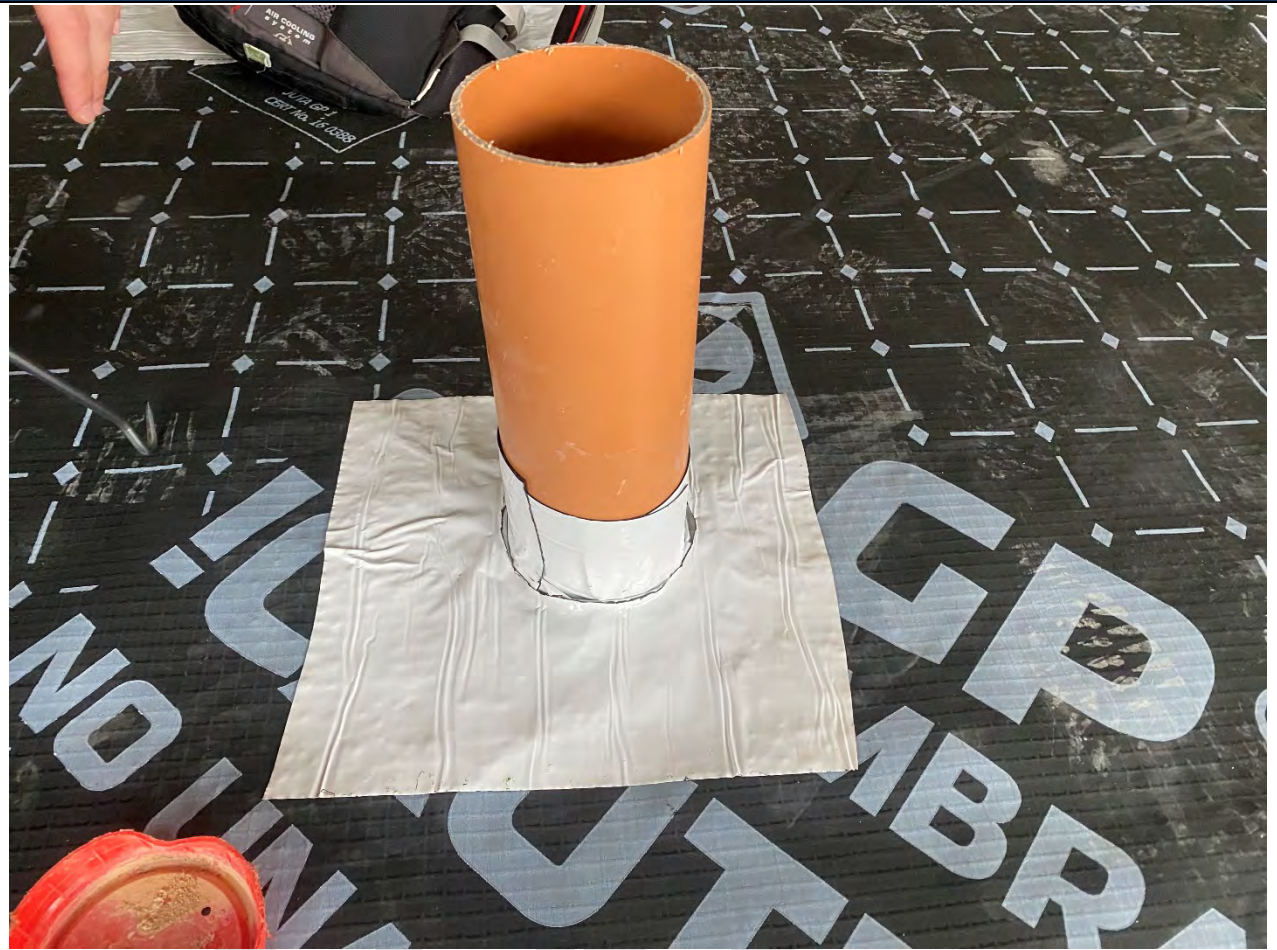
Photograph 5: Non-proprietary top hat service detailing.

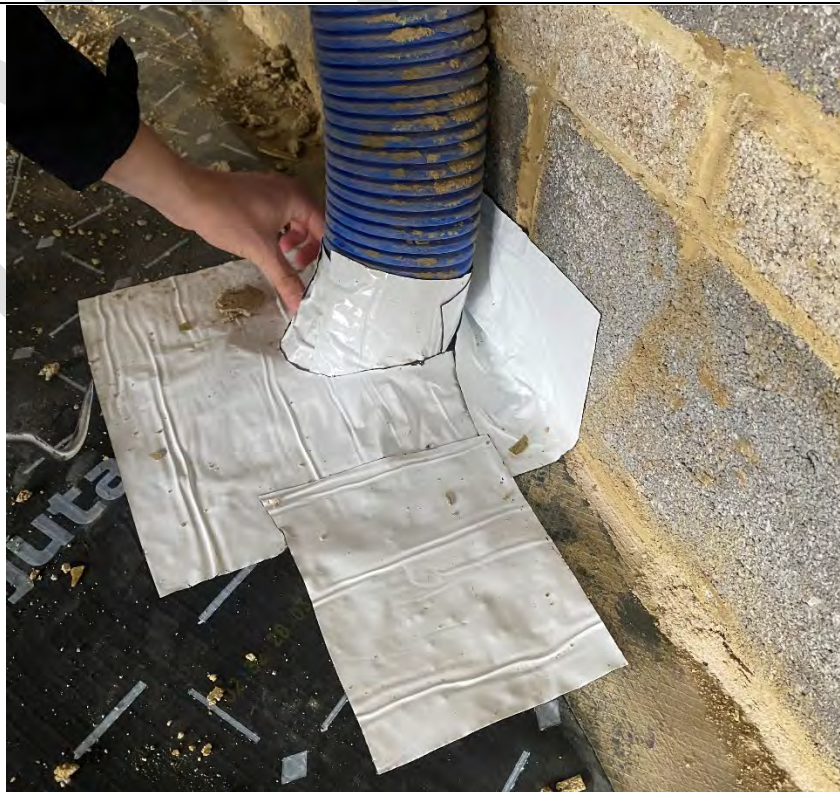
Photograph 6: Non-proprietary top hat service detailing.

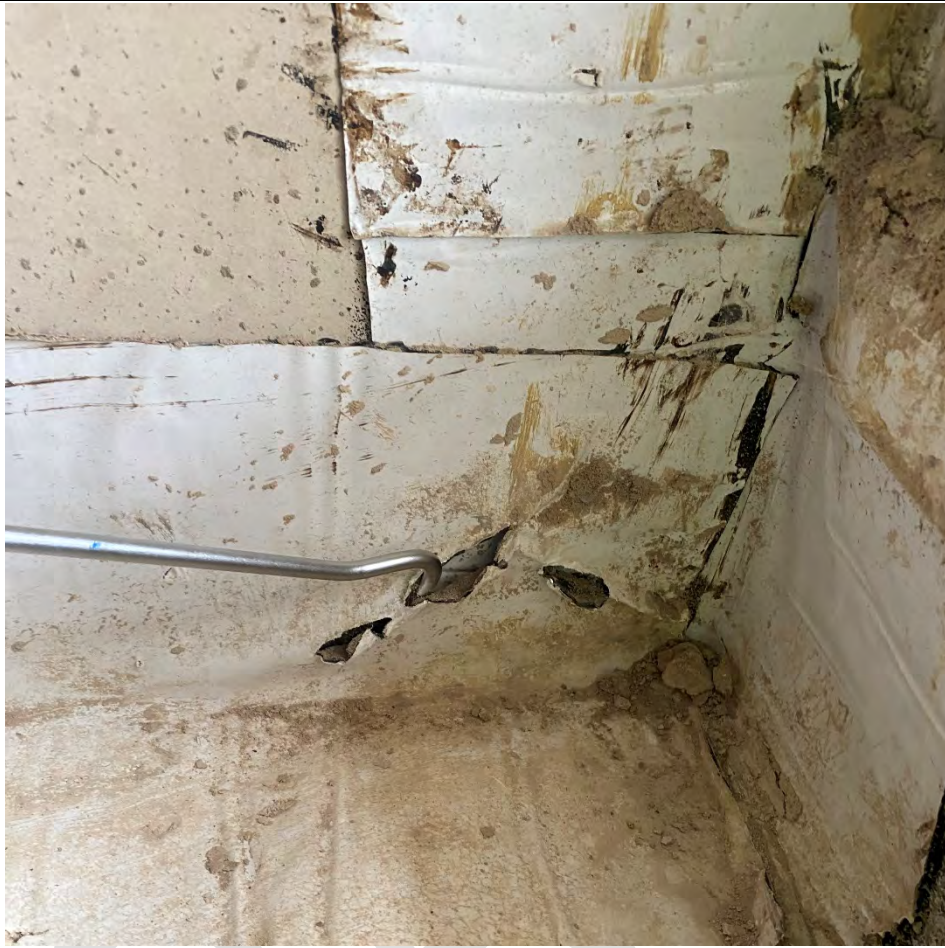
| No. | Item | Comments (see notes) |
|---|---|---|
| <p>Previously installed product has been damaged with holes noted in lapping tape<br/> Insufficient overlap on bricks<br/> Faults sprayed on previous visit don't appear to be rectified.</p> <p>The above comments have been raised to site manager to rectify before third party validation.</p> | | |

Photograph 7: Damage noted on lapping joints/seals.

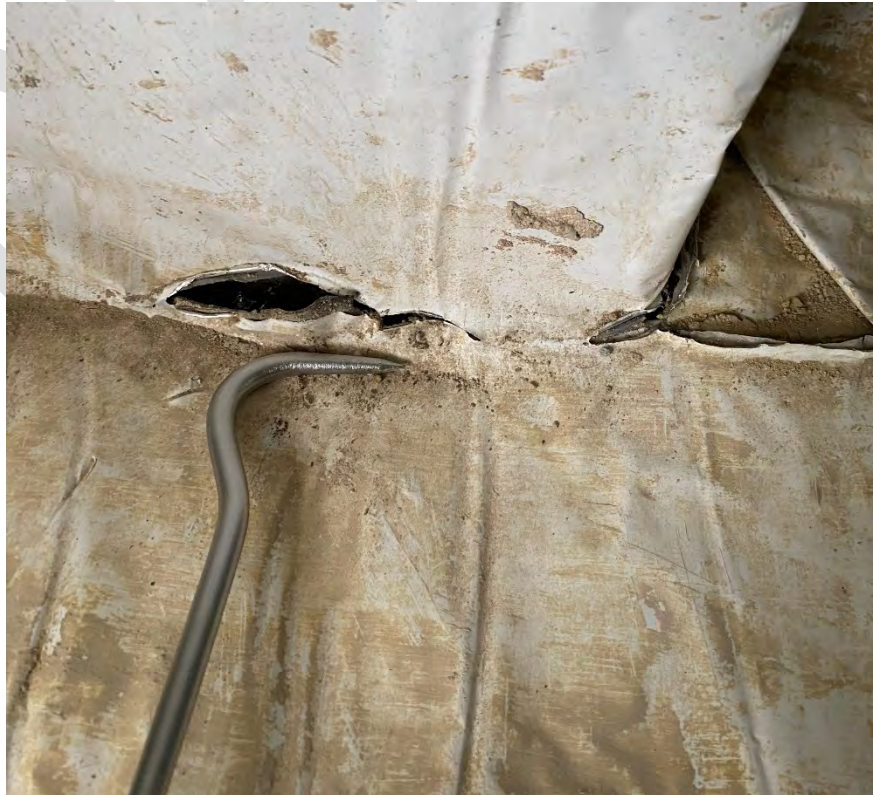
Photograph 8: Damage noted on lapping joints/seals.

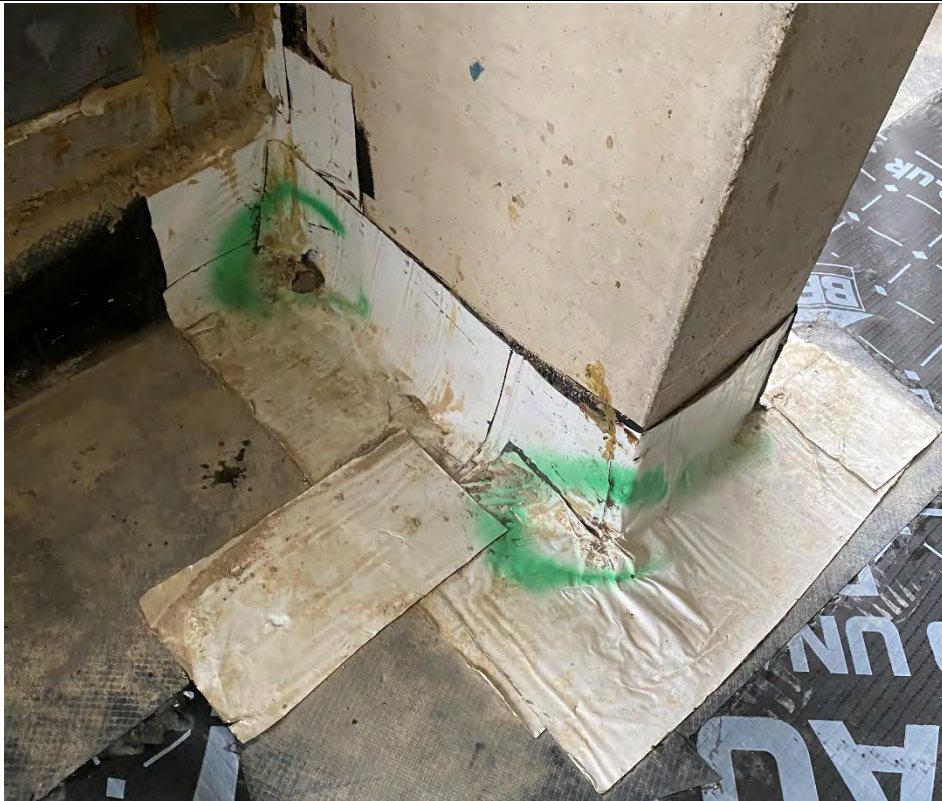
Photograph 9: Areas sprayed from previous Hydrock visit not rectified.

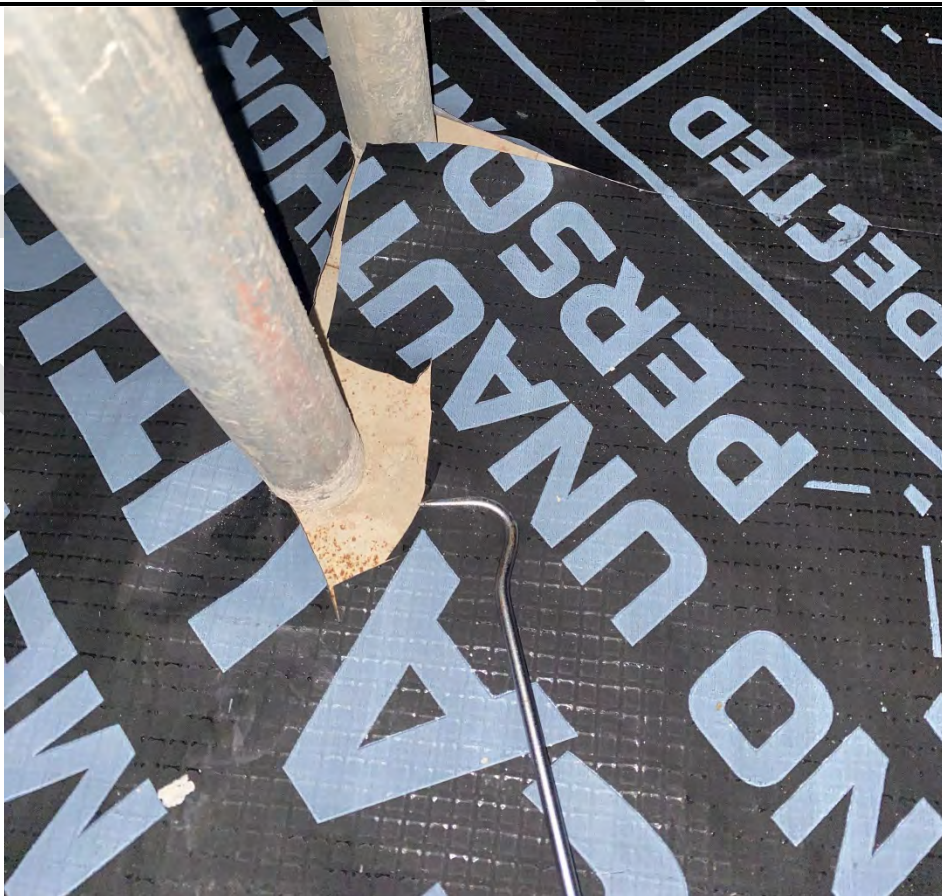
Photograph 10: Areas yet to be sealed.

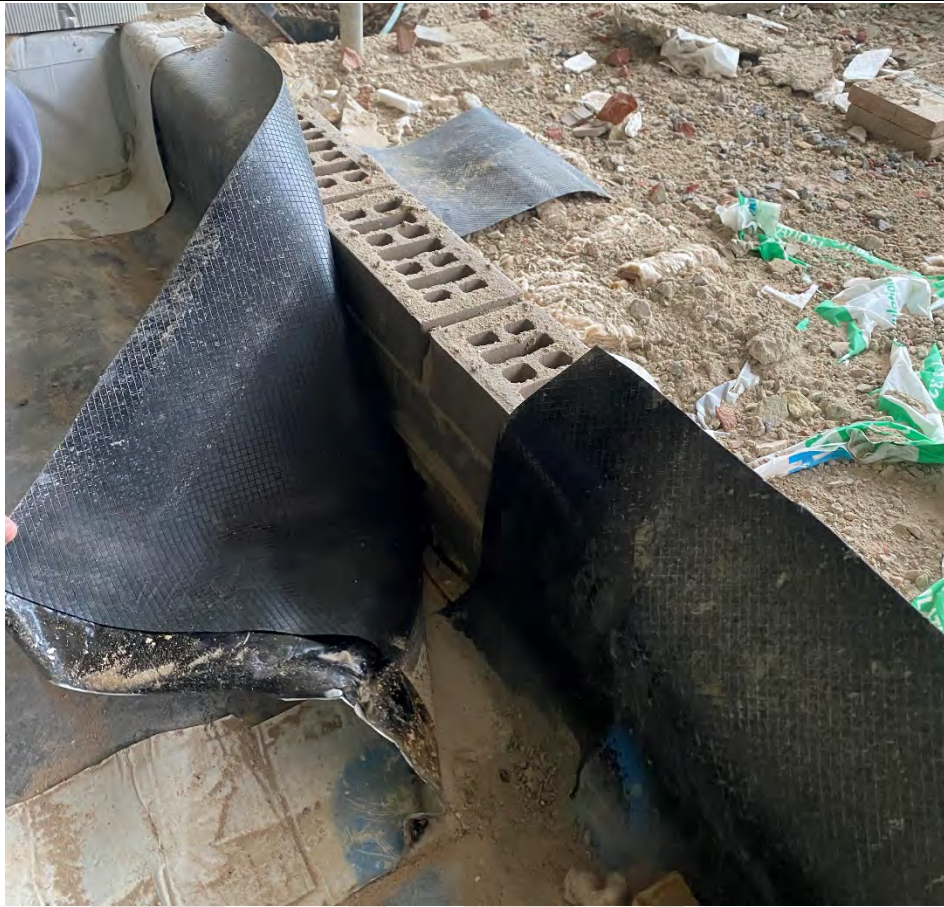
Photograph 11: Membrane not sealed and has come away from brickwork

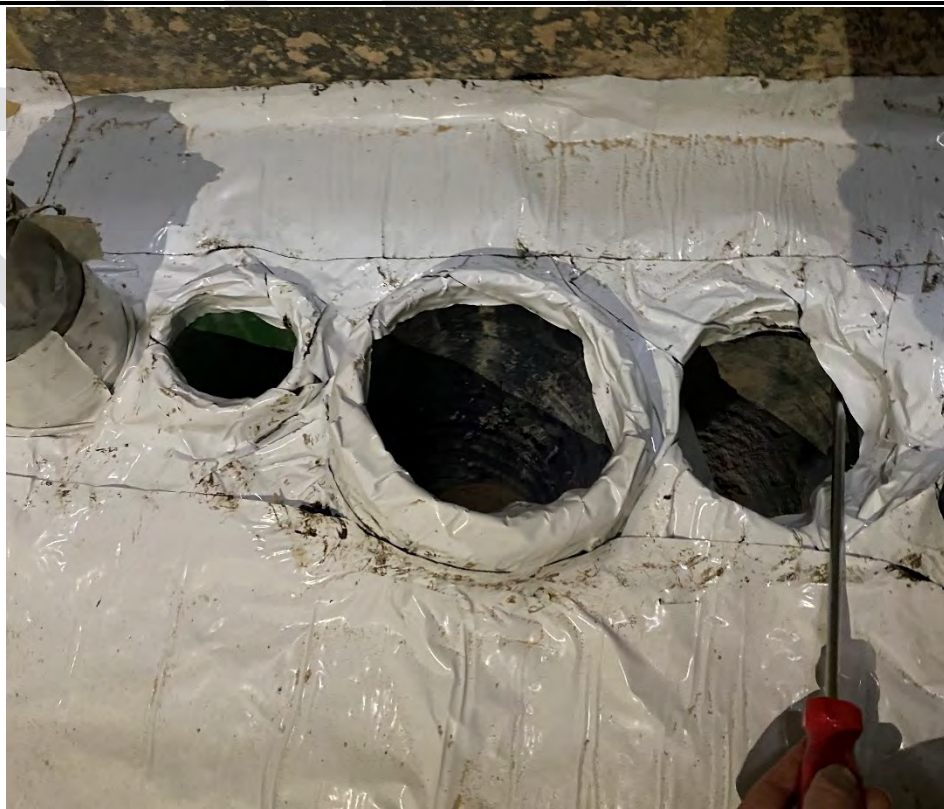
Photograph 12: Service points entry/exits.
