# Scope of Works Document

## Osbert House

Peppard Road, Notley Place, Reading, RG4 8PW

## Appendix A - Survey and Core Samples

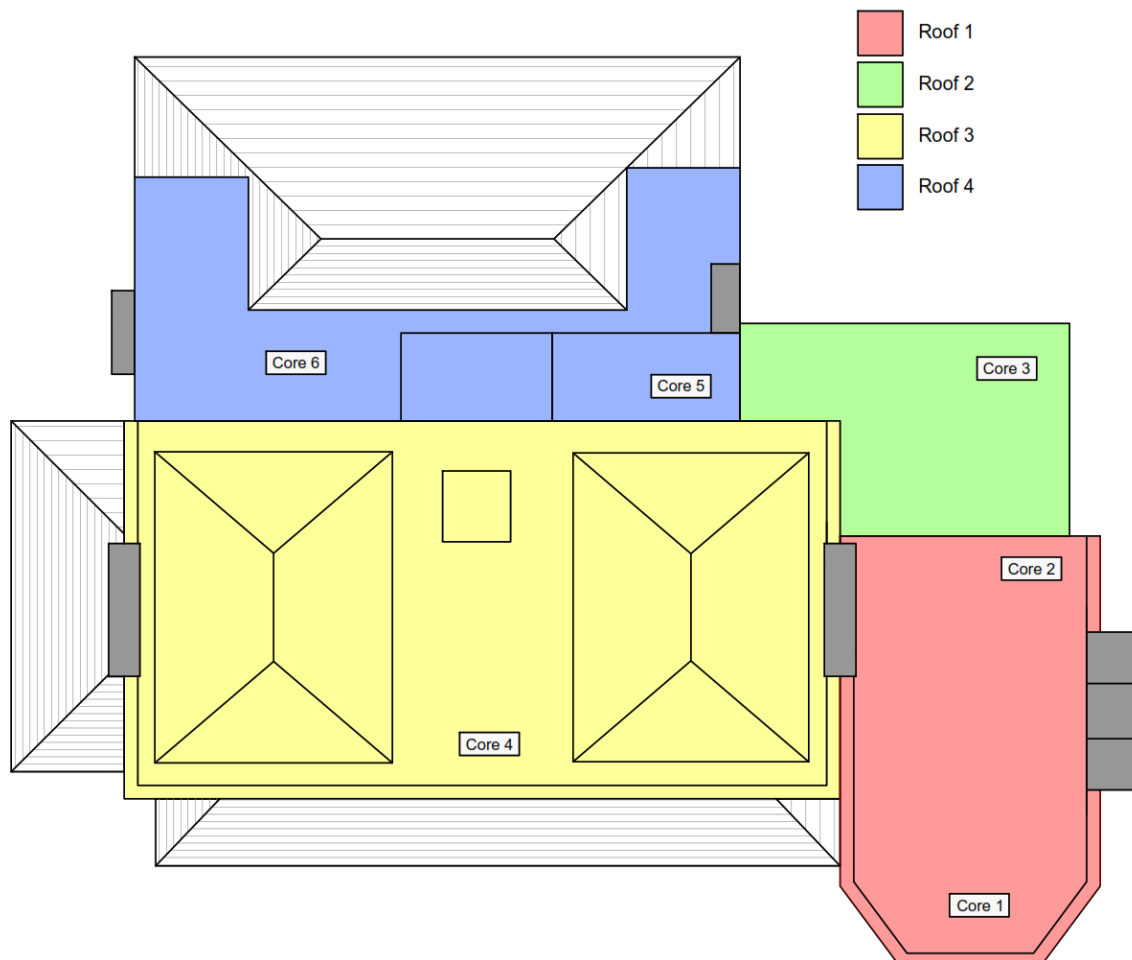
Investigation works, including core samples, have found that roofs 1, 2 and 3 have a build up of water beneath the bitumen felt which will lead to decay of the structure if not addressed. Roofs 5 and 6 do not have any insulation, nor ventilation, which provides poor thermal properties and also leaves the roofs vulnerable to condensation within the structure which will also cause decay of the structure if not addressed.

The following works are proposed to roofs 1, 2, 3 and 4 which are highlighted on the plan on the previous section:

- Strip the existing felt roof coverings back to the structural deck.
- Undertake repairs to the deck if required.
- Install a vapour control layer over the deck.
- Install insulation to meet current building regulations.
- Install a modern high performance felt roof covering with a mineral felt facing.
- Replace the existing modern Velux rooflight to the centre of Roof 3.

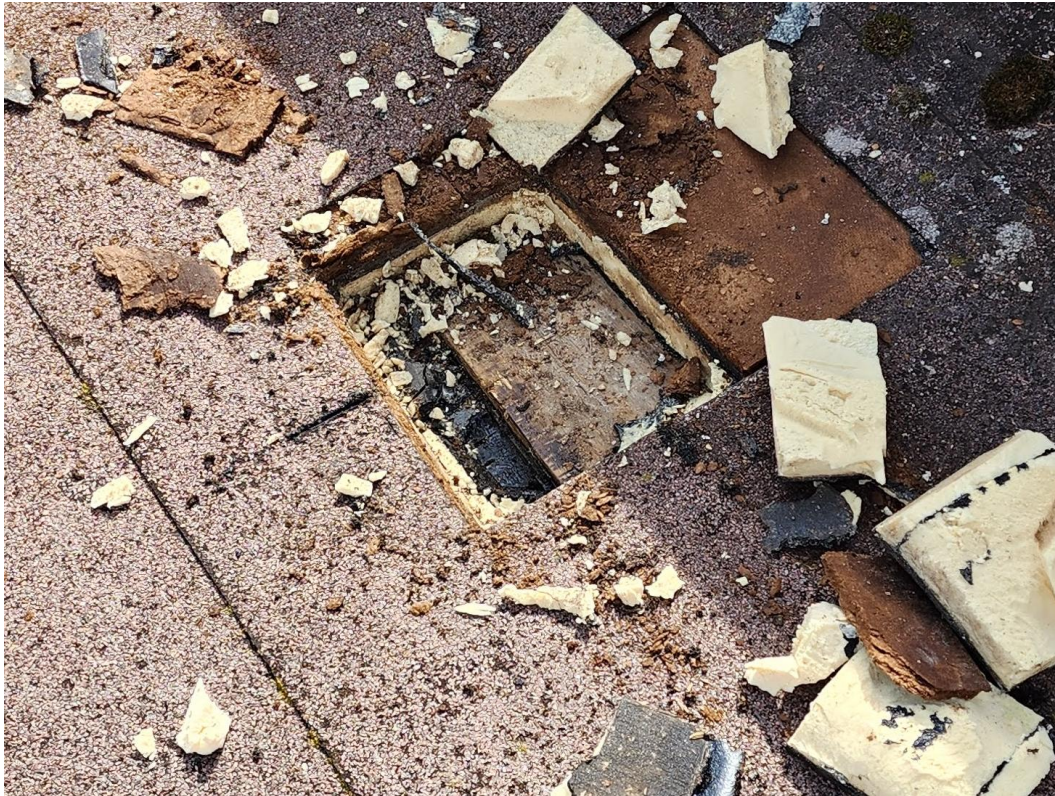
| Core 1 | Softwood timber boards<br>Bitumen felt.<br>Plywood (to perimeter, around 500mm only)<br>30mm PIR insulation<br>Fibreboard topping<br>2 layers felt |

The fibreboard lining beneath the felt was damp in both core sample areas. It is not known where water ingress is occurring.

*Photo 1 - Core 1 – Note plywood to perimeter.*

We recommend that the areas below this roof are monitored for water ingress and that an allowance is made to completely strip this roof back to the timber deck and recover the roof, including upgraded insulation to meet current building regulations, within the next 5 years.

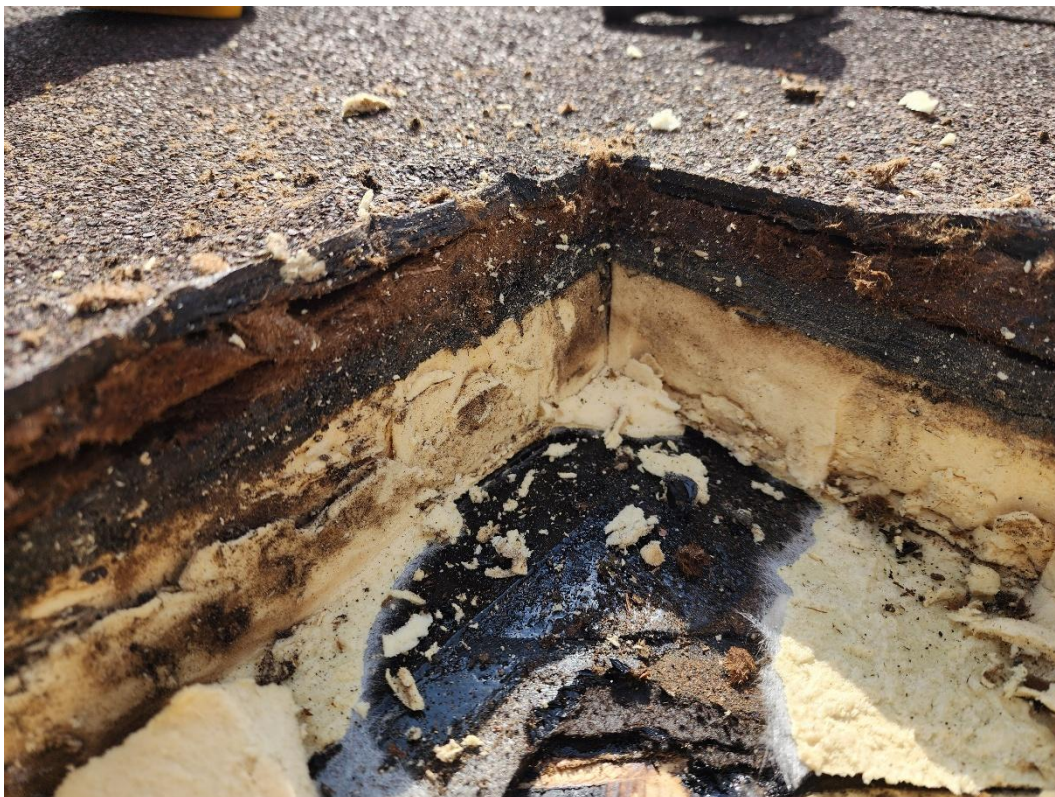
| Core 2 | As above, without plywood boarding |

*Photo 2 - Core 2 – Note damp fibre board over insulation.*

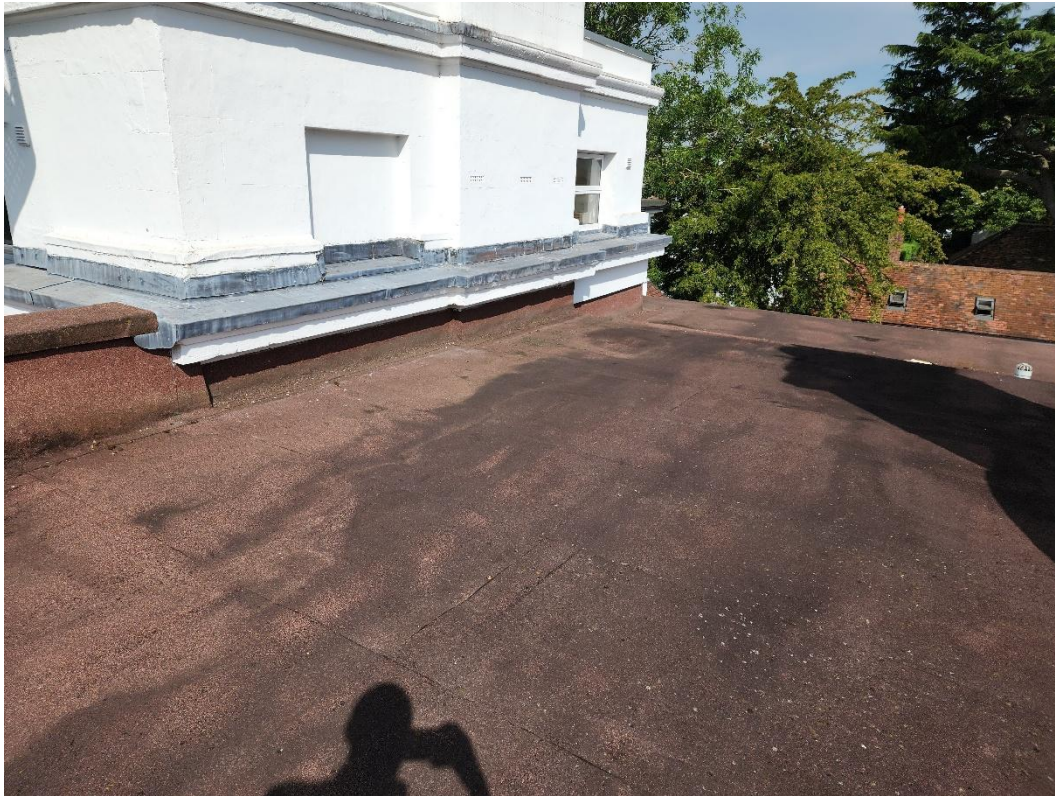
The mineral face cap sheet is in fair condition, however several areas of felt have 'ruckled' and joints appear to have been relatively poorly formed when the felt was first installed. There is no extruded 'bead' of bitumen to joints, and the mineral surface has not been removed to improve bond between layers.

*Photo 3 - General view of Roof 1*

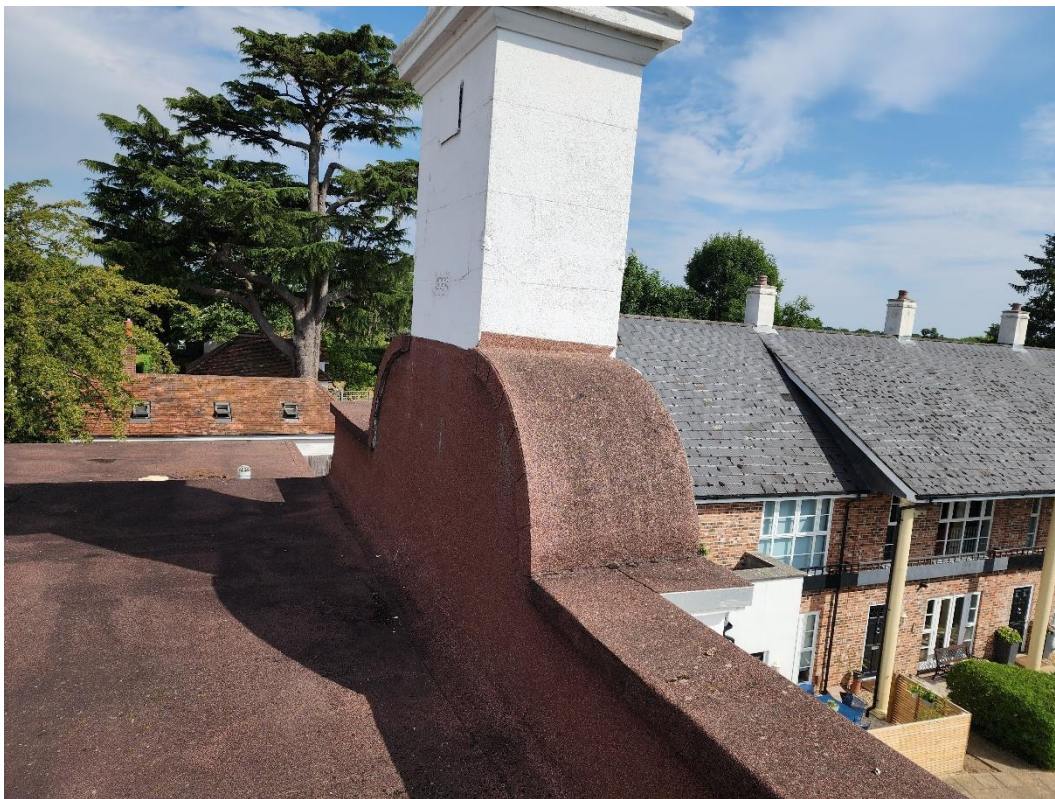
*Photo 4 - Chimney to Roof 1*

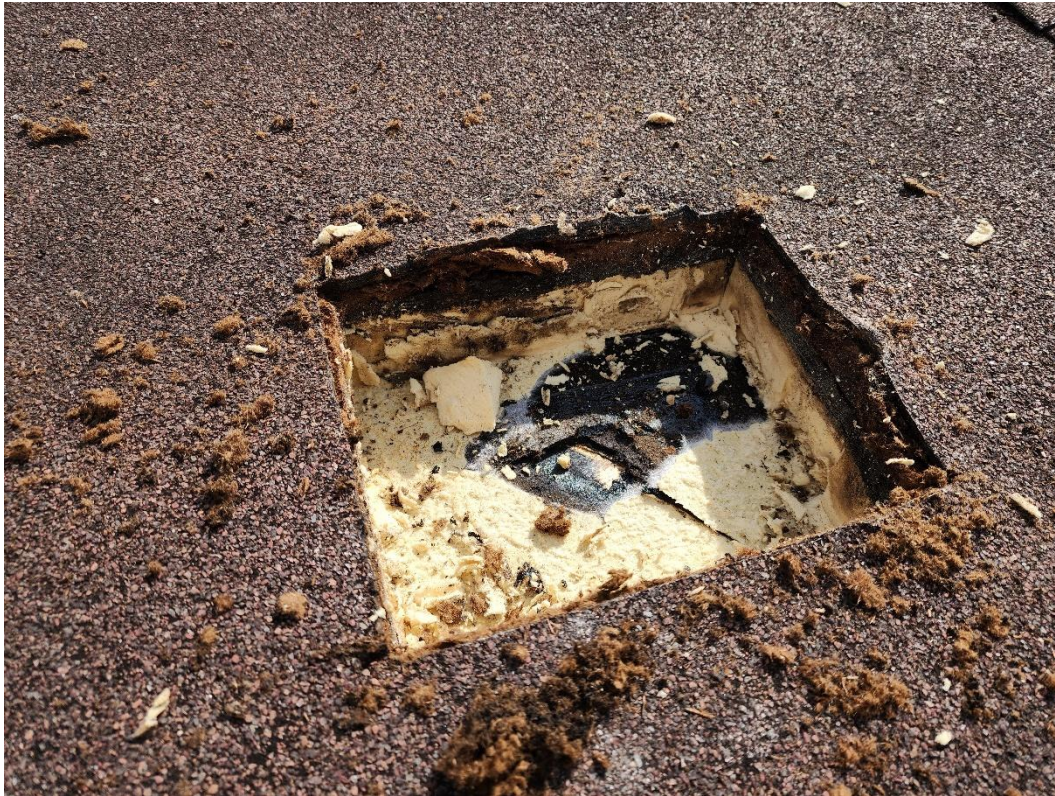
Core 3

The fibreboard lining beneath the felt was saturated. It is not known where water ingress is occurring, however several areas of poorly jointed felt was apparent.

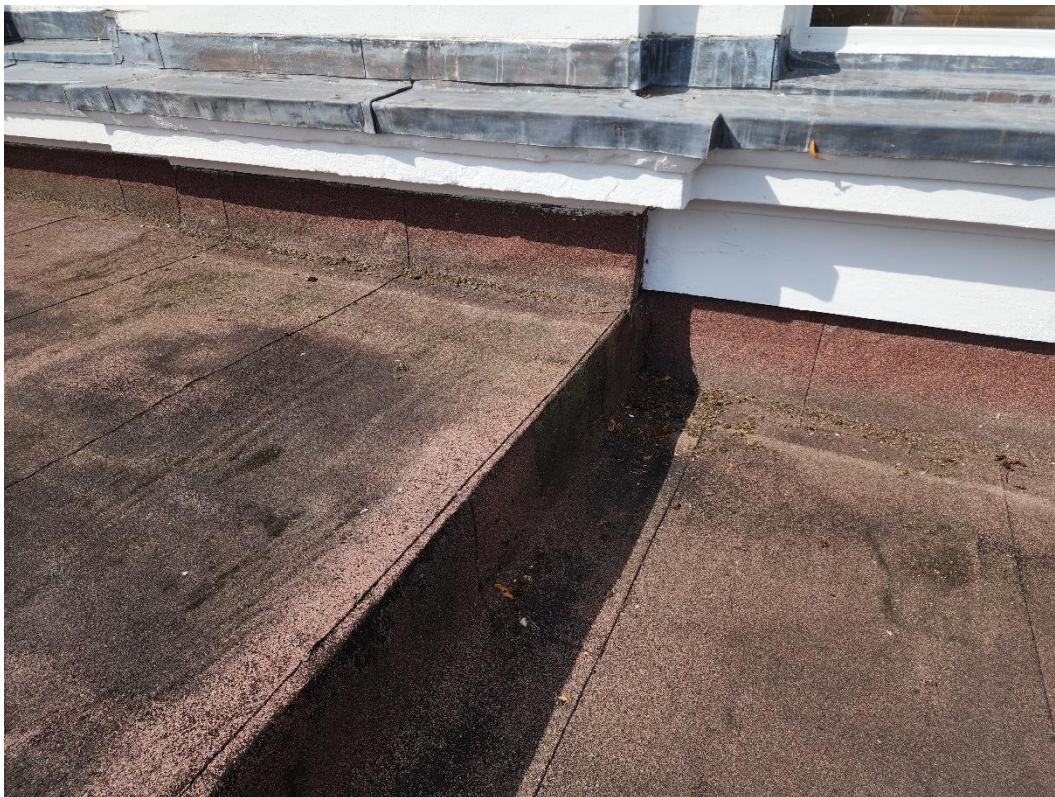
The mineral face cap sheet is in fair condition, however several areas of felt have ‘ruckled’ and joints appear to have been relatively poorly formed when the felt was first installed. There is no extruded ‘bead’ of bitumen to joints, and the mineral surface has not been removed to improve bond between layers.

Roof 1 (upper) and Roof 2 (Lower) – note 'ruckled' felt)

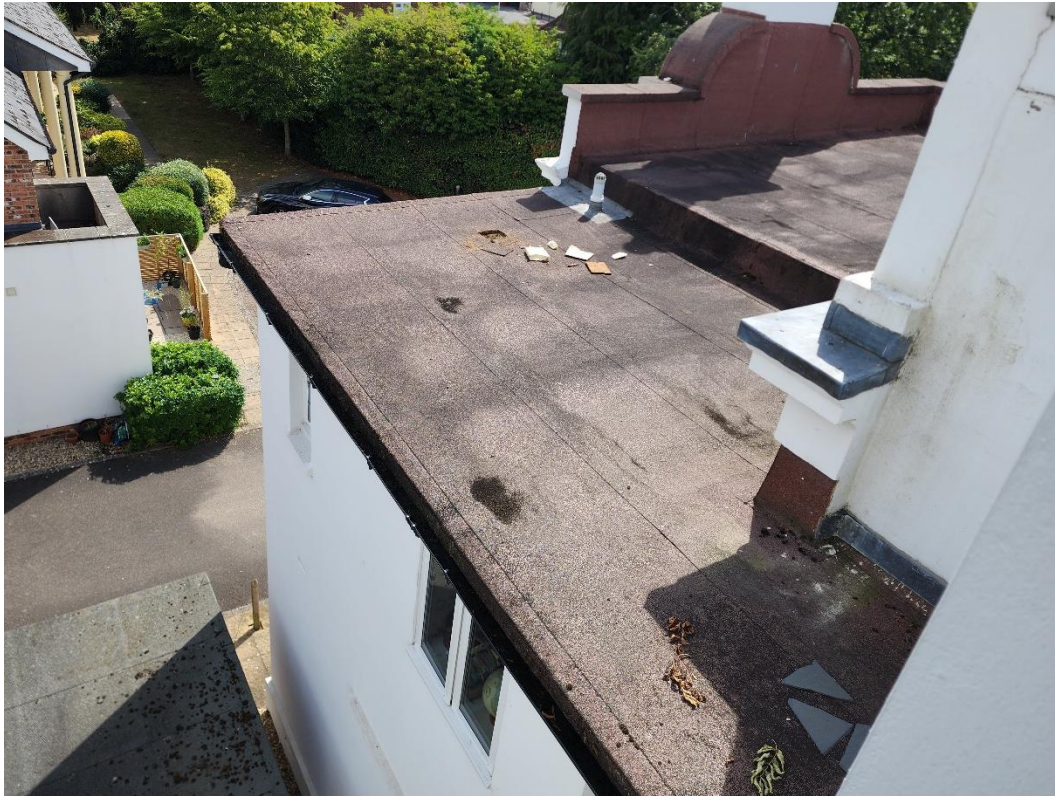
*Photo 5 - General view of roof 2 from above*

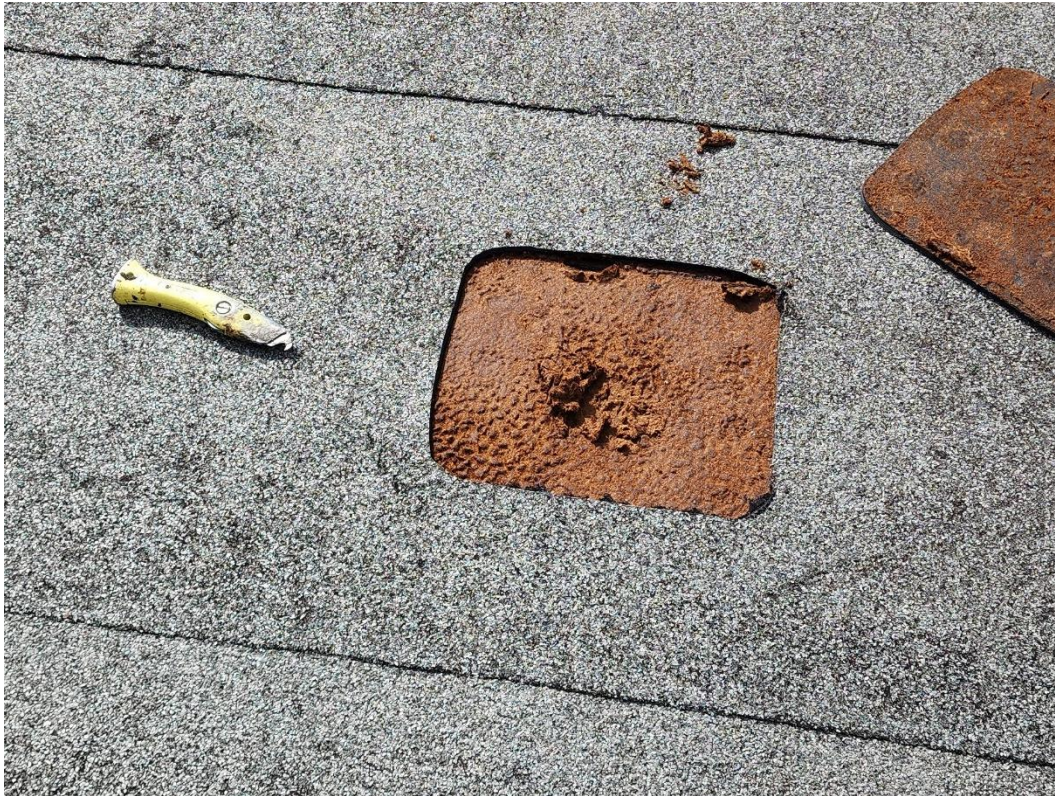
The fibreboard lining beneath the felt was saturated. (Refer to video issued by email alongside this report) It is not known where water ingress is occurring, however several areas of poorly jointed felt was apparent.

*Photo 6 - Core 4 - Saturated fibre board*

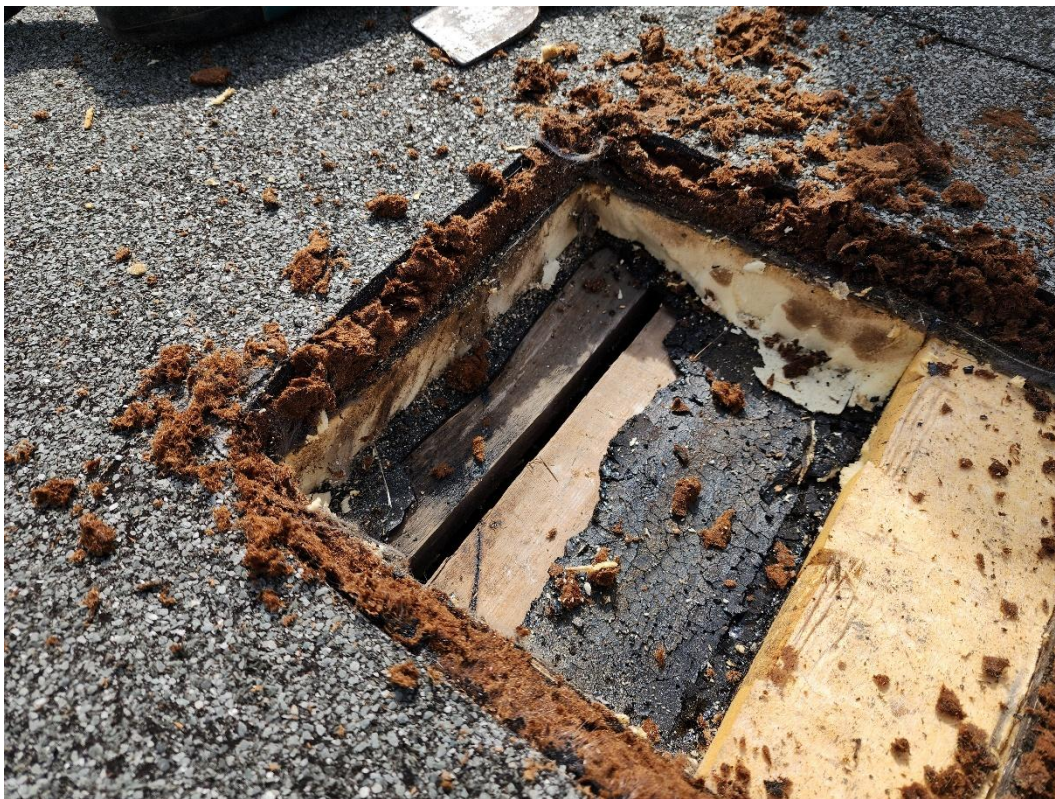
The roof deck in the two areas that were exposed was sound and comprises of what we assume are original softwood boards with 'penny gaps' between the boards.

*Photo 7 - Core 4 - Note insulation and softwood boards with ventilation gaps.*

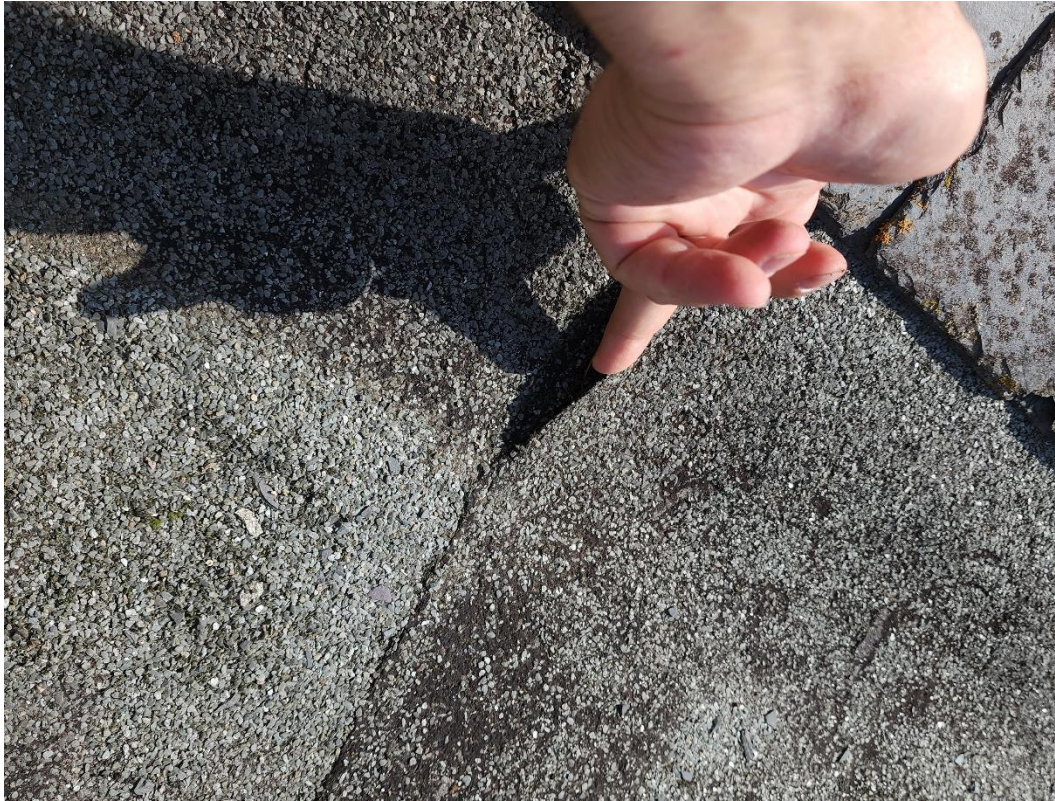
The mineral face cap sheet is in fair condition, however several areas of felt have 'ruckled' and joints appear to have been relatively poorly formed when the felt was first installed. There is no extruded 'bead' of bitumen to joints, and the mineral surface has not been removed to improve bond between layers.

*Photo 8 - Poorly bonded joint to roof 3.*

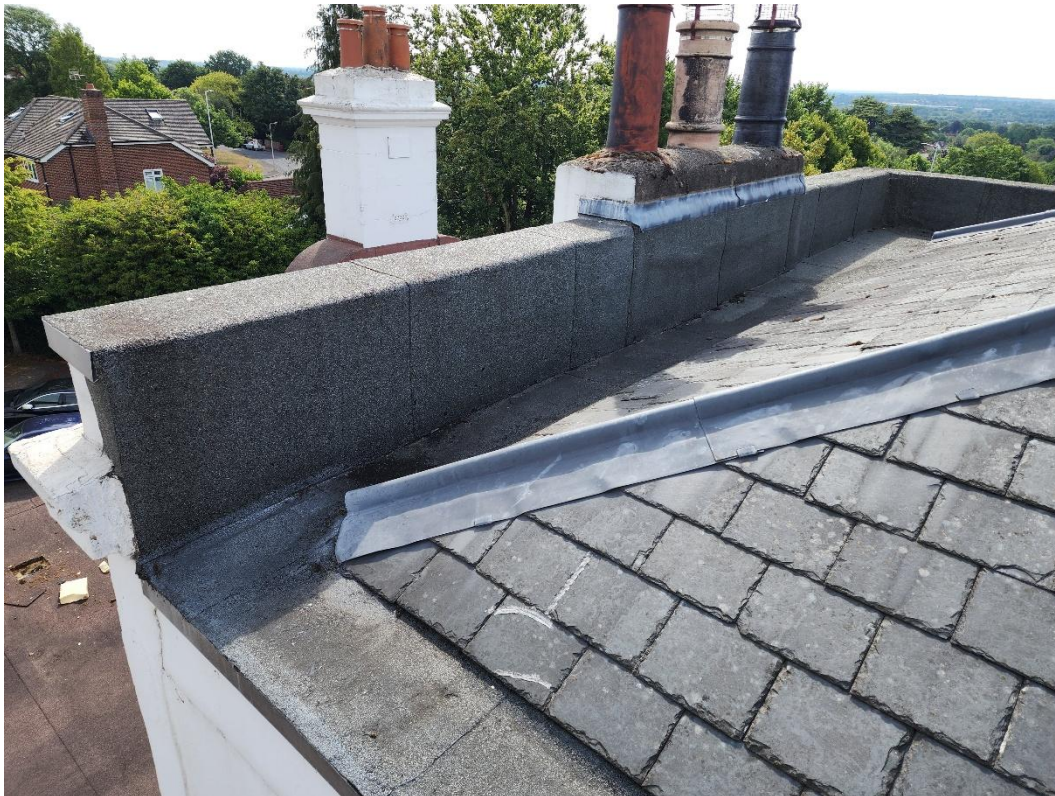
*Photo 9 - Perimeter detail to Roof 3*

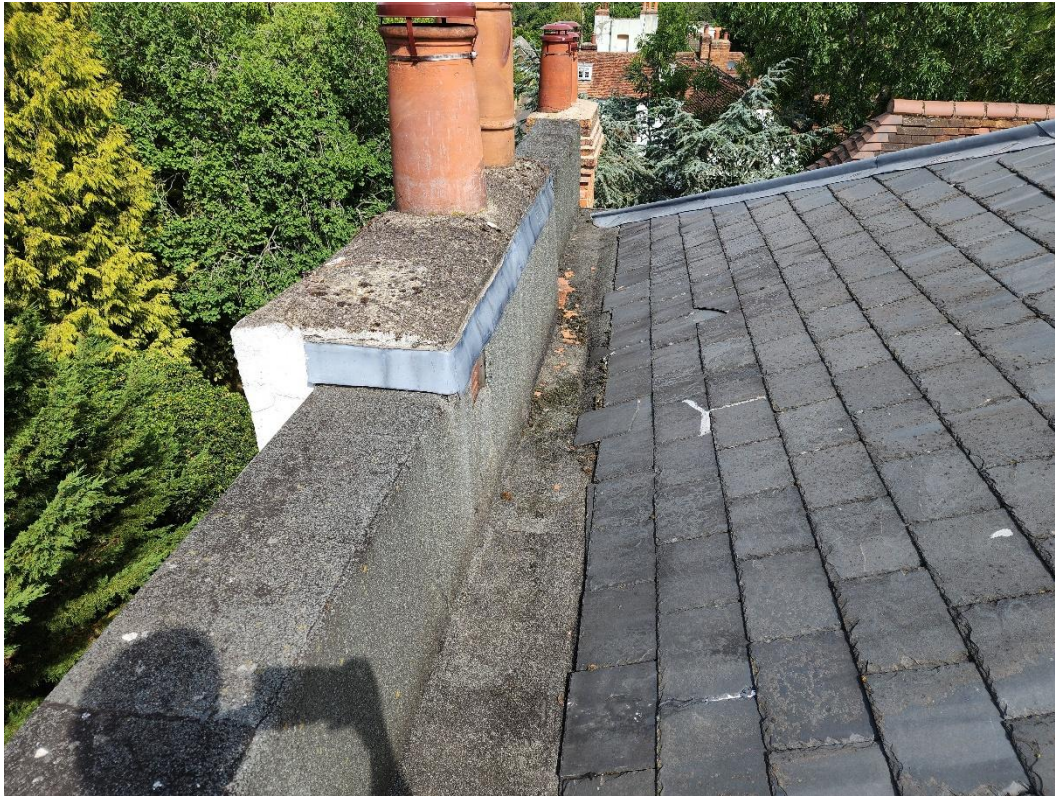
The roof incorporates 2 nr slate covered hipped roofs as part of the structure. Although there are several damaged slates these roofs are in fair condition, however, to undertake repair works to the flat roofs the lower courses of slate will need to be stripped and reinstated to provide a good weathering detail.

*Photo 10 – Opposite side of roof 3 parapet detail. Note slipped and cracked slates.*

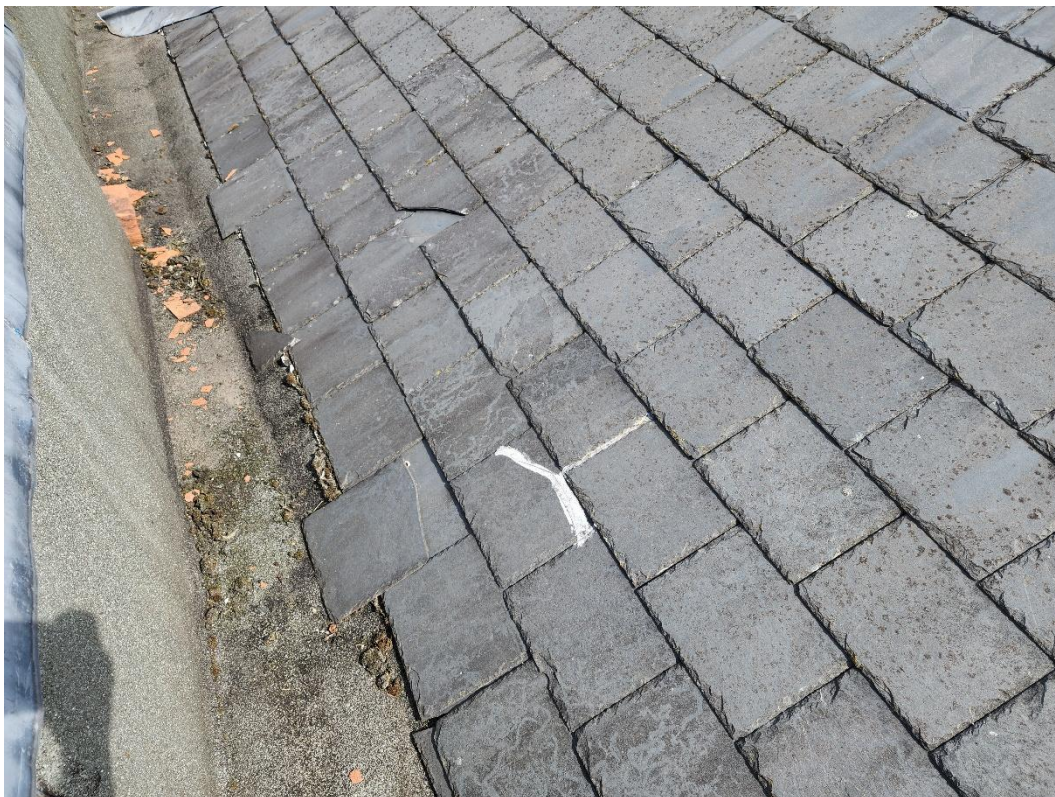
*Photo 11 - Detail of above*

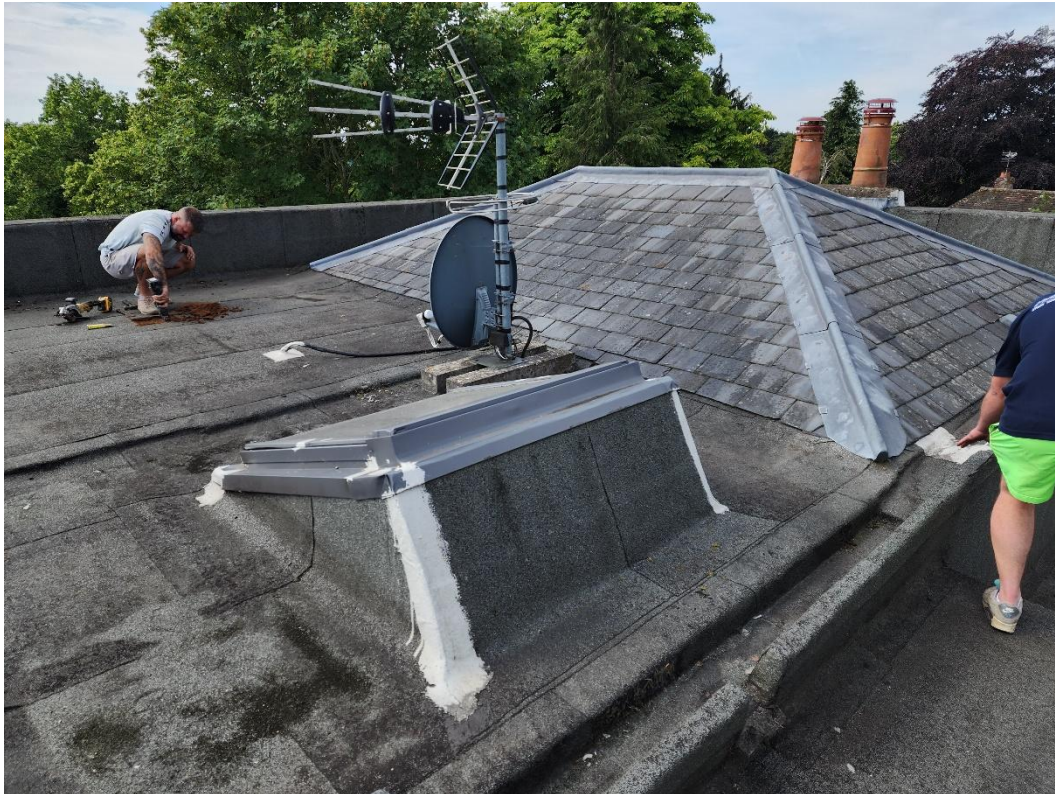
The modern Velux rooflight within the roof 3 area is showing signs of age, and the upstand requires re-placement

*Photo 12 – Roof 3 – Note liquid applied coating to rooflight.*

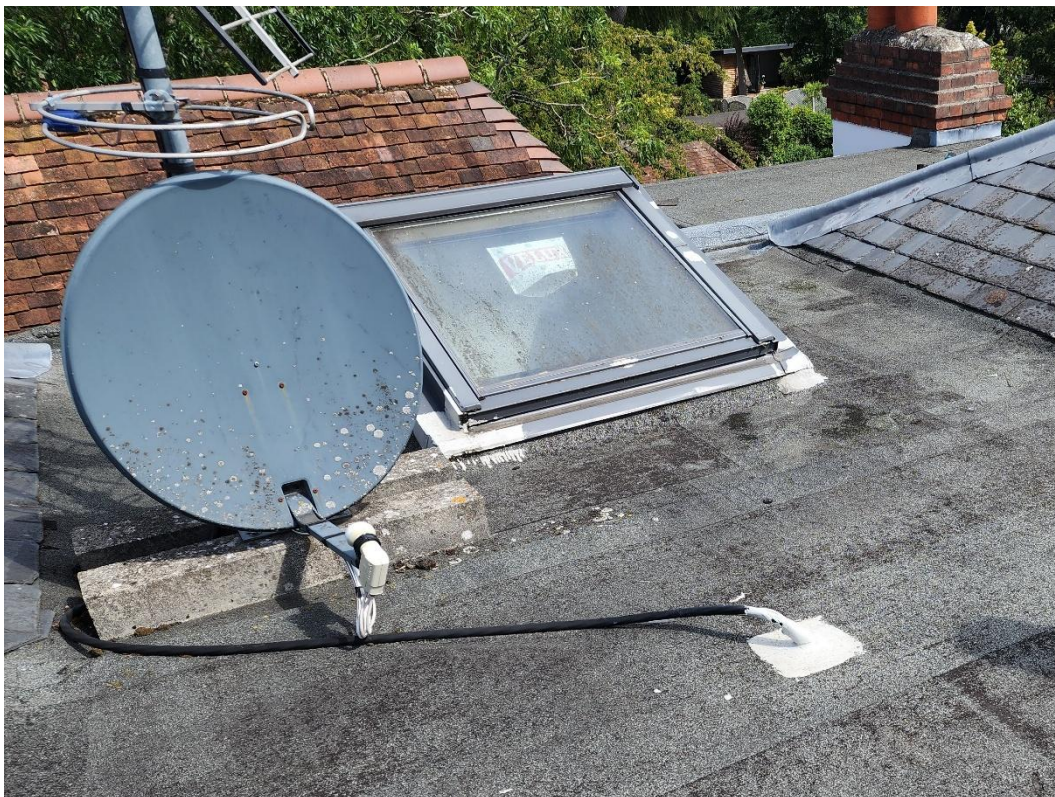
*Photo 13 - Roof 3 - Liquid applied coating to cable outlet*

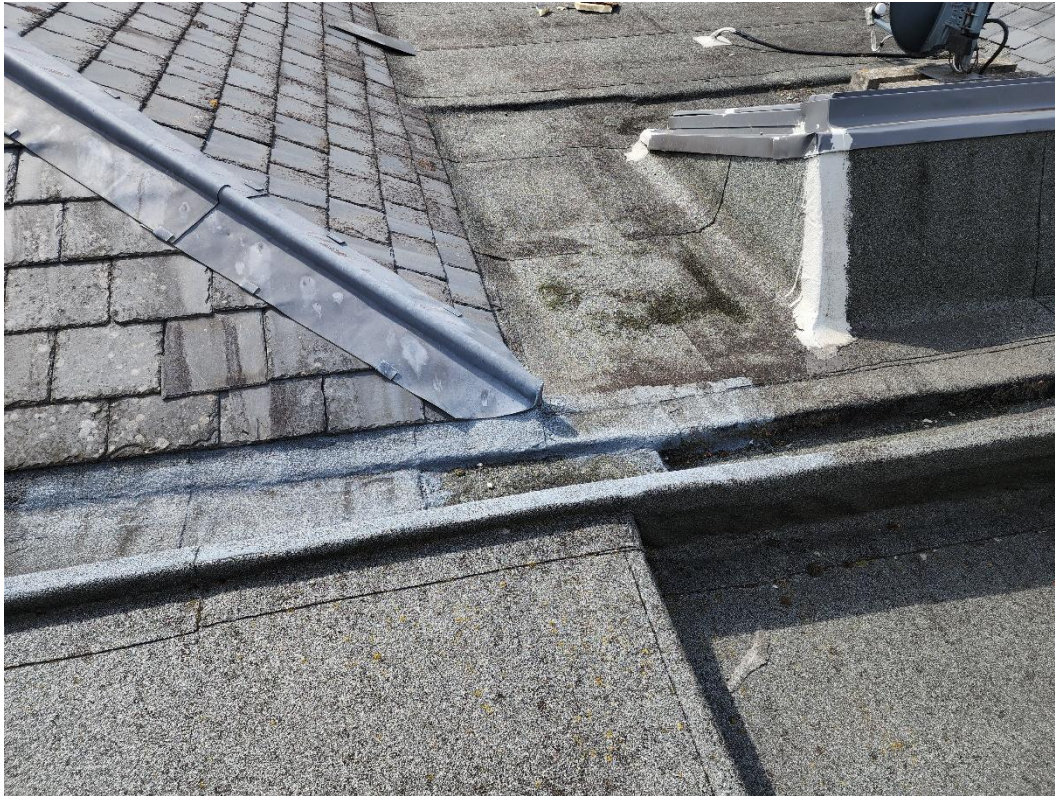
*Photo 14 - Unnecessary detailing to step between Roof 3 and Roof 4. Note liquid applied coating.*

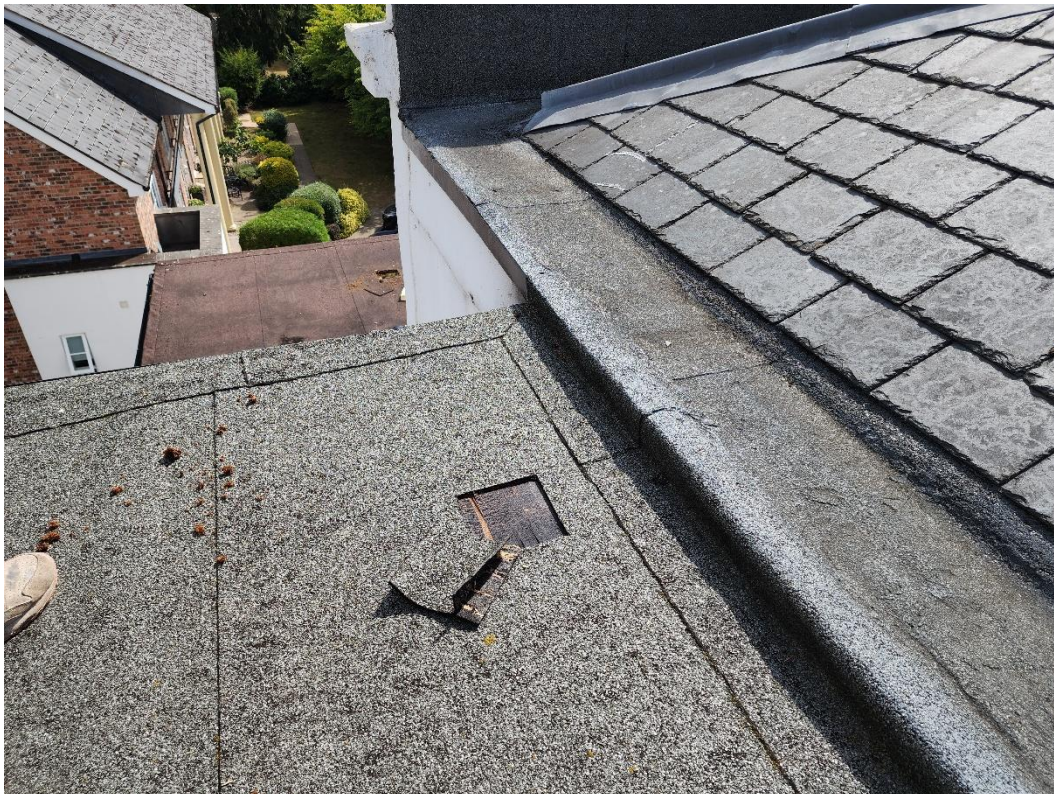
The mineral face cap sheet is in fair condition. The felt is laid directly onto a plywood deck. PIR insulation is visible within the roof void, between the joists.

This creates an unventilated 'cold void' which is vulnerable to condensation.

*Photo 15 – Core sample 5 (Upper section of roof area 4) – Felt directly onto plywood.*

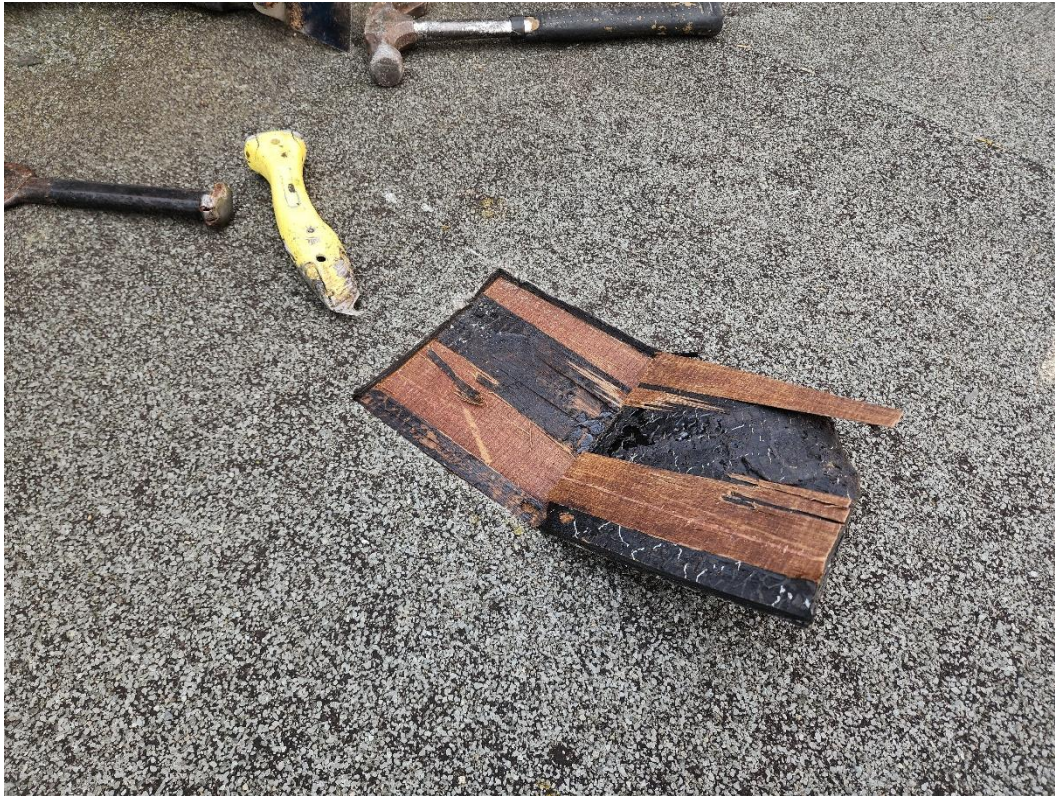
*Photo 16 - Core sample 6 – (Lower section of roof area 4)*

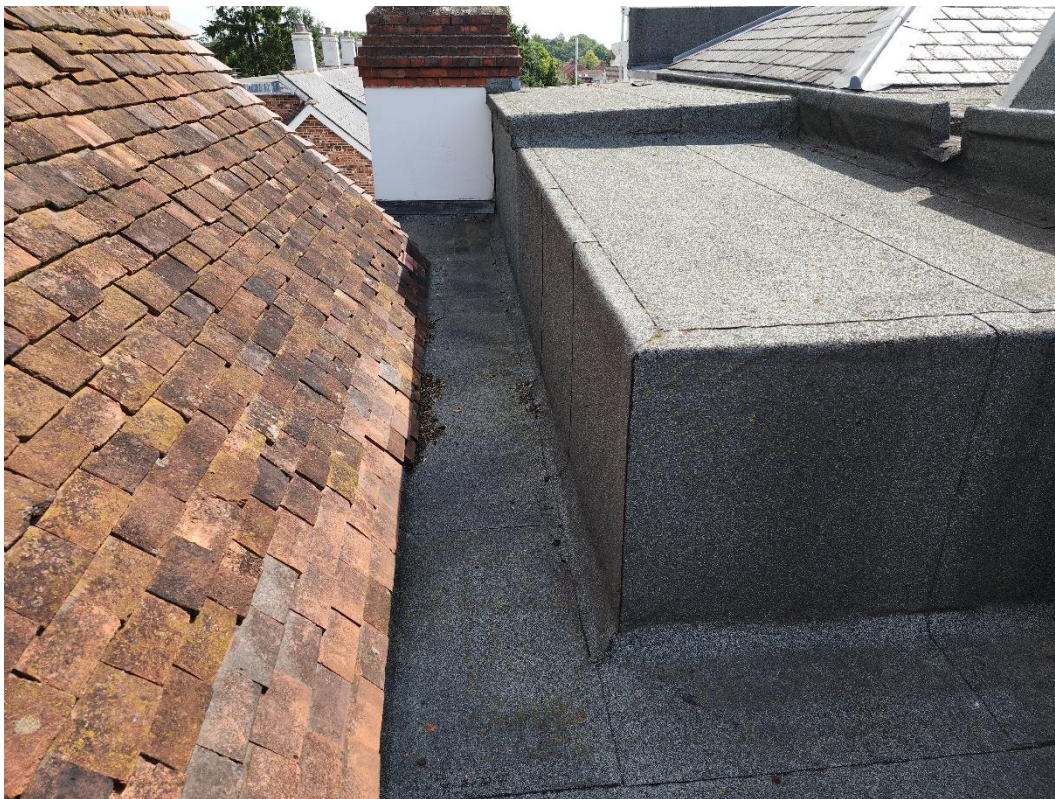
*Photo 17 - View looking towards upper section of roof area 4.*
