***Project ref:TV230727***

# ***CCTV Survey Report***

**CLIENT: ACORN CARE AND EDUCATION LTD**

**SITE: Pheonix College**

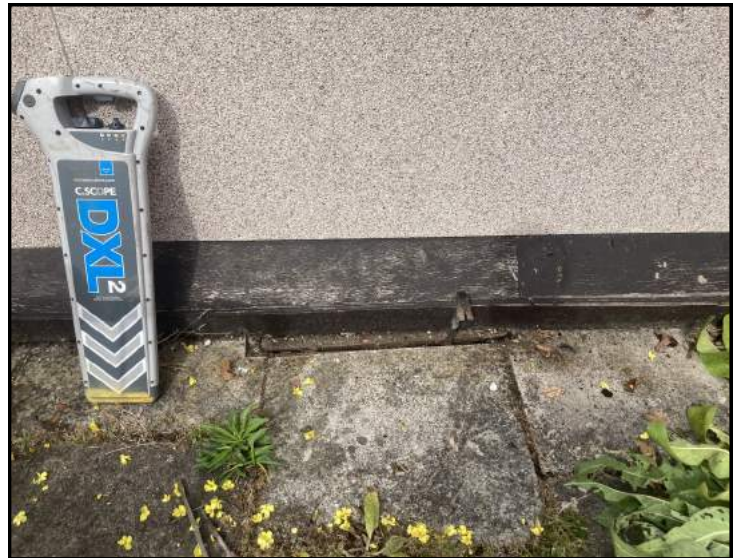
IC2. UNABLE TO FULLY LIFT.  
OBSTRUCTED

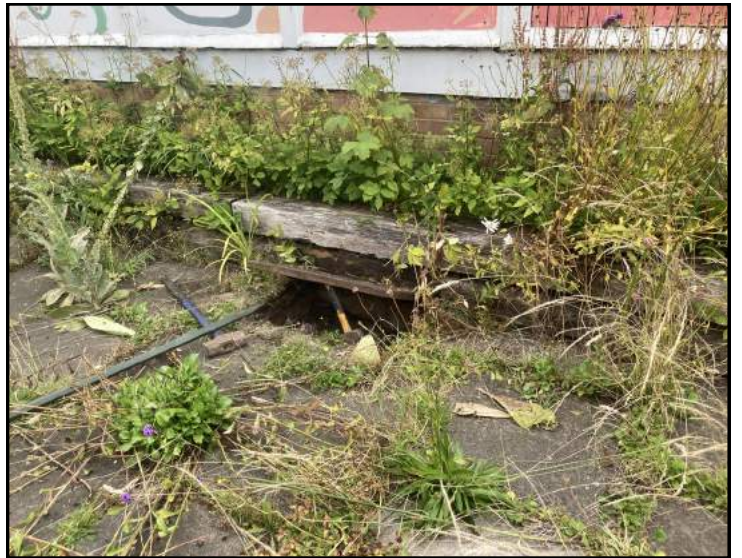
IC3. UNABLE TO FULLY LIFT.  
MANHOLE SILTED

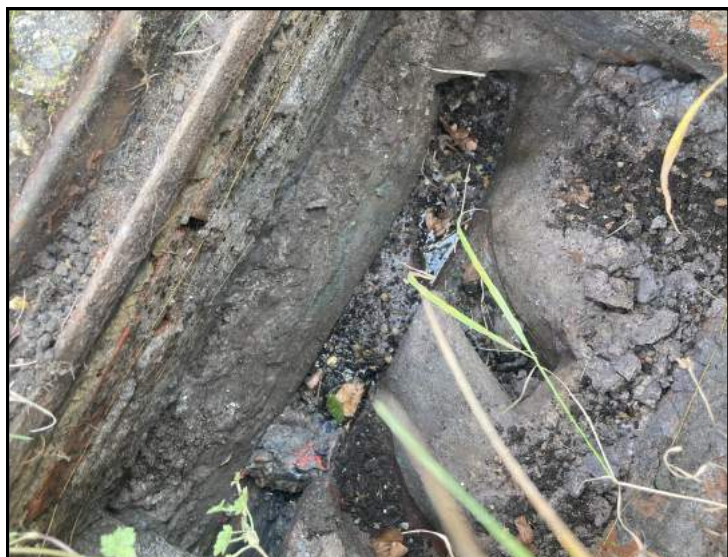
IC4.  
MANHOLE SILTED

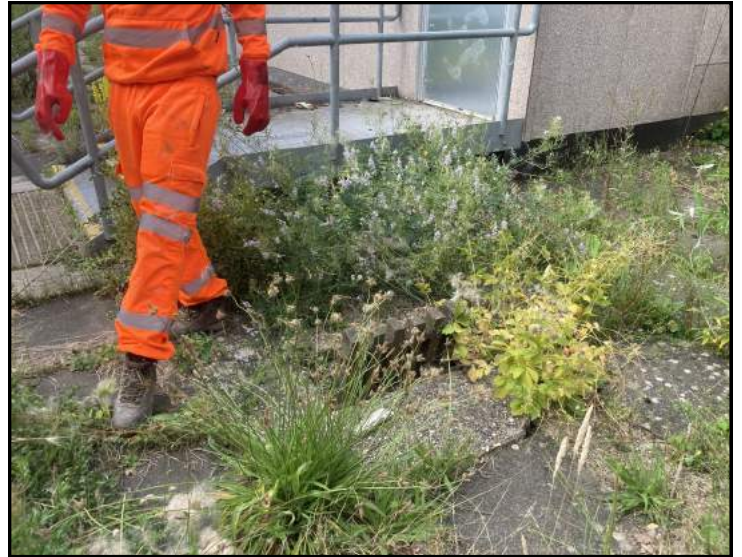
GULLY 1 - DEBRIS FILLED

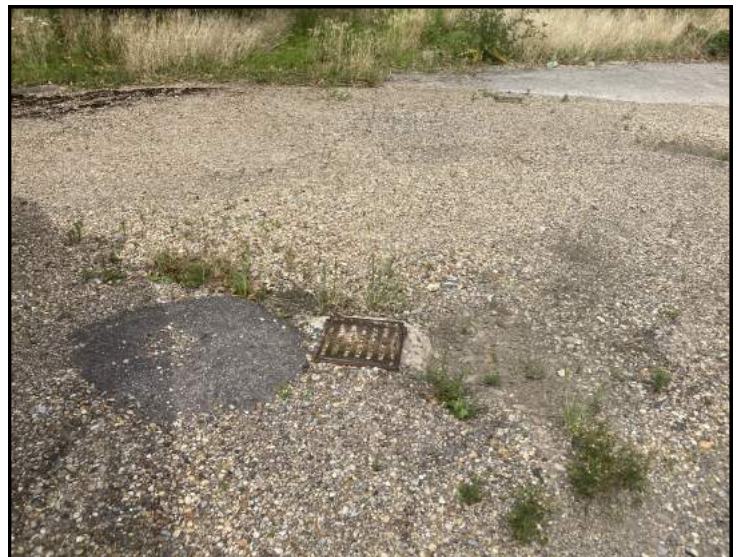
GULLY 2 - DEBRIS FILLED

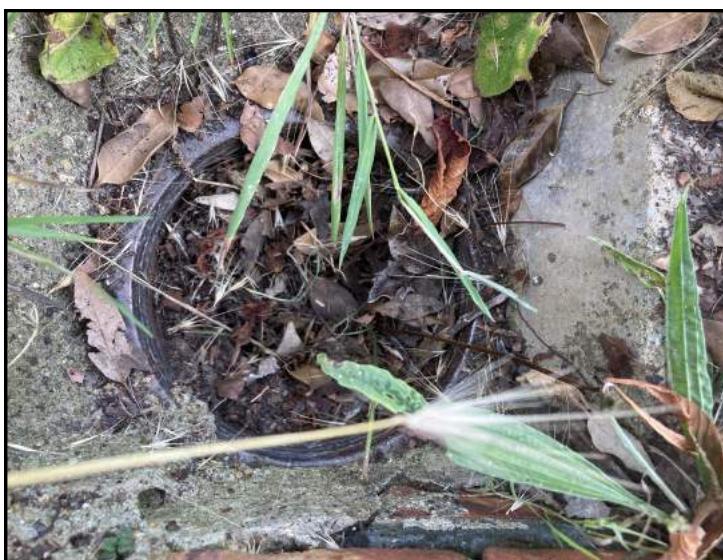
GULLY 3 - SILTED

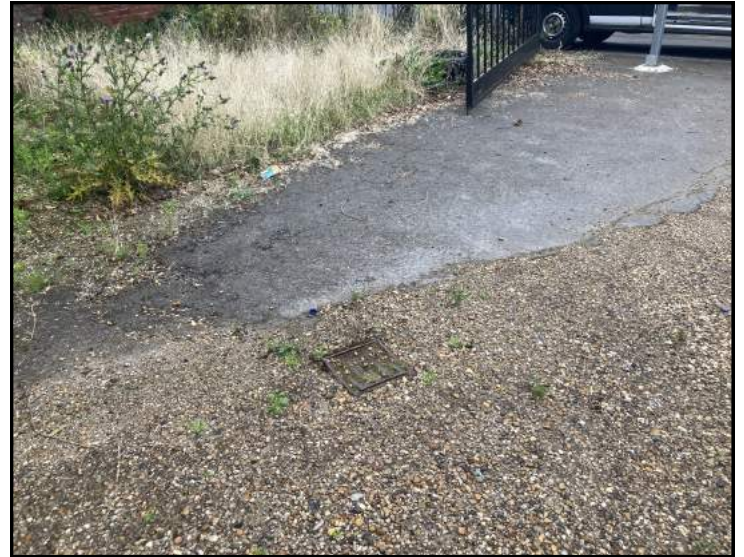
GULLY 4 - DEBRIS FILLED

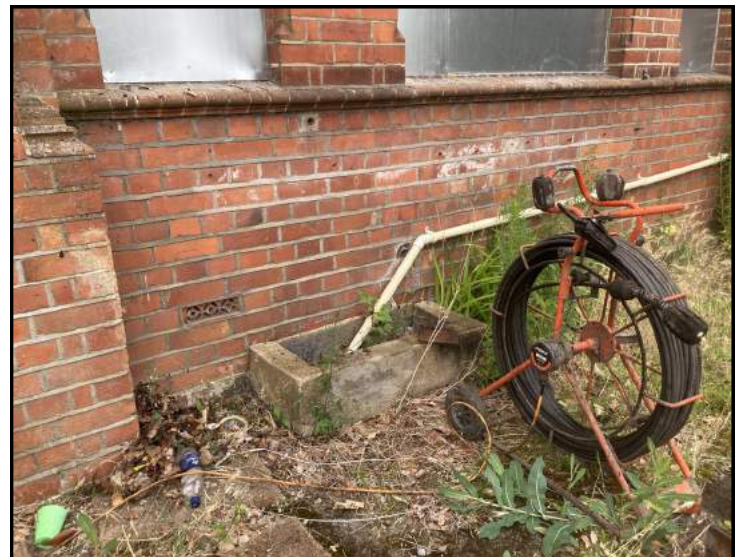
GULLY 5. TRAPPED - NO CCTV

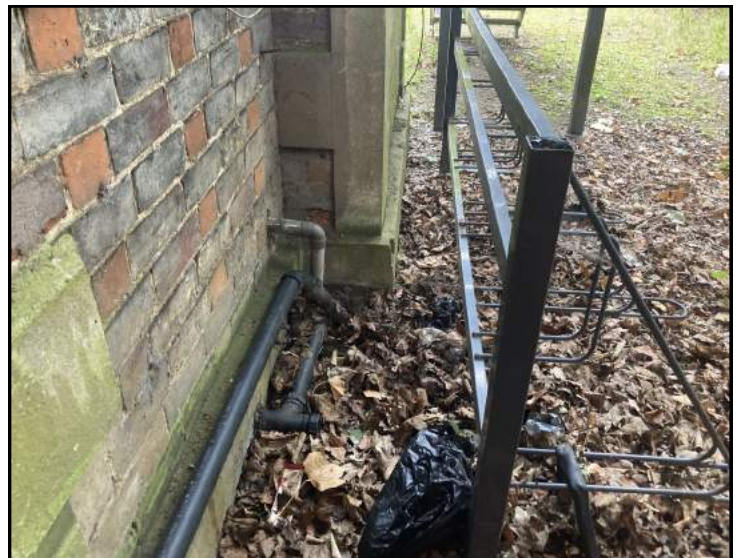
GULLY 6 - DEBRIS FILLED

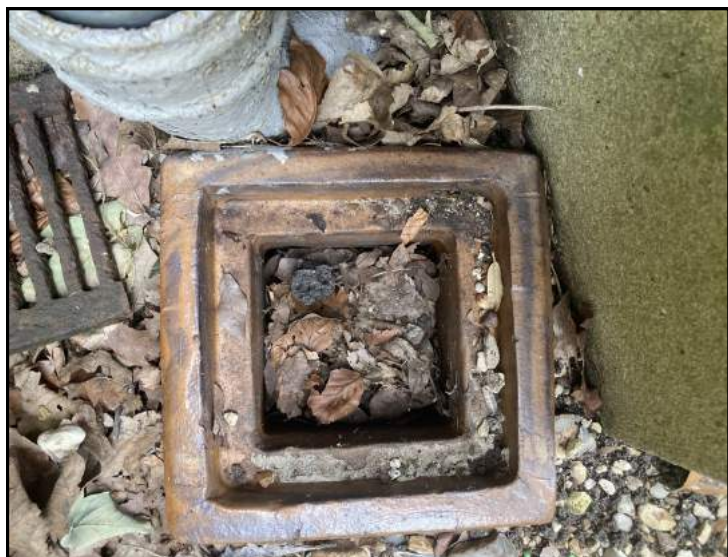
GULLY 7 - DEBRIS FILLED

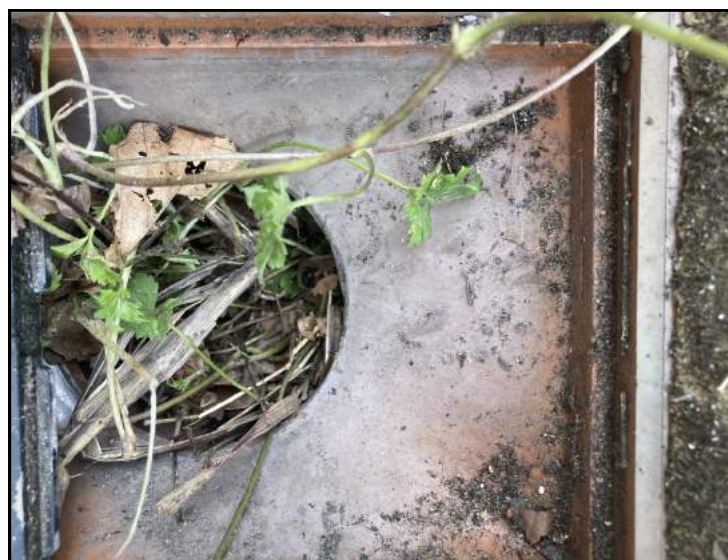
RWP 1 - DEBRIS FILLED

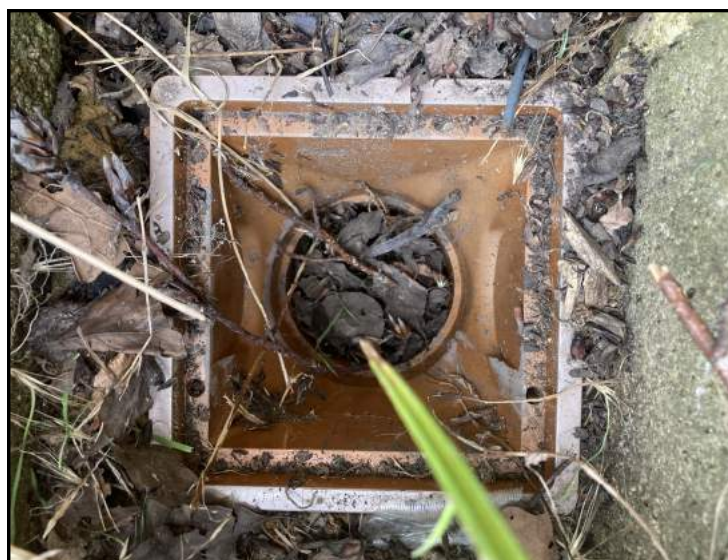
RWP 2 - DEBRIS FILLED

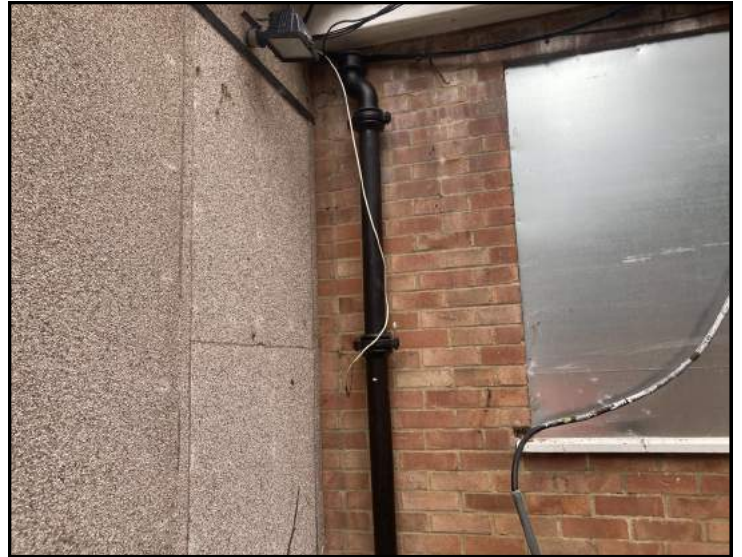
RWP 3 -  
APPEARS TO BE UNCONNECTED

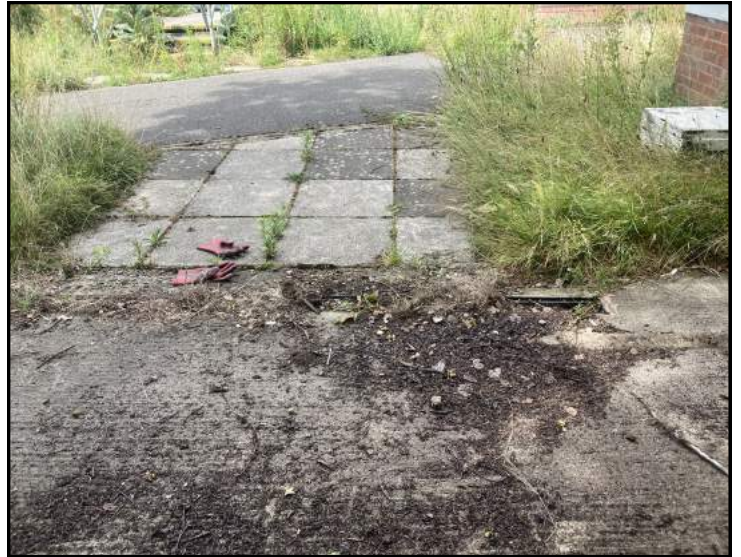
ACO 1. DEBRIS FILLED

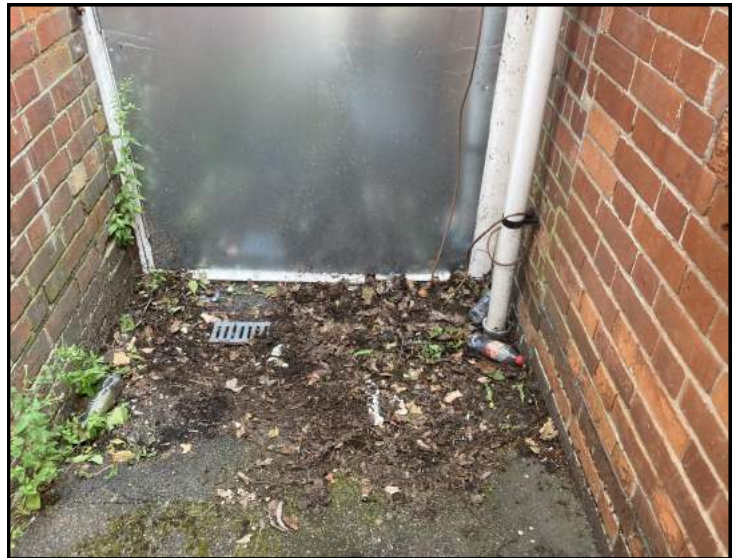
ACO 2 + RWP. DEBRIS FILLED

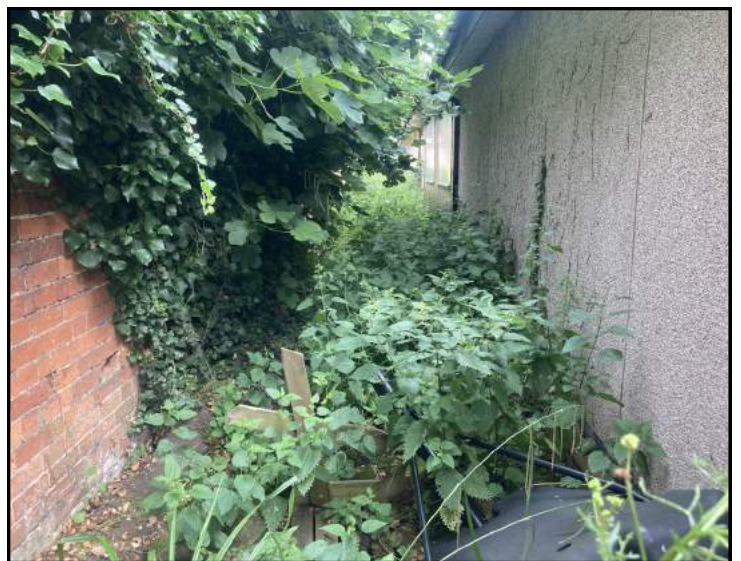
AREA OVERGROWN

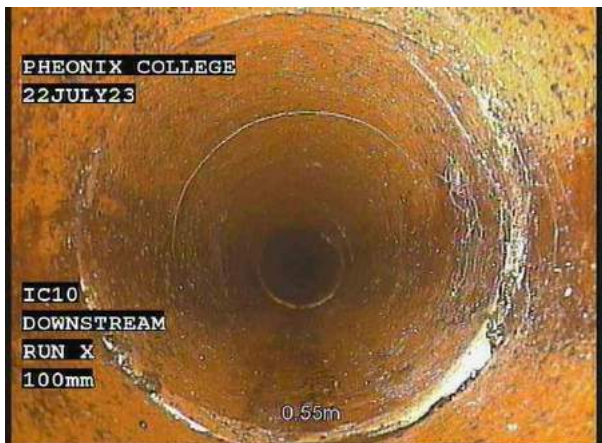
| Scale: 1:54 | Position [m] | Code | Observation | Grade |
|---|---|---|---|---|
| | 0.55 | CC | Crack, circumferential from 09 o'clock to 02 o'clock | 2 / 2 |

1, 00:00:08, 0.55 m  
Crack, circumferential from 09 o'clock to 02 o'clock

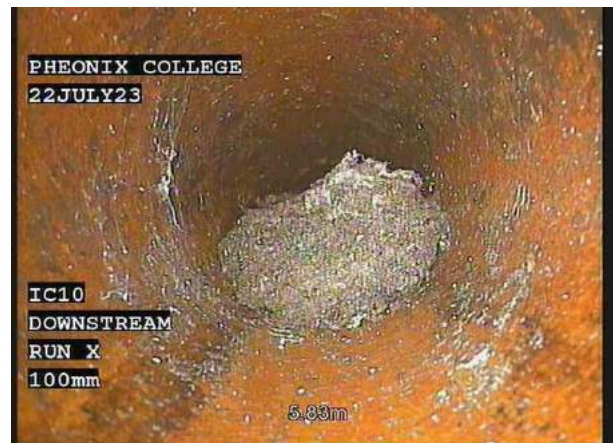
| Section | PLR | Grade | Description |
|---|---|---|---|
| 22 | IC10X | 4 | Settled deposits, hard or compacted, 50% cross-sectional area loss |

2, 00:00:45, 5.83 m  
Settled deposits, hard or compacted, 50% cross-sectional area loss

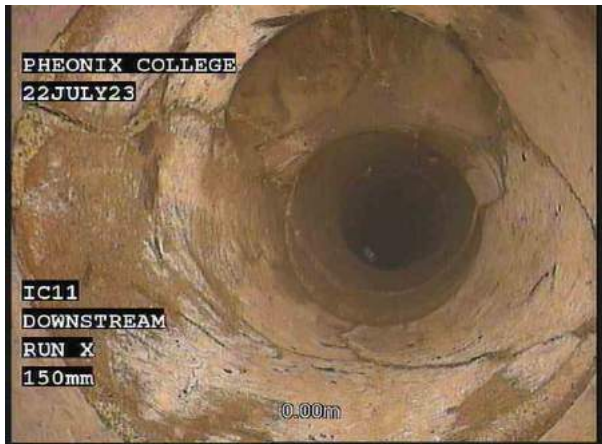
| Section | PLR | Grade | Description |
|---|---|---|---|
| 24 | IC11X | 4 | Fractures, multiple from 12 o'clock to 12 o'clock |

| Scale: | 1:50 | Position [m] | Code | Observation | Grade |
|---|---|---|---|---|---|
| | 0.00 | FM | Fractures, multiple from 12 o'clock to 12 o'clock | 4 / 2 | <br>FM - 0.00 |

1, 00:00:04, 0.00 m  
Fractures, multiple from 12 o'clock to 12 o'clock

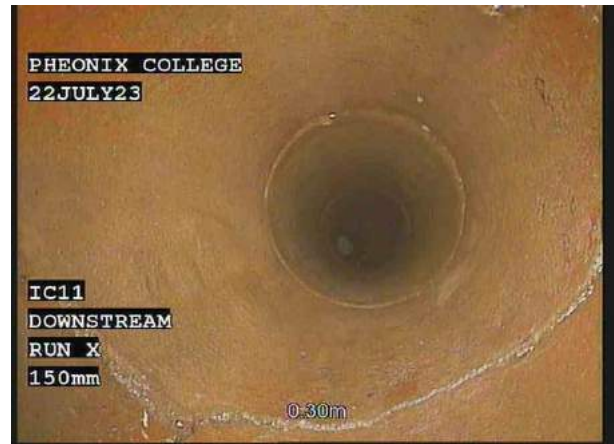
| Scale: | 1:50 | Position [m] | Code | Observation | Grade |
|---|---|---|---|---|---|
| | 0.30 | FCJ | Fracture, circumferential at joint from 03 o'clock to 09 o'clock | 3 / 2 | <br>FCJ - 0.30 |

2, 00:00:24, 0.30 m  
Fracture, circumferential at joint from 03 o'clock to 09 o'clock

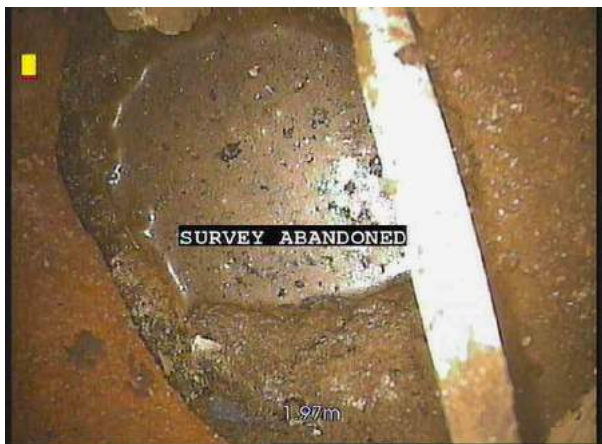
3, 00:01:18, 1.97 m  
Survey abandoned, Unable to continue - assumed debris filled  
interceptor / trap

| Section number | Upstream manhole | Flow direction | Downstream manhole | Recommendations |
|---|---|---|---|---|
| 24 | IC11 | Downstream | RUN X | Consider excavating to expose outgoing pipe to continue/complete survey |
