## Window Condition Survey at

189 Oxford Road  
Reading  
RG1 7UZ

### Metropolitan Thames Valley

Tel: [01689 885080](tel:01689885080)  
Email: [elliekeattch@effefftee.co.uk](mailto:elliekeattch@effefftee.co.uk)  
Date: 21/07/2025  
Project No: T1-7039

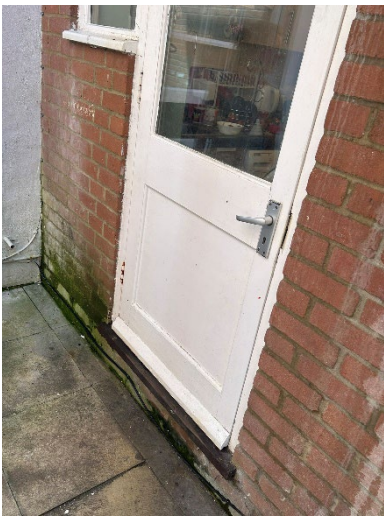
| Photo Name | Photograph |
|---|---|
| Rear patio timber door condition. | |

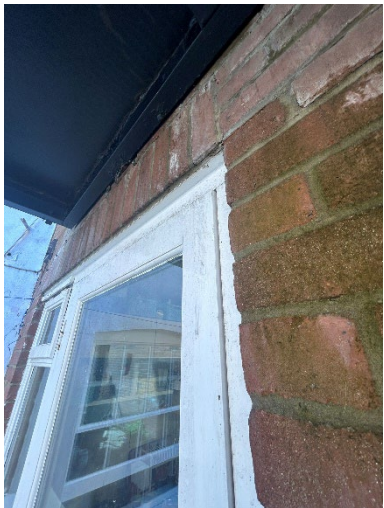
| Photo Name | Photograph |
|---|---|
| Rear patio timber door condition. | |

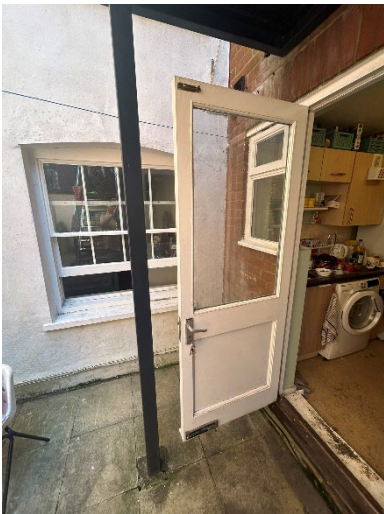
| Photo Name | Photograph |
|---|---|
| Rear patio timber door condition. | |

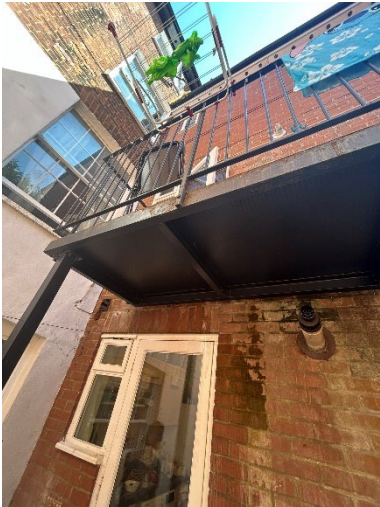
| Photo Name | Photograph |
|---|---|
| Rear patio timber door condition. | |

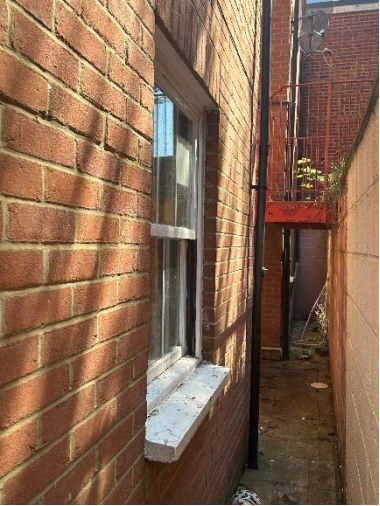
| Photo Name | Photograph |
|---|---|
| Rear sash window condition. | |

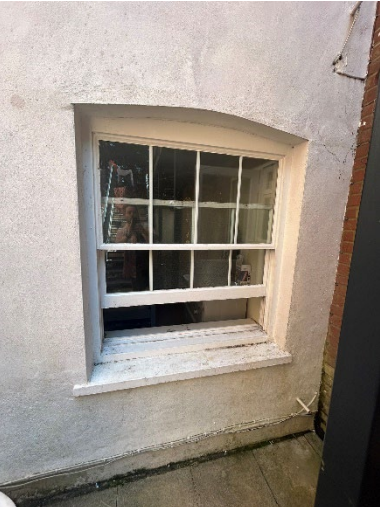
| Photo Name | Photograph |
|---|---|
| Rear sash window condition. | |

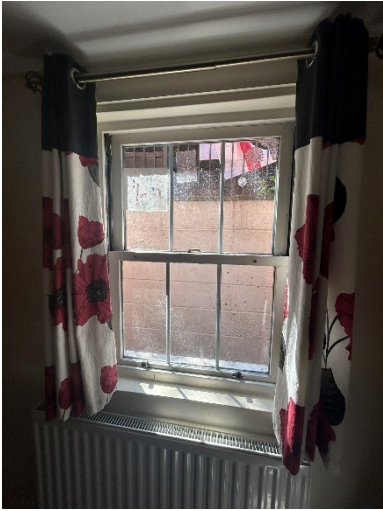
| Photo Name | Photograph |
|---|---|
| Rear sash condition, internal view. | |

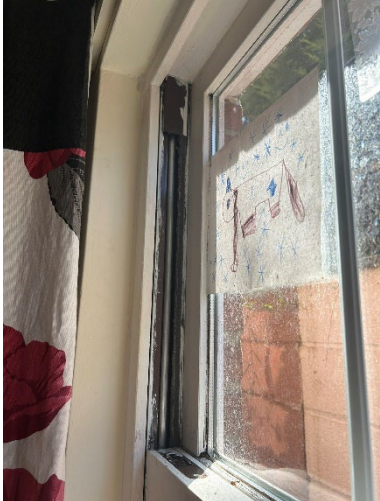
| Photo Name | Photograph |
|---|---|
| Rear sash window internal sash condition. | |

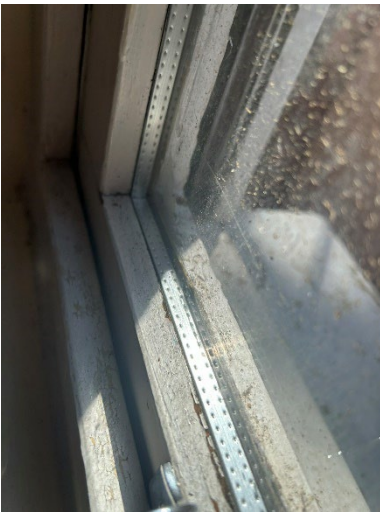
| Photo Name | Photograph |
|---|---|
| Rear sash double glazing | |

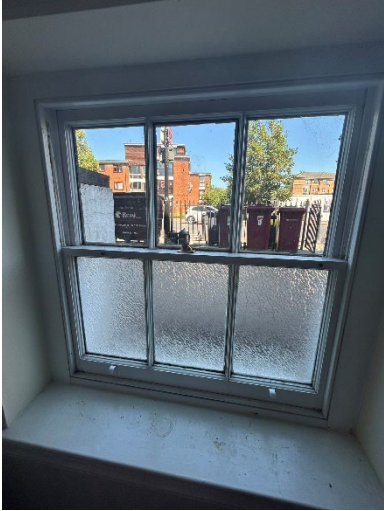
| Photo Name | Photograph |
|---|---|
| Internal view of front sash window. | <p>A photograph showing the interior of a front sash window. The window has a dark frame and is divided into three vertical panes. The top panes are clear, showing a view of a street with buildings and trees. The bottom panes are frosted. The window is set into a light-colored wall, and a white windowsill is visible below the panes.</p> |

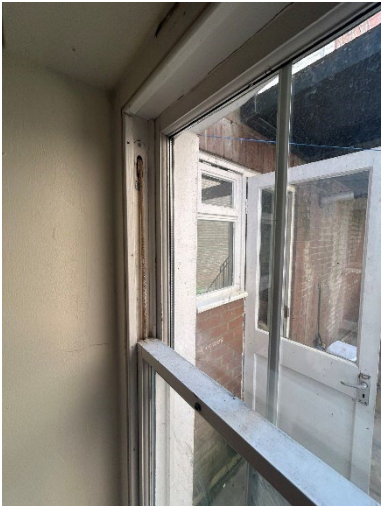
| Photo Name | Photograph |
|---|---|
| Internal view of rear sash window including sash pulley cord. | <p>A photograph showing the interior of a rear sash window. The window is partially open, revealing a white door with a glass panel. A sash pulley cord is visible on the left side of the window frame. The window is set into a light-colored wall.</p> |

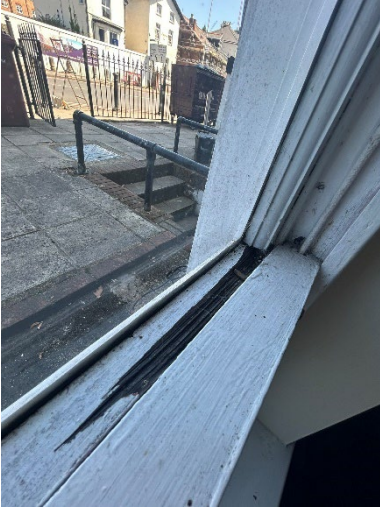
| Photo Name | Photograph |
|---|---|
| Internal condition of front timber sash window, decay of meeting rail. | |

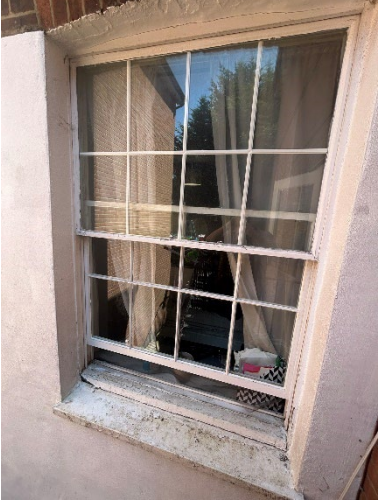
| Photo Name | Photograph |
|---|---|
| 189b Oxford Road<br><br>Rear sash windows condition. | |

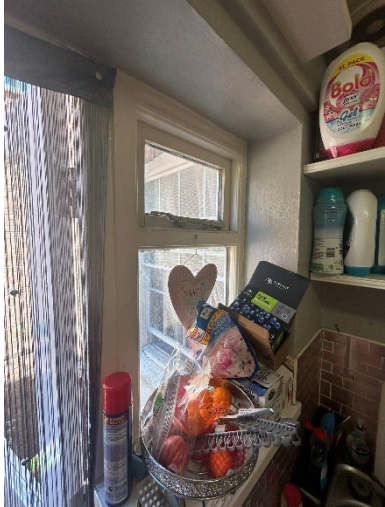
| Photo Name | Photograph |
|---|---|
| Internal condition of rear casement window. | |

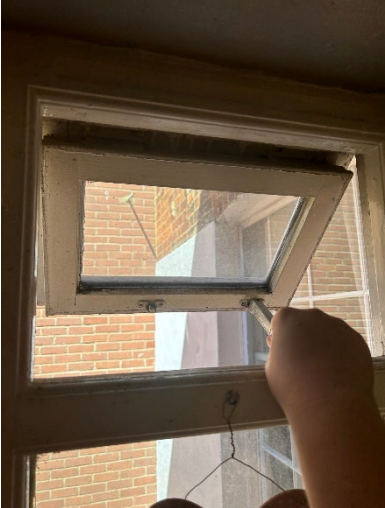
| Photo Name | Photograph |
|---|---|
| Internal condition of rear casement window. | |

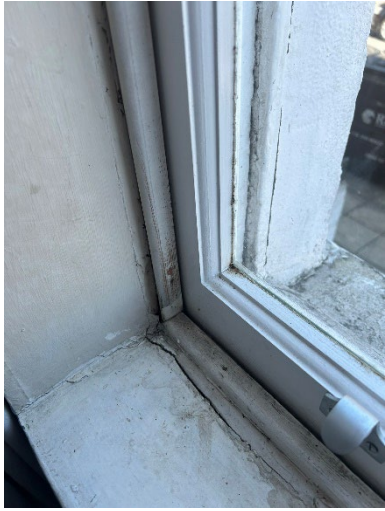
| Photo Name | Photograph |
|---|---|
| Internal condition of front sash window and draught excluder. | |

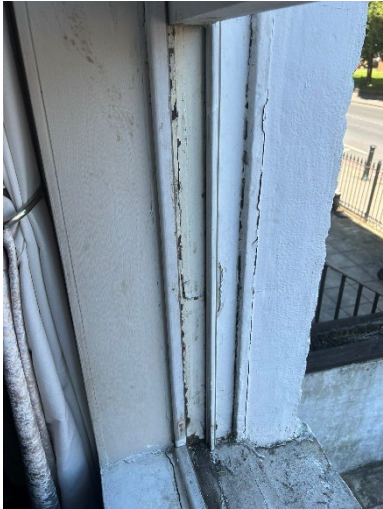
| Photo Name | Photograph |
|---|---|
| Condition of front sash window showing signs of decay. | |

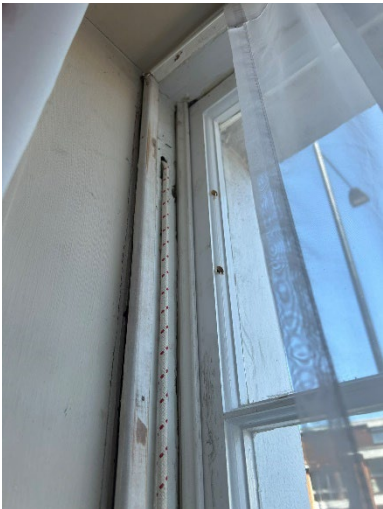
| Photo Name | Photograph |
|---|---|
| Internal condition of front sash window and pulley cord. | |

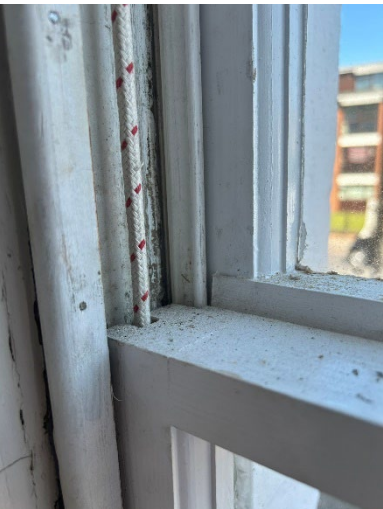
| Photo Name | Photograph |
|---|---|
| Internal condition of front sash window and pulley cord. | |

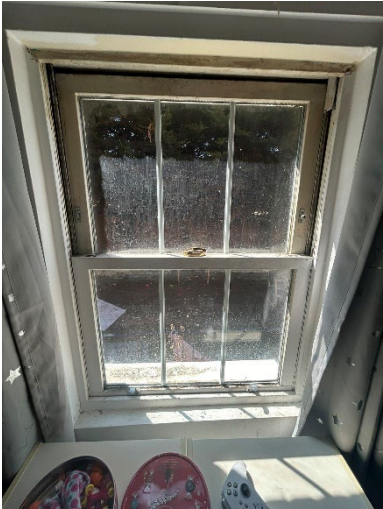
| Photo Name | Photograph |
|---|---|
| Internal condition of rear sash window. | |

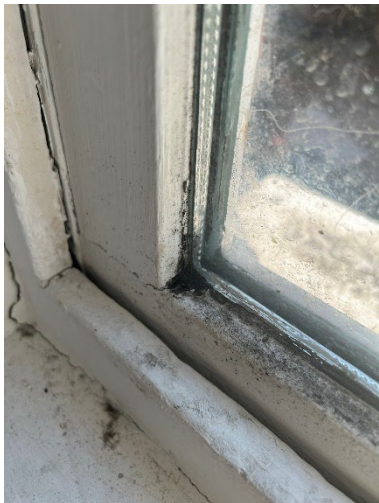
| Photo Name | Photograph |
|---|---|
| Internal condition of rear sash window, showing signs of mould growth and decay. | |

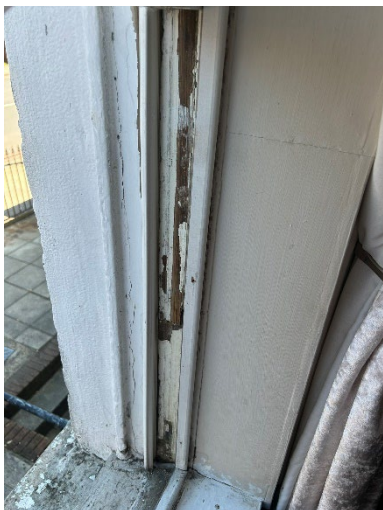
| Photo Name | Photograph |
|---|---|
| Internal front box sash window condition, showing signs of decay. | |

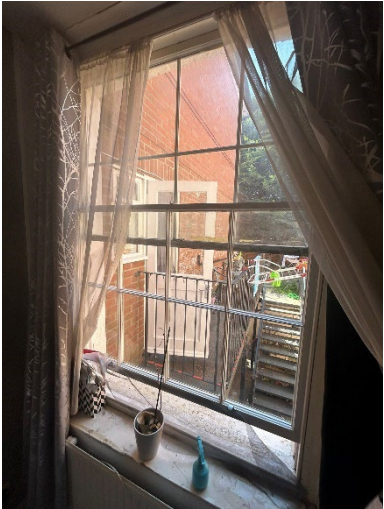
| Photo Name | Photograph |
|---|---|
| Internal rear sash window condition. | |

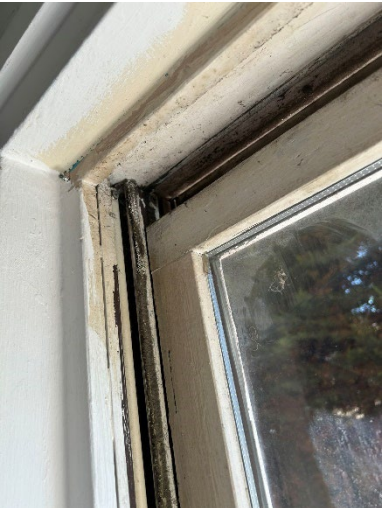
| Photo Name | Photograph |
|---|---|
| Internal rear sash window condition including sash pulley cord. | |

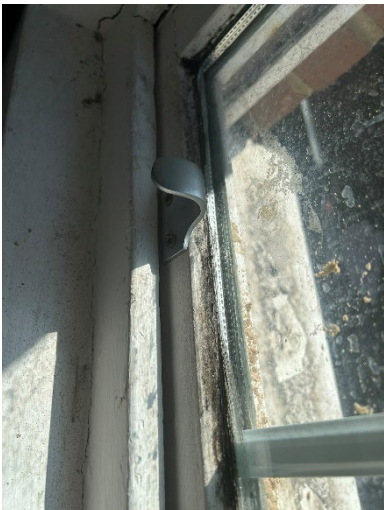
| Photo Name | Photograph |
|---|---|
| Internal rear sash window condition including bottom rail and non-original window handles. | |

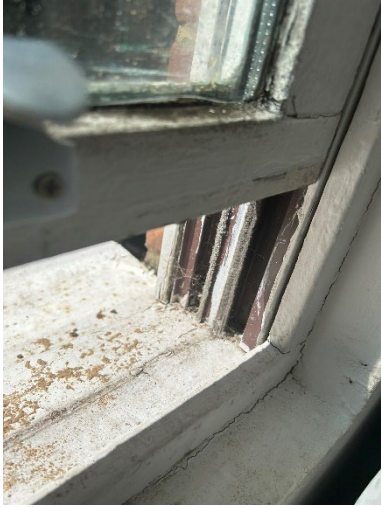
| Photo Name | Photograph |
|---|---|
| Internal condition of rear window, including non-original metal box sash frame. | |

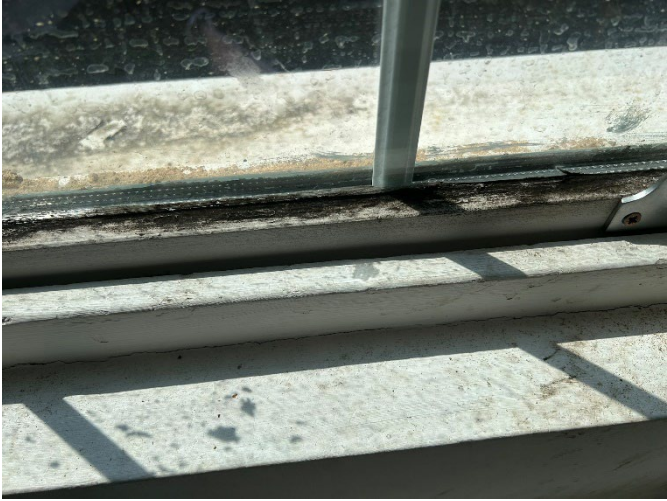
| Photo Name | Photograph |
|---|---|
| Internal condition of rear window, including bottom rail showing signs of decay. | |

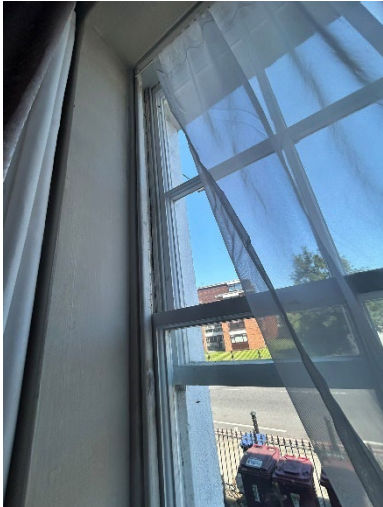
| Photo Name | Photograph |
|---|---|
| Internal condition of front sash window. | |

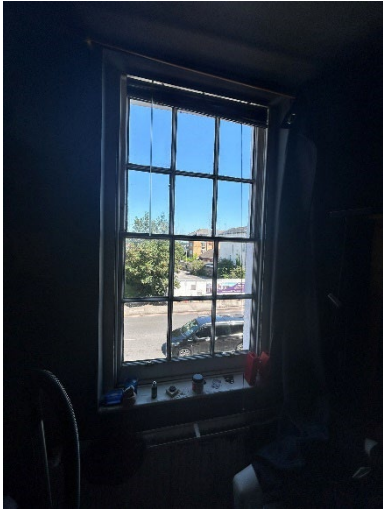
| Photo Name | Photograph |
|---|---|
| <p>189c Oxford Road</p> <p>Internal condition of front sash window.</p> | |

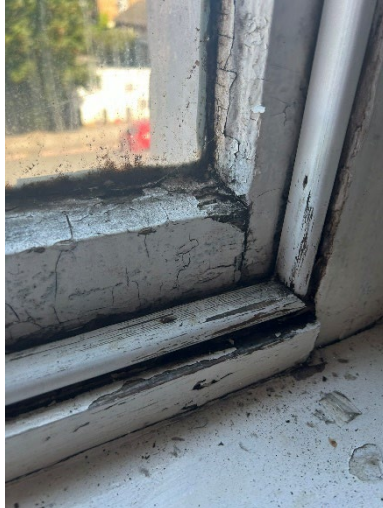
| Photo Name | Photograph |
|---|---|
| <p>Internal condition of front sash window showing signs of decay to the bottom rail, draught excluder and cill.</p> | |

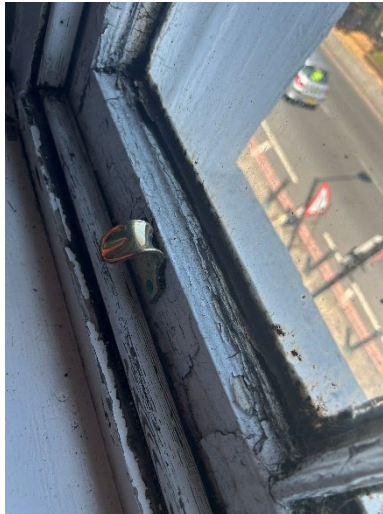
| Photo Name | Photograph |
|---|---|
| <p>Internal condition of front sash window showing signs of decay to the bottom rail, draught excluder and cill.</p> | |

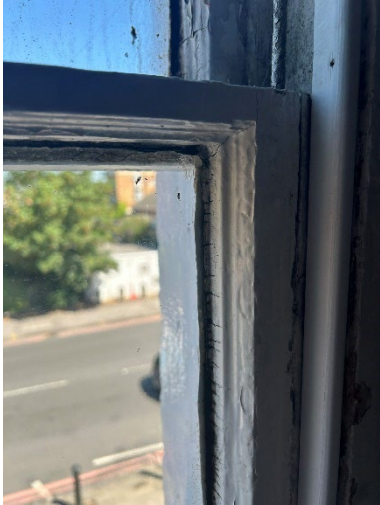
| Photo Name | Photograph |
|---|---|
| Internal condition of front sash window showing signs of decay to the box sash. | |

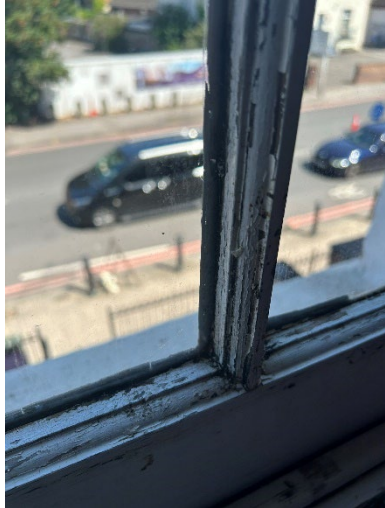
| Photo Name | Photograph |
|---|---|
| Internal condition of front sash window showing signs of decay to the glazing bar. | |

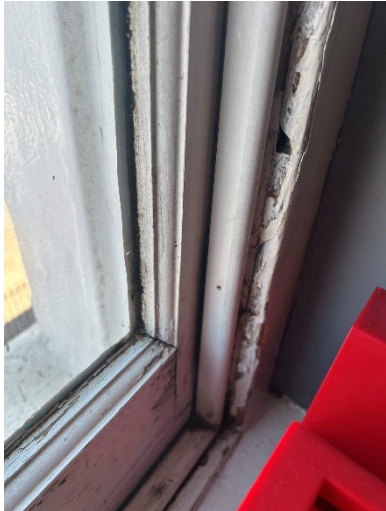
| Photo Name | Photograph |
|---|---|
| Internal condition of front sash window showing signs of decay to the box sash. | |

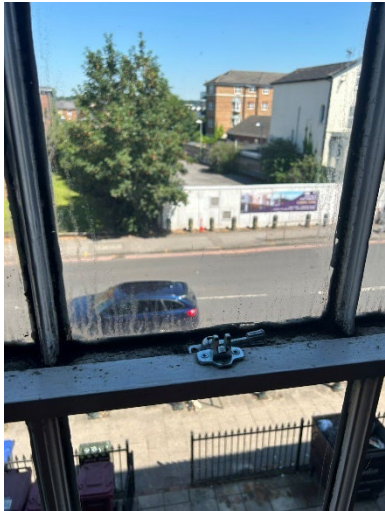
| Photo Name | Photograph |
|---|---|
| Internal condition of front sash window showing signs of decay to the meeting rail and mould growth. | |

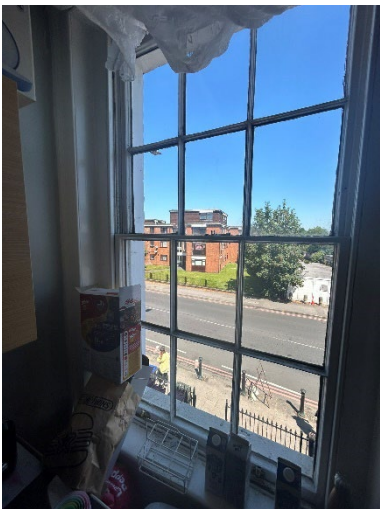
| Photo Name | Photograph |
|---|---|
| Internal condition of front sash kitchen window. | |

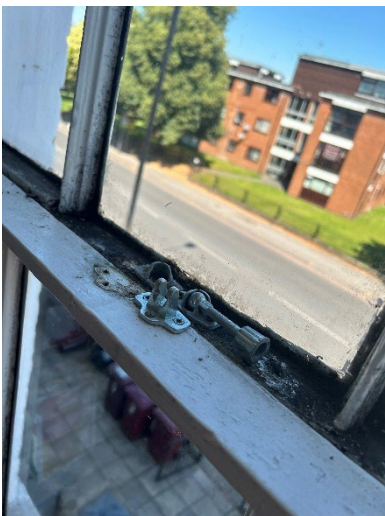
| Photo Name | Photograph |
|---|---|
| Condition of front sash kitchen window showing signs of mould growth and decay. Non-original metal ironmongery. | |

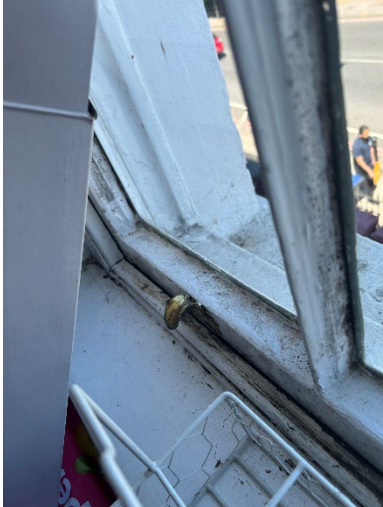
| Photo Name | Photograph |
|---|---|
| Condition of front sash kitchen window showing signs of mould growth and decay. | |

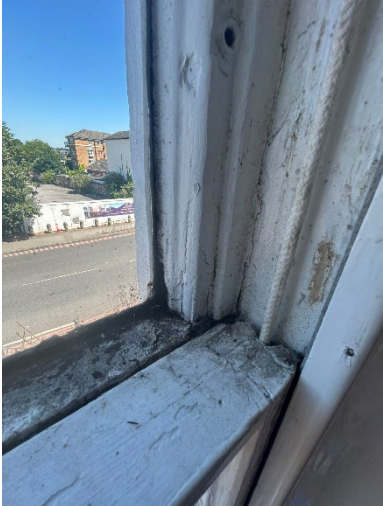
| Photo Name | Photograph |
|---|---|
| Condition of front sash kitchen window showing signs of mould growth and decay to the meeting rail. | |

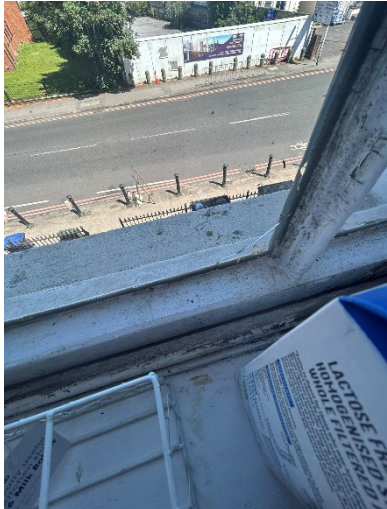
| Photo Name | Photograph |
|---|---|
| Condition of front sash kitchen window. | |

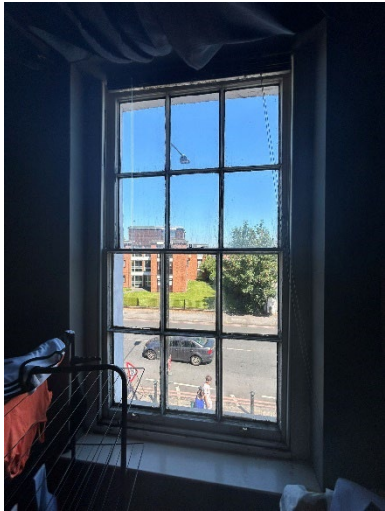
| Photo Name | Photograph |
|---|---|
| Internal condition of front sash bedroom window. | |

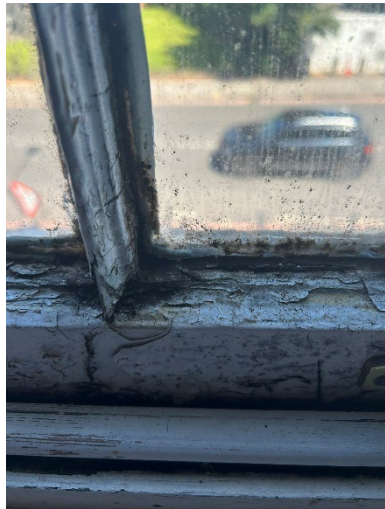
| Photo Name | Photograph |
|---|---|
| Internal condition of front sash bedroom window showing signs of decay to the bottom rail and glazing bars. | |

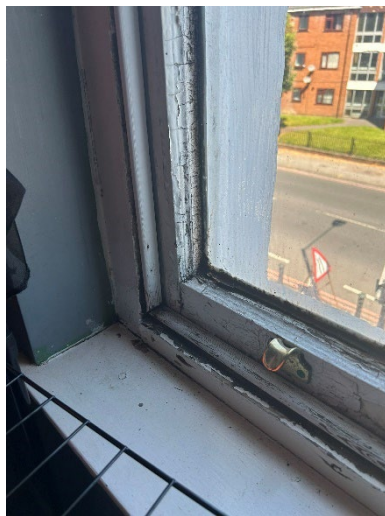
| Photo Name | Photograph |
|---|---|
| Internal condition of front sash bedroom window showing signs of decay to the bottom rail and glazing bars. | |

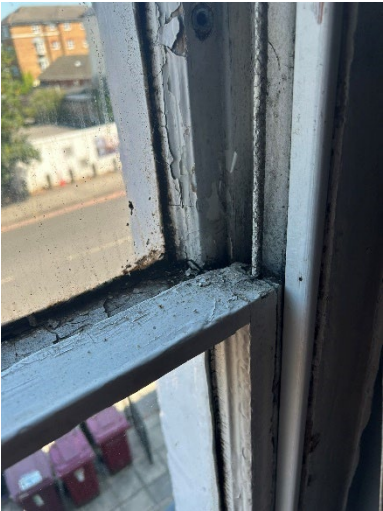
| Photo Name | Photograph |
|---|---|
| Internal condition of front sash bedroom window showing signs of decay to the meeting rail. | |

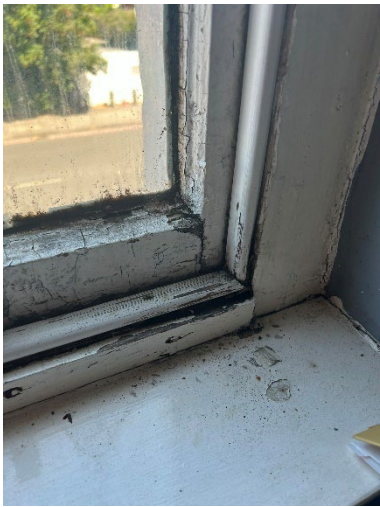
| Photo Name | Photograph |
|---|---|
| Internal condition of front sash bedroom window showing signs of decay to the bottom rail and draught excluders. | |

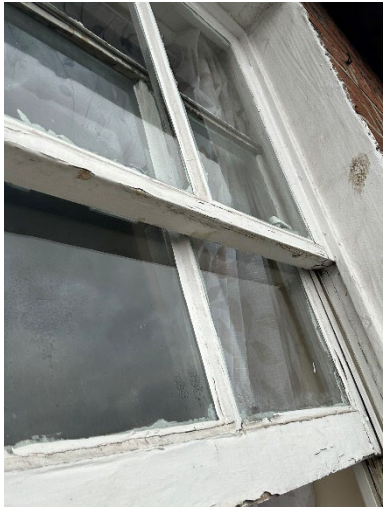
| Photo Name | Photograph |
|---|---|
| <p>189d Oxford Road</p> <p>External condition of front window.</p> | |

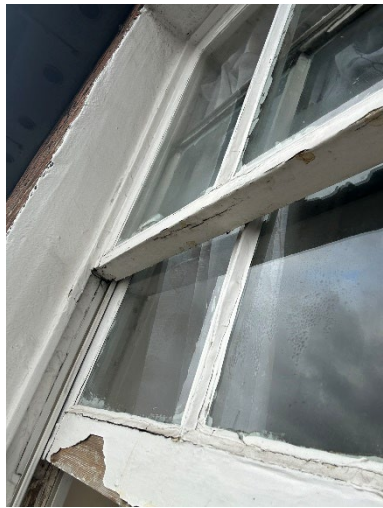
| Photo Name | Photograph |
|---|---|
| <p>External condition of front window showing paint missing and decay to the underside of the meeting rail.</p> | |

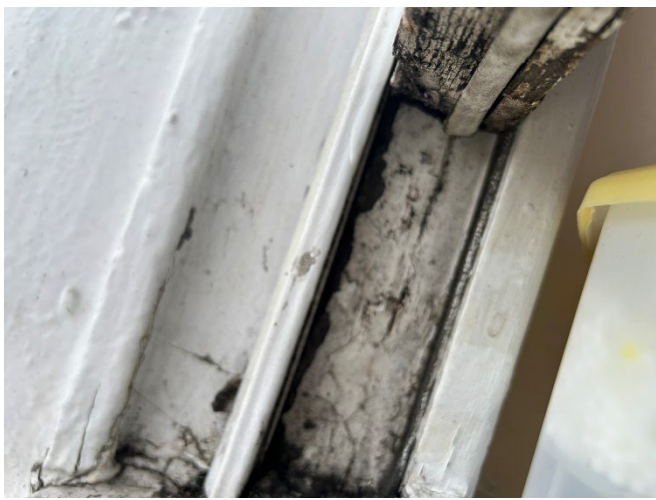
| Photo Name | Photograph |
|---|---|
| <p>Internal condition of the box sash window showing signs of decay.</p> | |

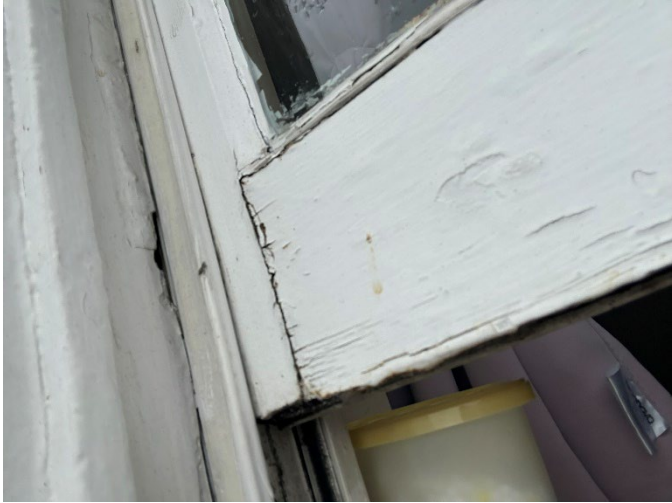
| Photo Name | Photograph |
|---|---|
| Internal condition of the box sash window showing signs of decay. | |

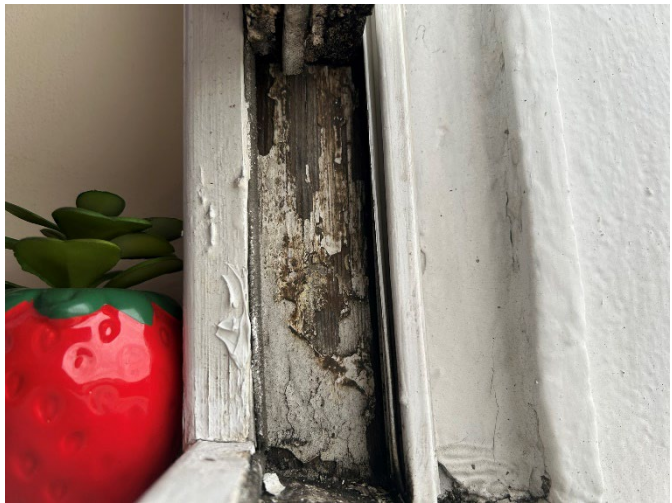
| Photo Name | Photograph |
|---|---|
| Internal condition of the box sash window showing signs of decay. | |

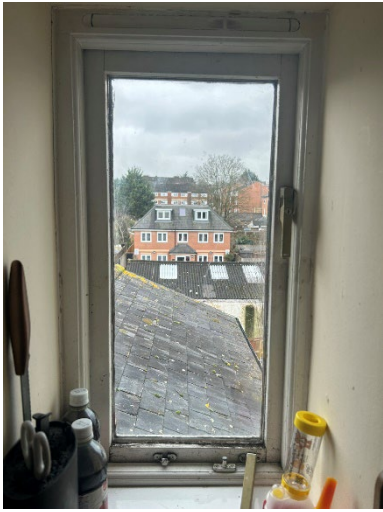
| Photo Name | Photograph |
|---|---|
| Internal condition of timber casement window. | |

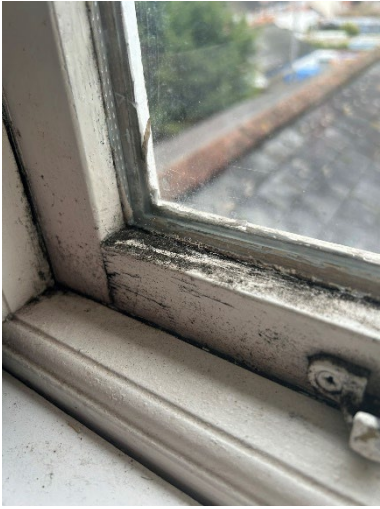
| Photo Name | Photograph |
|---|---|
| Internal condition of the casement window showing signs of decay on the lower frame. | |

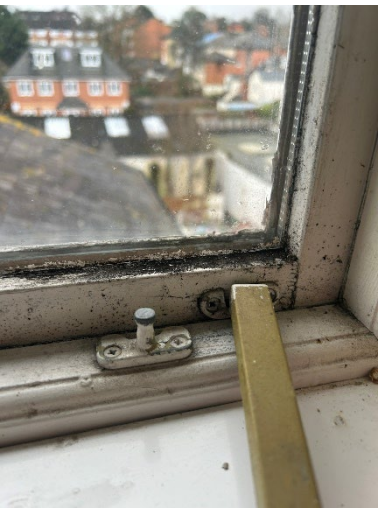
| Photo Name | Photograph |
|---|---|
| Internal condition of the casement window showing signs of decay on the lower frame. | |

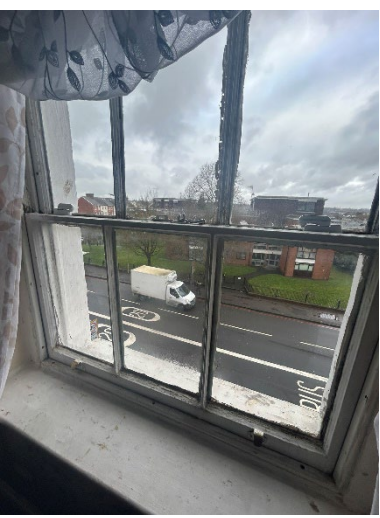
| Photo Name | Photograph |
|---|---|
| Internal condition of the front sash window. | |

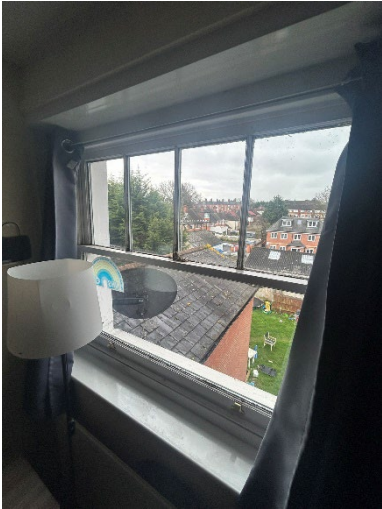
| Photo Name | Photograph |
|---|---|
| Internal condition of the rear sash window. | |

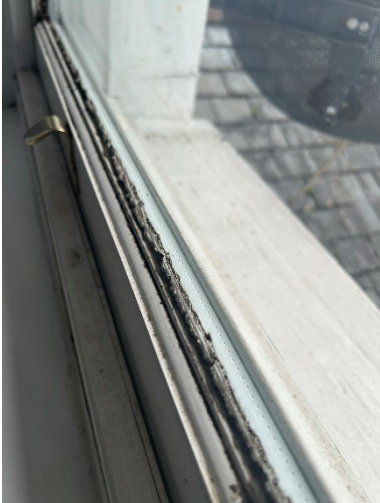
| Photo Name | Photograph |
|---|---|
| Internal condition of the rear sash window including double glazing and excess putty. | |

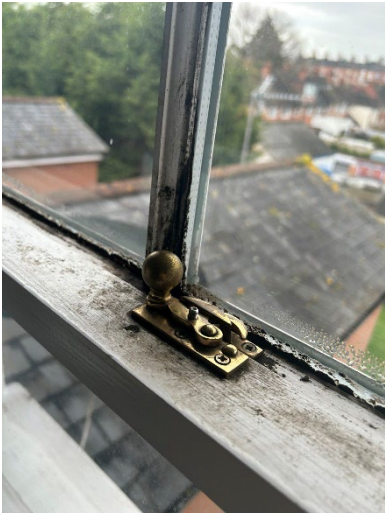
| Photo Name | Photograph |
|---|---|
| Internal condition of the rear sash window including brass ironmongery. | |

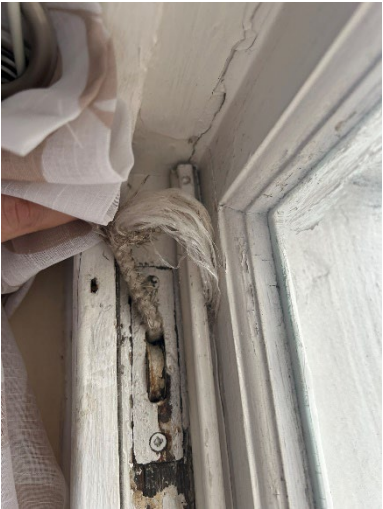
| Photo Name | Photograph |
|---|---|
| Internal condition of rear sash window showing broken sash pulley cord. | |

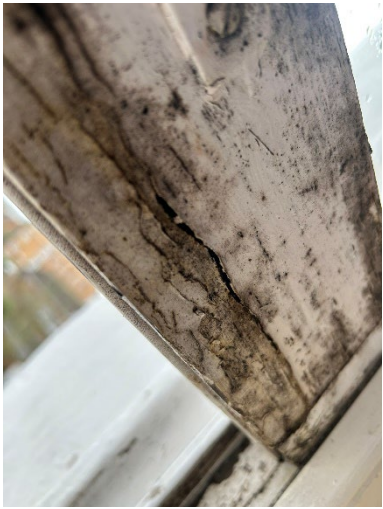
| Photo Name | Photograph |
|---|---|
| Internal condition of rear sash window showing timber decay. | |

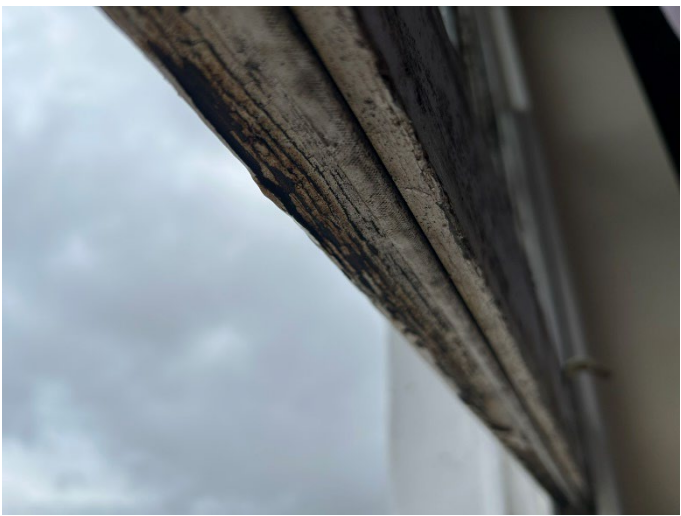
| Photo Name | Photograph |
|---|---|
| Internal condition of rear sash window showing timber decay. | |

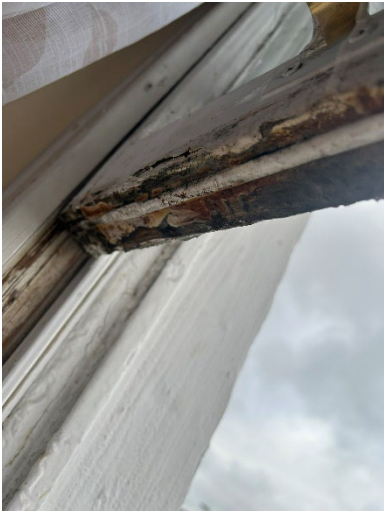
| Photo Name | Photograph |
|---|---|
| Internal condition of rear sash window showing timber decay to the underside of the bottom rail. | |

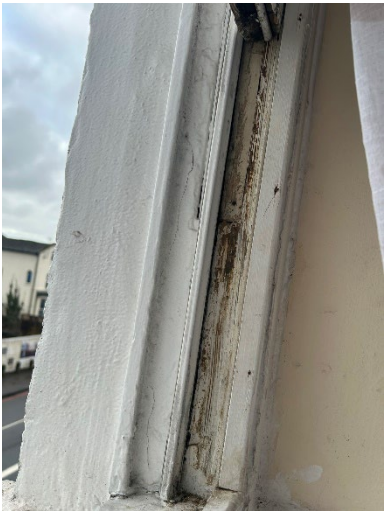
| Photo Name | Photograph |
|---|---|
| Internal condition of rear sash window showing timber decay to the internal box sash. | |

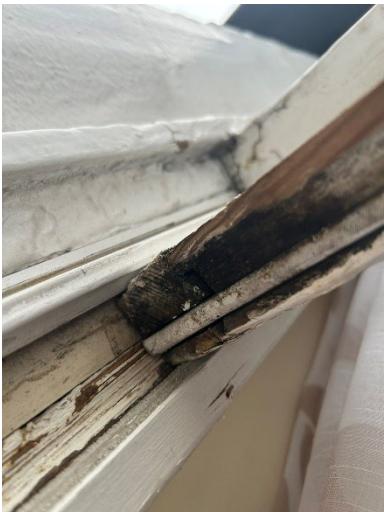
| Photo Name | Photograph |
|---|---|
| Internal condition of rear sash window showing timber decay to the underside of the lower sash. | |

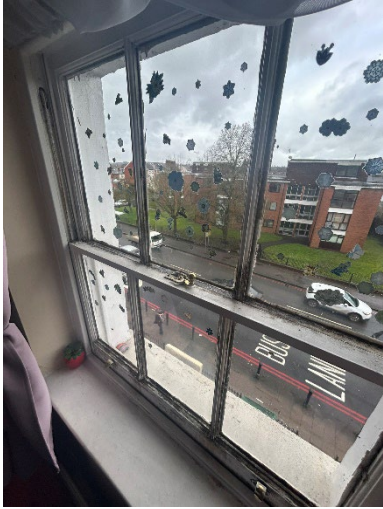
| Photo Name | Photograph |
|---|---|
| Internal condition of rear front sash timber window. | |

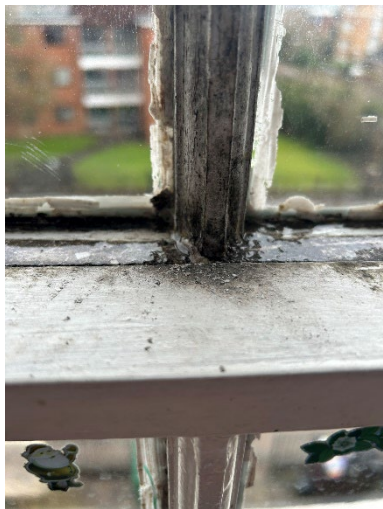
| Photo Name | Photograph |
|---|---|
| Internal condition of front sash timber window and glazing bars. | |

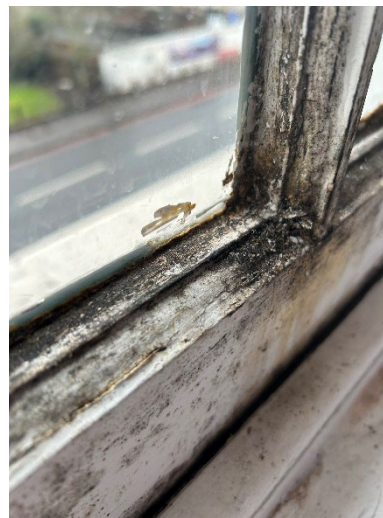
| Photo Name | Photograph |
|---|---|
| Internal condition of front sash timber window and glazing bars. | |

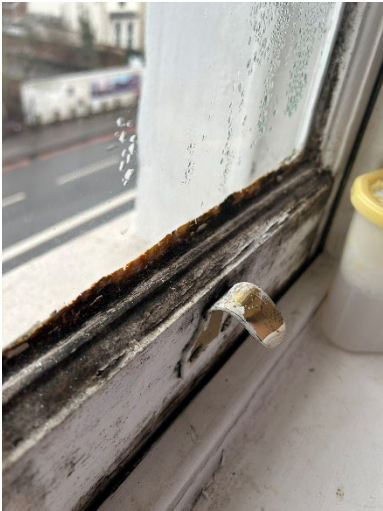
| Photo Name | Photograph |
|---|---|
| Internal condition of front sash timber window and bottom rail decay. | |

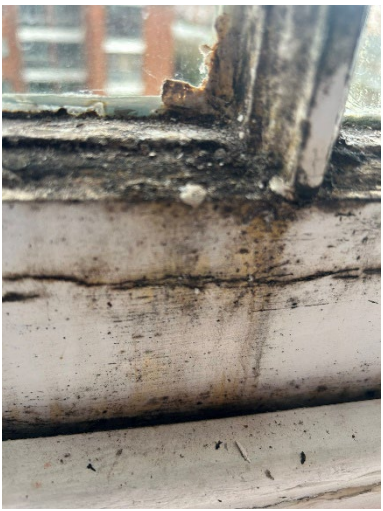
| Photo Name | Photograph |
|---|---|
| Internal condition of front sash timber window and bottom rail decay. | |

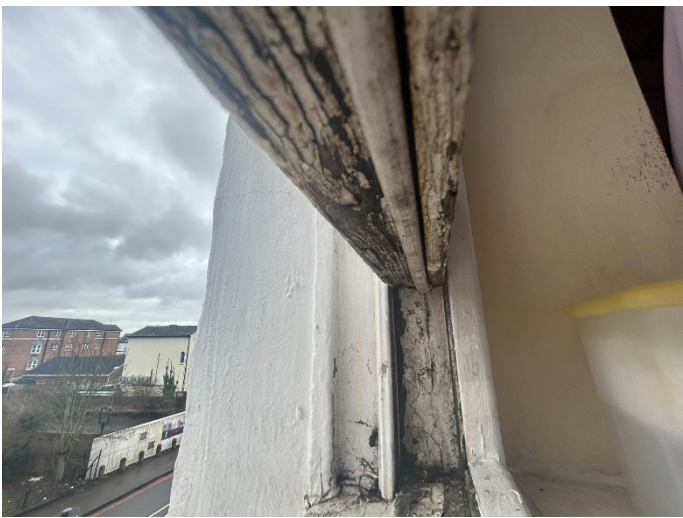
| Photo Name | Photograph |
|---|---|
| Internal condition of front sash timber window and bottom rail decay. | |
