## Window Condition Survey at

191 Oxford Road  
Reading  
RG1 7UZ

### Metropolitan Thames Valley

Tel: [01689 885080](tel:01689885080)  
Email: [elliekeattch@effefftee.co.uk](mailto:elliekeattch@effefftee.co.uk)  
Date: 21/07/2025  
Project No: T1-7039

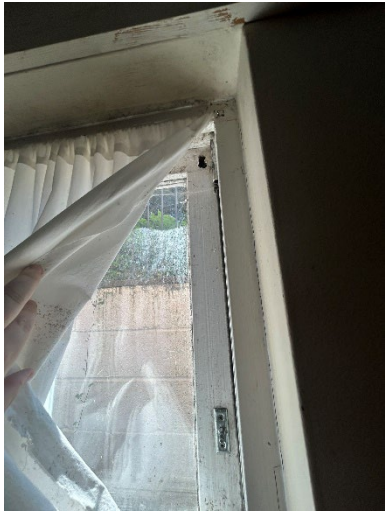
| Photo Name | Photograph | |
|---|---|---|
| Internal condition of rear sash window including double glazing. | | |

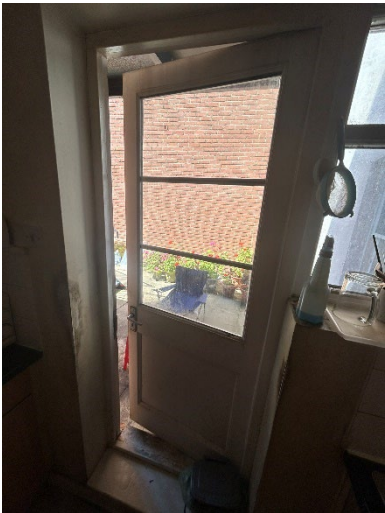
| Photo Name | Photograph | |
|---|---|---|
| Internal condition of rear timber patio door. | | |

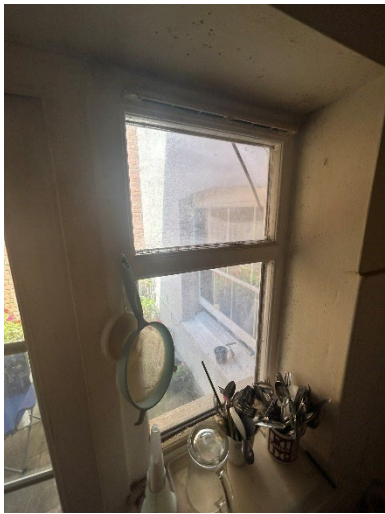
| Photo Name | Photograph | |
|---|---|---|
| Internal condition of rear casement window. | | |

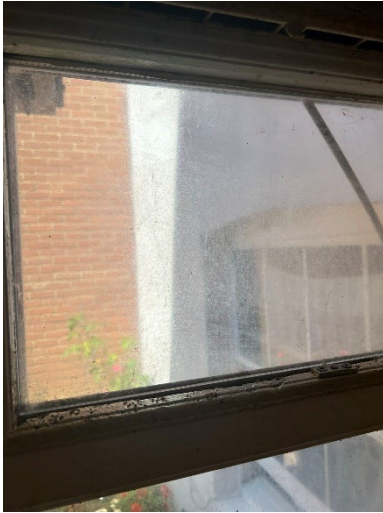
| Photo Name | Photograph |
|---|---|
| Internal condition of rear casement window. | |

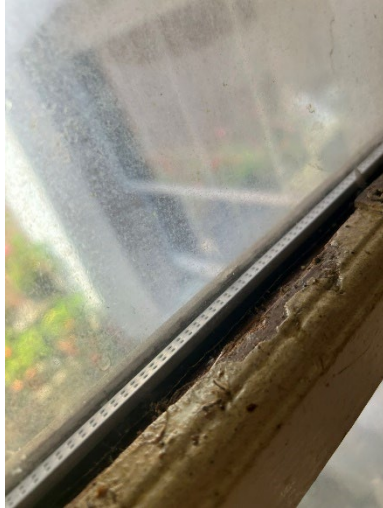
| Photo Name | Photograph |
|---|---|
| Internal condition of rear casement window. | |

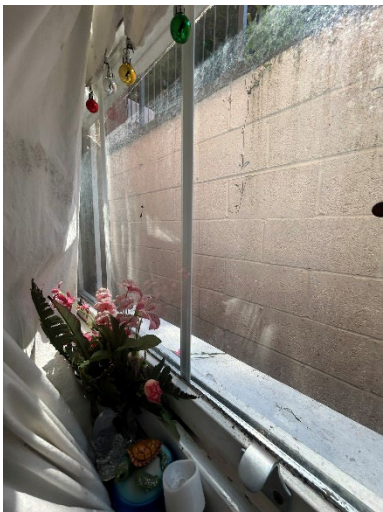
| Photo Name | Photograph |
|---|---|
| Internal condition of rear sash window. | |

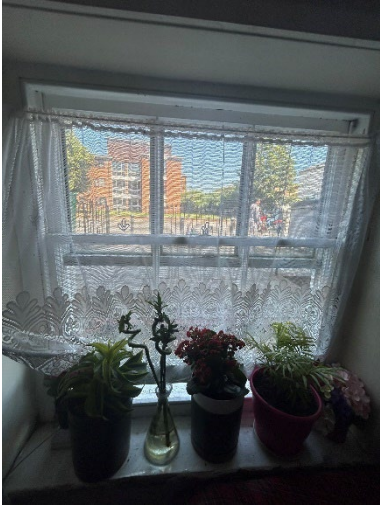
| Photo Name | Photograph |
|---|---|
| Internal condition of front sash window. | |

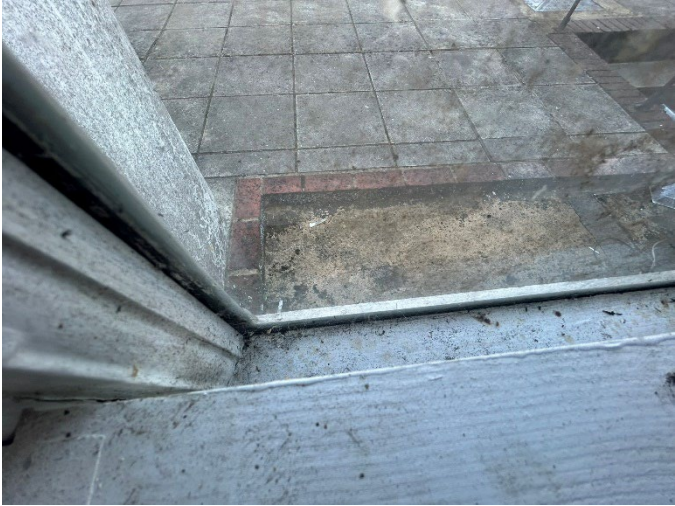
| Photo Name | Photograph |
|---|---|
| Internal condition of front sash window. | |

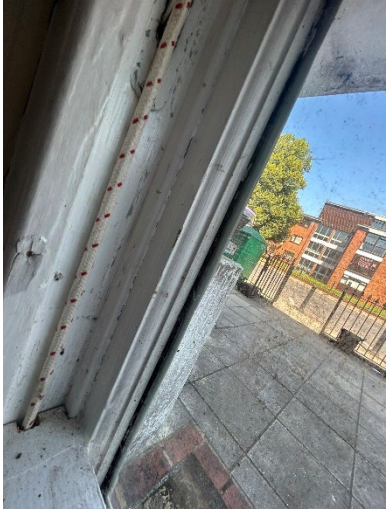
| Photo Name | Photograph |
|---|---|
| Internal condition of front sash window including pulley cord. | |

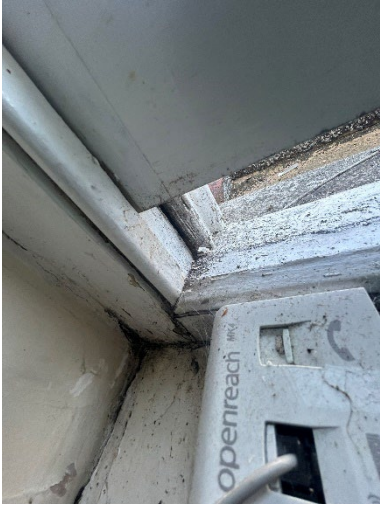
| Photo Name | Photograph |
|---|---|
| Internal condition of front sash window including box sash and frame. | |

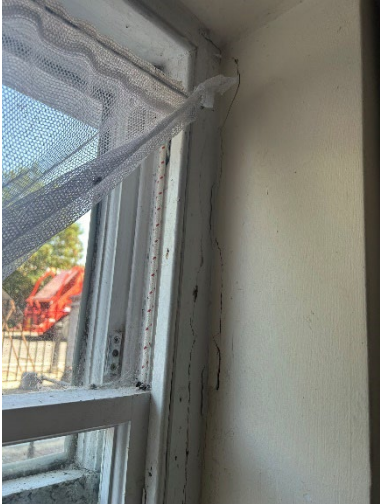
| Photo Name | Photograph |
|---|---|
| Internal condition of front sash window including box sash and frame. | |

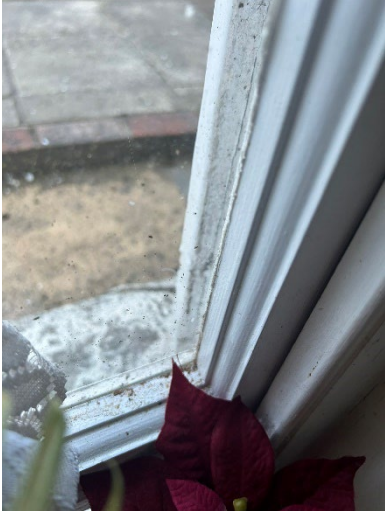
| Photo Name | Photograph |
|---|---|
| Internal condition of front sash window including box sash and frame. | |

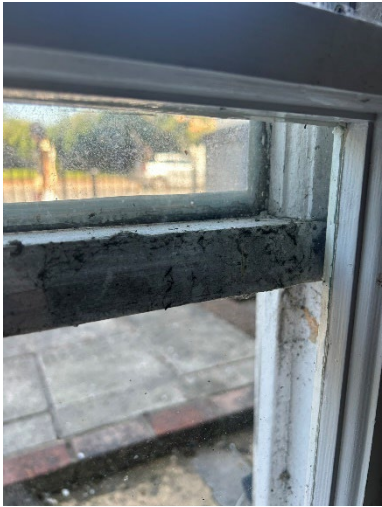
| Photo Name | Photograph |
|---|---|
| Internal condition of front sash window including meeting rail. | |

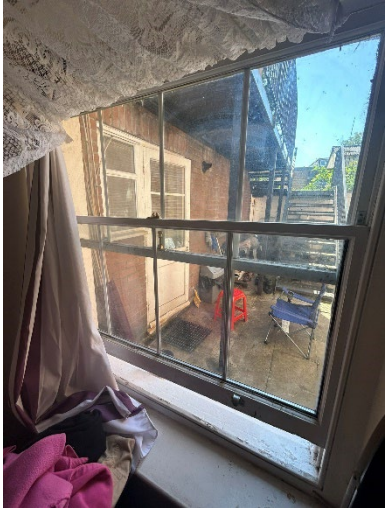
| Photo Name | Photograph |
|---|---|
| Internal condition of rear sash window including box sash and frame. | |

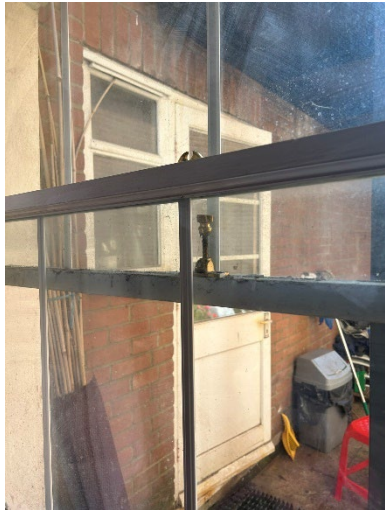
| Photo Name | Photograph |
|---|---|
| Internal condition of rear sash window including meeting rail and applied glazing bars. | |

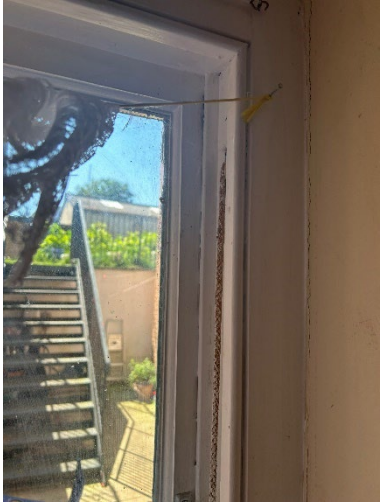
| Photo Name | Photograph |
|---|---|
| Internal condition of rear sash window including draught excluders. | |

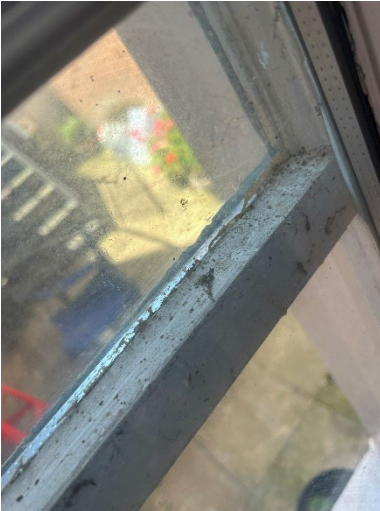
| Photo Name | Photograph |
|---|---|
| Internal condition of rear sash window including middle rail. | |

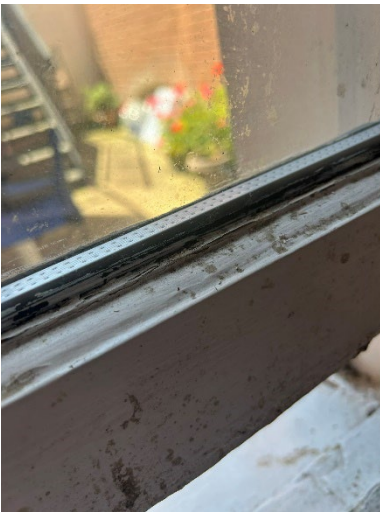
| Photo Name | Photograph |
|---|---|
| Internal condition of rear sash window including bottom rail. | |

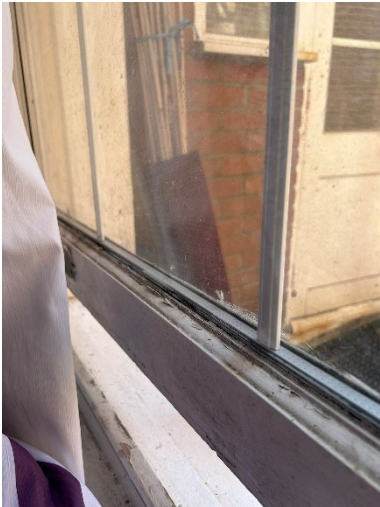
| Photo Name | Photograph |
|---|---|
| Internal condition of rear sash window including bottom rail and double glazing. | |

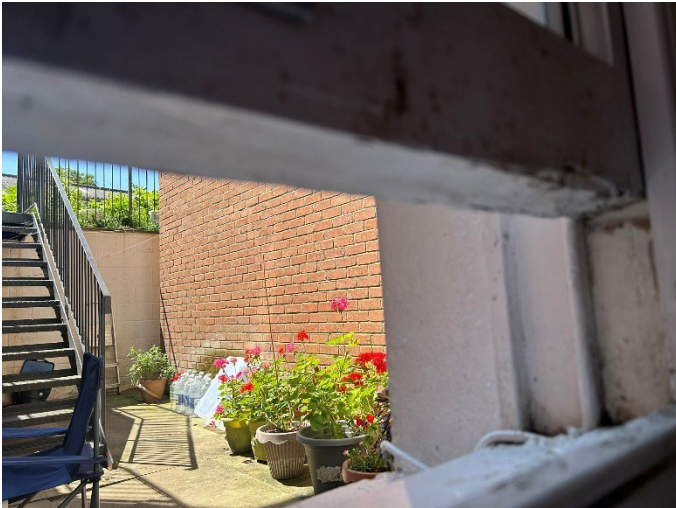
| Photo Name | Photograph |
|---|---|
| Internal condition of rear sash window including bottom rail. | |

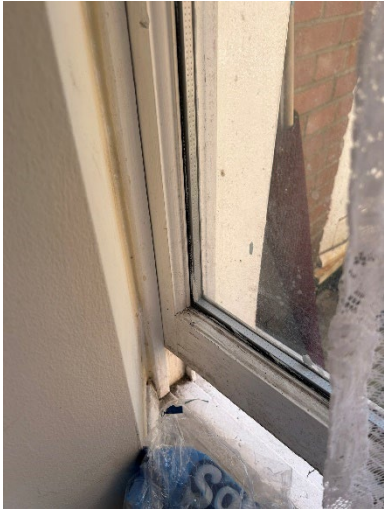
| Photo Name | Photograph |
|---|---|
| Internal condition of rear sash window including bottom rail and double glazing. | |

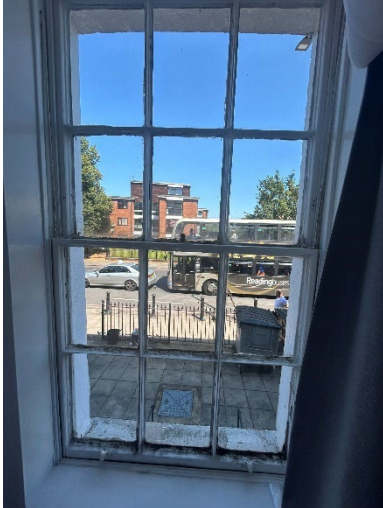
| Photo Name | Photograph |
|---|---|
| Internal condition of front sash timber window. | |

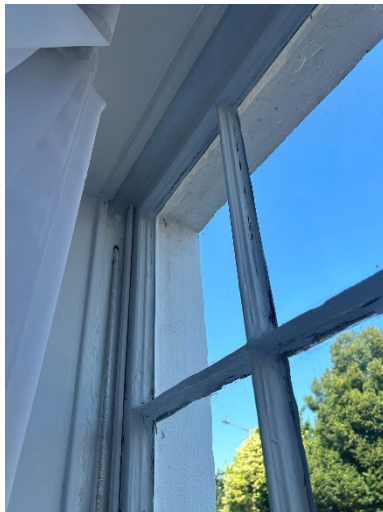
| Photo Name | Photograph |
|---|---|
| Internal condition of front sash timber window including glazing bars and sash pulley cord. | |

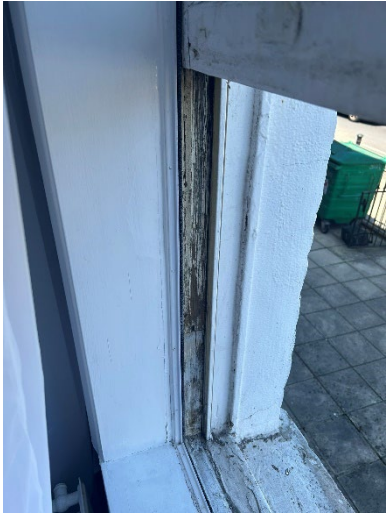
| Photo Name | Photograph |
|---|---|
| Internal condition of front sash timber window including box sash. | |

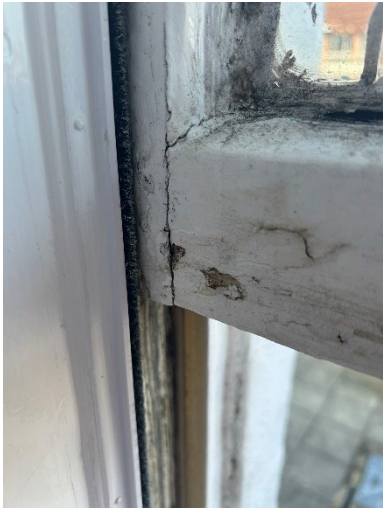
| Photo Name | Photograph |
|---|---|
| Internal condition of front sash timber window including close up of bottom rail. | |

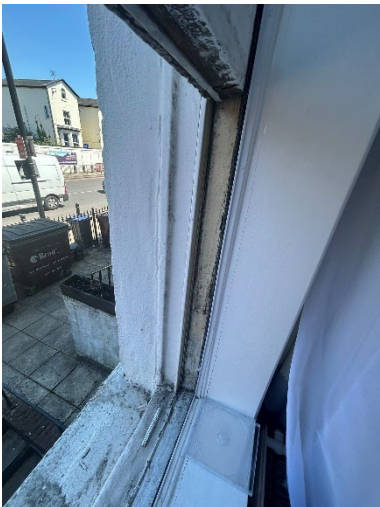
| Photo Name | Photograph |
|---|---|
| Internal condition of front sash timber window including close up of box sash. | |

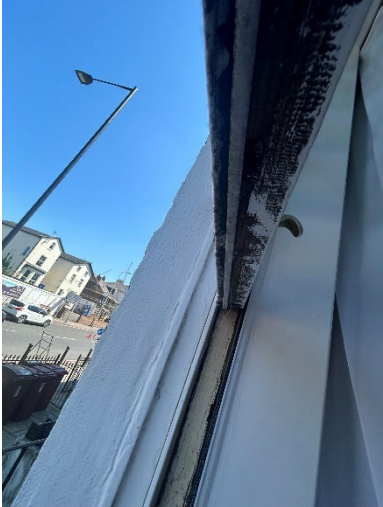
| Photo Name | Photograph |
|---|---|
| Internal condition of front sash timber window including close up of underside of the bottom frame. | |

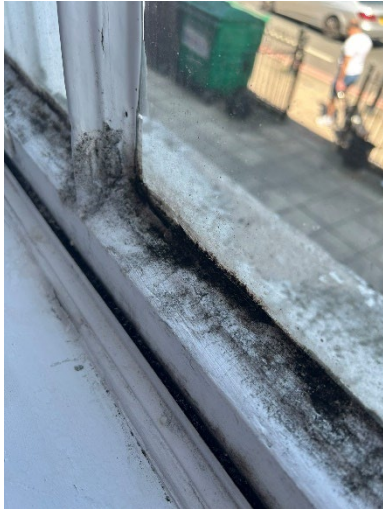
| Photo Name | Photograph |
|---|---|
| Internal condition of front sash timber window including bottom rail showing signs of mould growth and decay. | |

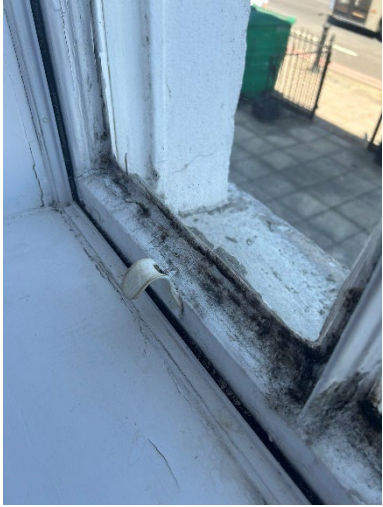
| Photo Name | Photograph |
|---|---|
| Internal condition of front sash timber window including bottom rail showing signs of mould growth and decay. | |

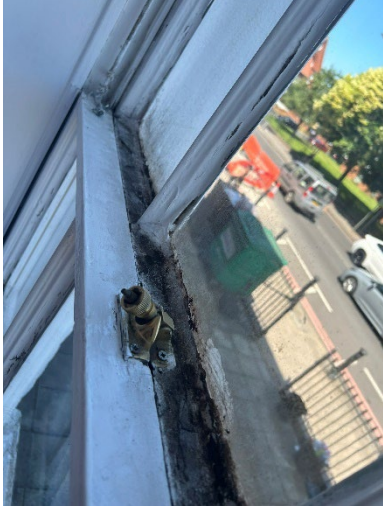
| Photo Name | Photograph |
|---|---|
| Internal condition of front sash timber window including meeting rail showing signs of mould growth and decay. | |

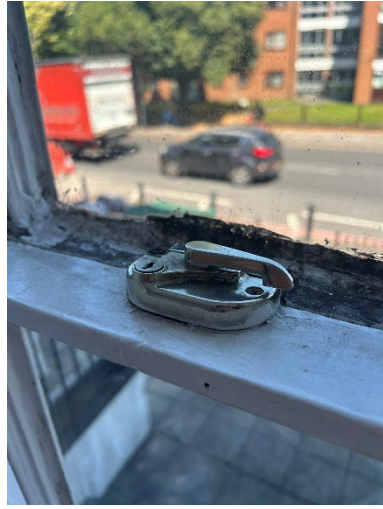
| Photo Name | Photograph |
|---|---|
| Internal condition of front sash timber window including non-original window lock. | |

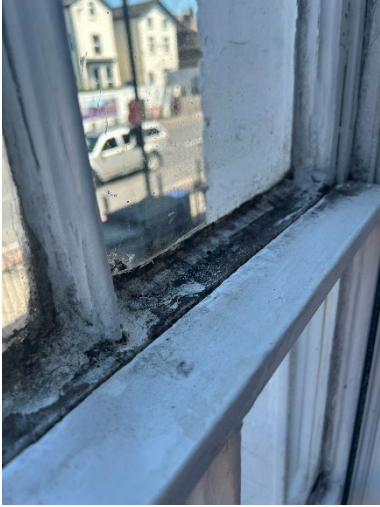
| Photo Name | Photograph |
|---|---|
| Internal condition of front sash timber window including meeting rail showing signs of mould growth and decay. | |

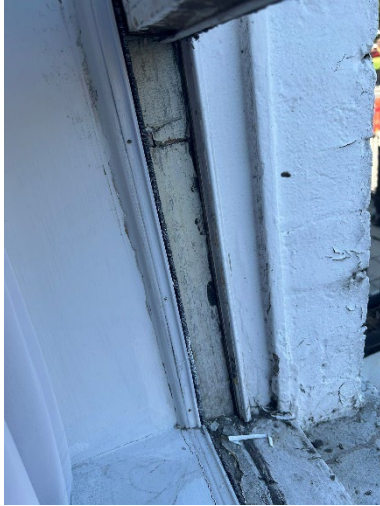
| Photo Name | Photograph |
|---|---|
| Internal condition of front sash timber window including box sash frame. | |

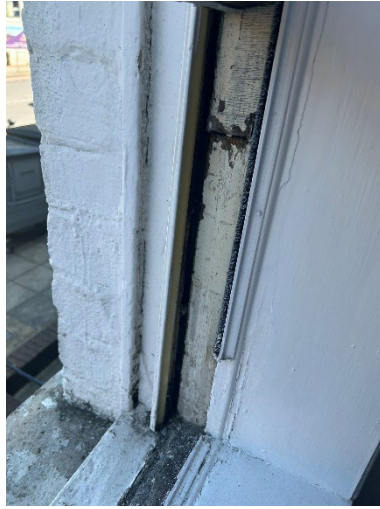
| Photo Name | Photograph |
|---|---|
| Internal condition of front sash timber window including box sash frame. | |

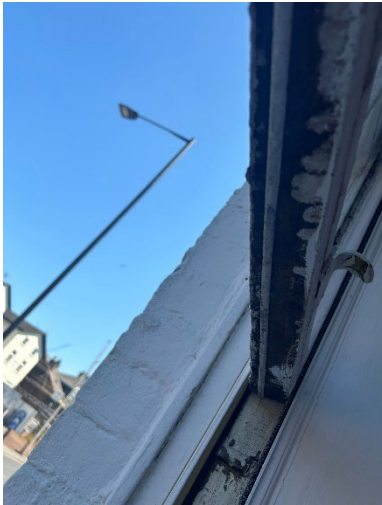
| Photo Name | Photograph |
|---|---|
| Internal condition of front sash timber window including underside of bottom rail. | |

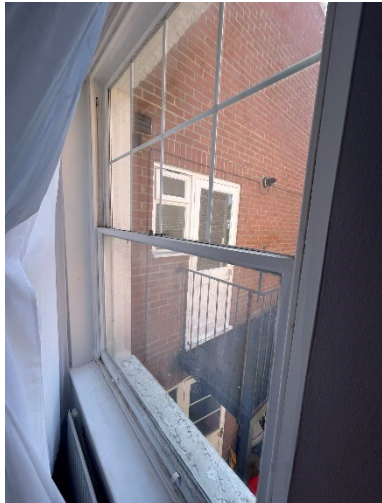
| Photo Name | Photograph |
|---|---|
| Internal condition of the rear timber sash window. | |

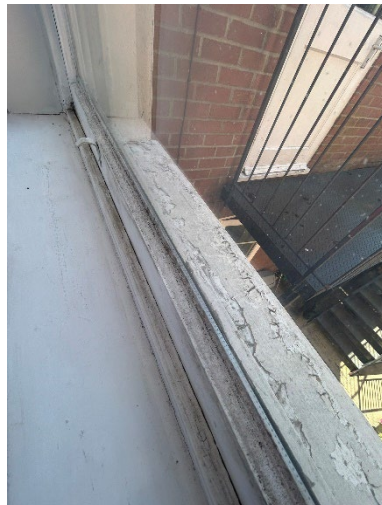
| Photo Name | Photograph |
|---|---|
| Internal condition of the rear timber sash window and frame. | |

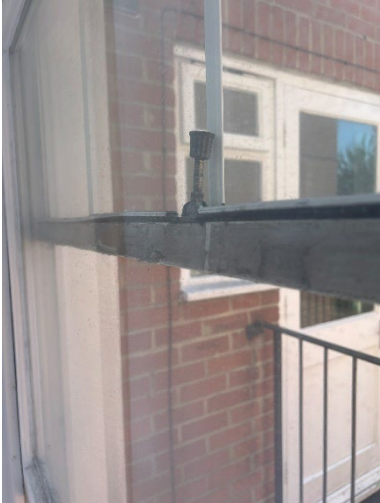
| Photo Name | Photograph |
|---|---|
| Internal condition of the rear timber sash window. | |

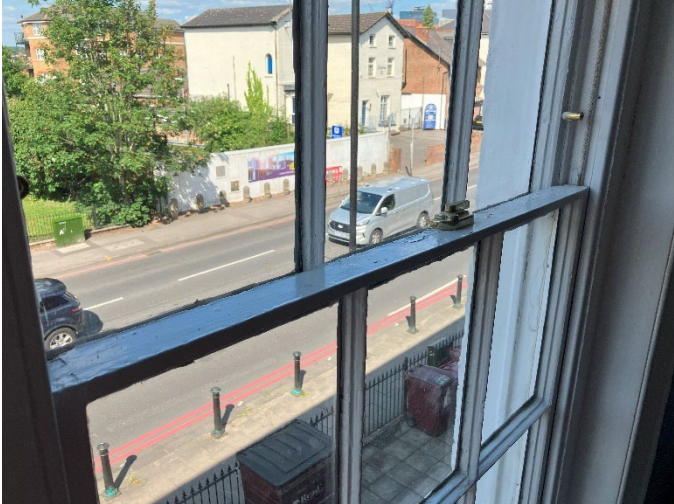
| Photo Name | Photograph |
|---|---|
| 191c Oxford Road<br>Internal condition of front sash timber window. | |

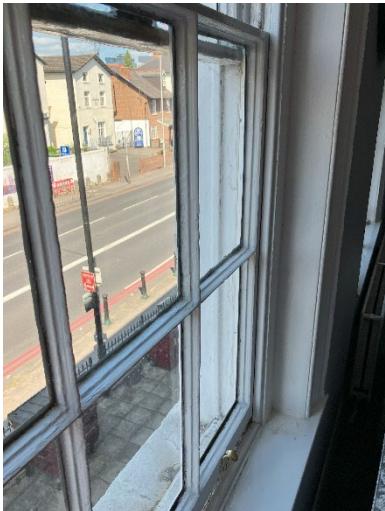
| Photo Name | Photograph |
|---|---|
| Internal condition of front sash timber window. | |

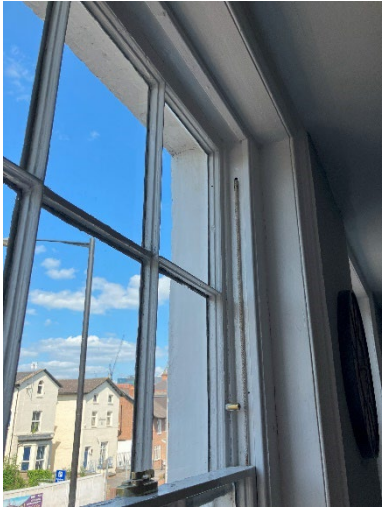
| Photo Name | Photograph |
|---|---|
| Internal condition of front sash timber window. | |

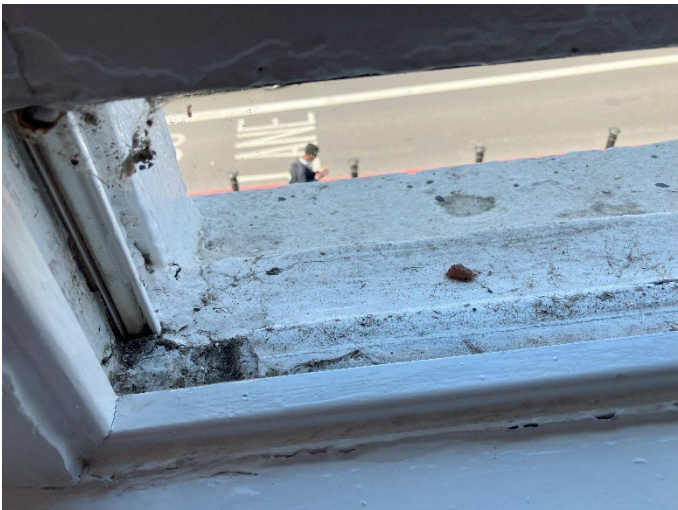
| Photo Name | Photograph |
|---|---|
| Internal condition of front sash timber window including bottom cill and frame. | |

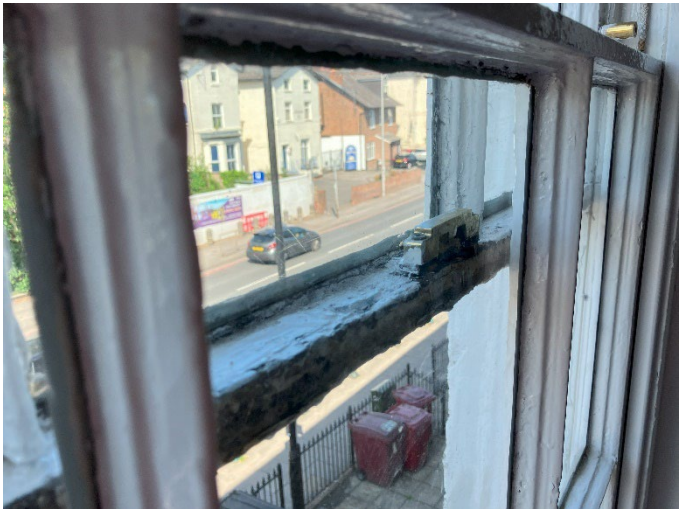
| Photo Name | Photograph |
|---|---|
| Internal condition of front sash timber window including meeting rail showing signs of decay. | |

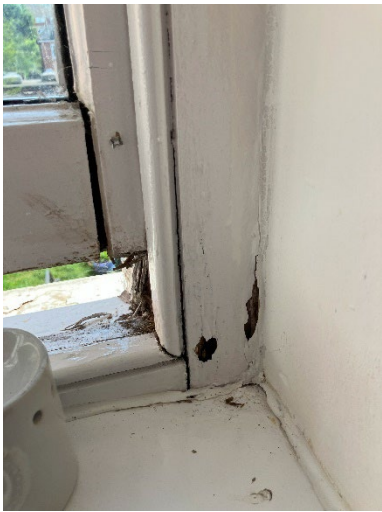
| Photo Name | Photograph |
|---|---|
| Internal condition of front sash timber window including box sash. | |

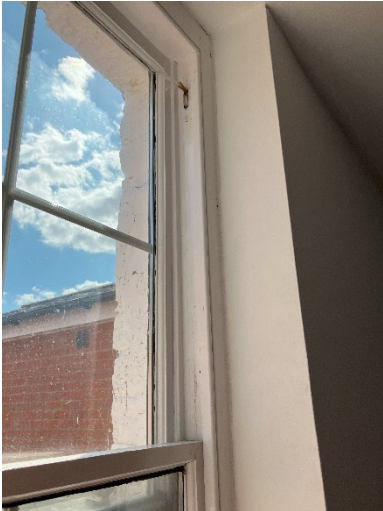
| Photo Name | Photograph |
|---|---|
| Internal condition of rear sash timber window including box sash. | |

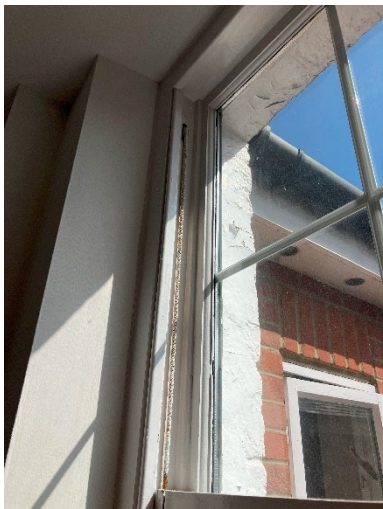
| Photo Name | Photograph |
|---|---|
| Internal condition of rear sash timber window including sash pulley cord and applied glazing bars. | |

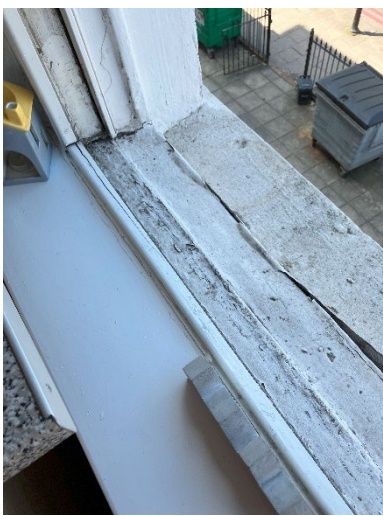
| Photo Name | Photograph |
|---|---|
| Internal condition of front sash timber window including bottom cill and frame. | |

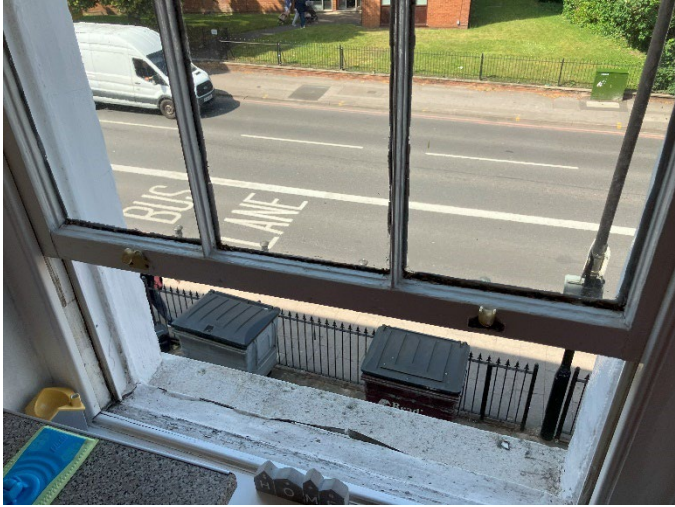
| Photo Name | Photograph |
|---|---|
| Internal condition of front sash timber window including lower sash, cill and frame. | |

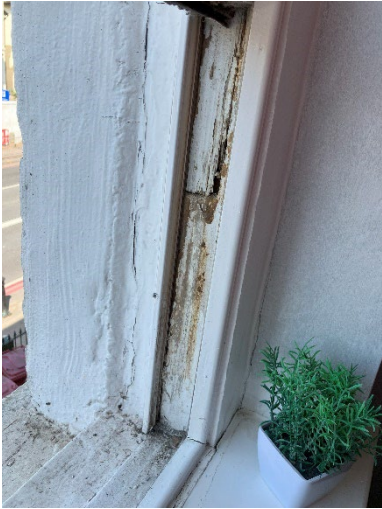
| Photo Name | Photograph |
|---|---|
| Internal condition of front sash timber window including box sash showing signs of decay. | |

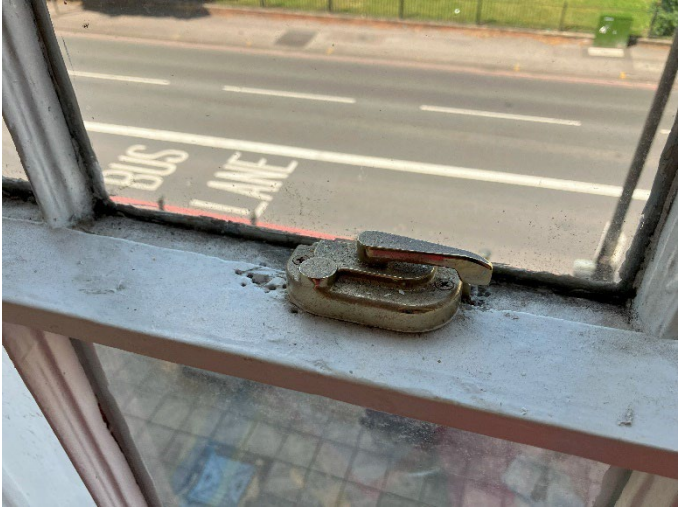
| Photo Name | Photograph |
|---|---|
| Internal condition of front sash timber window including brass lock. | |

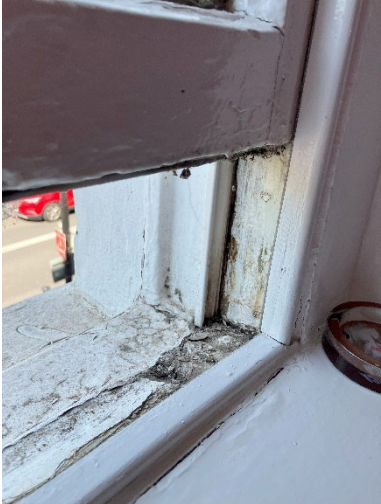
| Photo Name | Photograph |
|---|---|
| Internal condition of front sash timber window including box sash showing signs of decay. | |

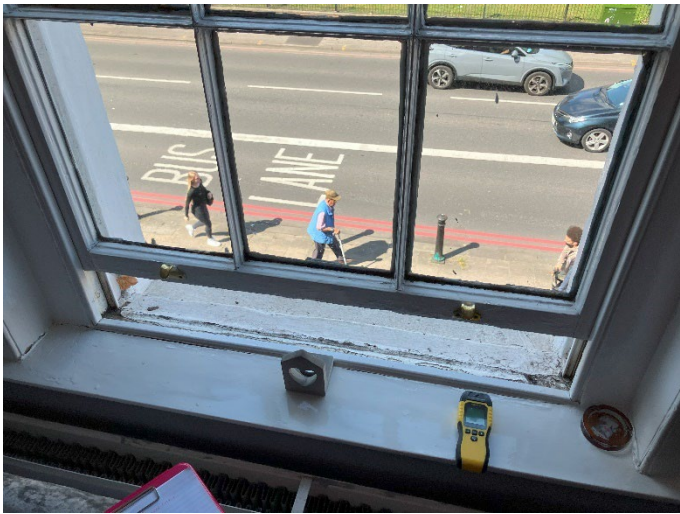
| Photo Name | Photograph |
|---|---|
| Internal condition of front sash timber window. | |

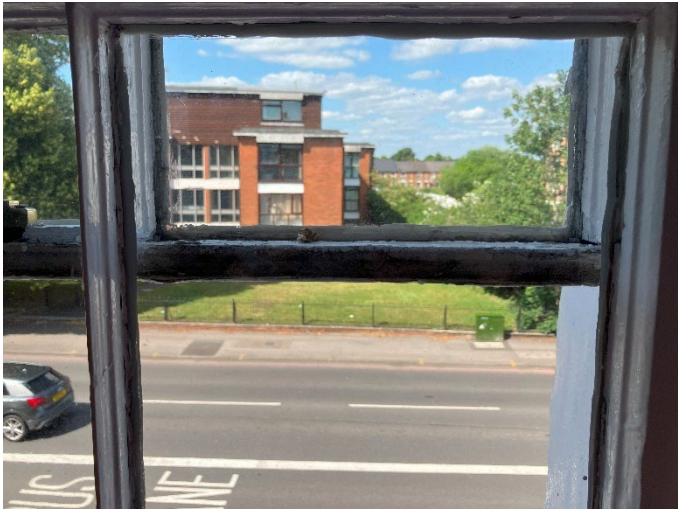
| Photo Name | Photograph |
|---|---|
| Internal condition of front sash timber window including meeting rail and glazing bars. | |

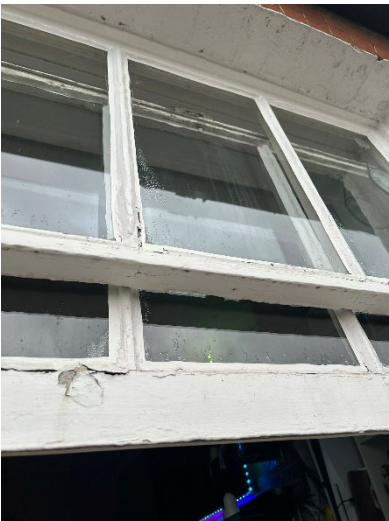
| Photo Name | Photograph |
|---|---|
| External condition of rear sash timber window. | |

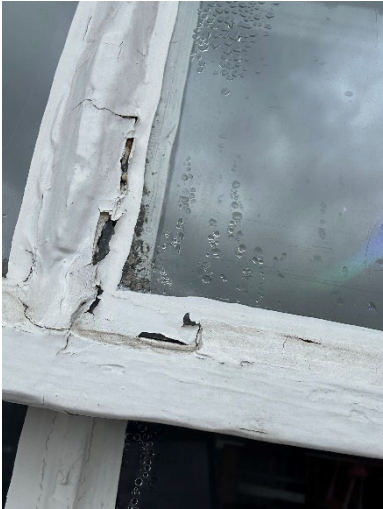
| Photo Name | Photograph |
|---|---|
| External condition of rear sash timber window. | |

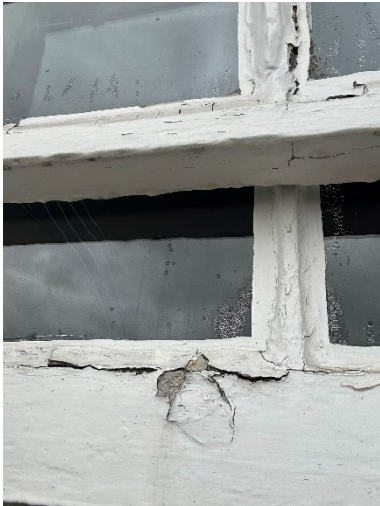
| Photo Name | Photograph |
|---|---|
| External condition of rear sash timber window. | |

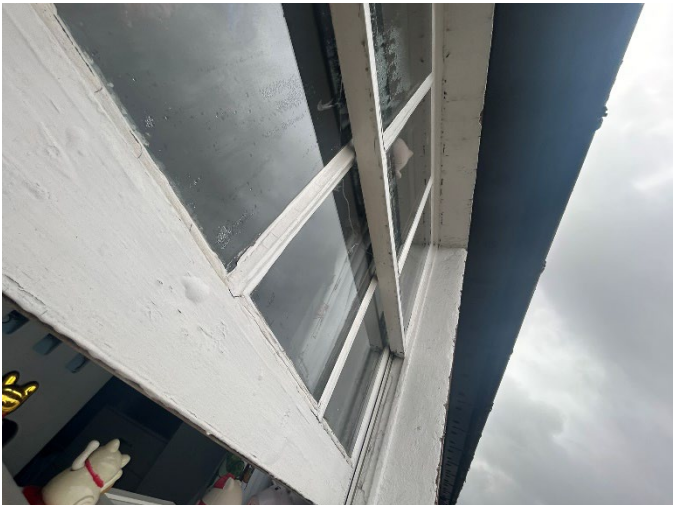
| Photo Name | Photograph |
|---|---|
| External condition of rear sash timber window. | |

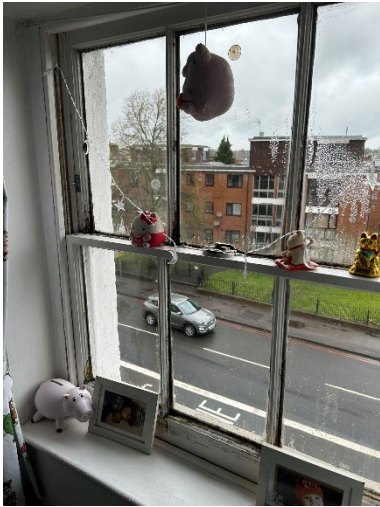
| Photo Name | Photograph |
|---|---|
| Internal condition of front sash timber window. | |

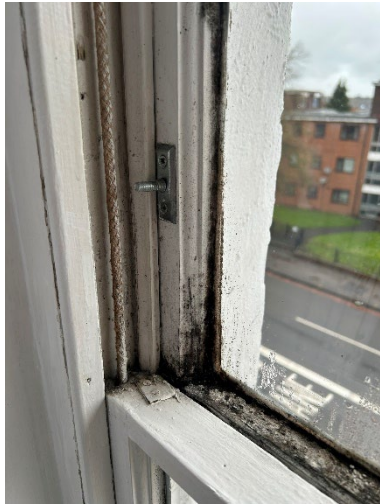
| Photo Name | Photograph |
|---|---|
| Internal condition of front sash timber window including sash pulley cord, decaying meeting rail and non-original ironmongery. | |

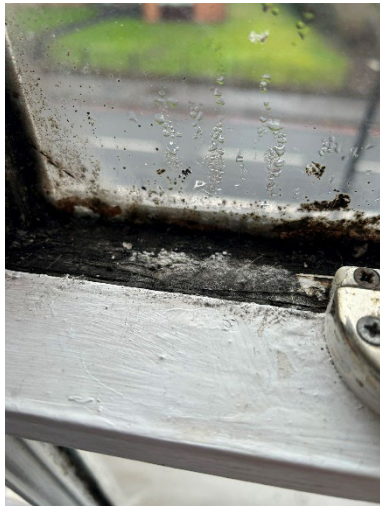
| Photo Name | Photograph |
|---|---|
| Internal condition of front sash timber window including decay of meeting rail. | |

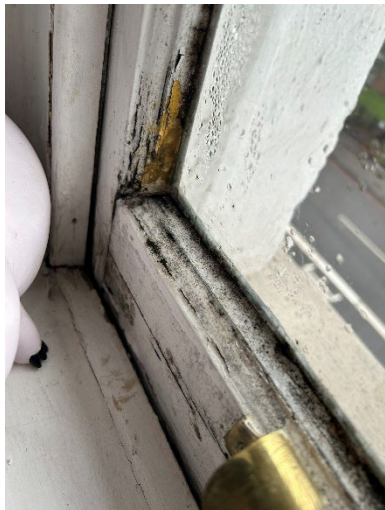
| Photo Name | Photograph |
|---|---|
| Internal condition of front sash timber window including decay of bottom rail. | |

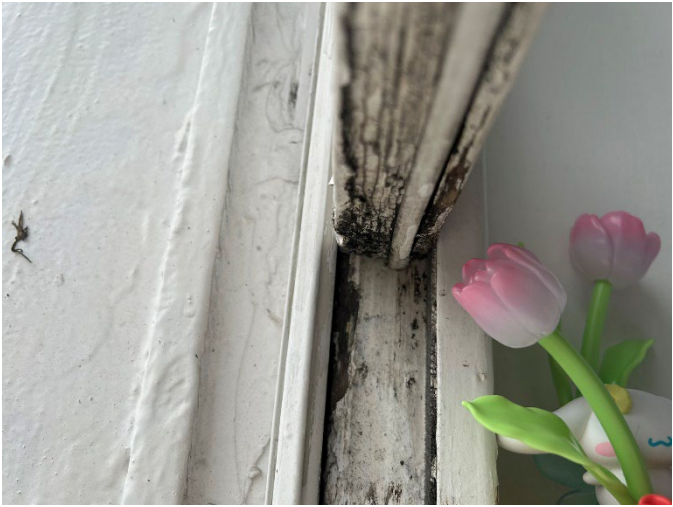
| Photo Name | Photograph |
|---|---|
| Internal condition of front sash timber window including decay of underside of bottom rail. | |

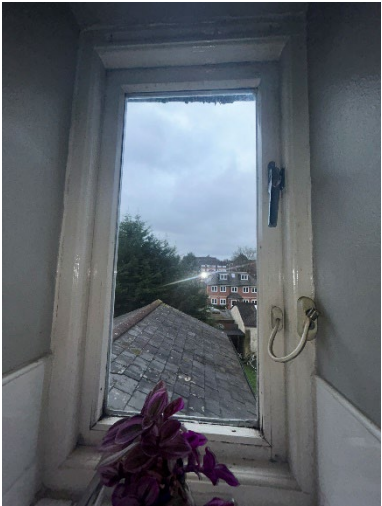
| Photo Name | Photograph |
|---|---|
| Internal condition of the rear timber casement window. | |

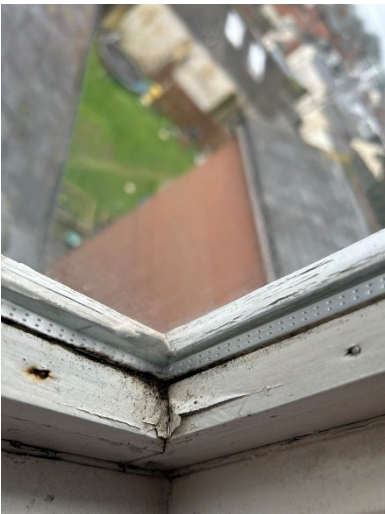
| Photo Name | Photograph |
|---|---|
| Internal condition showing double glazing of the rear casement window. | |

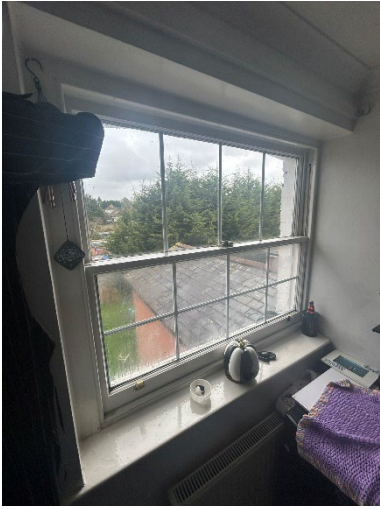
| Photo Name | Photograph |
|---|---|
| Internal condition of rear timber sash window. | |

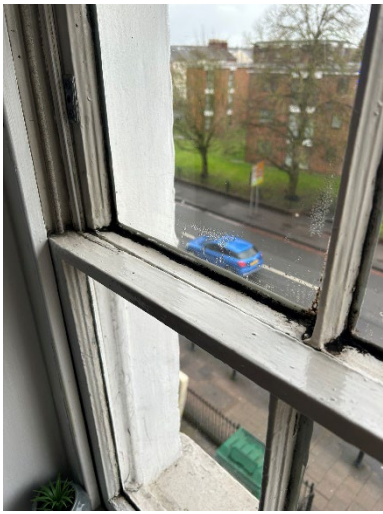
| Photo Name | Photograph |
|---|---|
| Internal condition of front timber sash window. | |

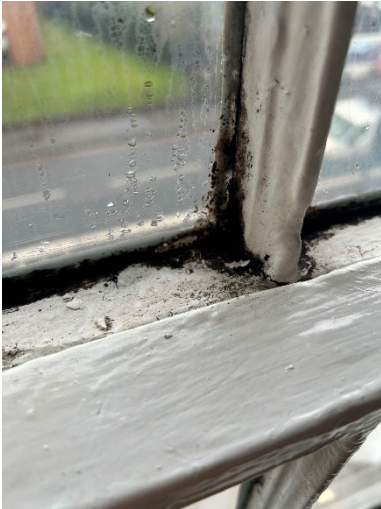
| Photo Name | Photograph |
|---|---|
| Internal condition of front timber sash window. | |

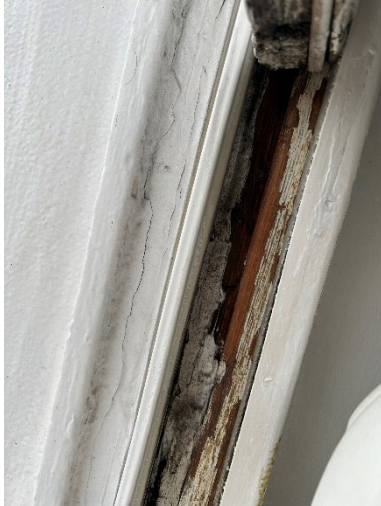
| Photo Name | Photograph |
|---|---|
| Internal condition of front timber sash window showing timber decay. | |

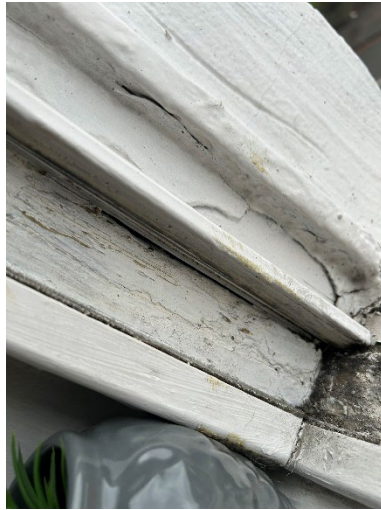
| Photo Name | Photograph |
|---|---|
| Internal condition of front timber sash window showing timber decay. | |
