# Your survey report

43 Church Road, Caversham, Reading, Berkshire,  
RG4 7AG

22nd April 2025

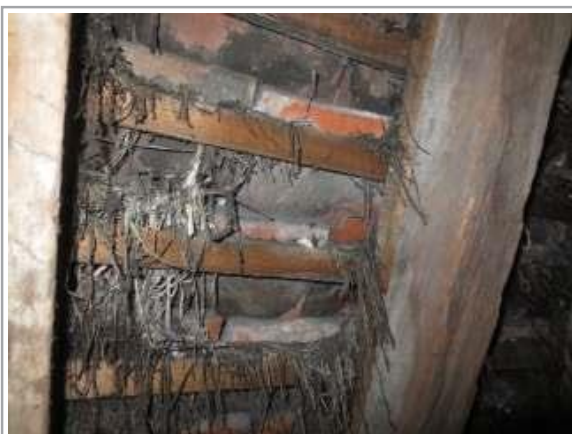
From within our roof void inspection we have come to the conclusion that very significant restoration of the roof tiles is now required due to missing nib tile nails and corrosion to nail security.

Roof tiles loft

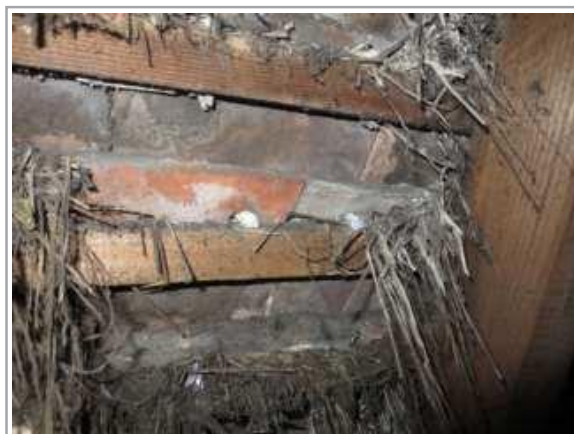
The roof tiles appear to be mainly of manmade clay plain tiles which are likely to have lower density and more vulnerable to weathering and frost action.

Patch repair to the roof tiles has clearly occurred over the years, with some machine made tiles noted, these will need to be replaced with reclaimed man made clay tiles.

Poor tile condition

There is no underlay to the roof tiles which acts as a secondary barrier. It is therefore very important that roof restoration or recladding is considered as part of your purchase decision because there is no secondary layer to prevent damp penetration to second floor or first floor accommodation, were roof tiles to fail as a result, potentially of an autumn or winter storm. This is likely to be the highest cost were you to purchase this property.

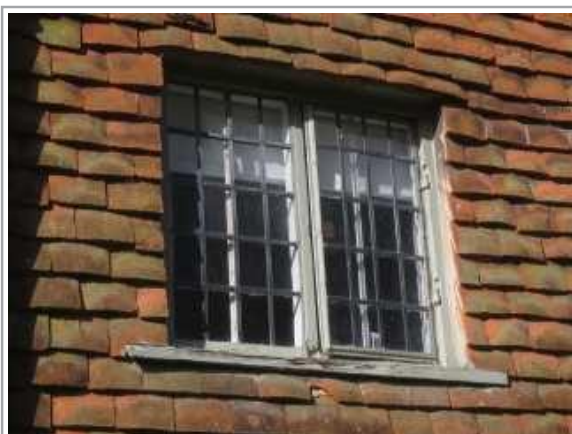
The windows are age worn and neglected.

Poor window joinery

Careful restoration of the outside timber and metal work window joinery is now required after long term neglect. As this is likely to be costly we recommend you obtain cost quotes for this by a conservation grade contractor prior to exchange of contracts.

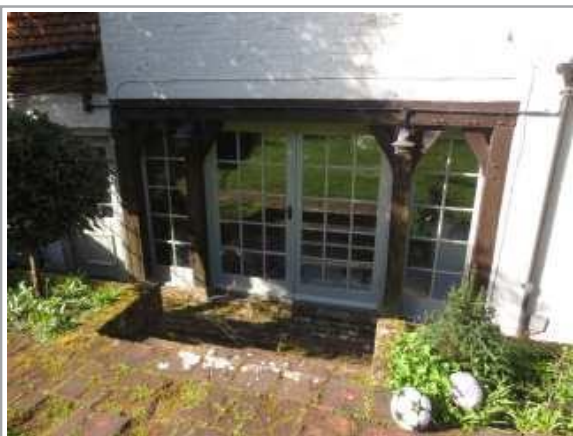
The double doors to the rear from the main sitting room have a defective Chubb lock which could not be opened.

Rear doors

Some adjustment to the door lock, latch and hinge mechanisms will be required and spray lubrication should be carried out from time to time to improve functionality, once restoration has been undertaken.

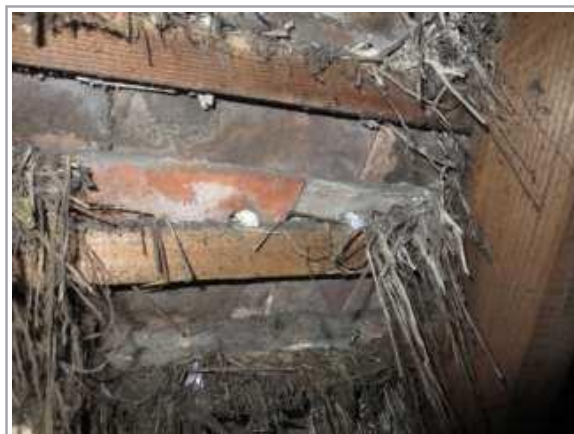
We have advised our concern with regard to the age deterioration of the manmade roof tiles, the absence of suitable roof tile peg fixings and age deterioration generally.

As there is no underlay this makes the roof cladding vulnerable to wind damage and blown rain and snow ingress affecting first and second floor accommodation.

Poor tile condition

The stripping and recladding or restoration of this roof could be undertaken with the provision of a felt underlay. Modern manmade synthetic fibre breathable underlays are not widely recommended as these can create dangerous habitats for a protected bat species. Within the limits of our inspection we did not note bat habitation within the loft but a restricted inspection was undertaken, but this could change over time.

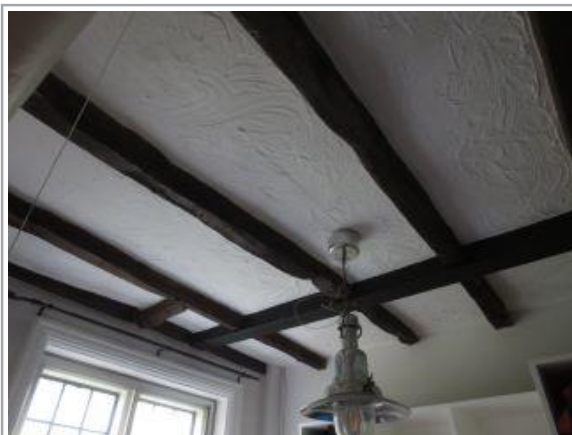
You will note that within the cloakroom Artex type textured ceilings have been incorporated which may have a small asbestos content. We recommend that this plasterboard textured ceiling is removed as part of your restoration.

Cloakroom artex.

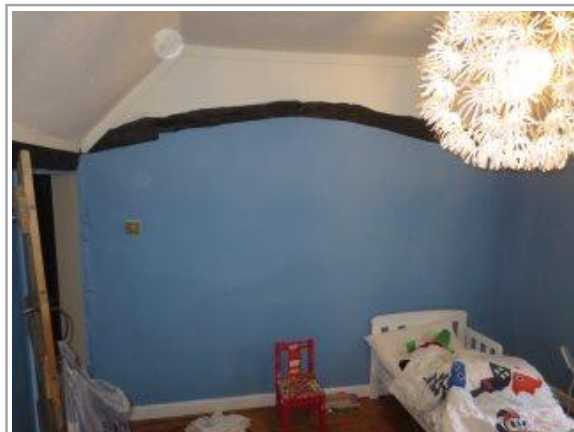
The partition between bedroom 5 and 6 is in very poor condition and needs full and thorough restoration.

Bed 5,6 partition

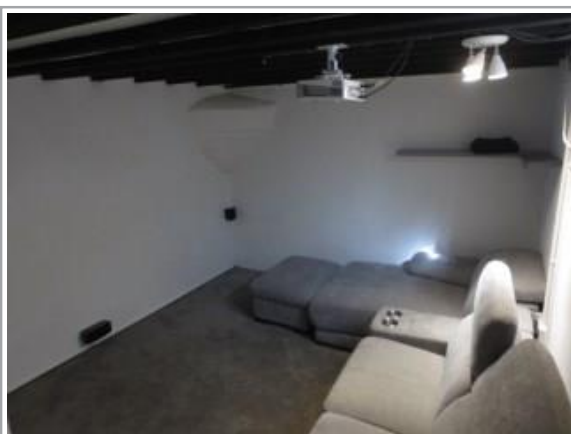
Carpets should not be used on ground floor Listed Buildings as this has the potential to sweat as there are no damp proof membranes within the ground floor structure. This is also the case for the cellar which has been lined with a cement based render to walls and has a carpet floor. The tenant advises that the cellar is damp with high humidity and the dehumidifier needs to be operating all the time to avoid condensation mildew staining accumulation.

Cellar carpet sweat

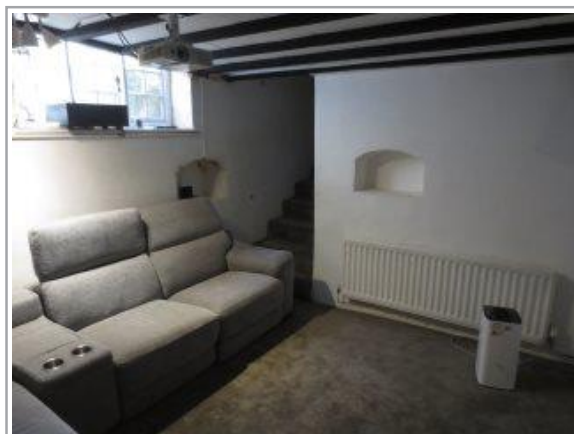
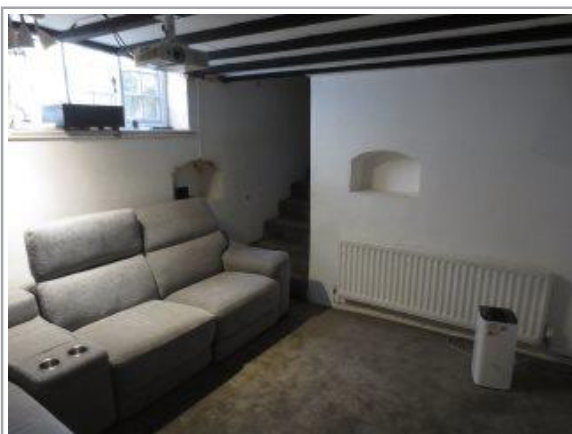
Cellar dehumidifier

The tenant advises that the dehumidifier needs to be operating all the time to reduce condensation within this particular room.

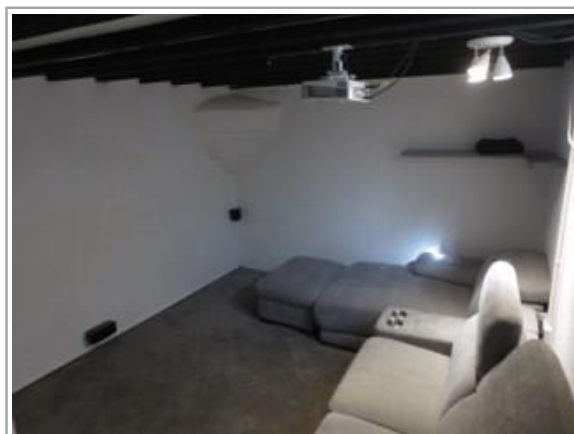
Cellar carpet sweat

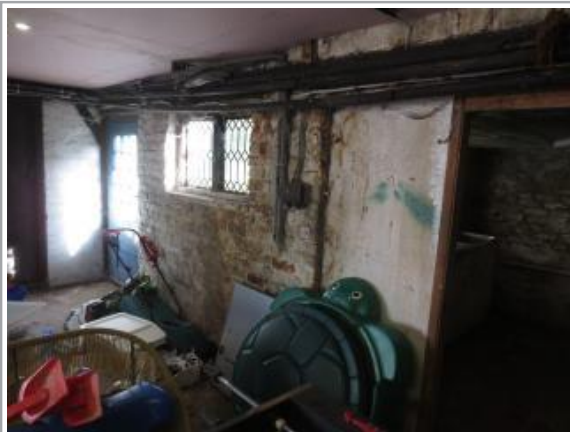
Poor pipe support.

You may wish to consider upgrading the central heating system, radiator and plumbing to more conventional small bore copper pipes.

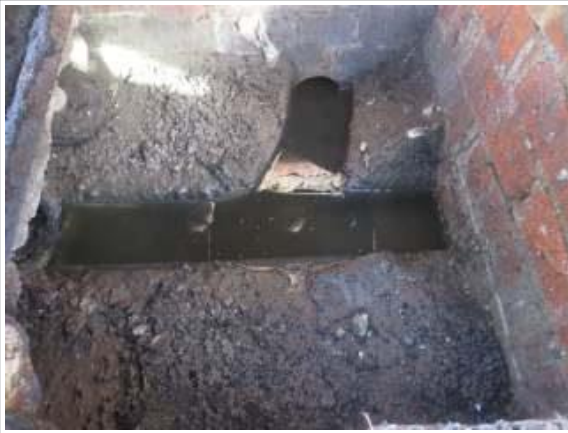
1. The below ground drainage to front is blocked and requires CCTV inspection, unblocking and possibly costly repairs.
2. Your legal adviser should confirm what works have been undertaken by the vendors and whether Listed Building consent has been obtained. Much of the non compliance works internally appear to predate the ownership of the vendors in 2021.
3. A precautionary test of the electrical system by way of an EICR electrical test is recommended.
4. The gas central heating system should be fully tested by a Gas Safe registered engineer prior to exchange of contracts.

Blocked front drain.

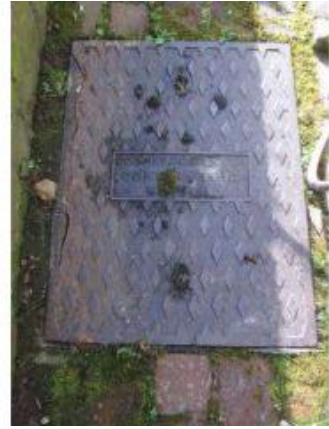
Broken drain cover.

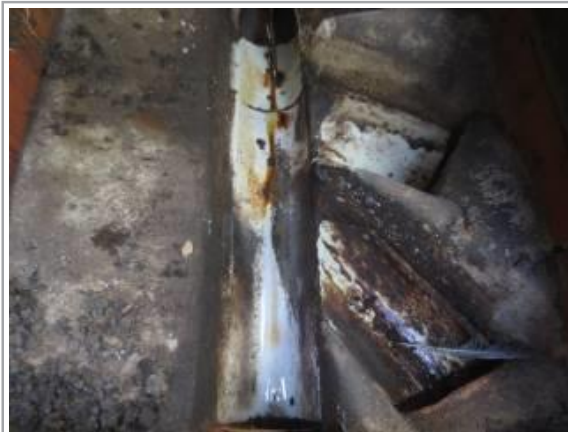
Shallow drains rear.

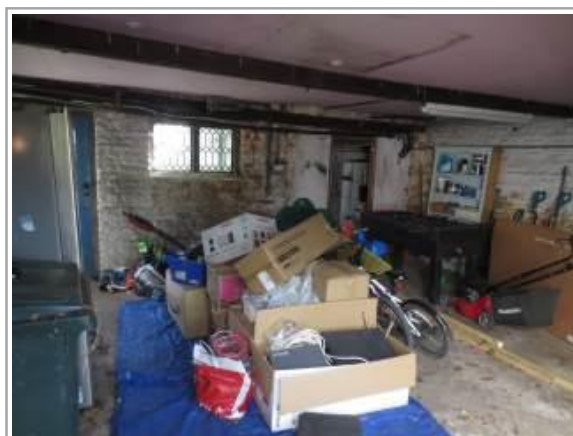
Garage neglected

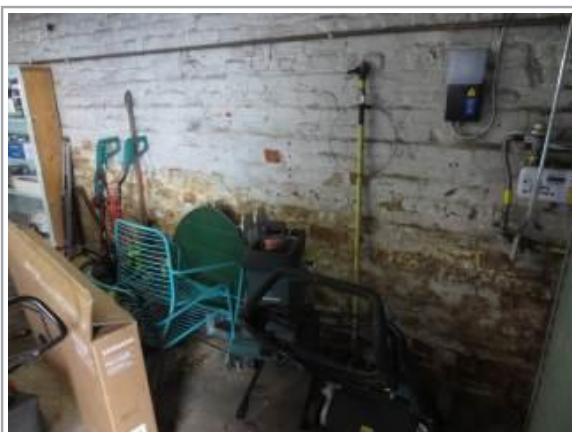
Significant damp was noted within the garage and utility room.

Garage damp

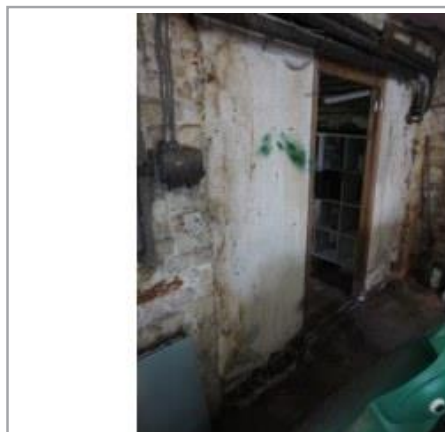
Decay garage wall
