## ASBESTOS SURVEY REPORT & MANAGEMENT PLAN

Address : 97 York Road  
Reading  
Berks  
RG1 8DU

Report date : 14<sup>th</sup>.May 2025

### STONEWALL PARTNERSHIP

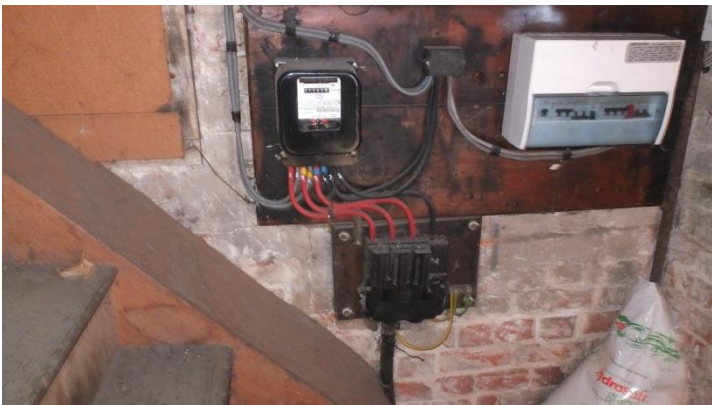
| Item no. | Level | Location/Room | Sample ref | Quantity | | |
|---|---|---|---|---|---|--|
| | | | Presumed to contain woven chrysotile 'Flash pads' | | | |
| | | | The photograph displays the three black 100 amp fuses at the bottom centre of the photo<br>(the assessor appended asbestos stickers on the day of the survey)<br>See photograph later | | | |
| Risk level | | Low | Activity type | 0 | | |
| Must only be accessed by qualified electrician<br>(Disposal must be of fixed units and not broken into) | | | | | | |

| Item Ref | Floor/Room | Location | Material – Asbestos Content | Action | Risk Level | Monitoring |
|---|---|---|---|---|---|---|
| 1 | Ground Floor | Electrical services cupboard<br>(by main entrance door & Stairway) | 'Presumed' as Chrysotile Woven material | <p>Append 'asbestos' labels to all 3 fuse boxes (Assessor provided this on day of survey)</p> <p>Any works to the electrical installation to be performed by:-</p> <ul style="list-style-type: none"> <li>• Qualified electrician only</li> <li>• Only persons who have had up to date 'Asbestos Awareness' training within the last 12 months</li> <li>• PPE to be worn when conducting any works (to level FP3 or greater)</li> <li>• If any removal work undertaken then fuse boxes not to be opened but disposed unopened</li> </ul> | Very Low | Annual re-inspection for deterioration or damage, re-fit any labels that have become misplaced |

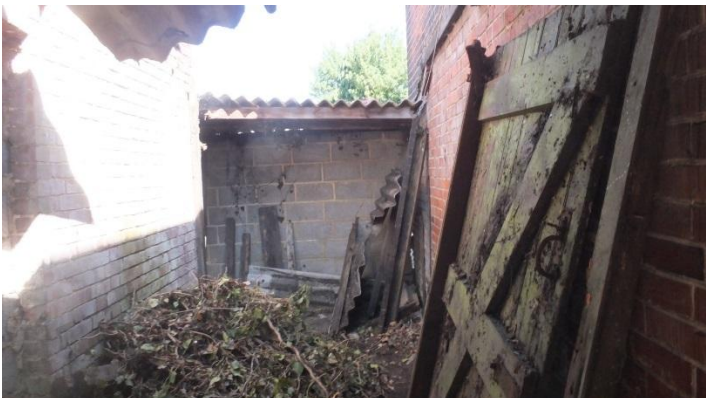
| Item no. | Level | Location/Room | Sample ref | Quantity | |
|---|---|---|---|---|---|
| | | | Confirmed to contain chrysotile within the corrugated asbestos cement sheeting | | |
| | | | The photograph displays the rear lean to roof (above rear wall)<br>There are a lot of fragments of the same composition on the floor nearby | | |
| Risk level | | Low | Activity type | 0 | |
| Unlikely unless roughly snapped or broken into | | | | | |

| Item Ref | Floor/Room | Location | Material – Asbestos Content | Action | Risk Level | Monitoring |
|---|---|---|---|---|---|---|
| 2 | Ground | Lean-to roof | 'Confirmed' to contain Chrysotile in cement cover | <p>Inform any persons likely to come into contact with the roof or fragments</p> <p>Paint raw edges with elastomeric fluid</p> <p>If removed, to be completed by a licensed removal contractor (disposal certification to be obtained)</p> | Low | Same as above<br>Re-paint edges annum |

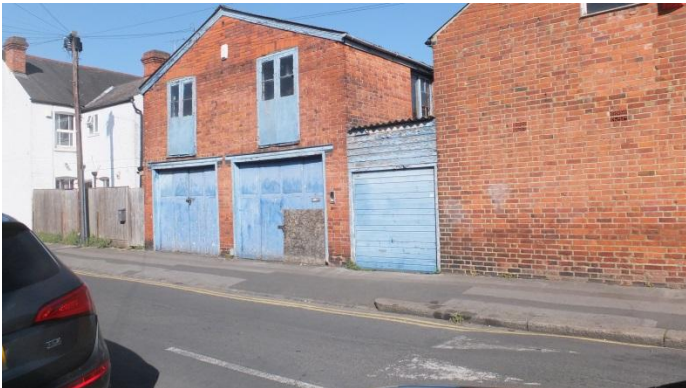
| Item no. | Level | Location/Room | Sample ref | Quantity | |
|---|---|---|---|---|---|
| 3 | Roof level | Main building roof | 'Presumed'<br>Chrysotile | Circa<br>16' x 35'x 2 | |

| Item no. | Level | Location/Room | Sample ref | Quantity | |
|---|---|---|---|---|---|
| | | | Presumed to contain chrysotile within the corrugated asbestos cement sheeting | | |
| | | | The photograph displays the main building.<br>The roof is pitched with 2 sides | | |
| Risk level | | Low | Activity type | 0 | |
| Unlikely unless broken (demolished) | | | | | |

| 3 | Roof | Main building | 'Presumed' to contain Chrysotile in cement cover | <p>Inform any persons likely to come into contact with the roof</p> <p>I removed, to be completed by a licensed removal contractor<br/>(disposal certification to be obtained)</p> | Low | Annual |
