# TREE REPORT

August End, Reading, RG30 2JP

Client: Chaney's

Date: 12/09/25

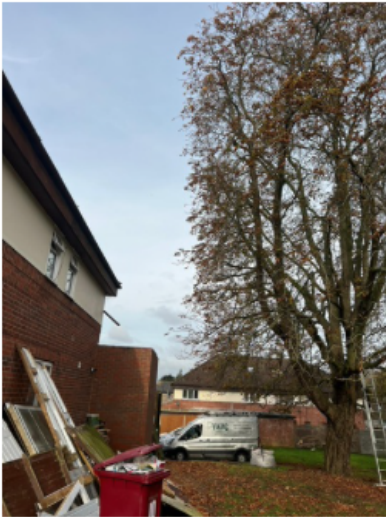
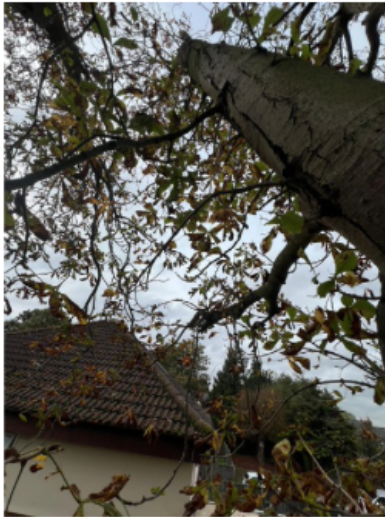
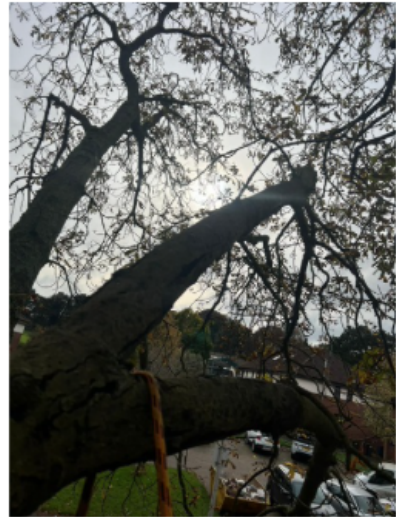
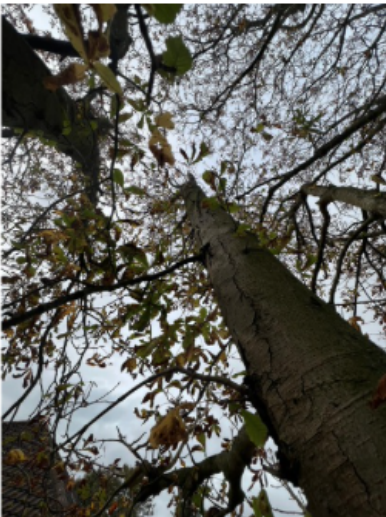
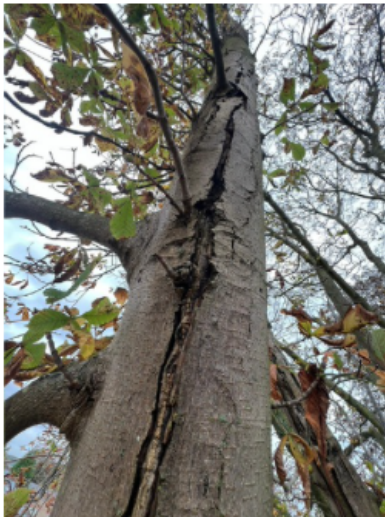
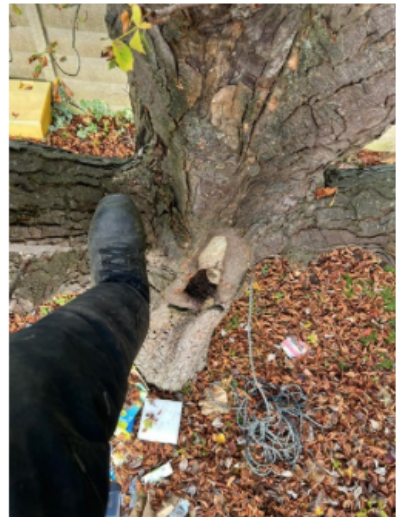
Visually from the ground the two trees T1 and T2 appear healthy with good leaf coverage and reasonably balanced crowns. Historically, T1 and T2 have been pollarded many years ago resulting in a multi stemmed canopy with many long, top heavy, stems and branches.

Upon aerial inspection, trees T1 and T2 showed many signs of stress fractures to the main stems at around 15 metres progressing upwards ranging from 1 metre to 8 metres in places. Some of these fractures are historic and show signs of occluding but some are more recent and have not yet begun to occlude.

There were also visible signs of previous failed limbs and some failed limbs still suspended in the canopies. The lateral limbs were very dense and heavy and appeared to be under a lot of stress. The buttresses and trunks of trees T1 and T2 were visibly healthy with no signs of fungal fruiting bodies at the time of the inspection.

| Tree No | Tree Species | Height (m) | Crown Spread | Trunk Circumference at 1.5m | Age Class | Crown density | Structural Condition | General Health | Comments | Recommendation | Timescale for recommended work |
|---|---|---|---|---|---|---|---|---|---|---|---|
| T01 | Horse Chestnut | Approx 25m | East to West Approx. 16m<br>North to South Approx. 25m | Approx 2.8 m | Mature | 75% - 100% | Fair | Good | Historically, the tree has been pollarded many years ago resulting in a multi stemmed canopy with many long, top heavy, stems and branches. As a result of this abnormal structure, the tree is displaying various stress fractures along many of the leading stems. There are also a number of failed limbs and cavities that may compromise the structural integrity of some unions. | The tree would benefit from being reduced all round by 3-4 meters to reduce the leverage imposed on the canopy.<br><br>Any broken branches and dead wood should be removed. | 1-2 years |

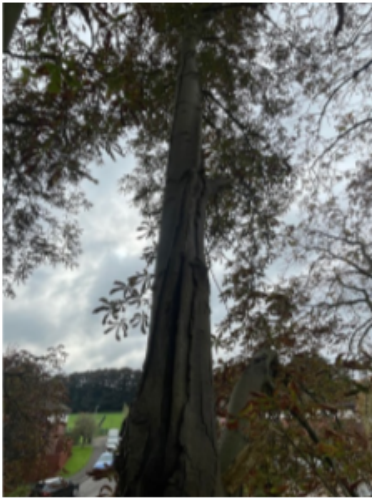
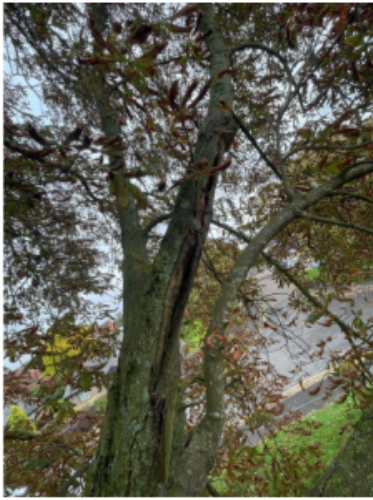
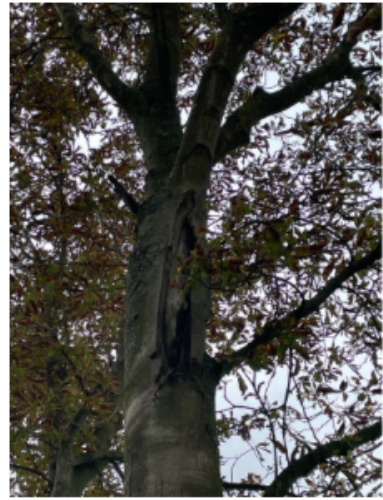
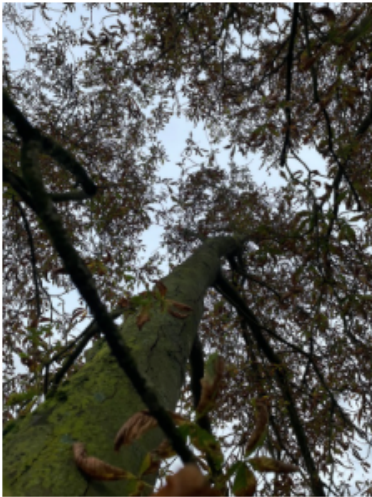
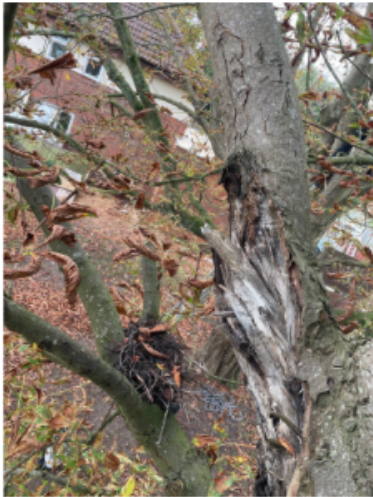
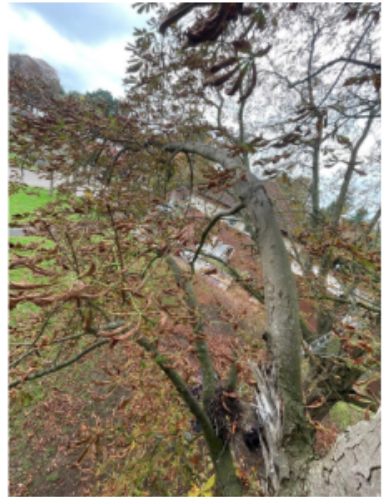
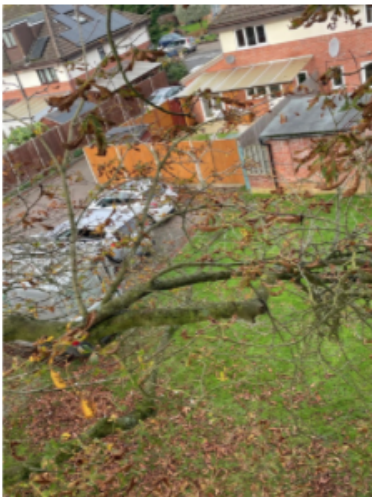
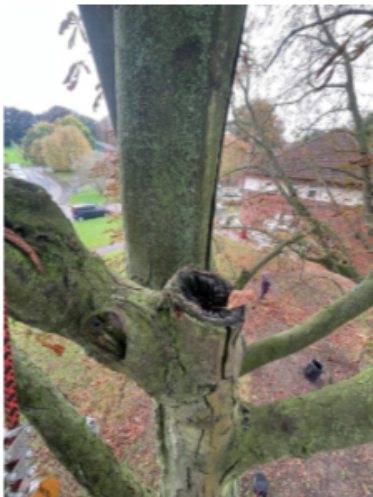
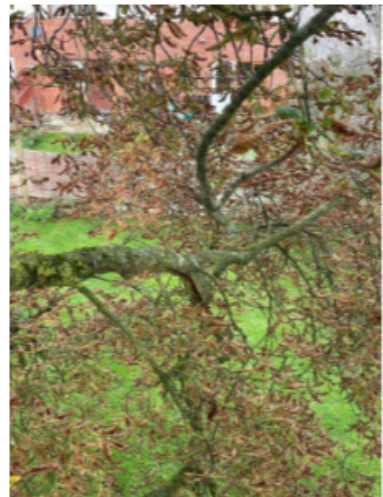
T2

| Tree No | Tree Species | Height (m) | Crown Spread | Trunk Circumference at 1.5m | Age Class | Crown density | Structural Condition | General Health | Comments | Recommendation | Timescale for recommended work |
|---|---|---|---|---|---|---|---|---|---|---|---|
| T02 | Horse Chestnut | Approx 25m | East to West<br>Approx. 18m<br><br>North to South<br>Approx. 27m | Approx 2.8 m | Mature | 75% - 100% | Fair | Good | <p>Historically, the tree has been pollarded many years ago resulting in a multi stemmed canopy with many long, top heavy, stems and branches.</p> <p>As a result of this abnormal structure, the tree is displaying various stress fractures along many of the leading stems.</p> <p>There are also a number of failed limbs and cavities that may compromise the structural integrity of some unions.</p> <p>The tree has also been pruned back away from number 10 August End at some point in the last few years.</p> | <p>The tree would benefit from being reduced all round by 3-4 meters to reduce the leverage imposed on the canopy.</p> <p>Any broken branches and dead wood should be removed.</p> | 1-2 years |

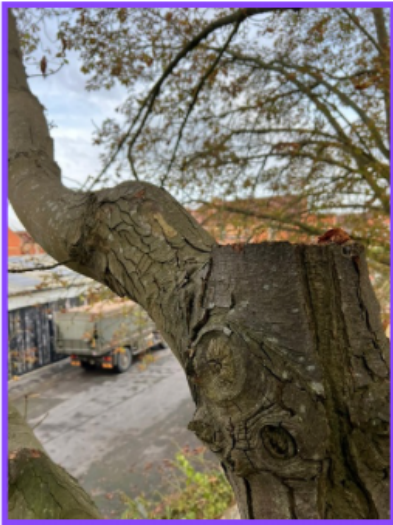
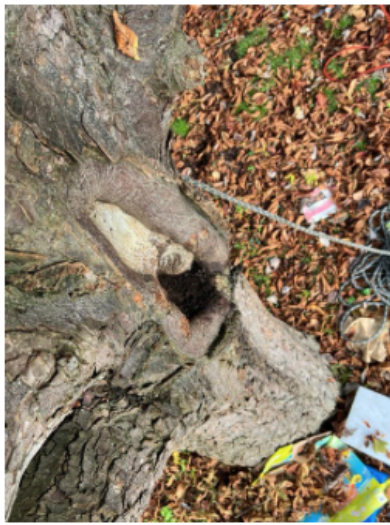
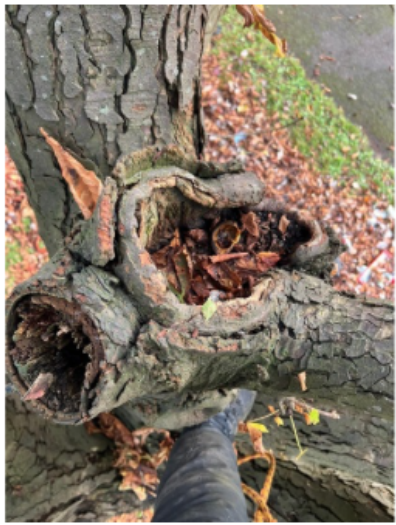
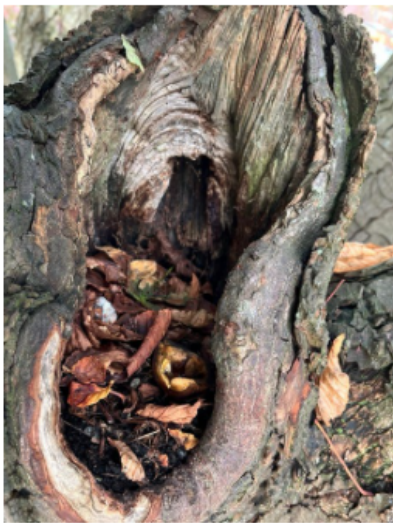
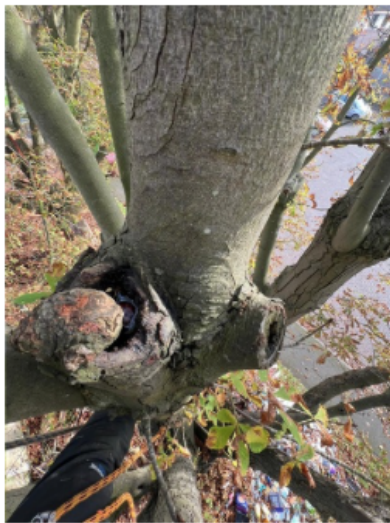
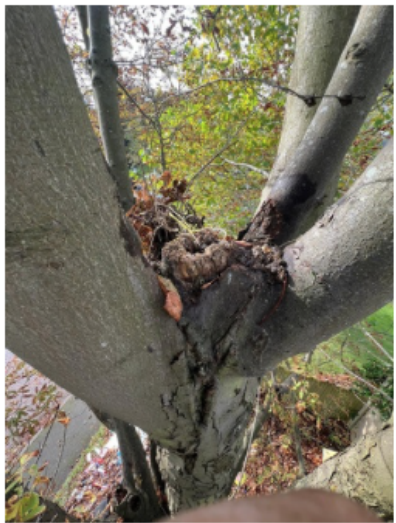
The two trees T3 and T4 from the ground appeared to be in reasonable condition. The buttresses and trunks of the trees were visibly healthy with no signs of fungal fruiting bodies at the time of the inspection.

Once aerially inspected, T3 and T4 had limited signs of stress fractures to the upper crown but a few failed limbs and dead wood still suspended in the canopies. There were also many previous pruning wounds that have failed to occlude, now early signs of rot are developing.

| Tree No | Tree Species | Height (m) | Crown Spread | Trunk Circumference at 1.5m | Age Class | Crown density | Structural Condition | General Health | Comments | Recommendation | Timescale for recommended work |
|---|---|---|---|---|---|---|---|---|---|---|---|
| T03 | Horse Chestnut | Approx 15m | East to West Approx. 8m<br><br>North to South Approx. 10m | Approx 1.5 m | Semi Mature | 75% - 100% | Good | Good | Historically, the tree has been pollarded many years ago resulting in a multi stemmed canopy with many long, top heavy, stems and branches. Unlike T1 & T2, T3 is smaller so is not experiencing as much leverage on the upper canopy. There are also a few failed limbs and cavities that may compromise the structural integrity of some unions. | Any broken branches and dead wood should be removed. | 1-2 years |

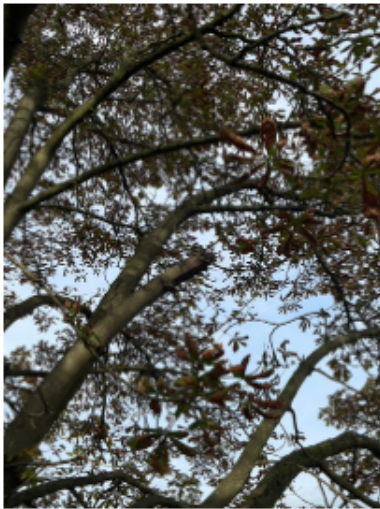
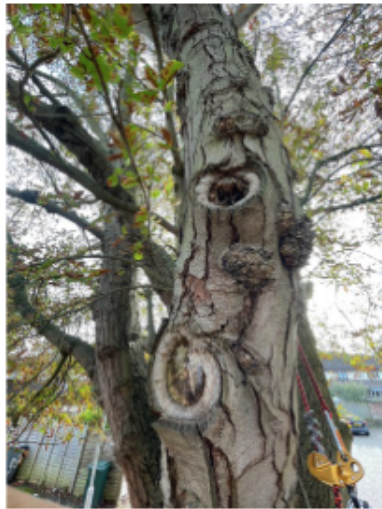
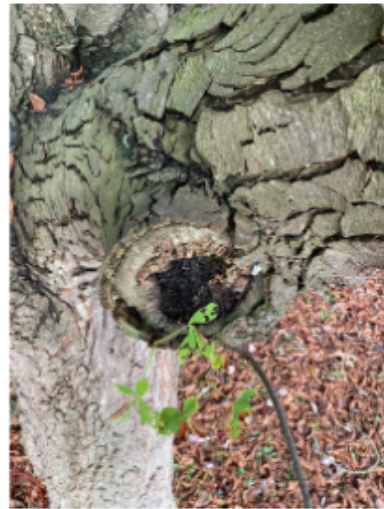
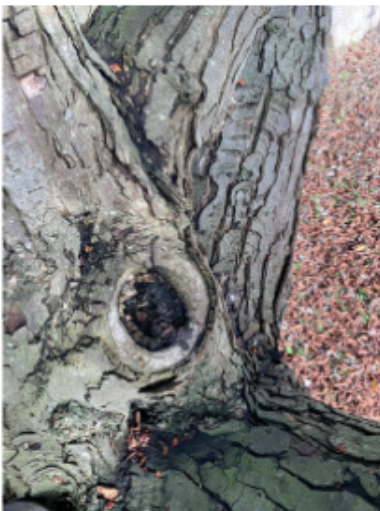
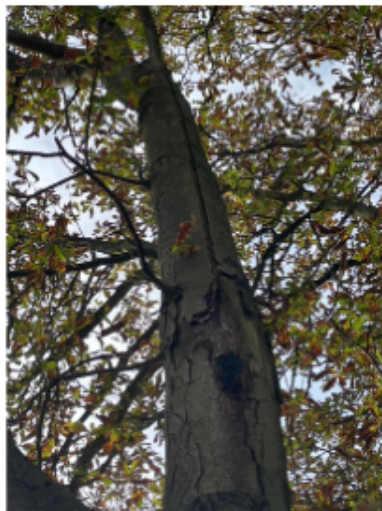
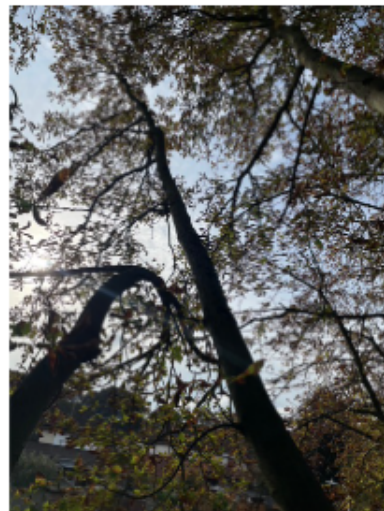
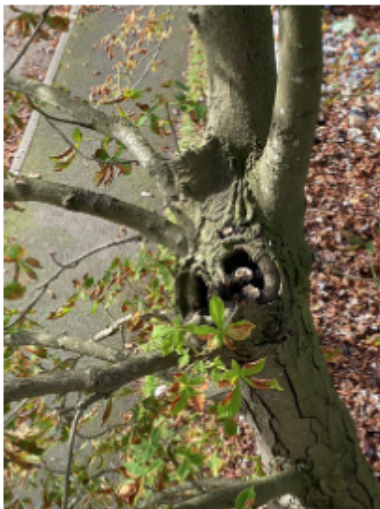
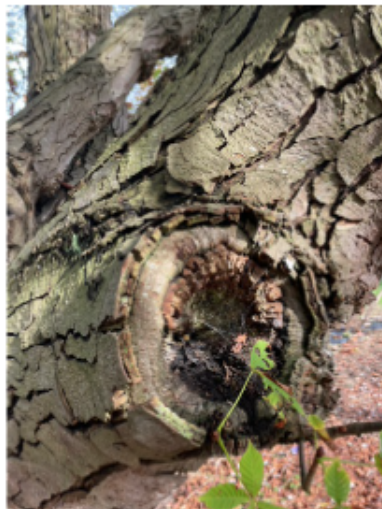
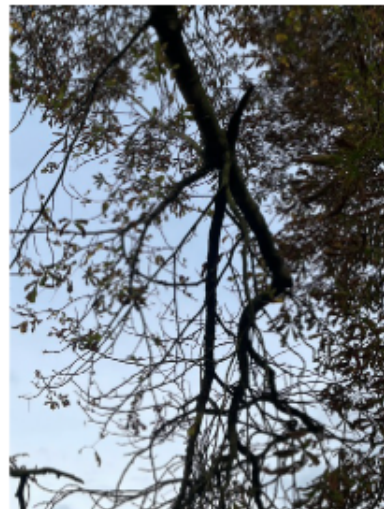
| Tree No | Tree Species | Height (m) | Crown Spread | Trunk Circumference at 1.5m | Age Class | Crown density | Structural Condition | General Health | Comments | Recommendation | Timescale for recommended work |
|---|---|---|---|---|---|---|---|---|---|---|---|
| T04 | Horse Chestnut | Approx 15m | East to West Approx. 8m<br>North to South Approx. 10m | Approx 1.5 m | Semi Mature | 75% - 100% | Good | Good | Historically, the tree has been pollarded many years ago resulting in a multi stemmed canopy with many long, top heavy, stems and branches. Unlike T1 & T2, T4 is smaller so is not experiencing as much leverage on the upper canopy. There are also a number of failed limbs and cavities that may compromise the structural integrity of some unions. | Any broken branches and dead wood should be removed. | 1-2 years |
