# **Southampton Street**

## **Internal Finishes and Joinery Schedule**

144 Southampton Street  
Reading  
RG1 2RD

24 September 2025  
Reference: 2449-P610-P1

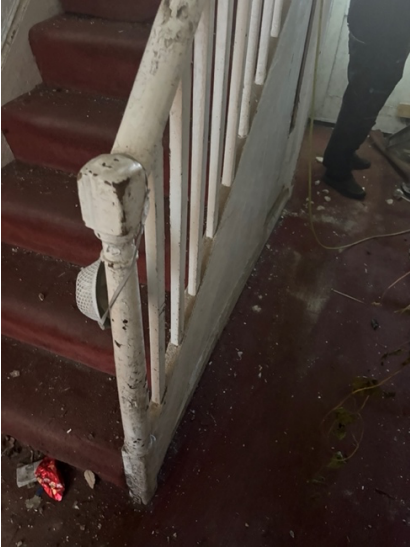
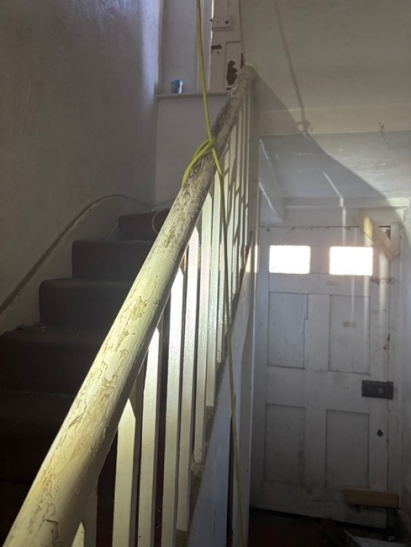
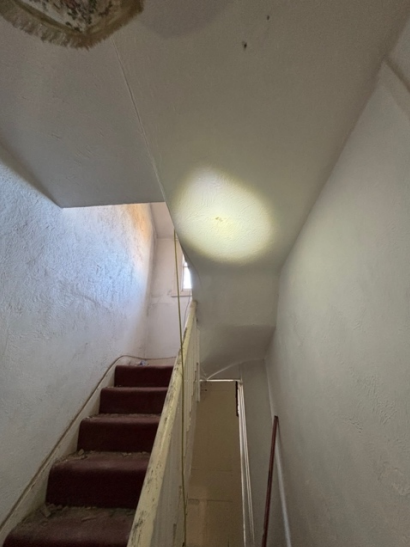
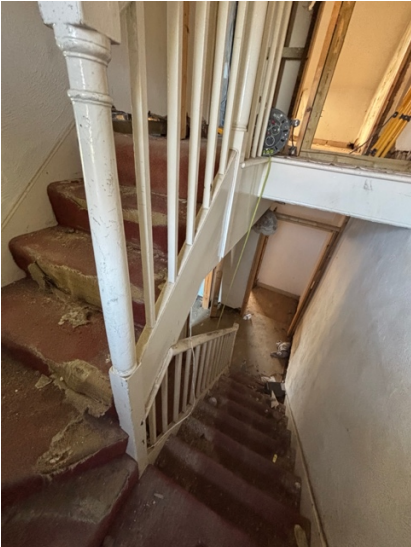
| Room | Joinery | Photos |
|---|---|---|
| Entrance, hallway and landing | Staircase balustrade and spindles from ground to first and first to second floors. These are all to remain, to be rubbed down and repainted. | |

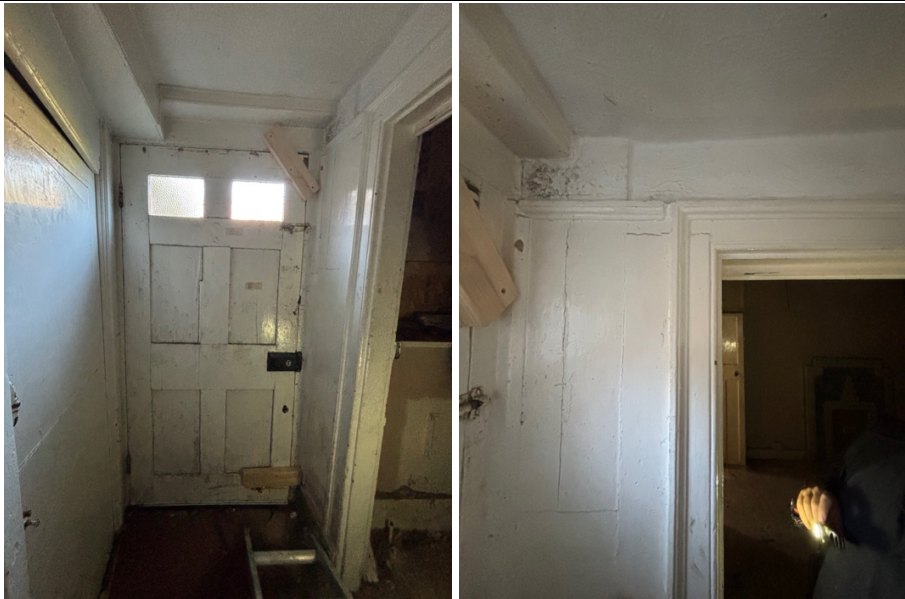
| <p>Rear entrance and hallway</p> | <p>The back door is original timber door, with a small section of timber panelling, this is all to remain as existing. To be rubbed down and repainted.</p> | |

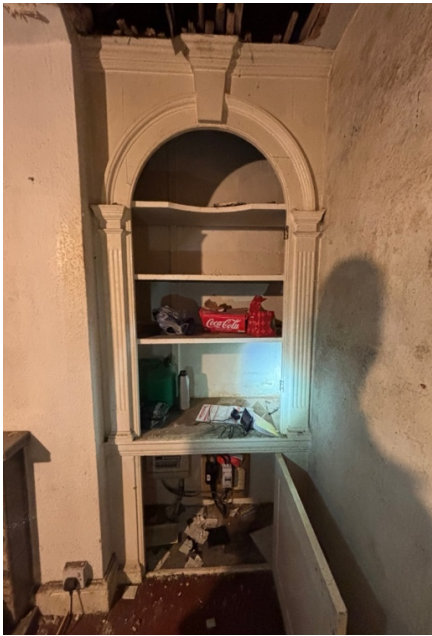
| <p>Front Lounge</p> | <p>Within the two recesses either side of the chimney, there are original timber archways, with cupboards at low level. The doors to the bottom cupboard have been removed and stored. The remaining sections will be rubbed down and repainted.</p> <p>One side of the fire place has collapsed due to the flood damage, we will reinstalled the archway and shelves out of new timber, to match the profile of the side that remains.</p> <p>The existing doors will then be re-installed.</p> | |

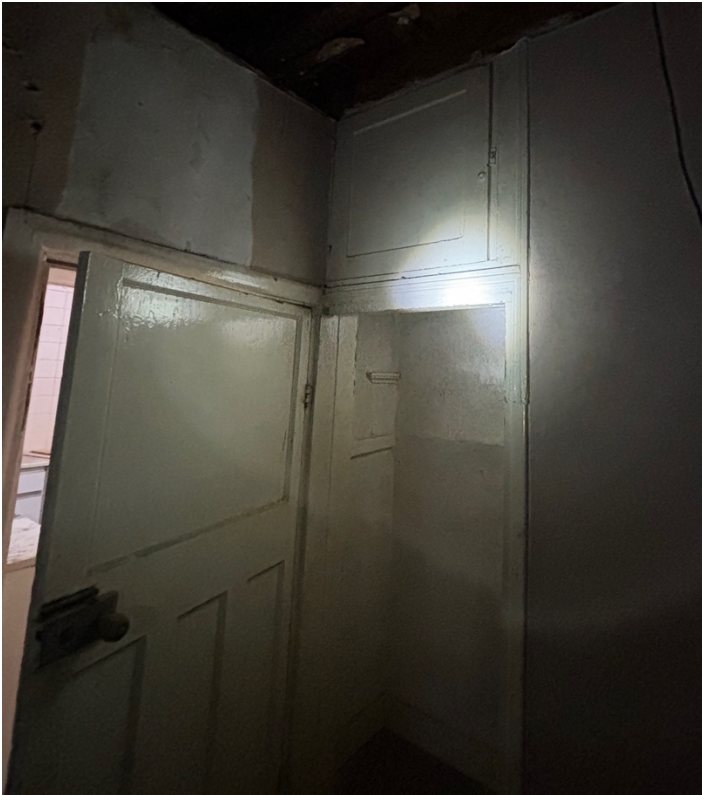
| Kitchen Diner | Within the recess to one side of the chimney, there are original timber cupboard, this is to remain as existing. | |
