# Asbestos Refurbishment/Demolition Survey for Reading Borough Council

Whitley Wood Community Centre  
Copenhagen Close  
Reading  
RG2 8UH

Project Number: AS13954

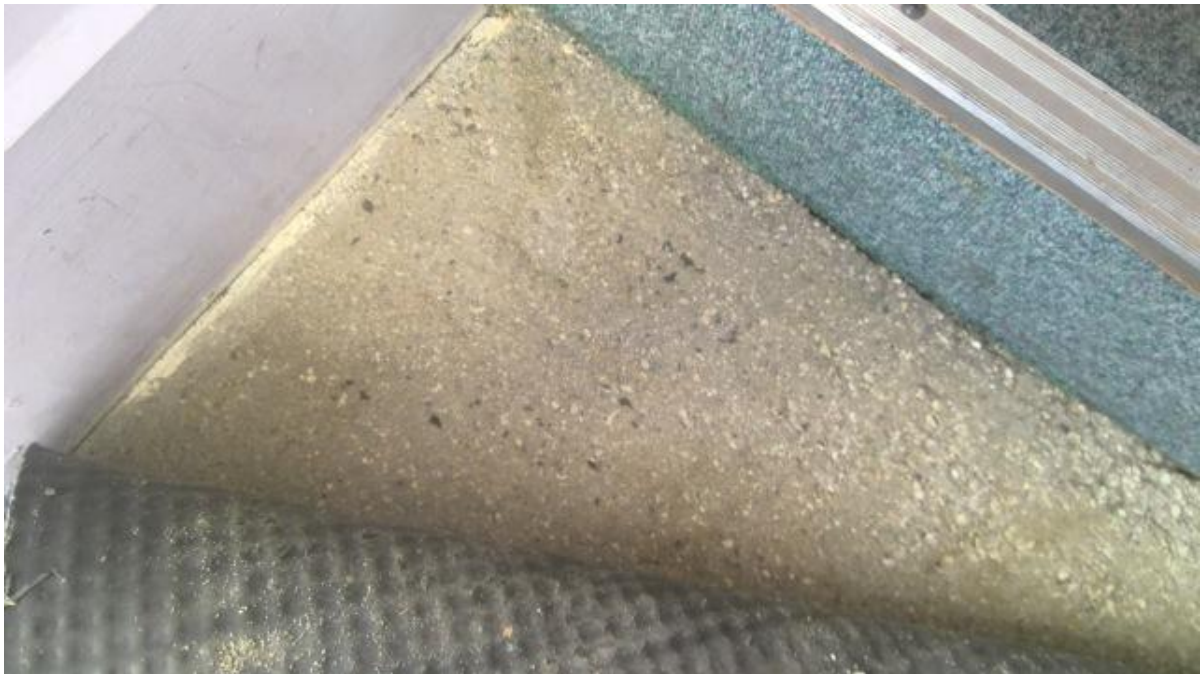
Material Comments: Flooring accessed, concrete below.

Action: No Action Required

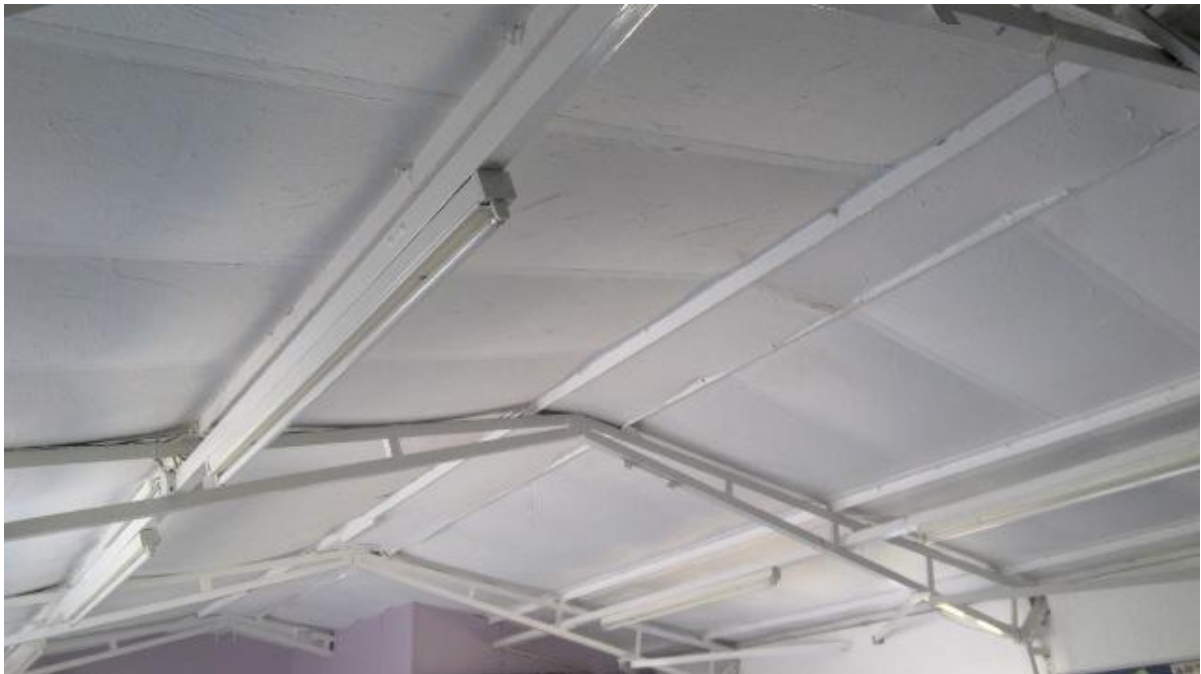
| Product: | Spray coating | Damage: | Low damage |

Sprayed coating to ceiling.

Remove by a Licensed Asbestos Removal Contractor

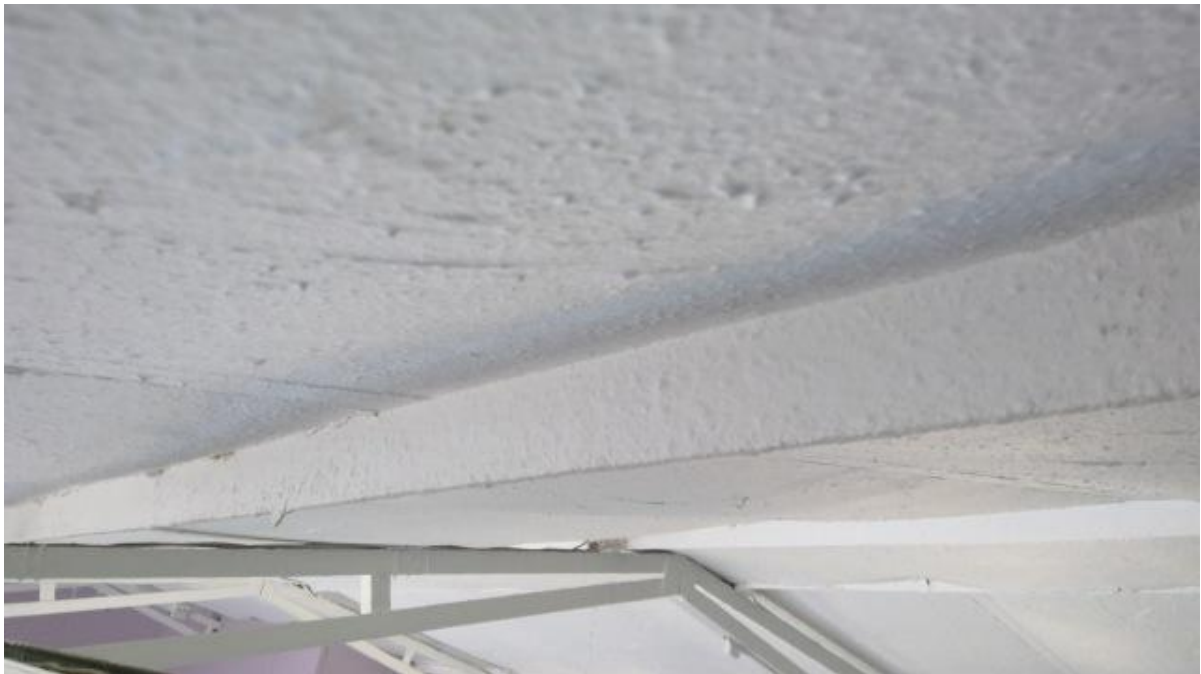
| Product: | <div>Spray coating</div> | Damage: | <div>Low damage</div> |

Sprayed coating residue to metal beams to ceiling, including high level parts of wall.

Remove by a Licensed Asbestos Removal Contractor

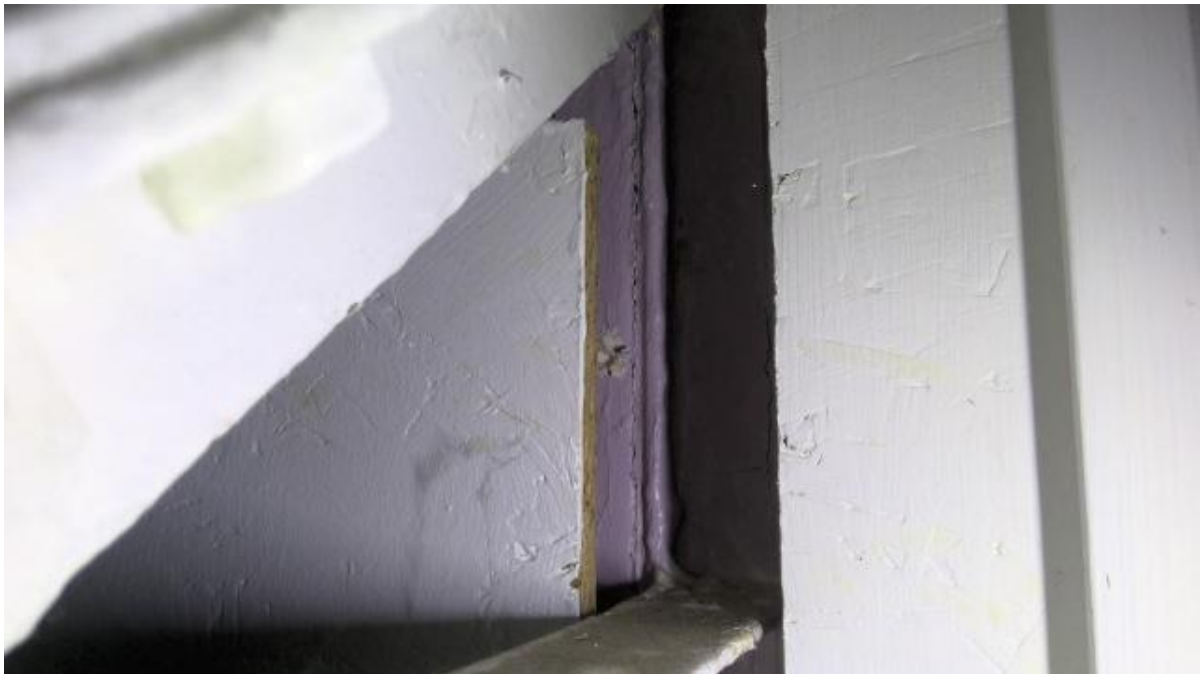
Limited access behind timber cladding to walls, plasterboard visible behind.

Proceed With Caution

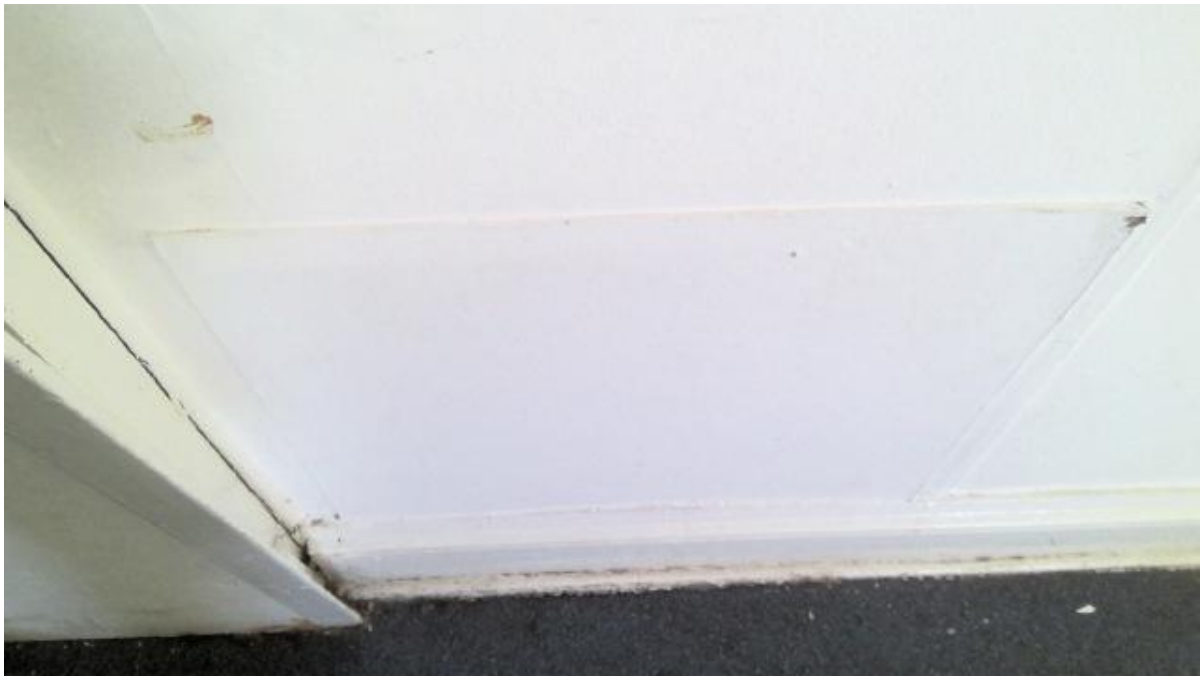
Fibreboard panel to wall.

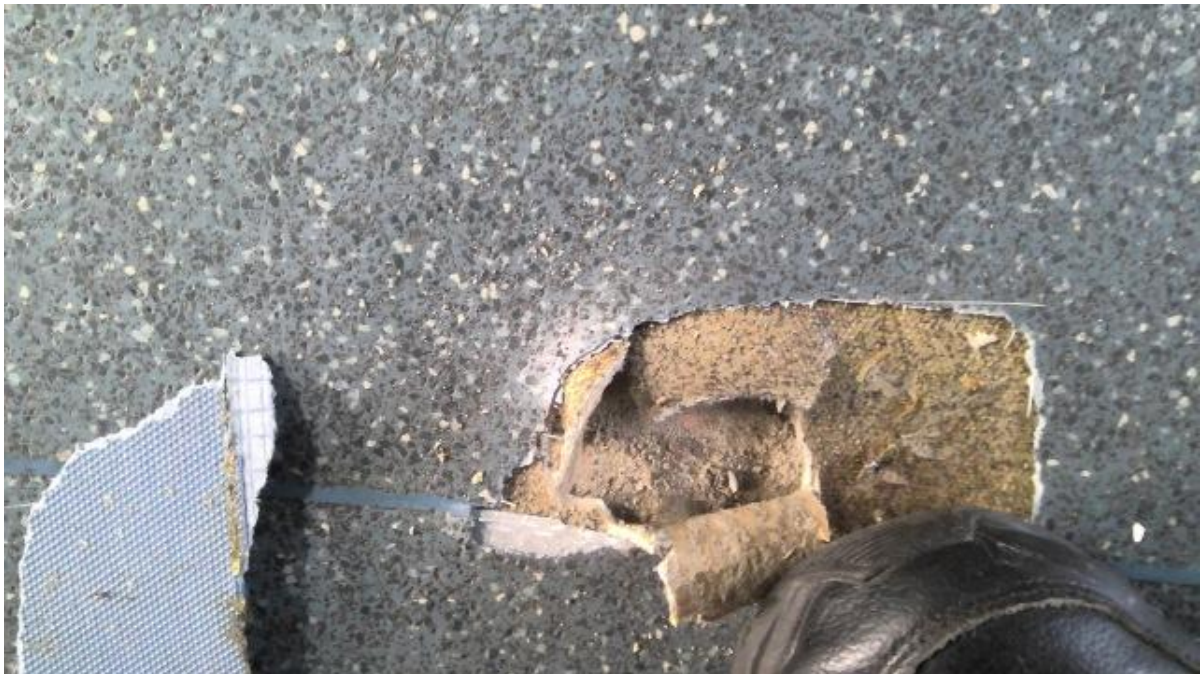
Flooring accessed, concrete below x2 layers of modern flor roll.

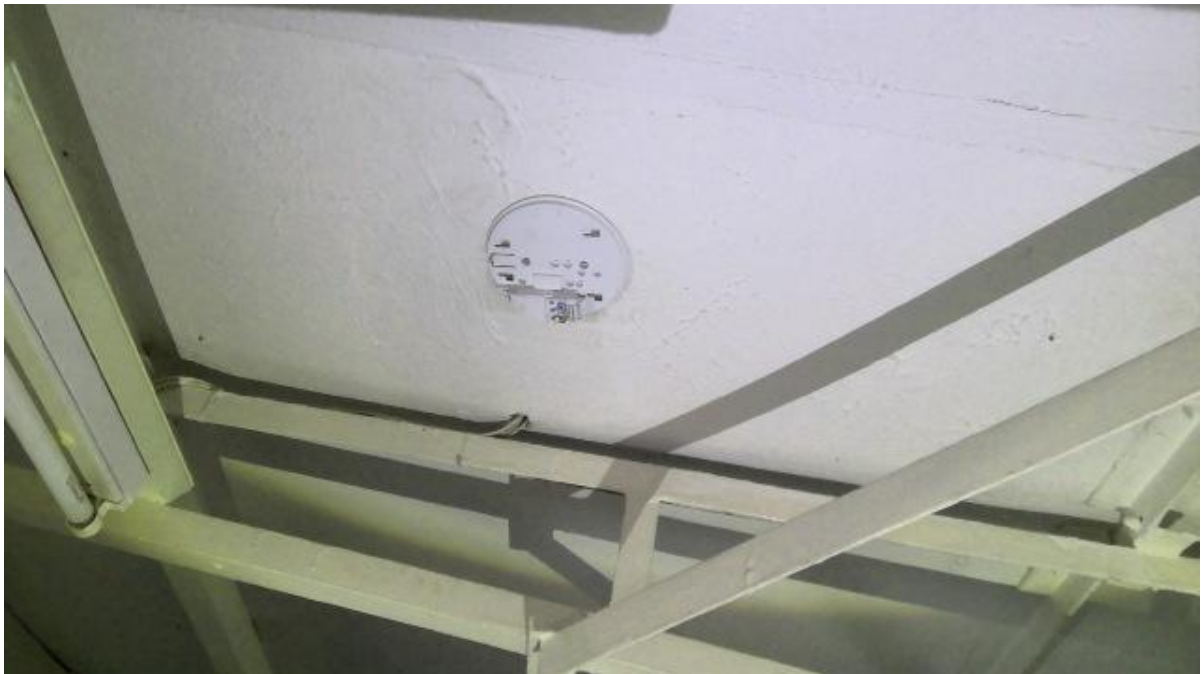
| Product: | Spray coating | Damage: | Low damage |

| Material Comments: | Sprayed coating to ceiling. |

| Action: | Remove by a Licensed Asbestos Removal Contractor |

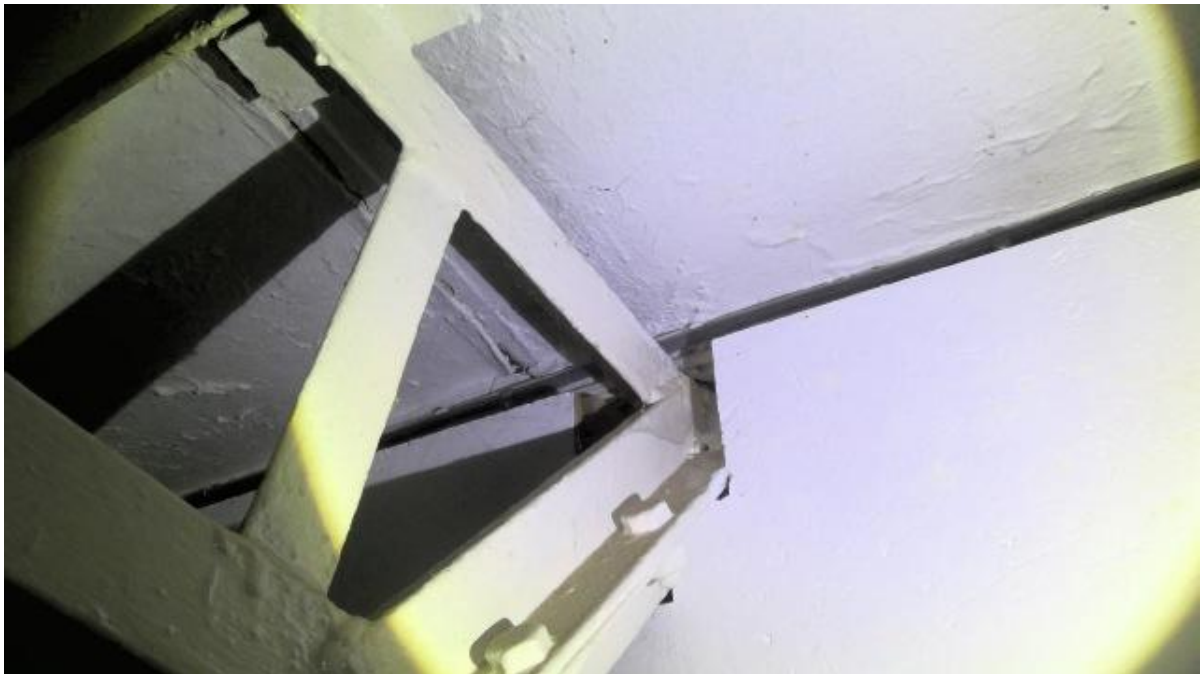
| Product: | Spray coating | Damage: | Low damage |

Sprayed coating residue to metal beams to ceiling, including high level parts of wall.

Remove by a Licensed Asbestos Removal Contractor

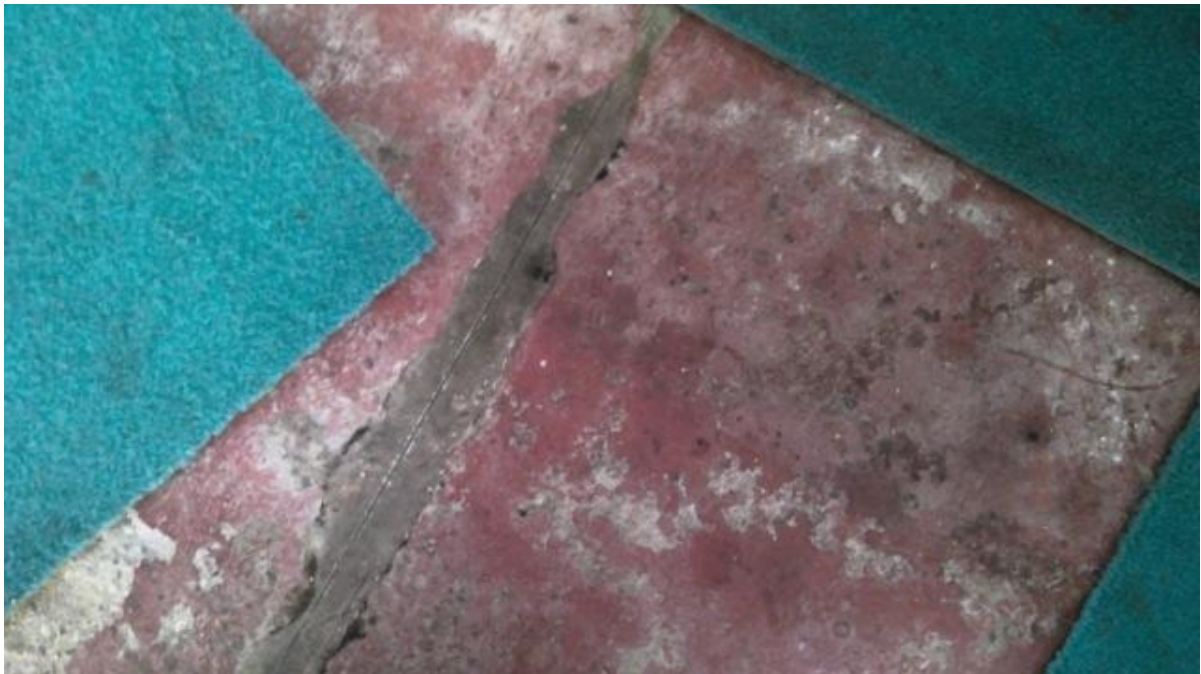
Material Comments: Below carpet tiles accessed, painted concrete below.

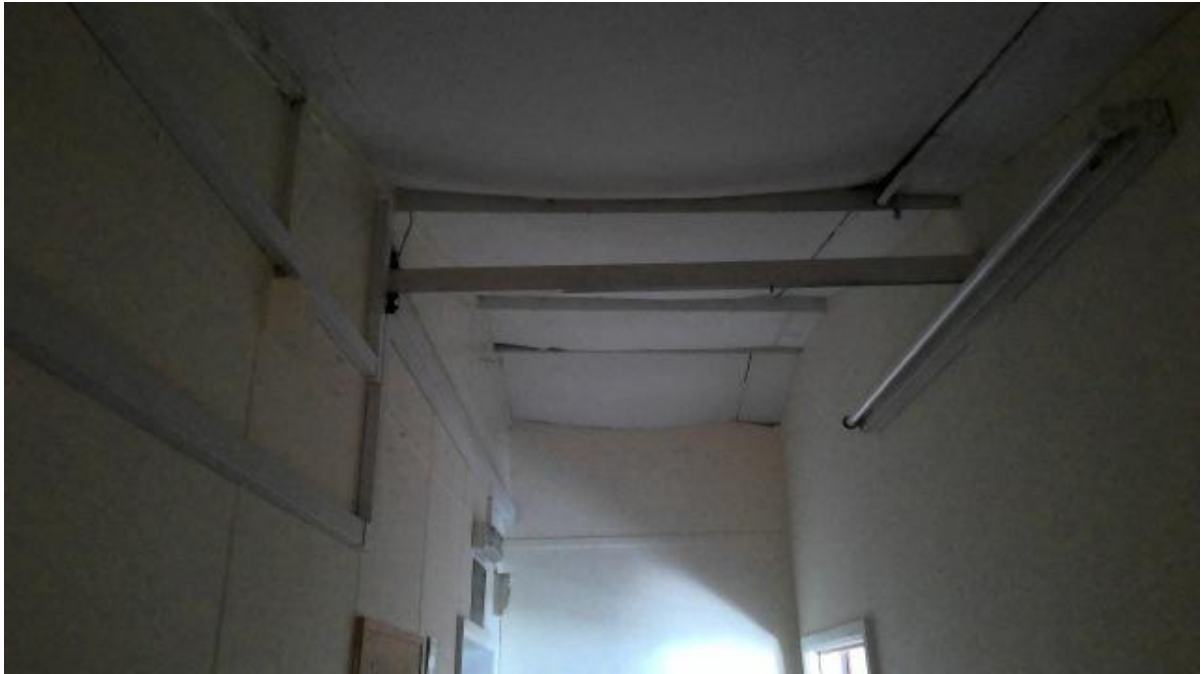
| Product: | Spray coating | Damage: | Low damage |

Sprayed coating to part of the ceiling, rest of ceiling is plasterboard and timber.

Remove by a Licensed Asbestos Removal Contractor

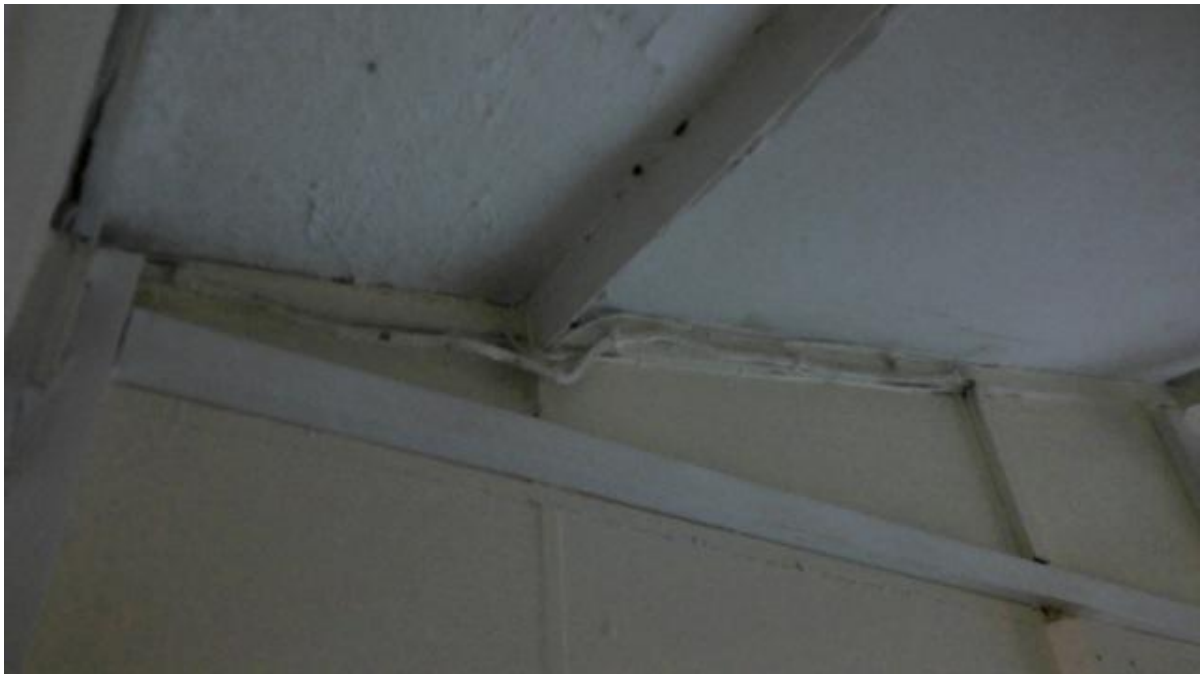
| Product: | Spray coating | Damage: | Low damage |

Sprayed coating residue to metal beams to ceiling, including high level parts of wall.

Remove by a Licensed Asbestos Removal Contractor

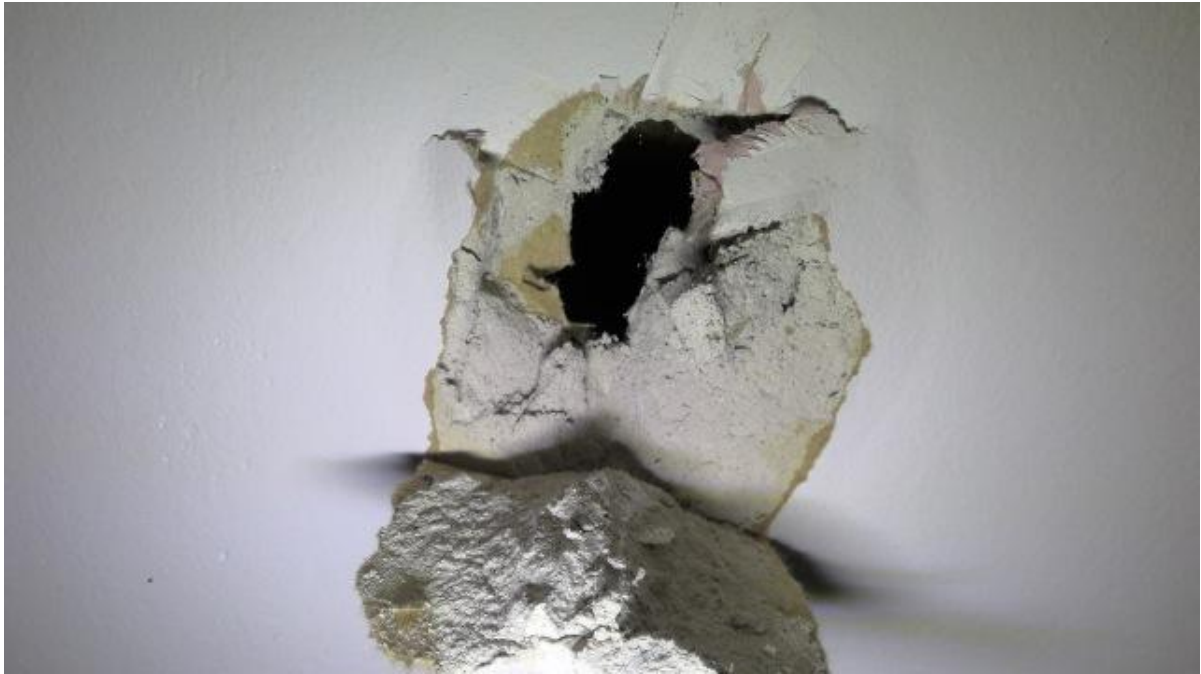
Material Comments: Plasterboard ceiling accessed, timber above

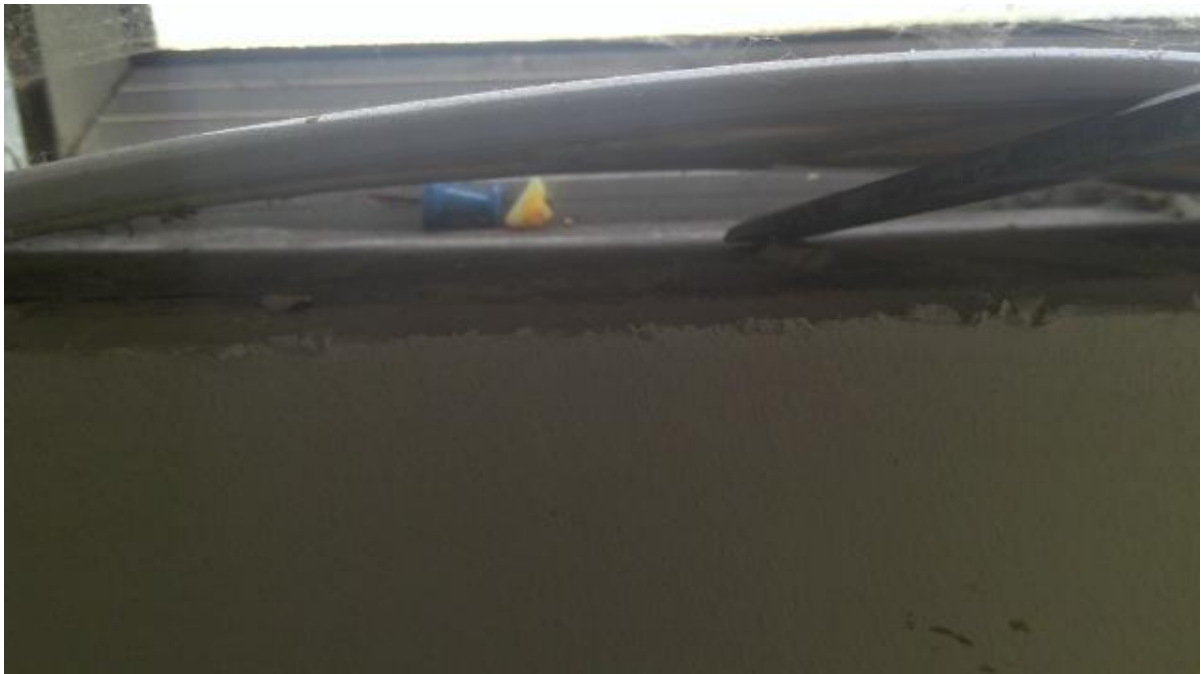
| Material Comments: | Below window sill accessed, timber beneath. |

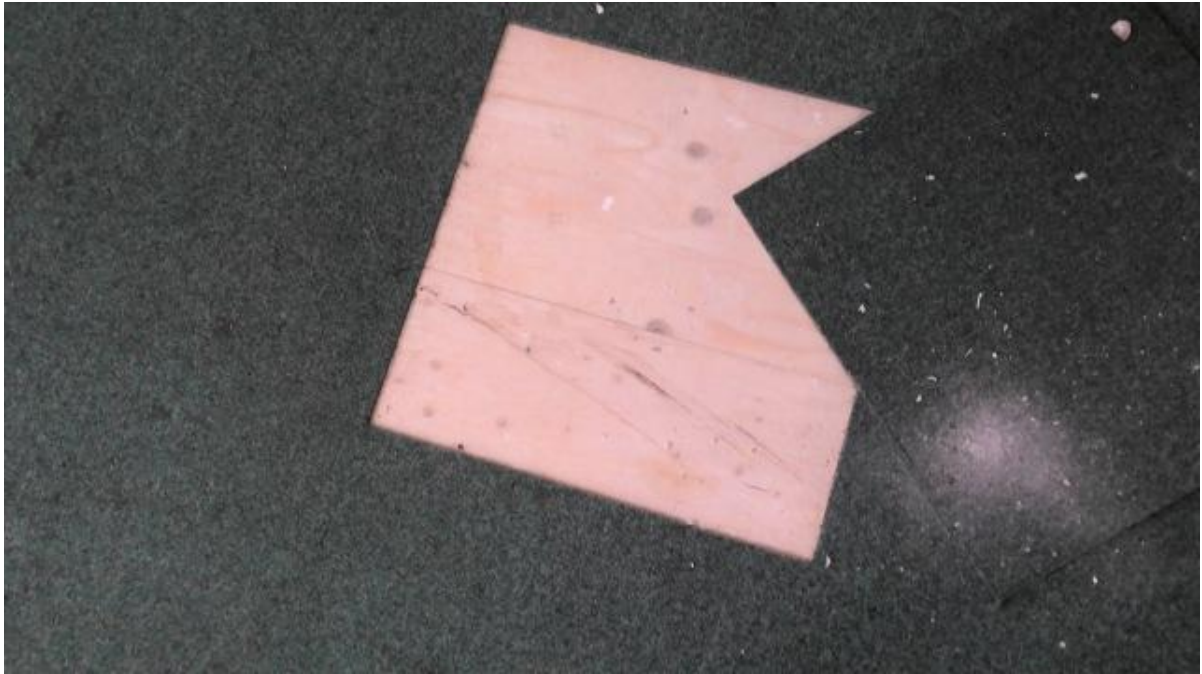
Carpet tiles accessed, timber below.

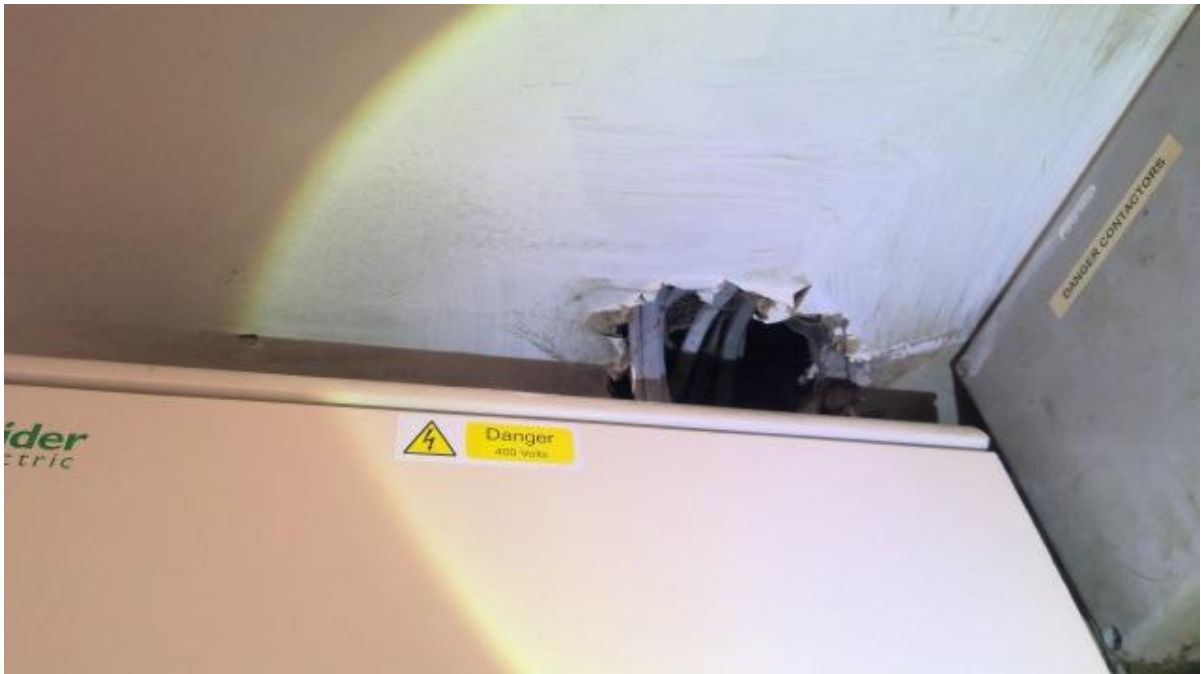
Material Comments: Plasterboard ceiling accessed, timber above.

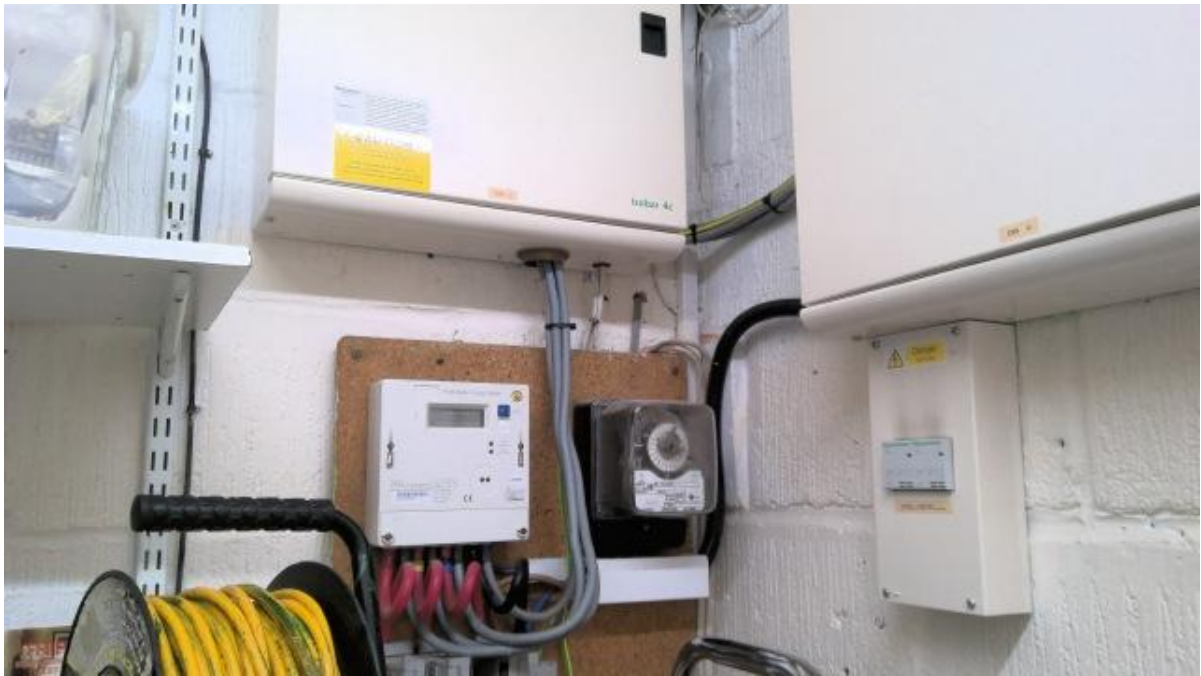
Material Comments: Modern fuse & switchgear.

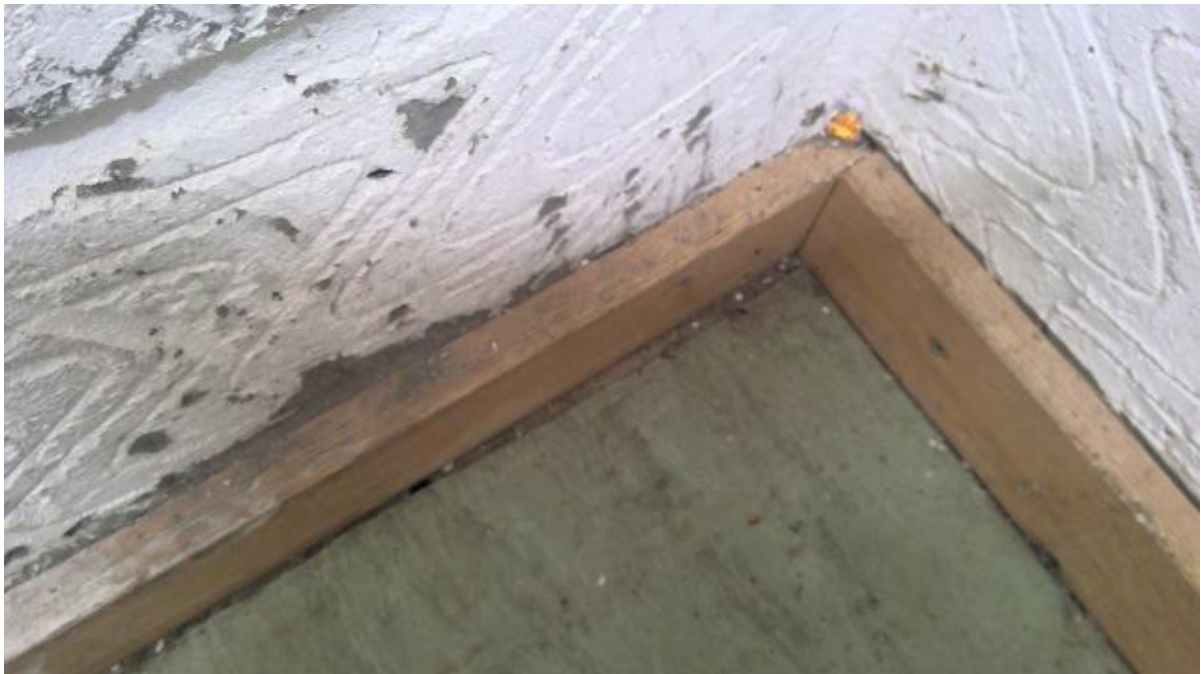
Material Comments: Flooring accessed, concrete below modern vinyl floor roll.

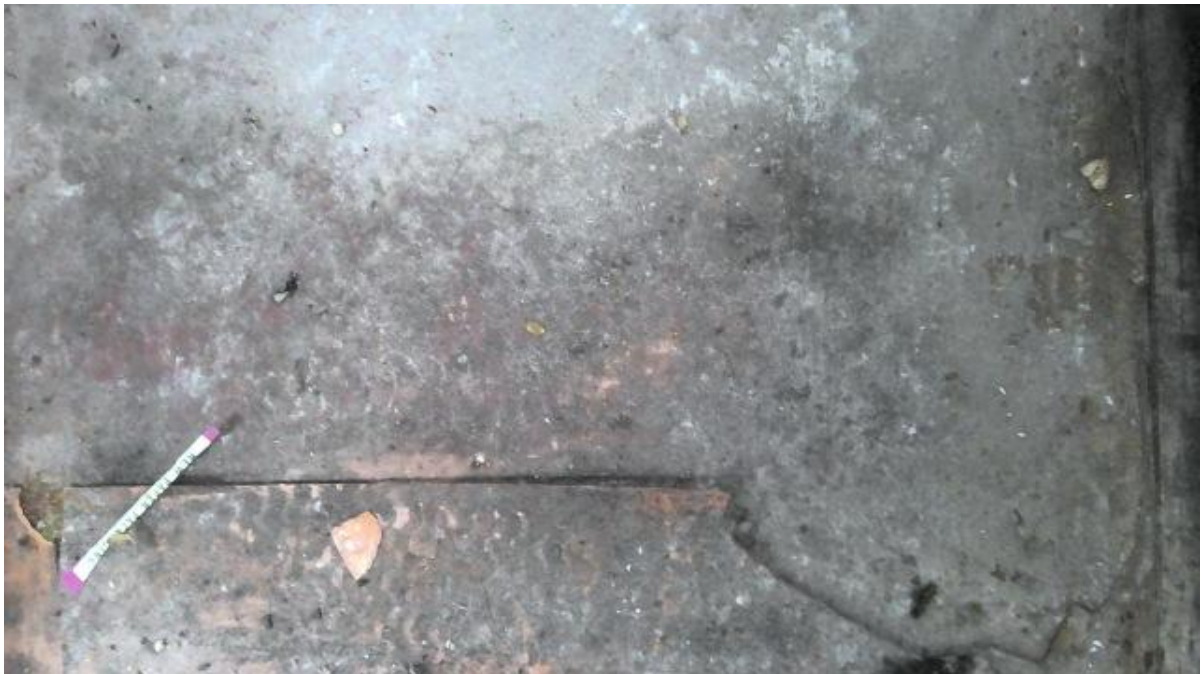
Below x3 layers of floor roll accessed, concrete below.

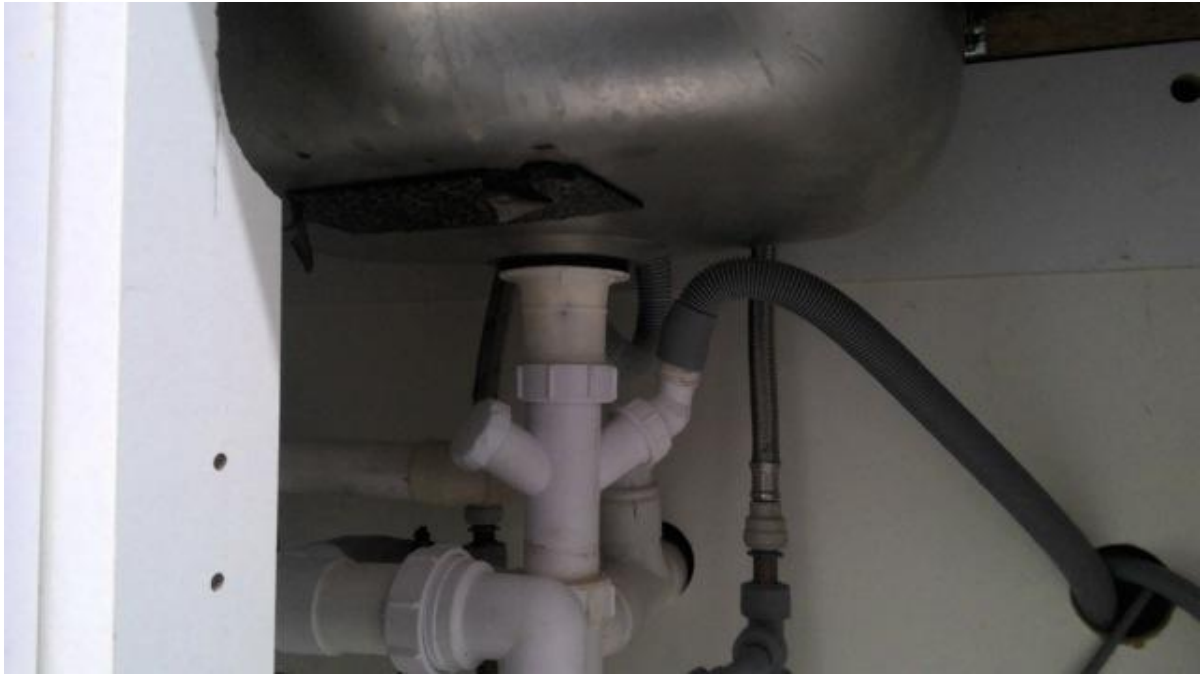
Sink and drainer pad to unit.

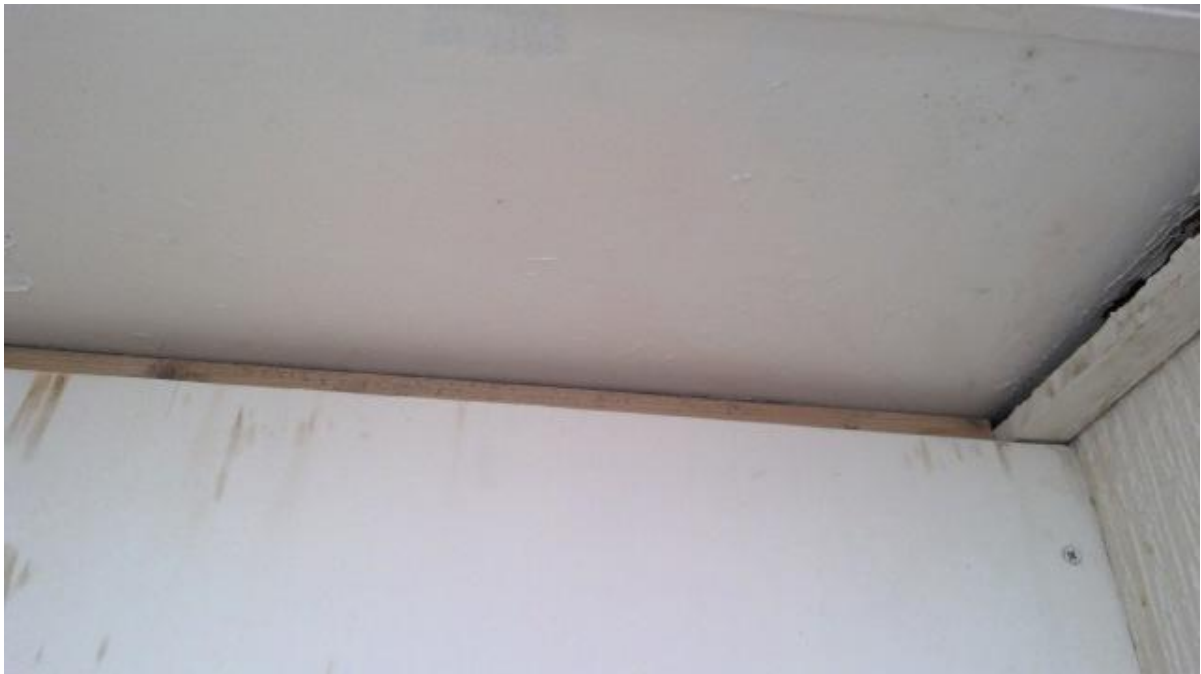
Plasterboard ceiling with timber above.

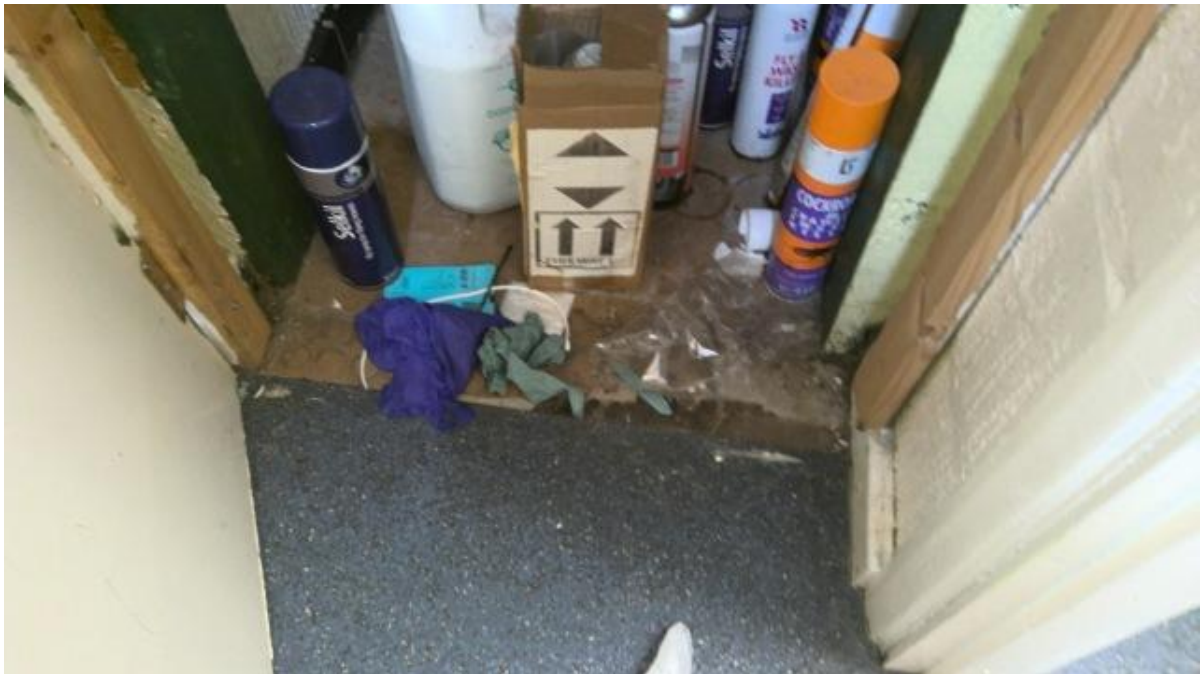
Material Comments: Concrete below modern floor roll.

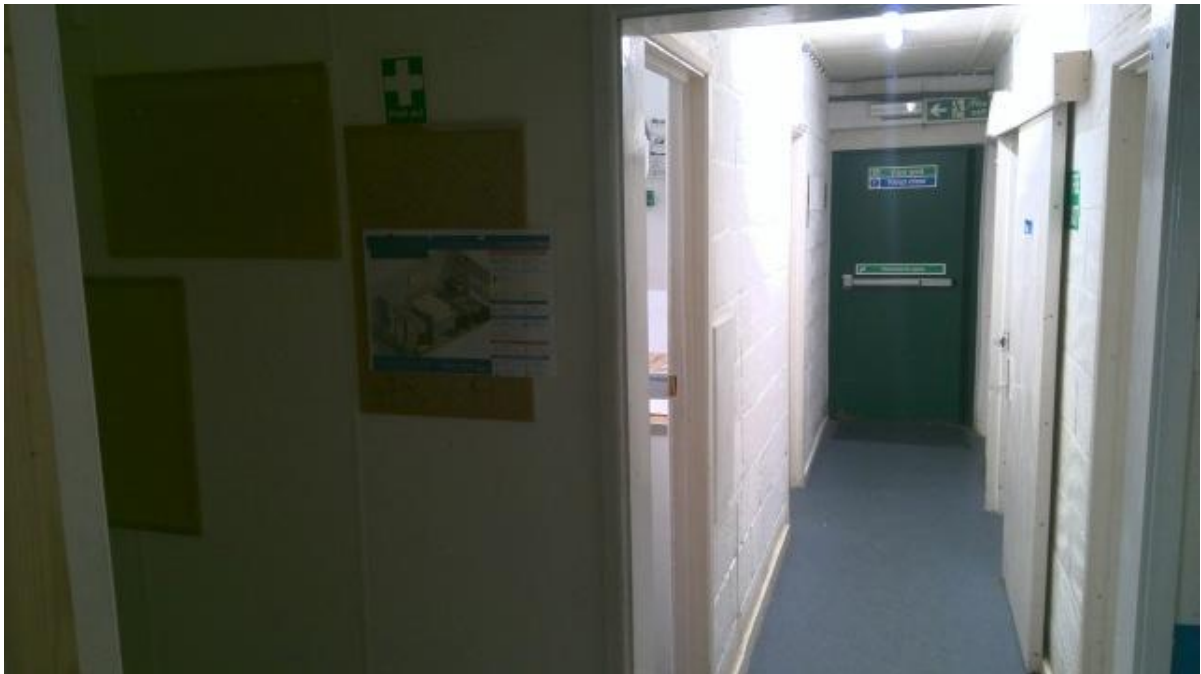
Material Comments: Breeze block construction to external wals with timber partition to internal walls.

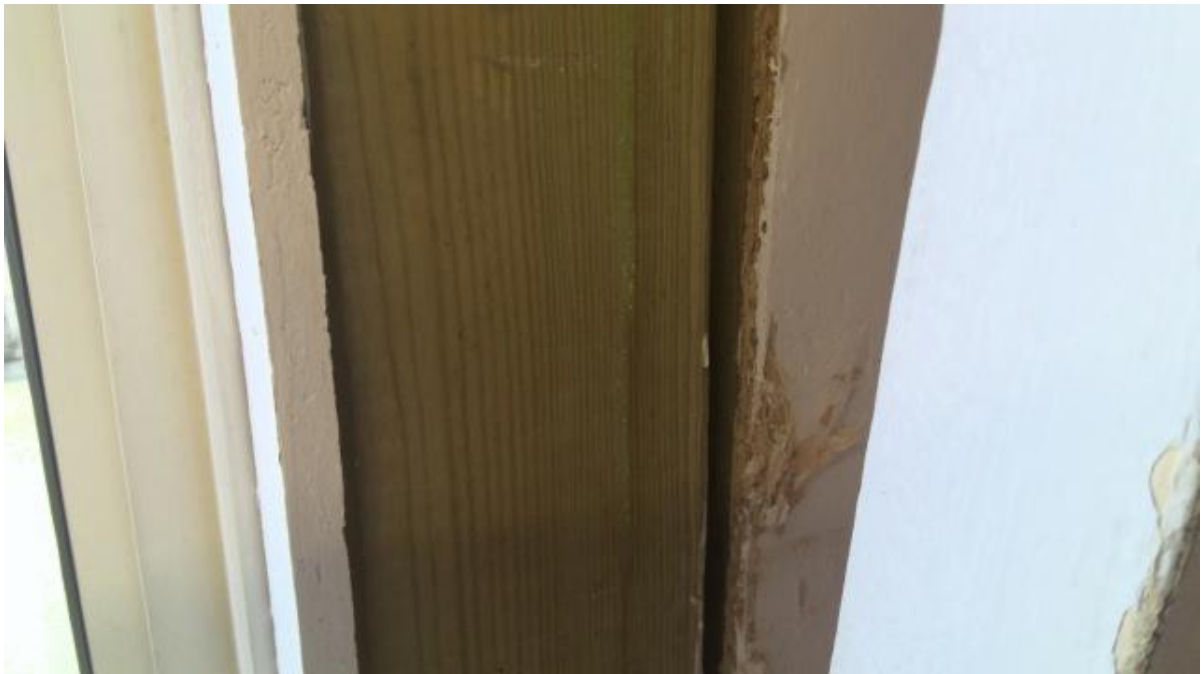
Material Comments: Limited access behind timber cladding to walls throughout. No ACM's present where inspected, unless otherwise mentioned.

Action: Proceed With Caution

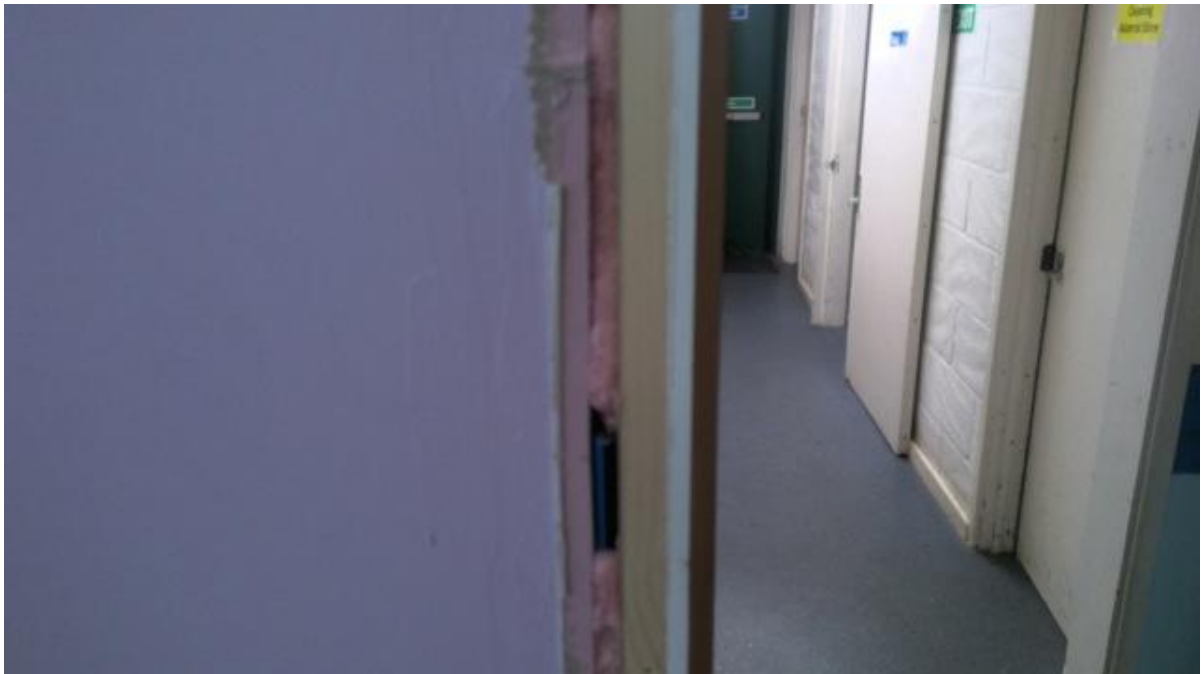
Material Comments: Door frames accessed throughout. No ACM's present where inspected.

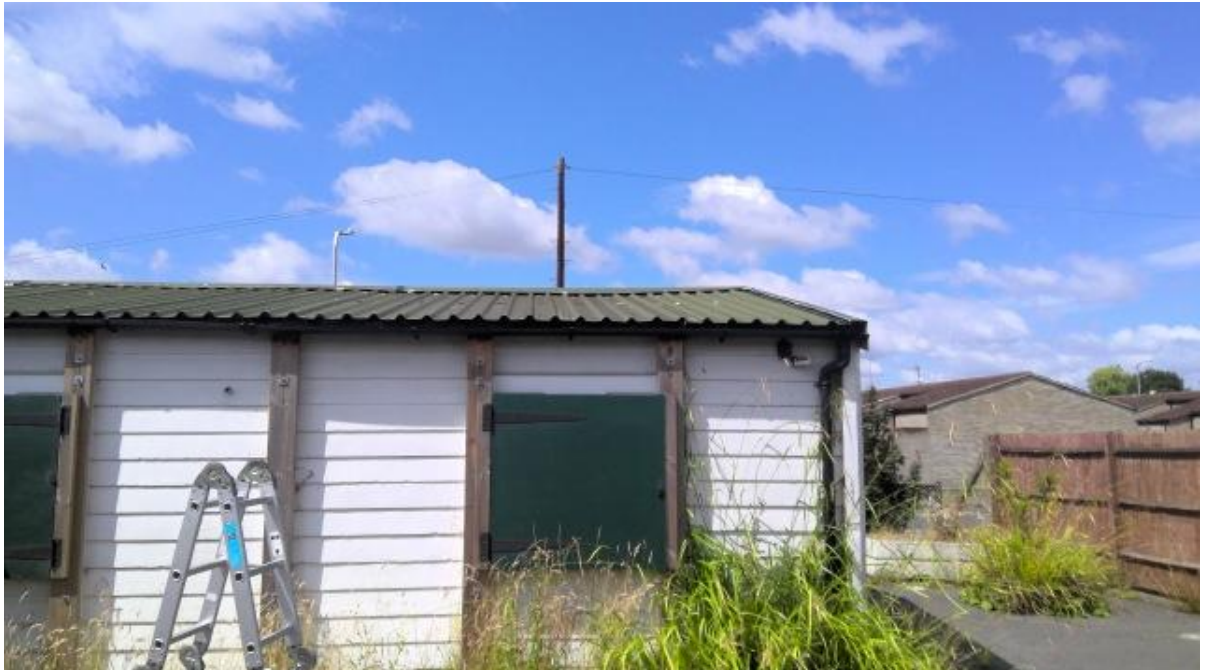
Concrete external cladding with galvanised metal roof above hall area.

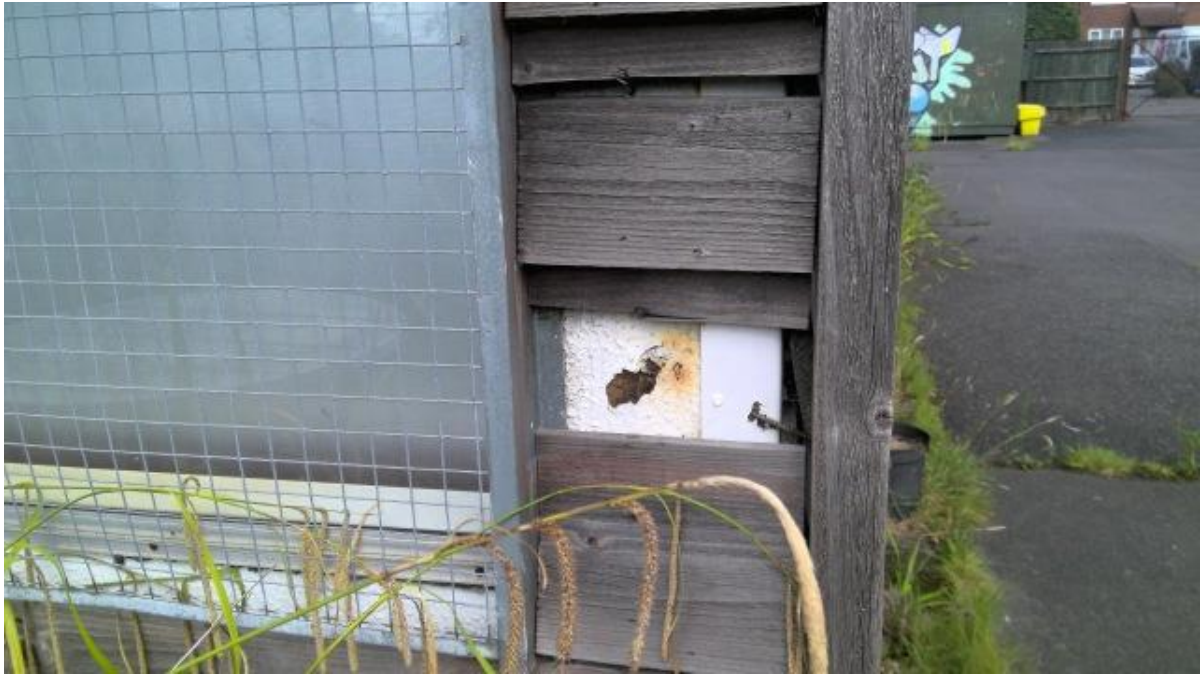
Material Comments: Textured coating to timber walls behind timber cladding.

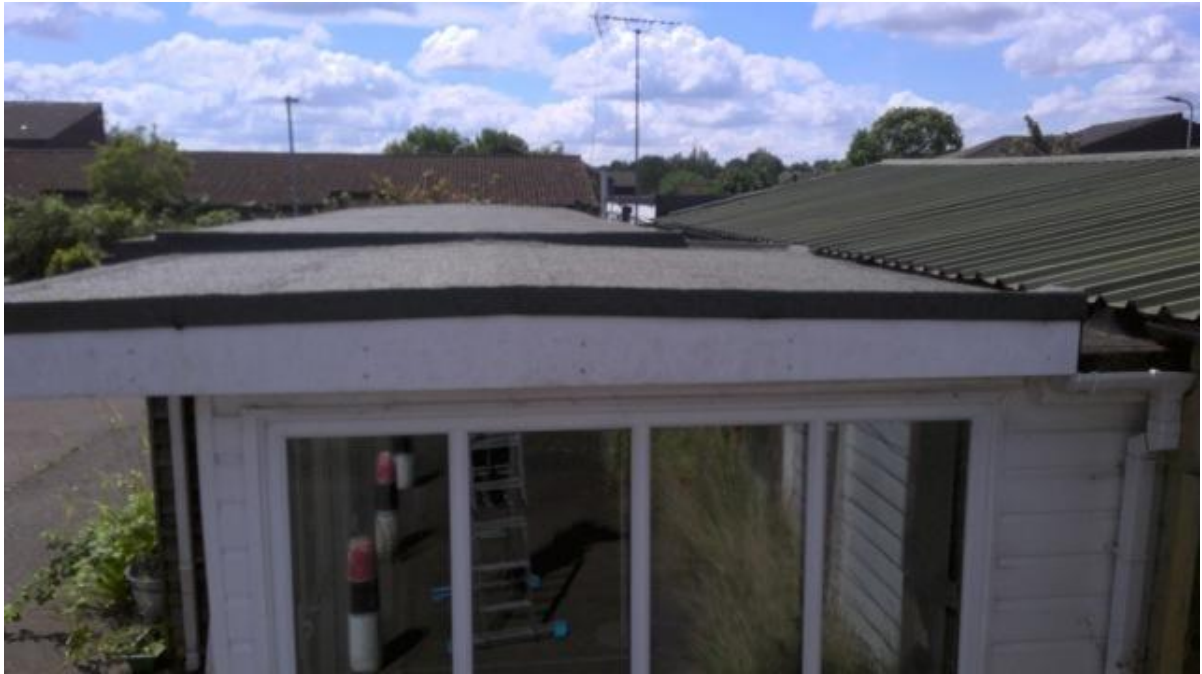
Roof felt to roof above sitting area.
