# Asbestos Refurbishment/Demolition Survey for Reading Borough Council

Whitley Wood Community Centre  
Copenhagen Close  
Reading  
RG2 8UH

Project Number: AS13954

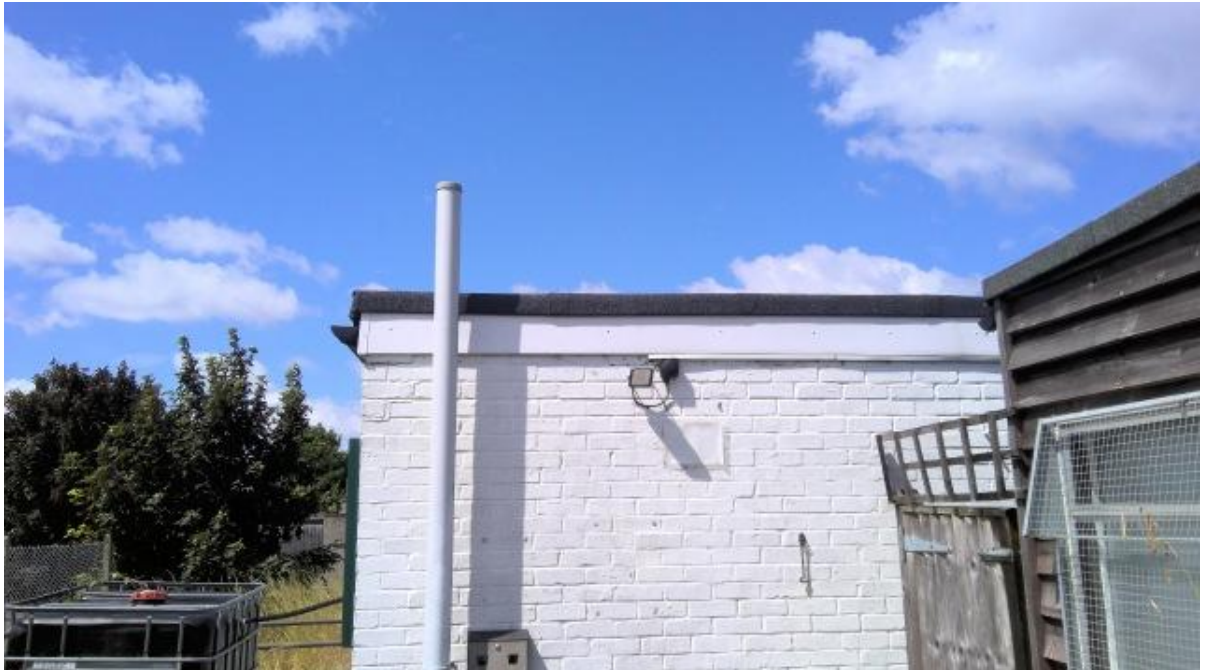
Roof felt to roof above W.C's.

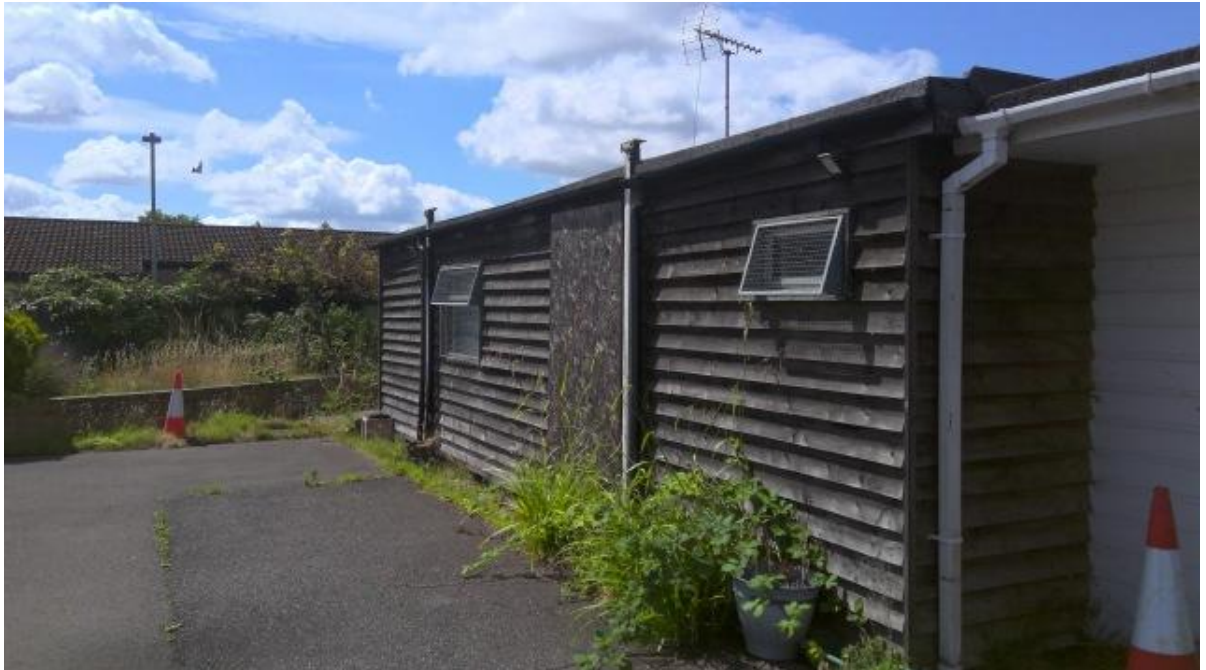
uPVC rainwater goods.

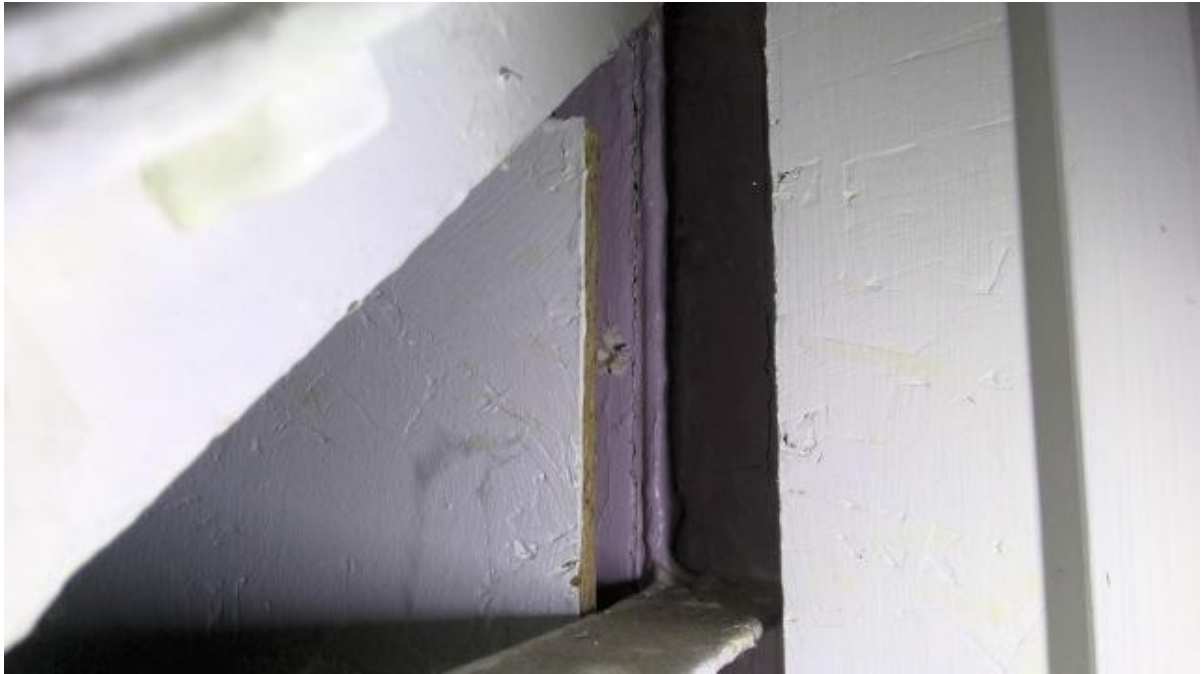
Limited access into wall cavities and behind cladding to walls within areas where sprayed coating is present due to risk of disturbing possible ACM's. Presumed residue and overspray to walls behind cladding and within cavities.

Remove by a Licensed Asbestos Removal Contractor
