43 Church Road, Caversham, RG4 7AG

Application:

To replace window

### Existing Window;

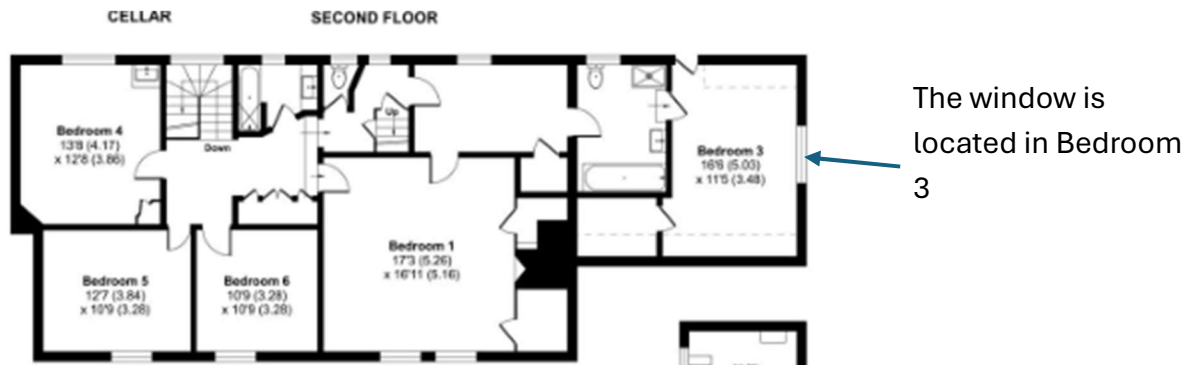
The current window is located to the right of the house in an extension that was built in the 1960's (exact date not known).

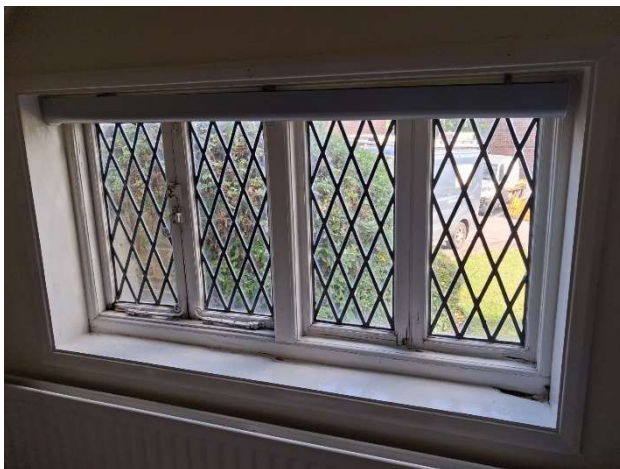
The current window is made of soft wood which does not comply with traditional materials for a house of this age. The soft wood frame is rotten and there is deterioration from dry rot in the window sill.

The window is a casement window with a leaded diamond grid pattern. Although this design is typical of Tudor and Victorian architectural styles, this is the only window of this style in this house. The other windows are either wooden sash windows or Crittall windows. As shown in photo of house above.

The extension has a leaking roof, a damp garage below and the window has been made of soft wood which has weathered badly in these conditions. There appears to have been little maintenance to the window inside or outside which has not protected the wood from exposure to moisture.

We invited a carpenter to repair the window and he said that it was beyond repair and needed to be replaced.

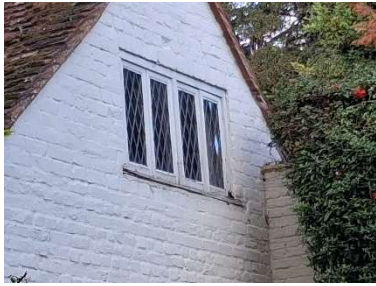
This external photo shows the deterioration of the frame outside. This is a security issue as can be pushed very little pressure and window would fall through.

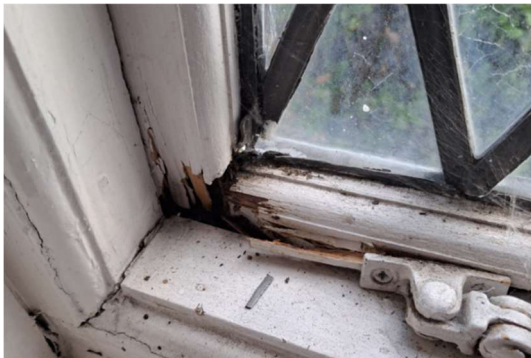
This is the bottom left corner of the window, the bottom section is so rotten that there is little wood left. Its hard to show in the photo because opening the window would probably lead to the window falling out completely. This is a security issue and is letting a great deal of cold into the room.

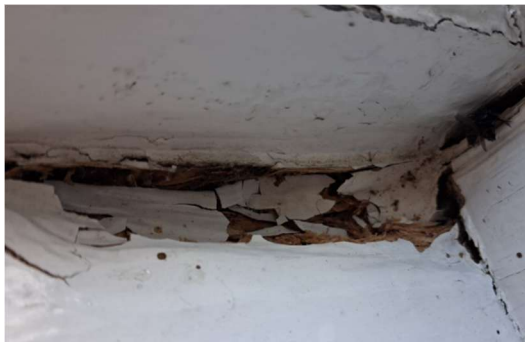
This is the inside sill on the bottom right hand corner, the dry rot has led to significant deterioration.

**Dry rot is a destructive fungal growth that devours timber, causing significant structural damage, decreased property value and potential health problems if left untreated. Unlike wet rot, which is confined to the immediate source of moisture, dry rot can spread aggressively through non-wood materials like masonry and plaster to find new wood to consume.**

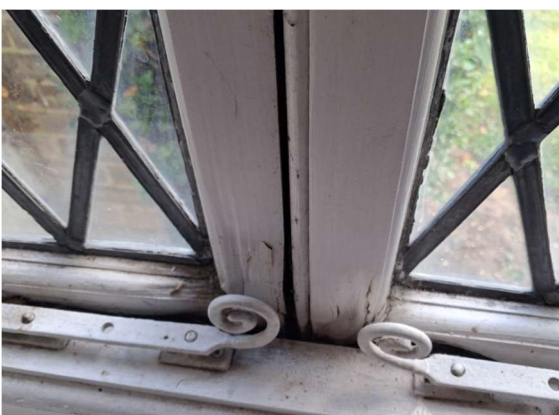
This is the bottom of the window which is very rotten. If opened the window will fall out completely.
