**17 Conisboro Avenue, Reading RG4 7JB**

# **Arboricultural impact assessment and tree protection measures v5 (October 2025)**

**Site inspected on 5<sup>th</sup> & 9<sup>th</sup> September 2023**

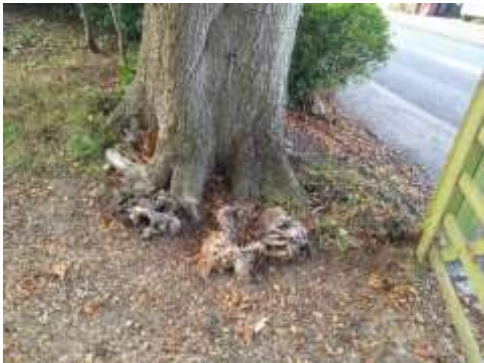
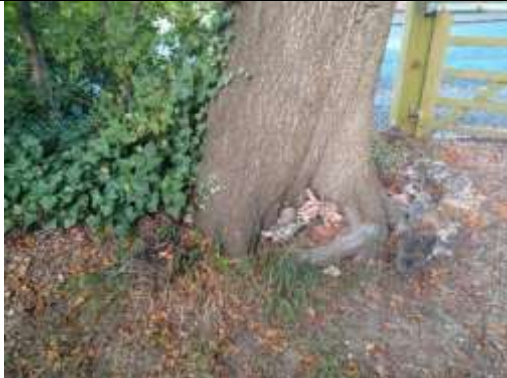
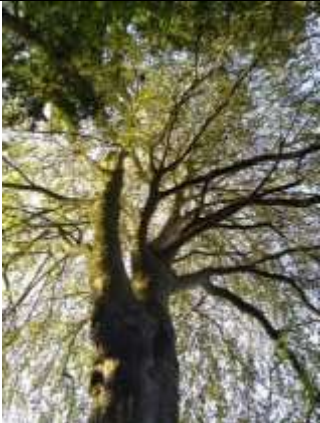
| Ref. | Species | Photo | Photo | Photo |
|---|---|---|---|---|
| T001 | Common Beech<br>( <i>Fagus sylvatica</i> )<br><b>REMOVED</b><br><b>January 2024</b><br><b>for H&amp;S</b><br><b>reasons</b> | | | |

| Ref. | Species | Location | Structure | Num. Stems | DBH (cm) | General Observations | RPA | Recommendations | Retention category |
|---|---|---|---|---|---|---|---|---|---|
| T001 | Common Beech<br>( <i>Fagus sylvatica</i> ) | Pavement, driveway and road | Tree | 1 | 90 | <ul style="list-style-type: none"> <li>• Canopy thin</li> <li>• <i>Meripilus giganteum</i> around majority of base</li> <li>• Water main under base</li> <li>• Poor vitality</li> </ul> | 10.8m radius<br><br>366.5m <sup>2</sup> | <ul style="list-style-type: none"> <li>• Dismantle Timescale: 05-Dec-2023 (3 months)</li> </ul> <p>Completed January 2024</p> | U |

T1, although it would not be directly impacted by the proposed development, has been removed due to the presence of *Meripilus giganteus*.

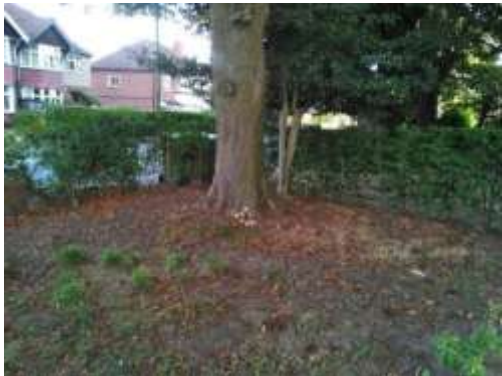
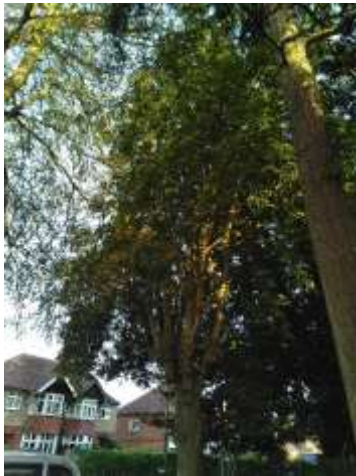
| Ref. | Species | Photo | Photo | Photo |
|---|---|---|---|---|
| T002 | Horse Chestnut<br>( <i>Aesculus hippocastanum</i> ) | | | |

| Ref. | Species | Location | Structure | Num. Stems | DBH (cm) | General Observations | RPA | Recommendations | Retention category |
|---|---|---|---|---|---|---|---|---|---|
| T002 | Horse Chestnut<br>( <i>Aesculus hippocastanum</i> ) | Road, pavement and driveway | Tree | 1 | 69 | <ul style="list-style-type: none"> <li>• Good condition</li> <li>• Mature</li> <li>• Lapsed Pollard</li> <li>• Normal vitality</li> </ul> | 8.3m radius<br><br>215.4m <sup>2</sup> | <ul style="list-style-type: none"> <li>• Mulch Timescale: 05-Sep-2024 (1 Year)</li> </ul> | B2 |

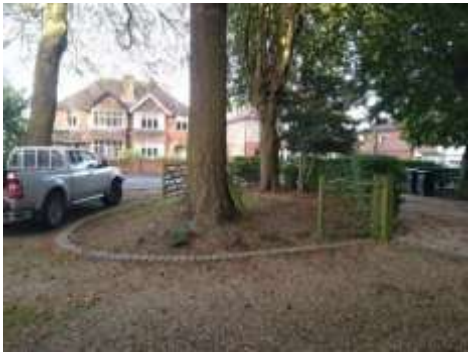
| Ref. | Species | Photo | Photo | Photo |
|---|---|---|---|---|
| T003 | Douglas Fir<br>( <i>Pseudotsuga menziesii</i> ) | | | |

| Ref. | Species | Location | Structure | Num. Stems | DBH (cm) | General Observations | RPA | Recommendations | Retention category |
|---|---|---|---|---|---|---|---|---|---|
| T003 | Douglas Fir<br>( <i>Pseudotsuga menziesii</i> ) | In driveway | Tree | 1 | 81 | <ul style="list-style-type: none"> <li>• Good condition</li> <li>• Mature</li> <li>• 7.8m from current wall</li> </ul> | 9.72m radius<br><br>296.9m <sup>2</sup> | <ul style="list-style-type: none"> <li>• Mulch Timescale: 05-Sep-2024 (1 Year)</li> </ul> | A2 |

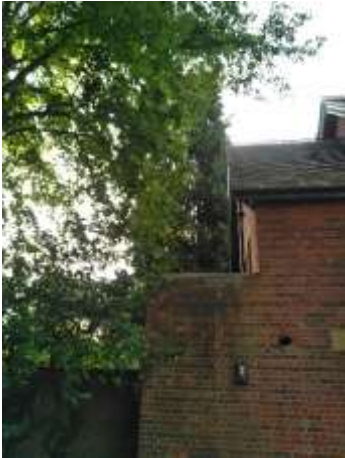
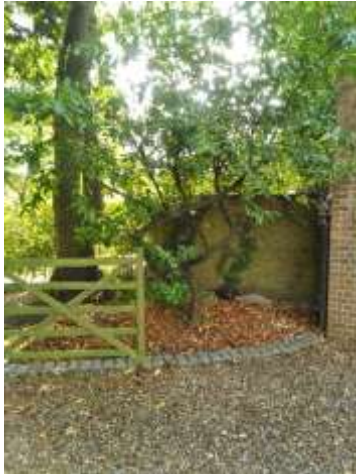
| Ref. | Species | Photo | Photo | Photo |
|---|---|---|---|---|
| T004 | Lime<br>( <i>Tilia sp.</i> ) | | | |

| Ref. | Species | Location | Structure | Num. Stems | DBH (cm) | General Observations | RPA | Recommendations | Retention category |
|---|---|---|---|---|---|---|---|---|---|
| T004 | Lime<br>( <i>Tilia sp.</i> ) | South East corner of building | Tree | 2 | 60cm below union<br><br>40cm and 37.5cm above union | <ul style="list-style-type: none"> <li>• Good condition</li> <li>• Mature</li> </ul> | 6.9m radius<br><br>149.6m <sup>2</sup> | <ul style="list-style-type: none"> <li>• Mulch</li> <li>• Some very minor pruning may be necessary to ensure clearance during construction (approx. 1m off select limbs on house side)</li> </ul> Timescale: 05-Sep-2024 (1 Year) | B1 |

The most significantly affected tree to be retained is Lime T4 which will require foundations well within its RPA. In order to minimise the impact of the foundations to T4, pile foundations in conjunction with a shallow concrete slab will be used rather than traditional concrete filled trenches. This will allow the majority of the roots to remain undisturbed and still allow for the free flow of water and oxygen beneath the newly built structure thereby retaining the soil's viability.

T4 may require a 1m reduction to selected limbs on the North-West side, depending on height of scaffolding.

For Lime T4 additional protective measures will be required due to the proximity of the construction activity and will be installed by a qualified arboriculturist. This will consist of a soft impact-resistant material, such as rubber or high-density foam, in contact with the stem of the tree, fixed in place with ratchet straps or similar to prevent it from sliding down/off of the stem. Around this, a hard protective barrier made from timber and plywood and gently braced against the cushioned stem to prevent any movement (e.g. rotation) of the outer barrier. This will prevent accidental mechanical damage to the tree's stem.

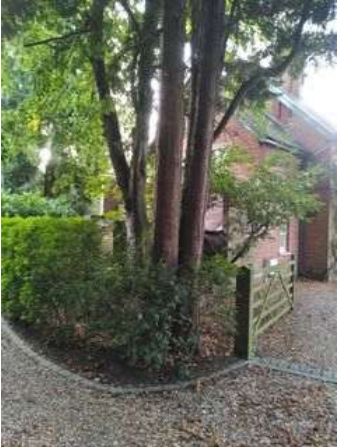
| Ref. | Species | Photo | Photo | Photo |
|---|---|---|---|---|
| T005 | Lawson<br>Cypress<br>( <i>Chamaecyparis lawsoniana</i> ) | | | |

| Ref. | Species | Location | Structure | Num. Stems | DBH (cm) | General Observations | RPA | Recommendations | Retention category |
|---|---|---|---|---|---|---|---|---|---|
| T005 | Lawson Cypress<br>( <i>Chamaecyparis lawsoniana</i> ) | Driveway | Tree | 3 | 35cm, 35cm, 15cm<br><br>0.52m combined stem diameter | <ul style="list-style-type: none"> <li>• Fair condition</li> <li>• Compression fork</li> <li>• Lowest limb over driveway quite low</li> <li>• Normal vitality</li> </ul> | 6.2m radius<br><br>120.8m <sup>2</sup> | <ul style="list-style-type: none"> <li>• Crown raise to 5m above ground level over driveway</li> </ul> Before works commence | B |

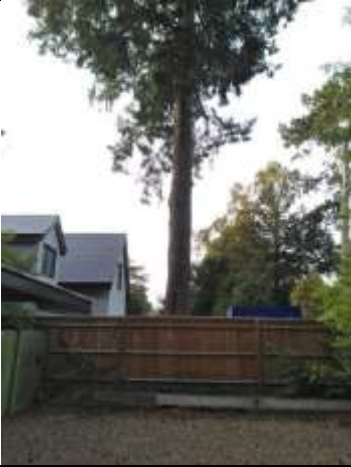
| Ref. | Species | Photo | Photo | Photo |
|---|---|---|---|---|
| T006 | Douglas Fir<br>( <i>Pseudotsuga menziesii</i> ) | | | |

| Ref. | Species | Location | Structure | Num. Stems | DBH (cm) | General Observations | RPA | Recommendations | Retention category |
|---|---|---|---|---|---|---|---|---|---|
| T006 | Douglas Fir<br>( <i>Pseudotsuga menziesii</i> ) | Neighbours | Tree | 1 | 75 | <ul style="list-style-type: none"> <li>• Good condition</li> <li>• Mature</li> <li>• Surface roots visible in drive</li> <li>• Normal vitality</li> </ul> | 9.0m radius<br><br>254.5m <sup>2</sup> | N/A | A12 |

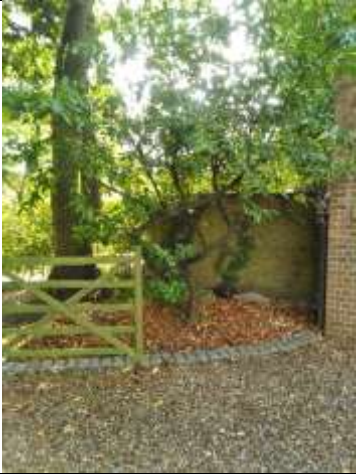
| Ref. | Species | Photo | Photo | Photo |
|---|---|---|---|---|
| T008 | Laurel Cherry<br>( <i>Prunus laurocerasus</i> ) | | | |

| Ref. | Species | Location | Structure | Num. Stems | DBH (cm) | General Observations | RPA | Recommendations | Retention category |
|---|---|---|---|---|---|---|---|---|---|
| T008 | Laurel Cherry<br>( <i>Prunus laurocerasus</i> ) | Next to house | Tree | 1 | 12cm at 1m | <ul style="list-style-type: none"> <li>Fair condition</li> <li>Small and easily replaced</li> </ul> | 1.4m radius<br><br>6.5m <sup>2</sup> | N/A | C |

T8, T10 and T11 are to be removed prior to work commencing, subject to approval from the Local Planning Authority. T8 is small and easily replaced; its location makes its retention untenable as it will be in the way of the proposed development. T10 is growing directly adjacent to a main wall of the property and is in the way of the proposed extension. It is small and easily replaced. T11, if retained, would be largely overhanging the new glazed extension, it has low visual amenity, low ecological value and has multiple structural defects as noted above, which would pose a risk to the new development. The removal of T11 would be advised regardless of whether or not permission is granted for the extension.

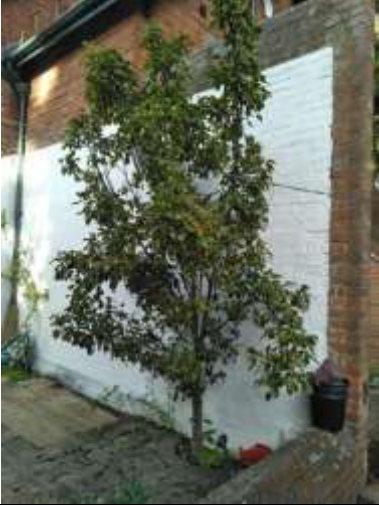
| Ref. | Species | Photo | Photo | Photo |
|---|---|---|---|---|
| T010 | Common Pear<br>( <i>Pyrus communis</i> ) | | | |

| Ref. | Species | Location | Structure | Num. Stems | DBH (cm) | General Observations | RPA | Recommendations | Retention category |
|---|---|---|---|---|---|---|---|---|---|
| T010 | Common Pear<br>( <i>Pyrus communis</i> ) | Against wall | Tree | 1 | 9 | <ul style="list-style-type: none"> <li>Semi-mature</li> <li>Small, easily replaced</li> </ul> | 1.1m radius<br><br>3.7m <sup>2</sup> | <ul style="list-style-type: none"> <li>Remove due to proximity to wall</li> </ul> Timescale: 05-Sep-2024 (1 Year) | U |

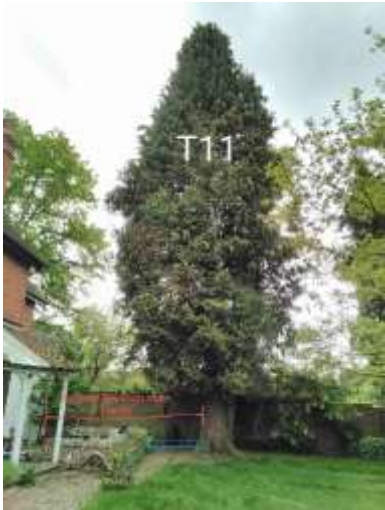
| Ref. | Species | Photo | Photo | Photo |
|---|---|---|---|---|
| T011 | Lawson<br>Cypress<br>( <i>Chamaecyparis lawsoniana</i> ) | | | |

| Ref. | Species | Location | Structure | Num. Stems | DBH (cm) | General Observations | RPA | Recommendations | Retention category |
|---|---|---|---|---|---|---|---|---|---|
| T011 | Lawson Cypress<br>( <i>Chamaecyparis lawsoniana</i> ) | Back garden | Tree | 4 | 150 | <ul style="list-style-type: none"> <li>• Close proximity to main house (5m)</li> <li>• Main unions are compression forks</li> <li>• East of stem has a large ear protruding from union of 2 main stems</li> <li>• Multiple compression forks throughout crown</li> <li>• Canopy overrun with climbing roses and clematis</li> </ul> | 18m radius<br><br>1,017.9m <sup>2</sup> | <ul style="list-style-type: none"> <li>• Dismantle to just above ground level</li> </ul> Timescale: 05-Sep-2024 (1 Year) | C |

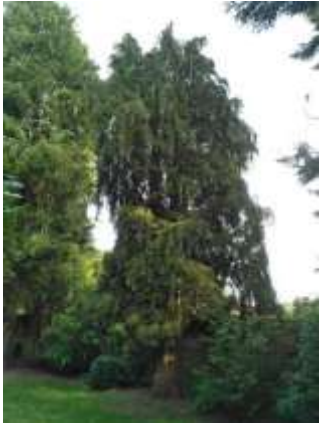
| Ref. | Species | Photo | Photo | Photo |
|---|---|---|---|---|
| T012 | Lawson<br>Cypress<br>( <i>Chamaecyparis lawsoniana</i> ) | | | |

| Ref. | Species | Location | Structure | Num. Stems | DBH (cm) | General Observations | RPA | Recommendations | Retention category |
|---|---|---|---|---|---|---|---|---|---|
| T012 | Lawson Cypress<br>( <i>Chamaecyparis lawsoniana</i> ) | Side boundary | Tree | 1 | 80 | <ul style="list-style-type: none"> <li>• Mature</li> <li>• Historically topped</li> </ul> | 9.6m radius<br><br>289.5m <sup>2</sup> | N/A | B2 |

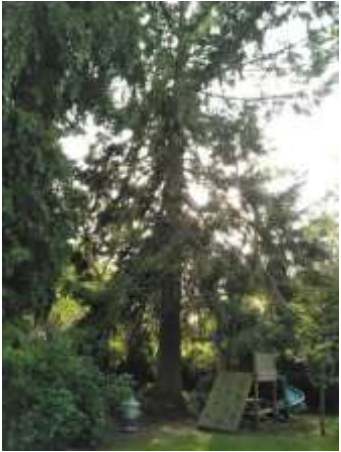
| Ref. | Species | Photo | | Photo | Photo |
|---|---|---|--|---|---|
| T014 | Douglas Fir<br>( <i>Pseudotsuga menziesii</i> ) | | | | |

| Ref. | Species | Location | Structure | Num. Stems | DBH (cm) | General Observations | RPA | Recommendations | Retention category |
|---|---|---|---|---|---|---|---|---|---|
| T014 | Douglas Fir<br>( <i>Pseudotsuga menziesii</i> ) | Back corner of garden | Tree | 1 | 85 | <ul style="list-style-type: none"> <li>• Good condition</li> </ul> | 10.2m radius<br><br>326.9m <sup>2</sup> | <ul style="list-style-type: none"> <li>• Mulch</li> </ul> Timescale: 05-Sep-2024 (1 Year) | A2 |

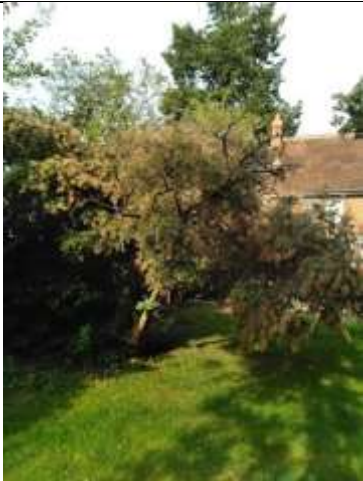
| Ref. | Species | Photo | Photo | Photo |
|---|---|---|---|---|
| T016 | Smoke bush<br>( <i>Cotinus<br/>Coggygria</i> ) | | | |

| Ref. | Species | Location | Structure | Num. Stems | DBH (cm) | General Observations | RPA | Recommendations | Retention category |
|---|---|---|---|---|---|---|---|---|---|
| T016 | Smoke bush<br>( <i>Cotinus Coggygria</i> ) | North boundary | Tree | 1 | 16 | <ul style="list-style-type: none"> <li>Historically fallen and self-corrected</li> </ul> | 1.9m radius<br>11.6m <sup>2</sup> | N/A | C2 |

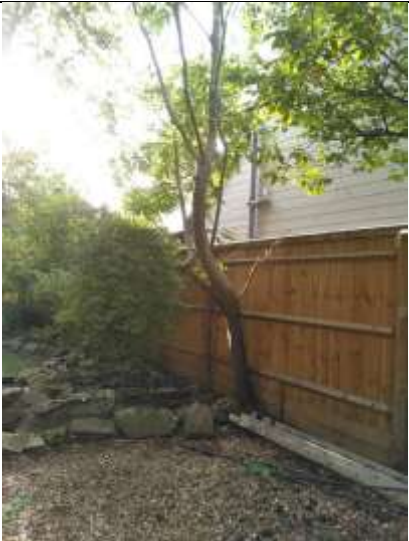
| Ref. | Species | Photo | | Photo | Photo |
|---|---|---|---|---|---|
| T019 | Ash<br>( <i>Fraxinus sp.</i> ) | | | | |

| Ref. | Species | Location | Structure | Num. Stems | DBH (cm) | General Observations | RPA | Recommendations | Retention category |
|---|---|---|---|---|---|---|---|---|---|
| T019 | Ash<br>( <i>Fraxinus sp.</i> ) | North boundary | Tree | 1 | 20 | <ul style="list-style-type: none"> <li>Next to fence</li> <li>Fair condition</li> </ul> | 2.4m radius<br>18.1m <sup>2</sup> | N/A | C |

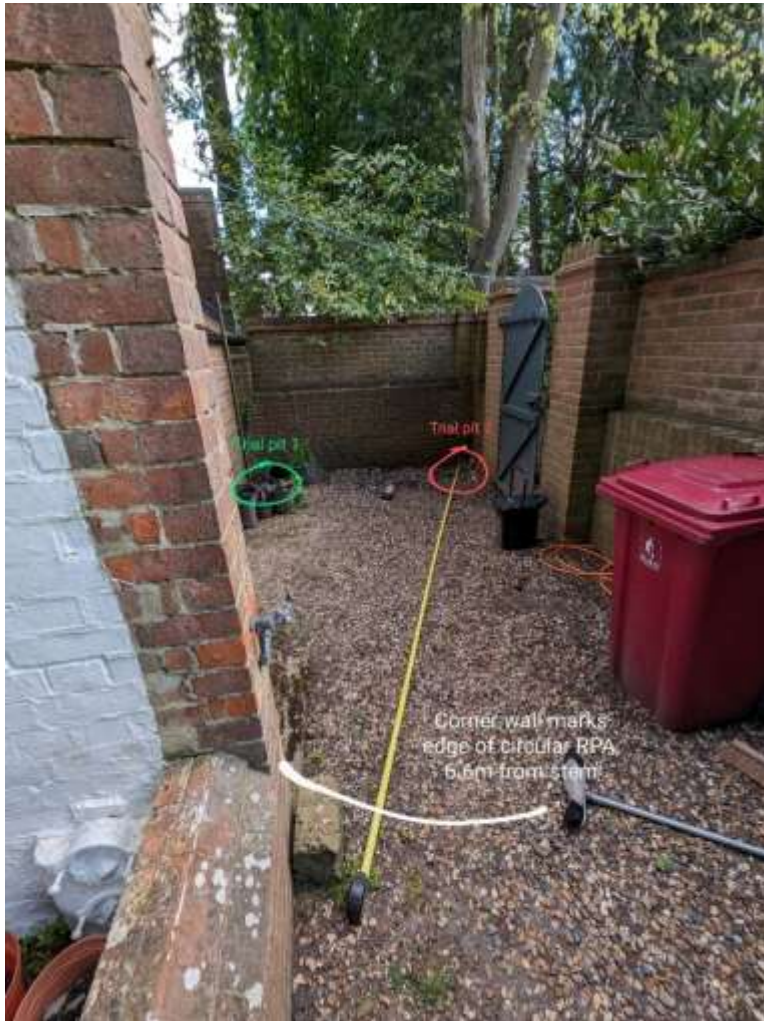
The RPA was rechecked by measuring the stem diameters of T4 at 1.5m above ground level which were 400mm and 375mm giving a 6.6m radius circle, which on the West side of the tree in the area behind the garden wall comes almost exactly to the corner of the wall pictured below.

It was anticipated that the garden wall was acting as an effective barrier to entry for roots from T4 as trial pit 1 (shown in green in the above photo) seemed to show that the wall's footings were approximately 60cm below ground level. The depth of the footings combined with a lack of evident root related damage i.e. lifting and cracking from expanding roots beneath the wall, seemed to suggest that there were no significant roots within this courtyard area.

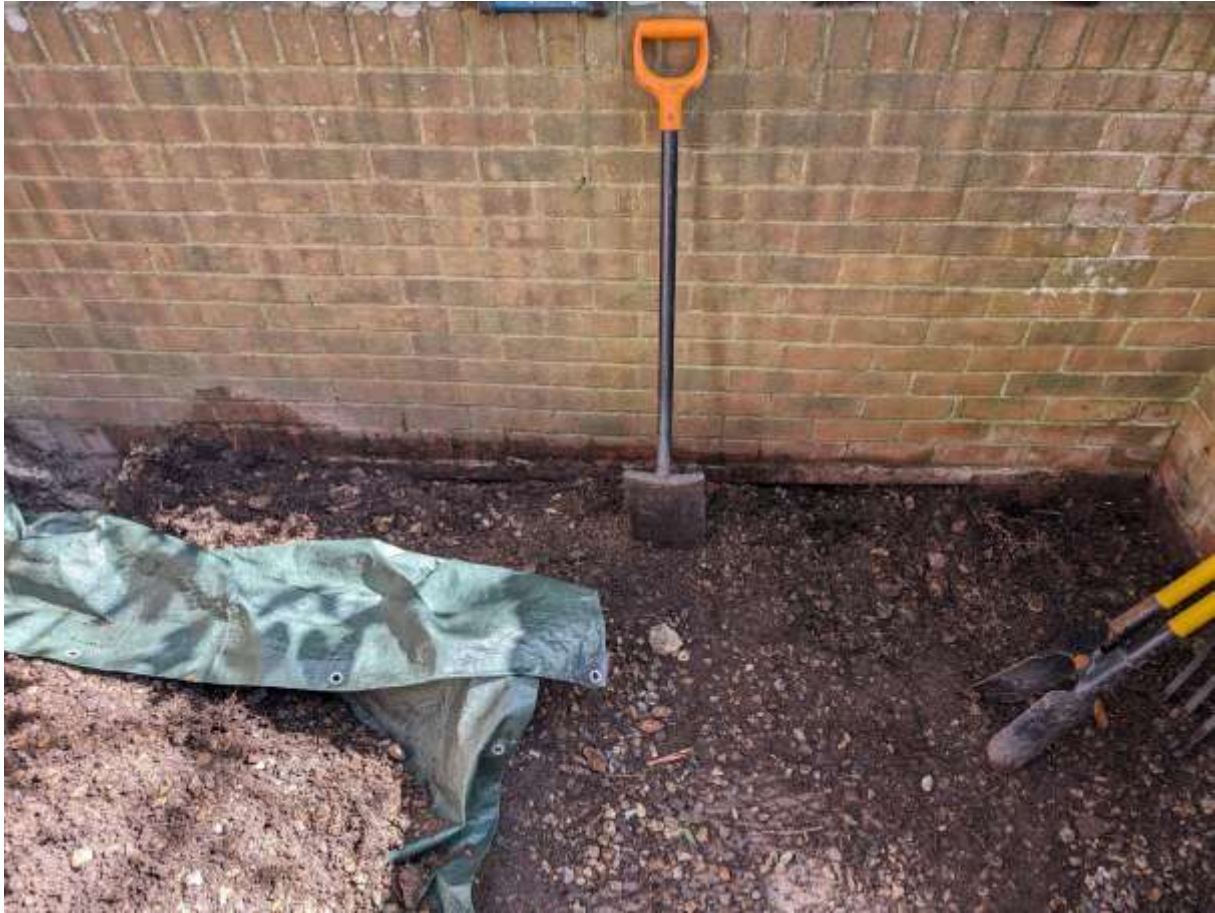
However, upon beginning to excavate trial pit 2 (red in the above picture), fine roots were quickly discovered, as was a concrete lintel spanning the northeast face of the wall (closest to T4) creating a 1500mm wide opening from 100mm below ground level (pictured below). This opening has allowed the roots to enter this area largely unhindered and also explains the lack of root-related damage to the wall.

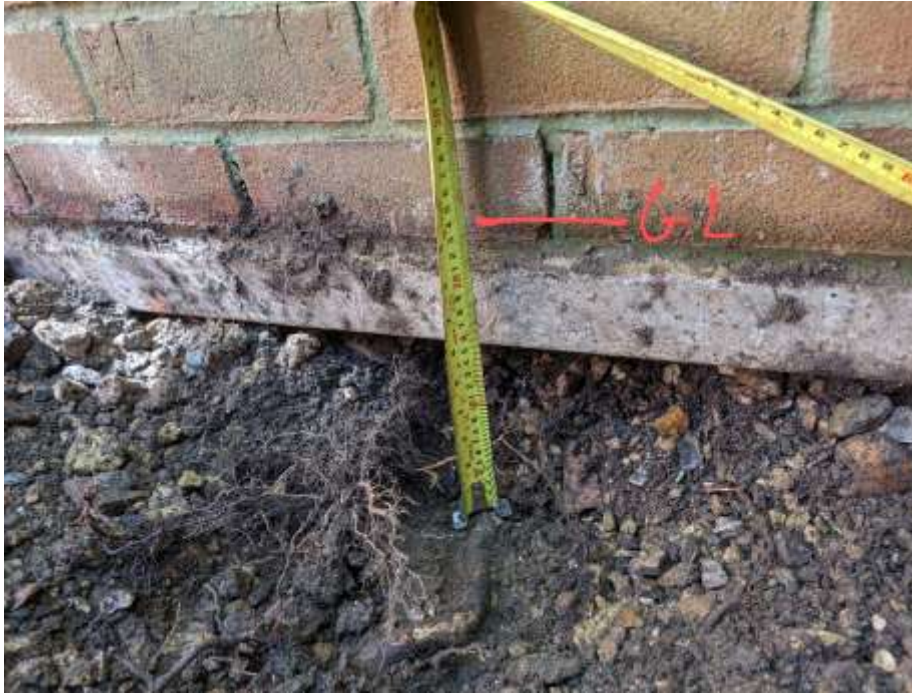
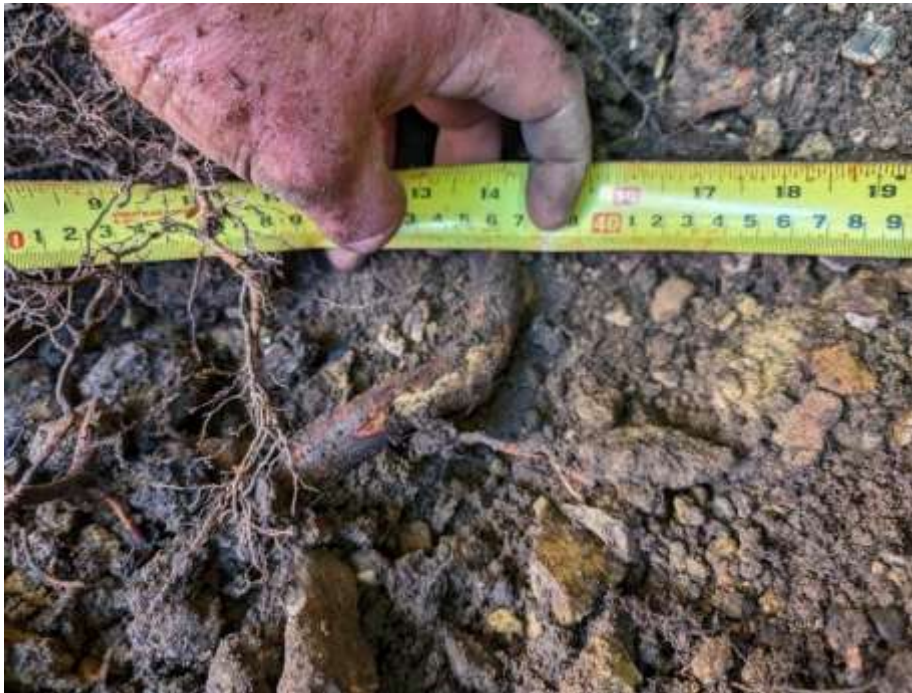
The first significant root was found beneath this lintel at 240mm below ground level (photos below)

Due to the unexpected complication of uncovering the lintel, the trench was not dug out to the extent of the RPA to check if all significant roots are at least 220mm below ground level for the foundations.

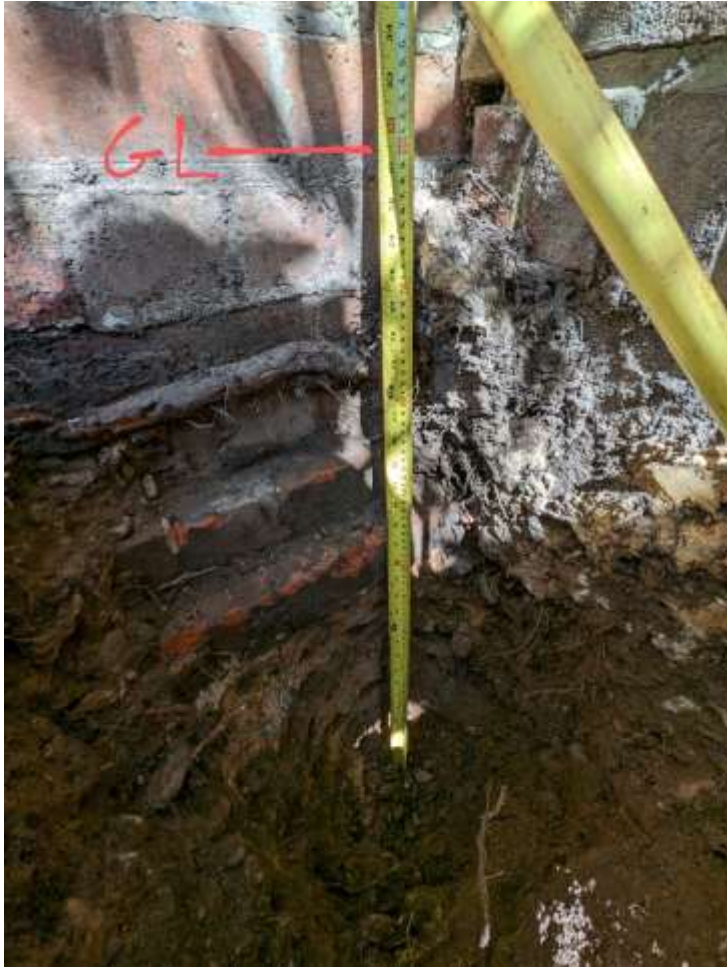
Trial pit 1 was also expanded to assess the depth of the footings of the existing building. The pit was dug to 800mm below ground level without reaching the bottom of the footings, with no roots seen beyond 700mm below ground level, suggesting the footprint of this structure is an effective barrier to roots.

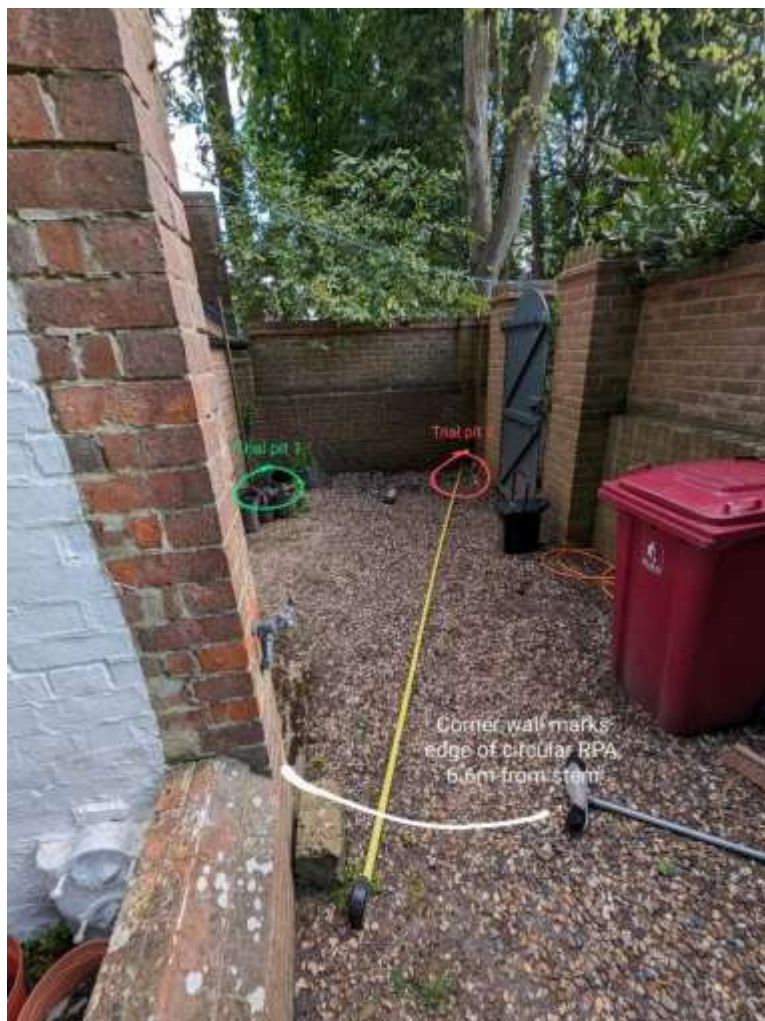
Figure 2: Annotated photo showing extent of RPA and locations of trial pits

The RPA was rechecked by measuring the stem diameters of T4 at 1.5m above ground level which were 400mm and 375mm giving a 6.6m radius circle, which on the West side of the tree in the area behind the garden wall comes almost exactly to the corner of the wall pictured below (figure 1).

It was anticipated that the garden wall was acting as an effective barrier to entry for roots from T4 as trial pit 1 (shown in green in the above photo) seemed to show that the wall's footings were approximately 600mm below ground level. The depth of the footings combined with a lack of evident root related damage i.e. lifting and cracking from expanding roots beneath the wall, seemed to suggest that there were no significant roots within this courtyard area.

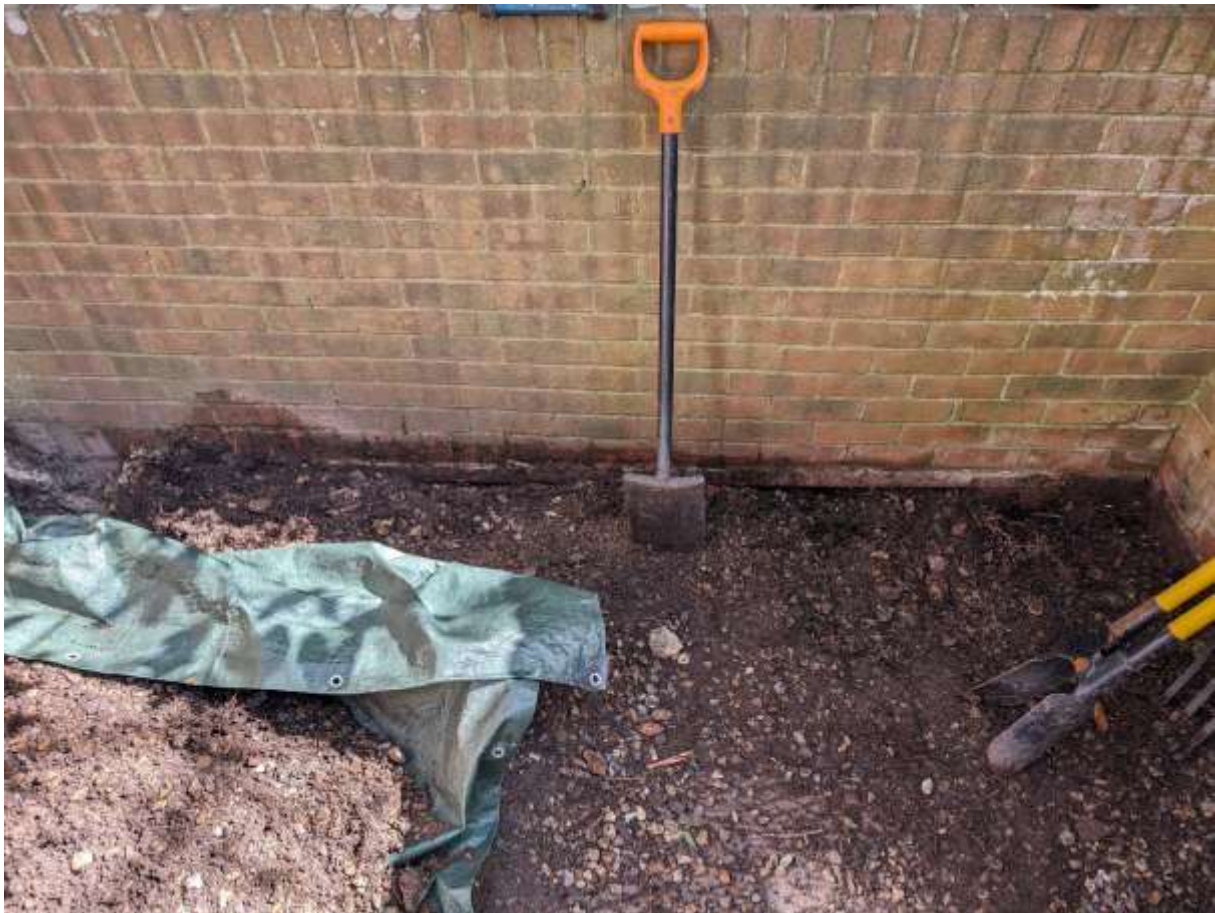
*Figure 3: Concrete lintel*

However, upon beginning to excavate trial pit 2 (red in the above picture), fine roots were quickly discovered, as was a concrete lintel spanning the northeast face of the wall (closest to T4) creating a 1500mm wide opening from 100mm below ground level (Figure 2). This opening has allowed the roots to enter this area largely unhindered and also explains the lack of root-related damage to the wall.

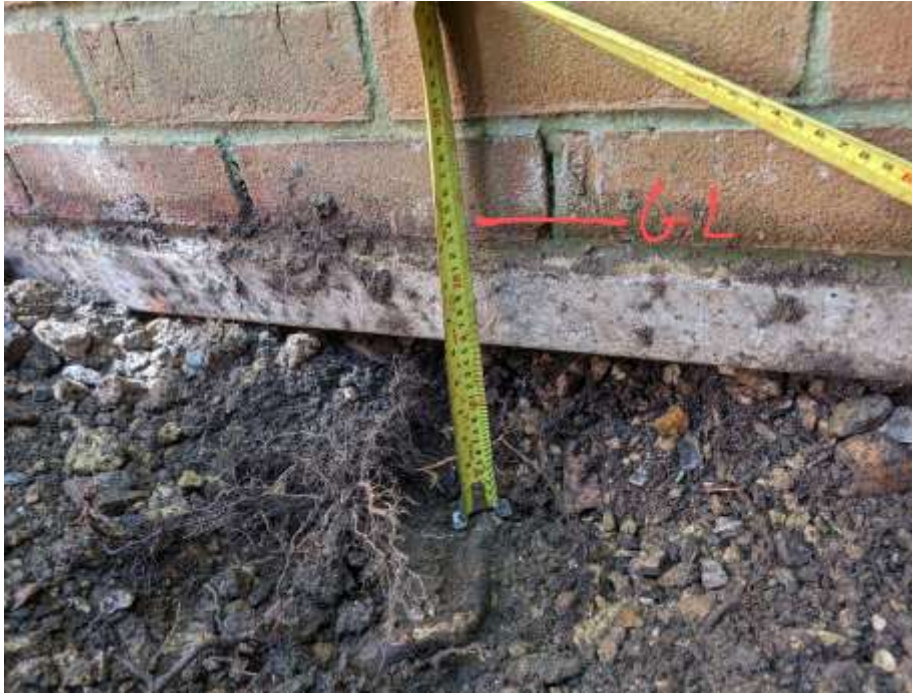
The first and largest noteworthy (but still less than 25mm diameter) root was found beneath this lintel at 240mm below ground level and measured 20mm in diameter (Figures 3 & 4).

Figure 4: showing depth of root 240mm below ground level (GL)

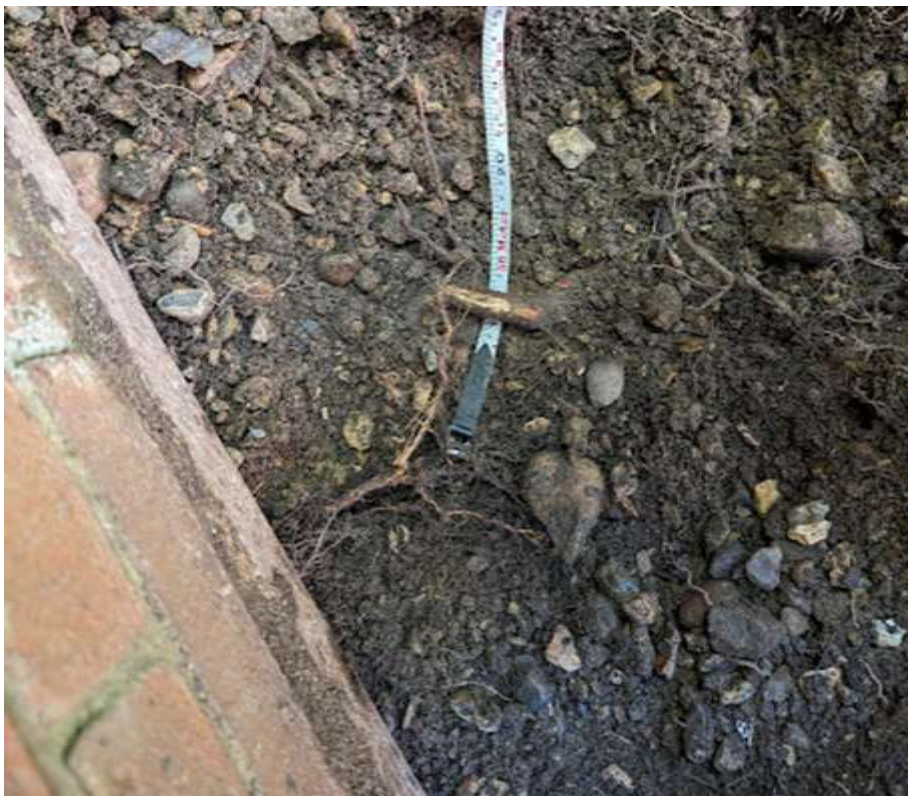
Figure 5: diameter of root 20mm

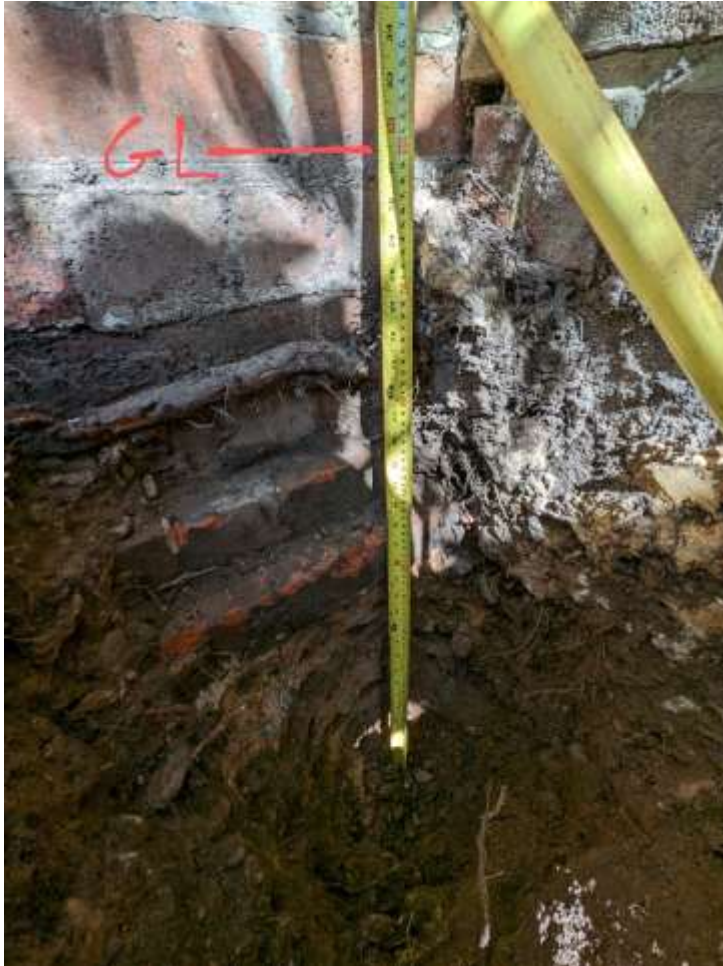
Trial pit 1 was also expanded to assess the depth of the footings of the existing building. The pit was dug to 800mm below ground level without reaching the bottom of the footings, with no roots seen beyond 700mm below ground level, suggesting the footprint of this structure is an effective barrier to roots (figure 5).

*Figure 6: extent of trial pit 1*

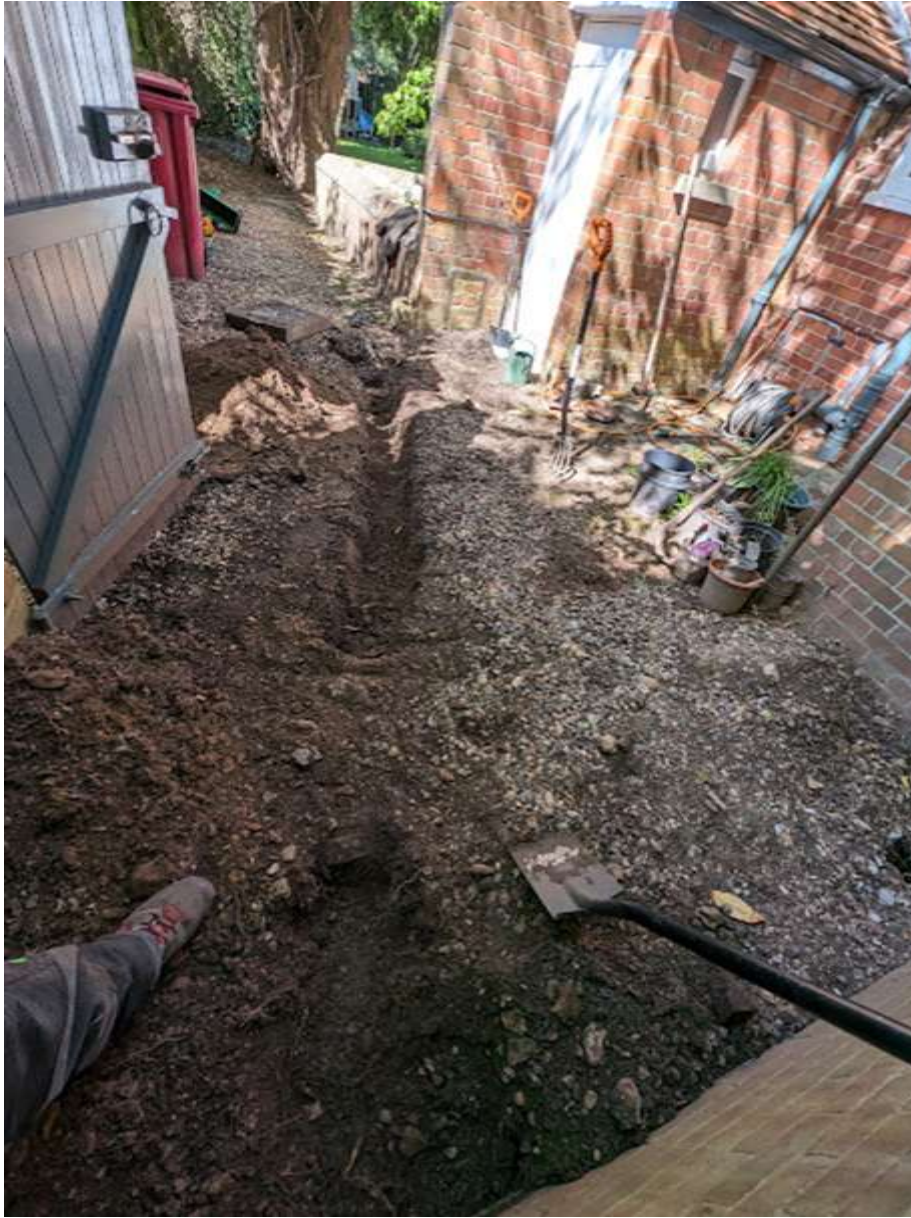
Trial pit 2 was then continued and the trench was dug up to approximately 0.5m from the edge of the RPA at which point an old drain was uncovered. (figures 6 & 7)

*Figure 7: extent of trial pit/trench 2*

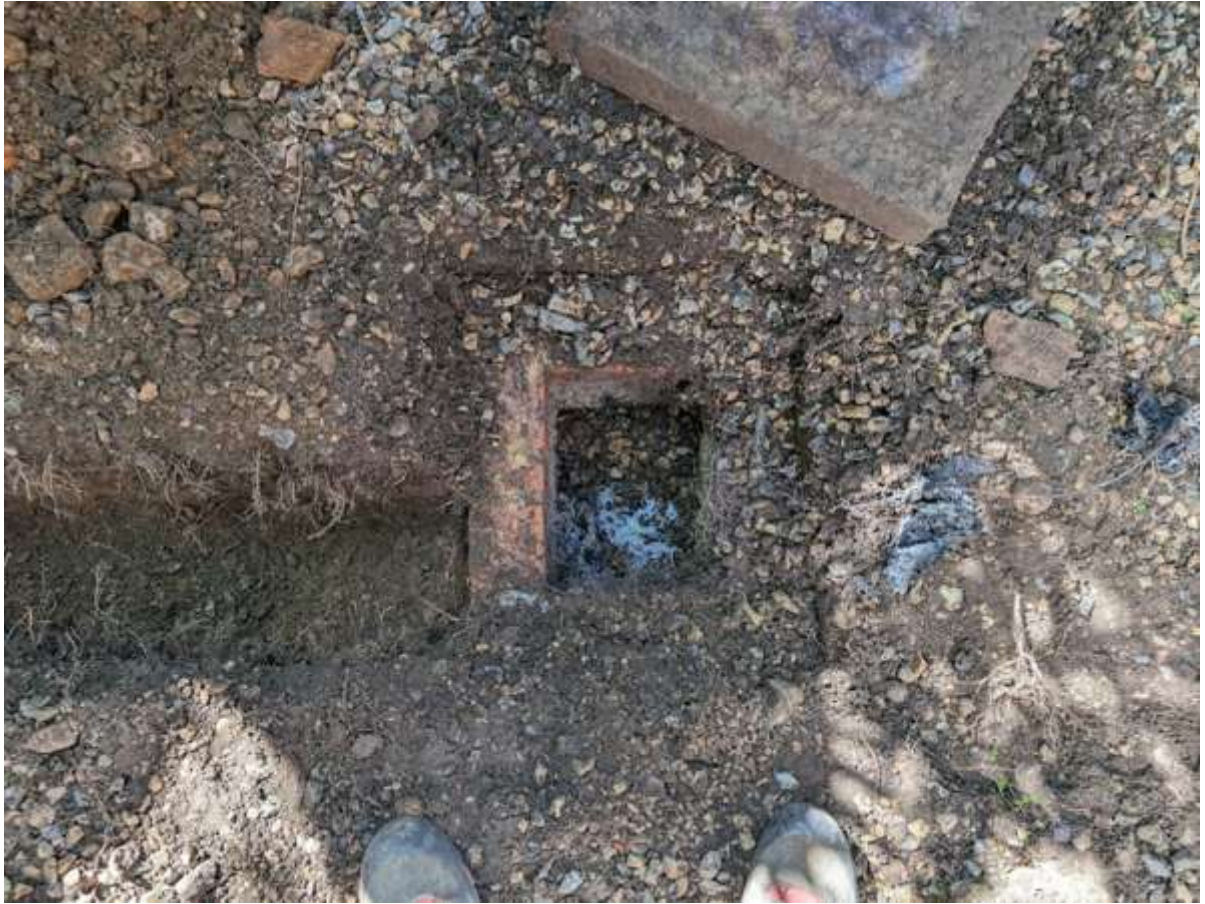
*Figure 8: old drain uncovered near edge of RPA*

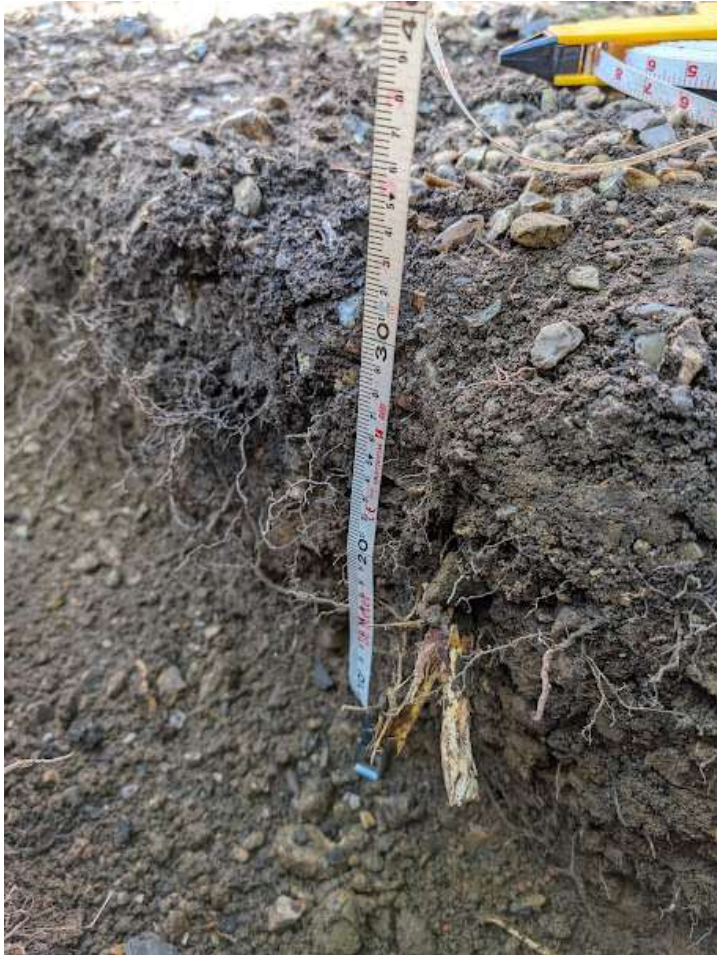
The trench was dug to approximately 300mm below ground level. (figure 8)

*Figure 9: showing the depth of trial pit/trench 2*

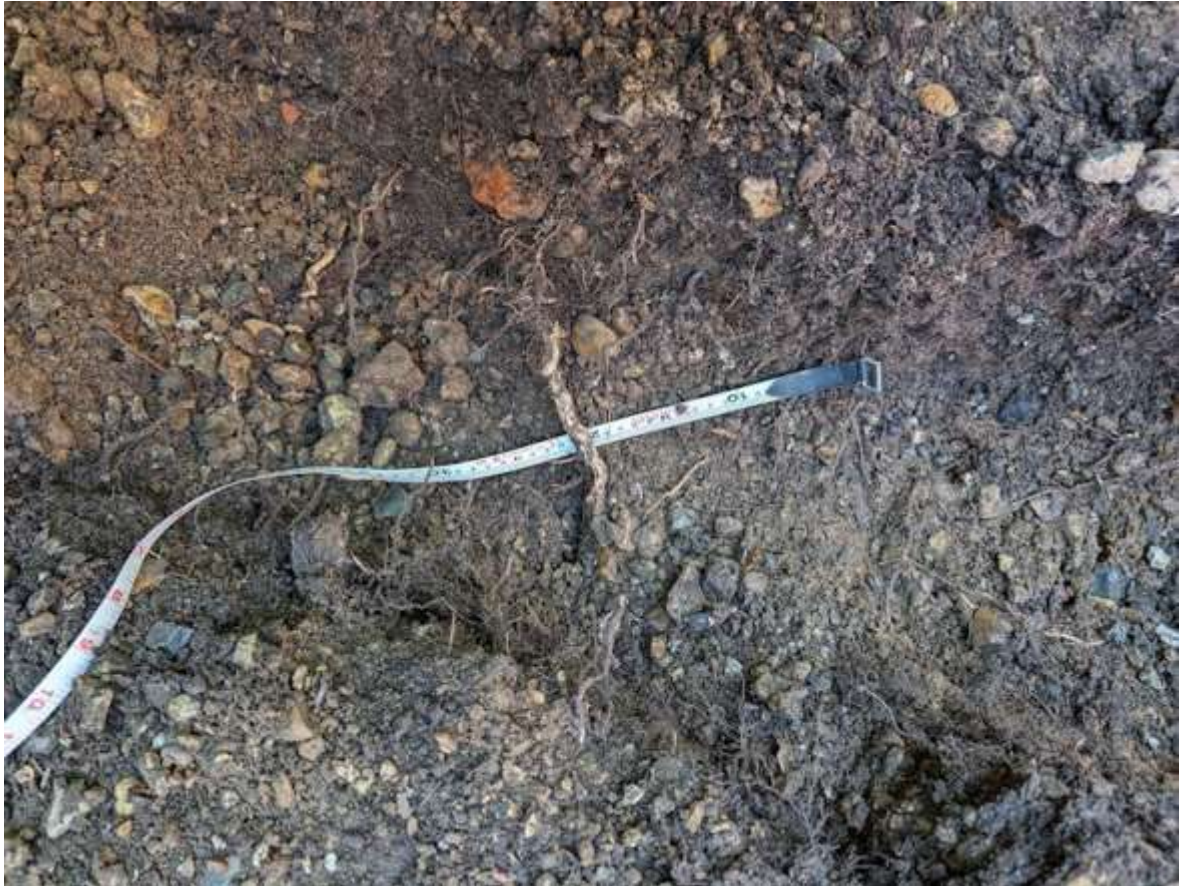
The largest diameter root uncovered (excluding the one directly by the wall) was 11mm diameter. (figure 9)

*Figure 10: 2nd largest root uncovered 11mm diameter*

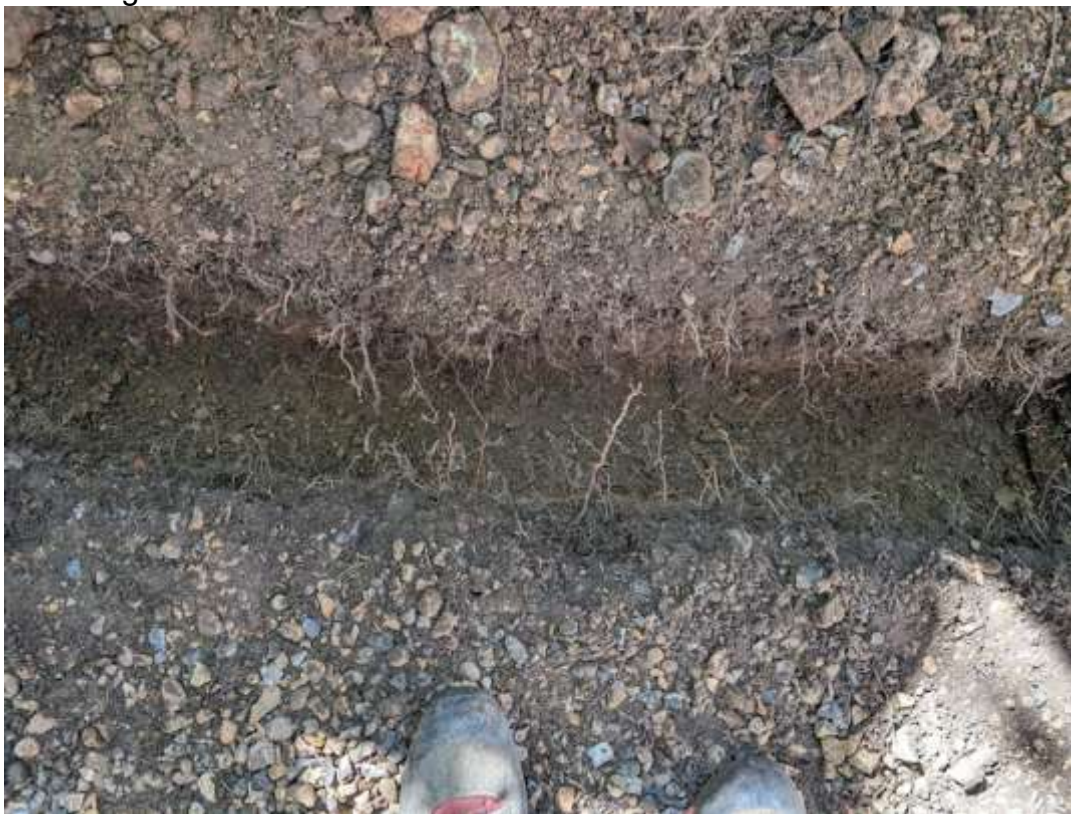
There were a reasonable amount of fine roots near the surface along the length of the trench (figure 10) but these could well be from closer vegetation, such as the shrubs bordering Lawsons drive.

*Figure 11: Fine roots near surface of trial pit/trench 2*
