# Structural Report

## Kendrick School – Gardeners Shed

**Job Ref.** C4952

**Date:** 08 April 2024

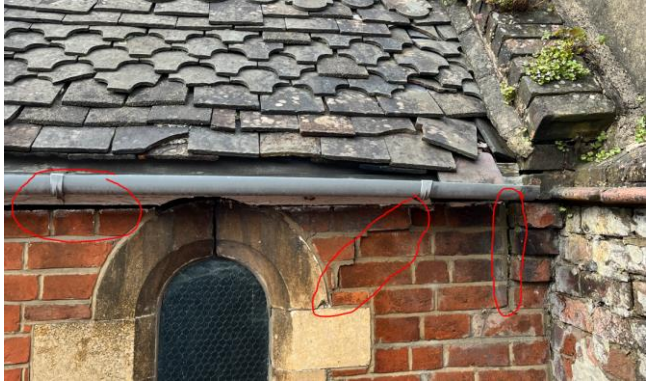
3.2.2 It has cracked around the window area, likely due to the action of the wooden eaves (see section 3.5). following the crack, the masonry above the crack appears to have moved outwards, suggesting that roof spread has pushed the top of the wall/wall plate outwards since it is no longer restrained by the mortar.

| Item | Description | Photograph |
|---|---|---|
| A1 | Right side wall is cracked around window diagonally and vertically where it meets the corbeling at the return wall; and timber wall plate has lifted off. Some tiles displaced. | |

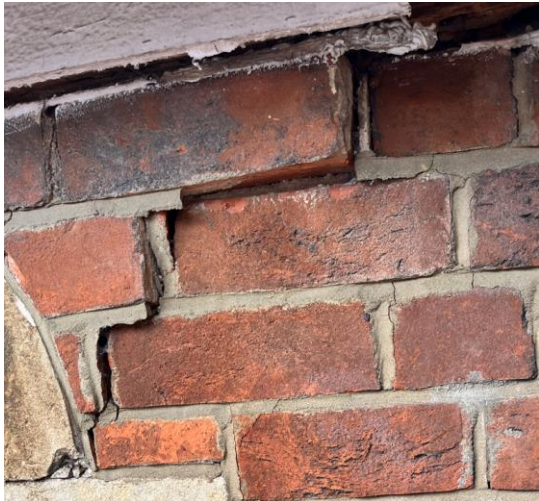
| Item | Description | Photograph |
|---|---|---|
| A2 | Above the crack, the wall has been pushed outwards 10-15mm (towards camera) | |

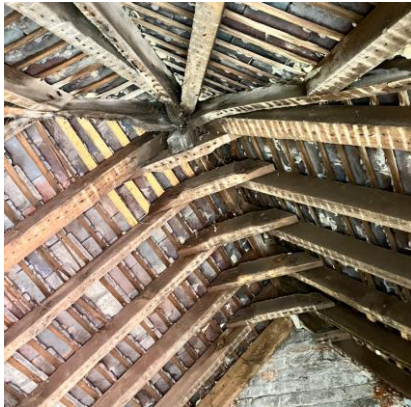
3.3.2 The two opposing sides of the roof are leaning on each other (and the front section leaning against this) much like a house of cards, the roof faces are placing a horizontal thrust on to the walls.

3.3.3 It is this thrust which is believed to have damaged the side wall. The boundary walls are thicker and more able to resist this thrust, so all movement has been forced onto the side wall.

| Item | Description | Photograph |
|---|---|---|
| A3 | Roof timbers have small collars at ridge level (connection unknown) but no ties at eaves level and no ceiling. All lateral restraint is provided by the side wall. | |

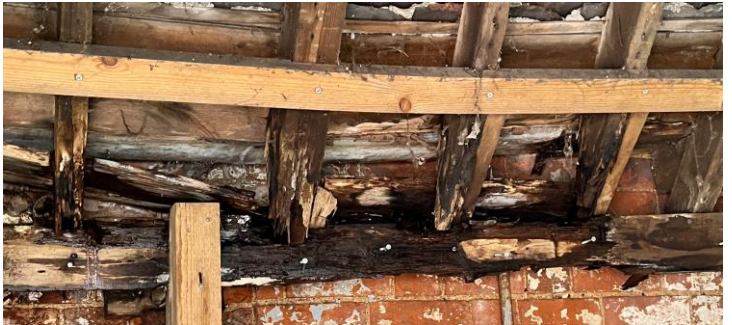
3.4.2 This beam has suffered from severe rot and deflection (likely as a result of the rot).

3.4.3 It may have been repaired or replaced, and is, or was at some point, propped at midspan by the vertical upright of the shelving. Unfortunately this prop only bears onto the ground.

| Item | Description | Photograph |
|---|---|---|
| A4 | On the left wall, rotting timbers and prior timber repair, which is itself sagging. | |

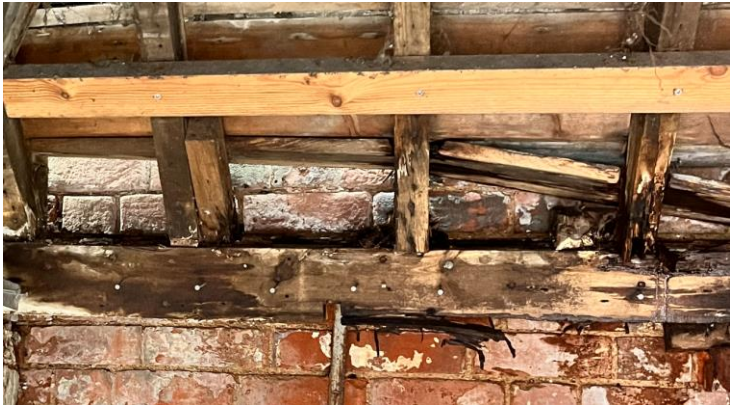
| Item | Description | Photograph |
|---|---|---|
| A5 | Rotting timbers. Visible daylight at front suggests that the gutter is not working at all, and all rainwater from half the roof is entering the shed. | |

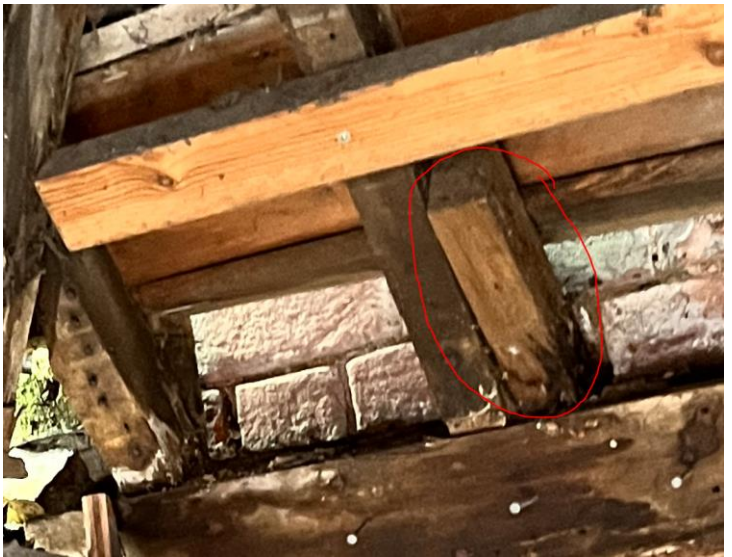
| Item | Description | Photograph |
|---|---|---|
| A6 | Prior repair (circled) appears to have shifted | |

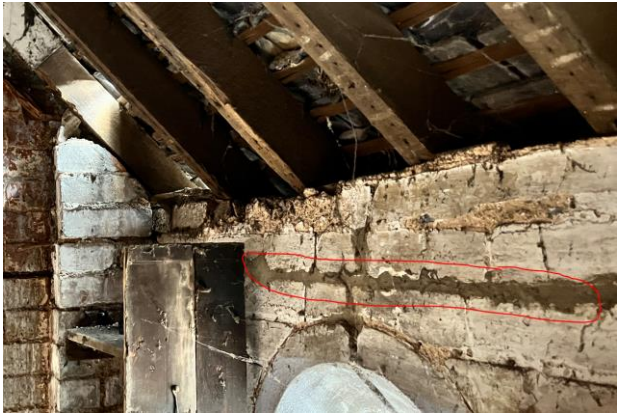
| Item | Description | Photograph |
|---|---|---|
| A7 | Prior mortar repair on inside face suggests further outward movement of the right side wall has been covered up. | |

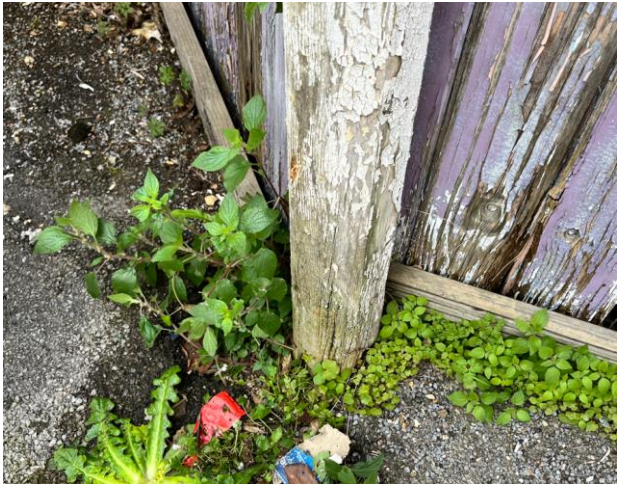
3.6.3 While the original external floor finish is unknown, the current ground is covered in tarmac. This is impermeable and likely at a higher level than the original floor, which can channel rainwater towards the base of the timber posts, causing rot just below ground.

| Item | Description | Photograph |
|---|---|---|
| A8 | Timber posts extend below current ground level. Vegetation growth suggests that rainwater is channelled this way by the impermeable tarmac. | |

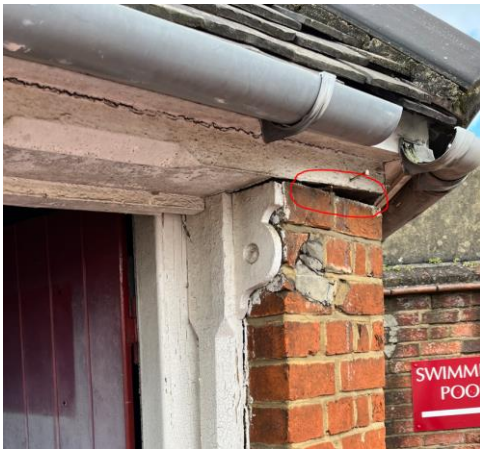
3.5.2 This timber has see-sawed over the top of the masonry, lifting off from the top of the wall and causing cracking in the wall.

| Item | Description | Photograph |
|---|---|---|
| A9 | Wallplate lifting off wall due to posts sinking | |

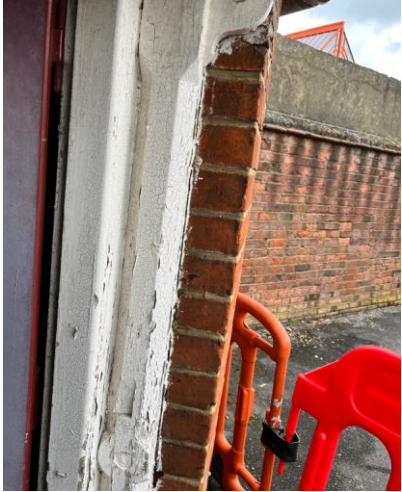
3.2.3 On the end of the wall, it is leaning outwards significantly – presumed due to the force from the roof spread. The top of the wall is about 50-60mm out of plumb. The wall has likely cracked below ground level to allow this outward rotation.

| Item | Description | Photograph |
|---|---|---|
| A10 | Wall is leaning outwards by about half a brick end (50mm) over its height. | |

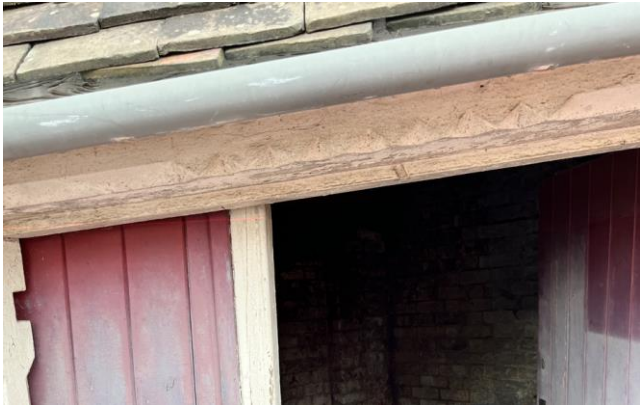
3.5.1 The front timber eaves beam has dropped due to the movement of the timber posts (see section 3.6).

3.6.1 The timber posts have sunk by approximately 100mm. Originally these posts were open (with no infill timber walls) and based on construction practices of the time, the posts would have a separate foundation, which would be quite basic.

| Item | Description | Photograph |
|---|---|---|
| A11 | Timber eaves beam sagging at timber posts, estimated 100mm drop. | |

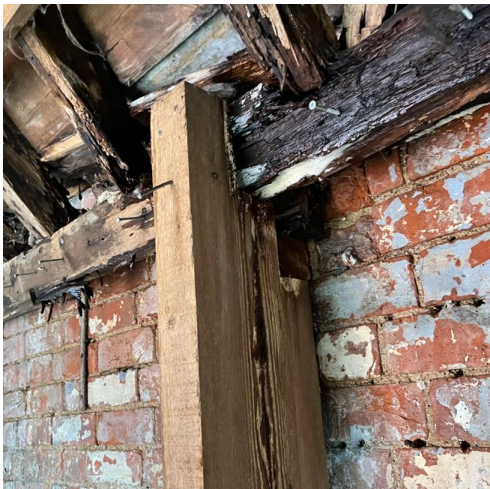
| Item | Description | Photograph |
|---|---|---|
| A12 | Shelving acts as a prop to the rotting beam | |

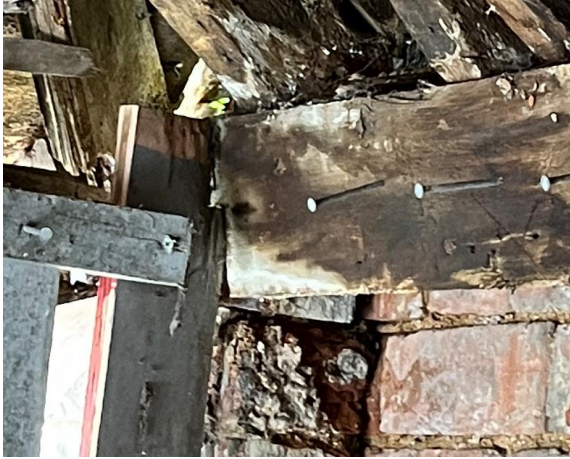
| Item | Description | Photograph |
|---|---|---|
| A13 | Beam is no longer supported at end | |

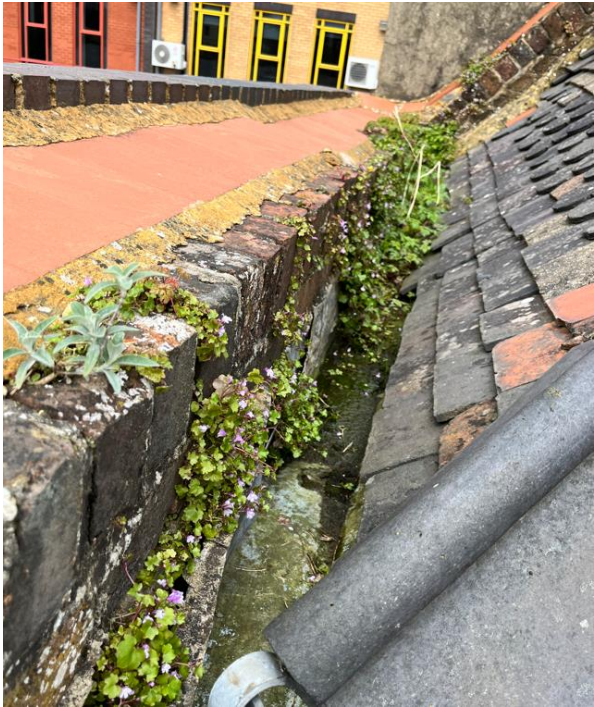
3.4.4 The deflection has caused the gutter to not function as intended. Vegetation can be seen growing in the wall. Water leaks will have further damaged the timber. Vegetation and water can cause long term damage to the wall and mortar.

| Item | Description | Photograph |
|---|---|---|
| A14 | Gutter not draining and full of vegetation | |
