# Tree Condition Survey Report (VTA)

**Site:** Forbury Retail Park, Kenavon Dr, Reading RG1 3HS

**Client:** JLL

| <i>GC Document Reference</i> | J251017 | | |

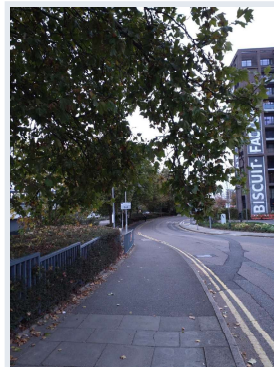
### London plane Tree ID #13

| Tree Survey Schedule | | | | | | | | | | | | | | | | | |
|---|---|---|---|---|---|---|---|---|---|---|---|---|---|---|---|---|---|
| 13 | | London plane | Platanus x hispanica | 16-20m | 480 | Mature | Good | Good | Low branches over footpath, almost encroaching road. | inaccessible | No Visible Issues or Defects | None Significant | None Observed | Building, Fence, Footpath, Road, Street light/furniture | High | No access to base/stem | Client |

| Tree / Group ID | Common Name | Work Task | Work Priority | Description | Tag No |
|---|---|---|---|---|---|
| 13 | London plane | Crown Lift to Statutory Height Over path 2.5m, 5.2m Over Road | Within 6 - 12 Months | Crown lift to clear the footpath and road.<br>No access to tag<br>W3W:///frost.grab.trash<br>Traffic management recommended | no access to tag |

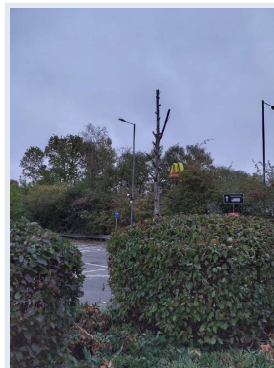
### Tree ID #15

| Tree Survey Schedule | | | | | | | | | | | | | | | | | |
|---|---|---|---|---|---|---|---|---|---|---|---|---|---|---|---|---|---|
| 15 | | Unidentifiable | Unidentifiable | 0-5m | 150 | Dead | Dead | Poor | small Dead tree, unstable. | Root-plate Movement / Loose in ground | | | | Car park | High | Good | Client |

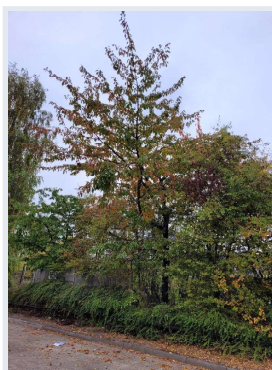
### Bird cherry Tree ID #50

| Tree Survey Schedule | | | | | | | | | | | | | | | | | |
|---|---|---|---|---|---|---|---|---|---|---|---|---|---|---|---|---|---|
| 50 | | Bird cherry | Prunus padus | 0-5m | 190 | Young | Good | Fair | low branches interfering with lorry access | No Visible Issues or Defects | No Visible Issues or Defects | Low Branches | None Observed | Car park | High | No access to base/stem | Client |

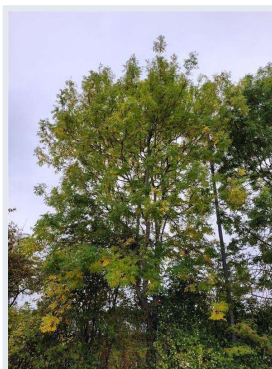
### Common ash Tree ID #51

| Tree Survey Schedule | | | | | | | | | | | | | | | | | |
|---|---|---|---|---|---|---|---|---|---|---|---|---|---|---|---|---|---|
| 51 | | Common ash | Fraxinus excelsior | 11-15m | 380 | Semi-mature | Good | Good | foliage obstructing light. Co-dominant stems joined at 1.5m | No Visible Issues or Defects | No Visible Issues or Defects | Crown Close to Building and/or Infrastructure | None Observed | Car park, Railway | High | No access to base/stem | Client |

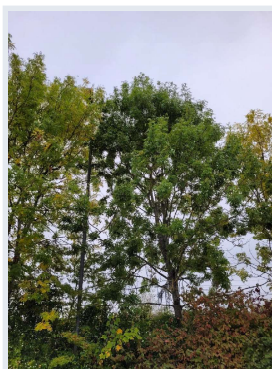
### Common ash Tree ID #52

| Tree Survey Schedule | | | | | | | | | | | | | | | | | |
|---|---|---|---|---|---|---|---|---|---|---|---|---|---|---|---|---|---|
| 52 | | Common ash | Fraxinus excelsior | 11-15m | 250 | Semi-mature | Good | Good | foliage obstructing light. Co-dominant stems joined at 1.5m | No Visible Issues or Defects | No Visible Issues or Defects | Crown Close to Building and/or Infrastructure | None Observed | Car park, Railway | High | No access to base/stem | Client |

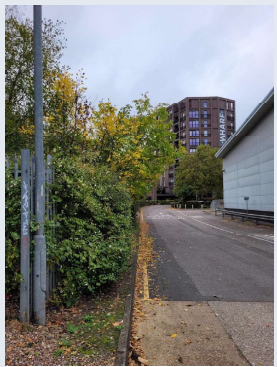
Group ID #5

| Tree Group Survey Schedule | | | | | | | | | | | | | | | | | | |
|---|---|---|---|---|---|---|---|---|---|---|---|---|---|---|---|---|---|---|
| 5 | | Mixed species | Mixed species | 20+ | 5-10m | 0-150mm | Mature | Good | Good | Third-party linear boundary with low branches obstructing lorry access | None Significant | None Significant | Low Branches | None Observed | Car park | High | No access to base/stem | Third Party |
