# Tree Inventory Report

Reading Borough Council

Unique ID: 0B7T

Quercus robur

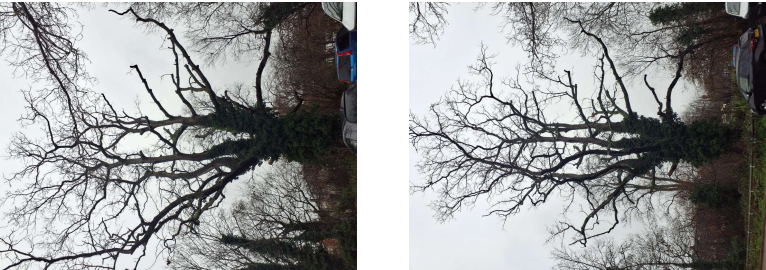
Overview Photos

| Comment | |
|---|---|
| Comment | It appears that the soil level around the tree has been altered due to repeated green waste dumping and dense ivy growth. As a result, the original main stem base is no longer visible. No fungal brackets were observed around the stem base. |

| Comment | |
|---|---|
| Comment | Ivy has been partially removed to allow inspection; however, access to the western side was restricted due to sloping ground and dense vegetation. A mallet inspection identified loose bark and indications of potential extensive internal decay |

| Comment | |
|---|---|
| Comment | on the eastern half of the main stem, from ground level to approximately 1m in height. The tree exhibits an open branch union structure with no significant structural defects noted. However, the majority of the western canopy is dead, |

| Comment | |
|---|---|
| Comment | with large dead branches overhanging the footpath. The eastern canopy remains alive but shows declining of vitality with sparseness and several large dead branches extending over the parking area. |

| Comment | |
|---|---|
| Comment | Further investigation using a microdrill on the N,E and S sides of the stem base revealed bark necrosis and sapwood decay, but no evidence of heartwood decay were recorded. The southern reading clearly indicates ongoing sapwood decay |

| Comment | |
|---|---|
| Comment | and declining of its canopy may be associated with this sapwood decay. Its declining has been recorded since 2020 in two previous inspections. The tree continues to deteriorate. It is unlikely to have stored sufficient level of reserved energy to recover |

| Comment | |
|---|---|
| Comment | from current condition and it is therefore considered to be in terminal decline. As most dead branches are located on the western side over the footpath, their removal would result in a significantly unbalanced canopy weighted toward the east, |

| Comment | |
|---|---|
| Comment | increasing the risk of instability. Given the extent of decline and associated safety concerns, removal of the tree is recommended rather than removing dead branches. New Oak tree and Hawthorn tree to be planted on the same ground |

| Comment | |
|---|---|
| Comment | subject to the removal of this Oak tree. |
