Job: Drawing: Revision:  
1025 05-10

Project:  
**15 Castle Street  
RG1 7SB**

Drawing:  
**Front Elevation As  
Proposed**

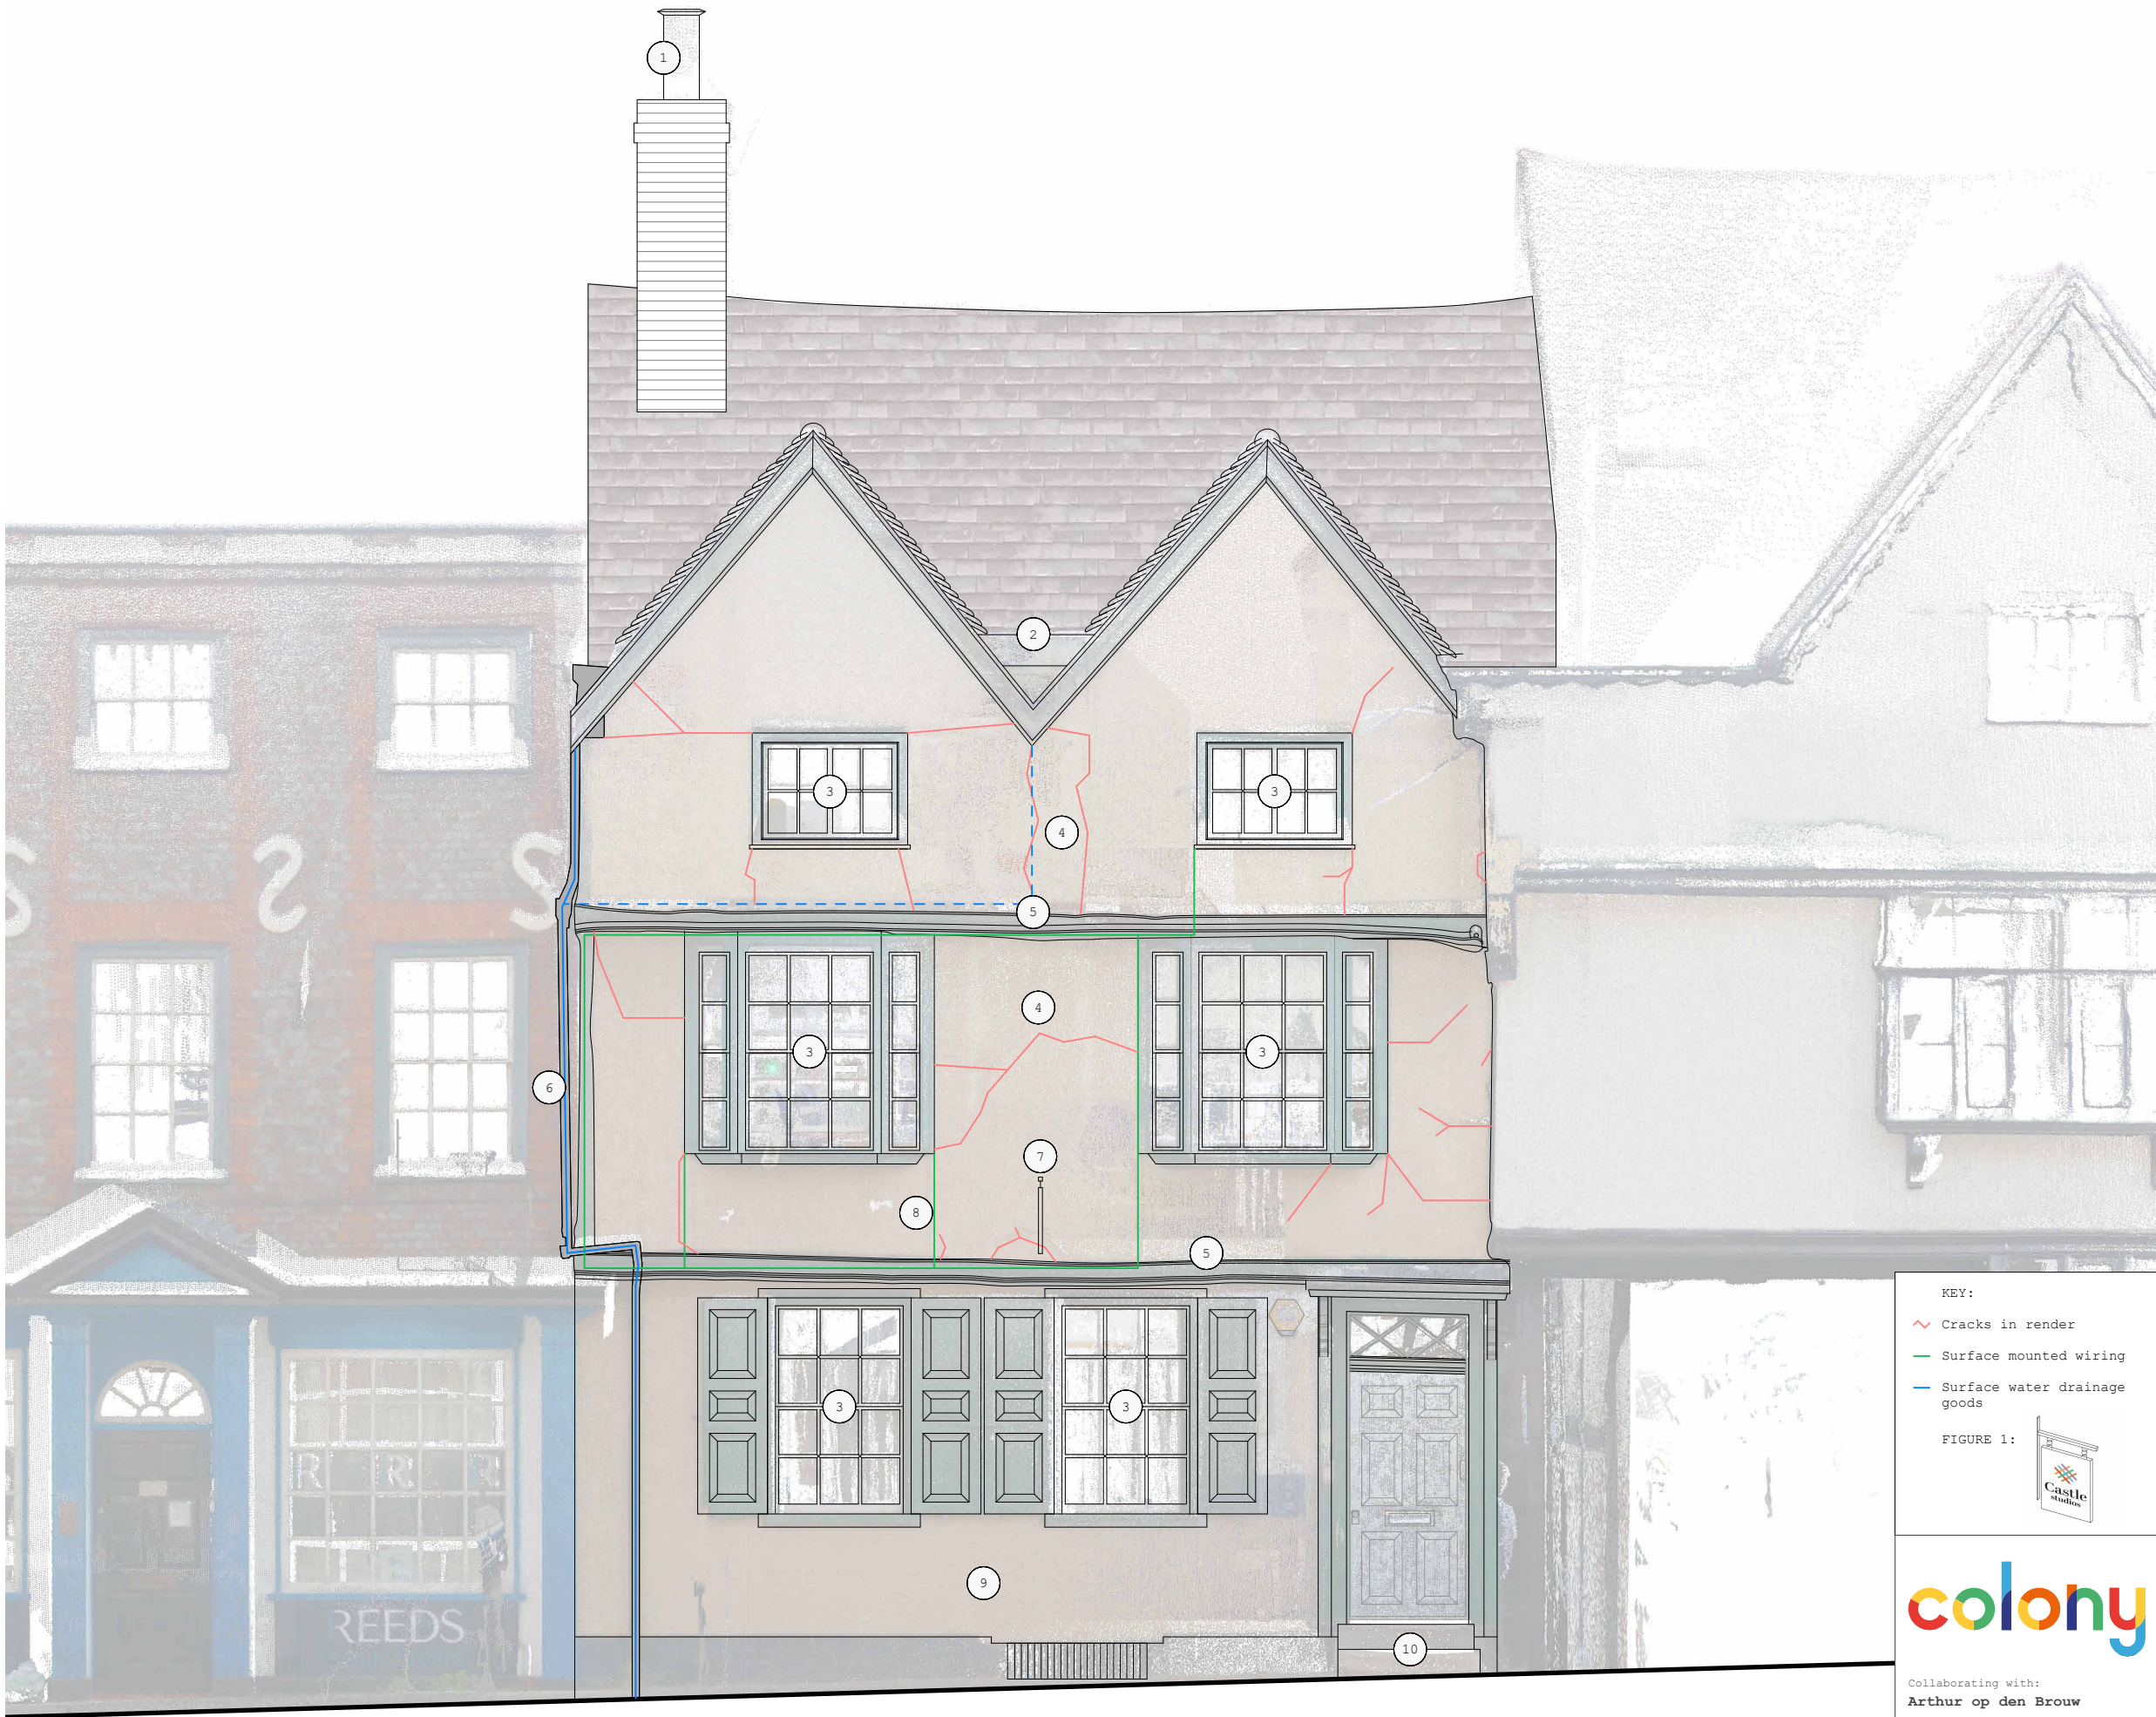
- 4 REPAIR OF LIME RENDERED WALLS**  
Significant cracking and some delamination can be seen in the existing render from street level. Full extent of existing plaster to be tested for soundness and removed if at risk of coming away from substrate. Areas that are in good condition but have started to come away to be pinned back to lathes with stainless steel screws, 40mm mesh squares and 25mm washers. Patch repairs to be undertaken with lime render in a mix with additives to match that found in the existing render being removed. If condition of whole rendered surface is found to be poor (this is not expected), all render to be removed and lathes/substrate checked for soundness and replaced like-for-like as necessary. It is not anticipated that structural timbers will be affected.

- 5 REPAIRS TO TIMBERWORK**  
Evidence of historic deterioration of timber elements can be seen from street level. Areas to be inspected and tested for soundness of timber. Timber in poor condition to be cut away to expose good wood and appropriate hardwood fillets fitted as patch repairs. Should any timber elements show significant rot and a patch repair would not suffice, said element should be replaced in full, using same-species material and respecting existing joints and techniques.

- 9 REPAINTING OF BRICKWORK WALLS**  
Existing brickwork walls have been painted in a non-breathable paint. It is likely that the removal of this paint may cause some damage to the substrate. A small inconspicuous patch should be tested and if the paint can be removed without damage to the brickwork beneath it should be stripped back carefully with chemical and/or low pressure water. Whether stripped or cleaned, the wall should be repainted in a colour to match render over. If paint is stripped, lime-based breathable paint must be used.

- 10 STONE STEP RE-LAID**  
Existing stone step has shifted due to poor foundation. Existing stone to be taken up and re-laid on solid footing so it sits level to ground.

- 1 REMOVE VEGETATION**  
Check chimney and roof for any vegetation taking hold and remove and check for damage.
- 2 ROOF REPAIRS**  
Existing leadwork has been historically repaired and this repair may have failed. Area to be inspected for broken tiles and leadwork inspected for cause of water ingress. If necessary, leadwork to be replaced. Underlying substrate to be inspected for signs of damp and rot and replaced if necessary. Breathable construction/good ventilation to be maintained throughout.

- 3 REPAINTING OF TIMBERWORK**  
Window and door frames and shutters, as well as roof verges and horizontal timber beam cornices to be carefully stripped with heat gun and inspected for the need for repairs. Assuming no repair work required, all woodwork to be repainted in new colour using lime-based breathable paint.

- 6 SURFACE WATER DRAINAGE**  
All rainwater goods assessed for continuity and effectiveness. If condition of overall system is insufficient, it should be replaced wholesale with metal rainwater goods in a 'cast-iron appearance' style. It is understood the central valley drains along a pipe enclosed in the external wall as shown dotted. This should be inspected and recorded during the replastering work (if possible without material damage) with repairs made at junctions if there are any signs of leaks. Internal pipe to be lagged if space permits with breathable material.
