41, Eastern Avenue  
Reading  
RG1 5RX

## Structural feasibility report

Clive Hudson Associates  
Consulting Structural & Civil Engineers

Jan 2026  
Project Ref: 256939

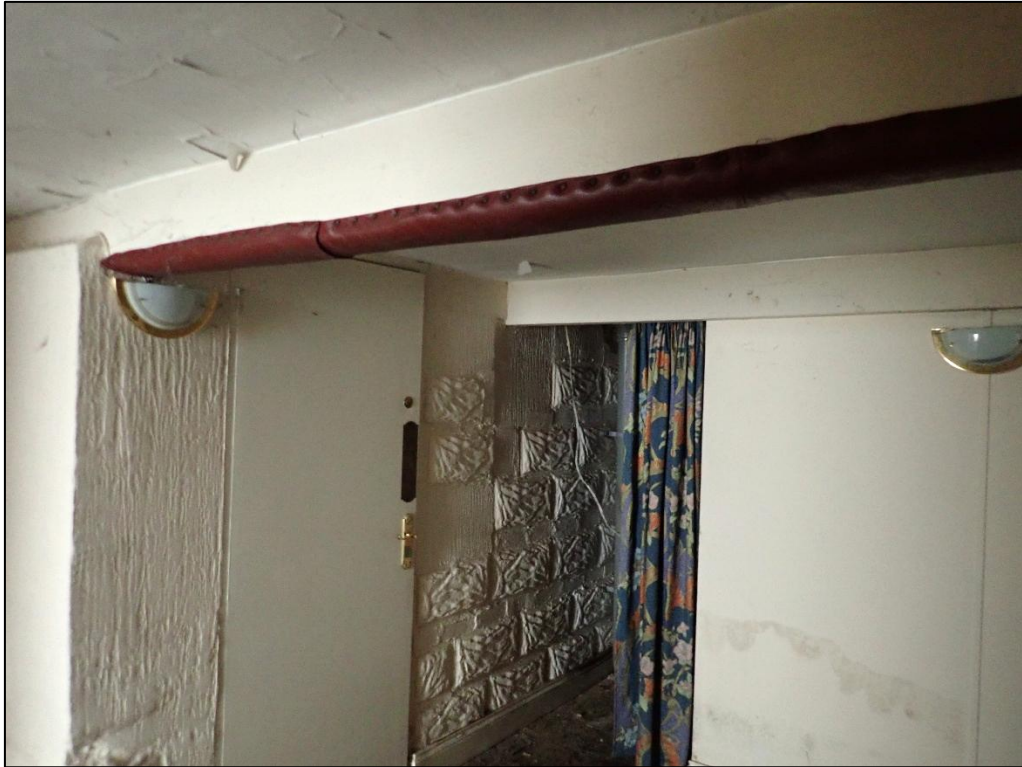
- i. The architectural drawings for the basement indicate that the proposed alterations comprise the removal of internal partitions from within the front room, and the insertion of two lightwells in the front wall (Fig. 8).
- ii. From the inspection, the partitions are clearly not historic. The east/west partition is of stud construction, while the partition towards the front elevation is of blockwork construction.
- iii. The ground floor construction comprises timber joists that span north-south, with internal support provided by two downstand timber beams that span east-south. Both beams are supported by the north/south blockwork partition (Fig. 9).

Figure 9. Partial view of the partitions within the basement, with the two downstand beams running left-to-right.

The beams are circa 185mm deep x 100mm wide and span c. 3.9m. During the inspection, it was not possible to confirm whether the joists are notched over the beam or not, i.e., the beams are deeper than the 185mm measured beneath the ceiling.

Based on an initial assessment for a 185mm deep x 100mm wide timber beam spanning c 3.9m, with assumed properties equivalent to a C24 grade, the beams would fail when assessed against modern codes of practice for bending stress and deflection, without the internal support. While we recognise that modern codes of practice should not be applied unthinkingly, in the context of building conservation, we would recommend that localised opening-up works be undertaken to confirm the exact size of the beam as part of the next phase of the project, and a provisional sum is allowed to strengthen the beams.

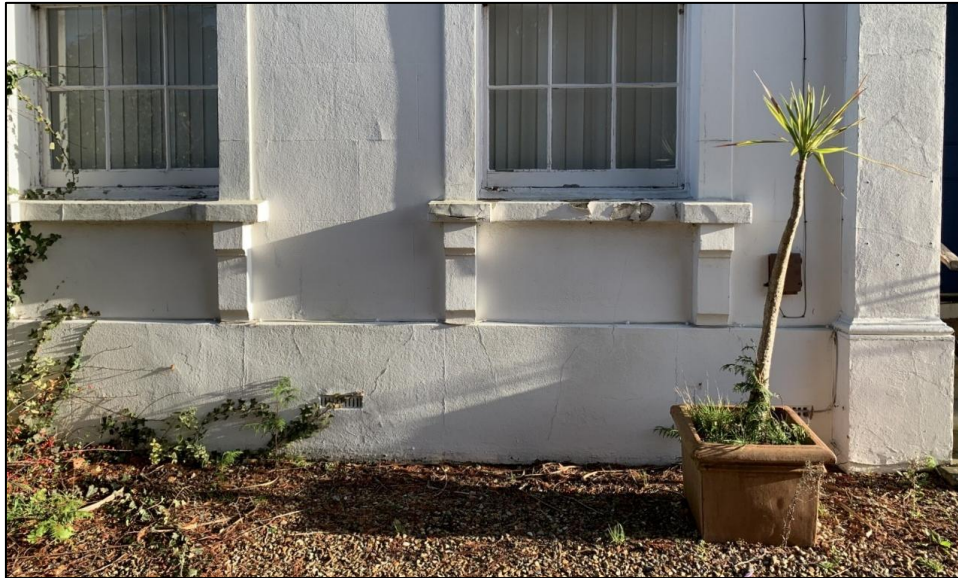
- iv. The formation of the two lightwells does not raise any significant structural concerns at present. However, the architectural drawings currently lack detail regarding their size and position. From a structural perspective, new lintels will be required over the openings, and new retaining structures will need to be added externally to form the well(s). At this stage, we would allow to use reinforced hollow blocks with a lightly reinforced concrete slab at its base. However, clarification should be sought with the arboricultural consultant, SJ Stephens Associates, as to

whether this, or any other construction, is feasible, considering the lightwells will lie within a Ground Protection Area.

Figure 10. Current view beneath the ground-floor windows, where the lightwells will be located.

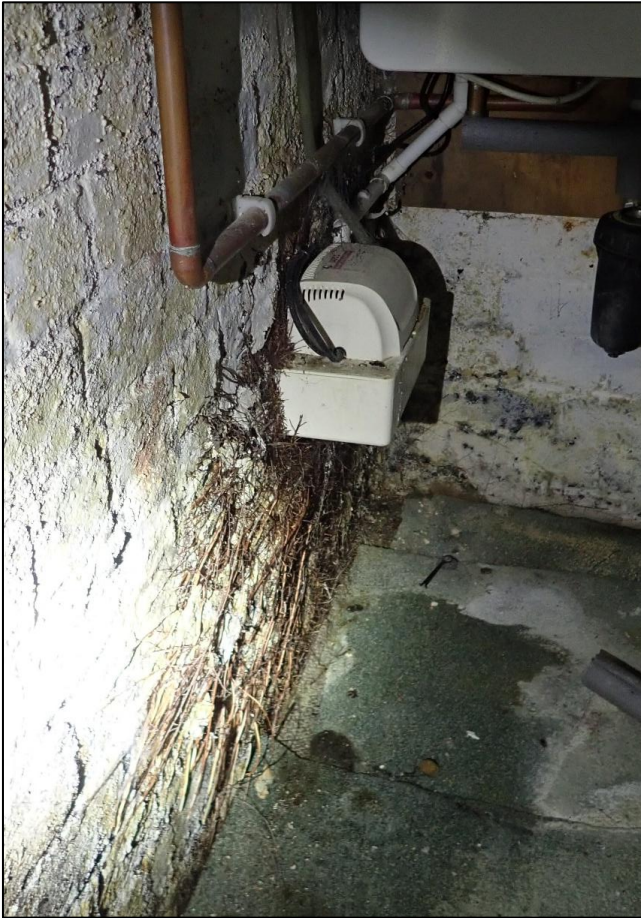
- vii. While outside of our brief, a localised bulge was observed in the brickwork beneath the boiler condensate pump at the base of the front wall in the north-west corner. There is also evidence of extensive root penetration and moisture ingress in this location (Fig. 11). We would recommend that this be investigated and a provisional sum set aside for remedial works as part of the project.

Figure 11.  
View of the localised  
bulge, root penetration  
and moisture ingress in  
the north-west corner.

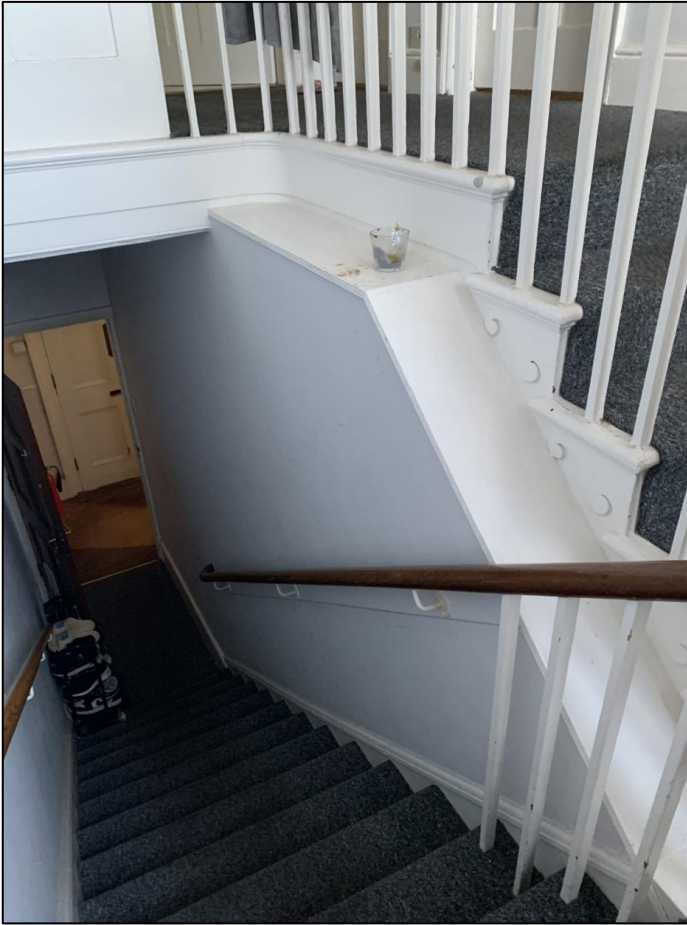
- iii. The removal of the wall that separates the principal staircase from the hall on the ground floor does not warrant immediate structural concern (Fig. 13). While the wall is not considered to be original, it may be providing support to the existing staircase and the first-floor landing. Should the wall be removed, a provisional sum should be allowed to either reinstate the staircase and landing or to undertake remedial works to the existing structures.

Figure 13.  
View of the wall that  
separates the principal  
staircase from the  
ground-floor hall (from  
the half-landing).

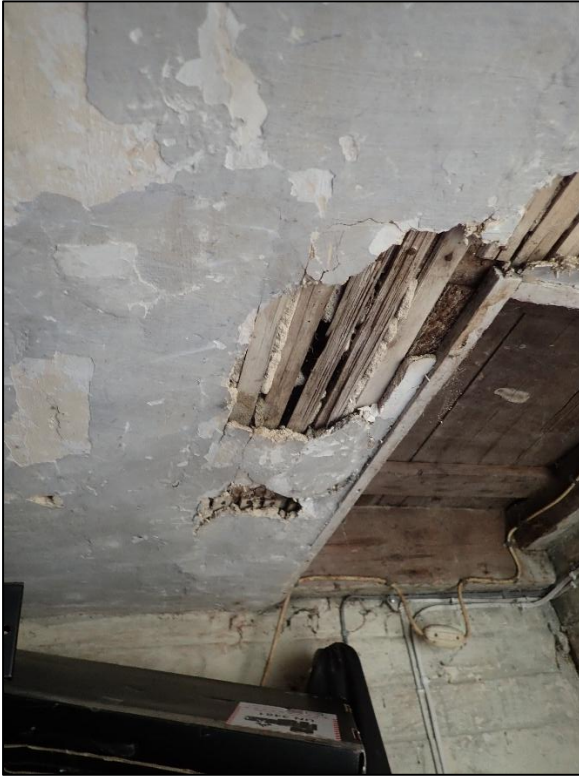
- iv. Although not entirely clear at this stage, it appears that the insertion of the window in the study may clash with the historic first-floor joists and lathe-and-plaster ceiling (Fig. 14). We would recommend that, as part of the next phase, the architects develop their drawings to include existing and proposed sections to clarify these relationships.

Figure 14.  
View of the historic lathe-  
and-plaster ceiling in the  
store.

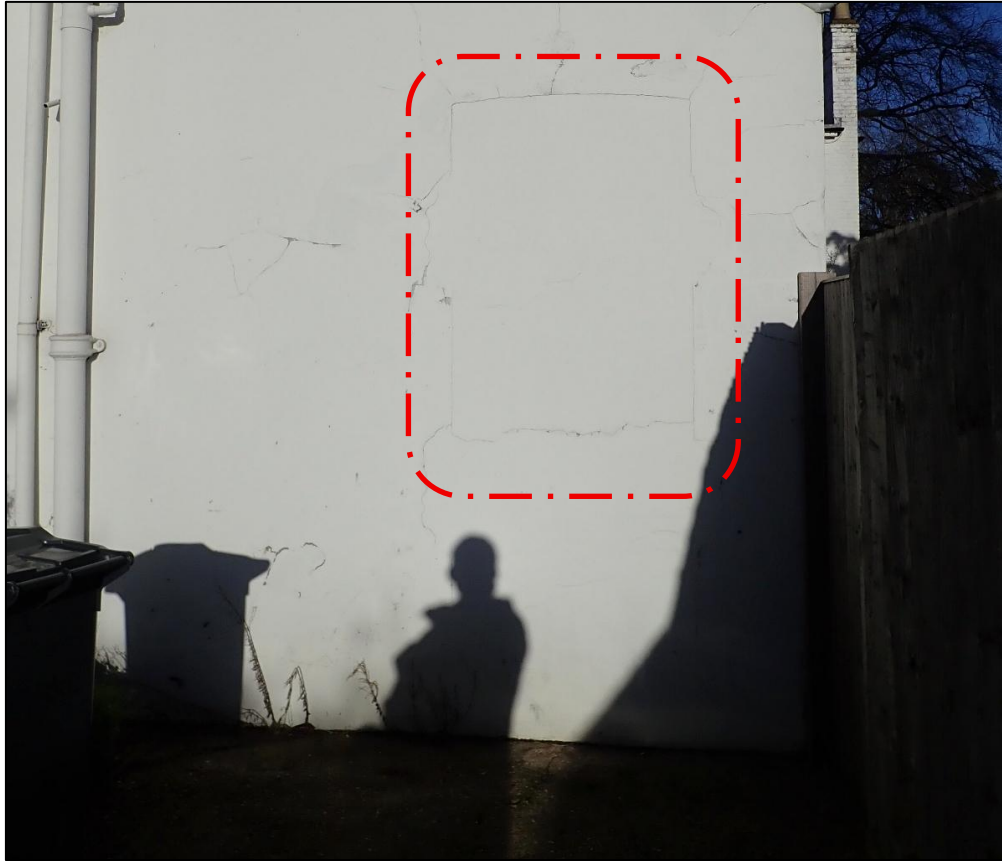
- v. As previously noted, the store has a brick paver floor, which is likely to be historic. To enable the conversion of this space to habitable usage, it is assumed that the floor will require upgrading, including the introduction of additional insulation. This should be developed by the architects before the submission of the listed building consent application.
- vi. On a similar basis, we would recommend that the floor and ceiling levels in the proposed study and playroom be confirmed before the submission of the listed building consent application.
- vii. Although it does not warrant immediate structural concern, we would allow to strengthen the brickwork over the existing opening in the proposed ground-floor bathroom (Fig. 15) using stainless steel, threaded bars and resin grout, such as Helifix Helibars and Helibond grout, should the opening be reinstated.

Figure 15. Outline of the infilled opening on the side/south elevation.

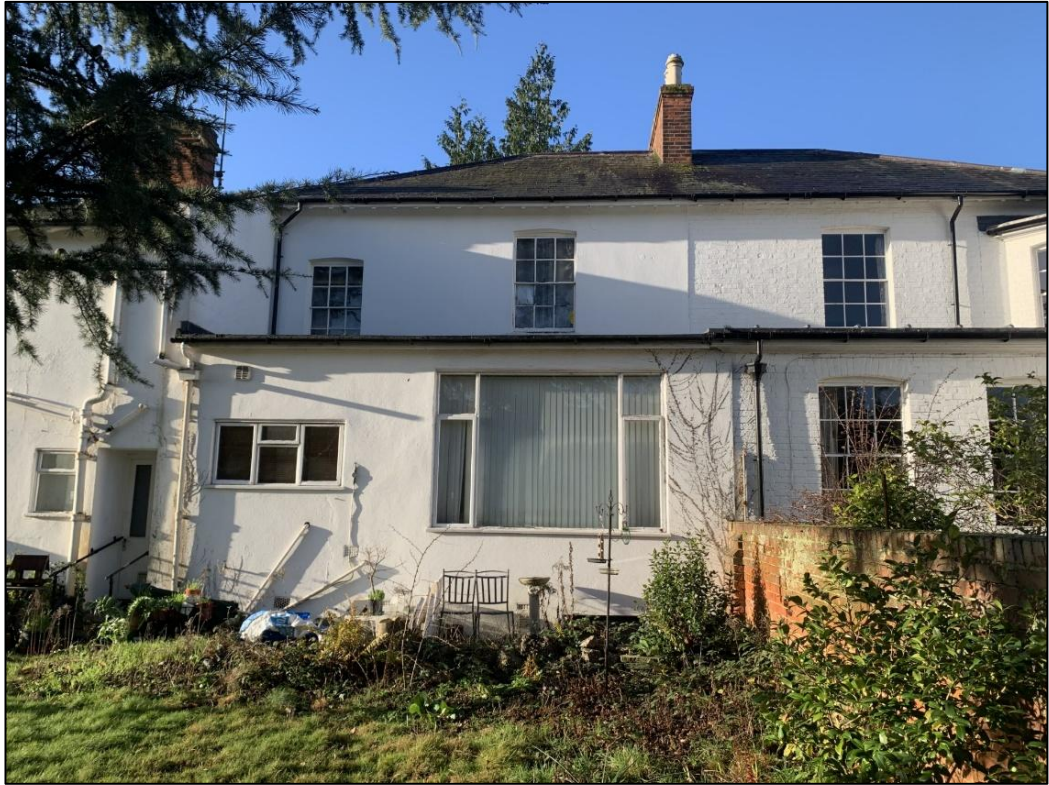
- viii. The proposed widening of the opening in the existing rear extension does not present any immediate structural concerns; however, a new intel will be required to support the altered span. As previously noted, the rear wall appears to have been rebuilt at some point, with exposed blockwork observed on the inner face in the existing kitchen (Fig. 17). The current window openings also have square heads rather than the shallow brick arches, which No. 39 has on its rear extension, indicating that the wall has been taken down and rebuilt (Fig. 16).

Figure 16. View of the rear elevation of the existing single-storey, rear extension, with No. 39 on the right-hand side.

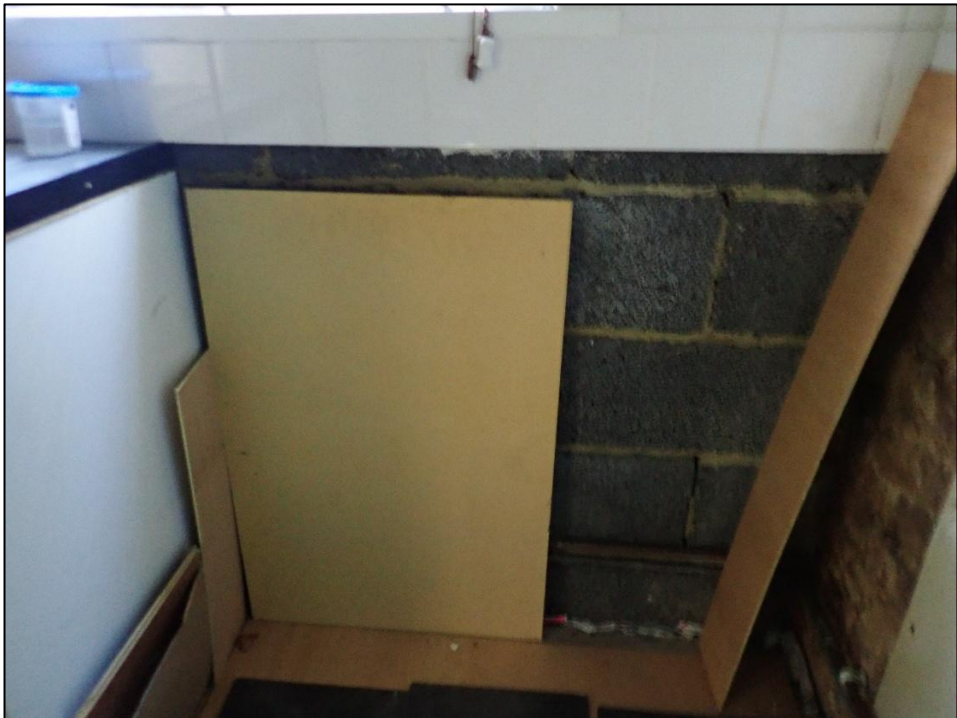
Figure 17. View of the exposed blockwork in the existing kitchen.
