Structural Appraisal  
of  
Ceiling repairs  
St. Mary's Church  
Castle Street  
Reading  
RG1 7RD

## 1.0 INTRODUCTION & BRIEF.

We were contacted by Mark Clements of St. Mary's Church, located at 14 Castle Street, Reading. RG1 7DH to inspect and advise on a number of fractures to the existing ceiling of the church.

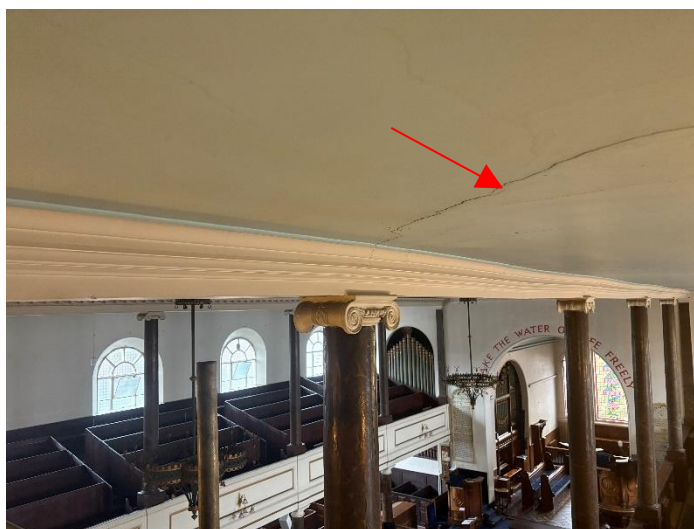
- 3.1 Our initial inspection of the ceiling was carried out from the gallery areas and revealed minor cracking of the ceiling surface. These areas of cracking are likely to have been caused by delamination of the plaster from the timber laths, triggered by roof leaks however, we now understand that the roof has been repaired. Michal Wolf of All-Things-Lime visited the church in February 2025 and advised that the minor cracking to the ceiling area can be repaired by inserting screws and penny washers each side of the crack prior to repairing the plaster using traditional techniques.

Figure 7. Minor cracking to ceiling over the nave.

- iv. We recommend All-Things-Lime are employed to advise on the appropriate repairs to the cracked ceiling areas. As discussed above, the initial advice from ATL was that minor cracking to the ceiling area can be repaired by inserting screws and penny washers each side of the crack prior to repairing the plaster using traditional techniques

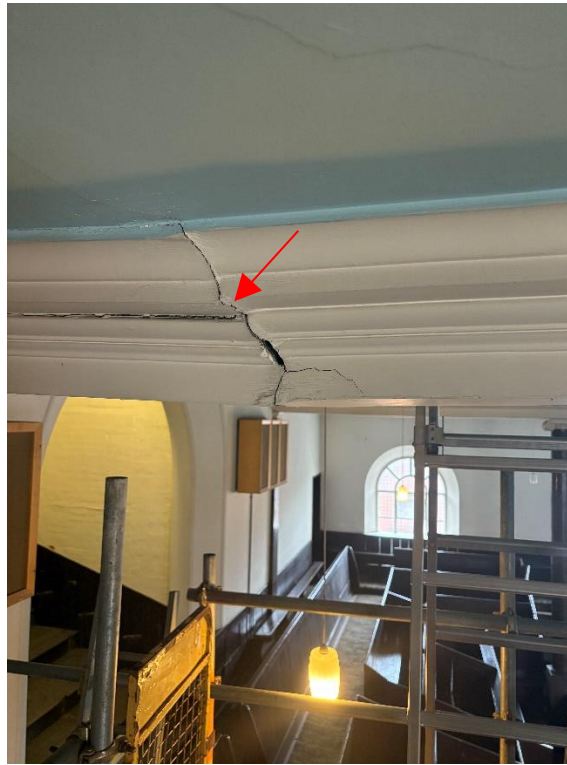
- 3.2 Of particular interest was a fracture in a timber valley beam over the gallery to the far south of the nave (see figure 3) where the timber beam supports a post from the main roof truss above.

Figure 8. Fracture in timber beam to the south end of the church.

4.1 There are three remedial options available:

### Option A – Replacement of existing beam.

Complete replacement of the existing timber valley beam is likely to be the most cost effective solution and would not require a specialist contractor.

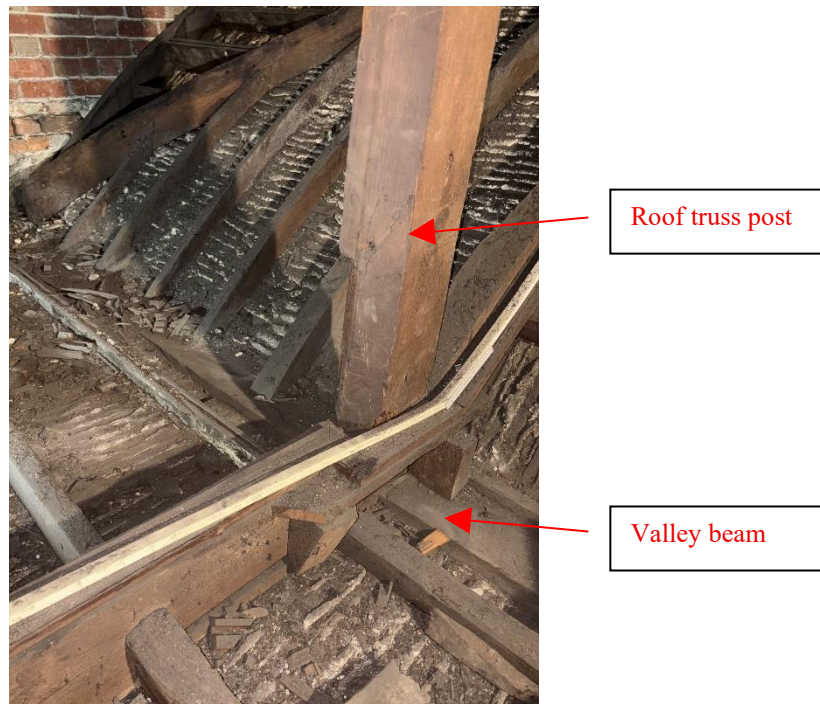
Figure 9. Roof truss supported by fractured beam.

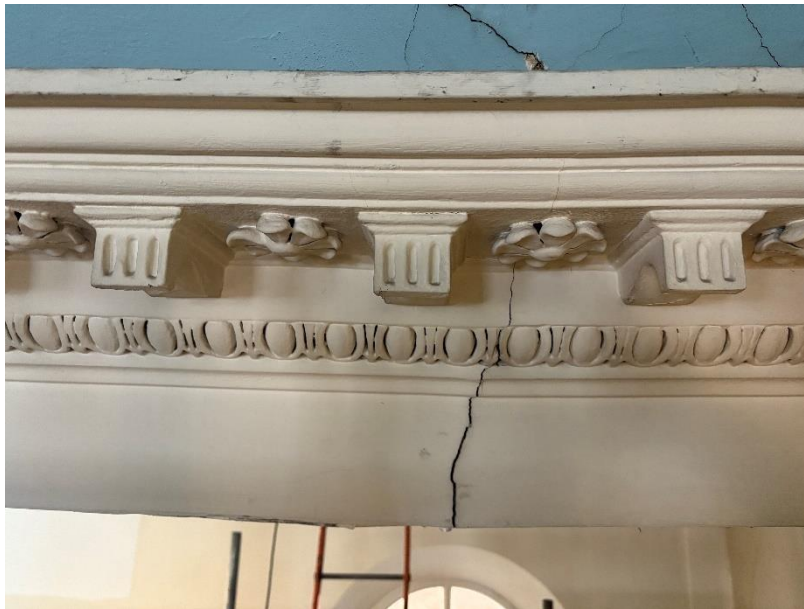
- 3.3 Clive Hudson Associates recommended an intrusive inspection of the valley beam which required partial removal of the plaster casing and the adjacent mouldings. Michal Wolf was employed to take insitu castings of the mouldings and carefully remove the plaster casing ready for CHA's inspection.

Figure 10. Valley beam prior to intrusive inspection.

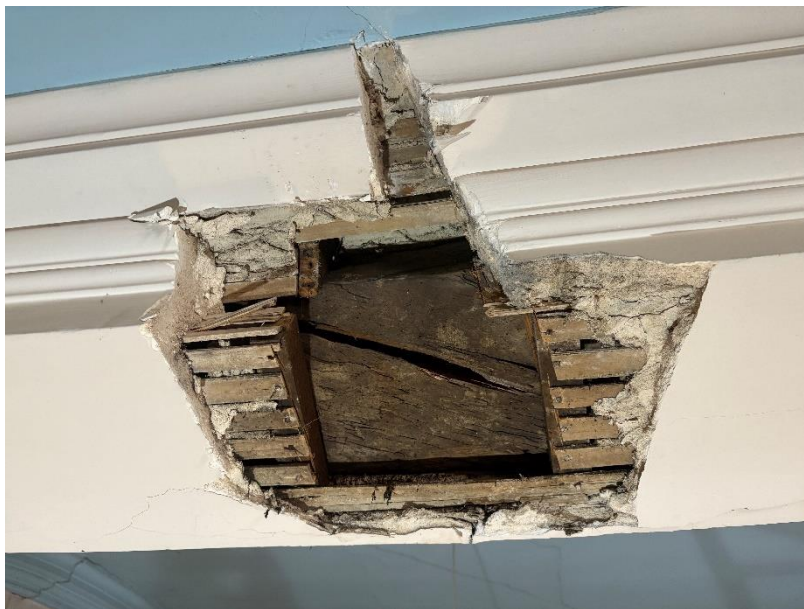
Figure 11. Valley beam after intrusive inspection.

- 3.4 The intrusive investigation revealed the timber valley beam to be approximately 150mm deep and 200mm wide. A severe split was observed within the valley beam, approximately 70mm deep and directly beneath the supported roof truss post.

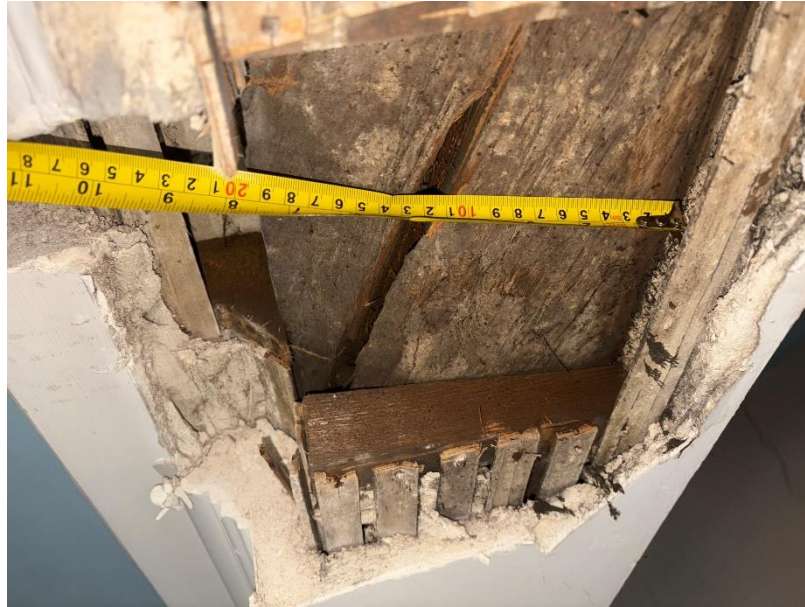
Figure 12. Valley beam width.

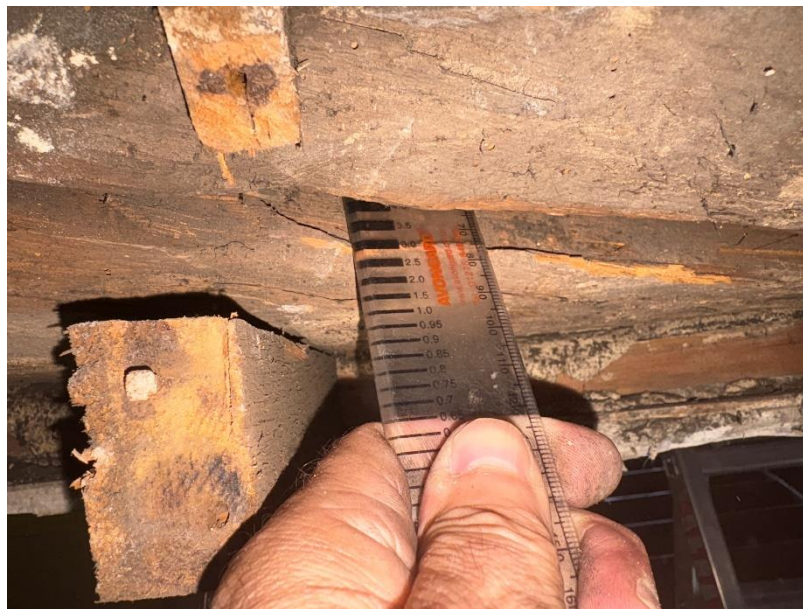
Figure 13. Split depth in valley beam width.
