# **SUPPLEMENTARY DESK STUDY REPORT ABBAY GARDENS ABBAY STREET, READING**

**Prepared for: Randalswood Construction UK Limited**

**ASL Report No. 018-25-1188-11R1**

**December 2025**

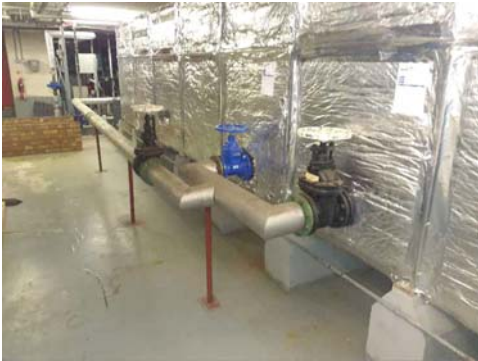
| <b>FLOOR/LOCATION:</b> | Z-Sub Level 2 Tank Room | |

| <b>DESCRIPTION:</b> | Gaskets to pipework | |
| <b>RESULT:</b> | Chrysotile | |

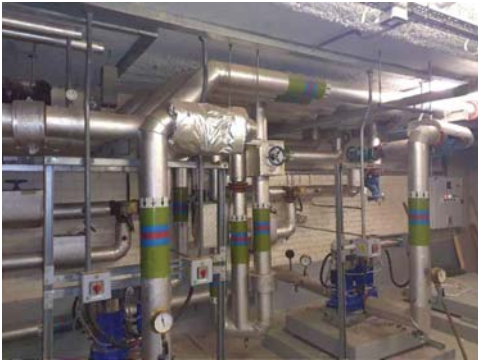
| <b>FLOOR/LOCATION:</b> | Z-Sub Level 2 Tank Room | |

| <b>DESCRIPTION:</b> | Gaskets to pipework | |
| <b>RESULT:</b> | Chrysotile | |

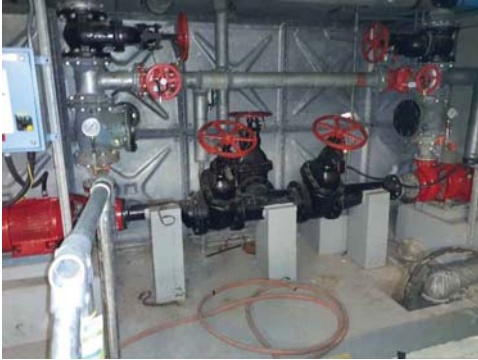
| <b>FLOOR/LOCATION:</b> | Z-Sub Level 2 Tank Room | |

| <b>DESCRIPTION:</b> | Gaskets to pipework | |
| <b>RESULT:</b> | Chrysotile | |

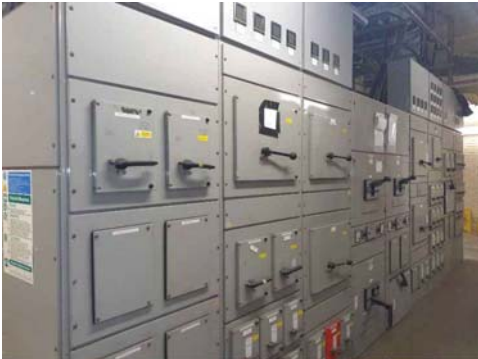
| <b>FLOOR/LOCATION:</b> | Z-Sub Level 2 Electrical Intake | |

| <b>DESCRIPTION:</b> | Presumed asbestos containing materials within electrics - unable to sample due to live services | |
| <b>RESULT:</b> | Presumed Crocidolite (or unknown) | |

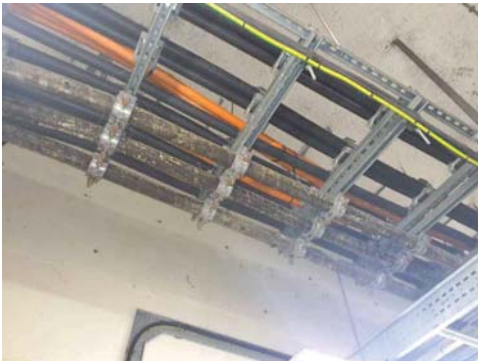
| <b>FLOOR/LOCATION:</b> | Z-Sub Level 2 Electrical Intake | |

| <b>DESCRIPTION:</b> | Presume asbestos containing materials within bitumen wrap to electrical mains cables - unable to sample due to live services | |
| <b>RESULT:</b> | Presumed Crocidolite (or unknown) | |

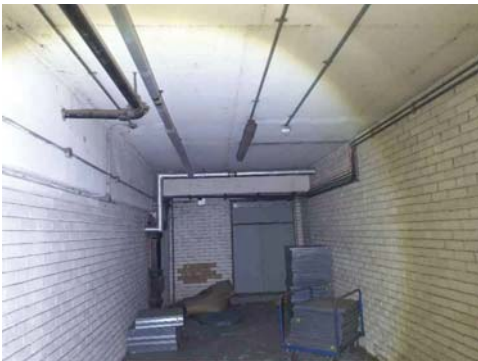
| <b>FLOOR/LOCATION:</b> | Z-Sub Level 2 Riser 1 | |

| <b>DESCRIPTION:</b> | Gasket to flange joint - Unable to locate gasket from opening at front of room, there is no full access | |
| <b>RESULT:</b> | Chrysotile | |

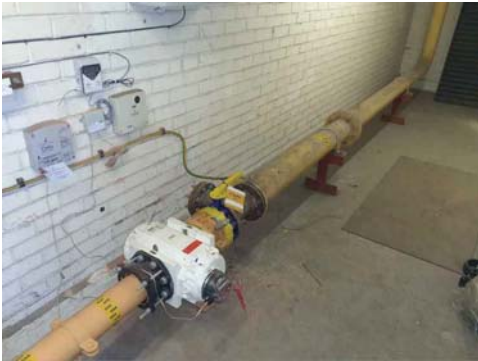
| <b>FLOOR/LOCATION:</b> | Z-Sub Level 2 Gas Intake Cupboard | |

| <b>DESCRIPTION:</b> | Gasket to flange joint | |
| <b>RESULT:</b> | Chrysotile | |

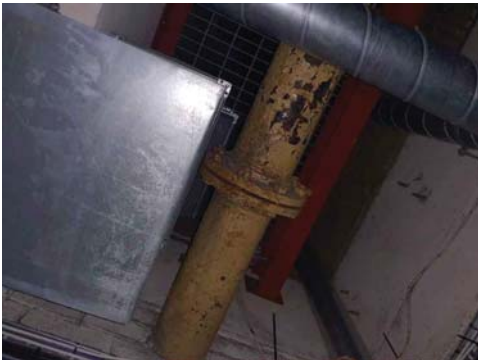
| <b>FLOOR/LOCATION:</b> | Z-Sub Level 2 Riser 3 | |

| <b>DESCRIPTION:</b> | Gasket to flange joint | |
| <b>RESULT:</b> | Chrysotile | |

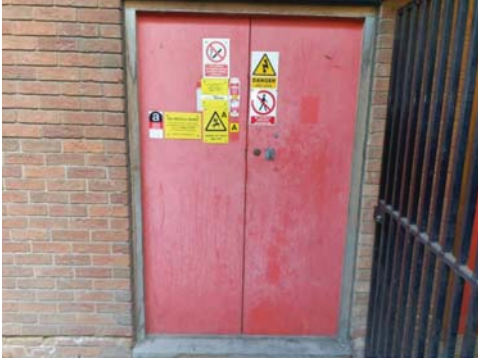
| <b>FLOOR/LOCATION:</b> | Z-Sub Level 2 Transformer Room | |

| <b>DESCRIPTION:</b> | Inaccessible | |
| <b>RESULT:</b> | Presumed | |

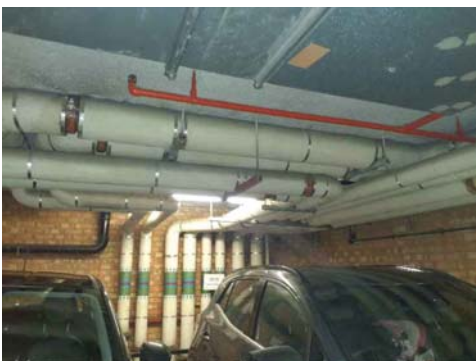
| <b>FLOOR/LOCATION:</b> | Z-Sub Level 1 Car Park | |

| <b>DESCRIPTION:</b> | Gaskets to cloth wrapped pipework presumed to all alike pipework throughout building | |
| <b>RESULT:</b> | Chrysotile | |

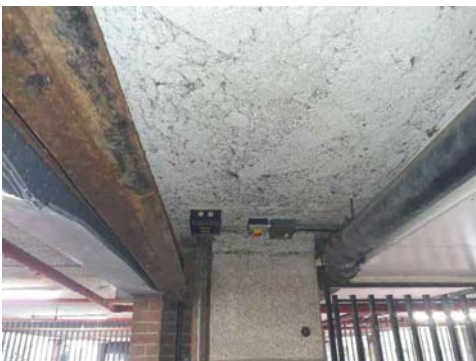
| <b>FLOOR/LOCATION:</b> | Z-Sub Level 1 Car Park | |

| <b>DESCRIPTION:</b> | Presumed asbestos containing materials within electrics throughout - unable to sample due to live services | |
| <b>RESULT:</b> | Presumed Crocidolite (or unknown) | |

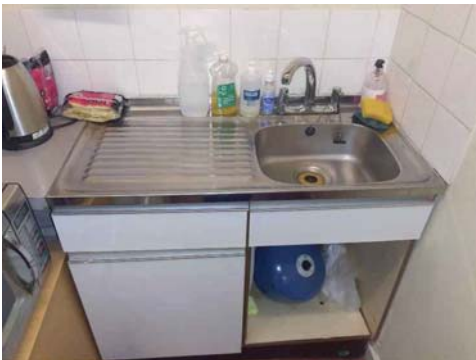
| <b>FLOOR/LOCATION:</b> | Z-Sub Level 1 Maintenance Office Store | |

| <b>DESCRIPTION:</b> | Sink pads | |
| <b>RESULT:</b> | Chrysotile | |

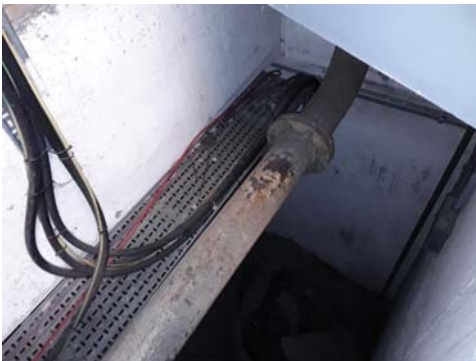
| <b>FLOOR/LOCATION:</b> | Z-Sub Level 1 Riser 1 | |

| <b>DESCRIPTION:</b> | Presumed asbestos containing materials within gasket to flange joint - unable to safely access to sample | |
| <b>RESULT:</b> | Presumed Crocidolite (or unknown) | |

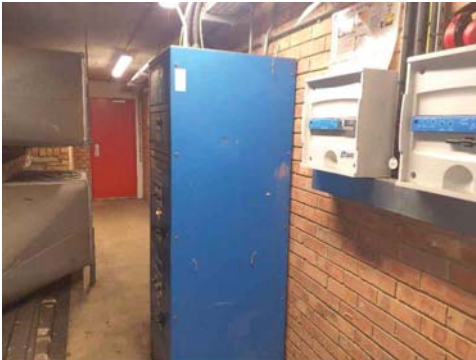
| <b>FLOOR/LOCATION:</b> | Z-Sub Level 1 Generator Room | |

| <b>DESCRIPTION:</b> | Presumed asbestos containing materials within electrical units - unable to sample due to live services | |
| <b>RESULT:</b> | Presumed Crocidolite (or unknown) | |

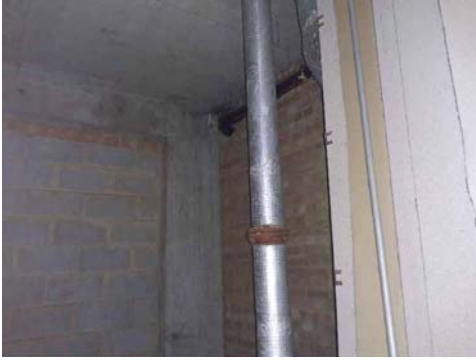
| <b>FLOOR/LOCATION:</b> | 4th Floor Riser 1 | |

| <b>DESCRIPTION:</b> | Presumed asbestos containing materials within gasket to flange joint | |
| <b>RESULT:</b> | Presumed Crocidolite (or unknown) | |

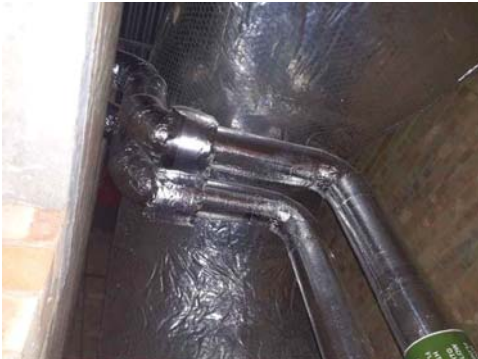
| <b>FLOOR/LOCATION:</b> | 5th Floor Riser 1 | |

| <b>DESCRIPTION:</b> | Presumed asbestos containing materials within gasket to flange joints - unable to sample due to live services *Presumed to remain sealed beneath foil backed MMMF | |
| <b>RESULT:</b> | Presumed Crocidolite (or unknown) | |

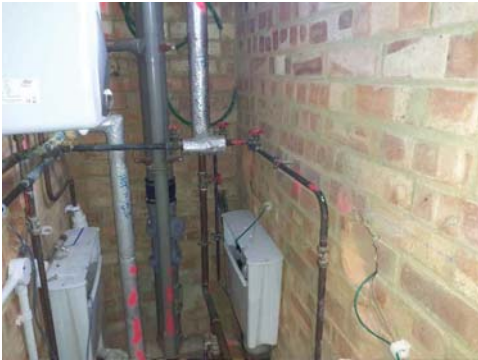
| <b>FLOOR/LOCATION:</b> | 5th Floor Riser 2 | |

| <b>DESCRIPTION:</b> | Tiny gaskets to copper pipework | |
| <b>RESULT:</b> | Chrysotile | |

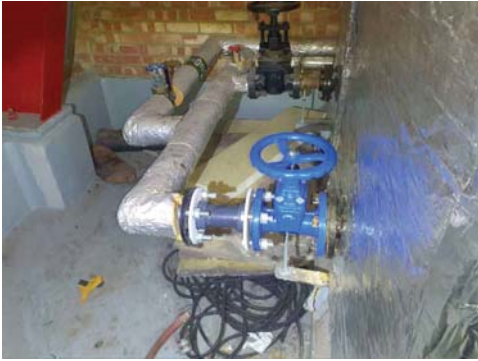
| <b>FLOOR/LOCATION:</b> | 6th Floor Tank Room | |

| <b>DESCRIPTION:</b> | Gaskets to pipework behind tank | |

| <b>RESULT:</b> | Presumed Crocidolite (or unknown) |

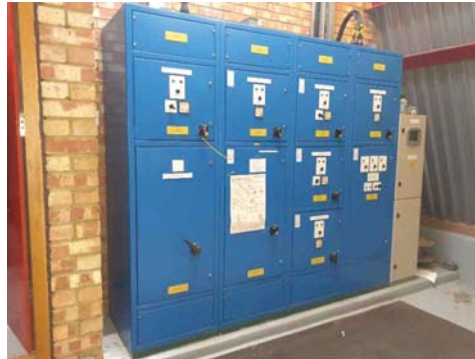
| <b>FLOOR/LOCATION:</b> | 6th Floor Pump Room |

| <b>RESULT:</b> | Chrysotile |

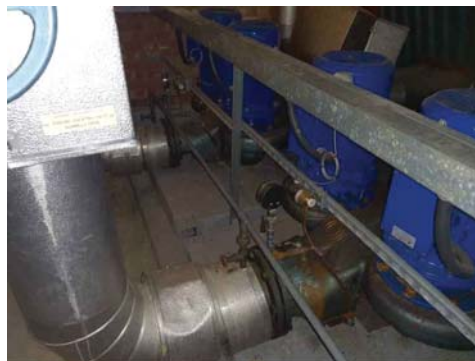
| <b>FLOOR/LOCATION:</b> | 6th Floor Chiller Units |

| <b>RESULT:</b> | Chrysotile |

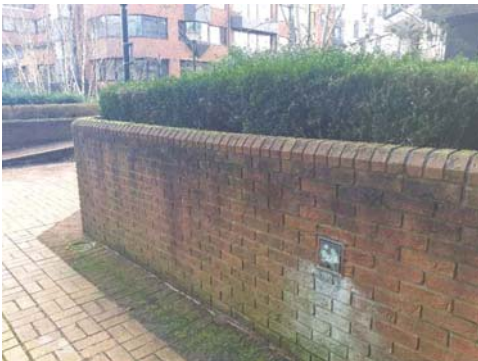
| <b>FLOOR/LOCATION:</b> | External | |

| <b>DESCRIPTION:</b> | Damp proof course to low level brickwork on building and within surrounding rear areas | |
| <b>RESULT:</b> | Chrysotile | |

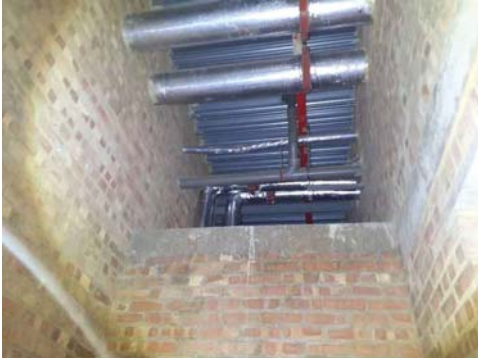
| <b>FLOOR/LOCATION:</b> | 5th Floor Plant Room 3 | |

| <b>DESCRIPTION:</b> | Gaskets to pipework | |
| <b>RESULT:</b> | Chrysotile | |

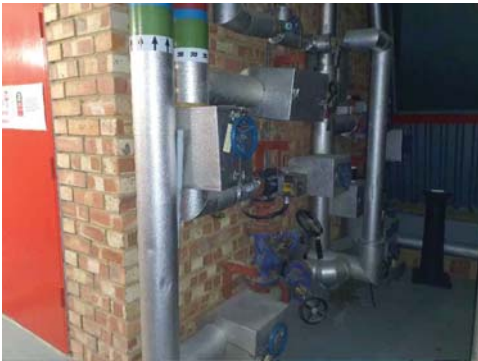
| <b>FLOOR/LOCATION:</b> | 5th Floor Plant Room 1 | |

| <b>DESCRIPTION:</b> | Gaskets to pipework throughout | |

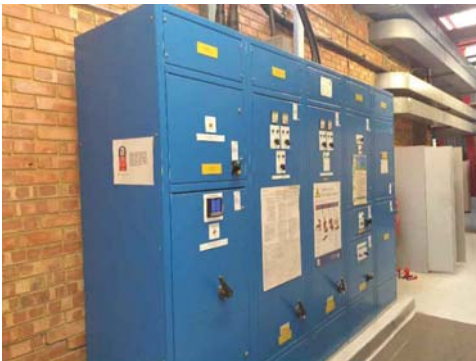
| <b>FLOOR/LOCATION:</b> | 5th Floor Plant Room 1 | |

| <b>DESCRIPTION:</b> | Presumed asbestos containing materials within electrics - unable to sample due to live services | |
| <b>RESULT:</b> | Presumed Crocidolite (or unknown) | |

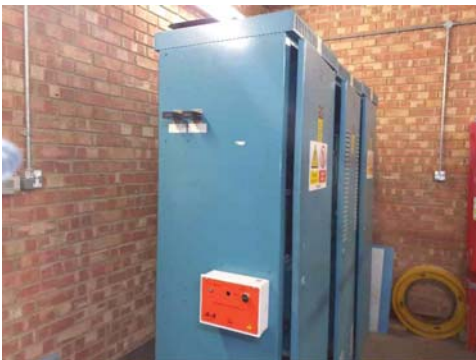
| <b>FLOOR/LOCATION:</b> | 5th Floor Lift Motor Room | |

| <b>DESCRIPTION:</b> | Presumed asbestos containing materials within arc shields within control panels - unable to sample due to live services | |
| <b>RESULT:</b> | Presumed Crocidolite (or unknown) | |

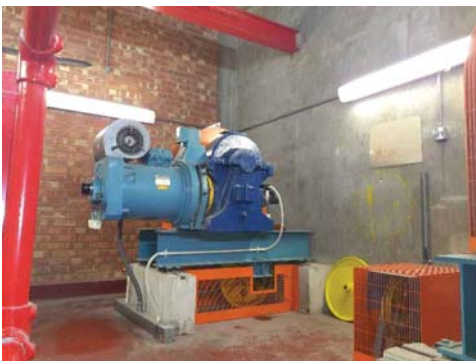
| <b>FLOOR/LOCATION:</b> | 5th Floor Lift Motor Room | |

| <b>DESCRIPTION:</b> | Presumed asbestos containing materials within textile break shoes to lift motors - unable to sample due to live services | |

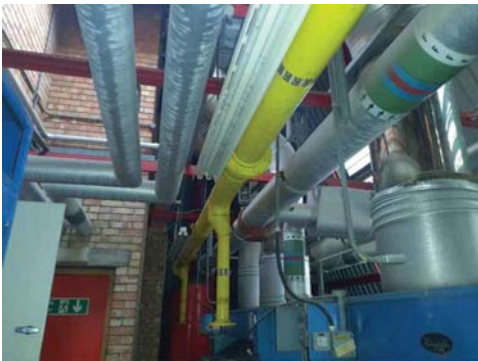
| <b>FLOOR/LOCATION:</b> | 8th Floor Boiler Room 1 | |

| <b>DESCRIPTION:</b> | Gaskets to pipework at high level throughout | |
| <b>RESULT:</b> | Chrysotile | |

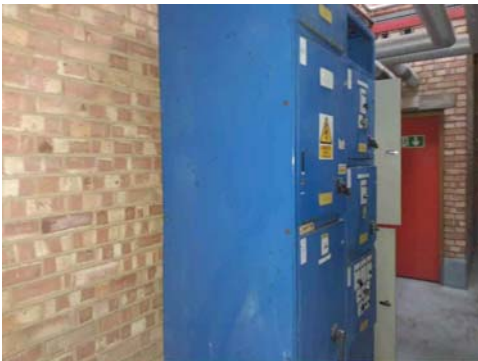
| <b>FLOOR/LOCATION:</b> | 8th Floor Boiler Room 1 | |

| <b>DESCRIPTION:</b> | Presumed asbestos containing materials within electrical units - unable to sample due to live services | |
| <b>RESULT:</b> | Presumed Crocidolite (or unknown) | |

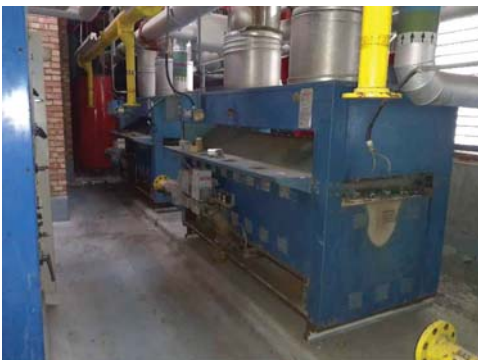
| <b>FLOOR/LOCATION:</b> | 8th Floor Boiler Room 1 | |

| <b>DESCRIPTION:</b> | Presumed asbestos containing materials within sealed boiler units - unable to sample due to live services | |

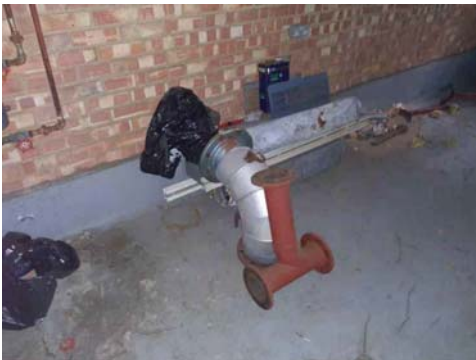
| <b>FLOOR/LOCATION:</b> | 8th Floor Boiler Room 1 | |

| <b>DESCRIPTION:</b> | Gasket residues to flanges points to redundant pipework adjacent to wall of boiler room | |
| <b>RESULT:</b> | Chrysotile | |

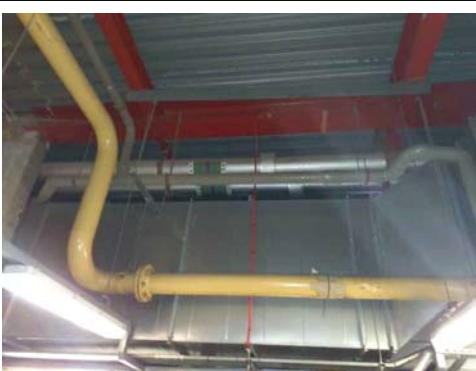
| <b>FLOOR/LOCATION:</b> | 8th Floor Plant 1 | |

| <b>DESCRIPTION:</b> | Gaskets to pipework throughout | |
