# Site Investigation Report

129603.1.USI

## Job Summary

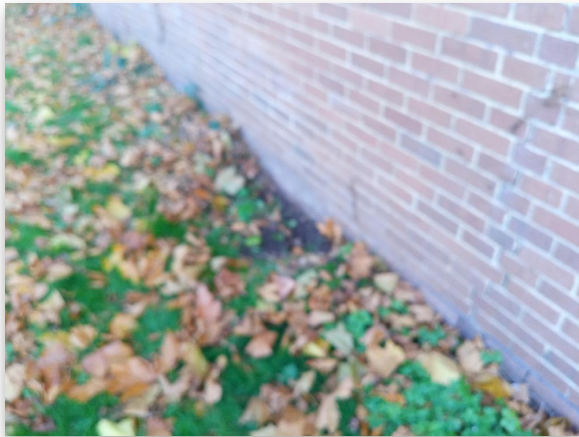
Fig 1.1: Trial Hole 1 Location

| Trial Hole Findings | We were unable to reach the required depth on TH1 and TH2 because stiff ground was encountered at 1.6m in both TH1 and TH2, unable to hand auger. |

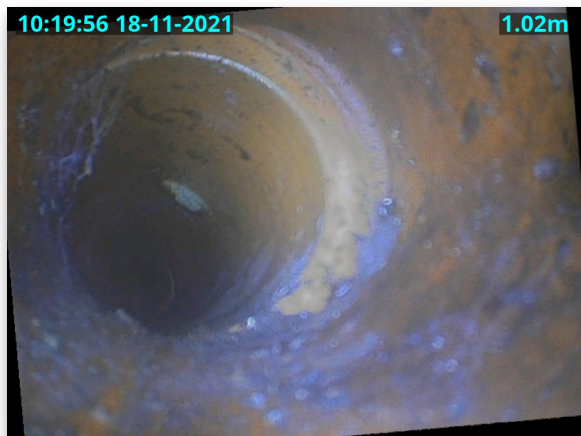
Fig 3.1: Line 1.

| Drain Survey | <p><b>Line 1 - From RWG1 downstream to Unknown</b></p> <p>Our CCTV survey revealed joint displacements at <b>throughout the pipework</b>. This is resulting in an escape of water.</p> <p>The above mentioned defects to the below ground drainage system have been caused by ground movement.</p> |

| Refer Back to Client | <p>It is recommended that the following repairs are carried out to prevent an escape of water from the system:</p> <p><b>On line 1:</b></p> <p>Excavate and replace RWDP and 5m of 100mm pipework including a new 2 cell soakaway at a depth no greater than 1m through grass.</p> <p>The soakaway will need to be installed at least 5m from the property in order to comply with current building regulations.</p> <p>These works will require a 6 yard skip to be present on the day of repairs.</p> <p><b>Please note:</b></p> <p>As we are unable to confirm how many garages / people derive benefit from the RWDP we would ask that this is confirmed by the loss adjuster prior to our return visit to carry out the recommended repair works.</p> <p>We will now refer the claim back to the client in order to progress.</p> |

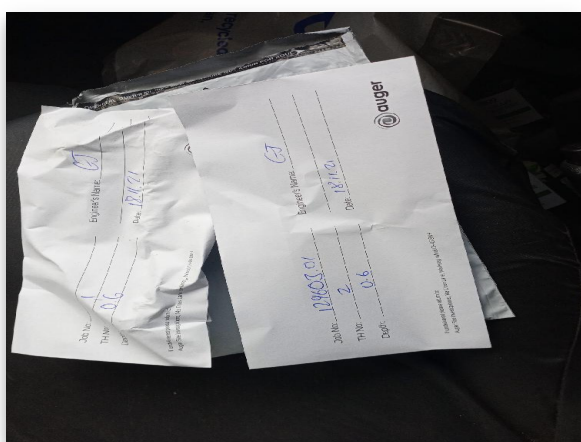
Fig 4.1: Root Samples Collected.

| TH1, 0.8m | | |
|---|---|---|
| 2 no. | Examined root: PLATANUS (Plane). | <a href="#">Alive, recently*</a> . |
| 3 no. | Examined root: PLATANUS (Plane). | <a href="#">Alive, recently*</a> . |

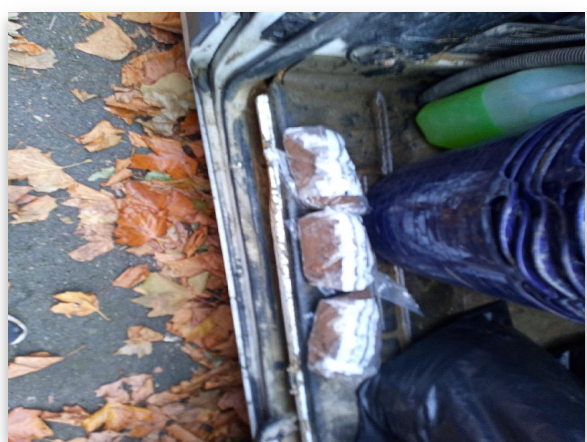
Fig 4.2: Soil Samples Collected
