## Asbestos Refurbishment/Demolition Survey

104 – 112 Oxford Road,  
Reading,  
RG1 7FU

Lotus Living 5 Ltd.

Survey ID: SF-S-25-1147  
Surveyor: Steve Fenton  
Survey Date: 20/10/25  
Report Date: 20/10/25

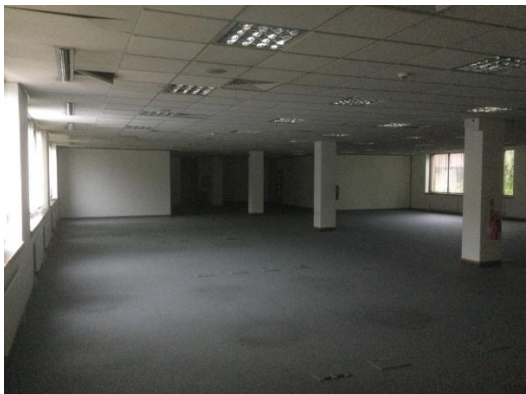
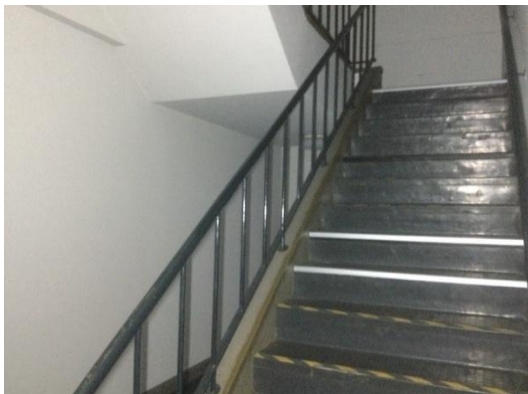
| <b>Comments:</b> | Stair nosing sampled, carpet to raised timber floor, plaster to wall, no asbestos detected including ceiling voids. | | |

| <b>Action:</b> | None | | |

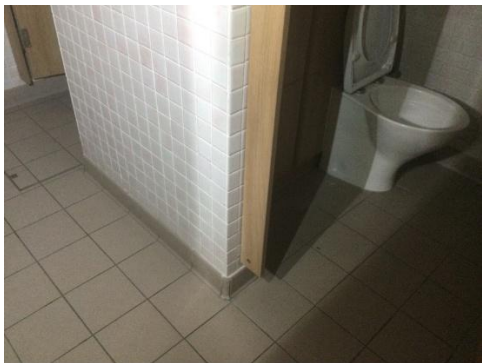
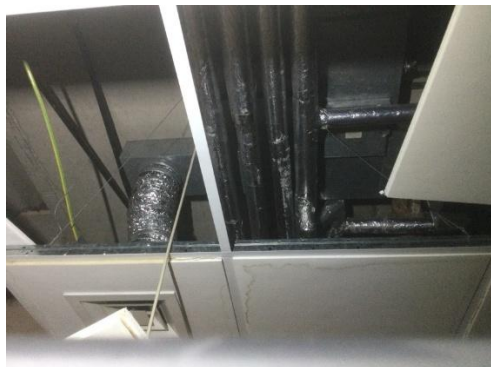
| <b>Sample Reference: SF02/104/Grnd floor</b> | | | |

| <b>Comments:</b> | Ceramic tiles to floor and walls, insulation to ceiling sampled, voids no asbestos detected | | |

| <b>Action:</b> | None | | |

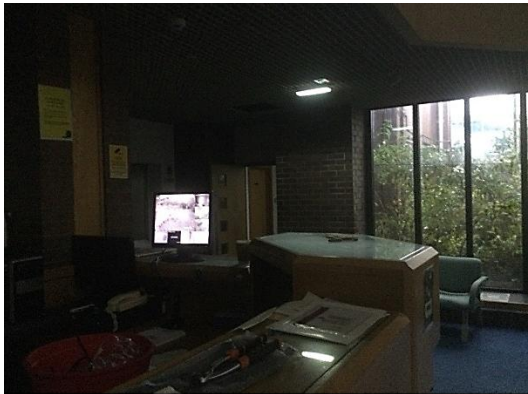
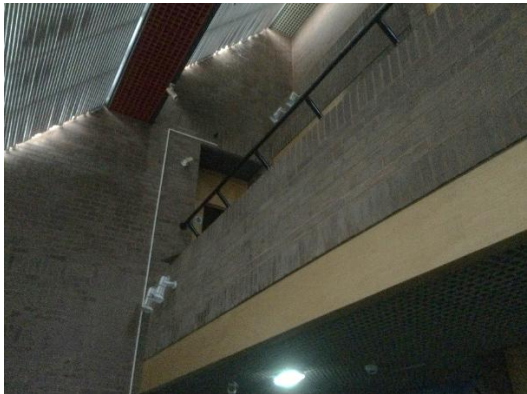
| <b>Sample Reference: SF03/104/Grnd floor</b> | | | |

| <b>Comments:</b> | Brick and mortar, timber panels, carpet to concrete, no asbestos detected including ceiling voids | | |

| <b>Action:</b> | None | | |

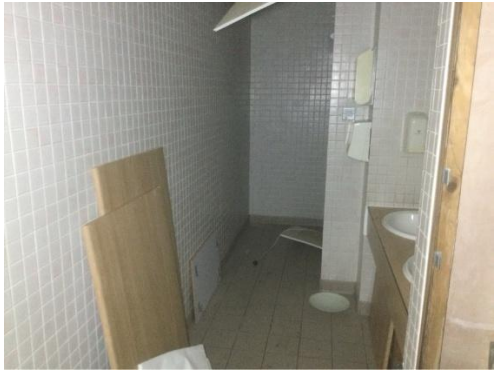
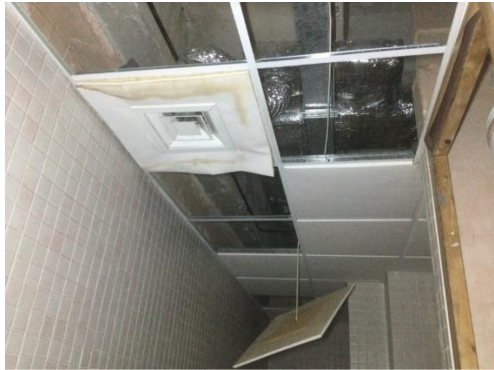
| <b>Sample Reference: SF04/104/Grnd floor</b> | | | |

| <b>Comments:</b> | Ceramic tiles to floor and walls, no asbestos detected including ceiling voids | | |

| <b>Action:</b> | None | | |

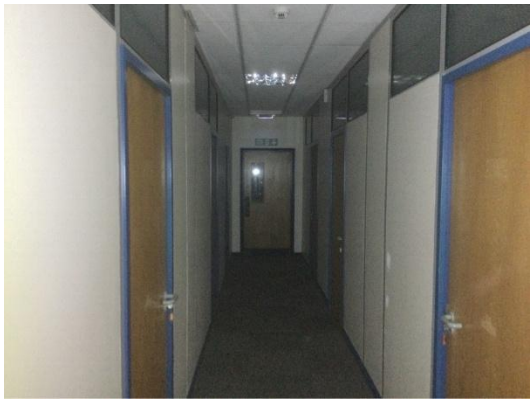
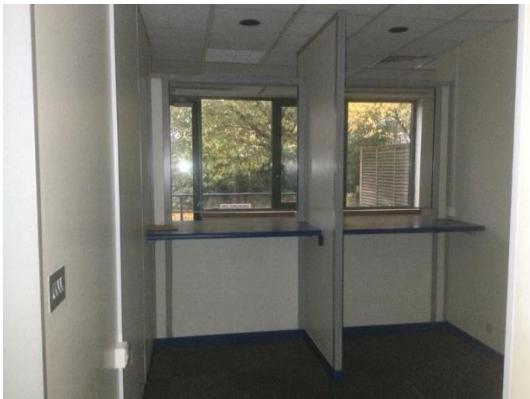
| <b>Sample Reference: SF05/104/Grnd floor</b> | | | |

| <b>Comments:</b> | Carpet to raised floor, plaster to walls, no asbestos detected including ceiling voids | | |

| <b>Action:</b> | None | | |

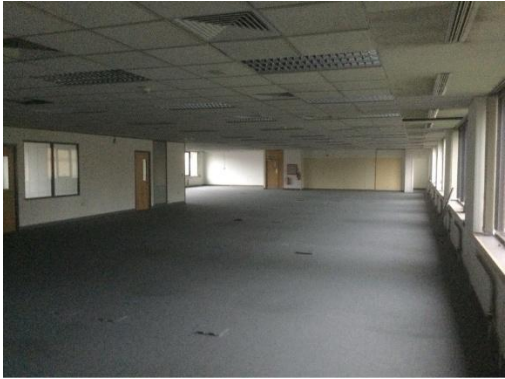
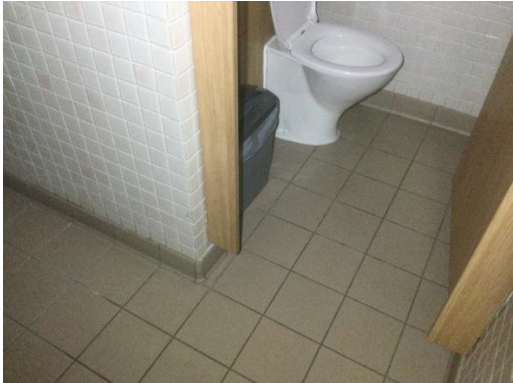
| Sample Reference: SF06/104/1 <sup>st</sup> floor | | | |
|---|---|---|---|
| <b>Comments:</b> | Carpet to raised floor, plaster to walls, ceramic tiles, no asbestos detected including ceiling voids | | |

| Sample Reference: SF06/104/1 <sup>st</sup> floor | | | |
|---|---|---|---|
| <b>Action:</b> | None | | |

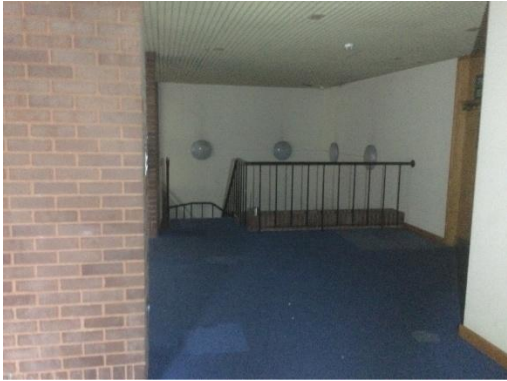
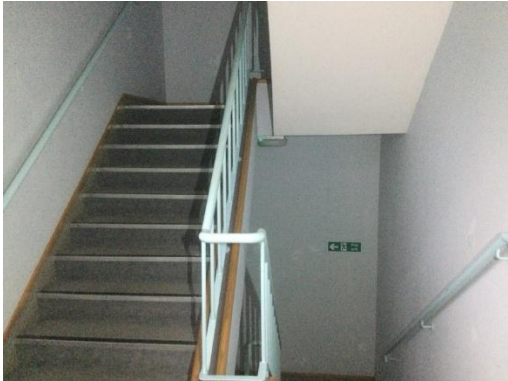
| <b>Comments:</b> | Carpet to concrete, steel and concrete stairs, no asbestos detected including ceiling voids | | |

| <b>Action:</b> | None | | |

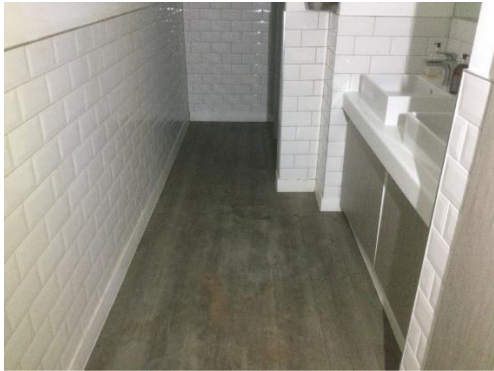
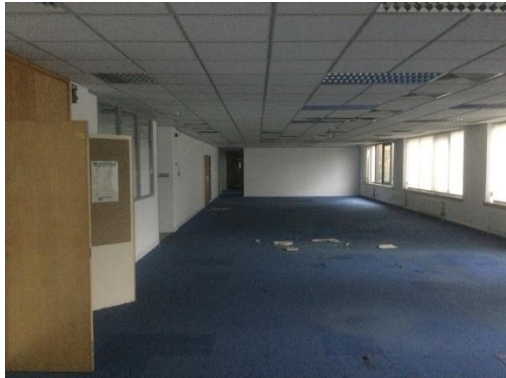
| Sample Reference: SF08/104/1 <sup>st</sup> floor | | | |
|---|---|---|---|
| <b>Comments:</b> | Ceramic tiles to floor and walls, carpet to raised floor, no asbestos detected including ceiling voids. | | |

| Sample Reference: SF08/104/1 <sup>st</sup> floor | | | |
|---|---|---|---|
| <b>Action:</b> | None | | |

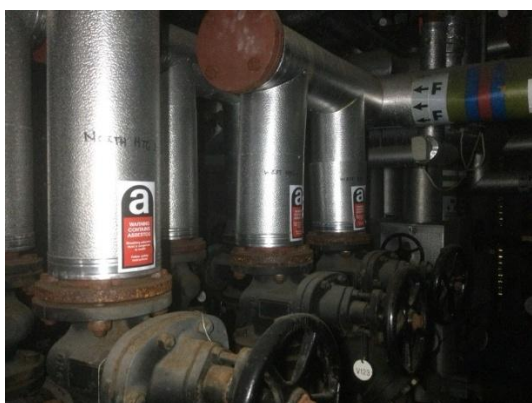
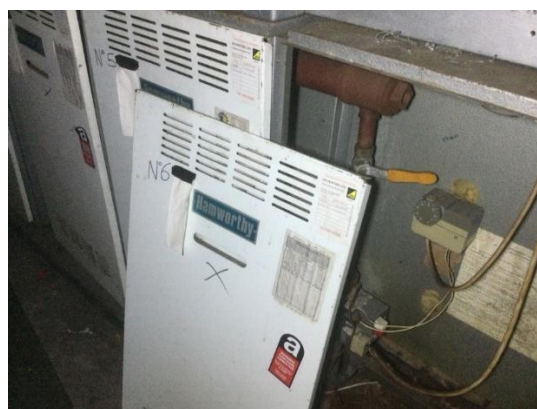
## Sample Reference: SF09/104/2<sup>nd</sup> floor

| AREA | PRODUCT | ASBESTOS TYPE | QUANTITY |
|---|---|---|---|
| SF09 2 <sup>ND</sup> FL | GASKETS | PRESUMED CHRYSOTILE | ALL BOILERS AND PIPE |

| <b>Product type:</b> | Gaskets | <b>Condition:</b> | Low damage (1) |
| <b>Accessibility:</b> | Poor | <b>Asbestos type:</b> | Presumed Chrysotile |
| <b>Comments:</b> | Presumed all gaskets on pipes and boilers | | |

| <b>Action:</b> | Remove as hazardous waste or manage in situ | | |

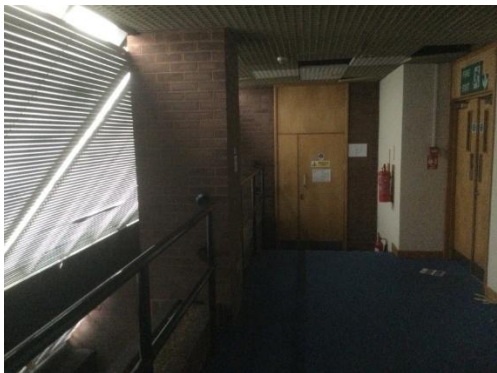
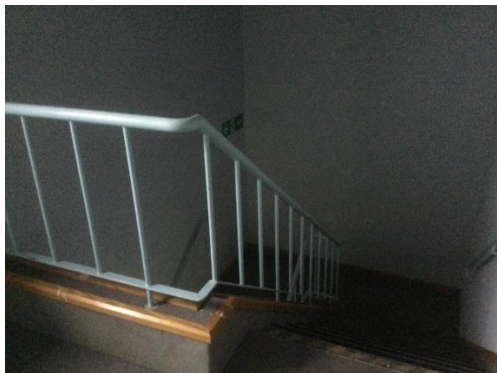
| Sample Reference: SF10/104/2 <sup>nd</sup> floor | | | |

| Sample Reference: SF10/104/2 <sup>nd</sup> floor | | | |
|---|---|---|---|
| Comments: | Carpet, plaster to walls, no asbestos detected including ceiling voids | | |

| Sample Reference: SF10/104/2 <sup>nd</sup> floor | | | |
|---|---|---|---|
| Action: | None | | |

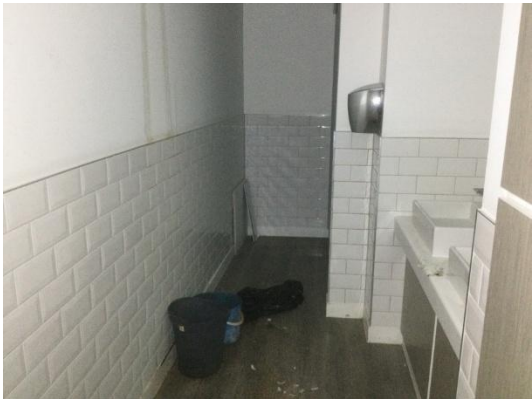
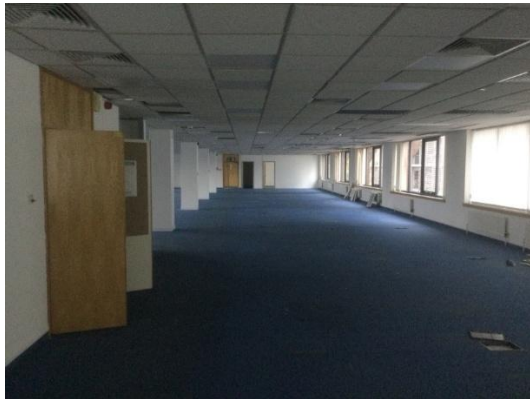
| <b>Comments:</b> | Ceramic tiles, plaster to walls, carpet to raised floor, no asbestos detected including ceiling voids | | |

| <b>Action:</b> | None | | |

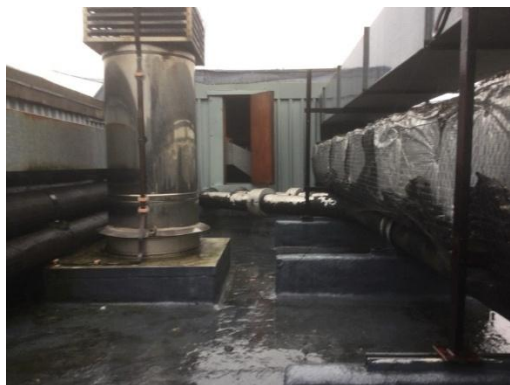
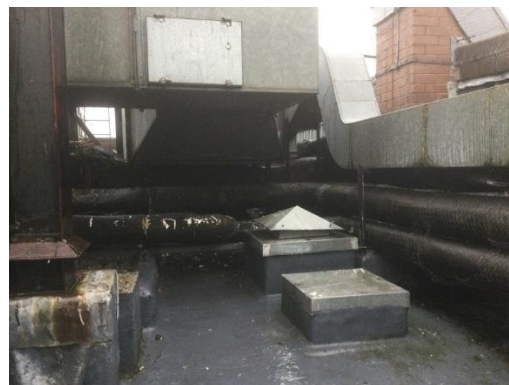
## Sample Reference: SF12/104/Roof

| <b>Comments:</b> | Superlux boarding to top of ladder sampled, fibreglass insulation to all pipe, no asbestos detected | | |

| <b>Action:</b> | None | | |
