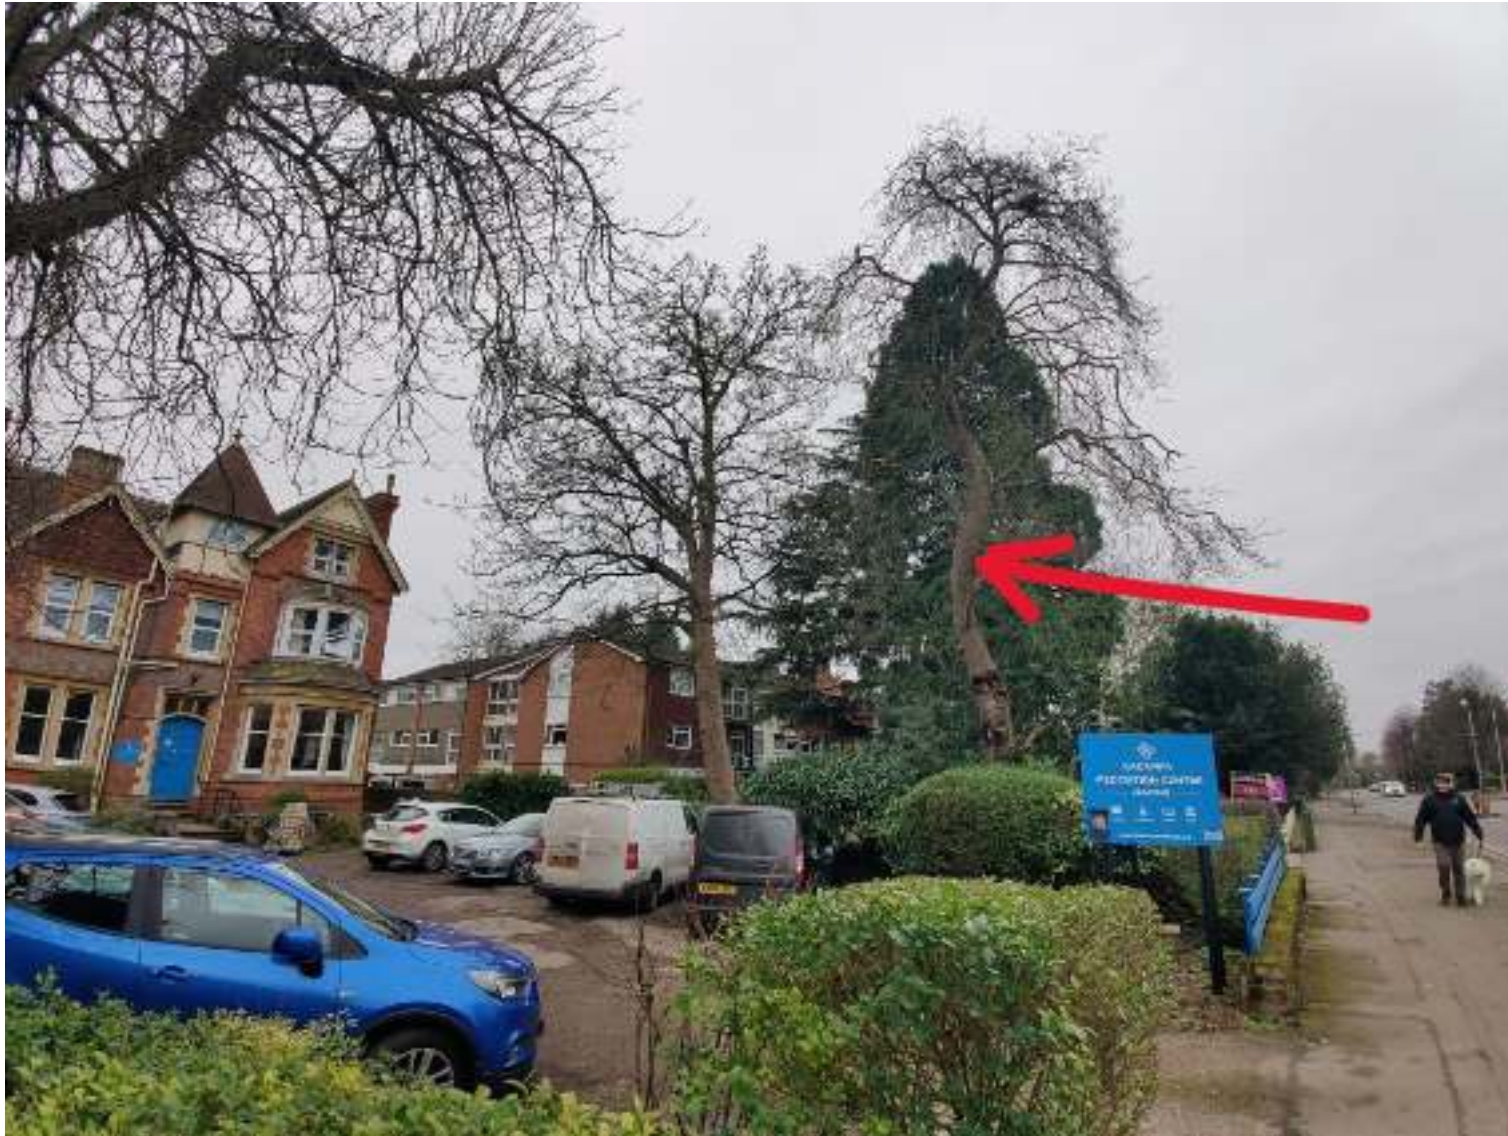
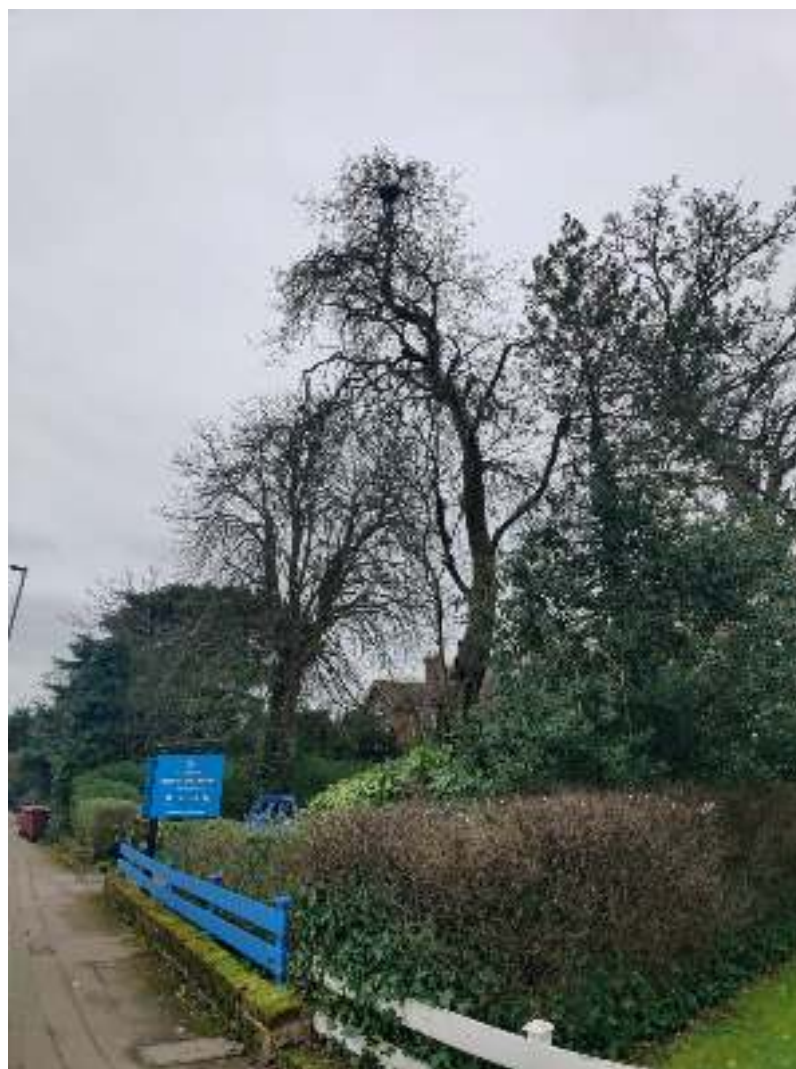
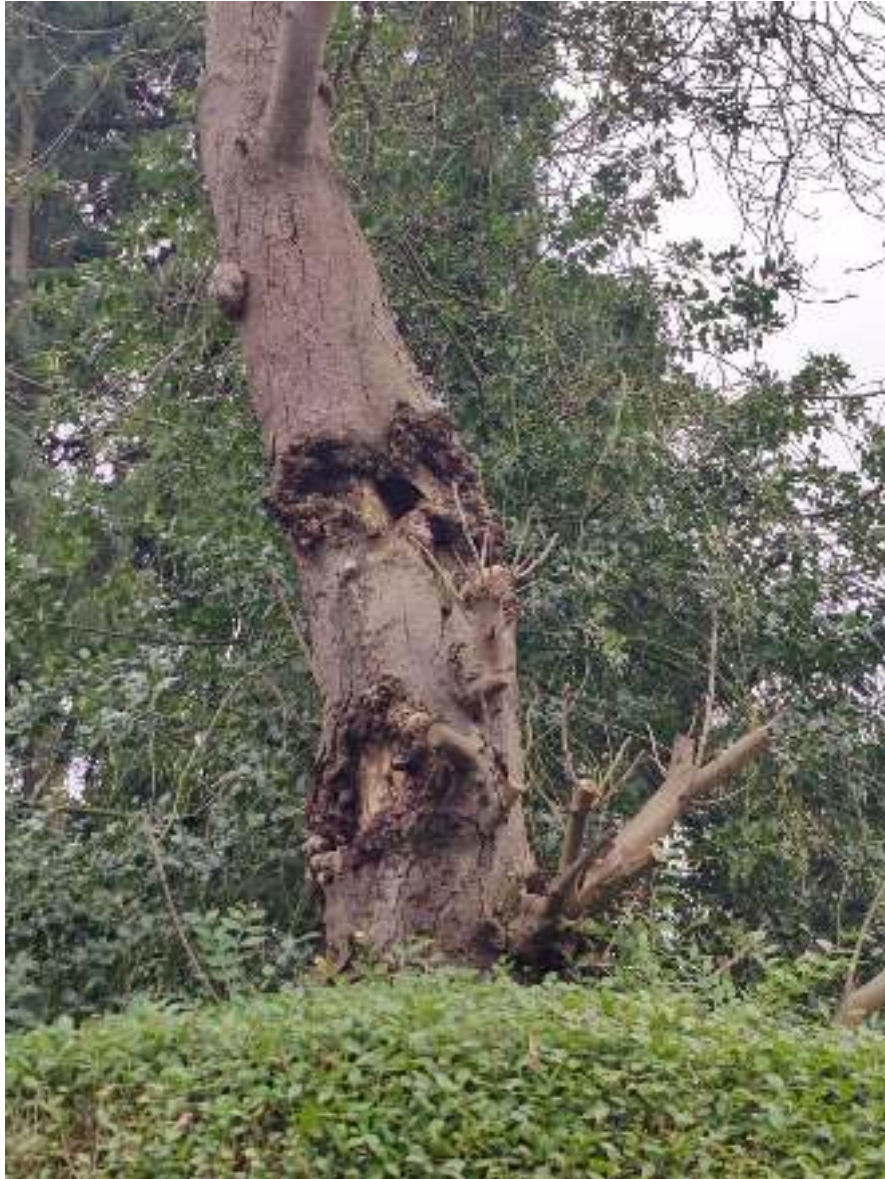
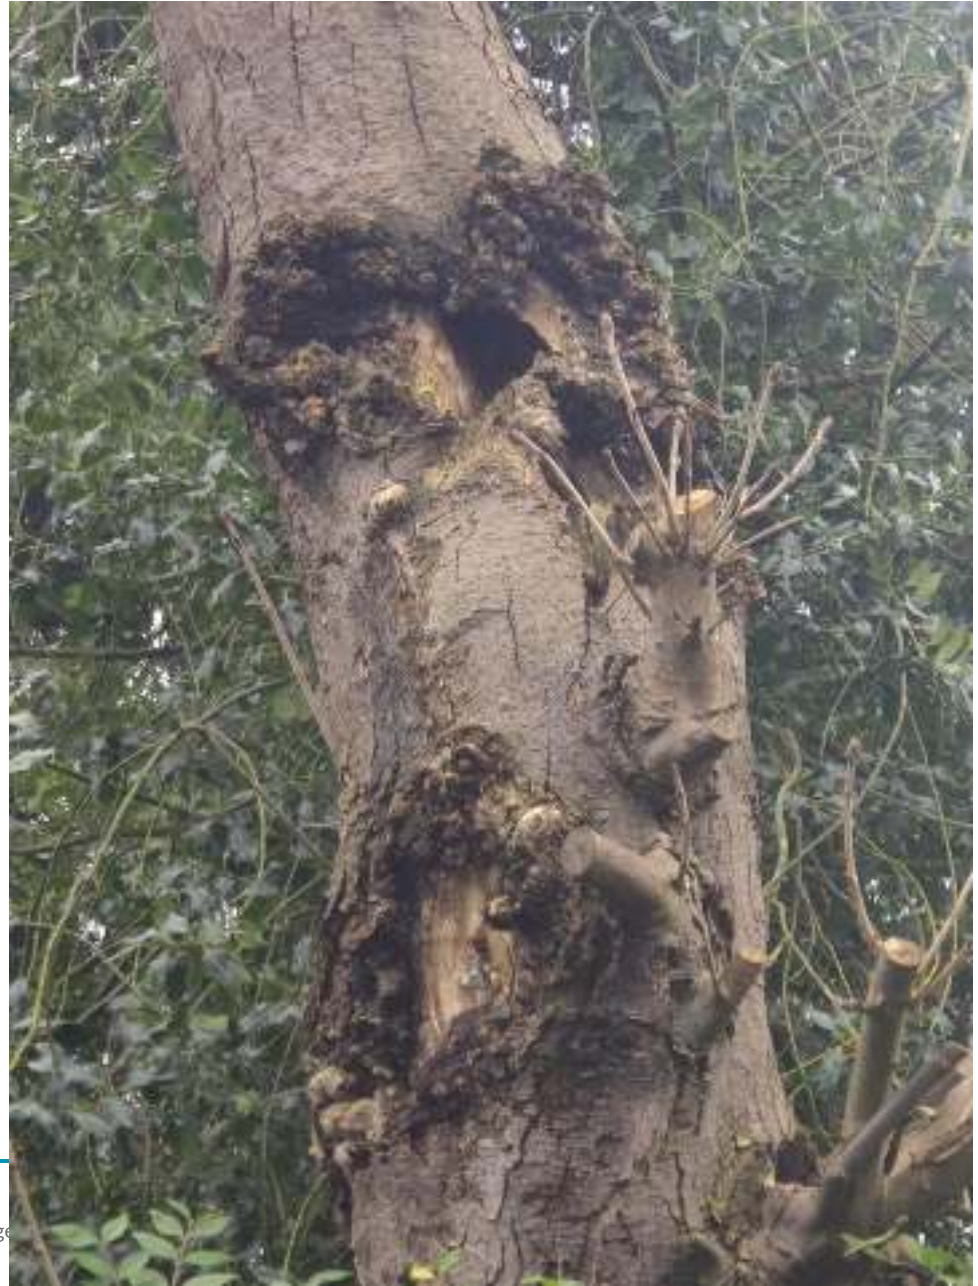
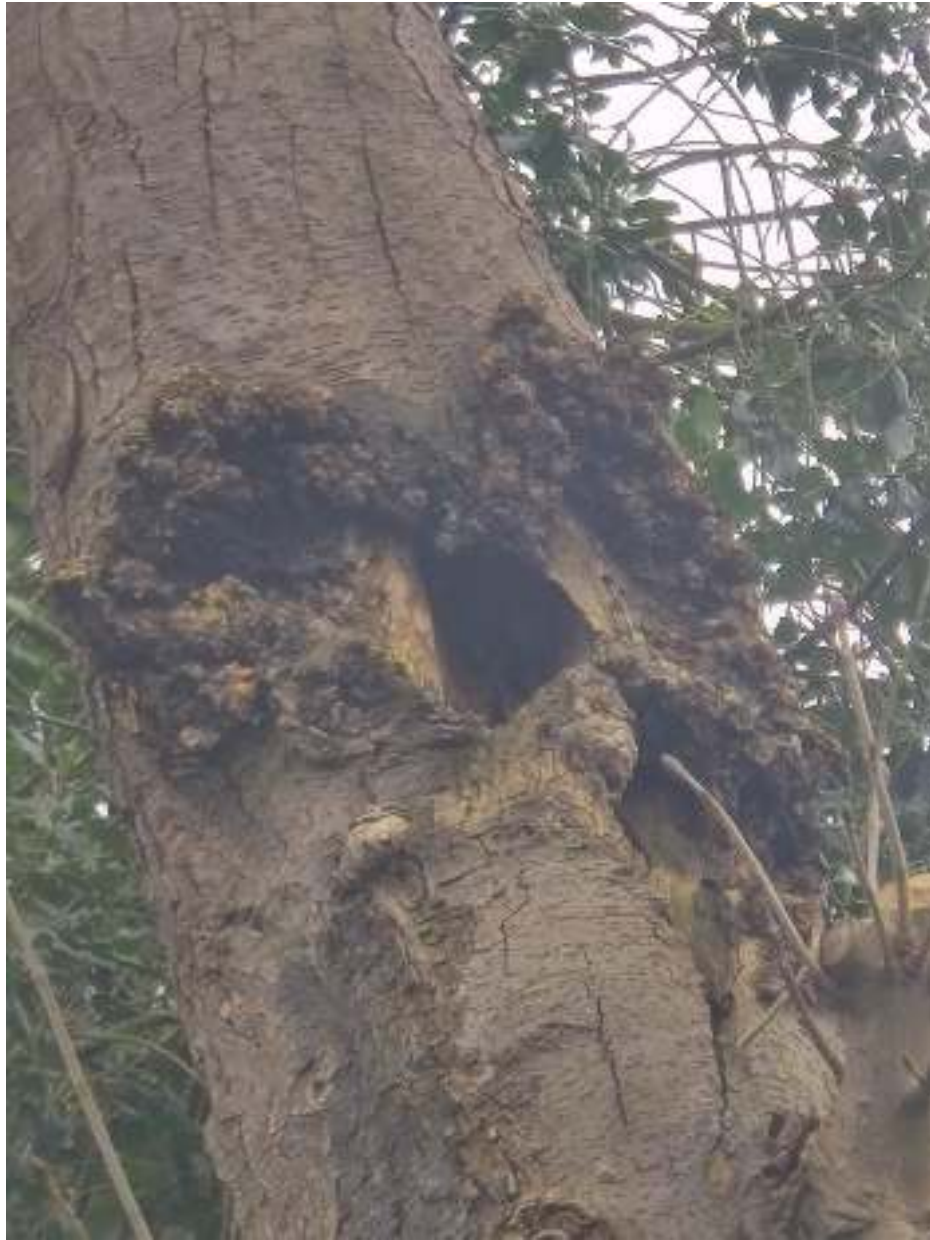
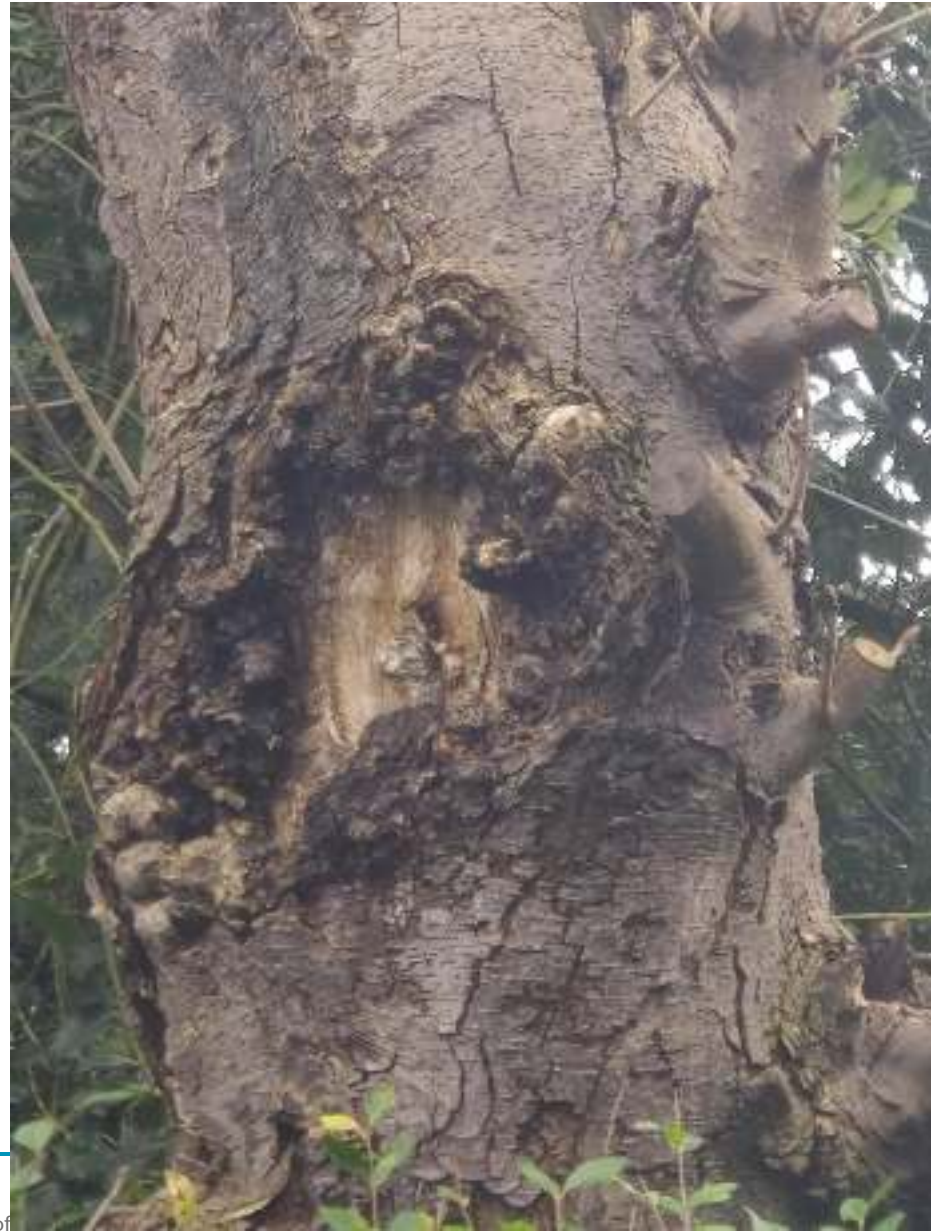
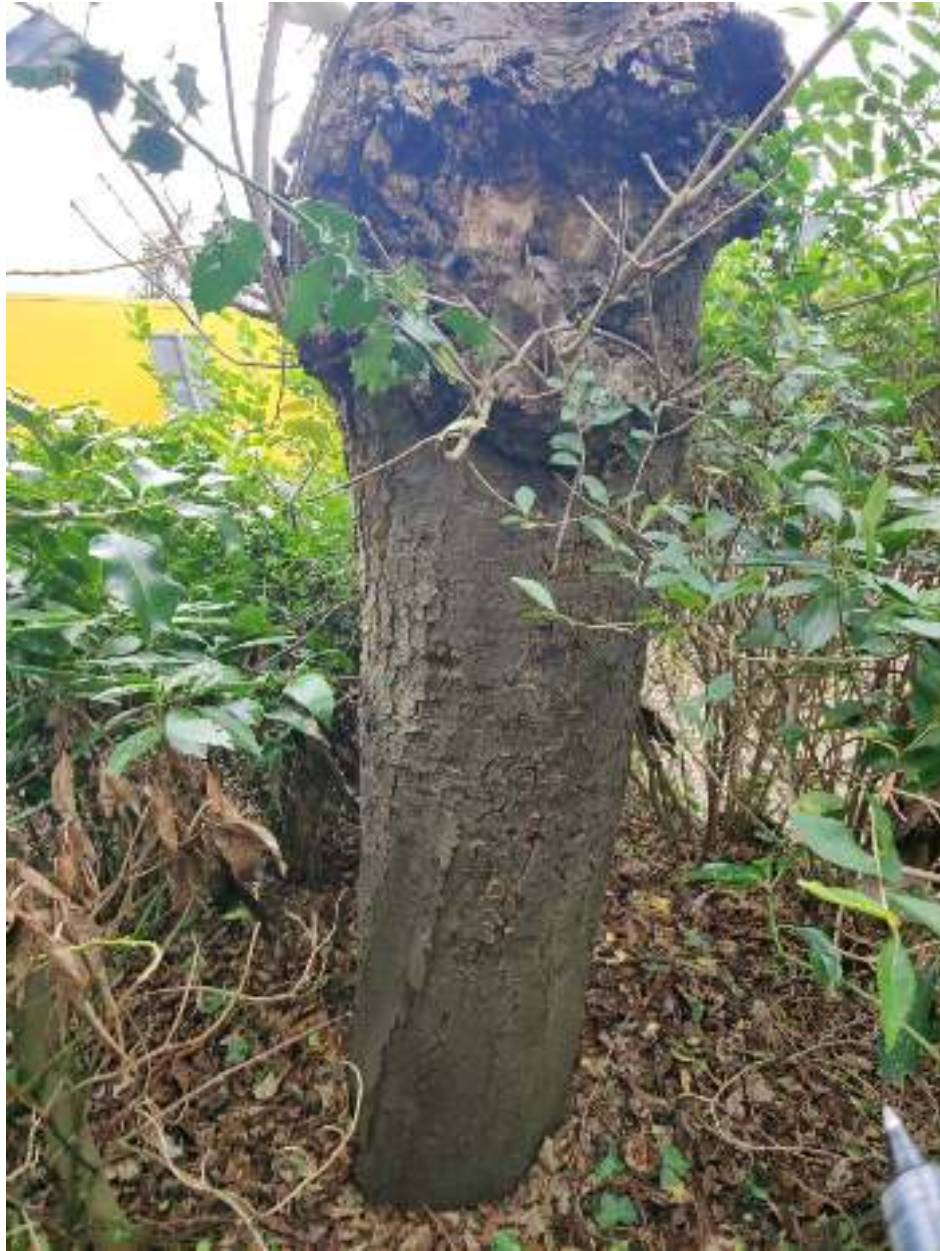
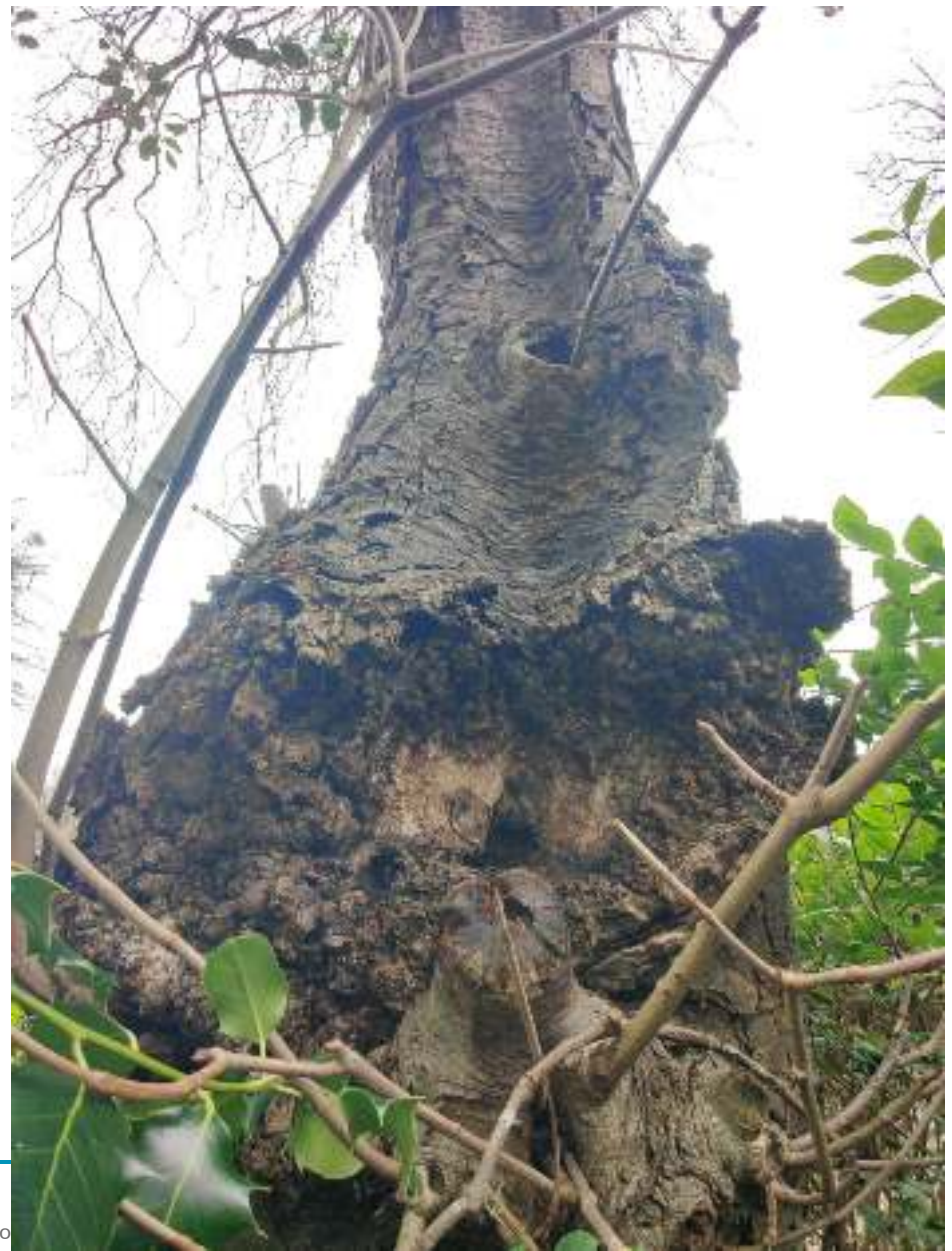
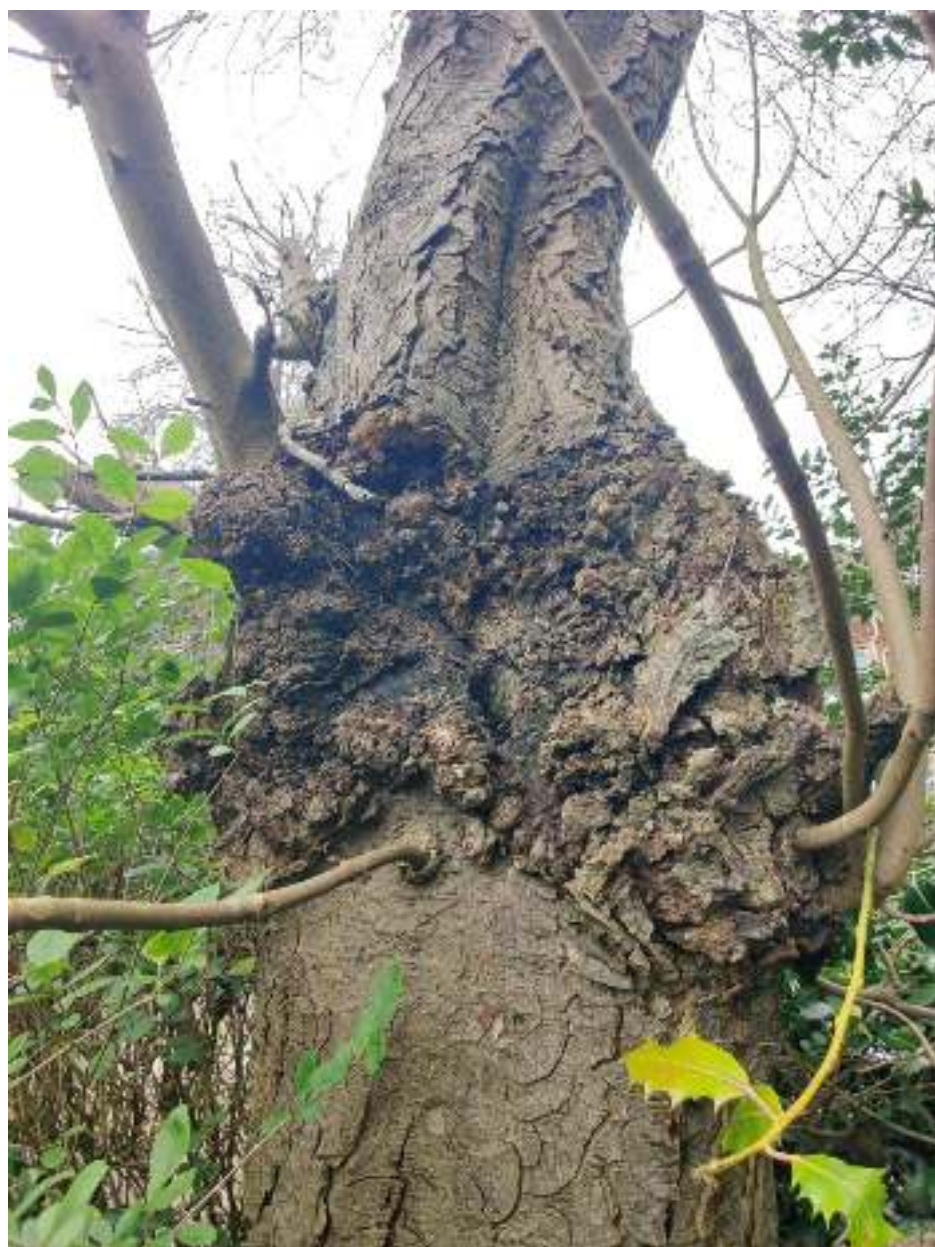
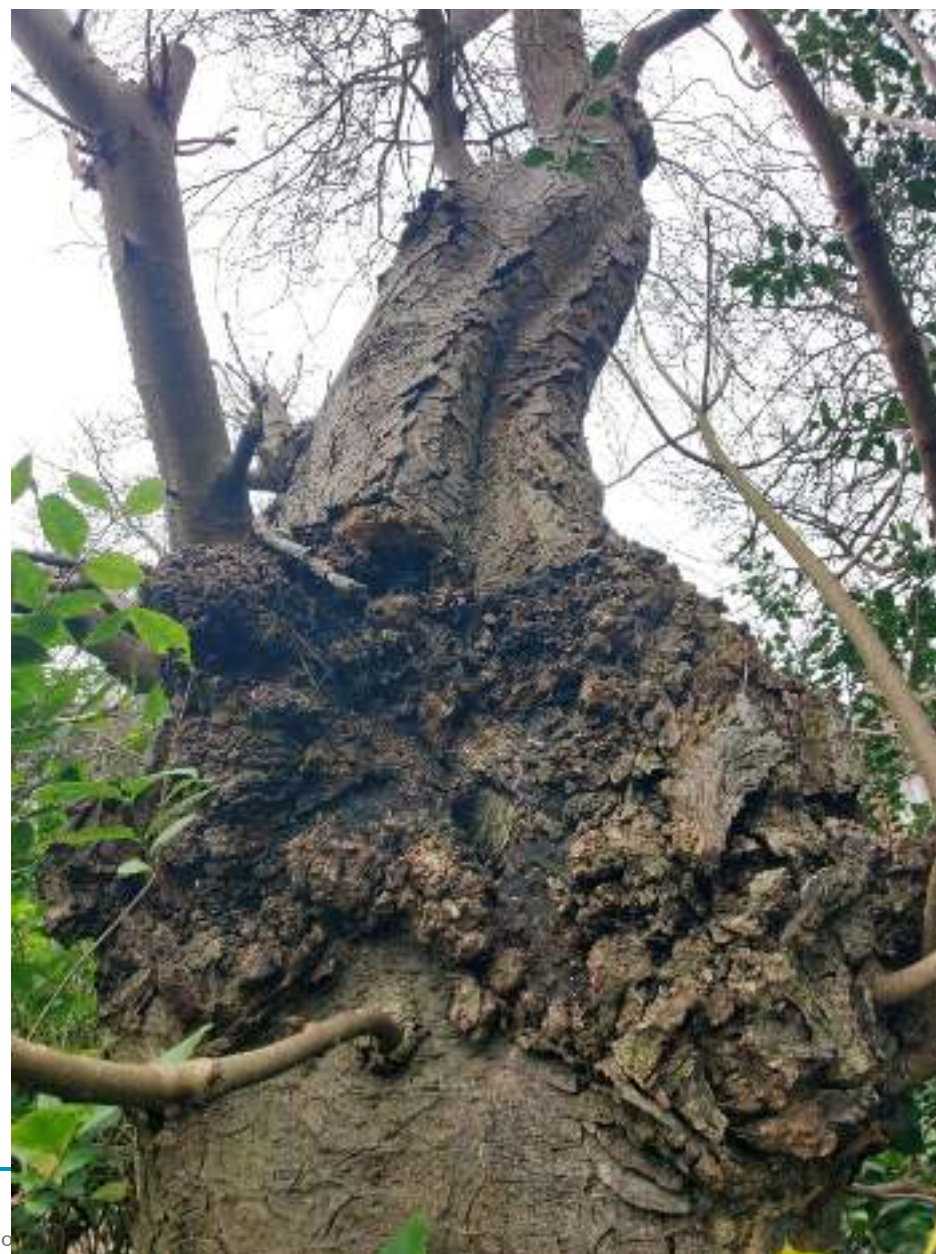
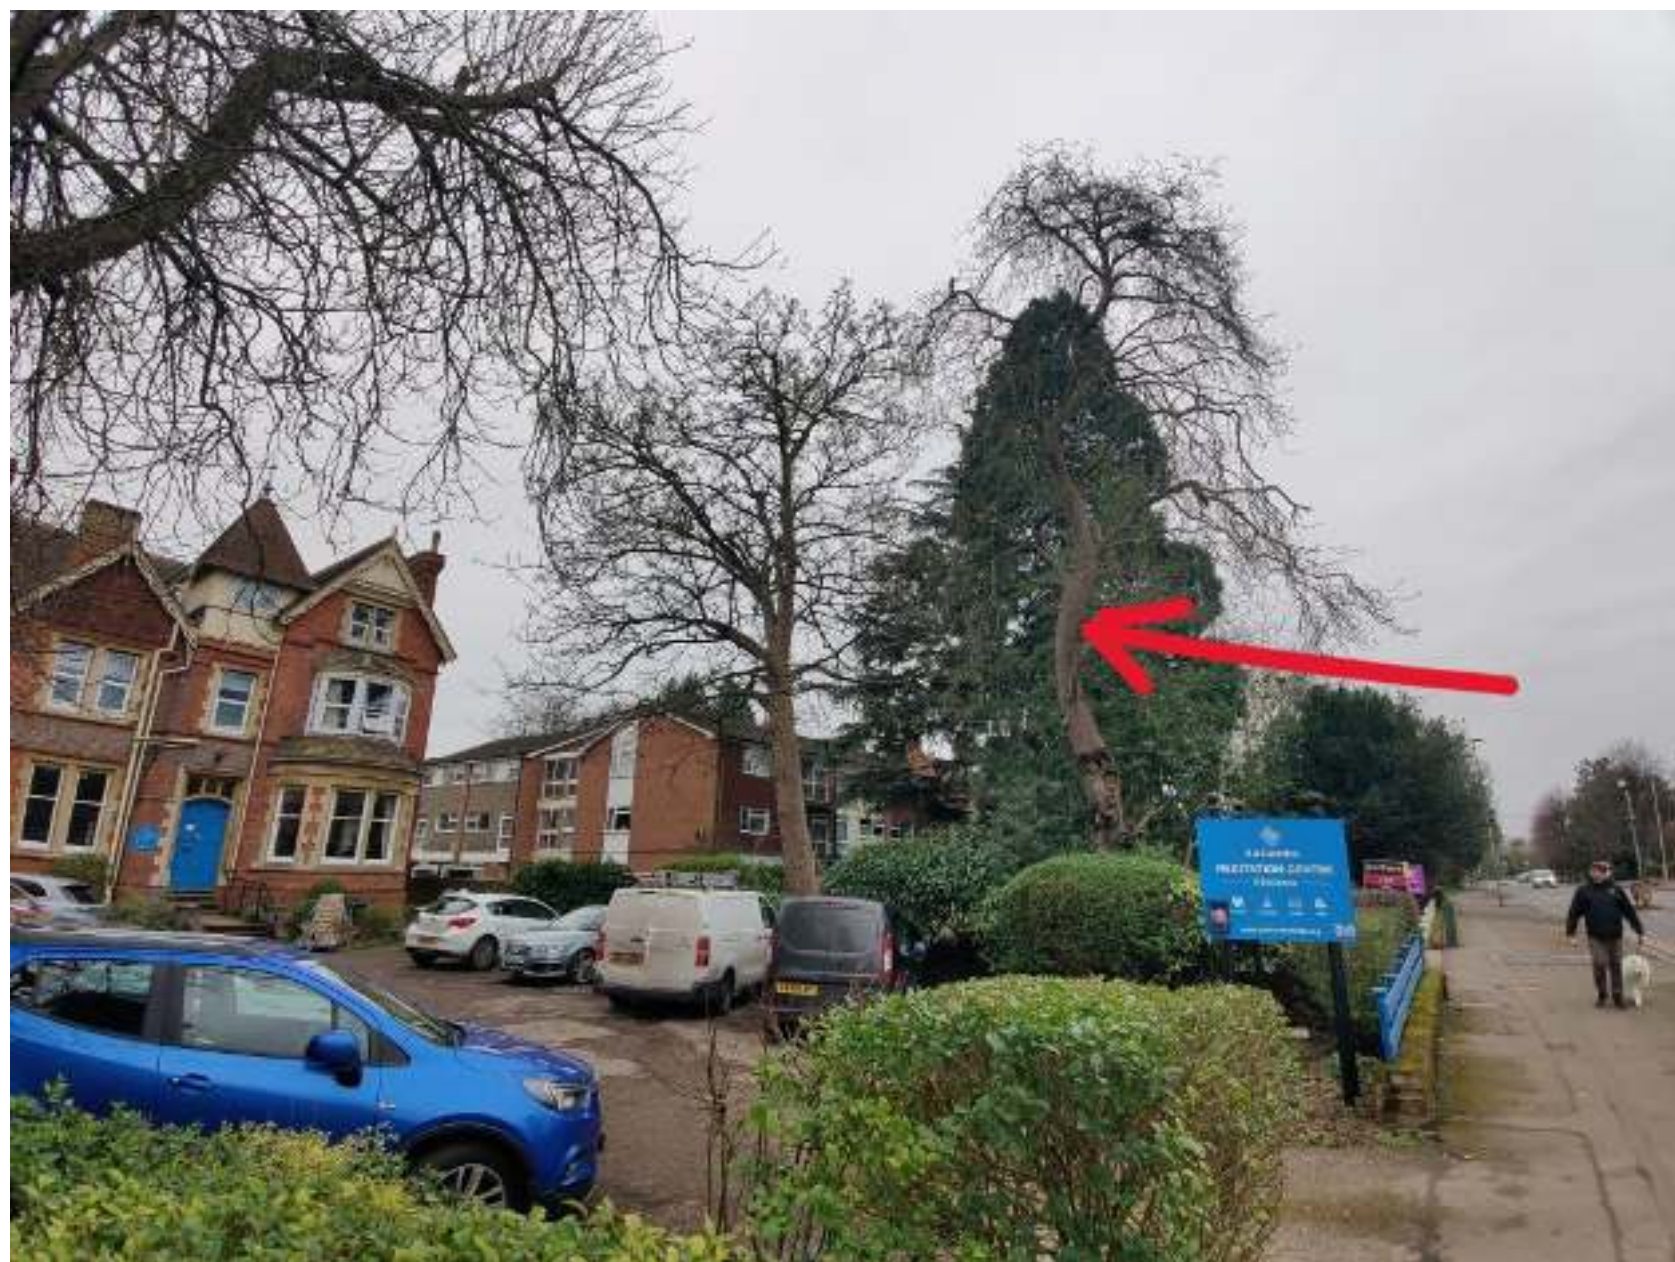
| No. | Species | Height | Trunk Dia. | Life Stage | Physiology | Structure | Comments | Target | Work Recommendation | Work timeframe |
|---|---|---|---|---|---|---|---|---|---|---|
| 1 | Red Horse Chestnut | 14m | 535mm | Mature | Below Average | Hazardous | Growing c.0.5m above the level of the car park; several cankers/wounds on lower trunk; canker/wound S side at approx. height of 2m - assessed with steel probe indicating cavity/decayed wood to a depth of 10cm; further cankers NW at approx. 2m, SE at 3m and E at 3.5m with visible cavity/decayed wood; small historic un-occluded pruning wound, approx. H:10xW:10cm, at 2.5m to S - probed indicating cavity/decay to a depth of 15cm; trunk 'dog-legs' at approx. heights of 7m and 10m; visible crown dieback. | Highway, Car parking, neighbouring access driveway | Fell to ground level and consider replacement tree planting | Within 3 months |
