CLIENT  
**University of Reading**

PROJECT  
**The Fernery at the Acacias**

TITLE  
**Metalwork Repairs 1**

DRAWING NUMBER  
**242925-PUR-01-XX-DR-A-3005**

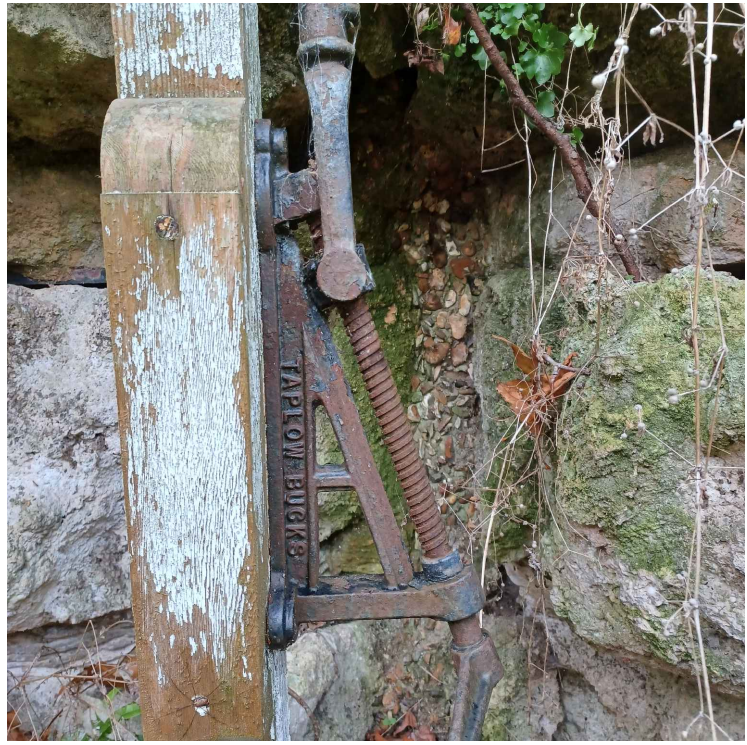
1 Screw Winch

Total 2 no. winches required, both existing ones intact, one with threaded coupling missing.

Repair 2 no. cast iron winches with likely replacement mild steel threaded rolls - Ease and adjust threaded rod. Allow for stabilisation if any cracks are showing on cast iron winch prior to moving any parts. Clean flaking paint with manual tools and treat for rust. Redecorate to match existing.

Source for salvaged Whitworth (BSW) coupling nut matching existing where possible. Allow for new coupling to be made from mild steel if no existing piece can be found, to match existing.

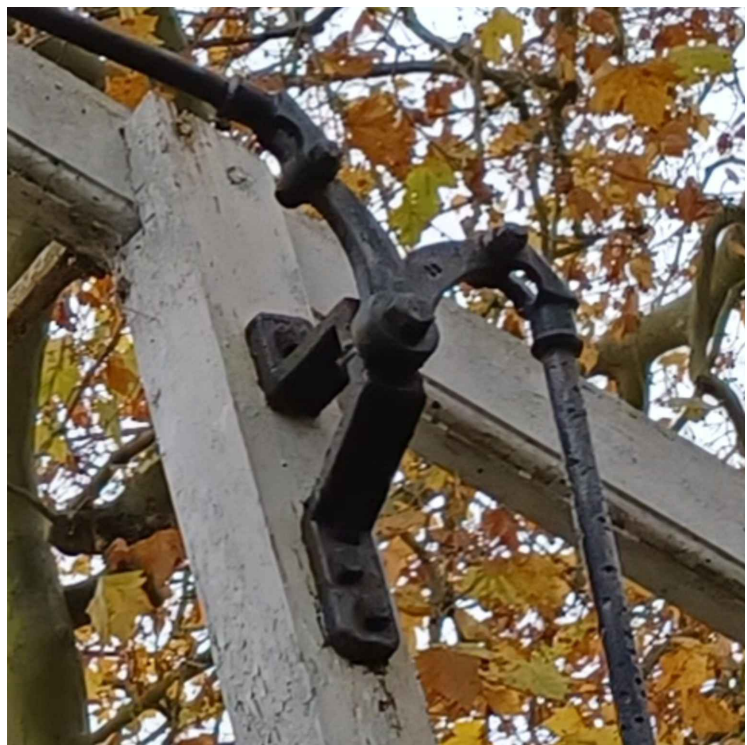
3 Bell crank

Total 2 no. bellcranks required, one intact with lever, one has lever half broken off.

Braze broken lever arm is missing piece can be found. Allow for fabricating and bolting new steel arm is original piece cannot be located once leaves are cleared, with associated clevis joint to rod.

Ease and adjust both bell crank levers. Allow for stabilisation if any cracks are showing on cast iron prior to moving any parts. Clean flaking paint with manual tools and treat for rust. Redecorate to match existing.

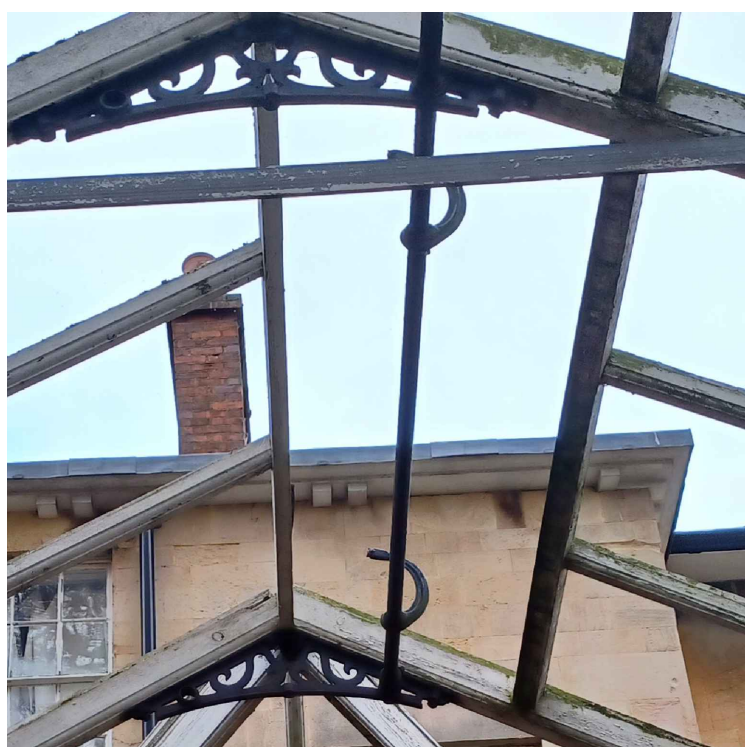
5 Main Vent Shaft

Allow for straightening of existing main vent rods, which are slightly bowed when removed. 2 no. in total, one to north wing and one to west wing.

Clean flaking paint with manual tools and treat for rust. Redecorate to match existing.

Replace any missing length /section with mild steel in matching diameter, thread type on the ends, and lengths between joints. Joined to existing sections with threaded coupling matching existing.

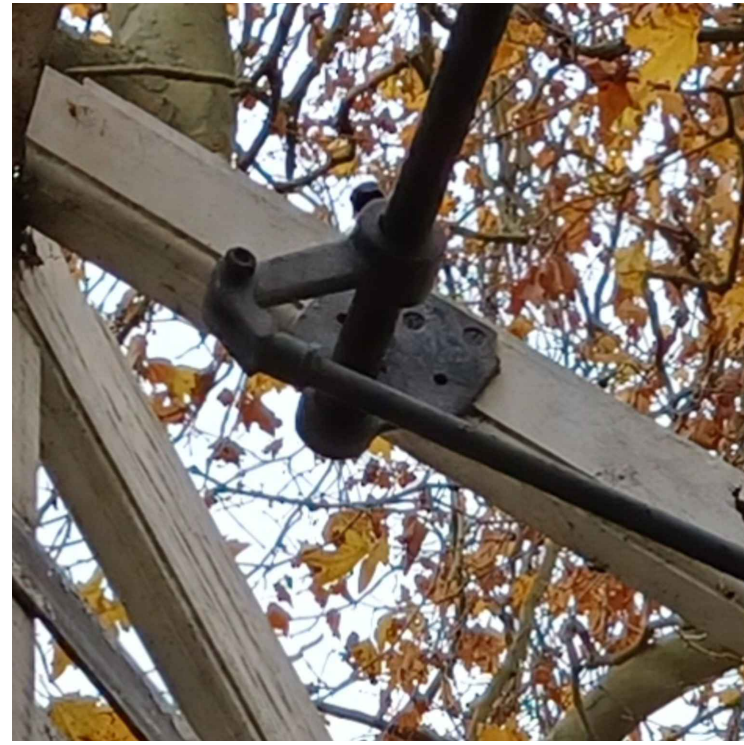
6 Mounting Plate

Total 2 no. mounting plates needed, one to each wing, at hip.

Clean flaking paint with manual tools and treat for rust. Redecorate to match existing.

Allow for replacement of 1 piece in mild steel matching existing (only one intact plate was identified on site visit on the 28th January 2026, the second piece is presumed to be concealed under leaf debris - to be confirmed once ground has been cleared).

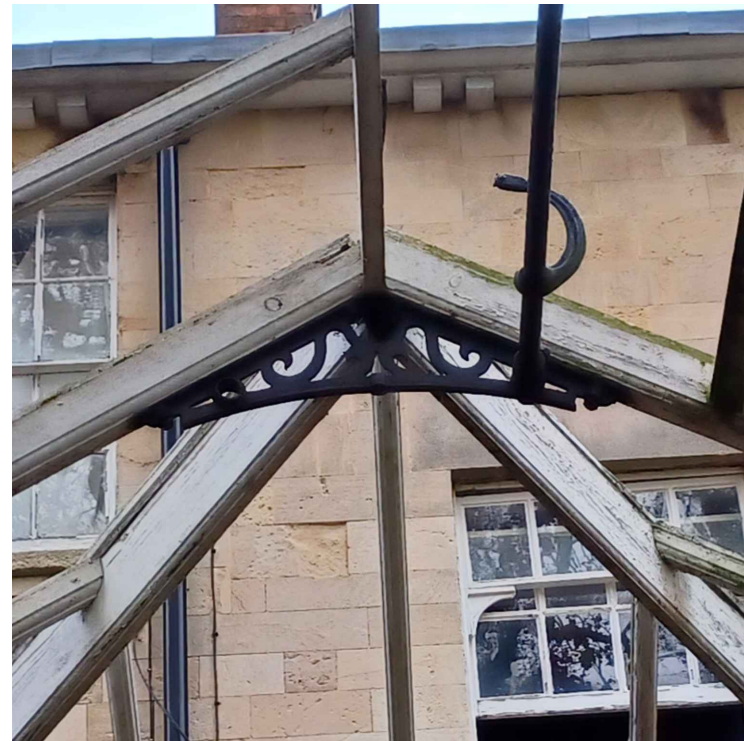
7 Ridge Brackets

Total 6 no. ridge brackets required, 4 no. to north wing and 2 no. to west wing.

2 no. intact, mounted on vent rod. Clean flaking paint with manual tools and treat for rust. Redecorate to match existing.

2 no. broken, with broken off edge still mounted on vent rod. Clean flaking paint with manual tools and treat for rust. Stitch fragments back to bracket, and braze the surface seams for better weathering protection. Redecorate to match existing.

In case any missing fragments cannot be found, allow for templating missing geometry from the intact bracket, and fabric replacement parts in mild steel, and mechanically fix back to brackets.

Should any piece be missing completely. replace in mild steel bracket to match existing, redecorated to match existing.

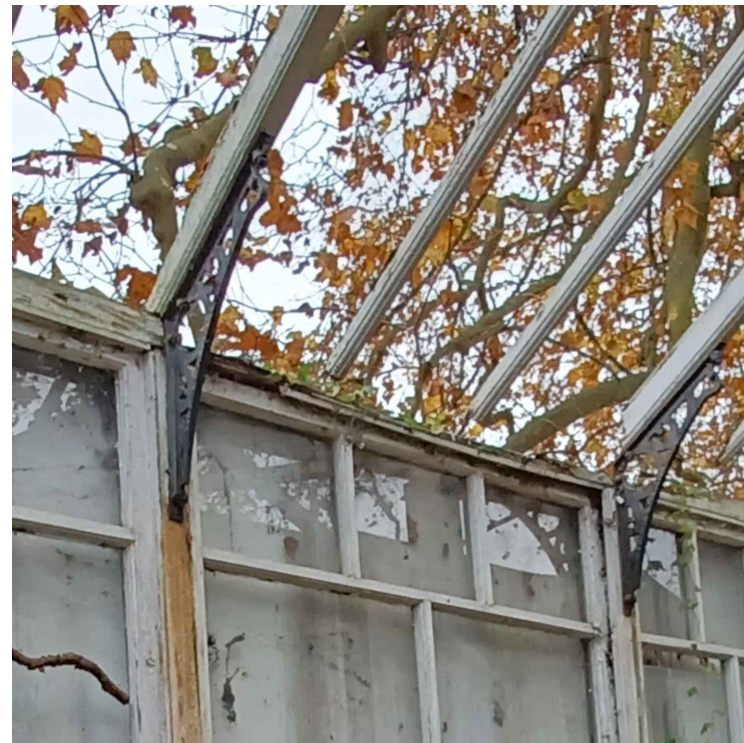
8 Eaves Brackets

Total 5 no. eaves brackets required, to north wing only between timber posts and primary rafters.

4 no. intact, 1 no. likely buried under leaf debris. Clean flaking paint with manual tools and treat for rust. Redecorate to match existing.

In case the missing piece cannot be located. replace in mild steel bracket to match existing, redecorated to match existing.

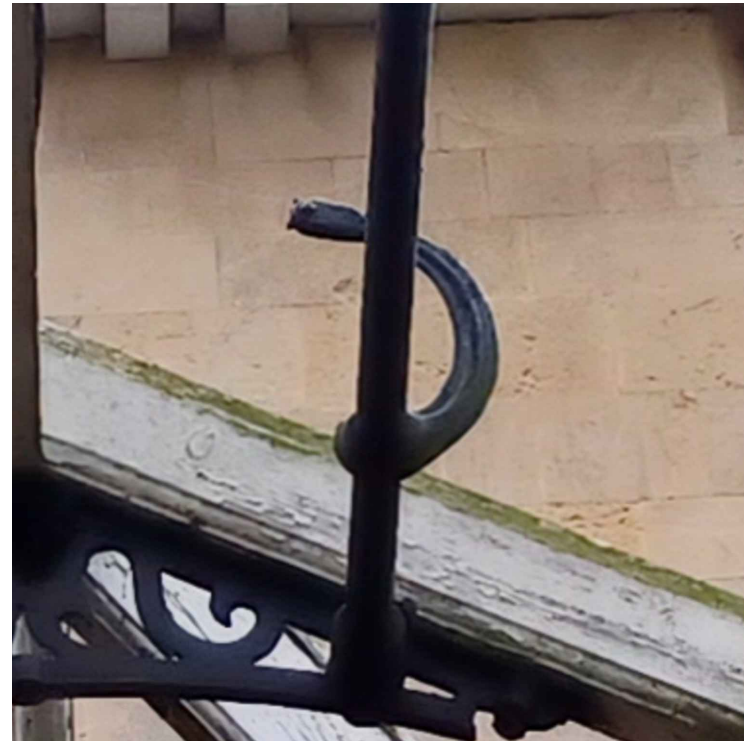
9 Ventilator Arm

Total 8 no. ventilator arms needed, 5 no. to north wing and 3 no. to west wing.

Only curved crank arms remain, short section of straight drop link between the curved arms and ventilator frames appear to be missing. Allow for replacing these straight rods and associated joints in mild steel, to specialist metal contractor design of shape and dimension that allow the ventilators to open correctly and sympathetic to the overall appearance of the historic system.

For existing curved arms, clean flaking paint with manual tools and treat for rust. Redecorate to match existing.
