# **Appendix 15**

## **Yeomanry House**

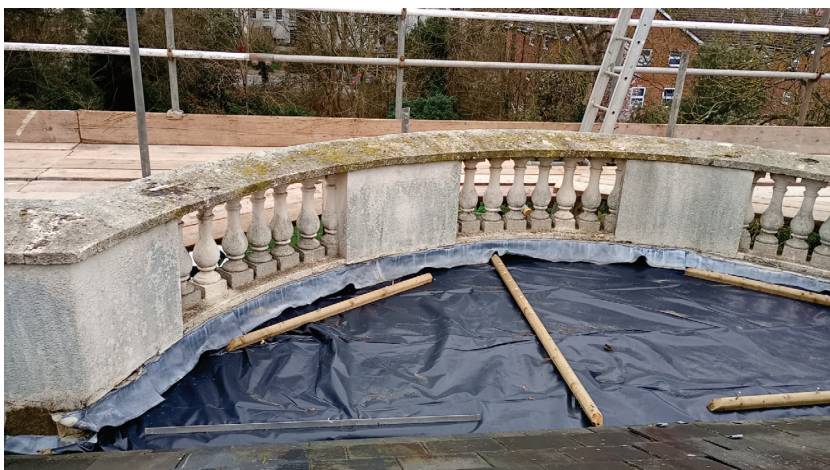
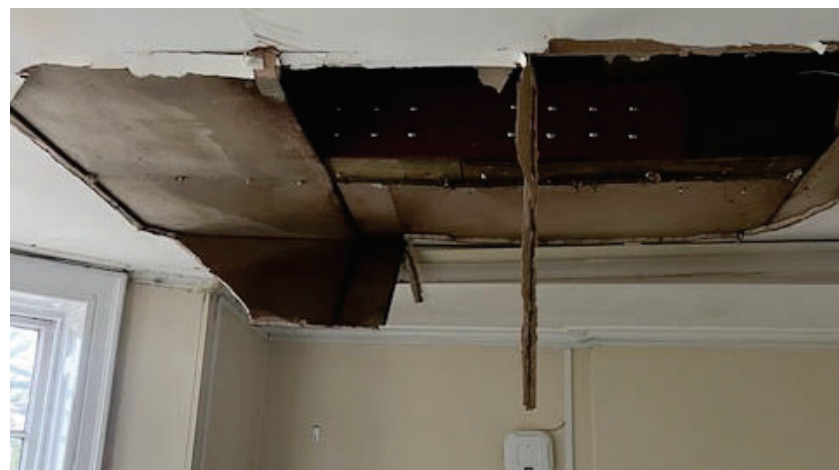
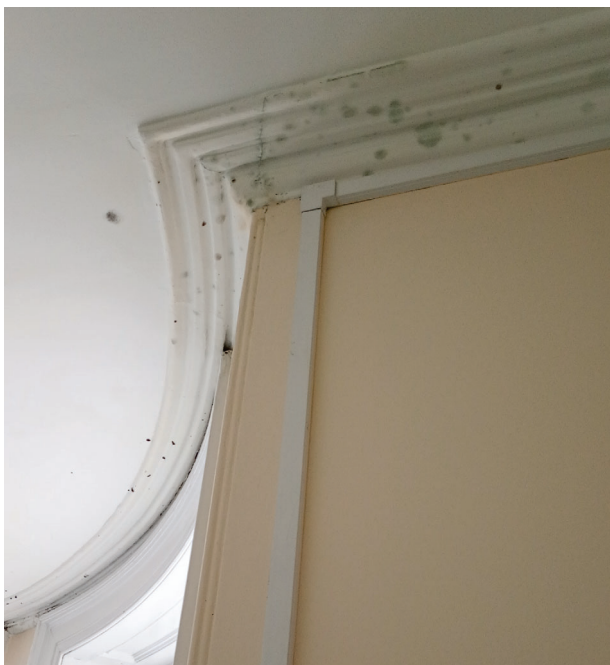
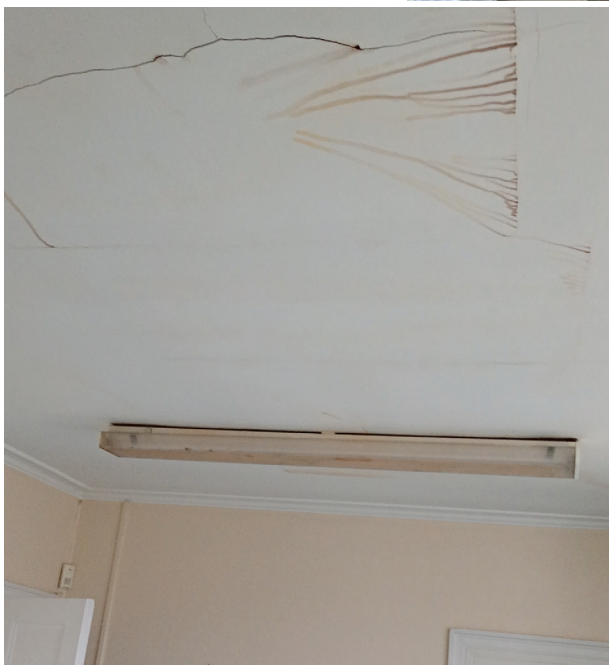
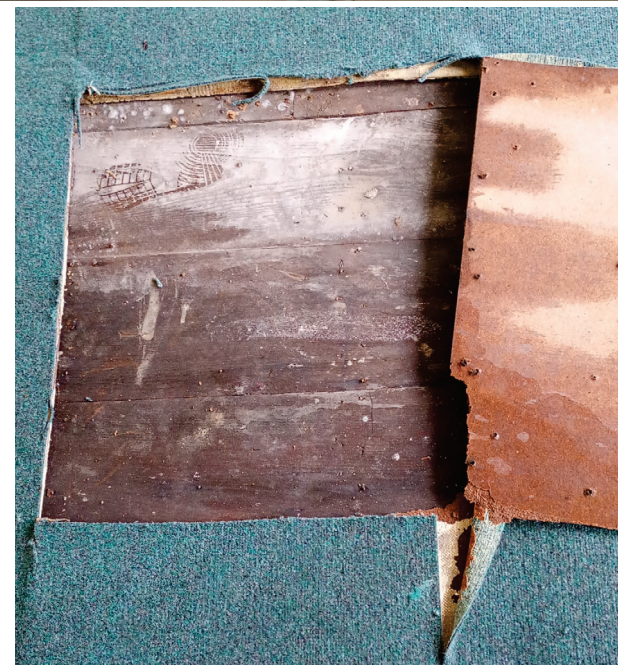
Plate 1: The photos above show the area of lead theft on the roof and those below the damage to second floor ceiling and floor. Where lath and plaster has been replaced, and joists repaired, these have been exposed due to the damage.

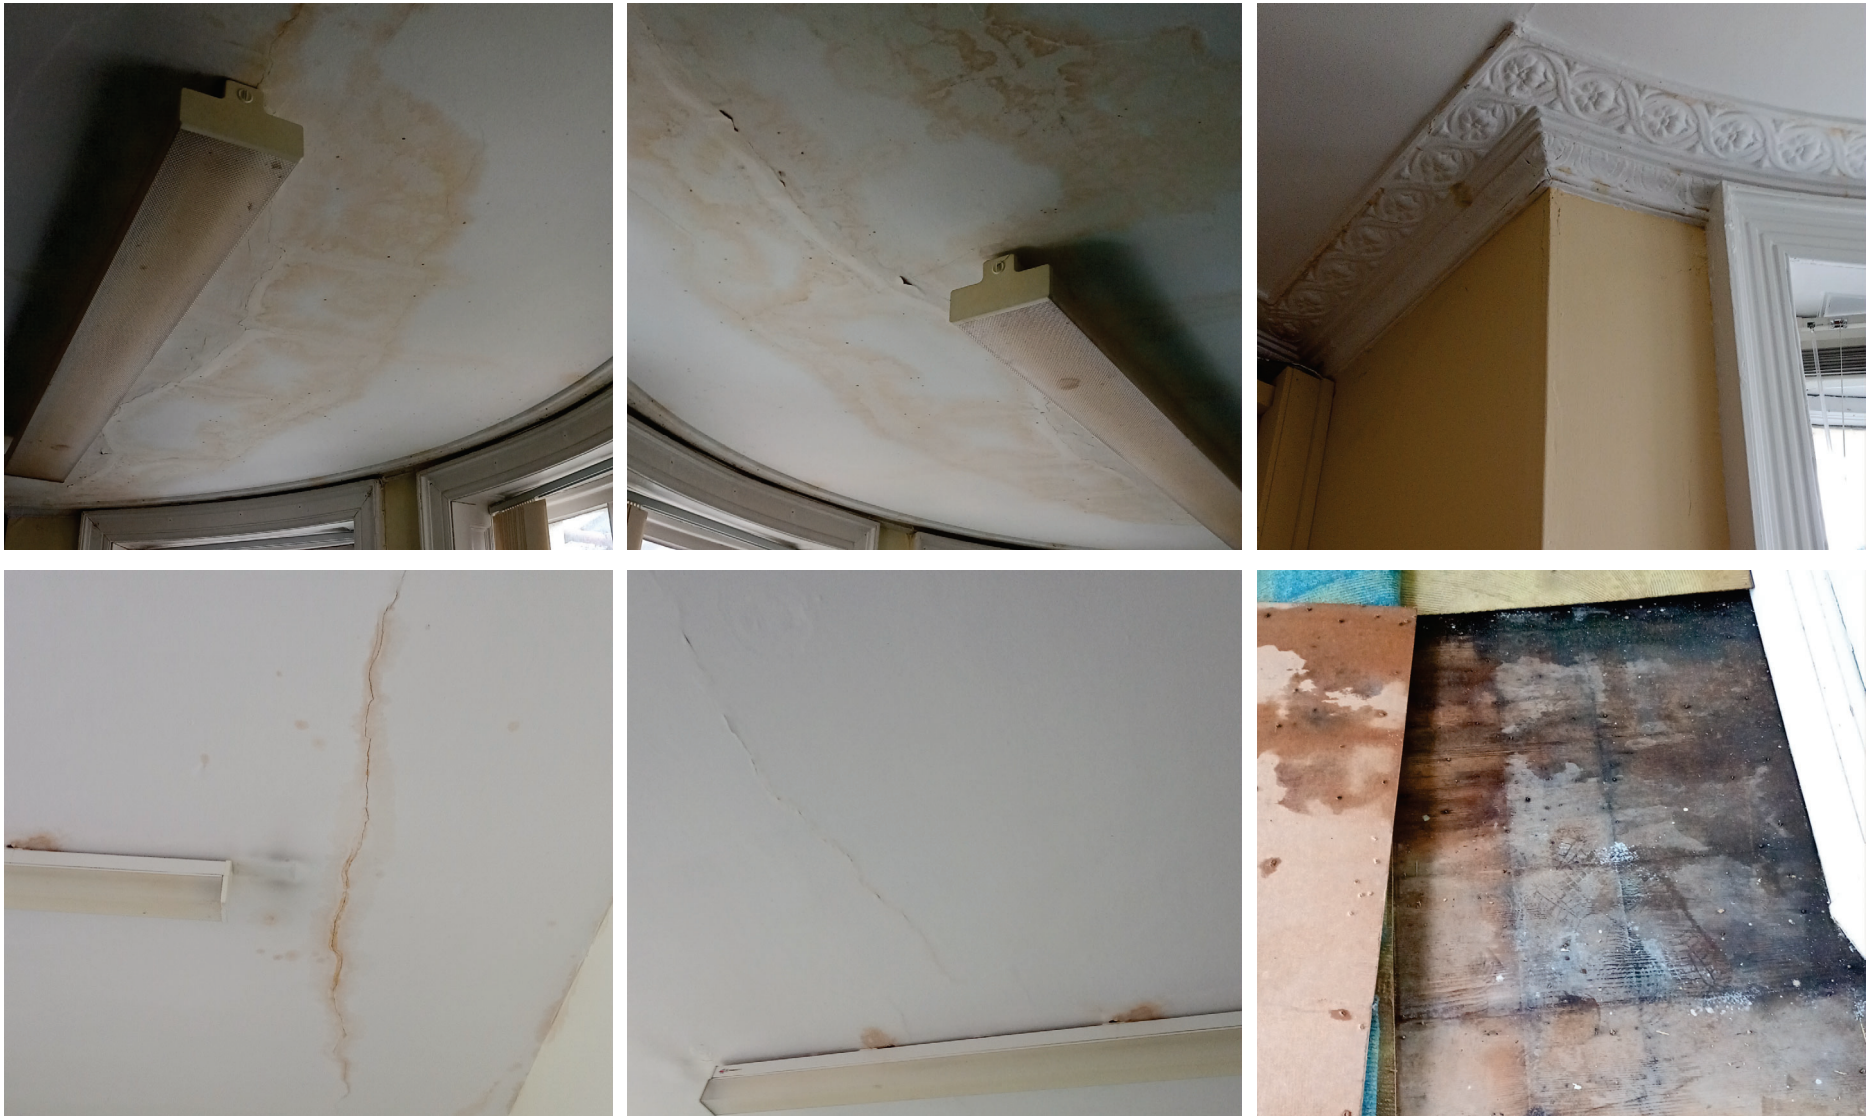
Plate 2: The internal damage is noticeable comparative to the previous images, on the first floor and ground floor due to lead theft on the roof.
