Archway Heritage

# Appendix 11

## Yeomanry House

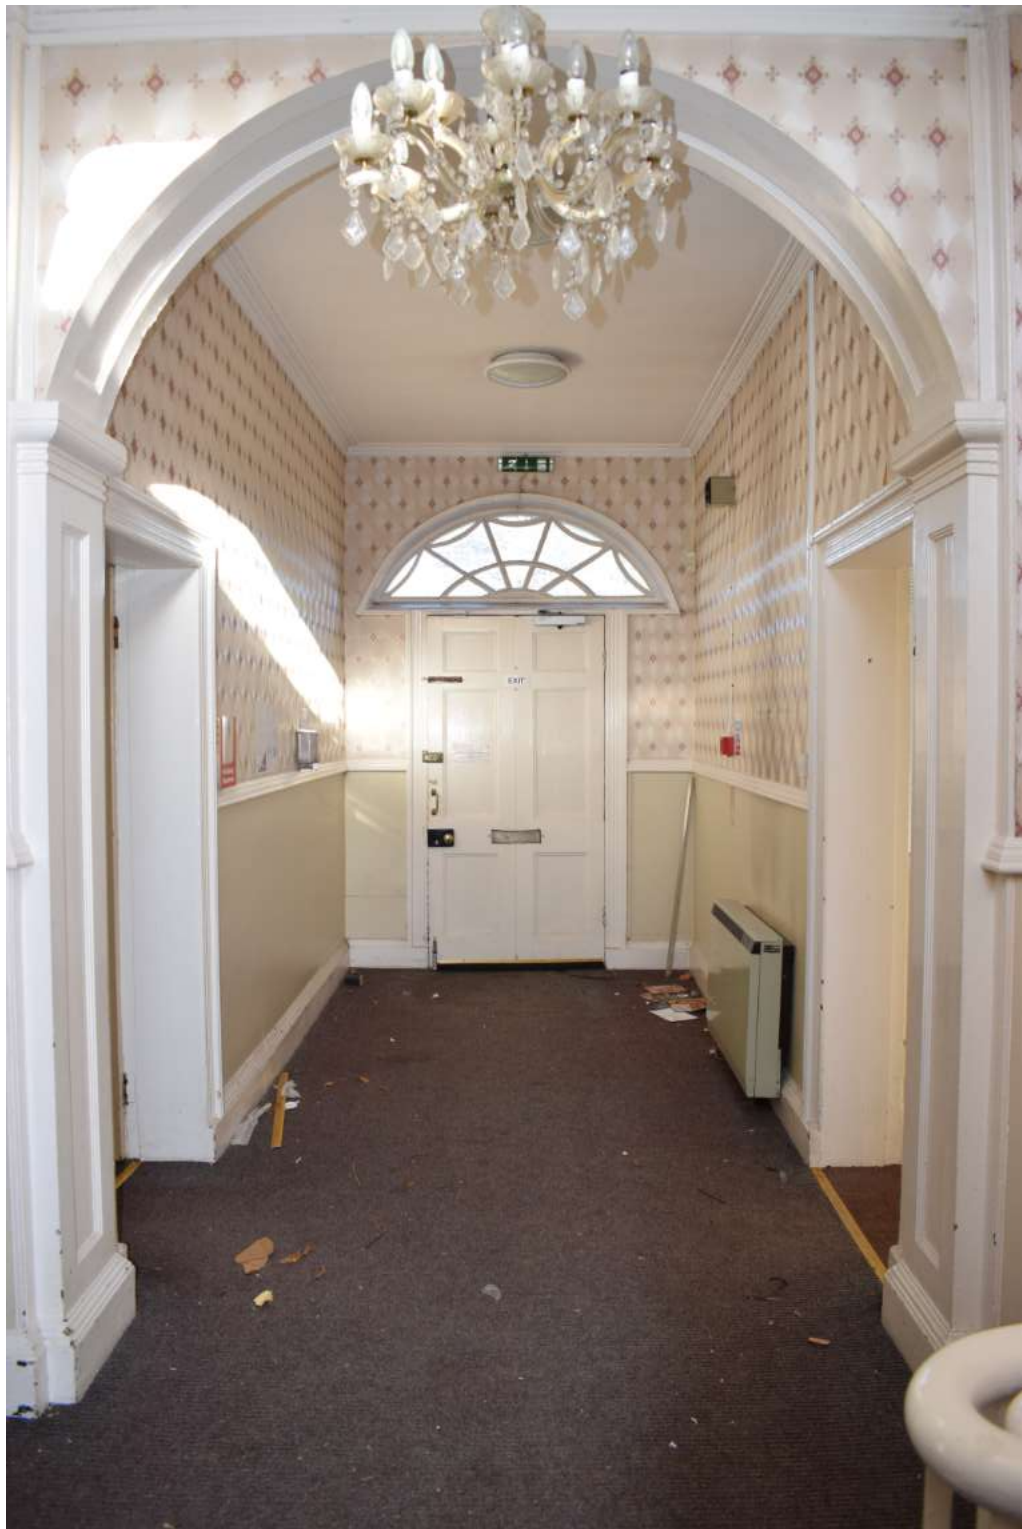
Plate 1  
General photographs of the entrance hallway illustrating the presence of non-decorative coving, relatively decorative, low-profile skirting, and a historically retained dado rail.

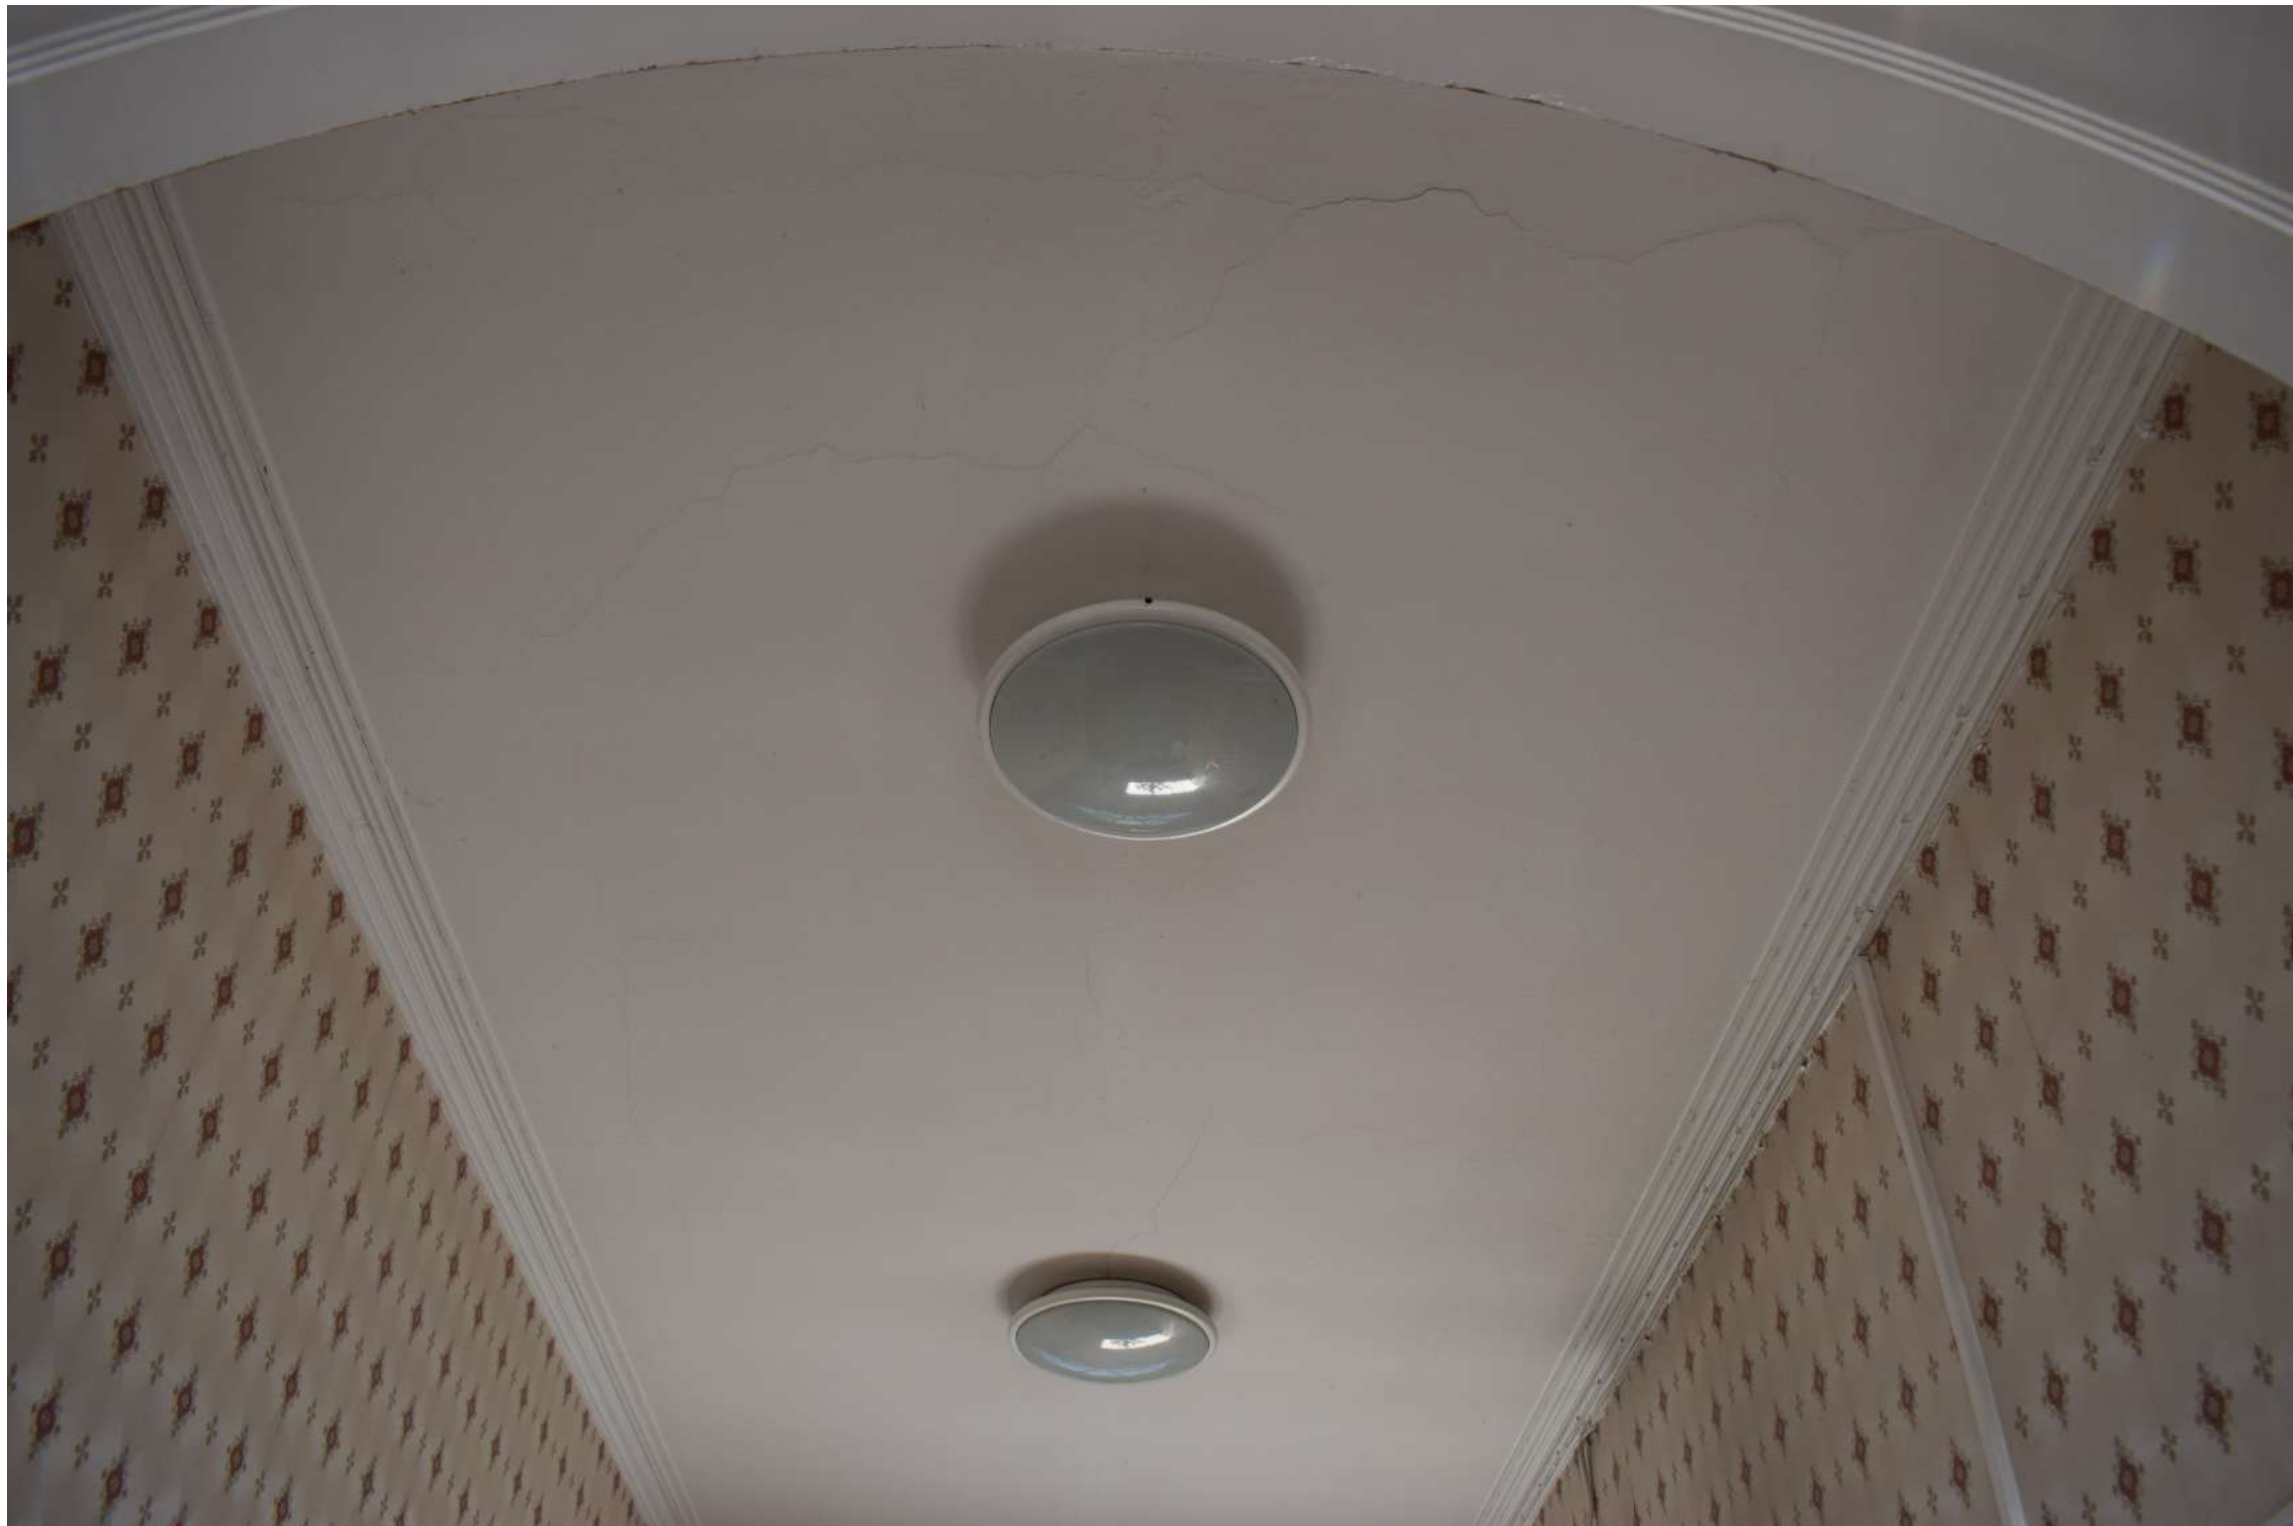
Plate 5

A condition issue: Detailed image showing evidence of hairline cracking across the ceiling and within the alcove return adjacent to the stair transition.

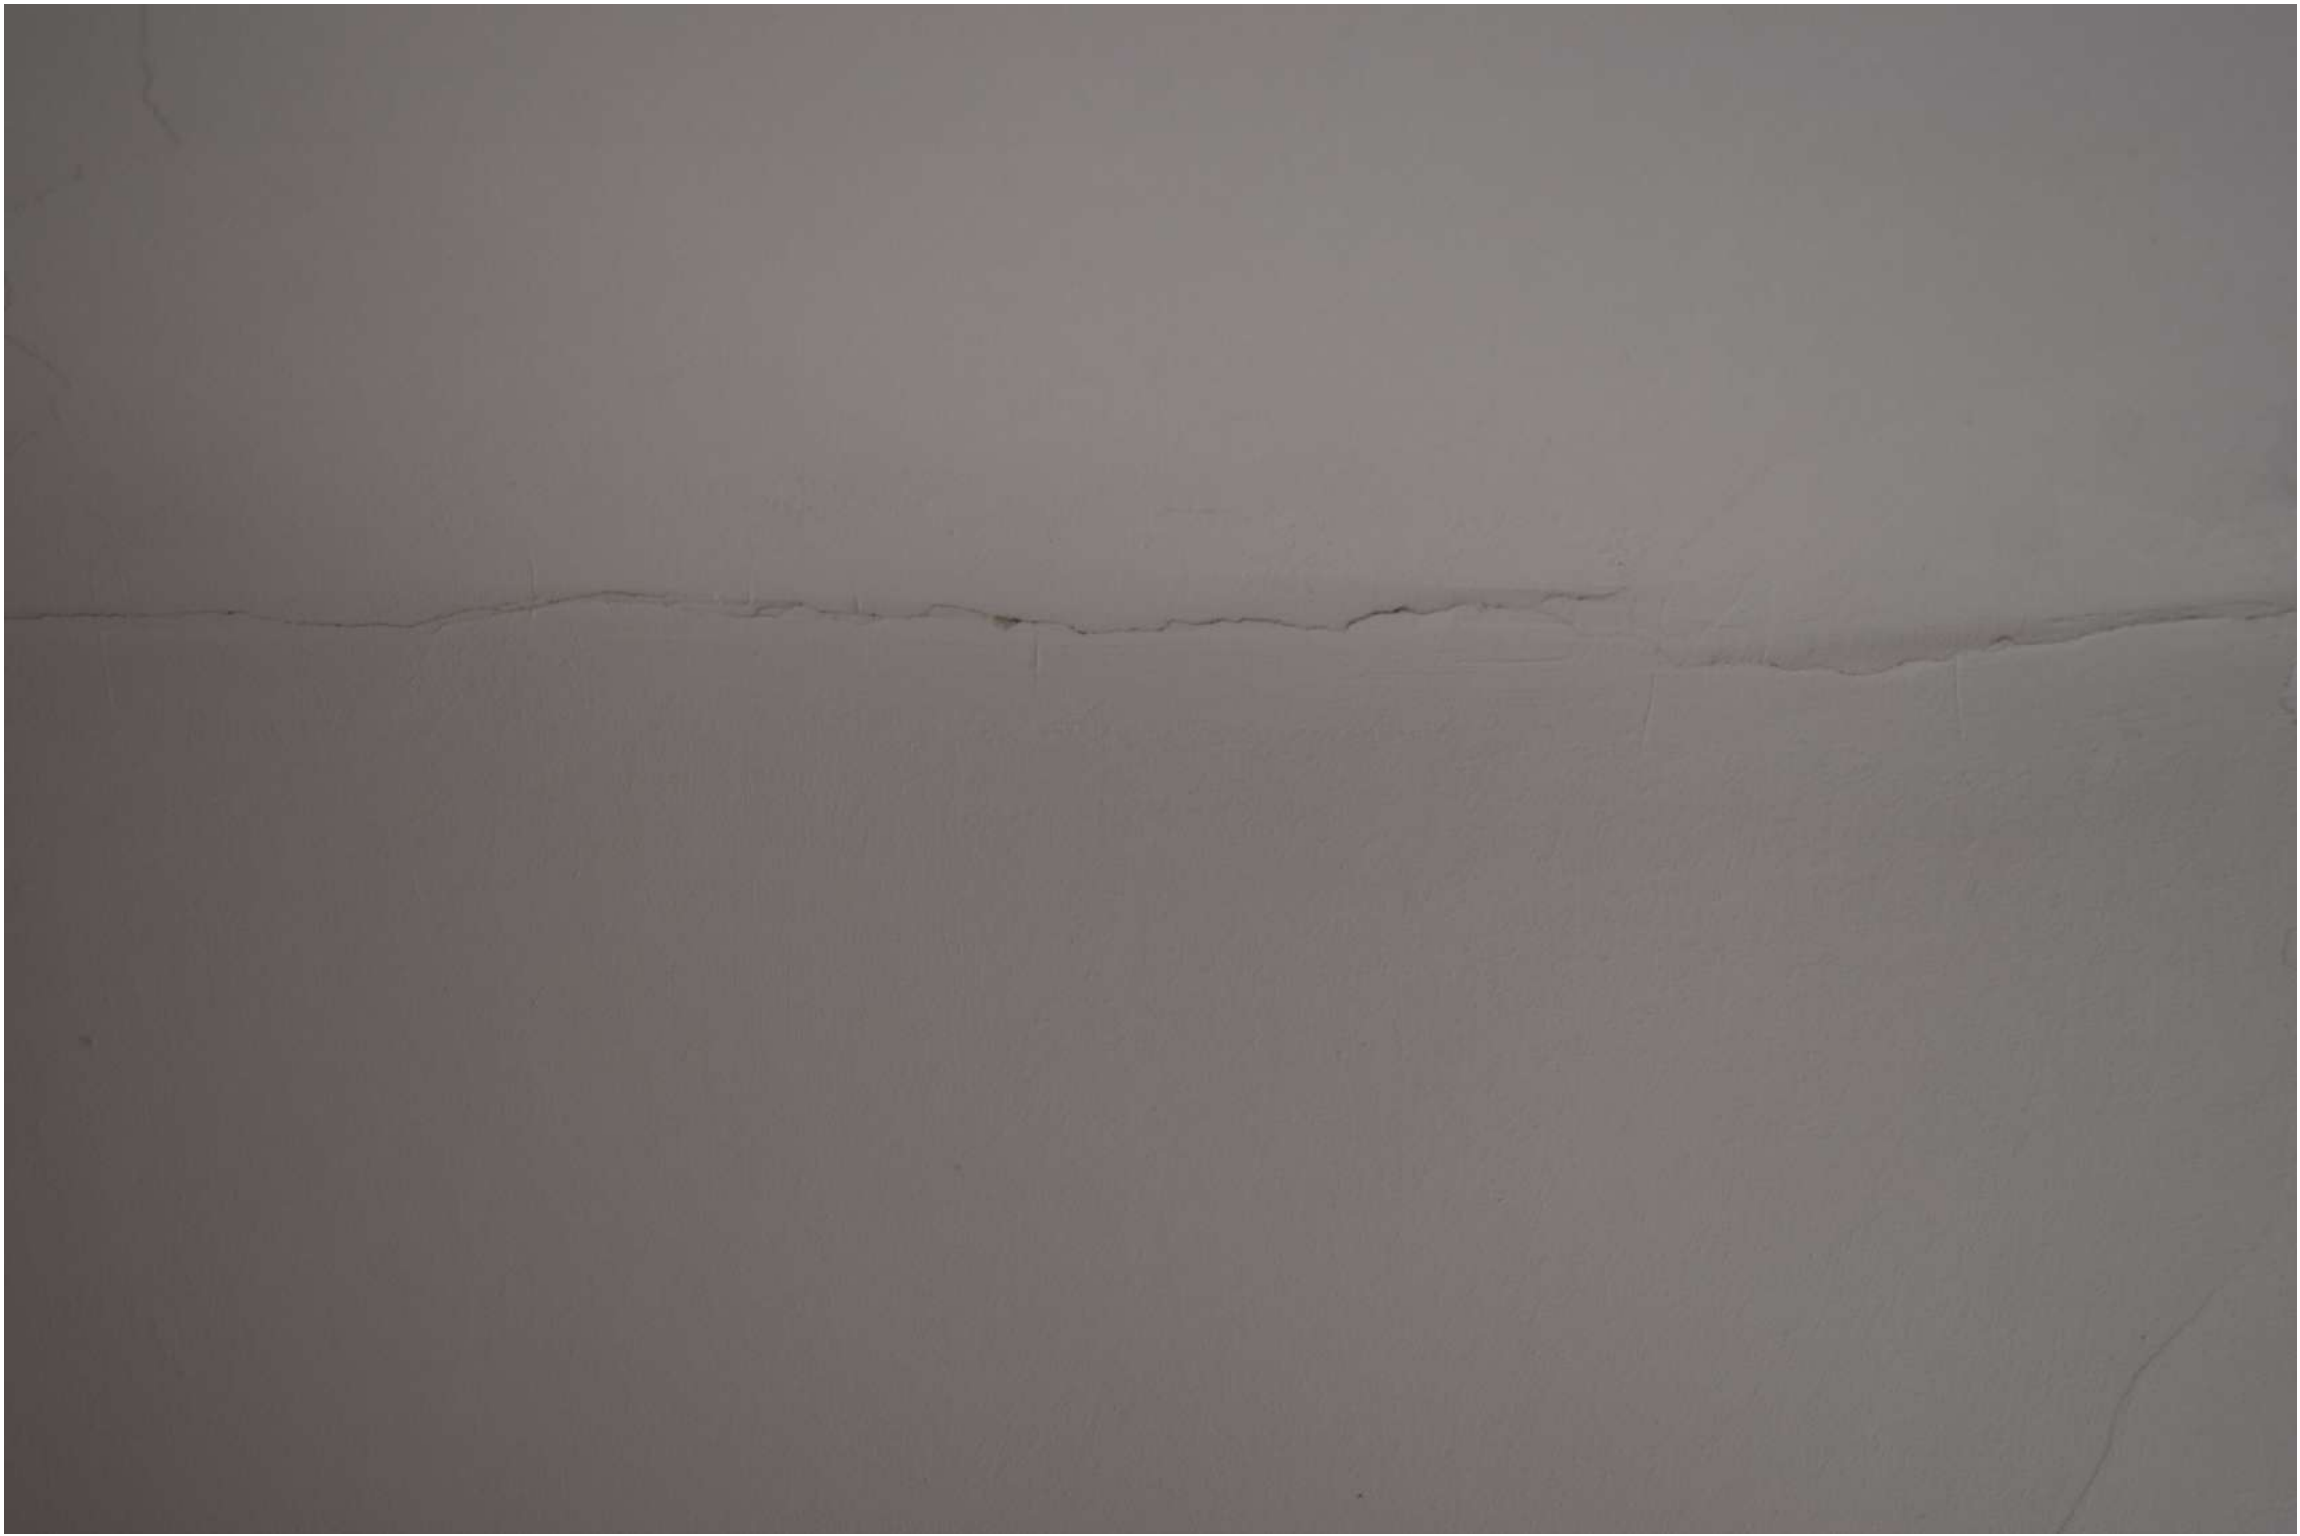
Plate 6  
A condition issue: Detailed image of surface cracks beneath the main staircase, necessitating remedial repair works.

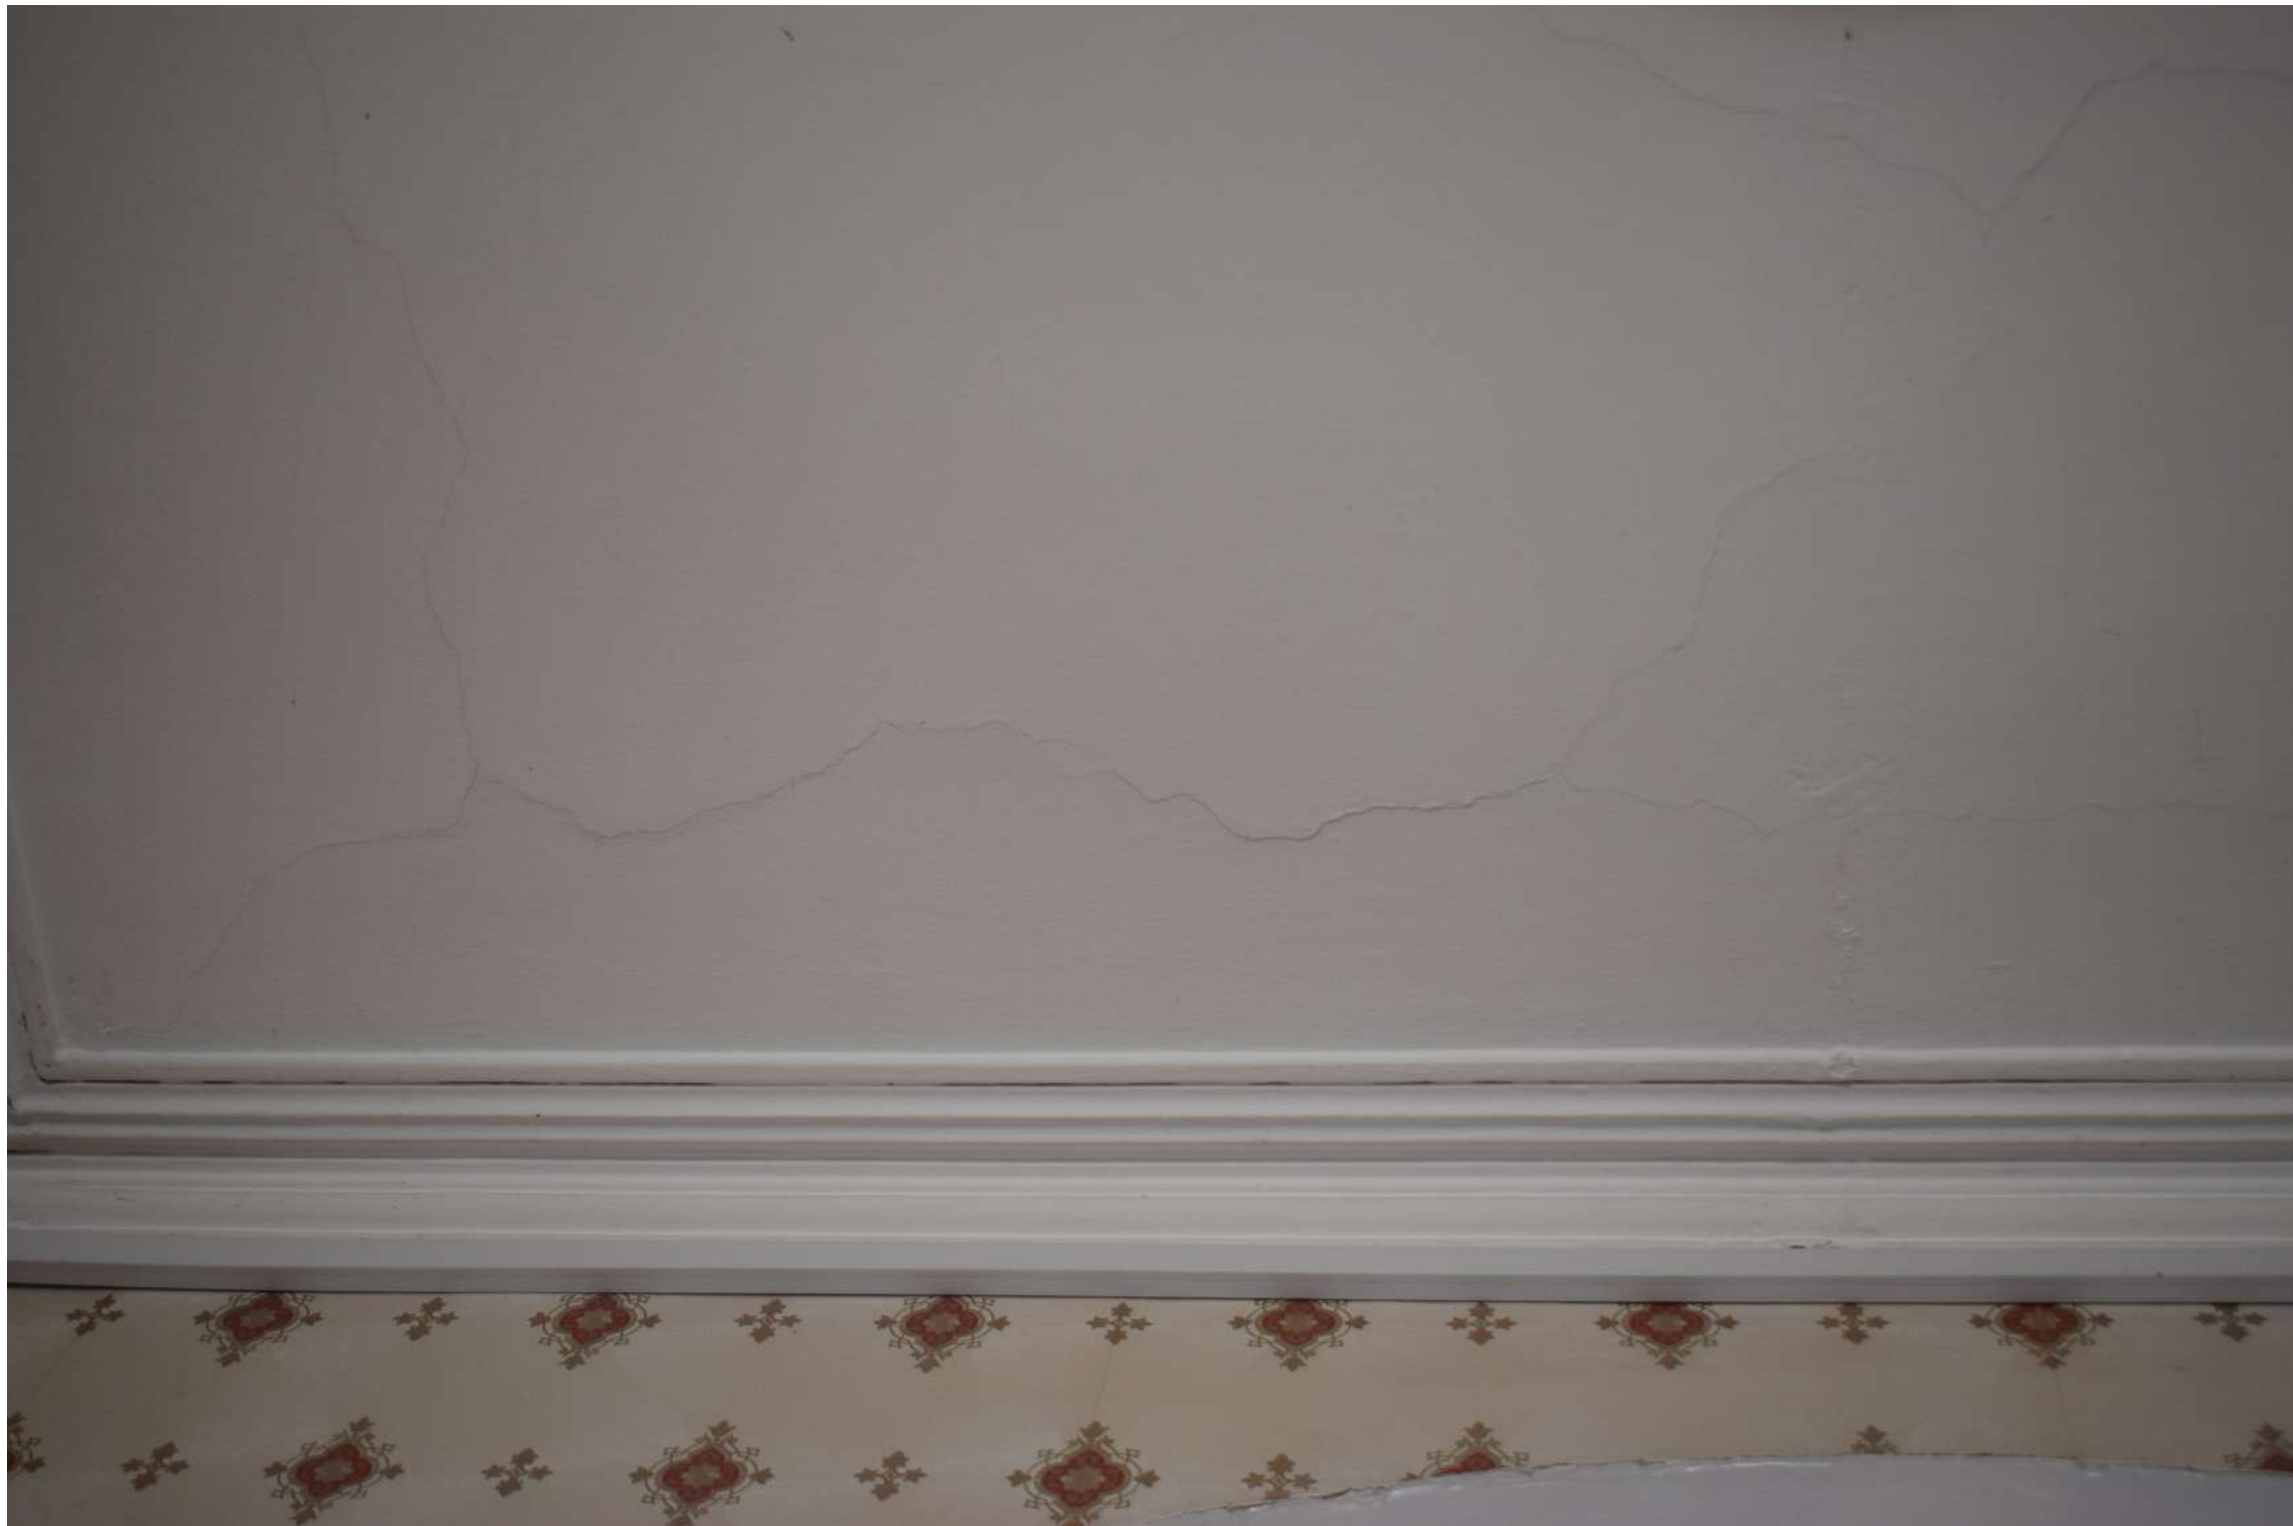
Plate 7

A condition issue: Detailed image of fine ceiling cracks which require immediate addressing and filling for conservation.

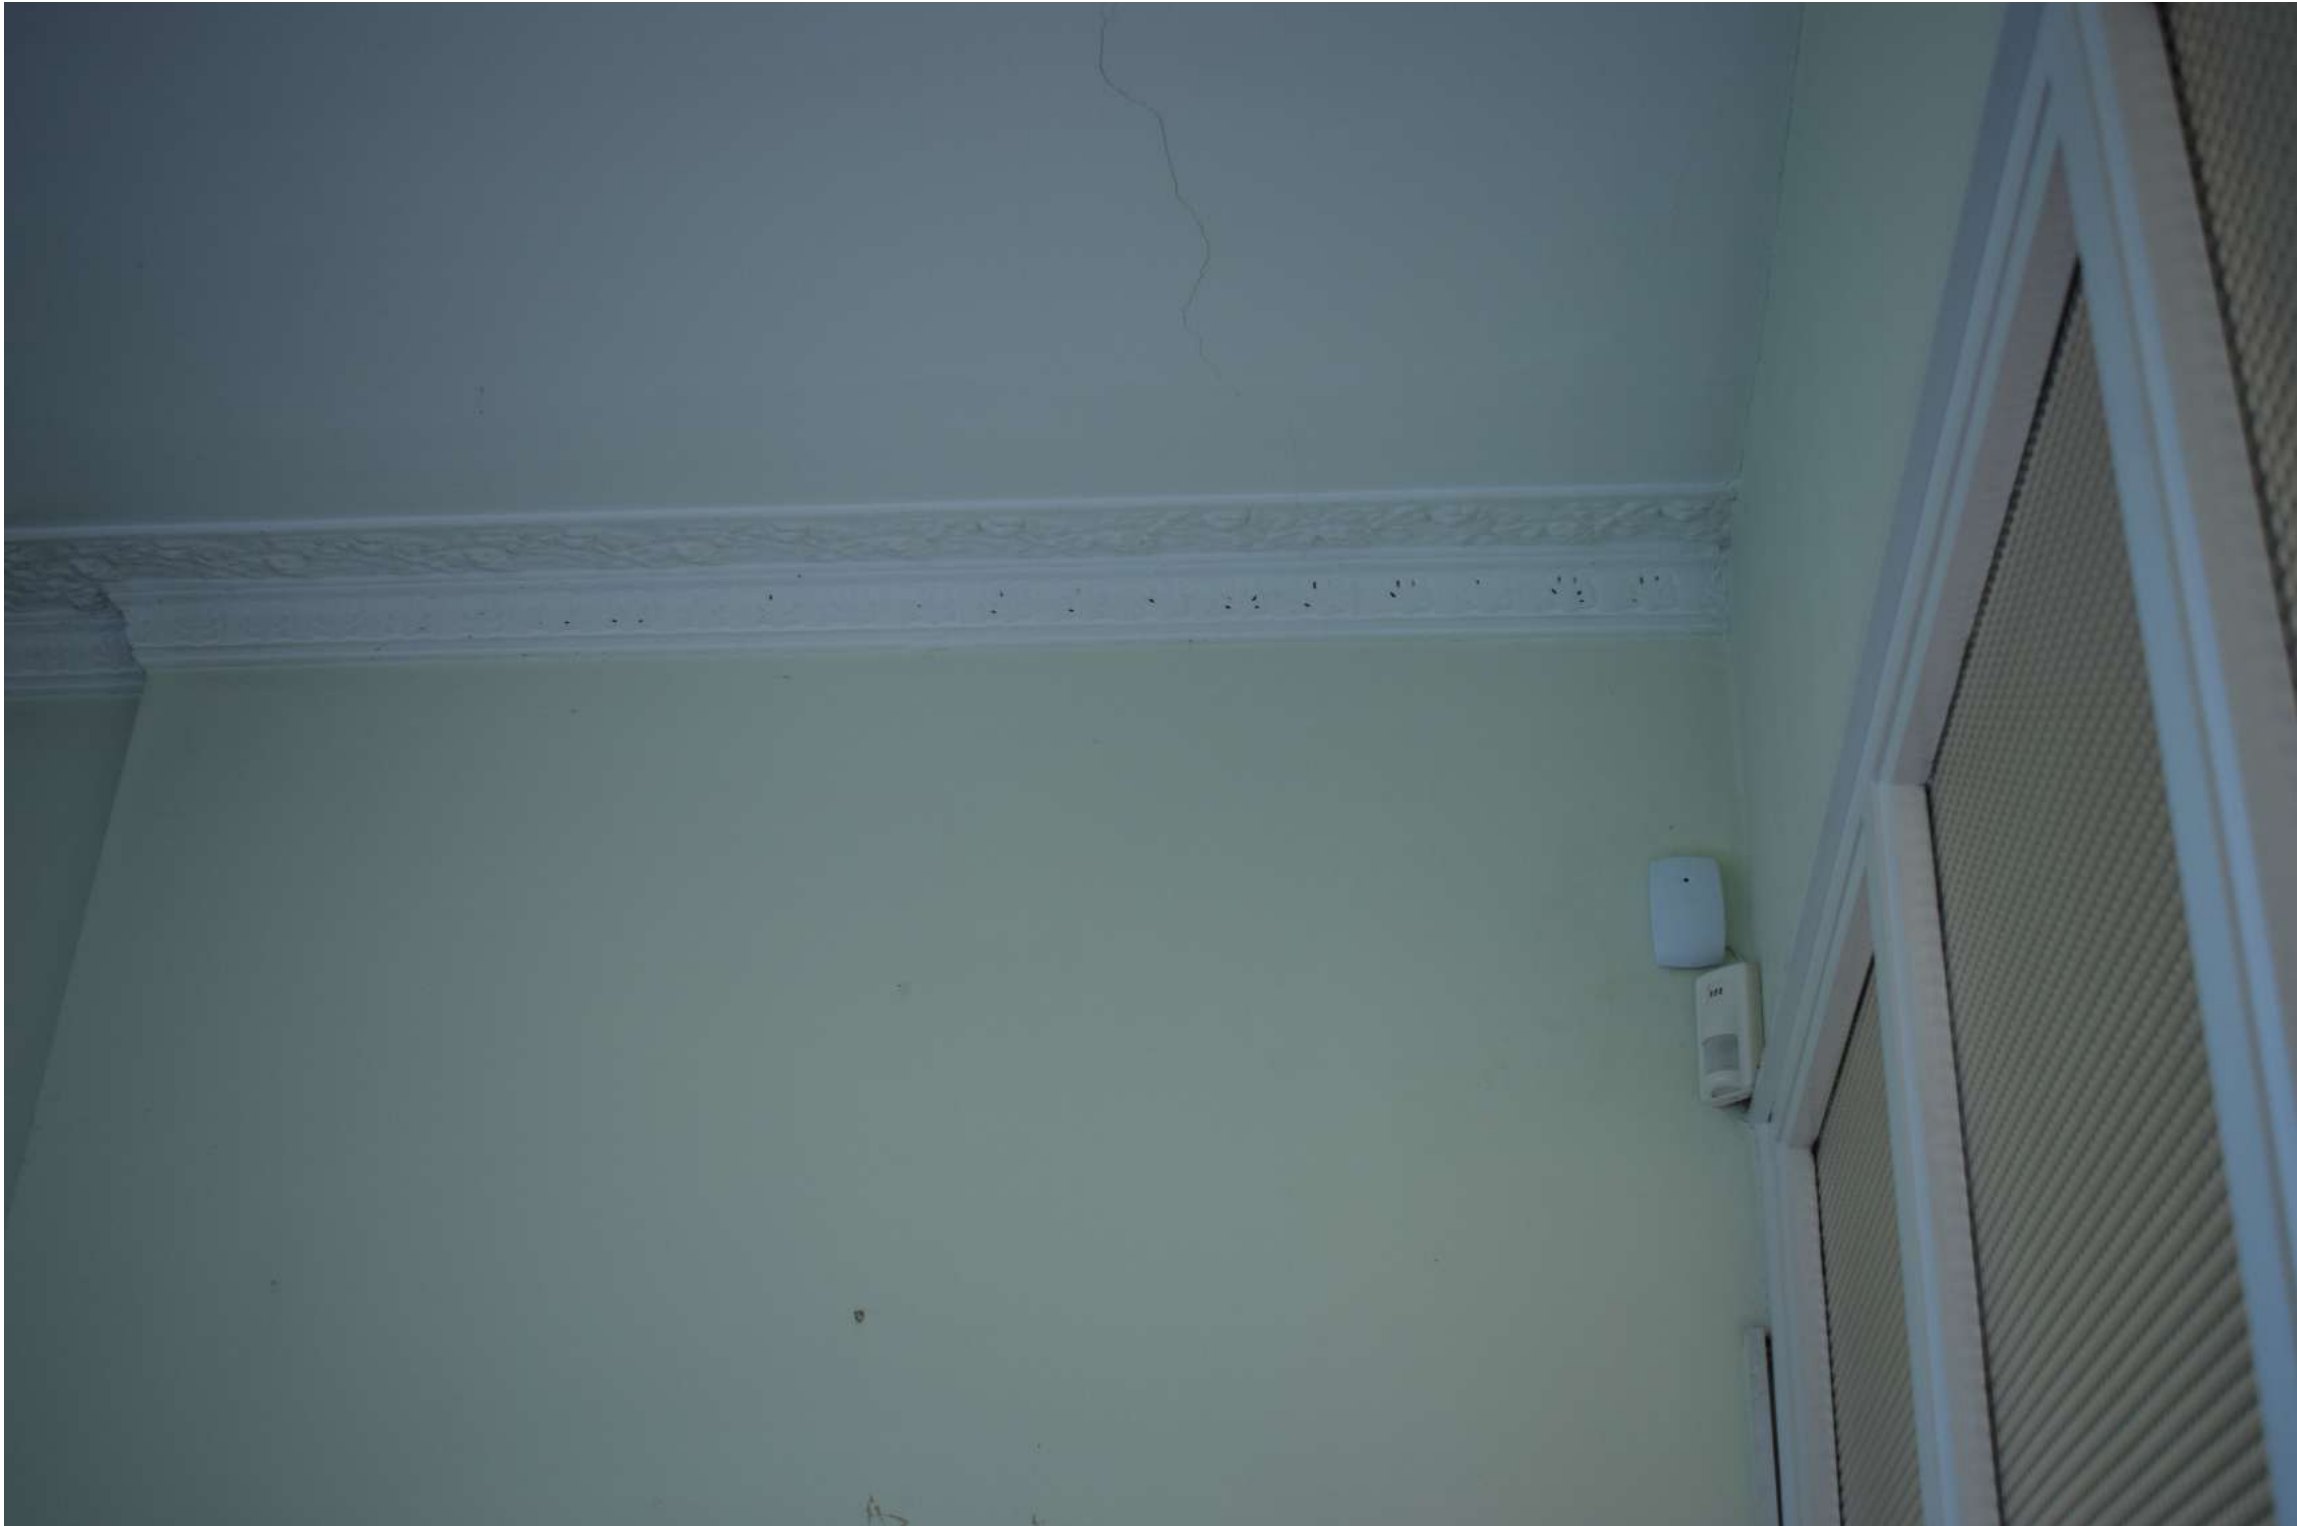
Plate 8

Interpretation: Detailed image of the corridor wall partition, which currently subdivides the former book room (now the Deputy Office). Evidence of intervention where the cornice and skirting have been interrupted to accommodate the modern partition. The continuation of the cornice and skirting profile suggests the space was originally a single, large room.

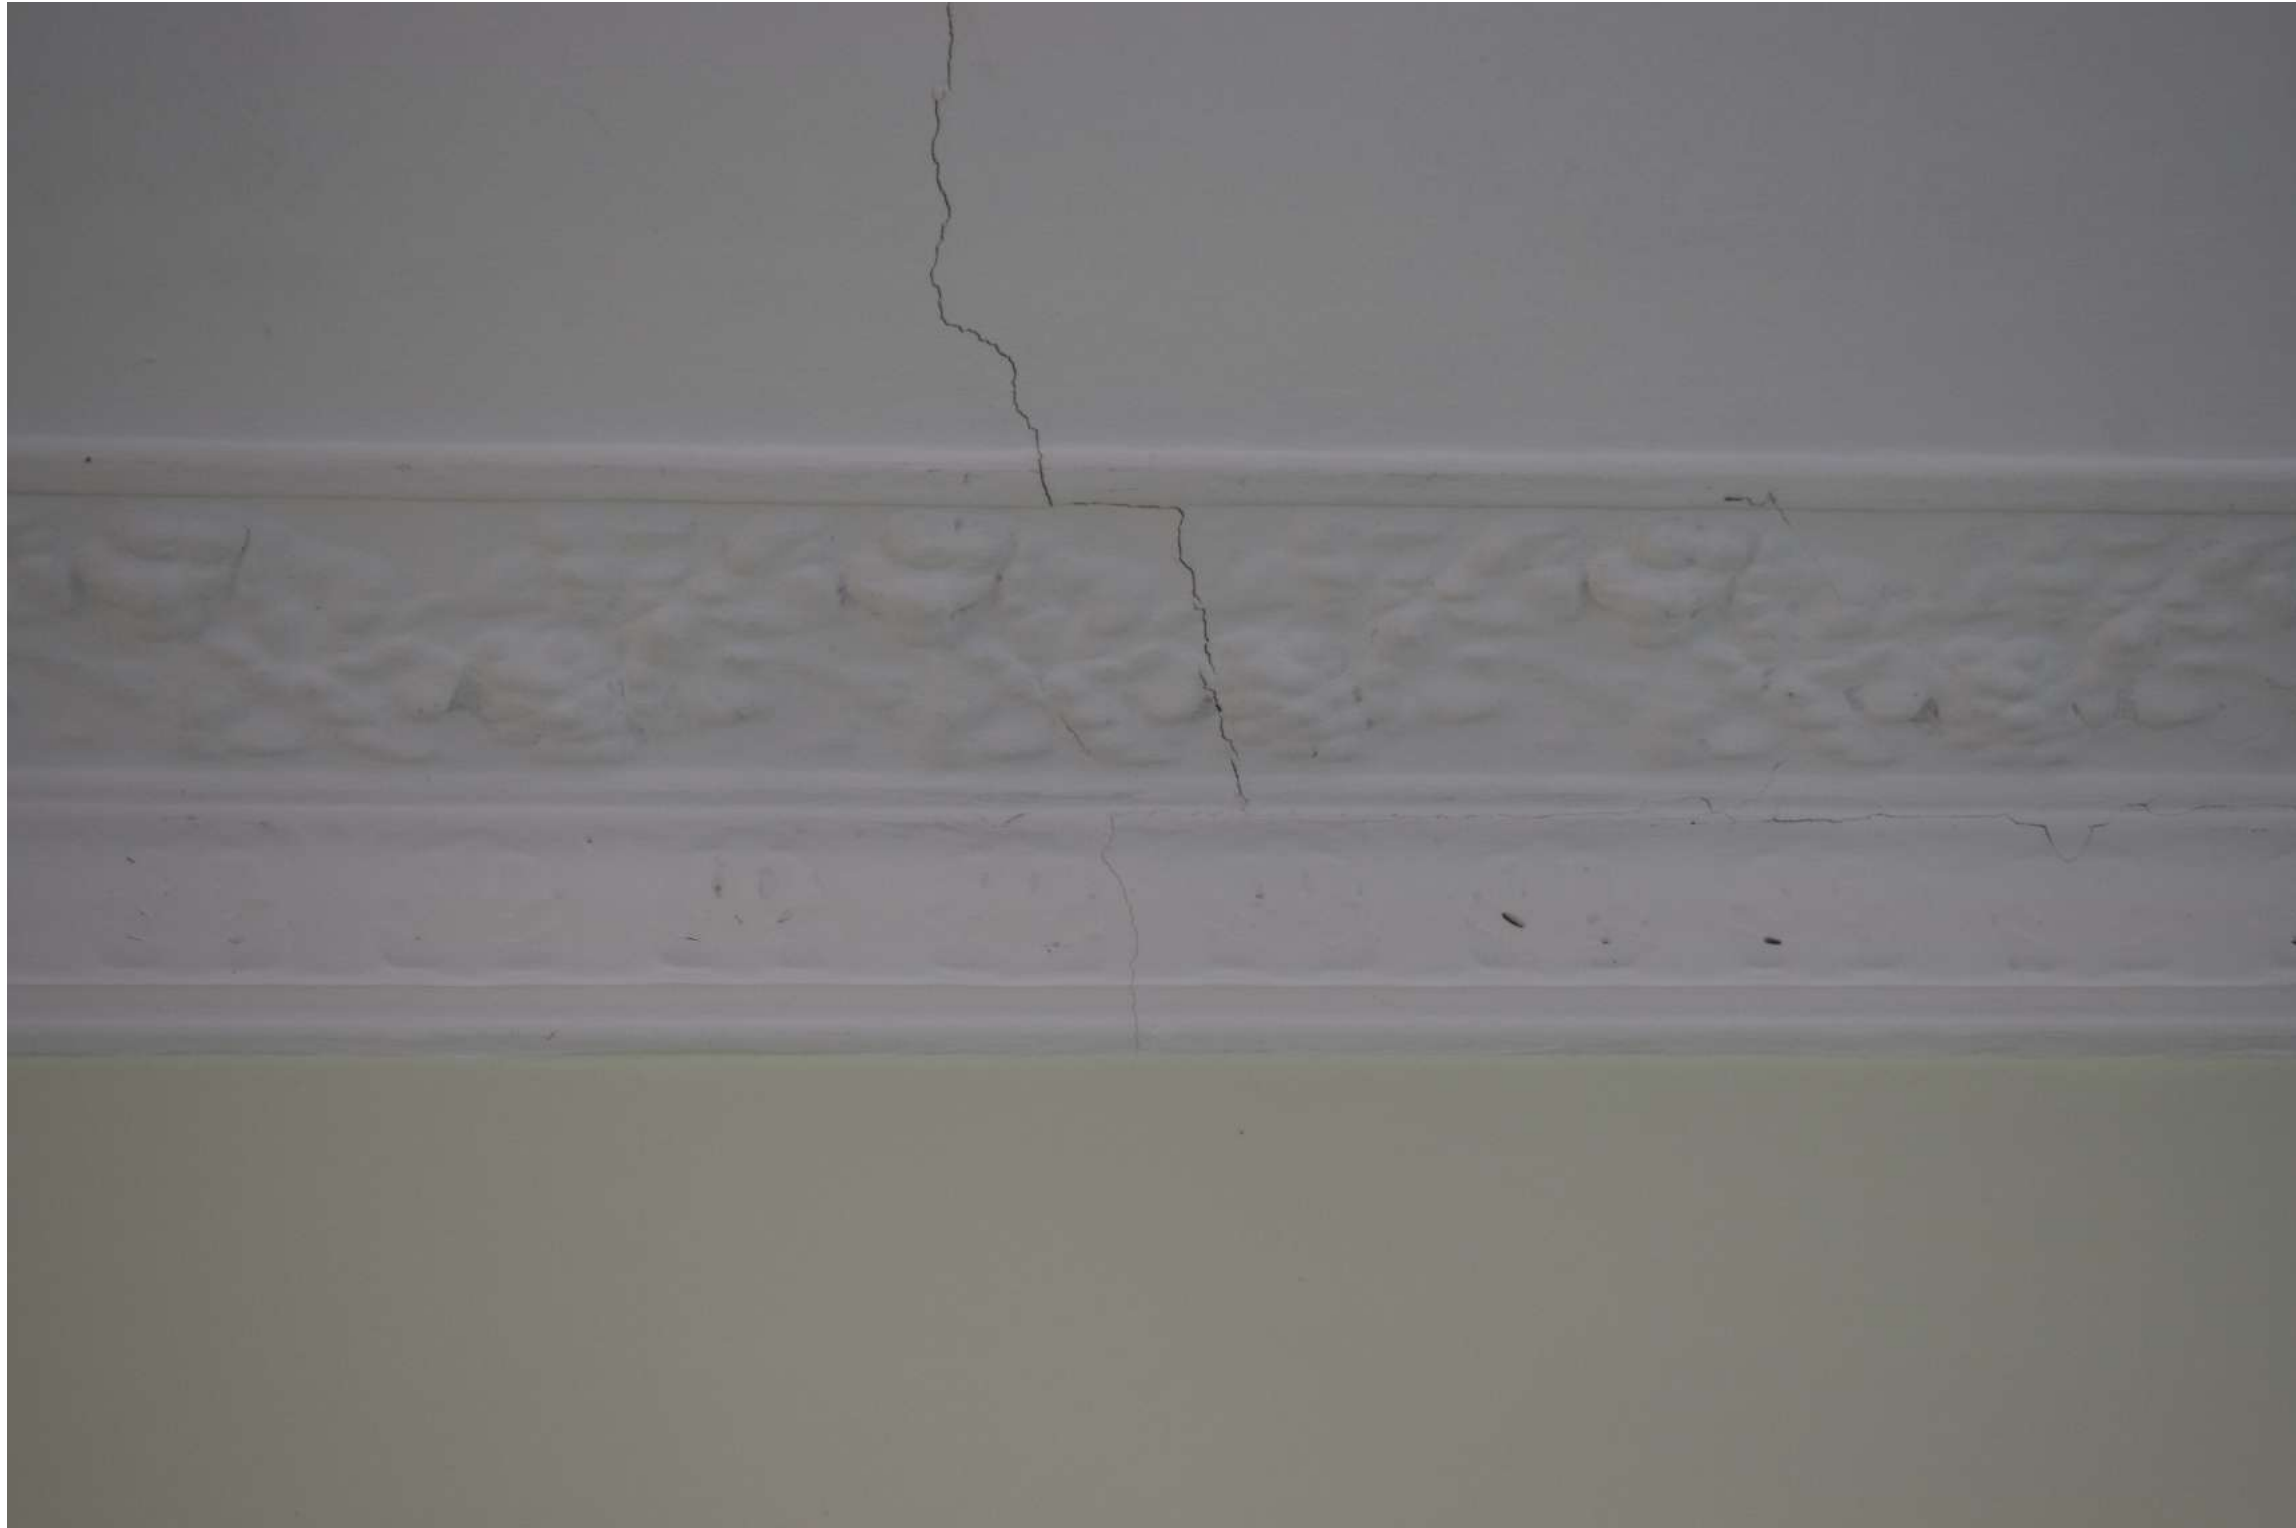
Plate 11

Condition issue: Hairline cracks observed on the cornice section opposite the fireplace.

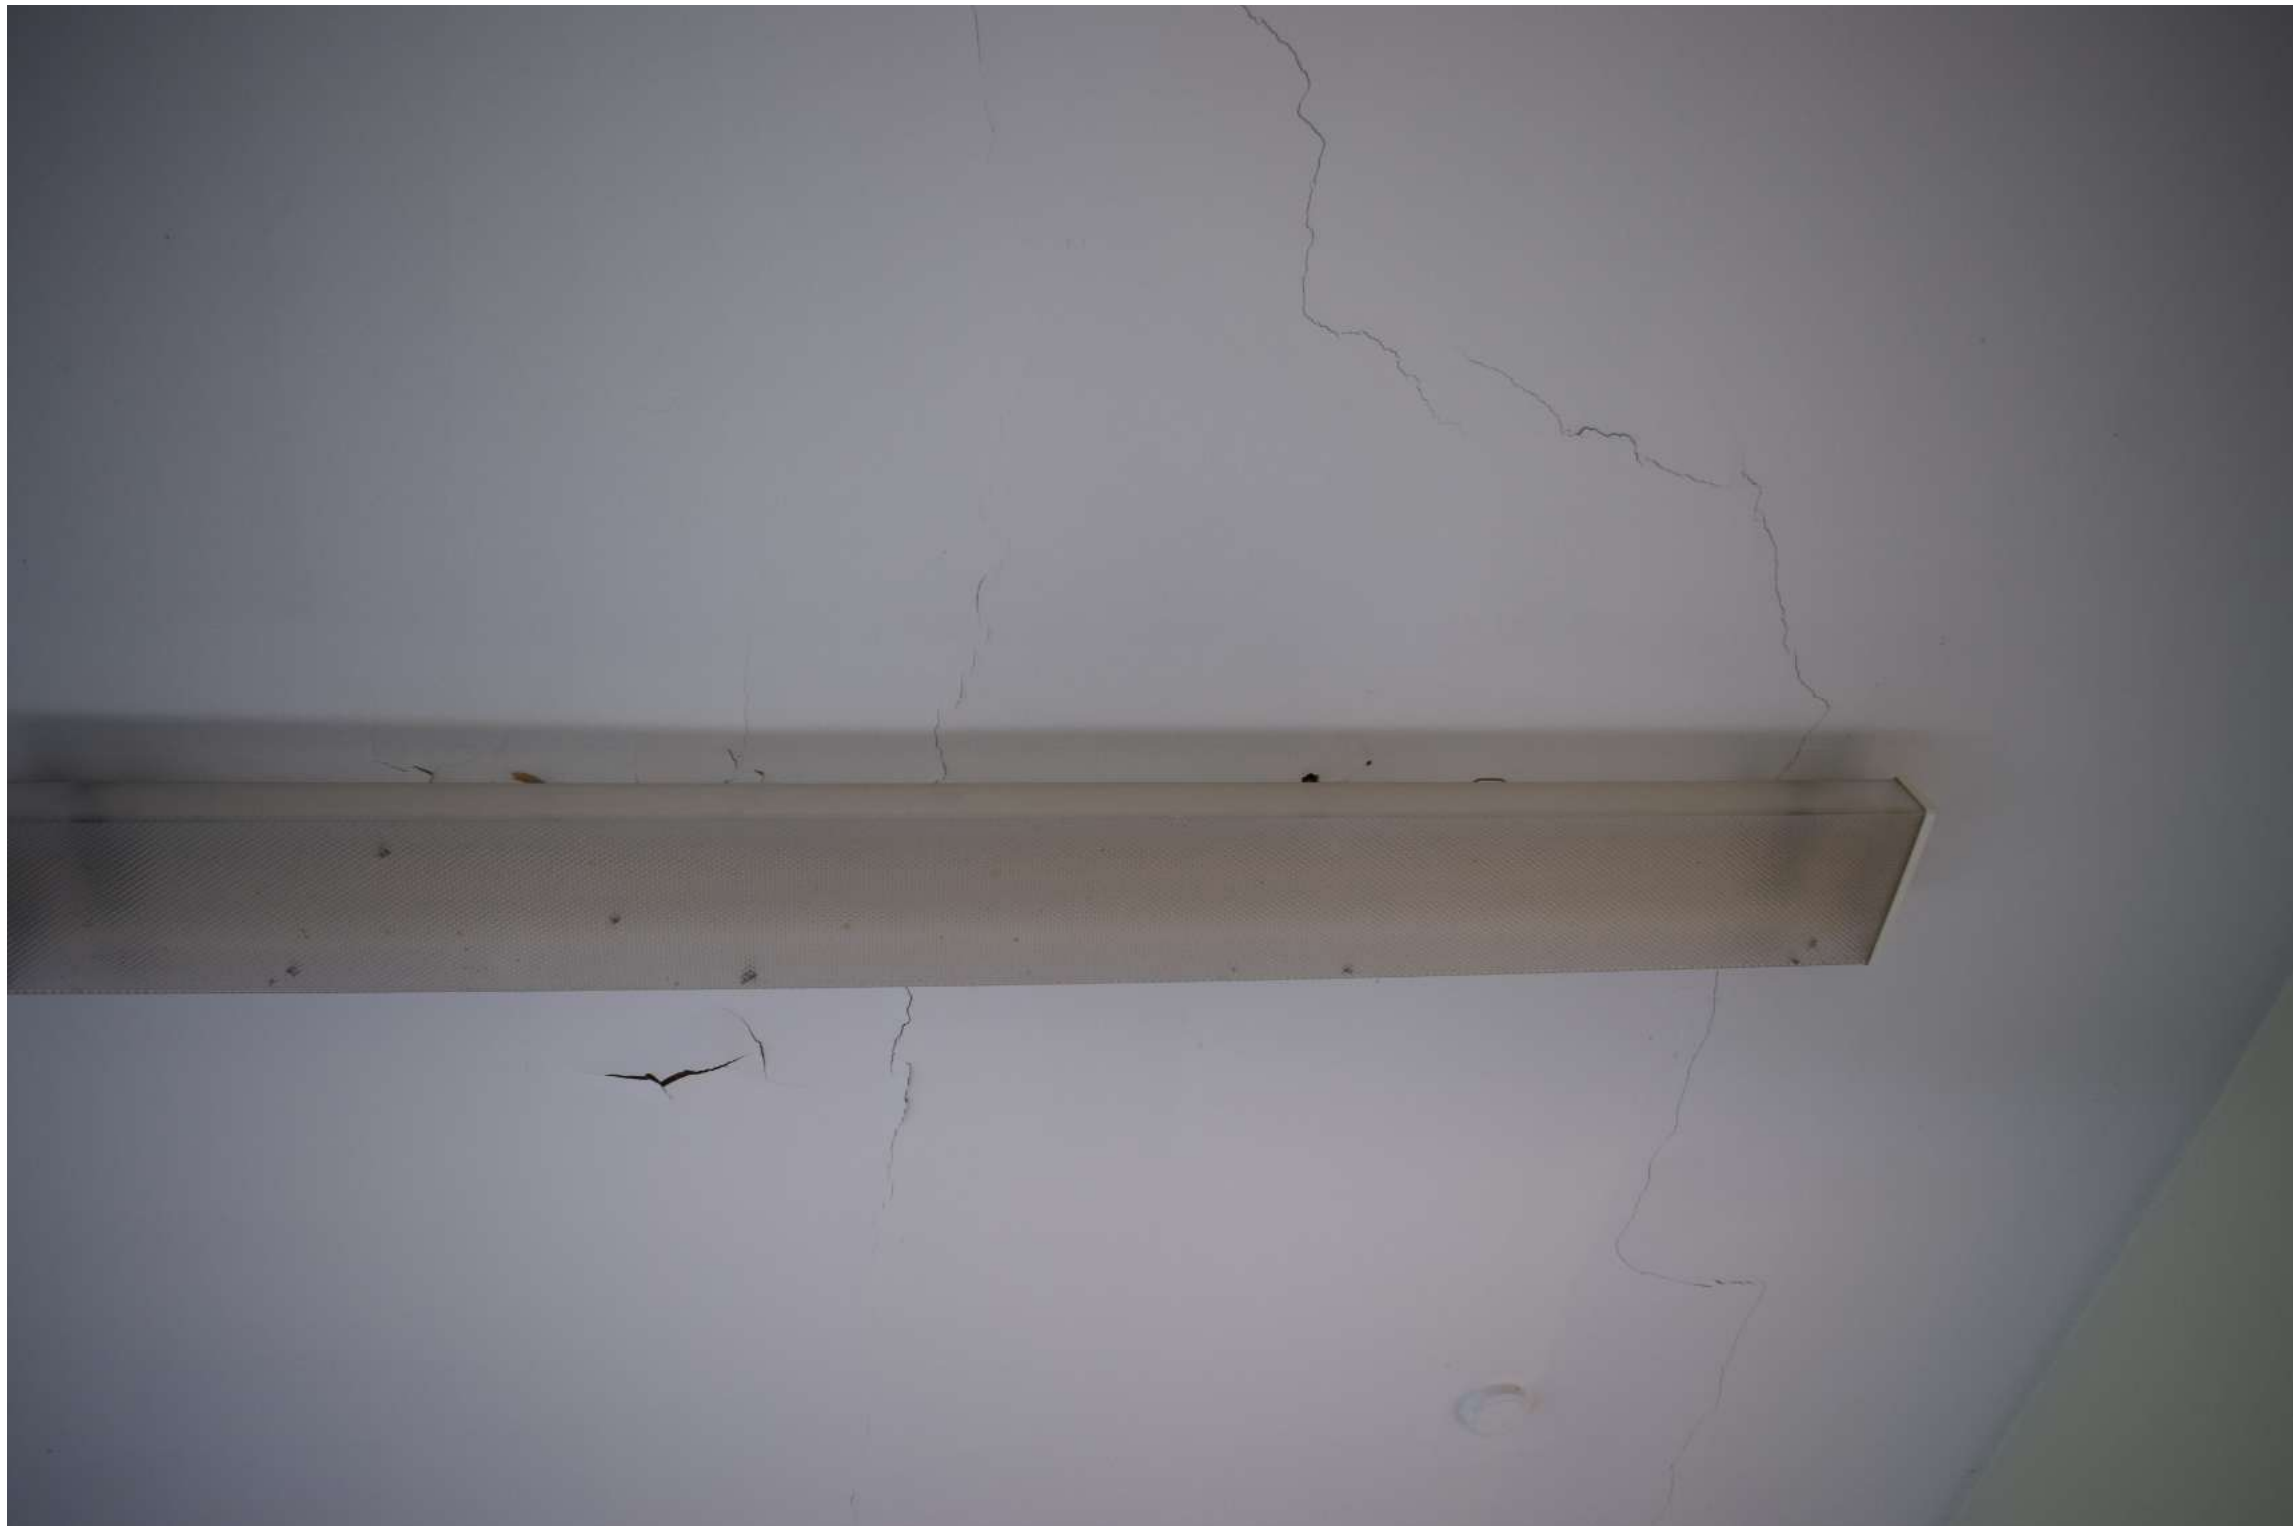
Plate 12

Condition issue: Detailed image of the hairline cracks observed on the ceiling, likely lath and plaster construction.
