Archway Heritage

# Appendix 11

## Yeomanry House

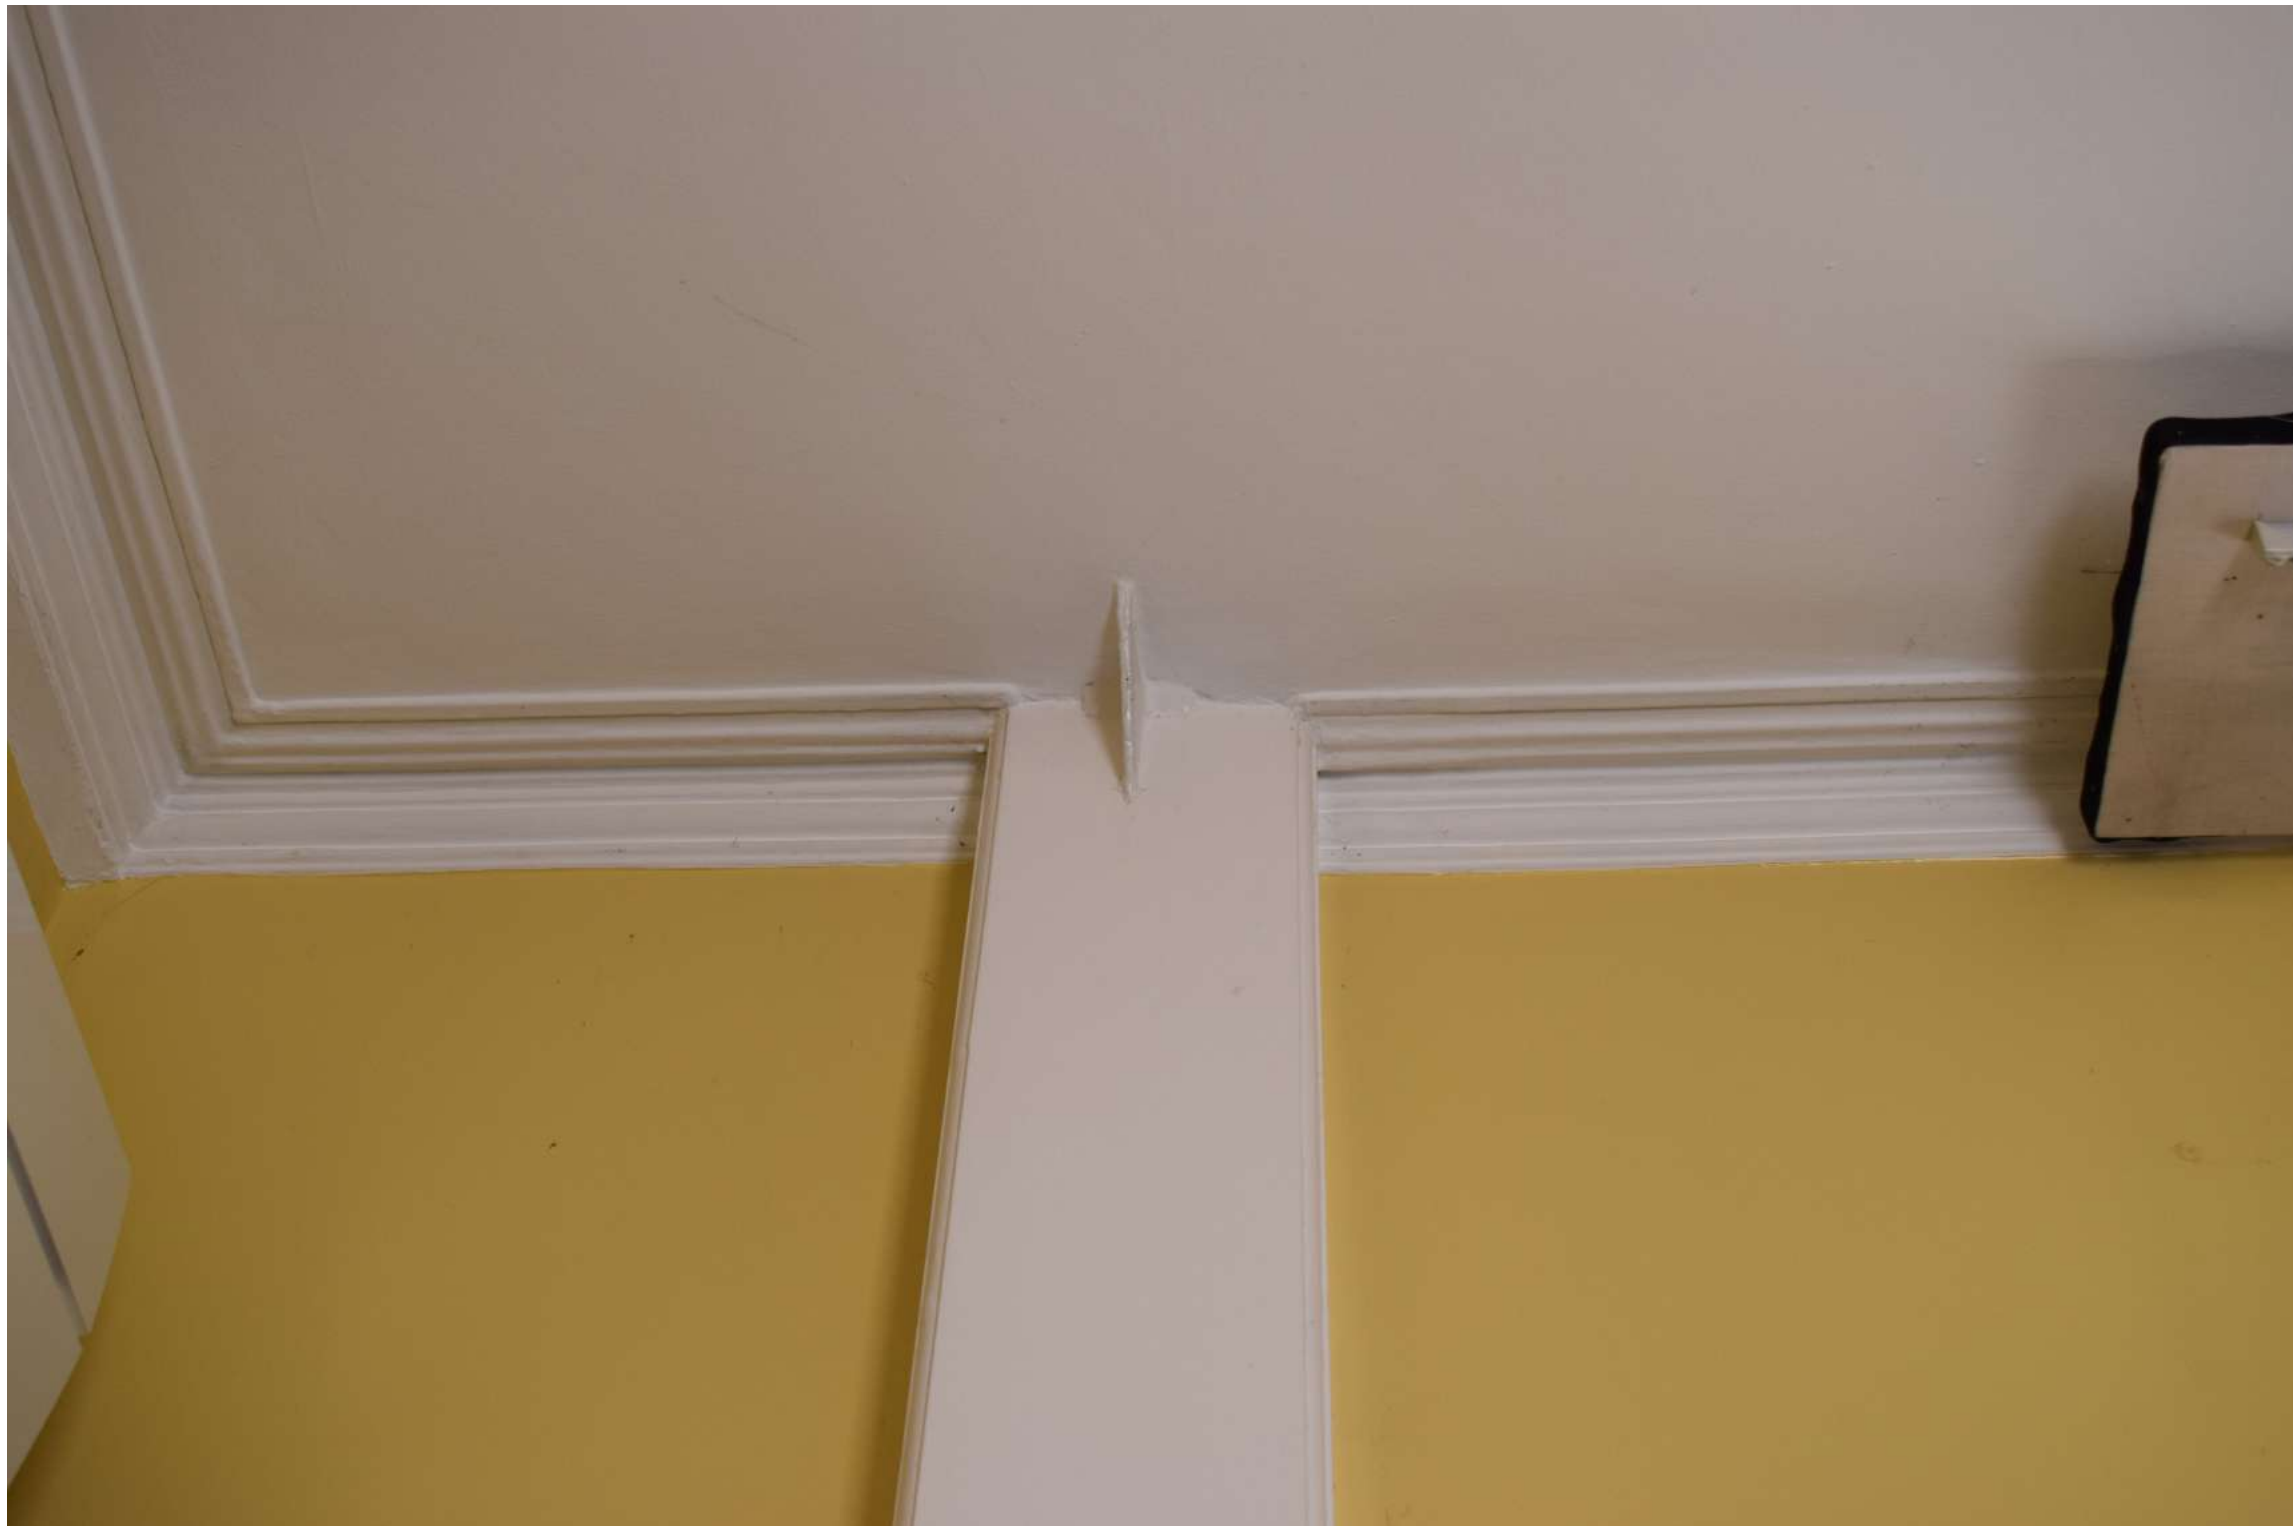
Plate 14

Structural detail: Detailed image of an iron tie rod protruding from its encasing, indicating previous requirements for structural support in this section of the rear wall.

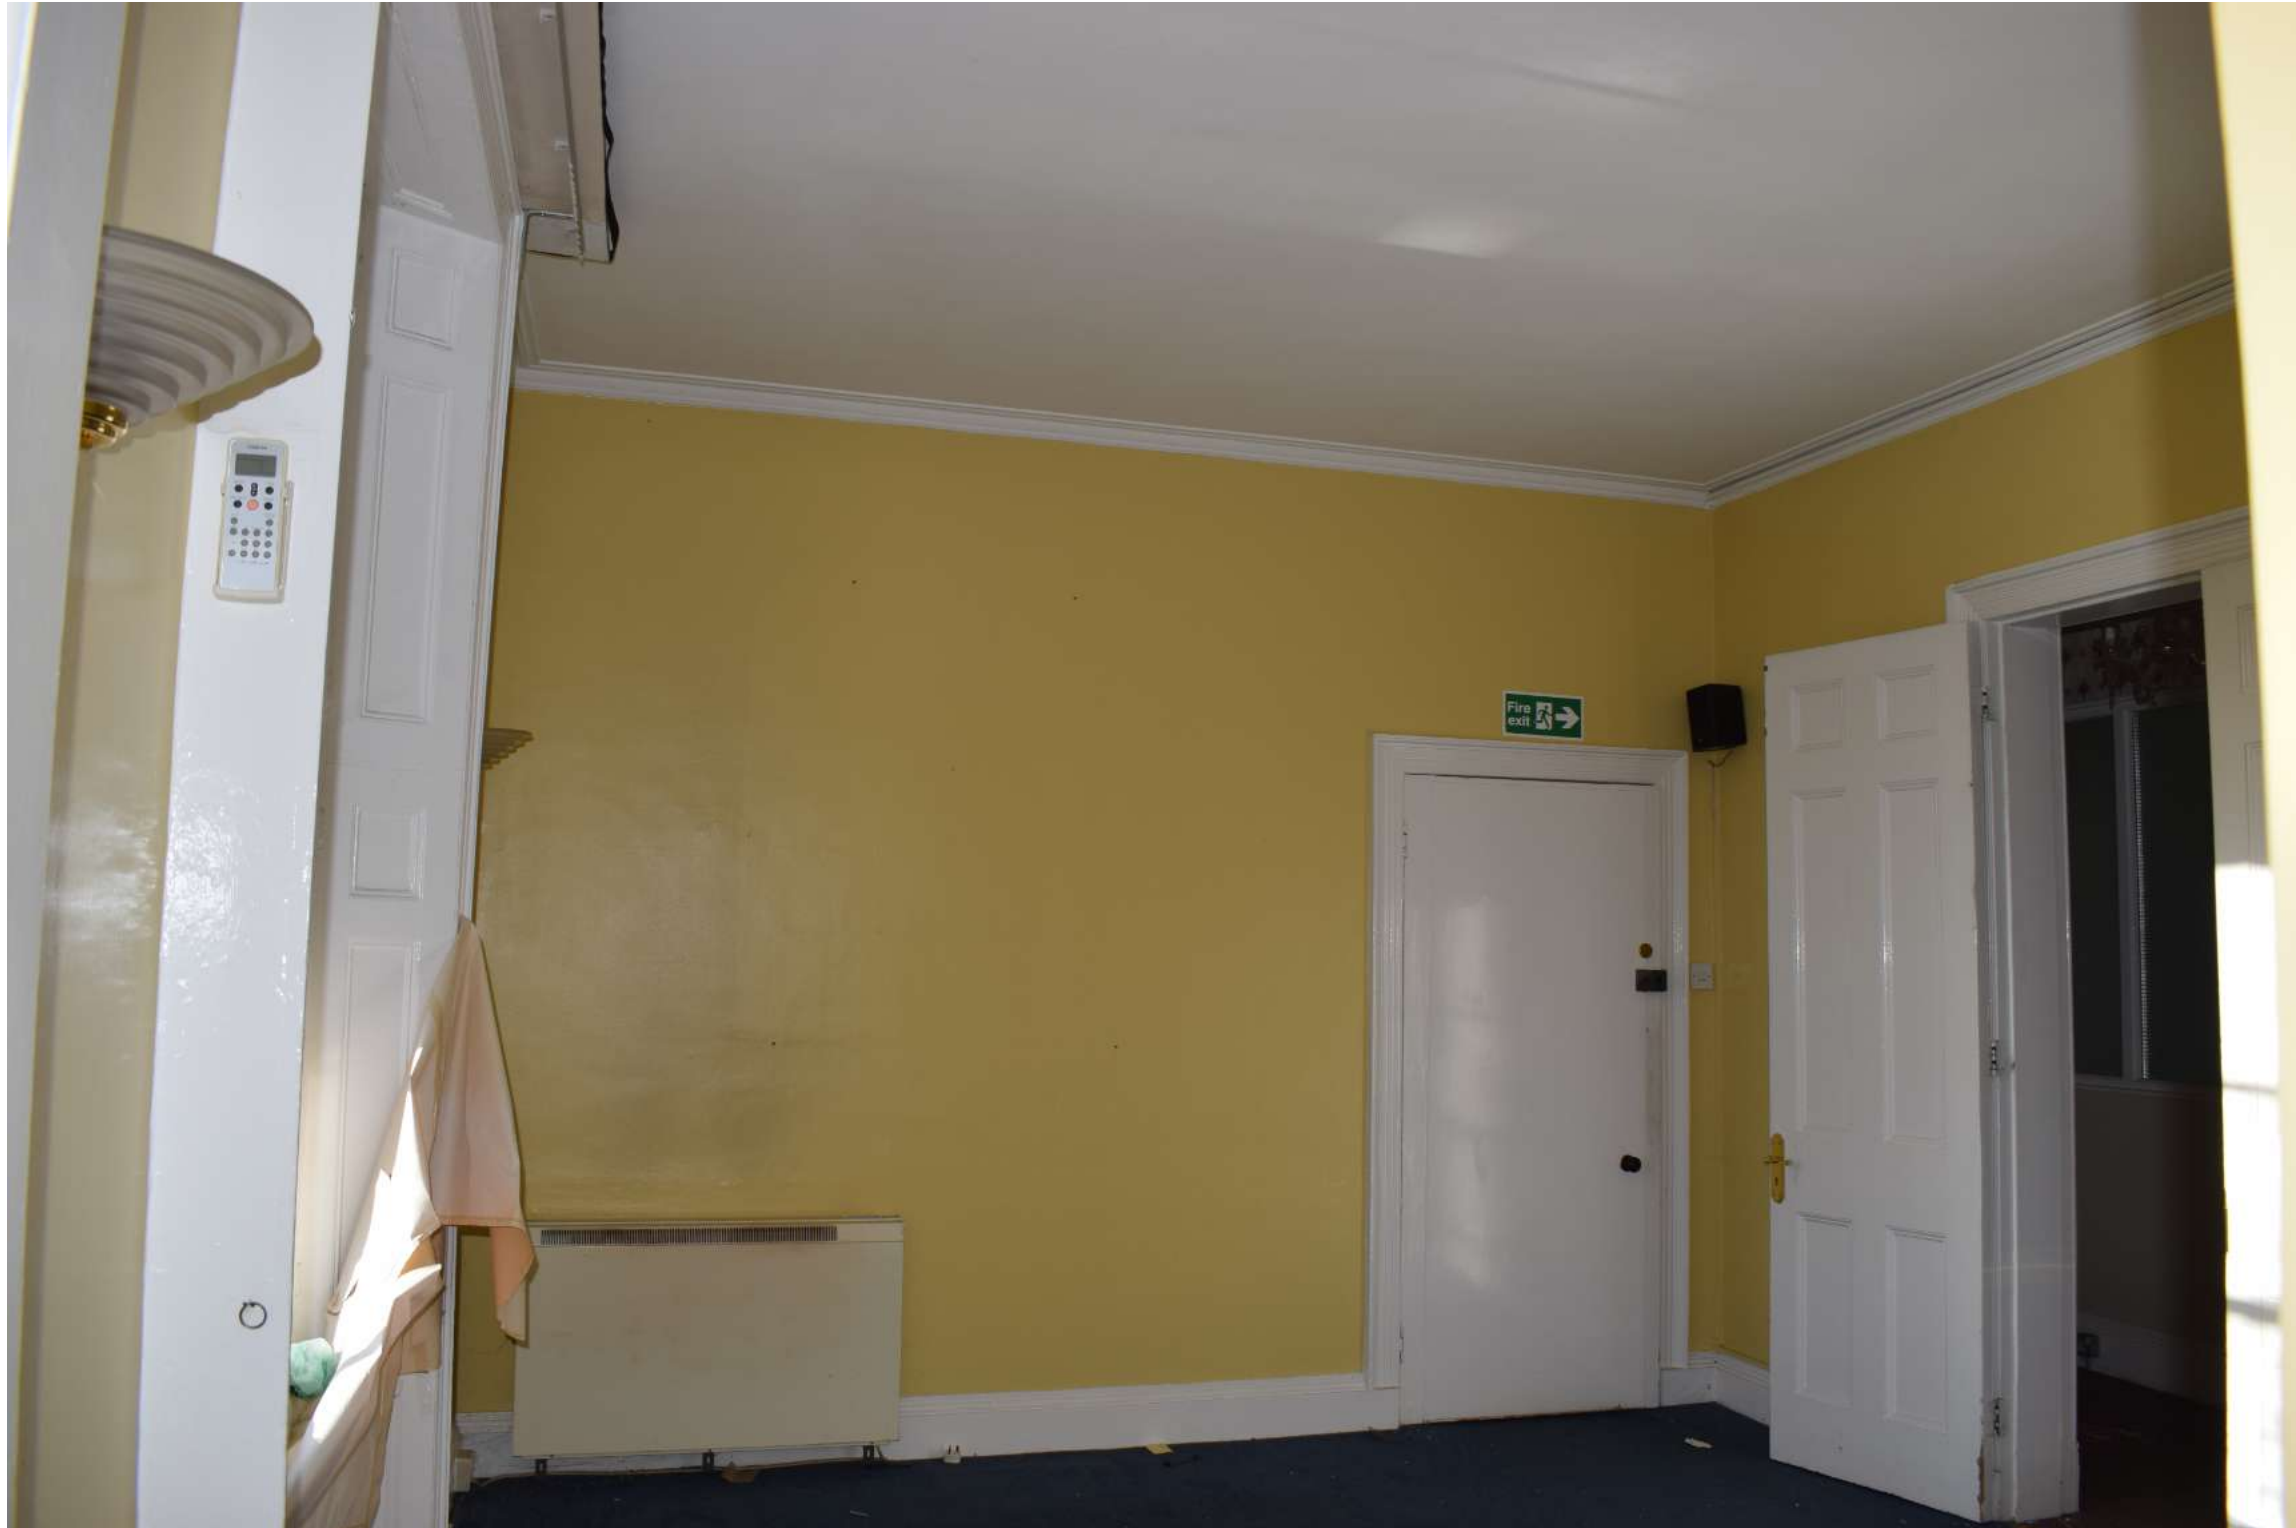
Plate 15

The general room view of the smooth finish of the ceiling, characteristic of lath and plaster construction, with minor paint cracking in this room.

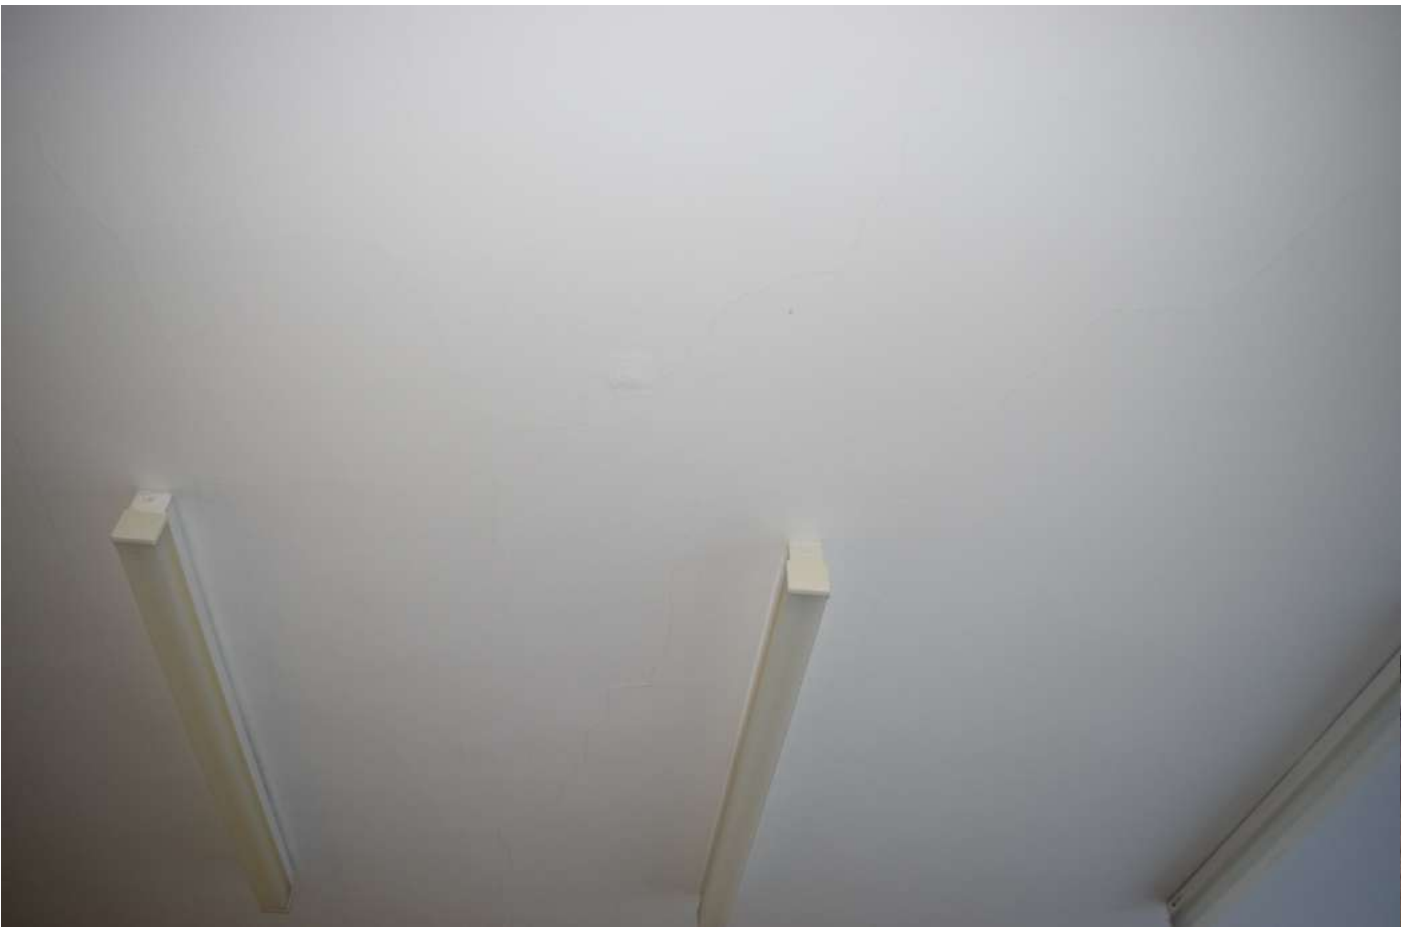
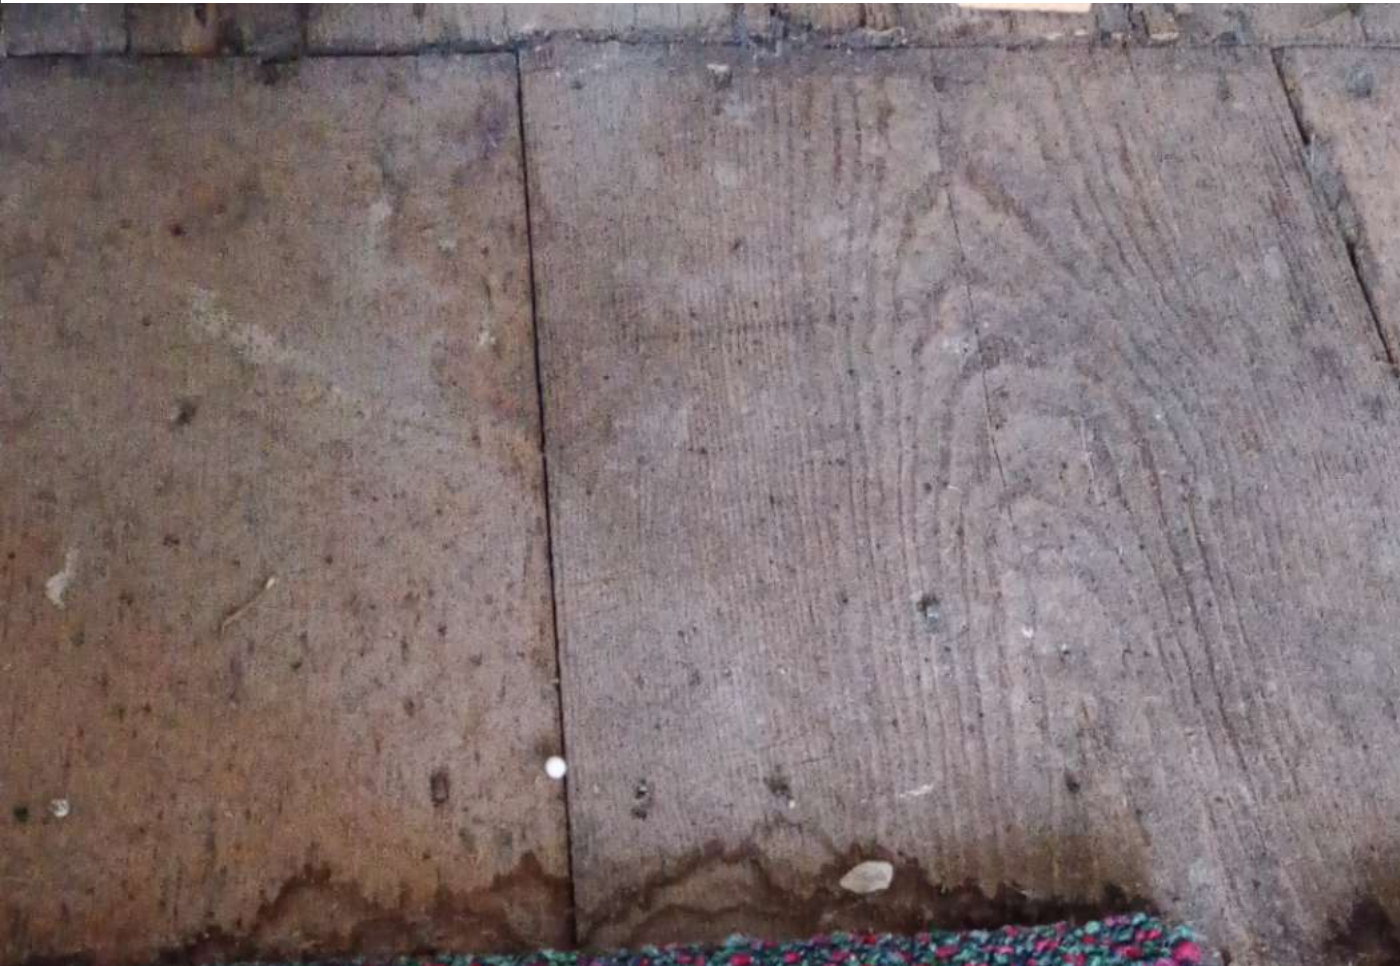
Plate 20  
This ceiling appears to be in good condition. Inset: a detail of the timber flooring.

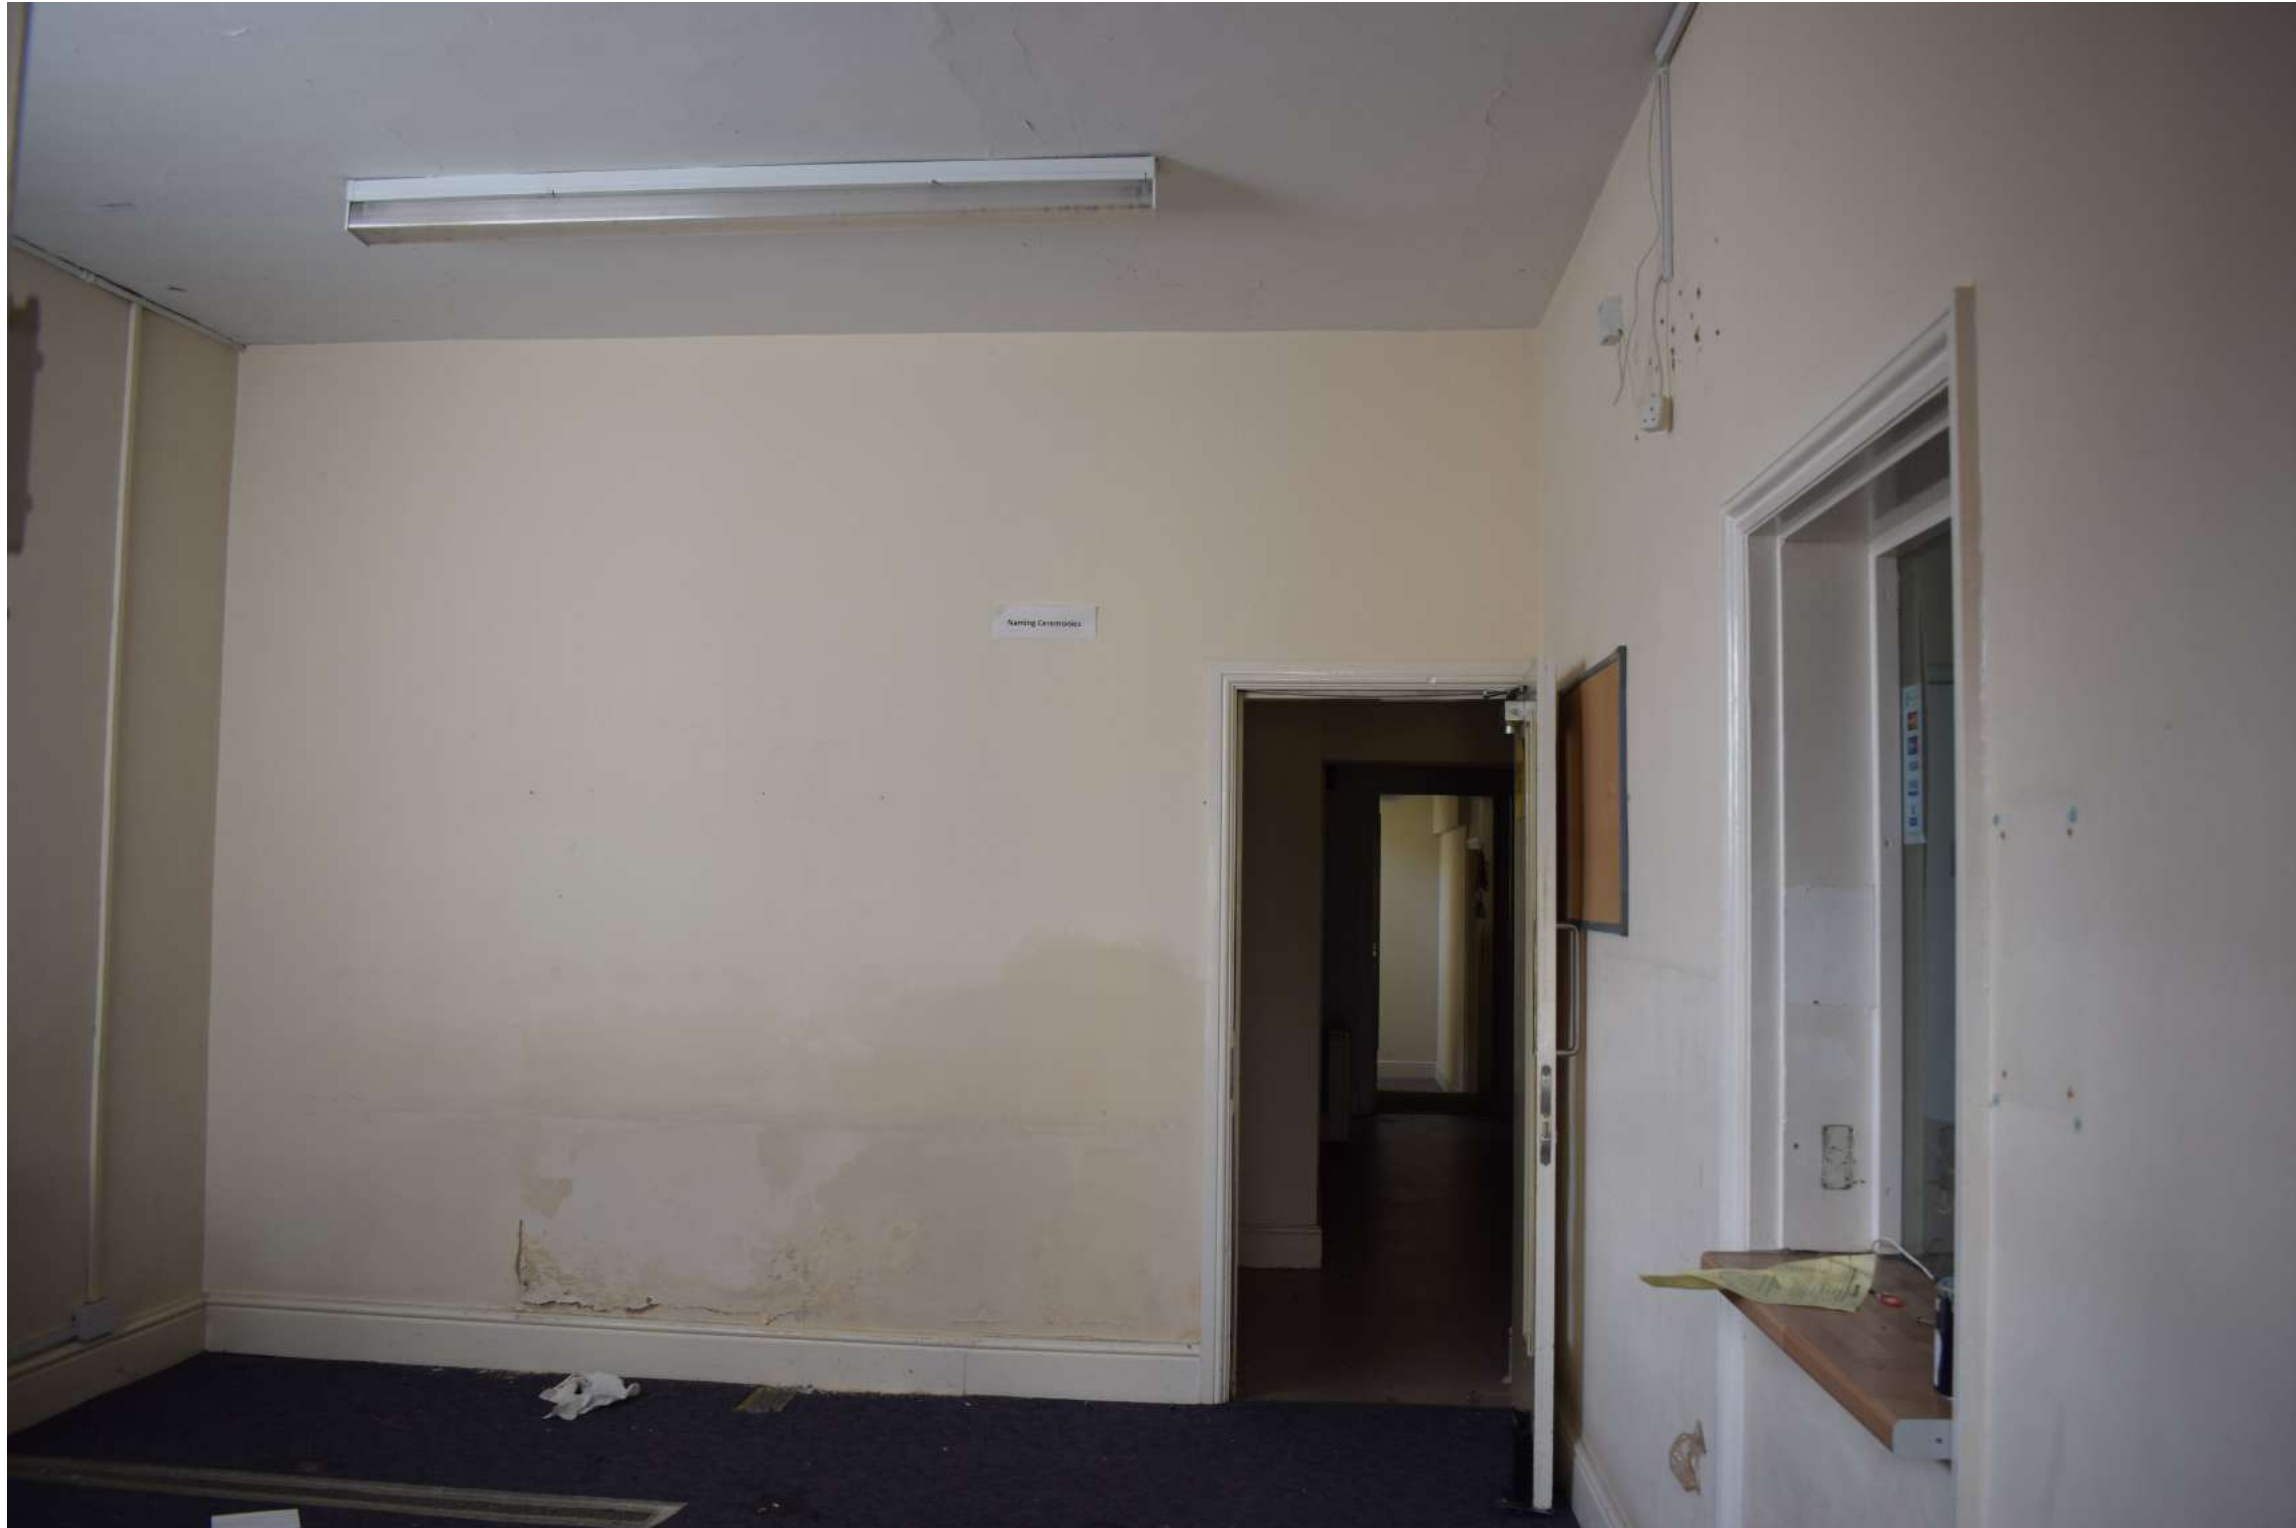
Plate 21

The source of this damp in the waiting room requires investigation.

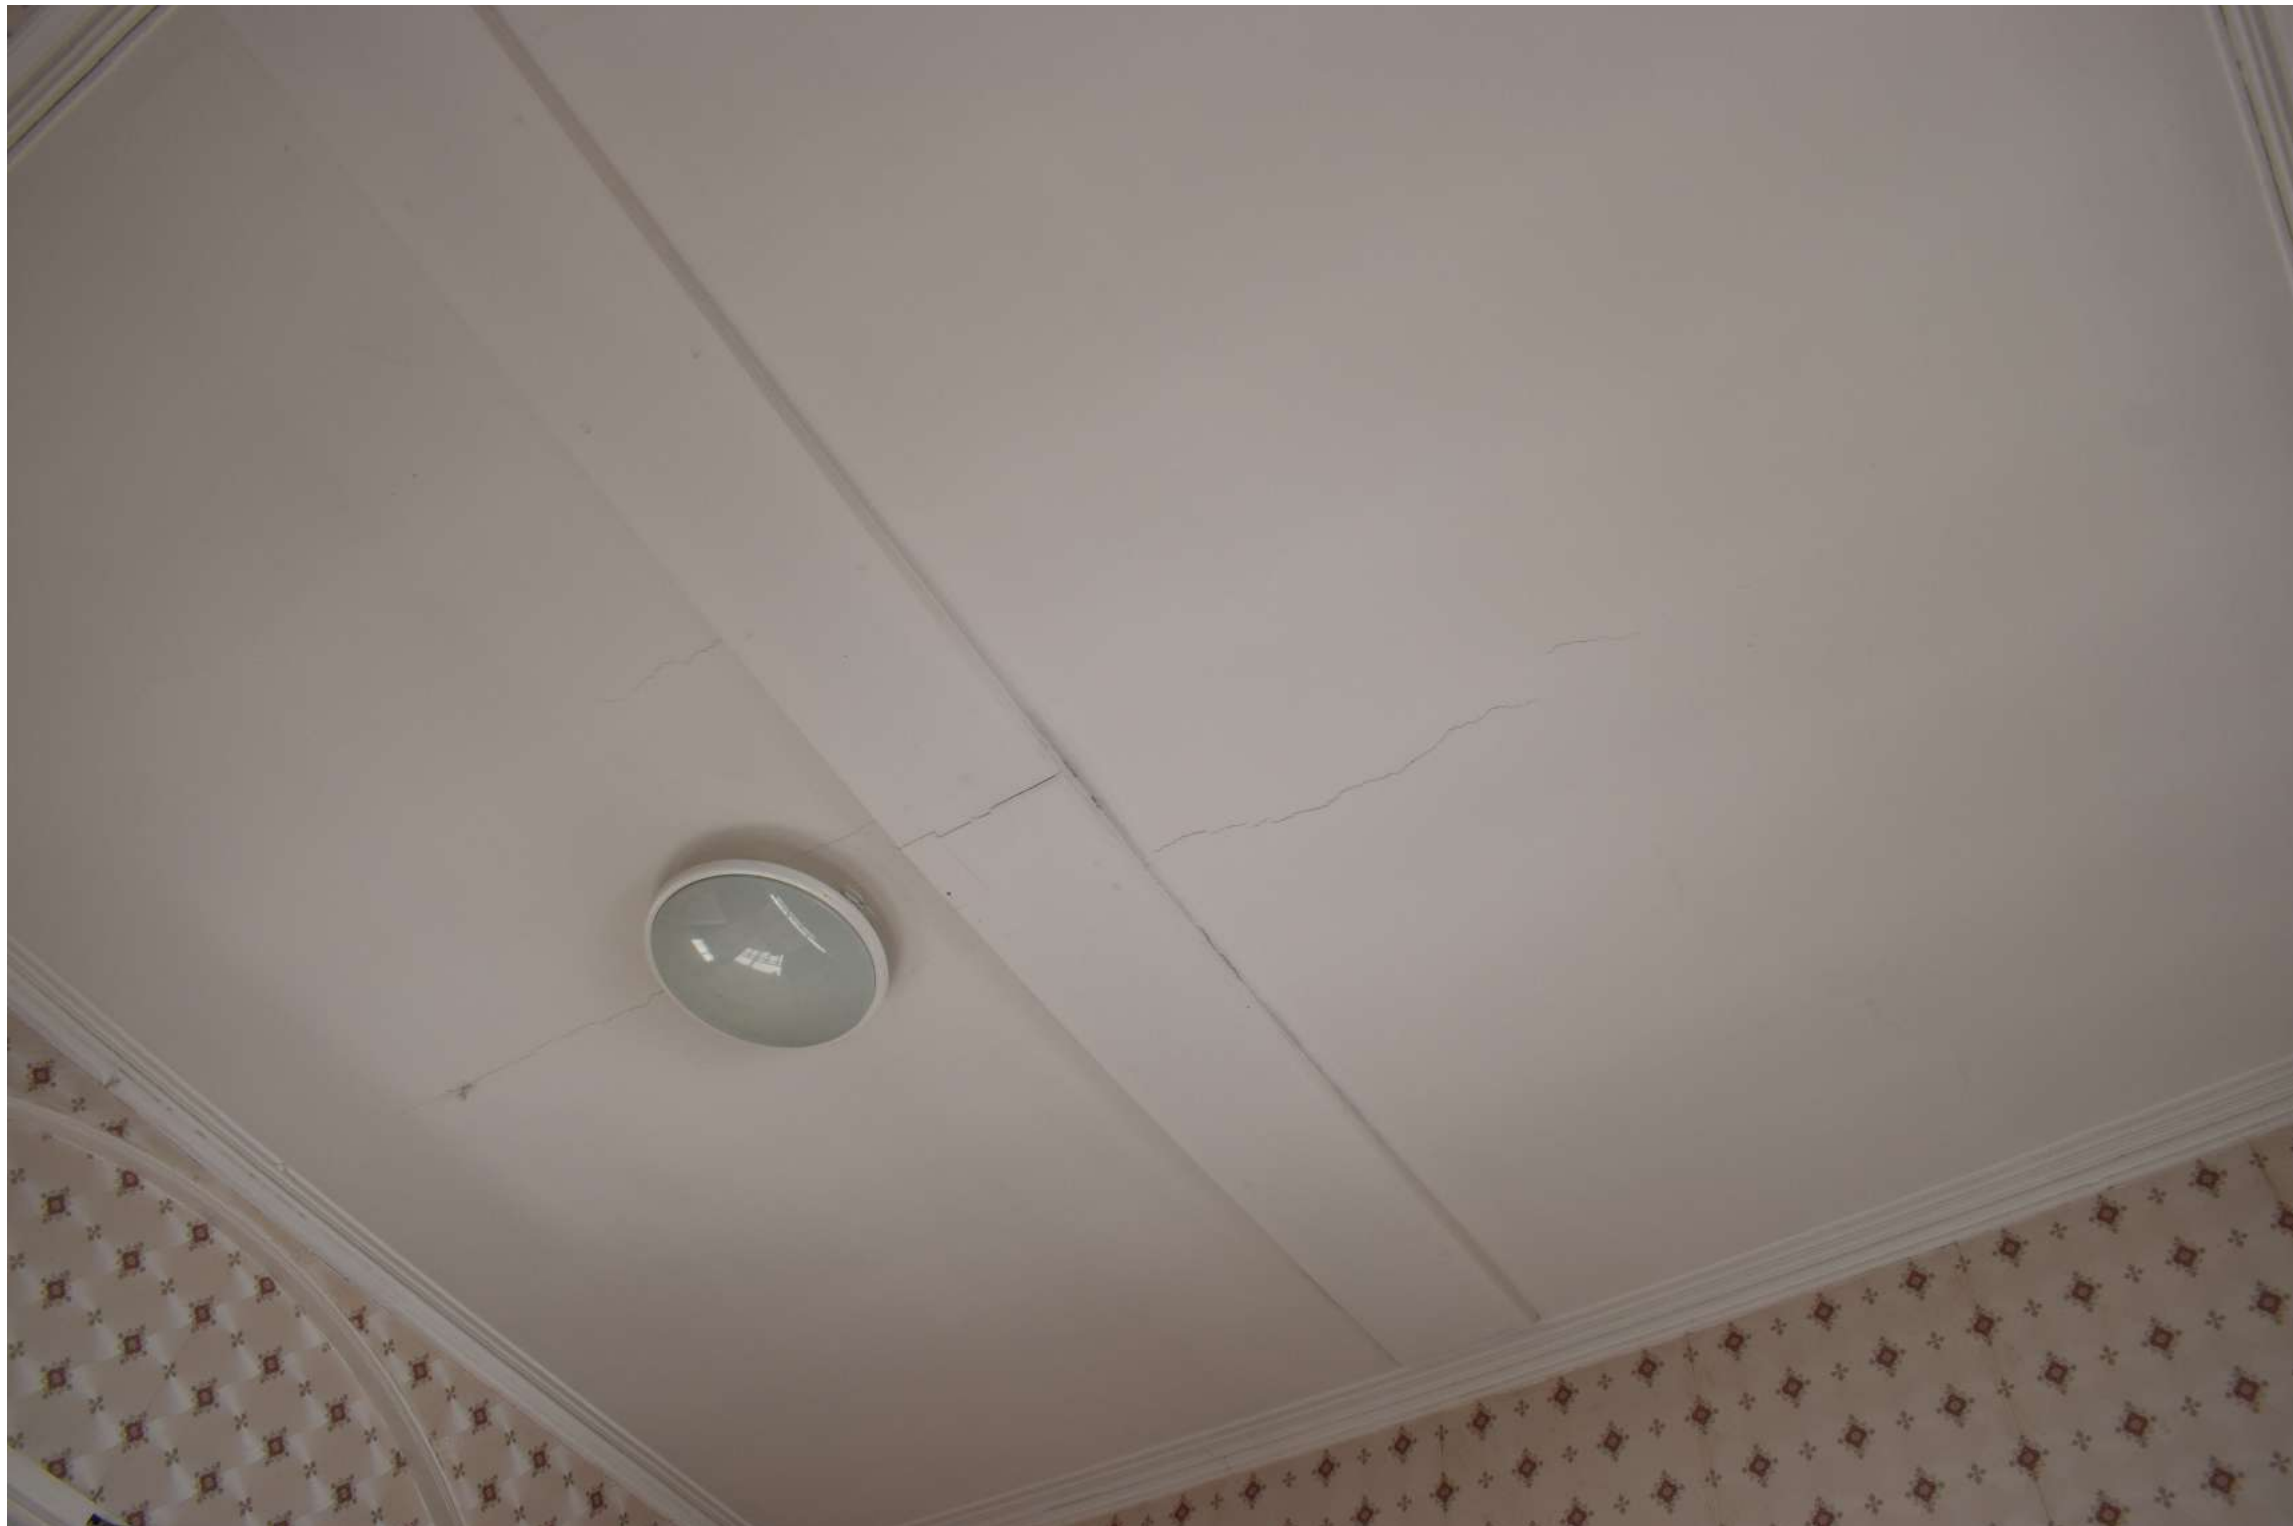
Plate 25

A crack and deflection (bowing) is evident across the beam supporting the lath and plaster ceiling construction of the principle stairs.

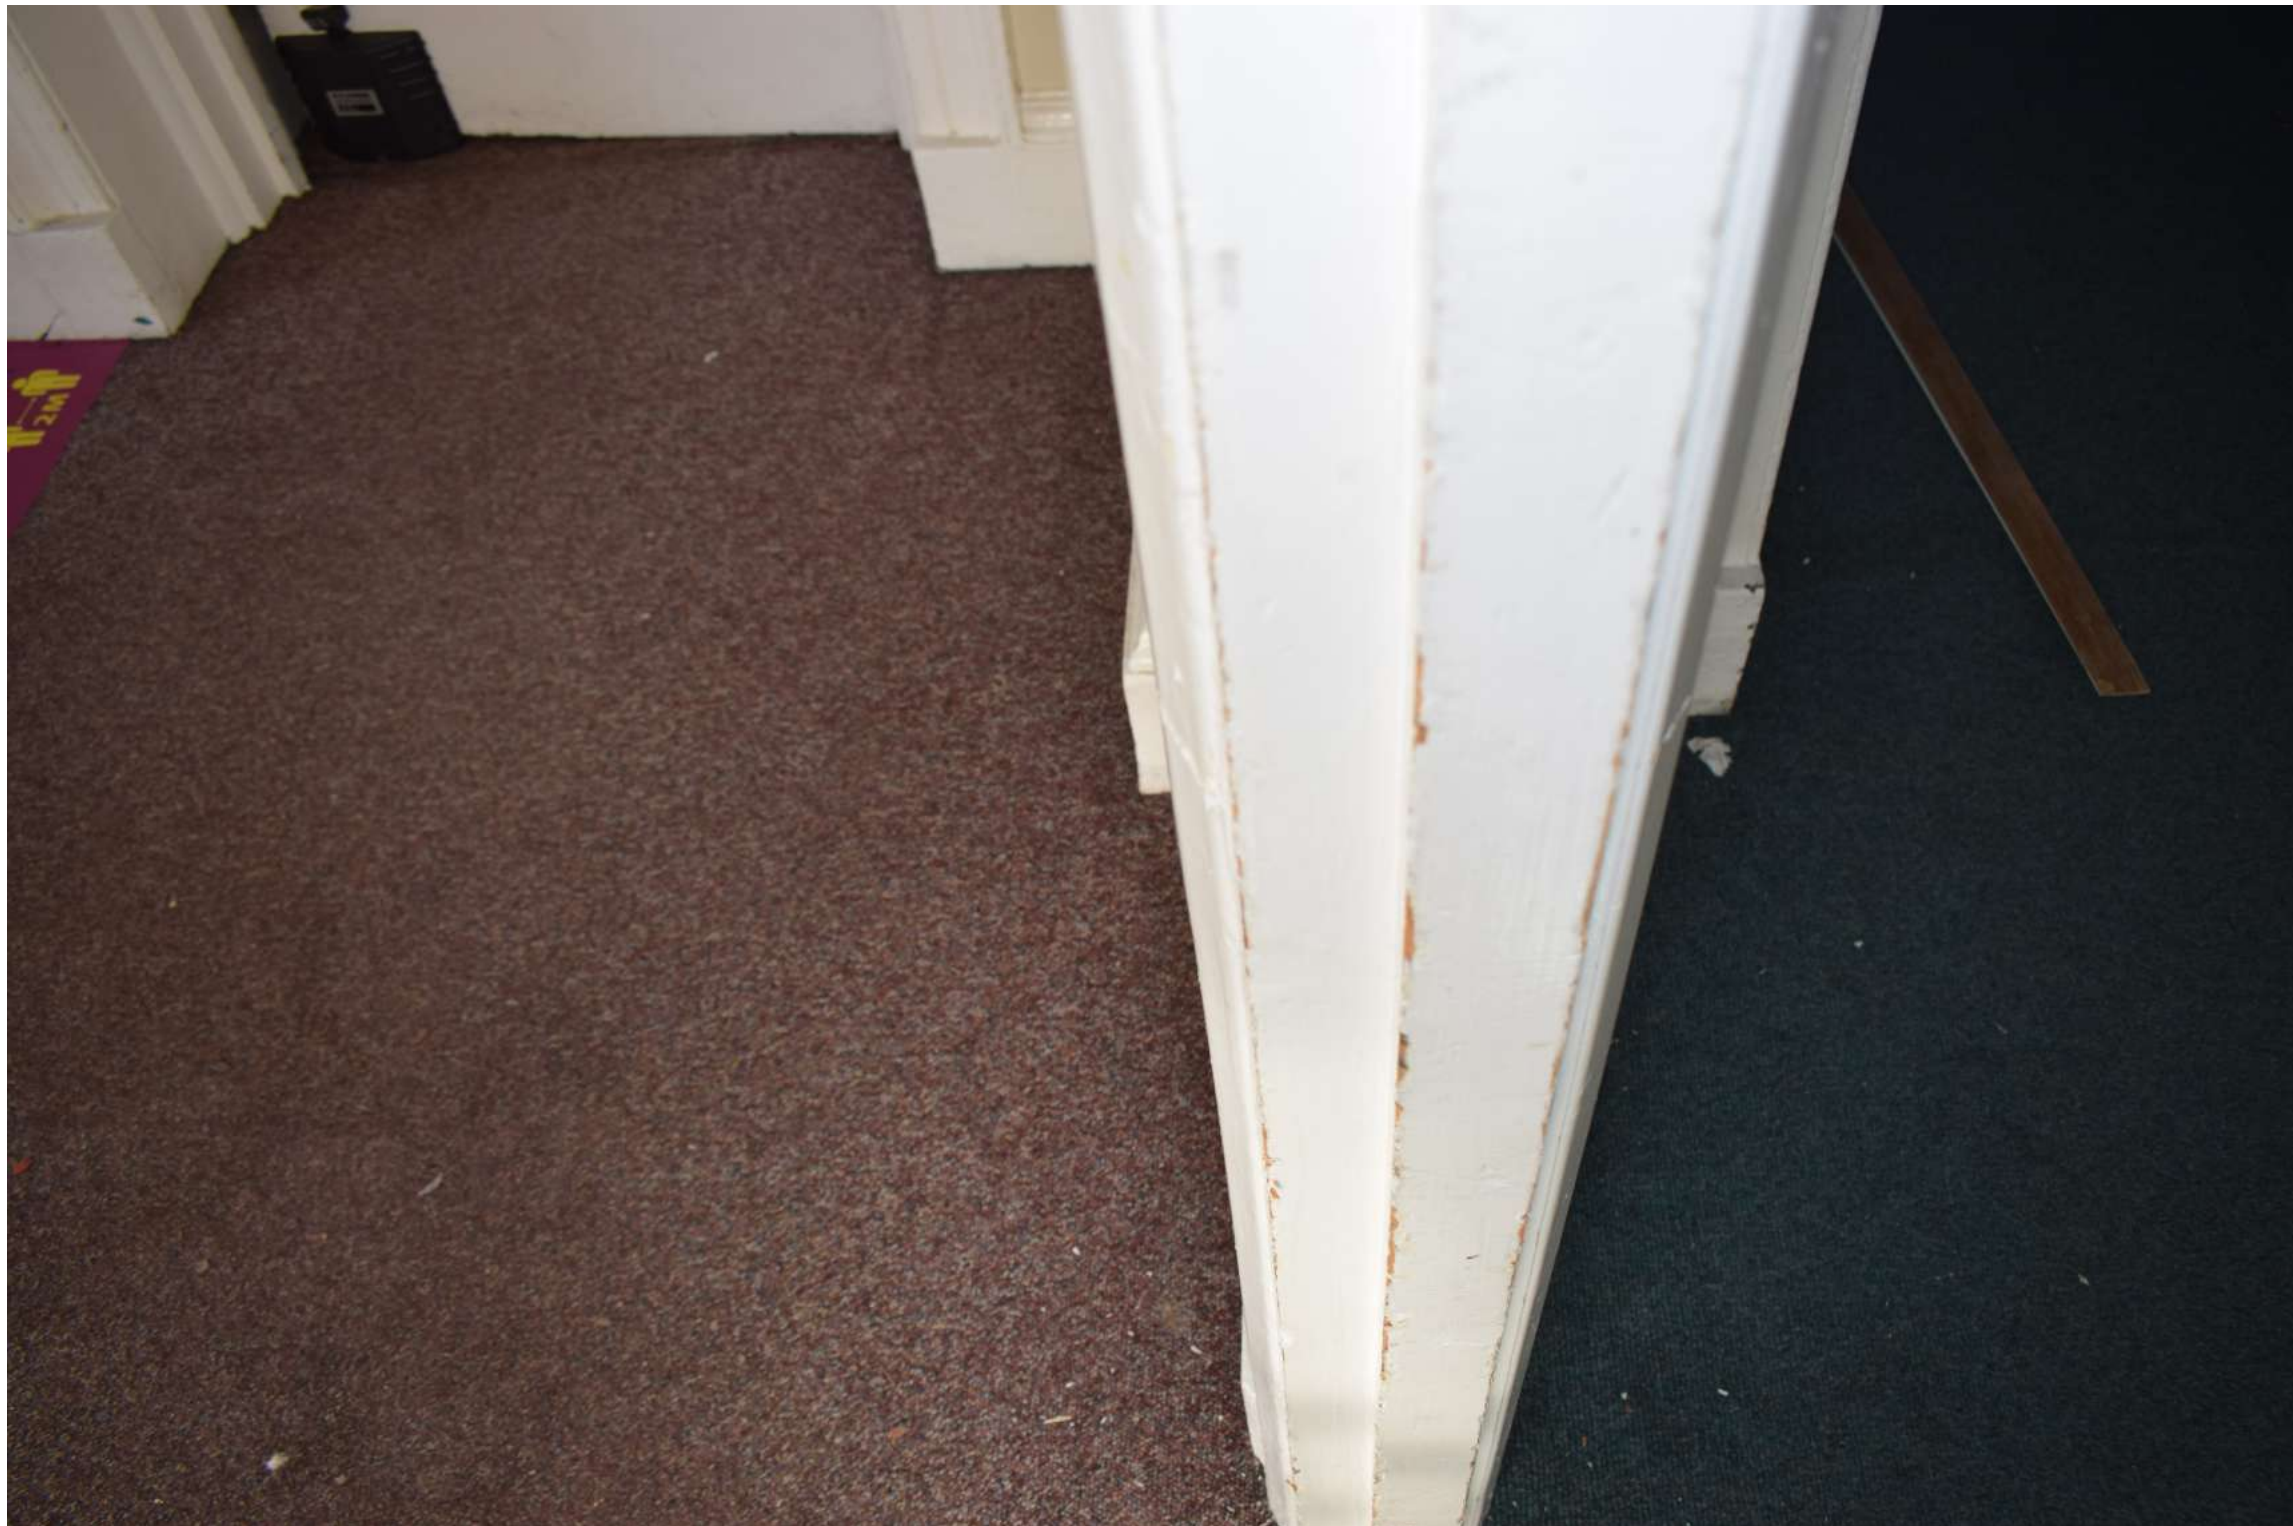
Plate 26

A detailed image of the timber panel installed at the stairhead appears to be an infill section, potentially closing off a previous double doorway opening.
