Archway Heritage

# Appendix 11

## Yeomanry House

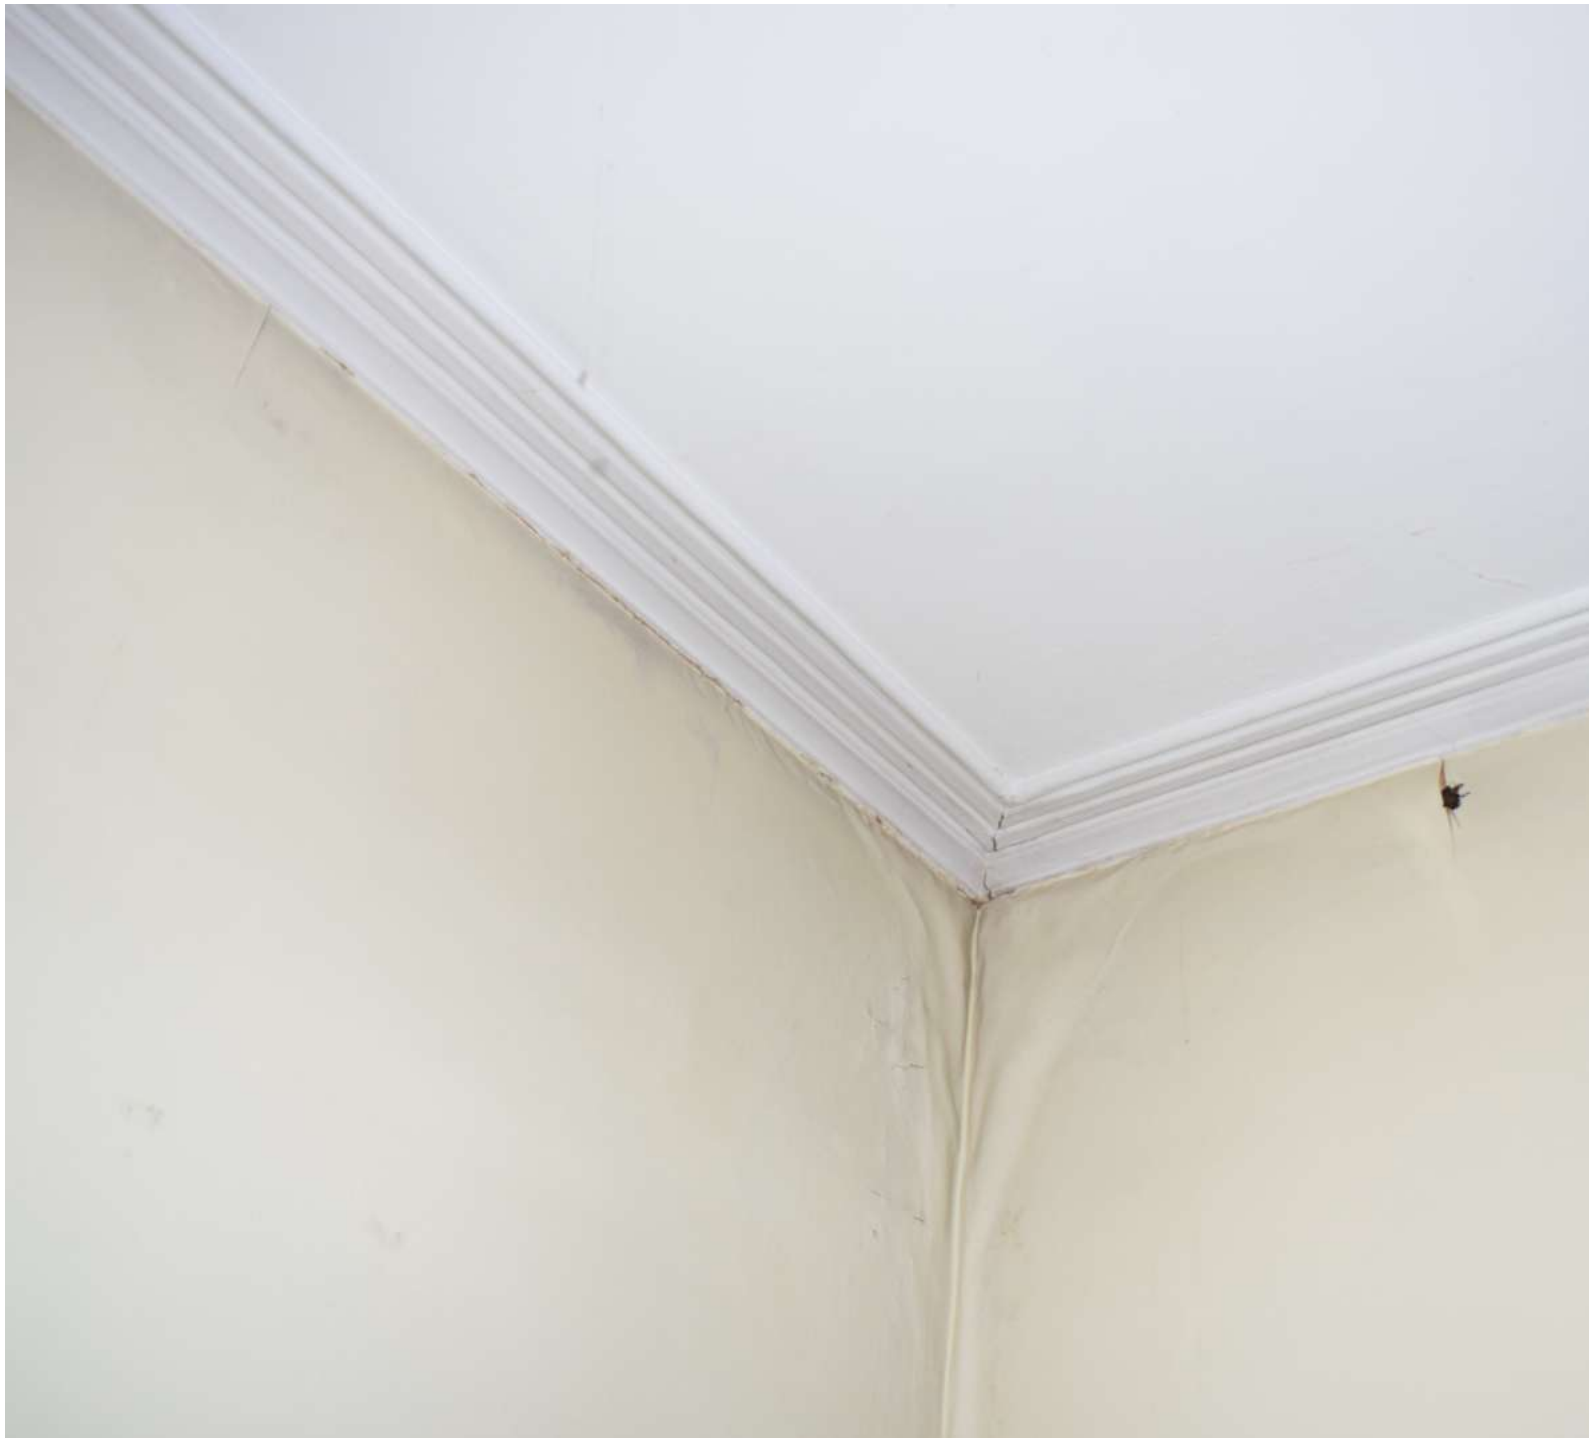
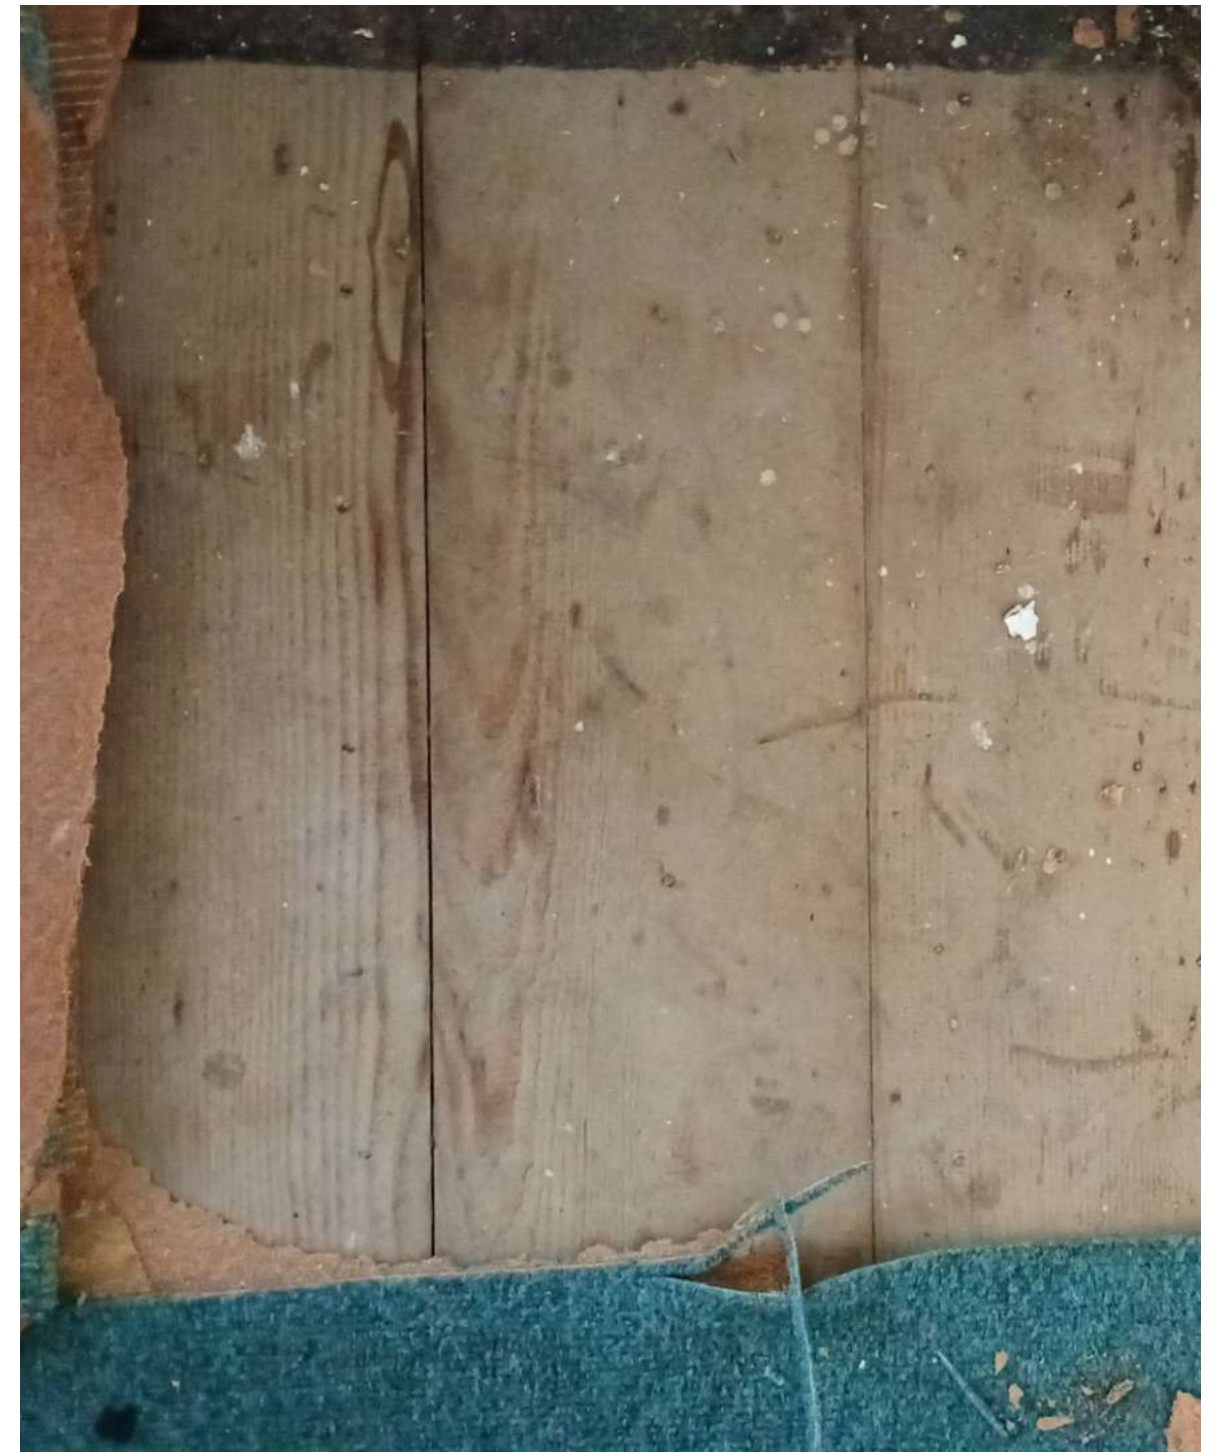
Plate 35

Condition issue: Noting signs of damp on the corner wall, concurrent with minor damage to the coving. Inset: a detail of the timber flooring.

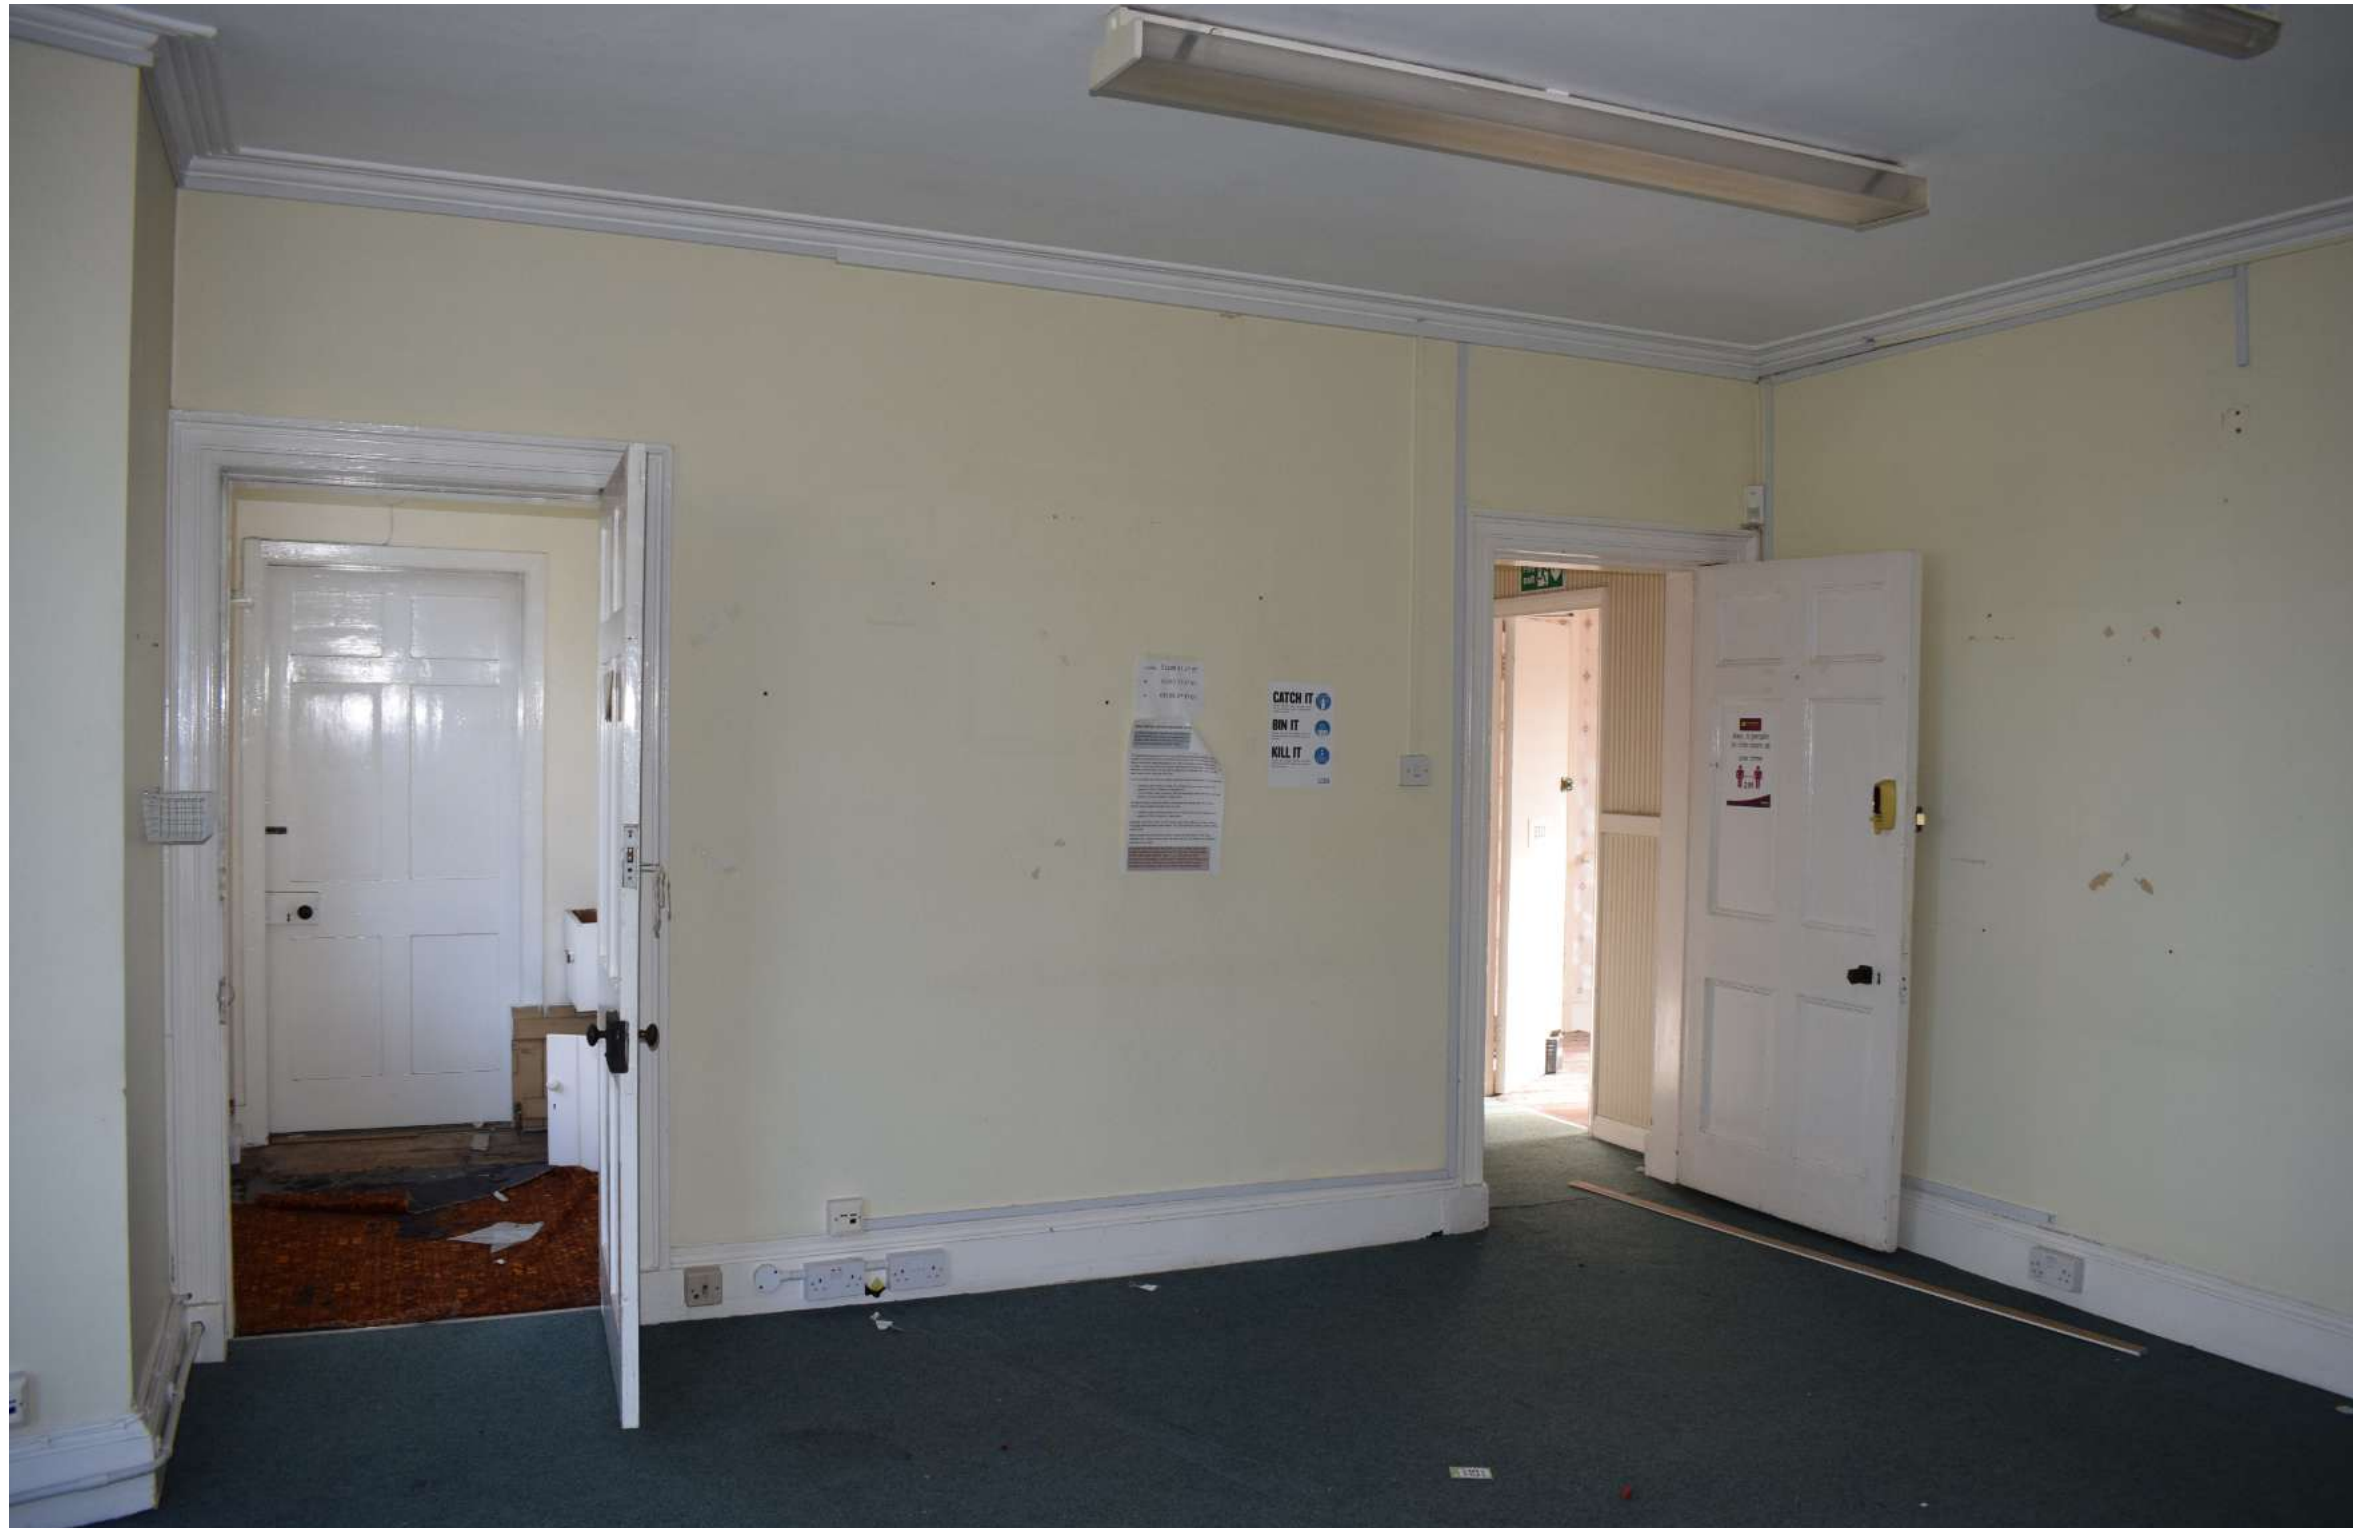
Plate 36

The ceilings in both bow window rooms appear to be lath and plaster with signs of historic damage but are otherwise in good condition.

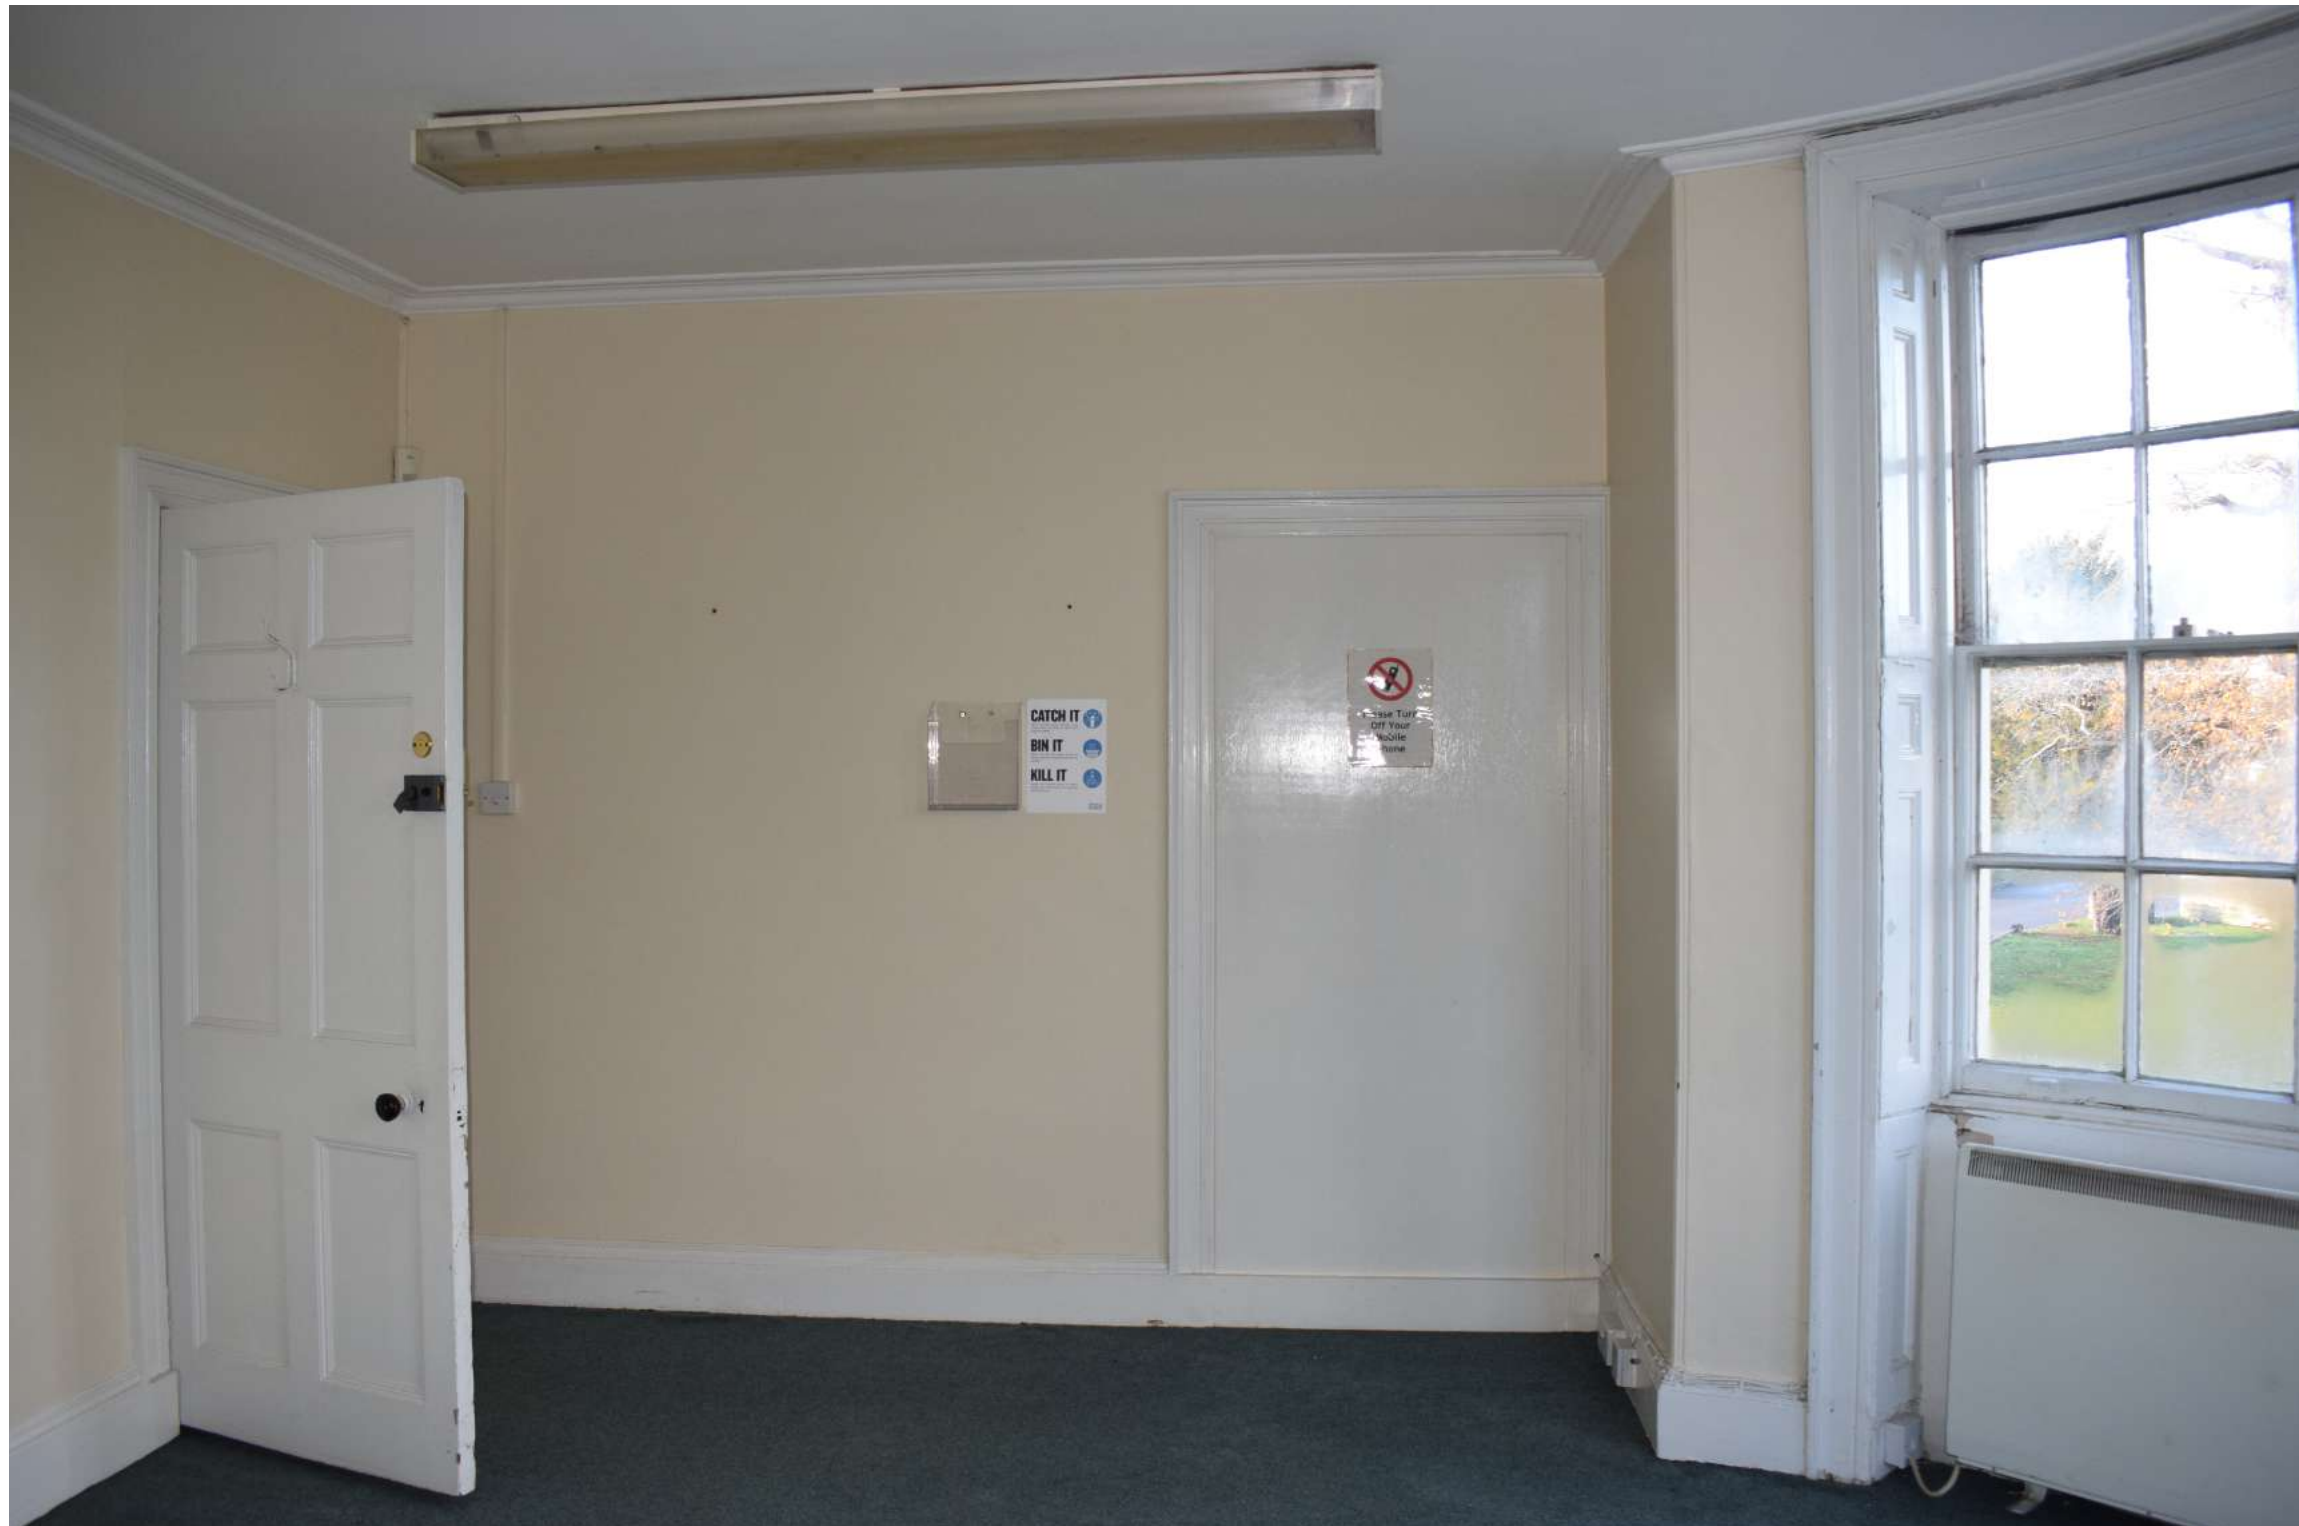
Plate 40

A former doorway that is blocked-up, once gave access to the serving room (larder).

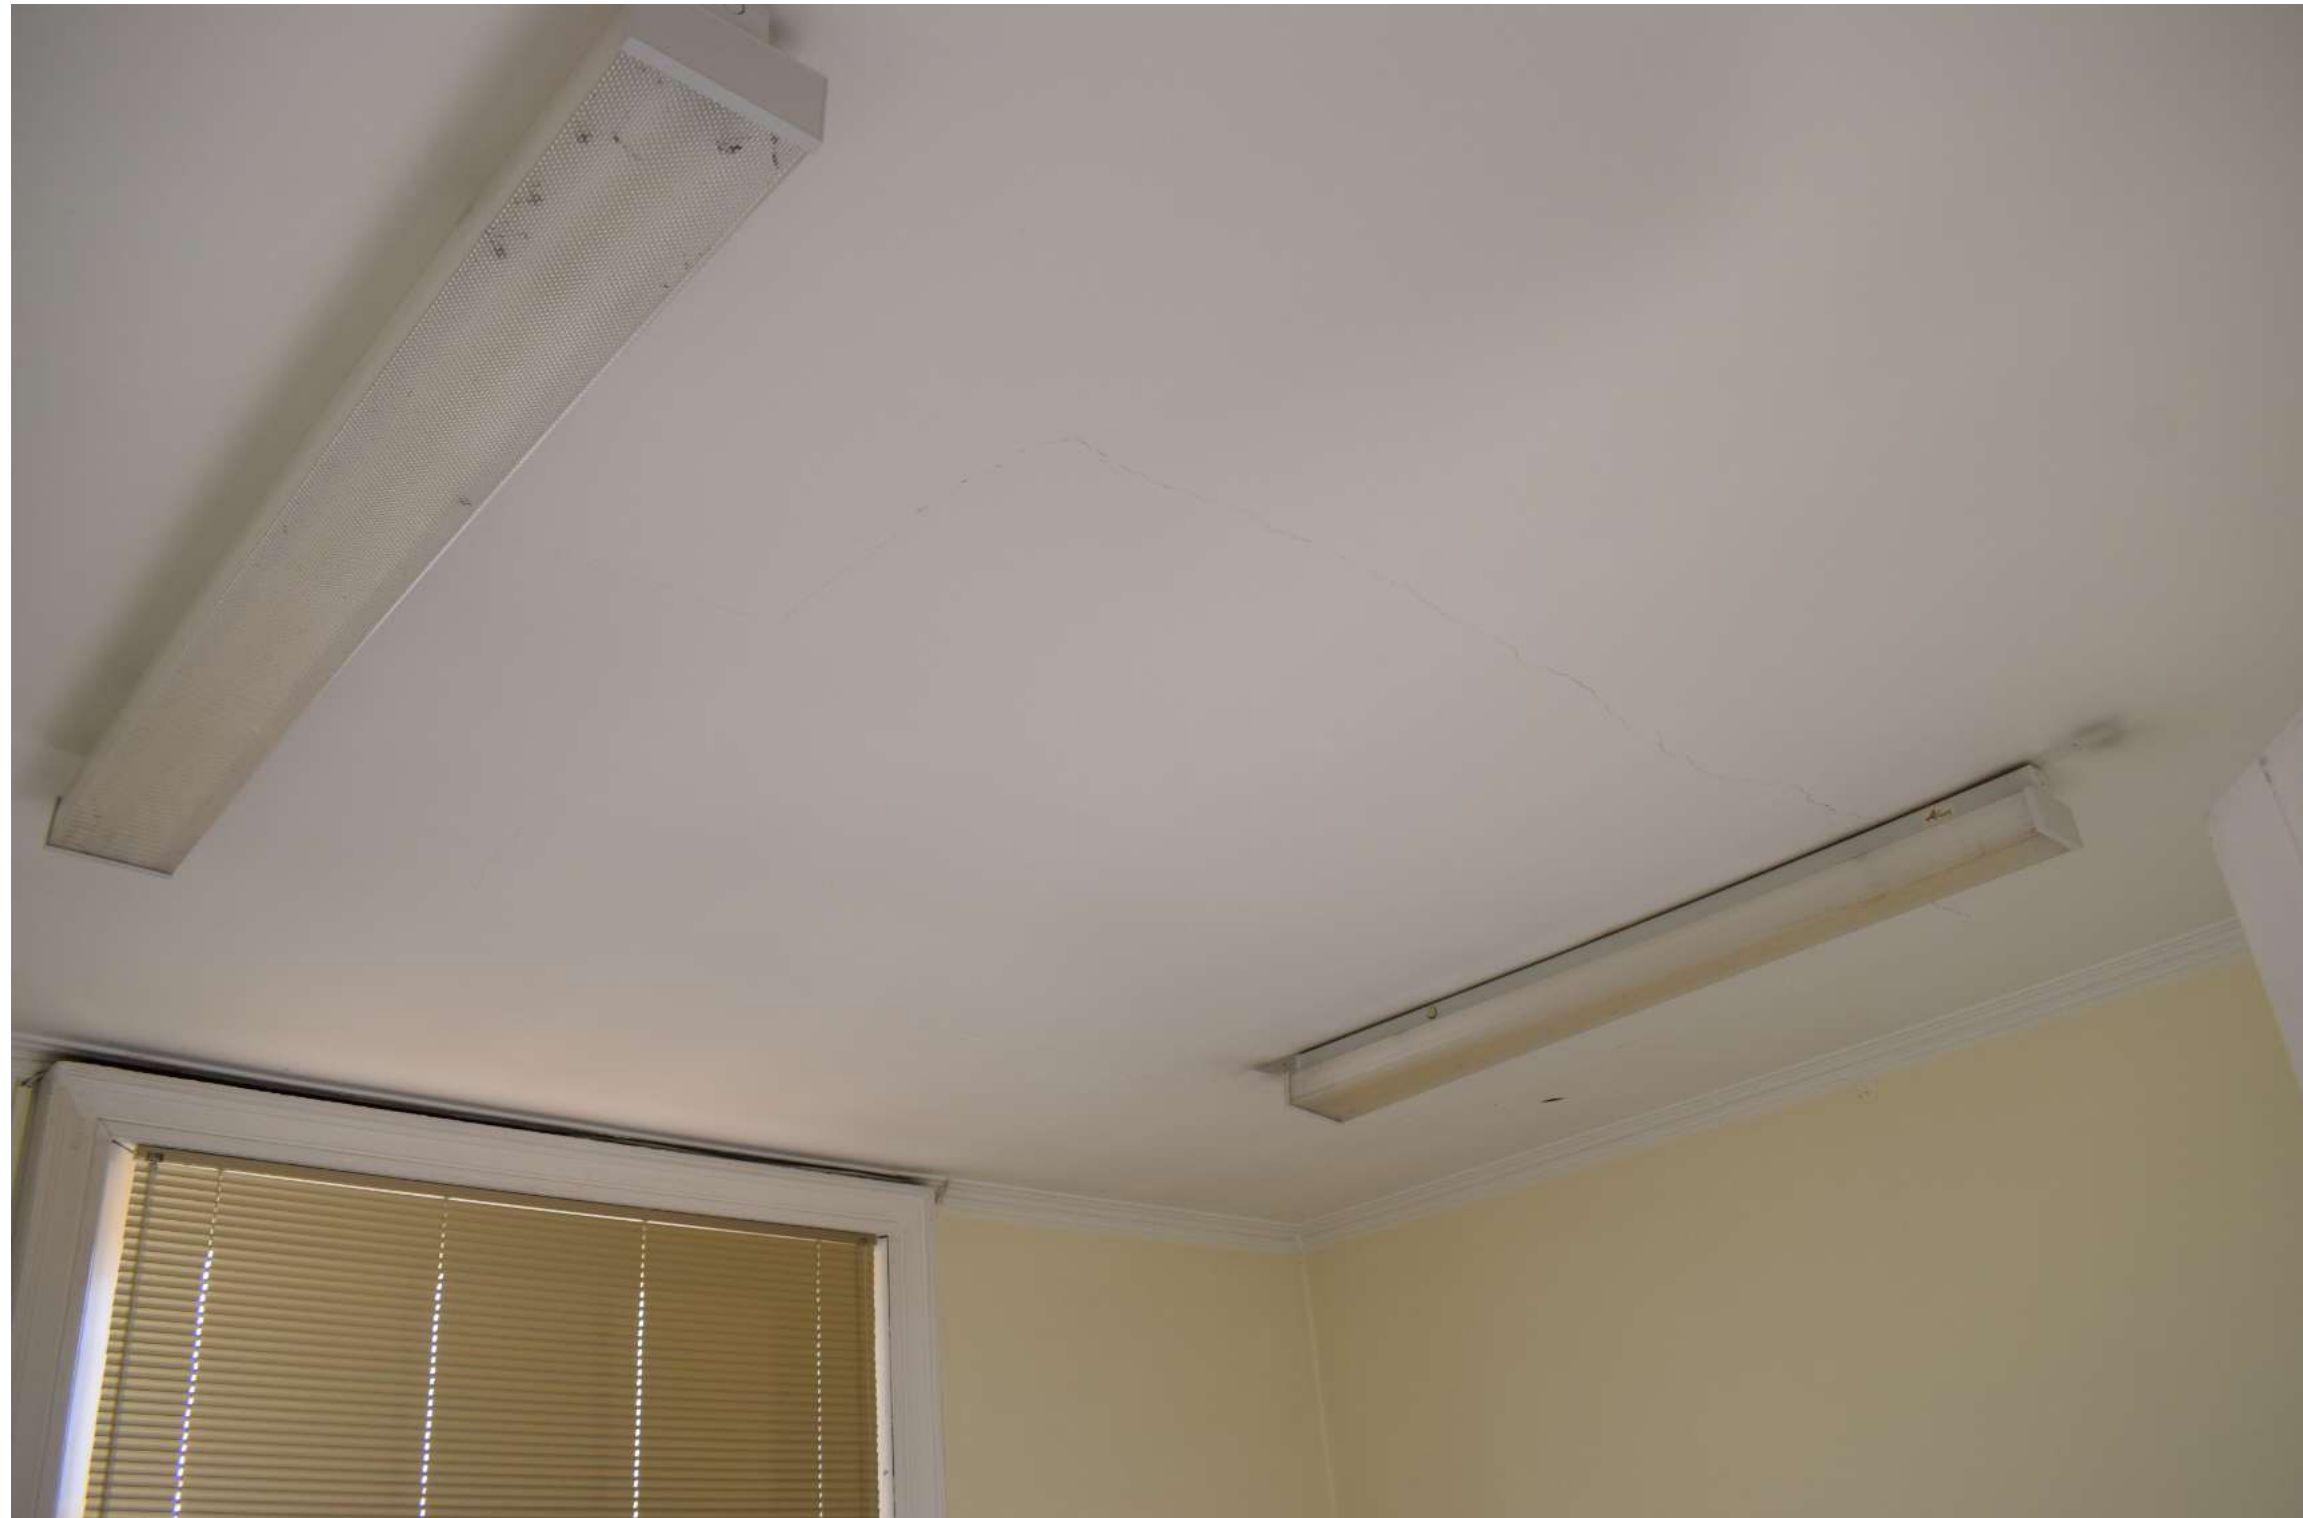
Plate 45

Small crack in the ceiling

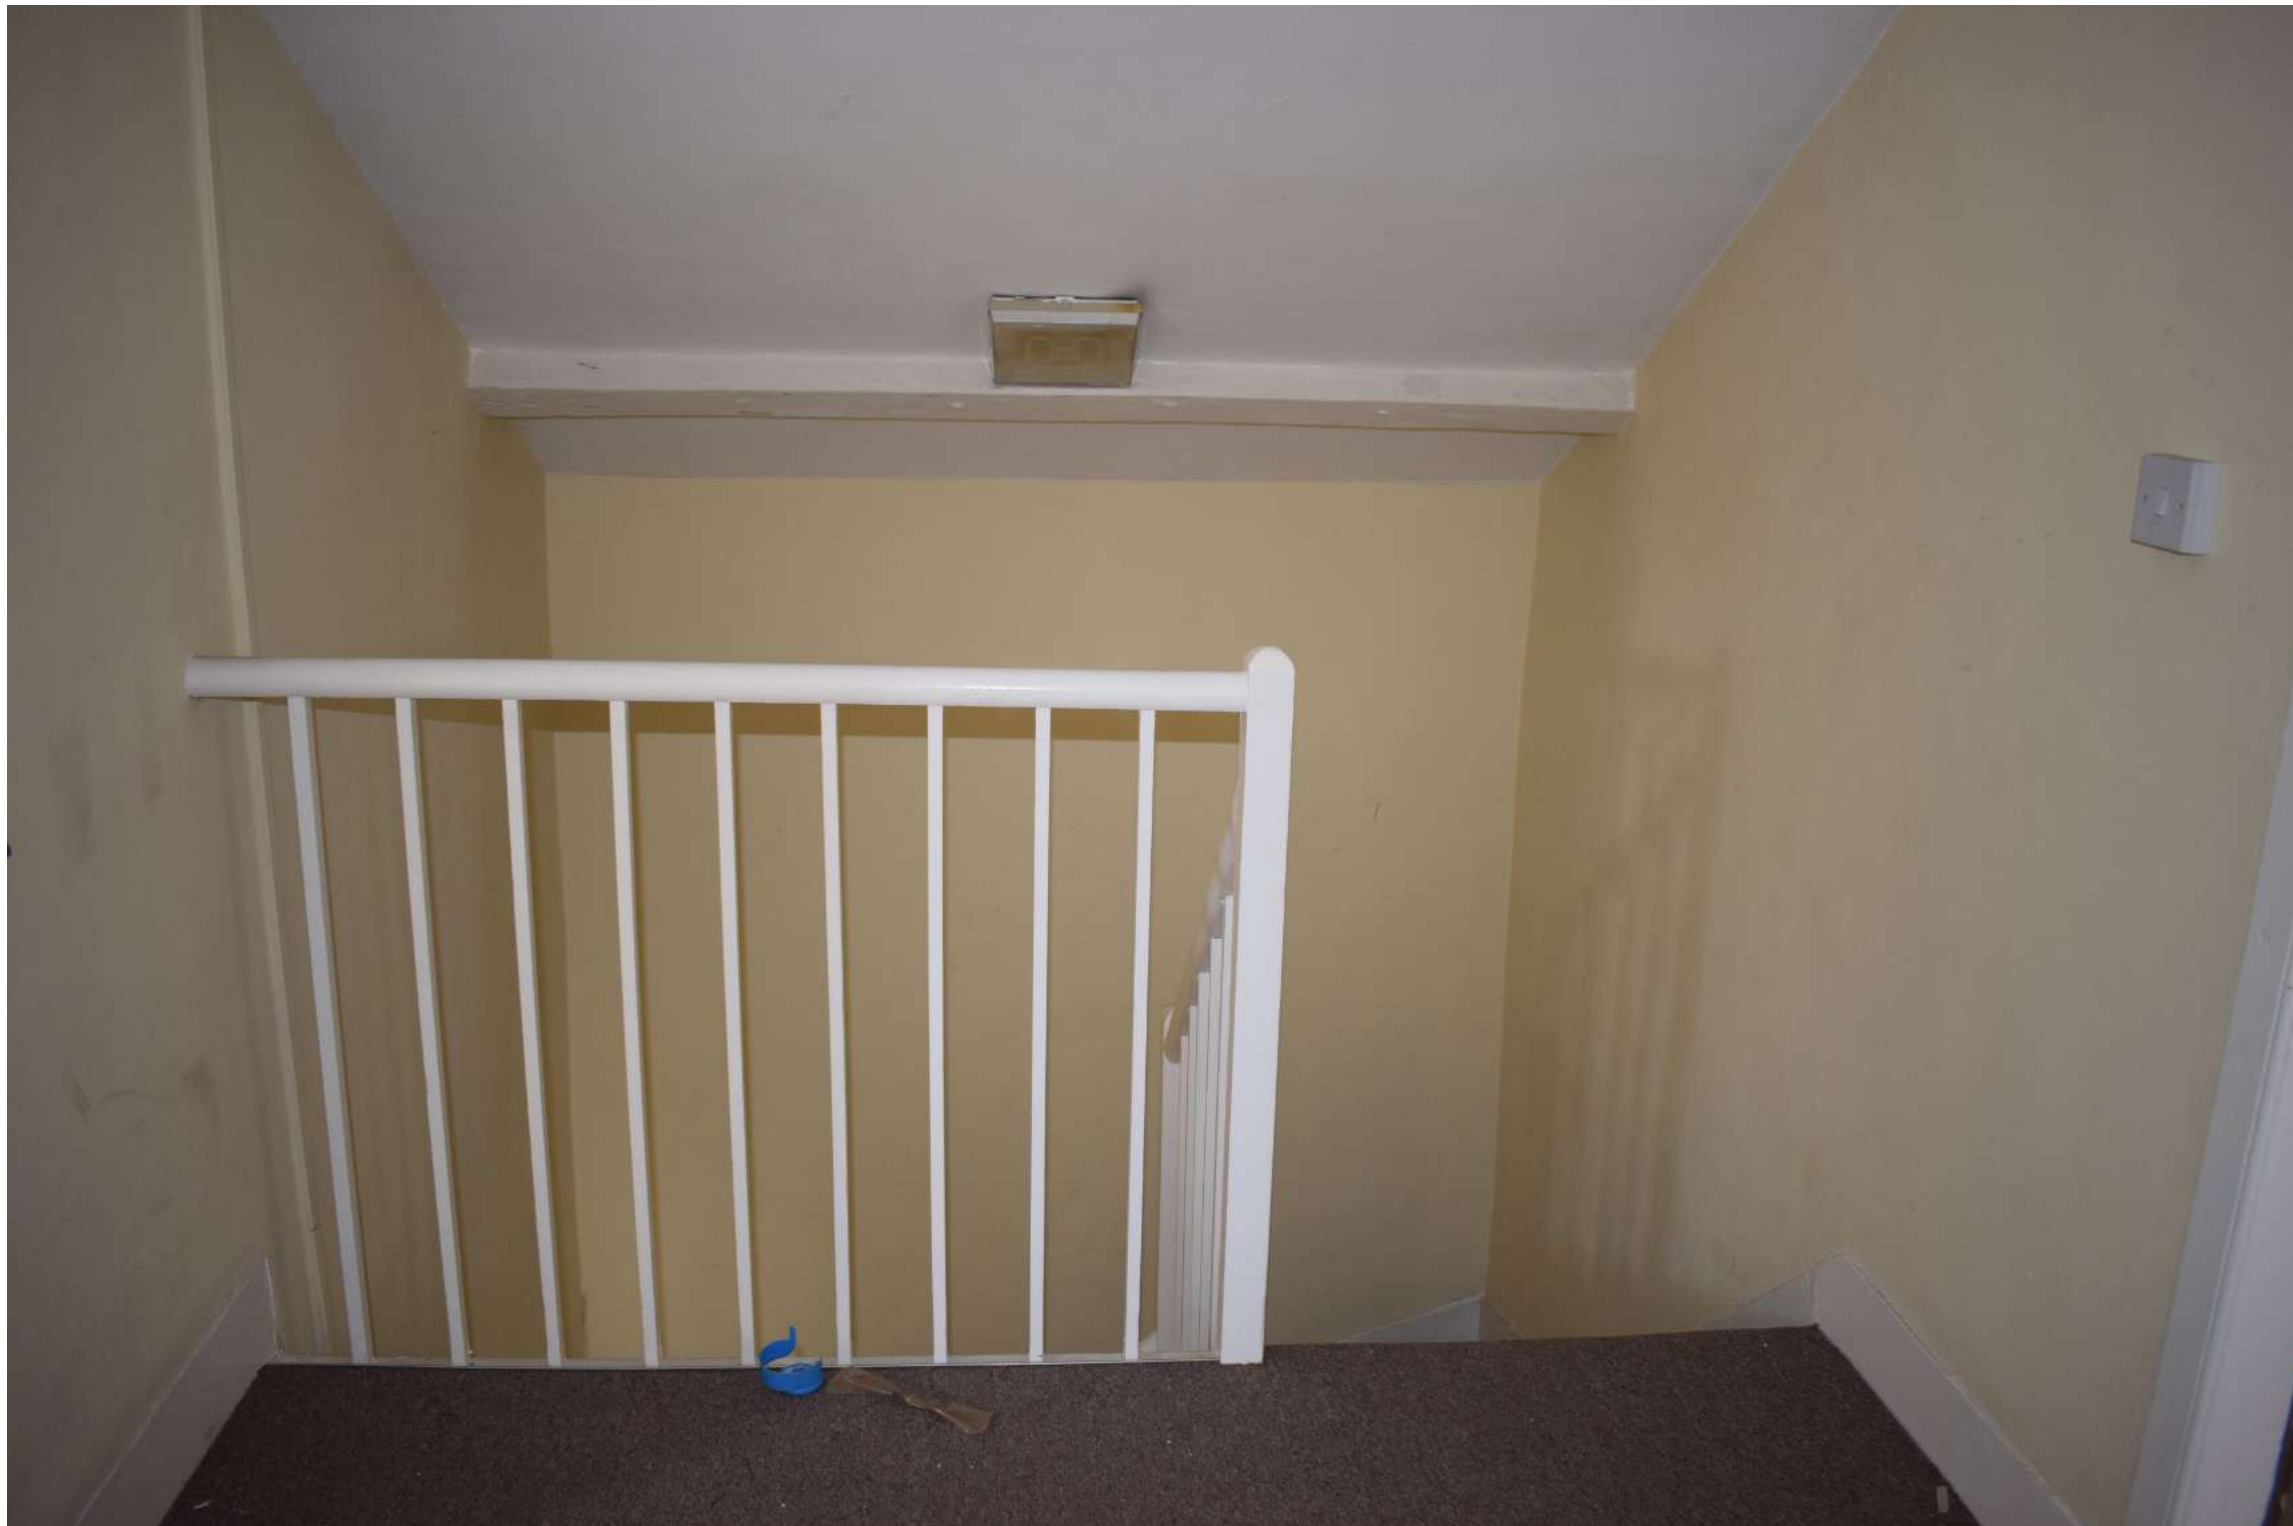
Plate 49

The landing is in good condition, but the walls either side are in very poor condition and suffering from damp.

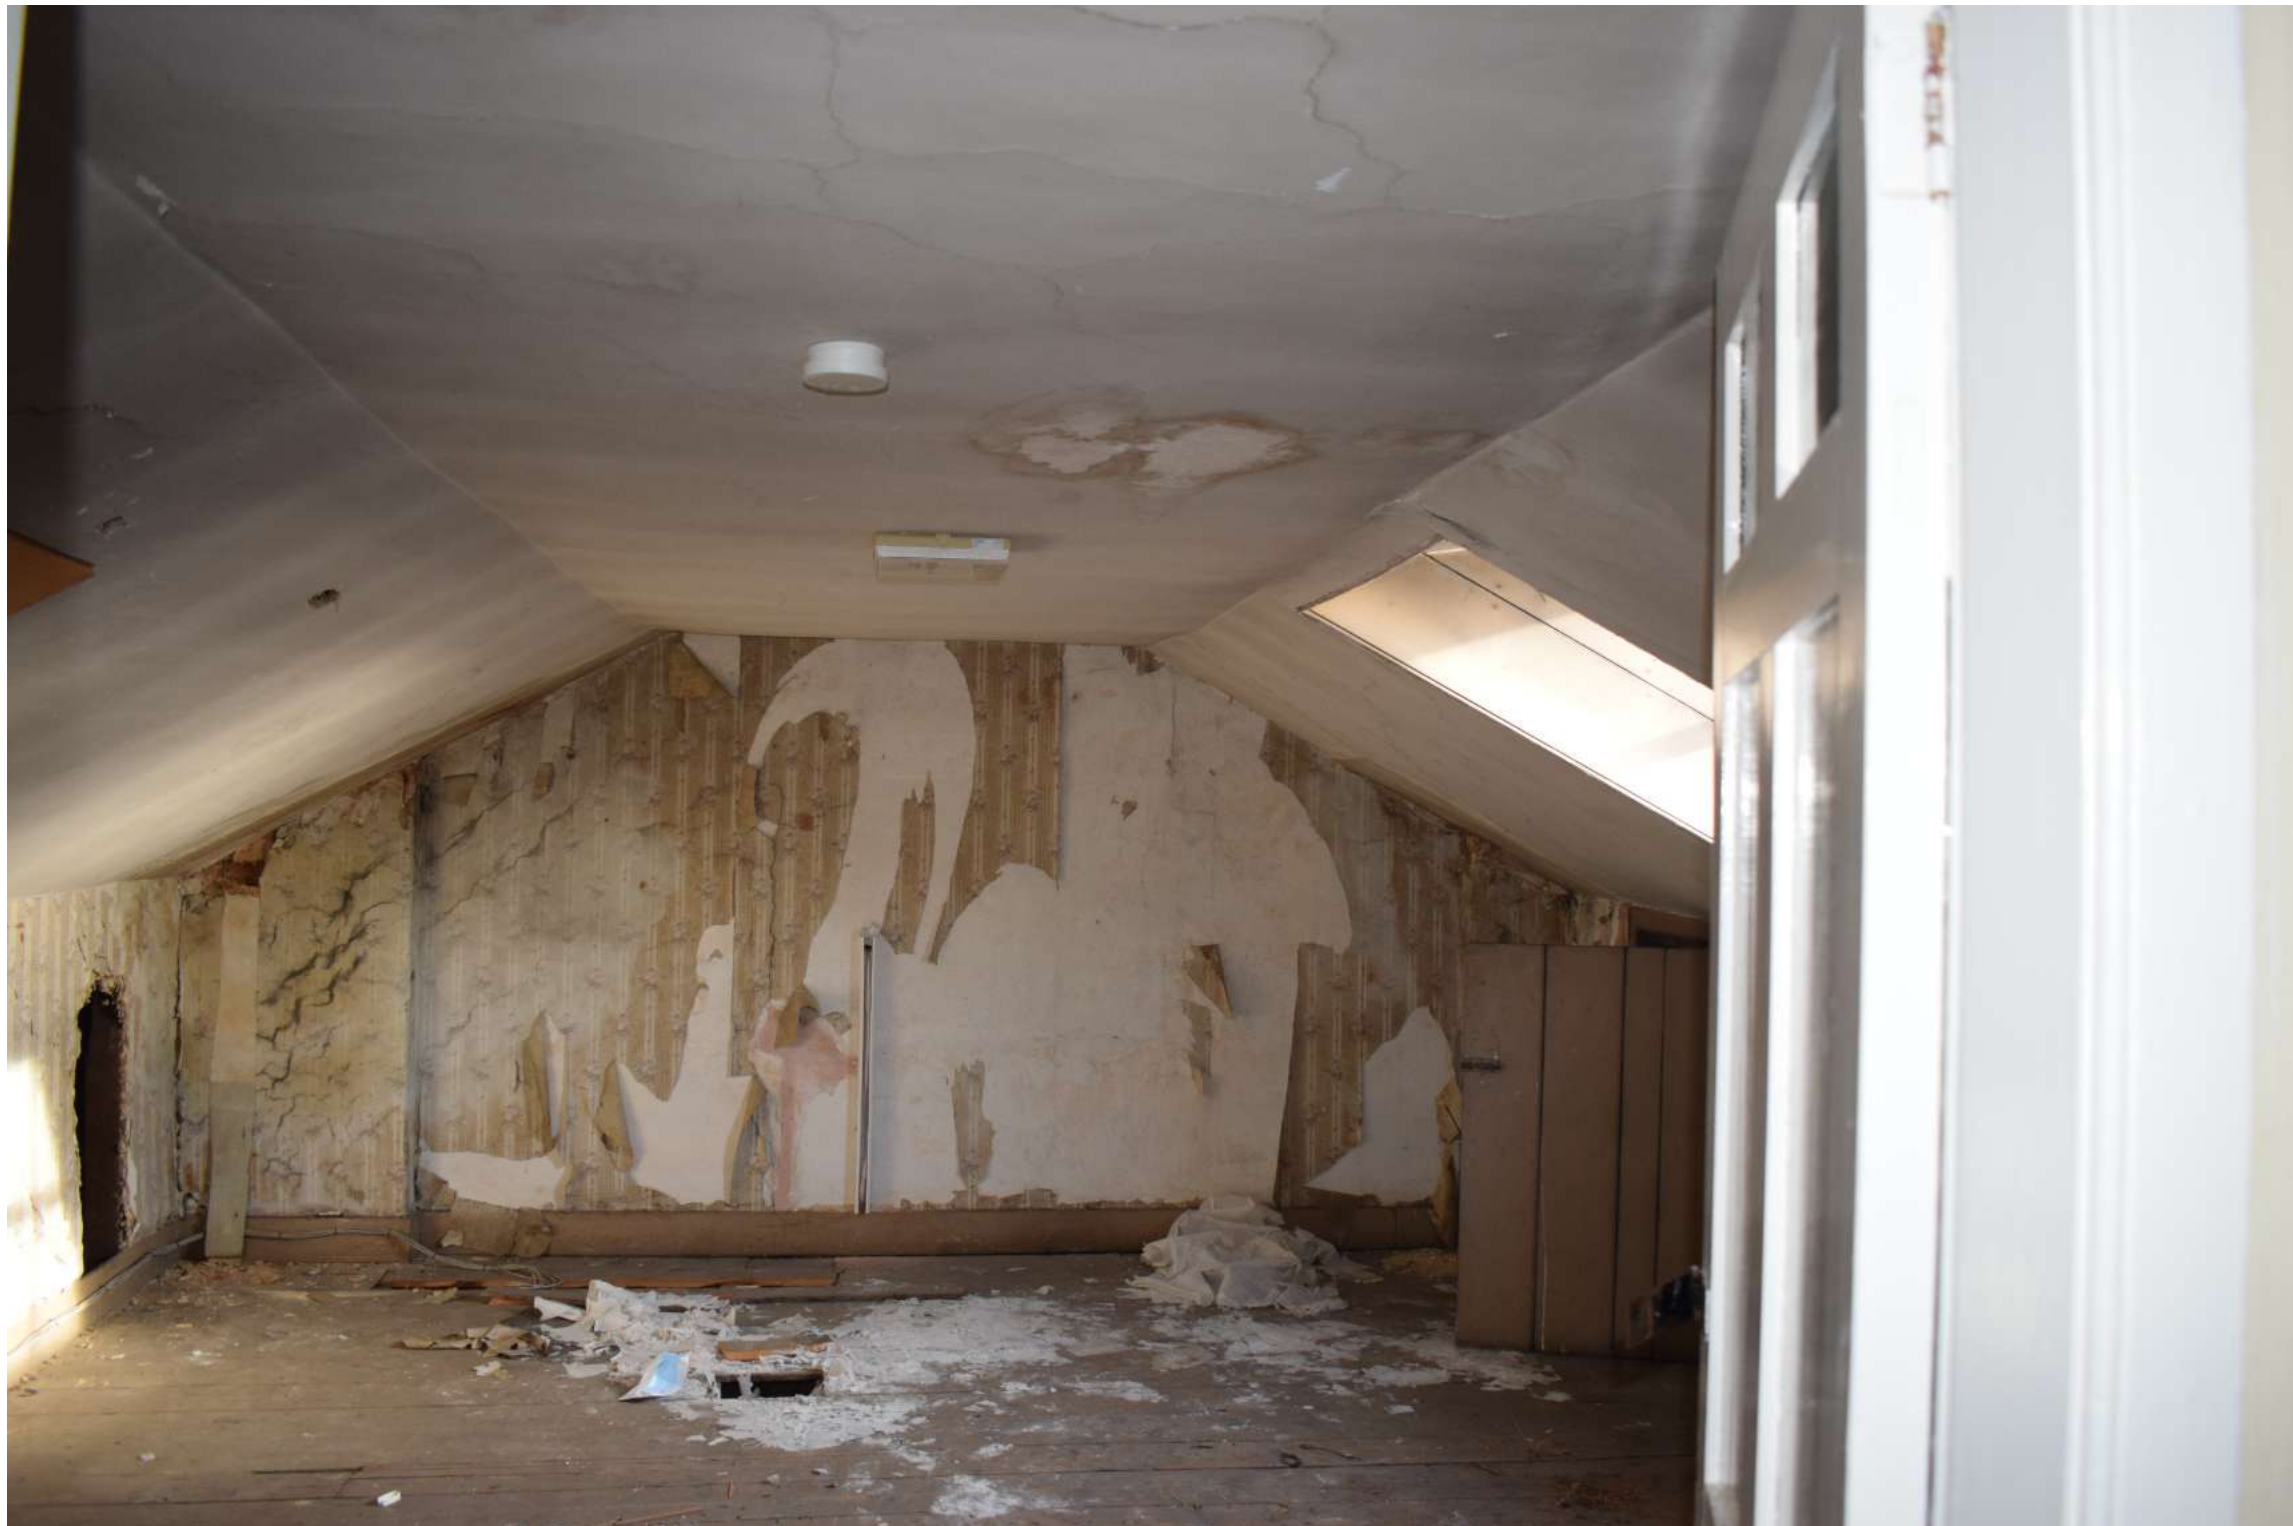
Plate 50

The poor state of the wall may necessitate the complete removal of both plaster and supporting laths. The historic floorboards have been retained within the main space.
