Archway Heritage

# Appendix 11

## Yeomanry House

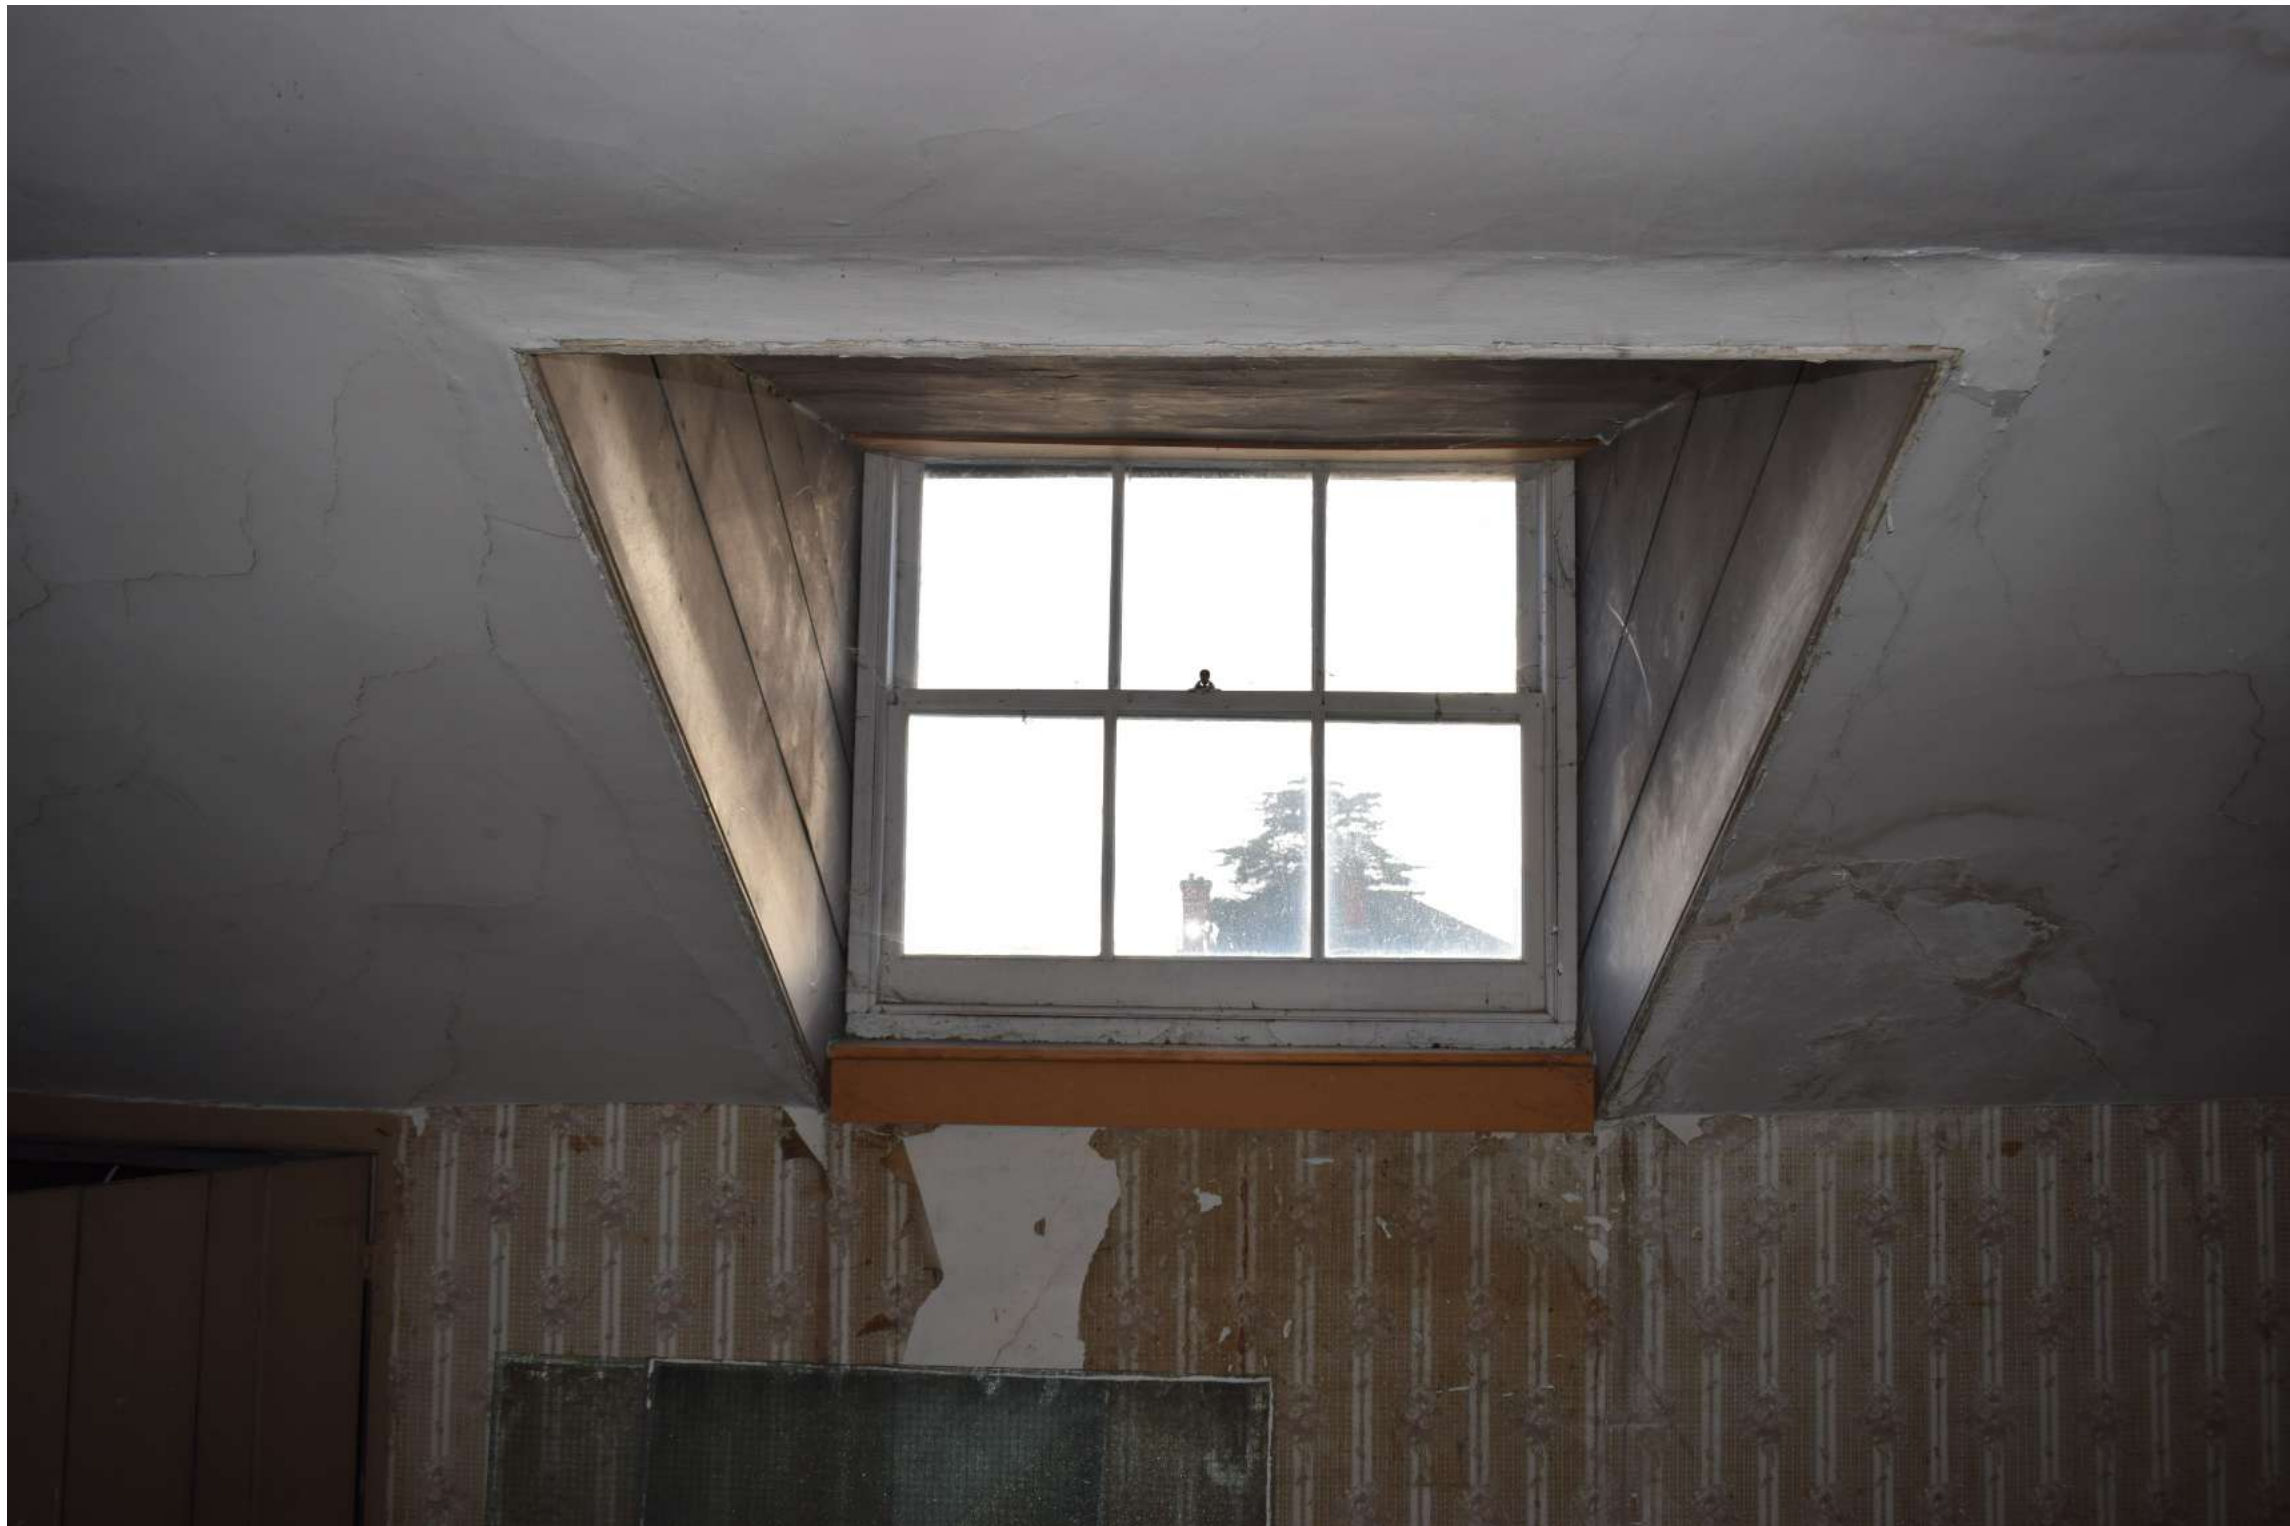
Plate 53

The roof timbers are relatively new on the dormer elevation.

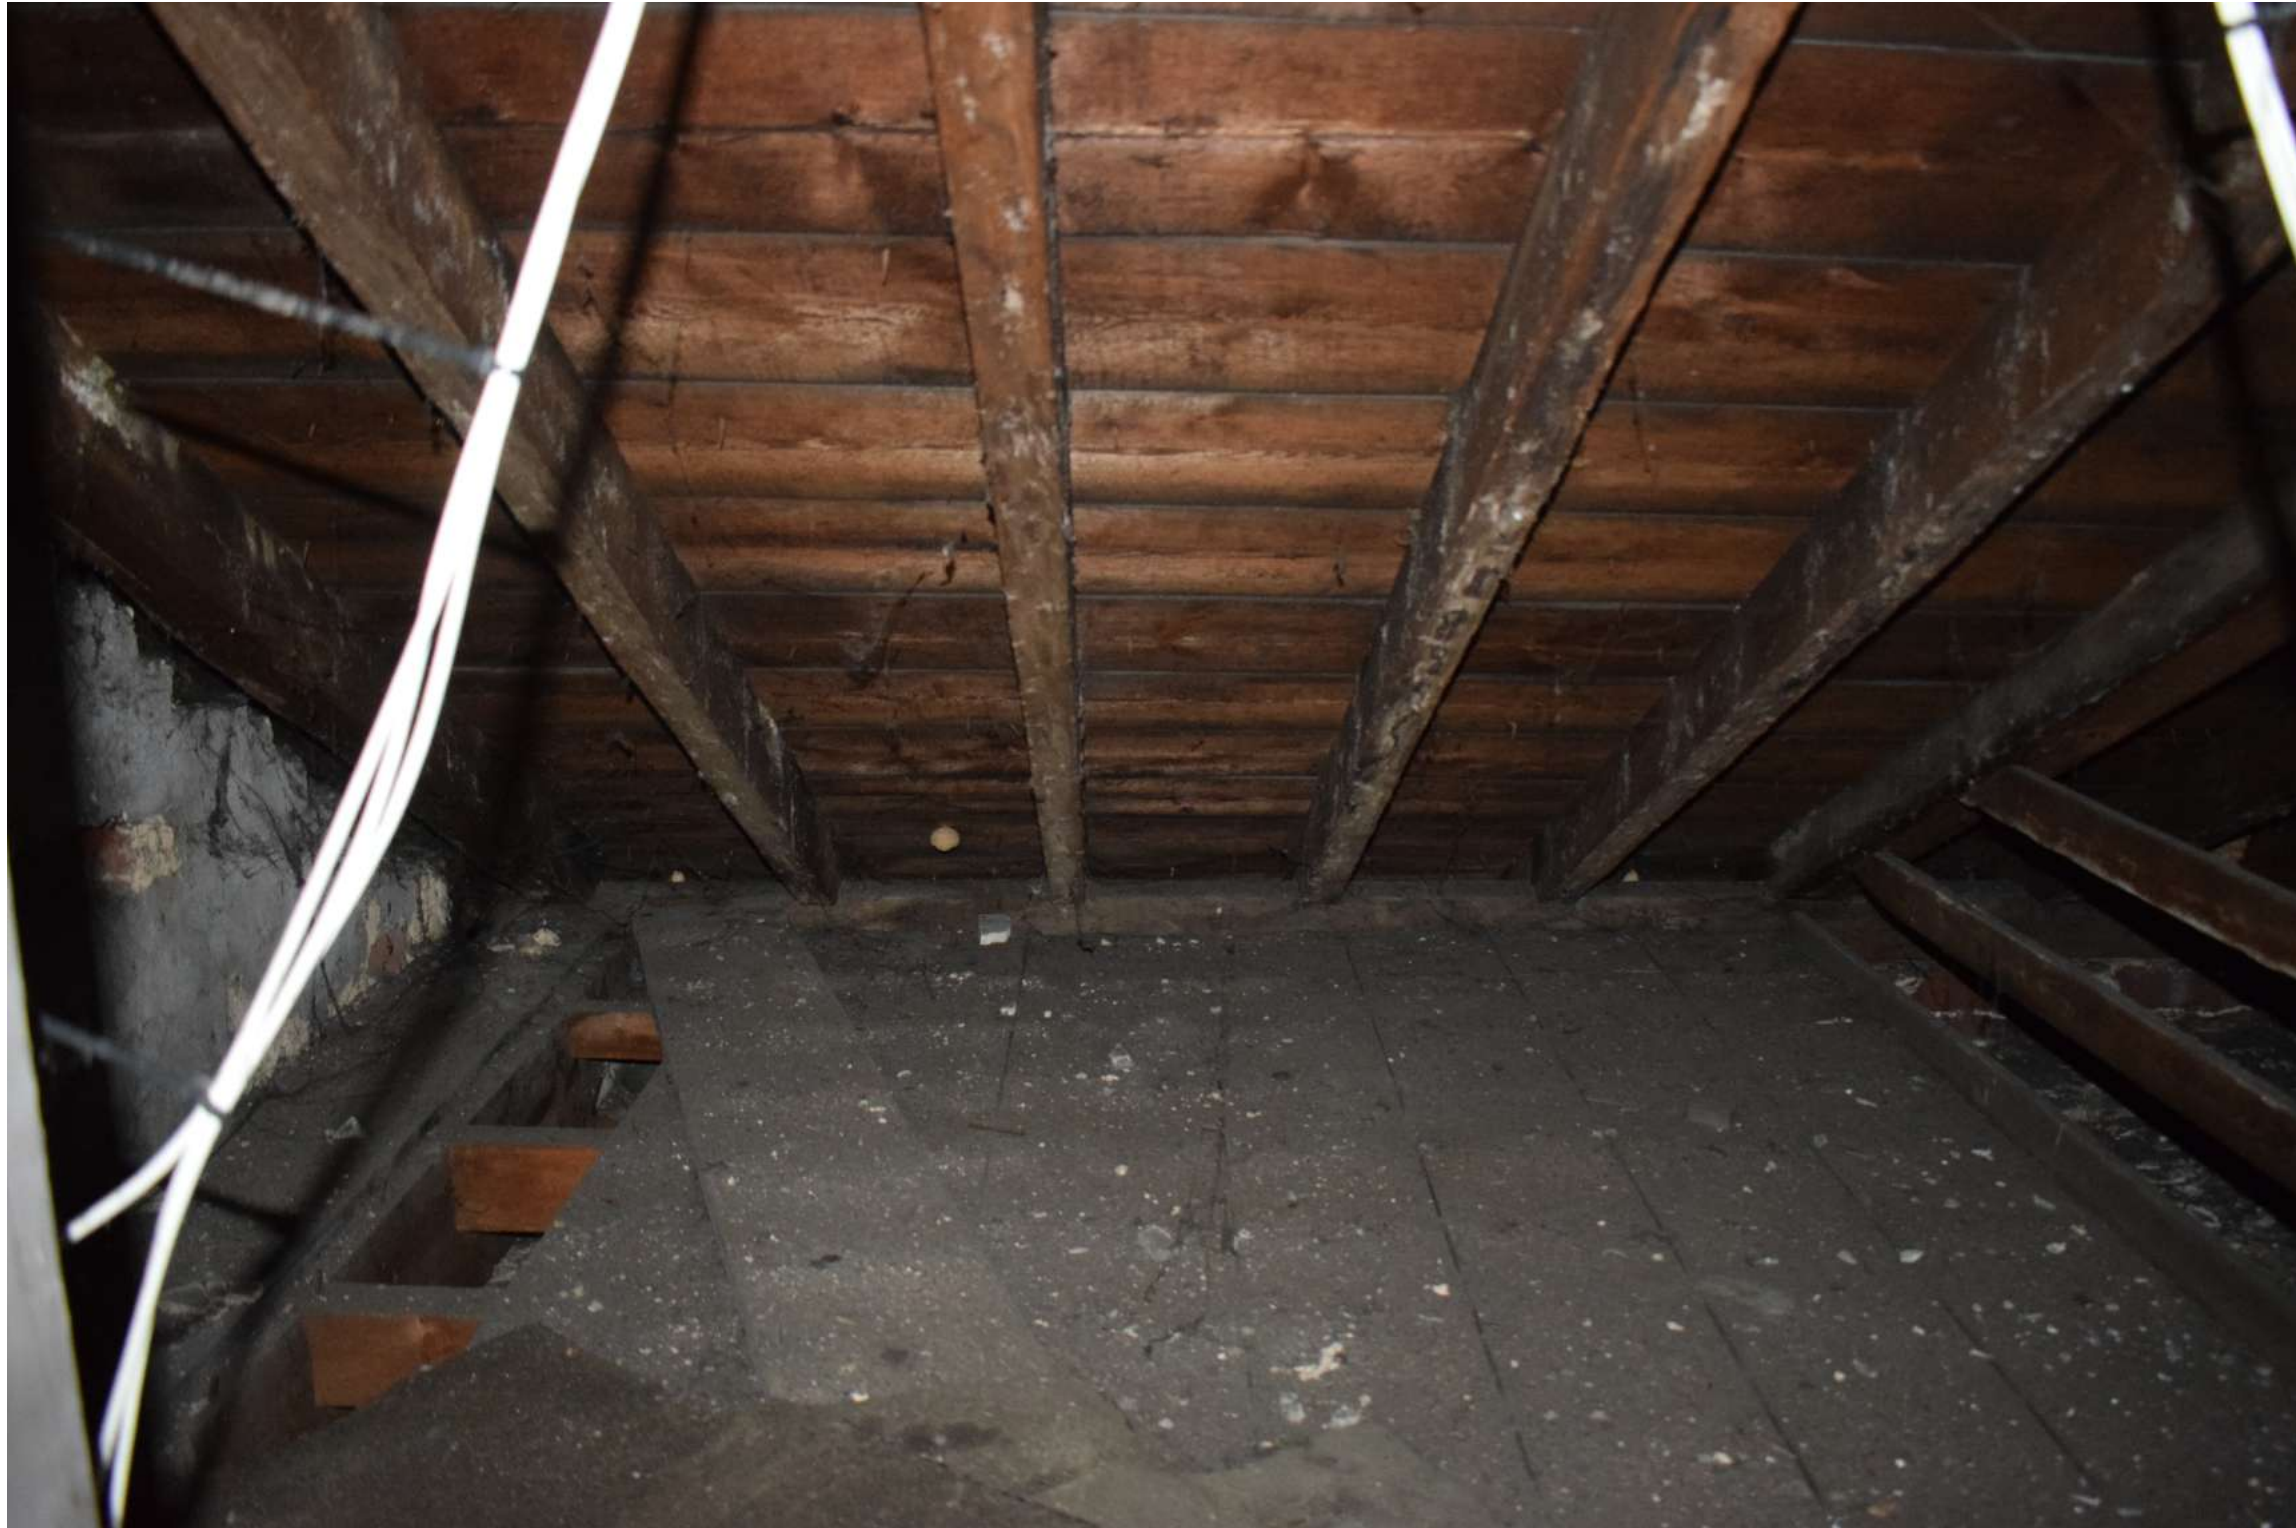
Plate 54

No historic timber remains on either roofline.

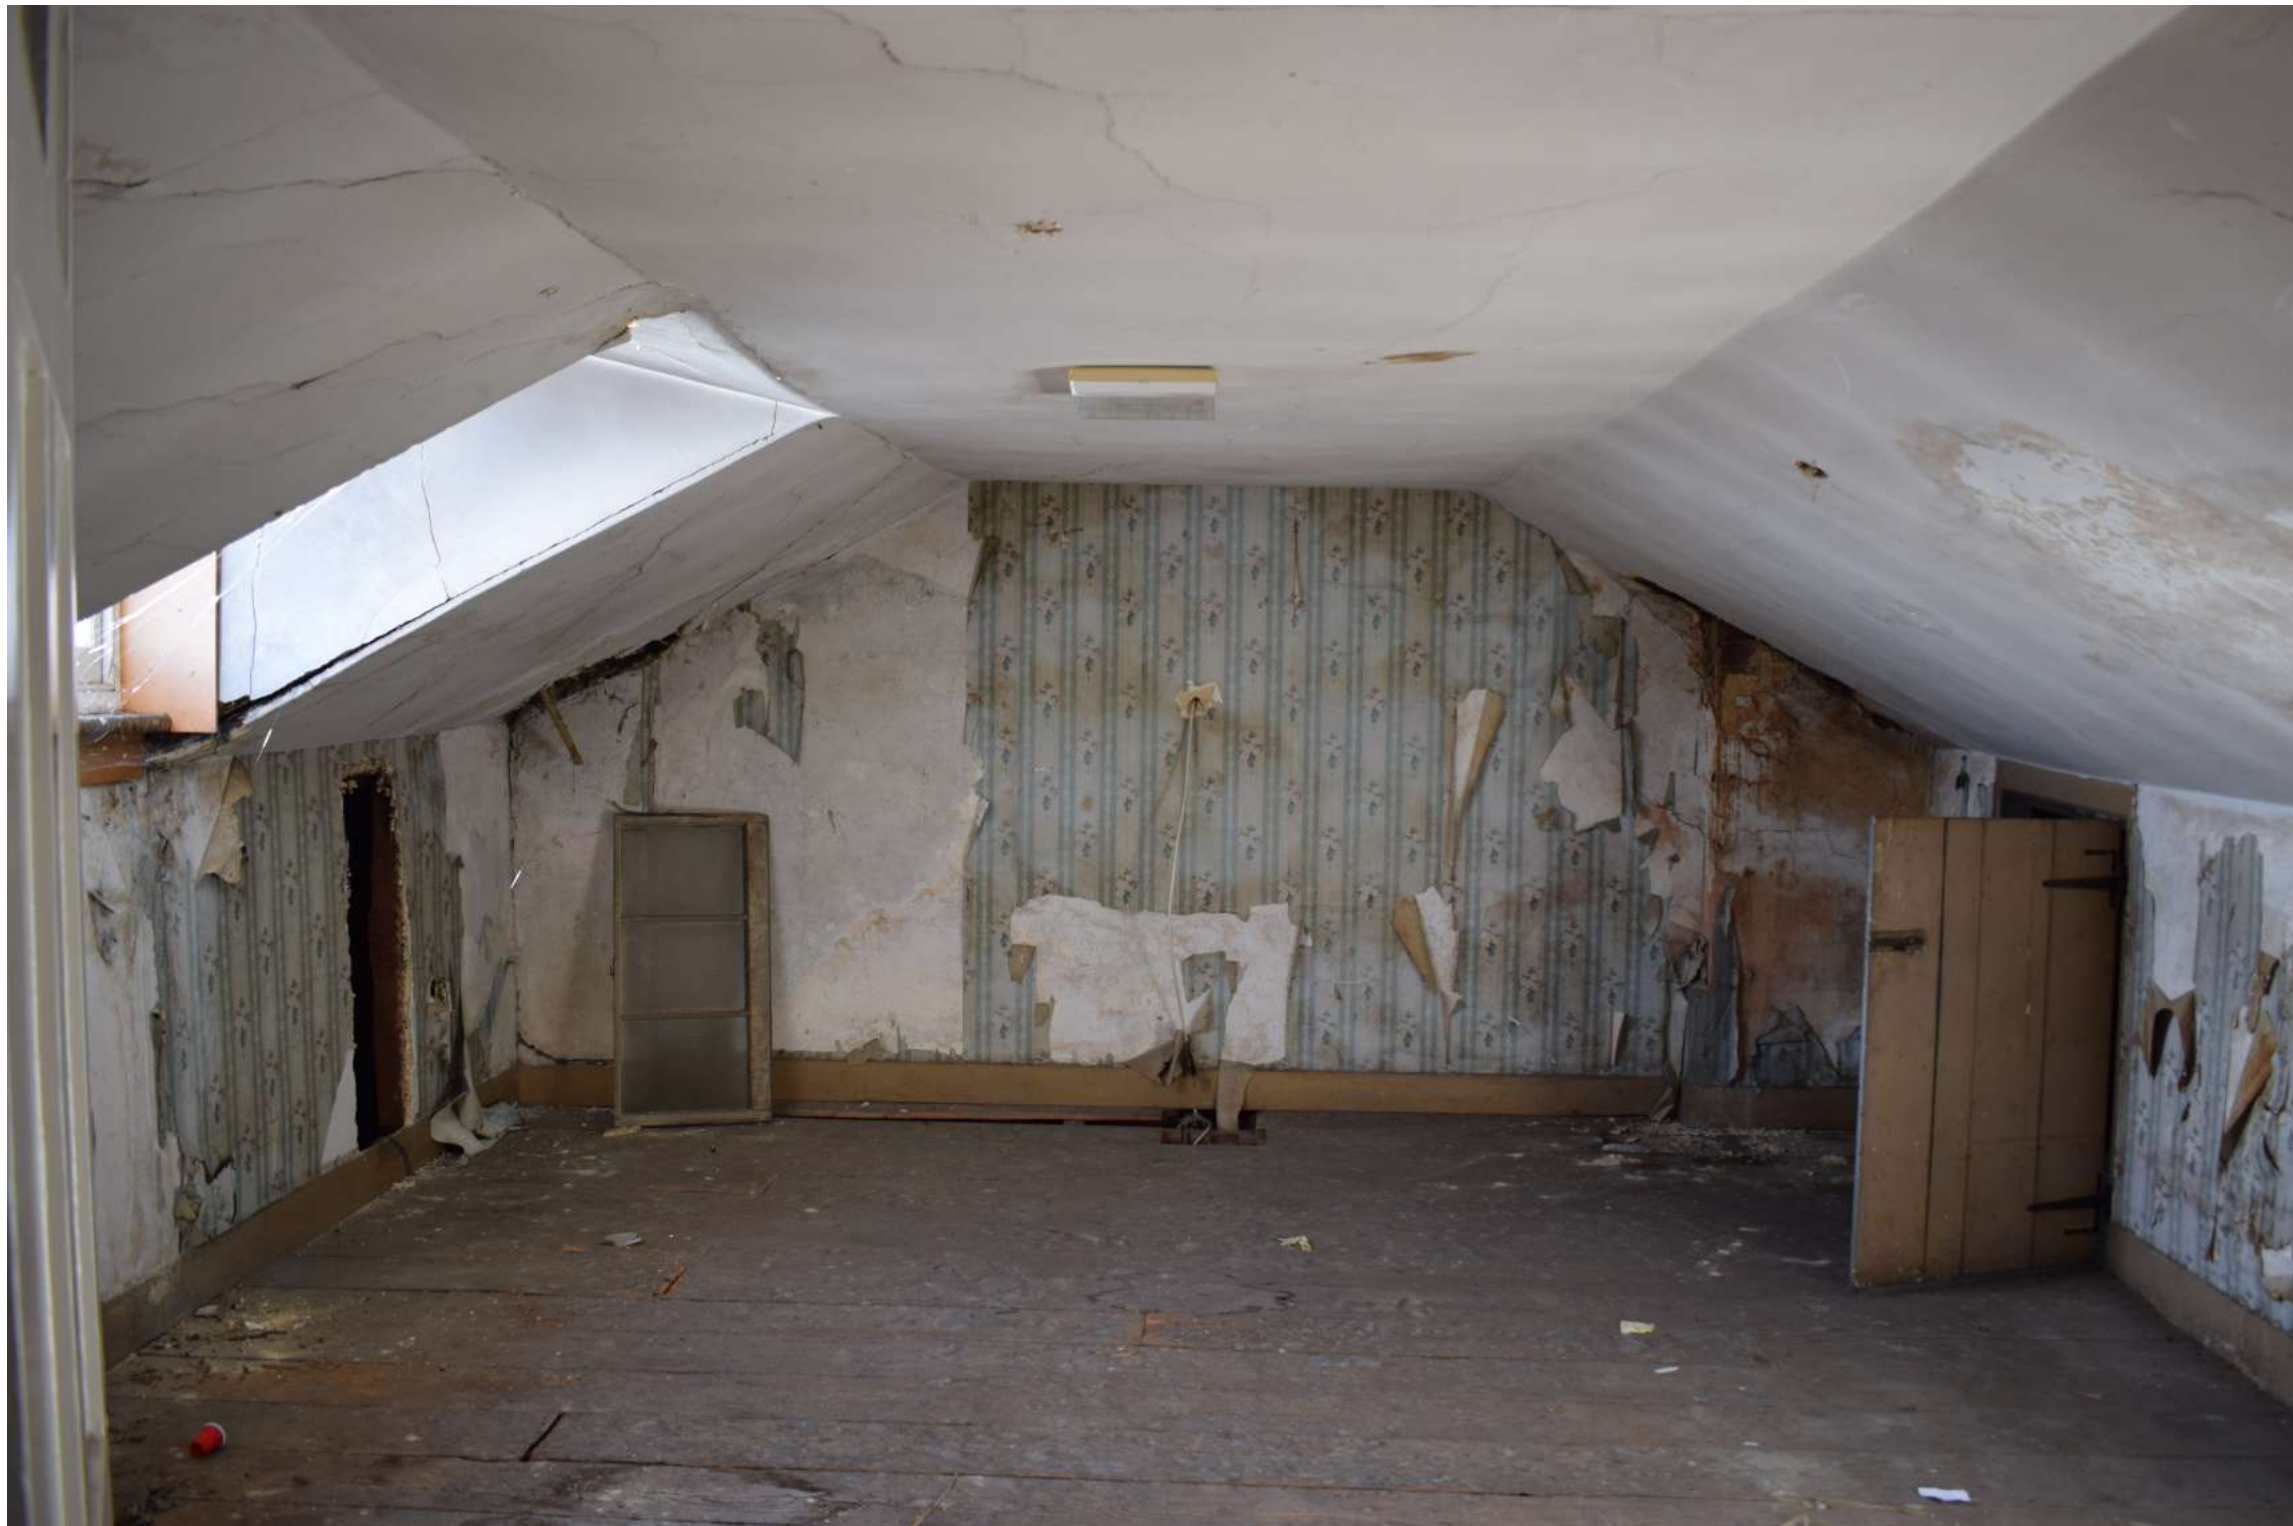
Plate 57

The condition of the dilapidated plaster and lath requires removal. Historic floorboards have been retained within the main space.

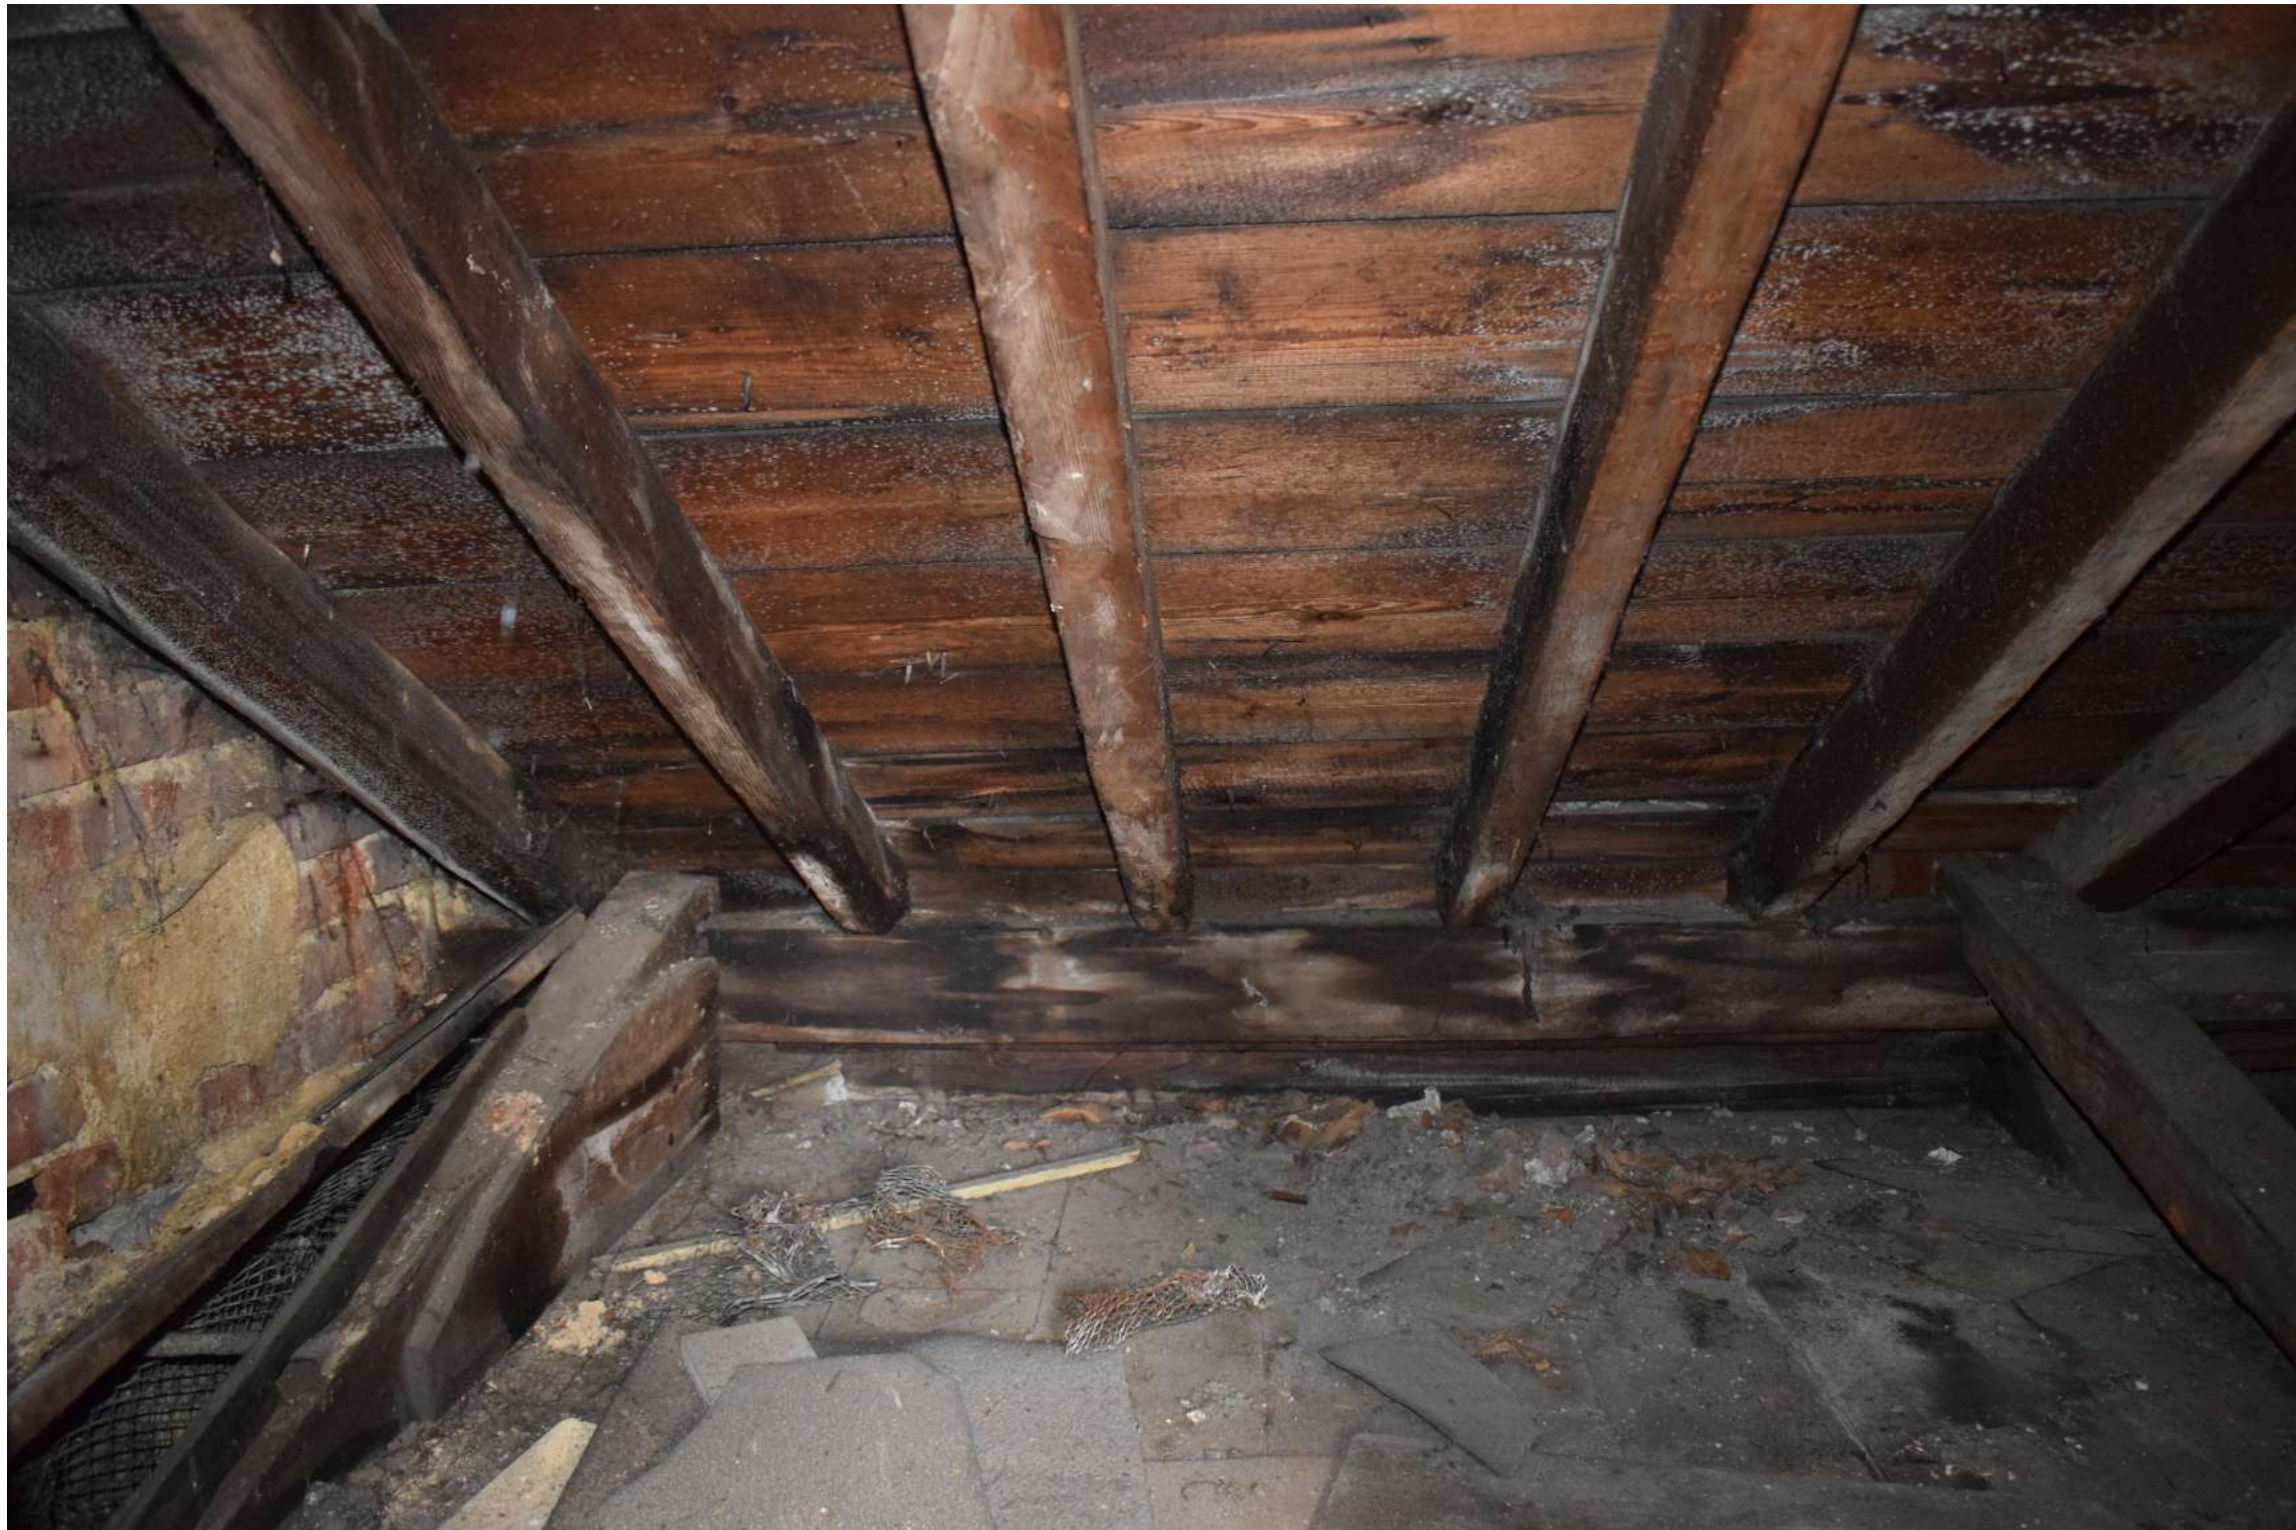
Plate 58

Plate 58: Modern roof timbers with evidence of mould (Room 18).

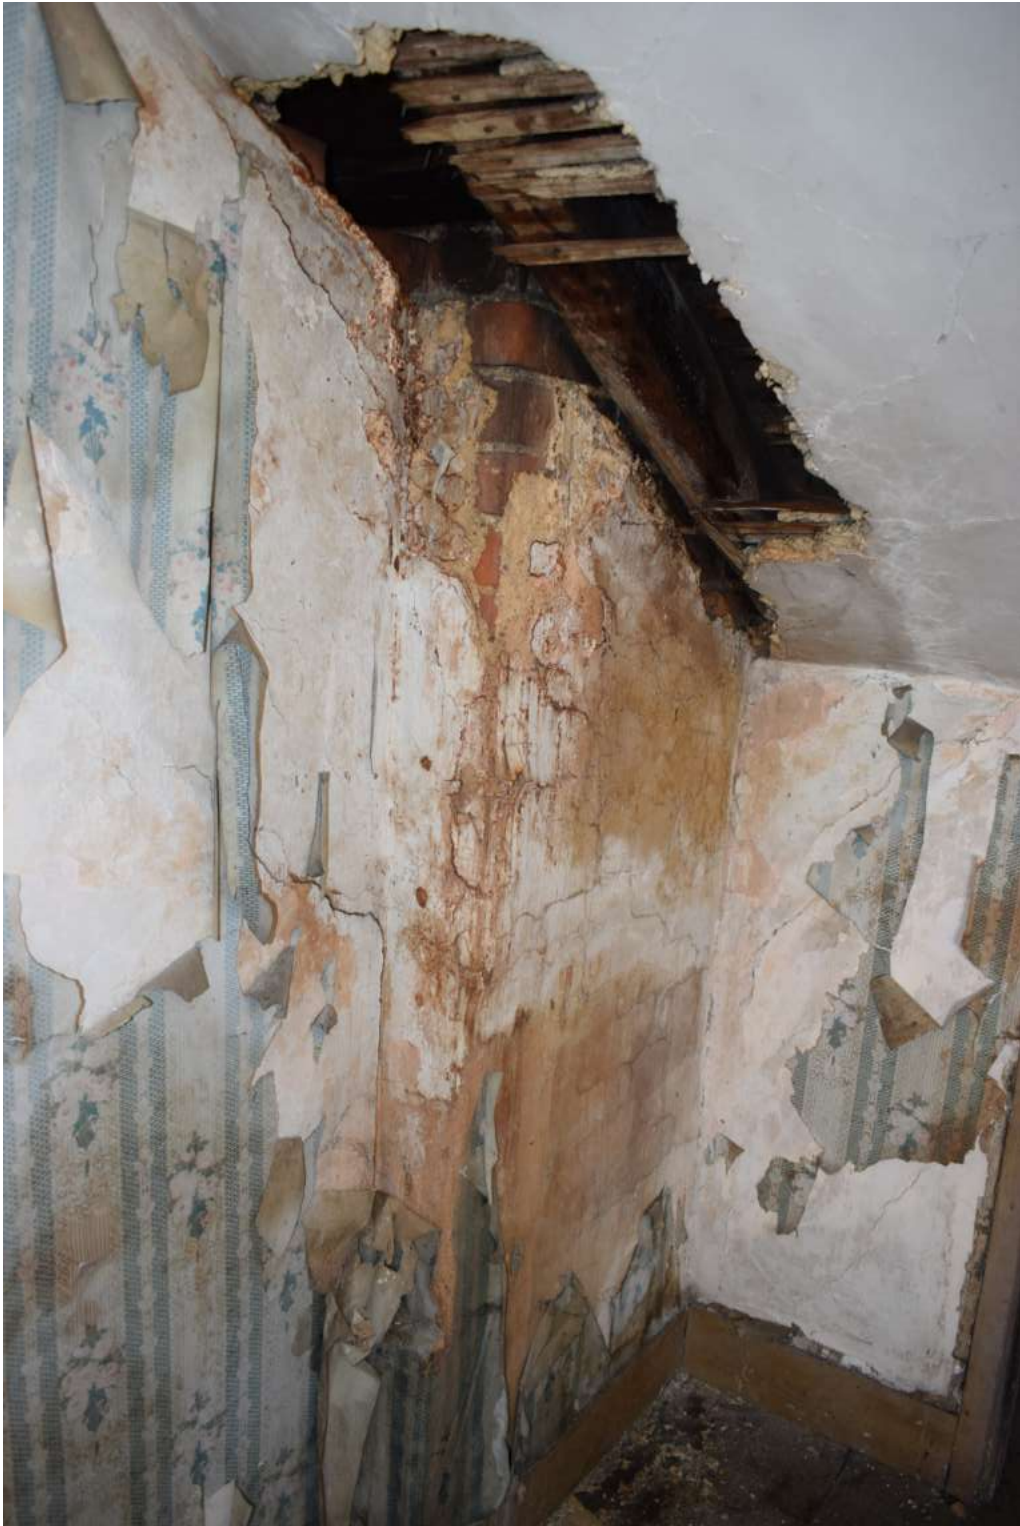
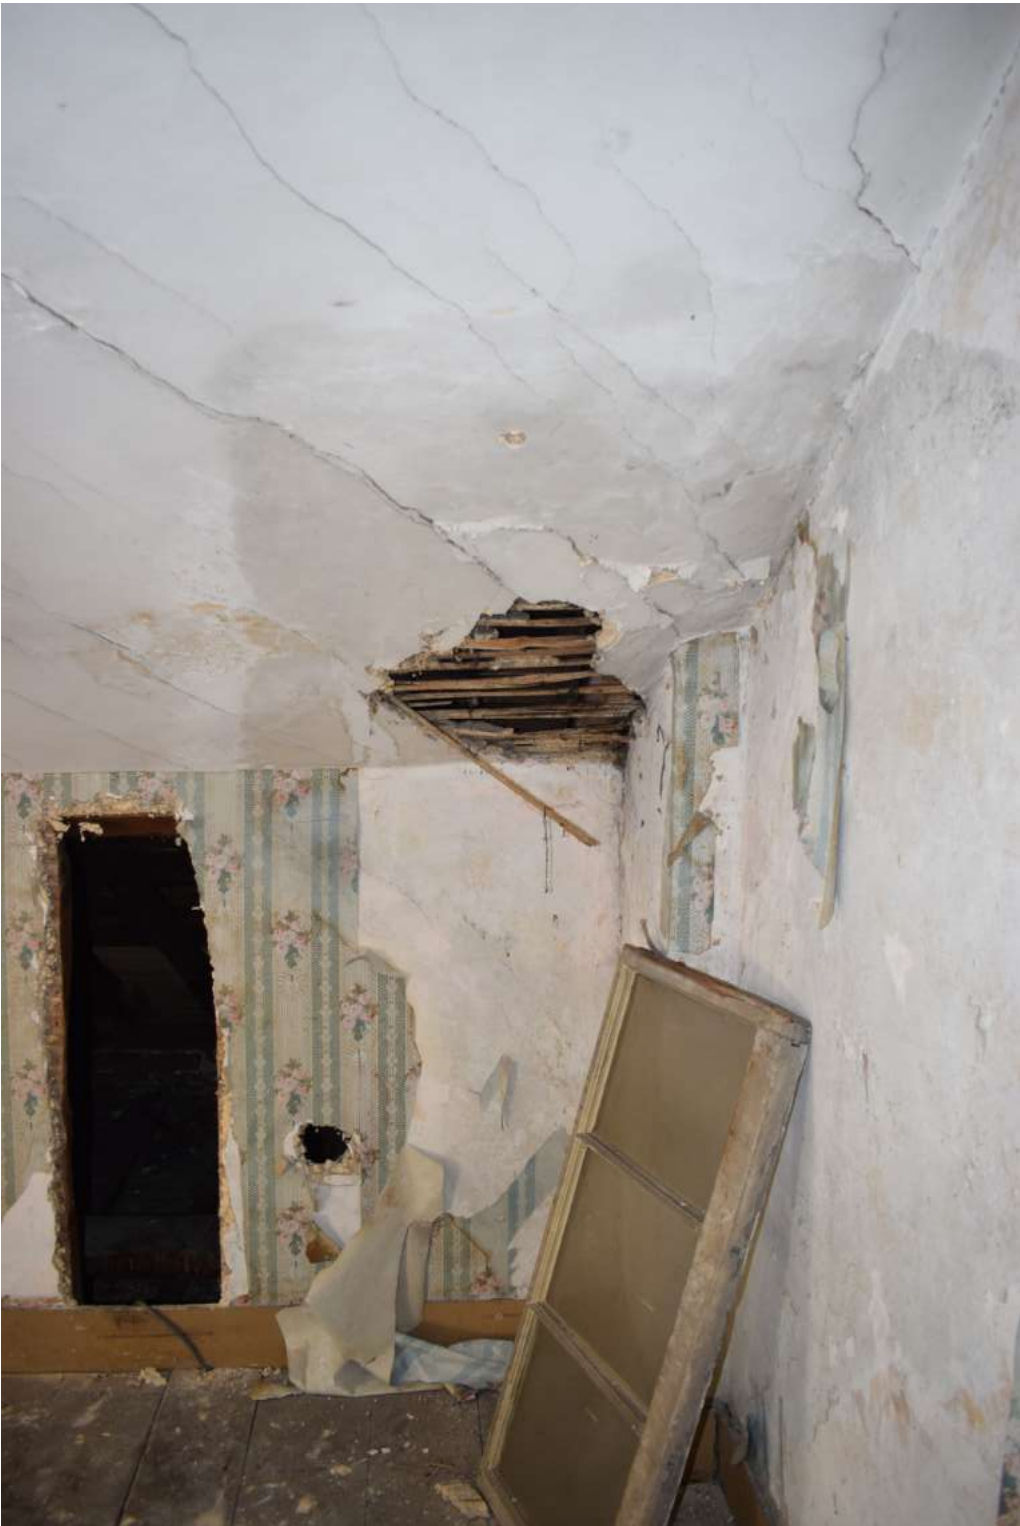
Plate 61  
Detail images of the condition of the lath and plaster ceilings.
