Phases 2a and 2b west wing

## Appendix 11

Yeomanry House

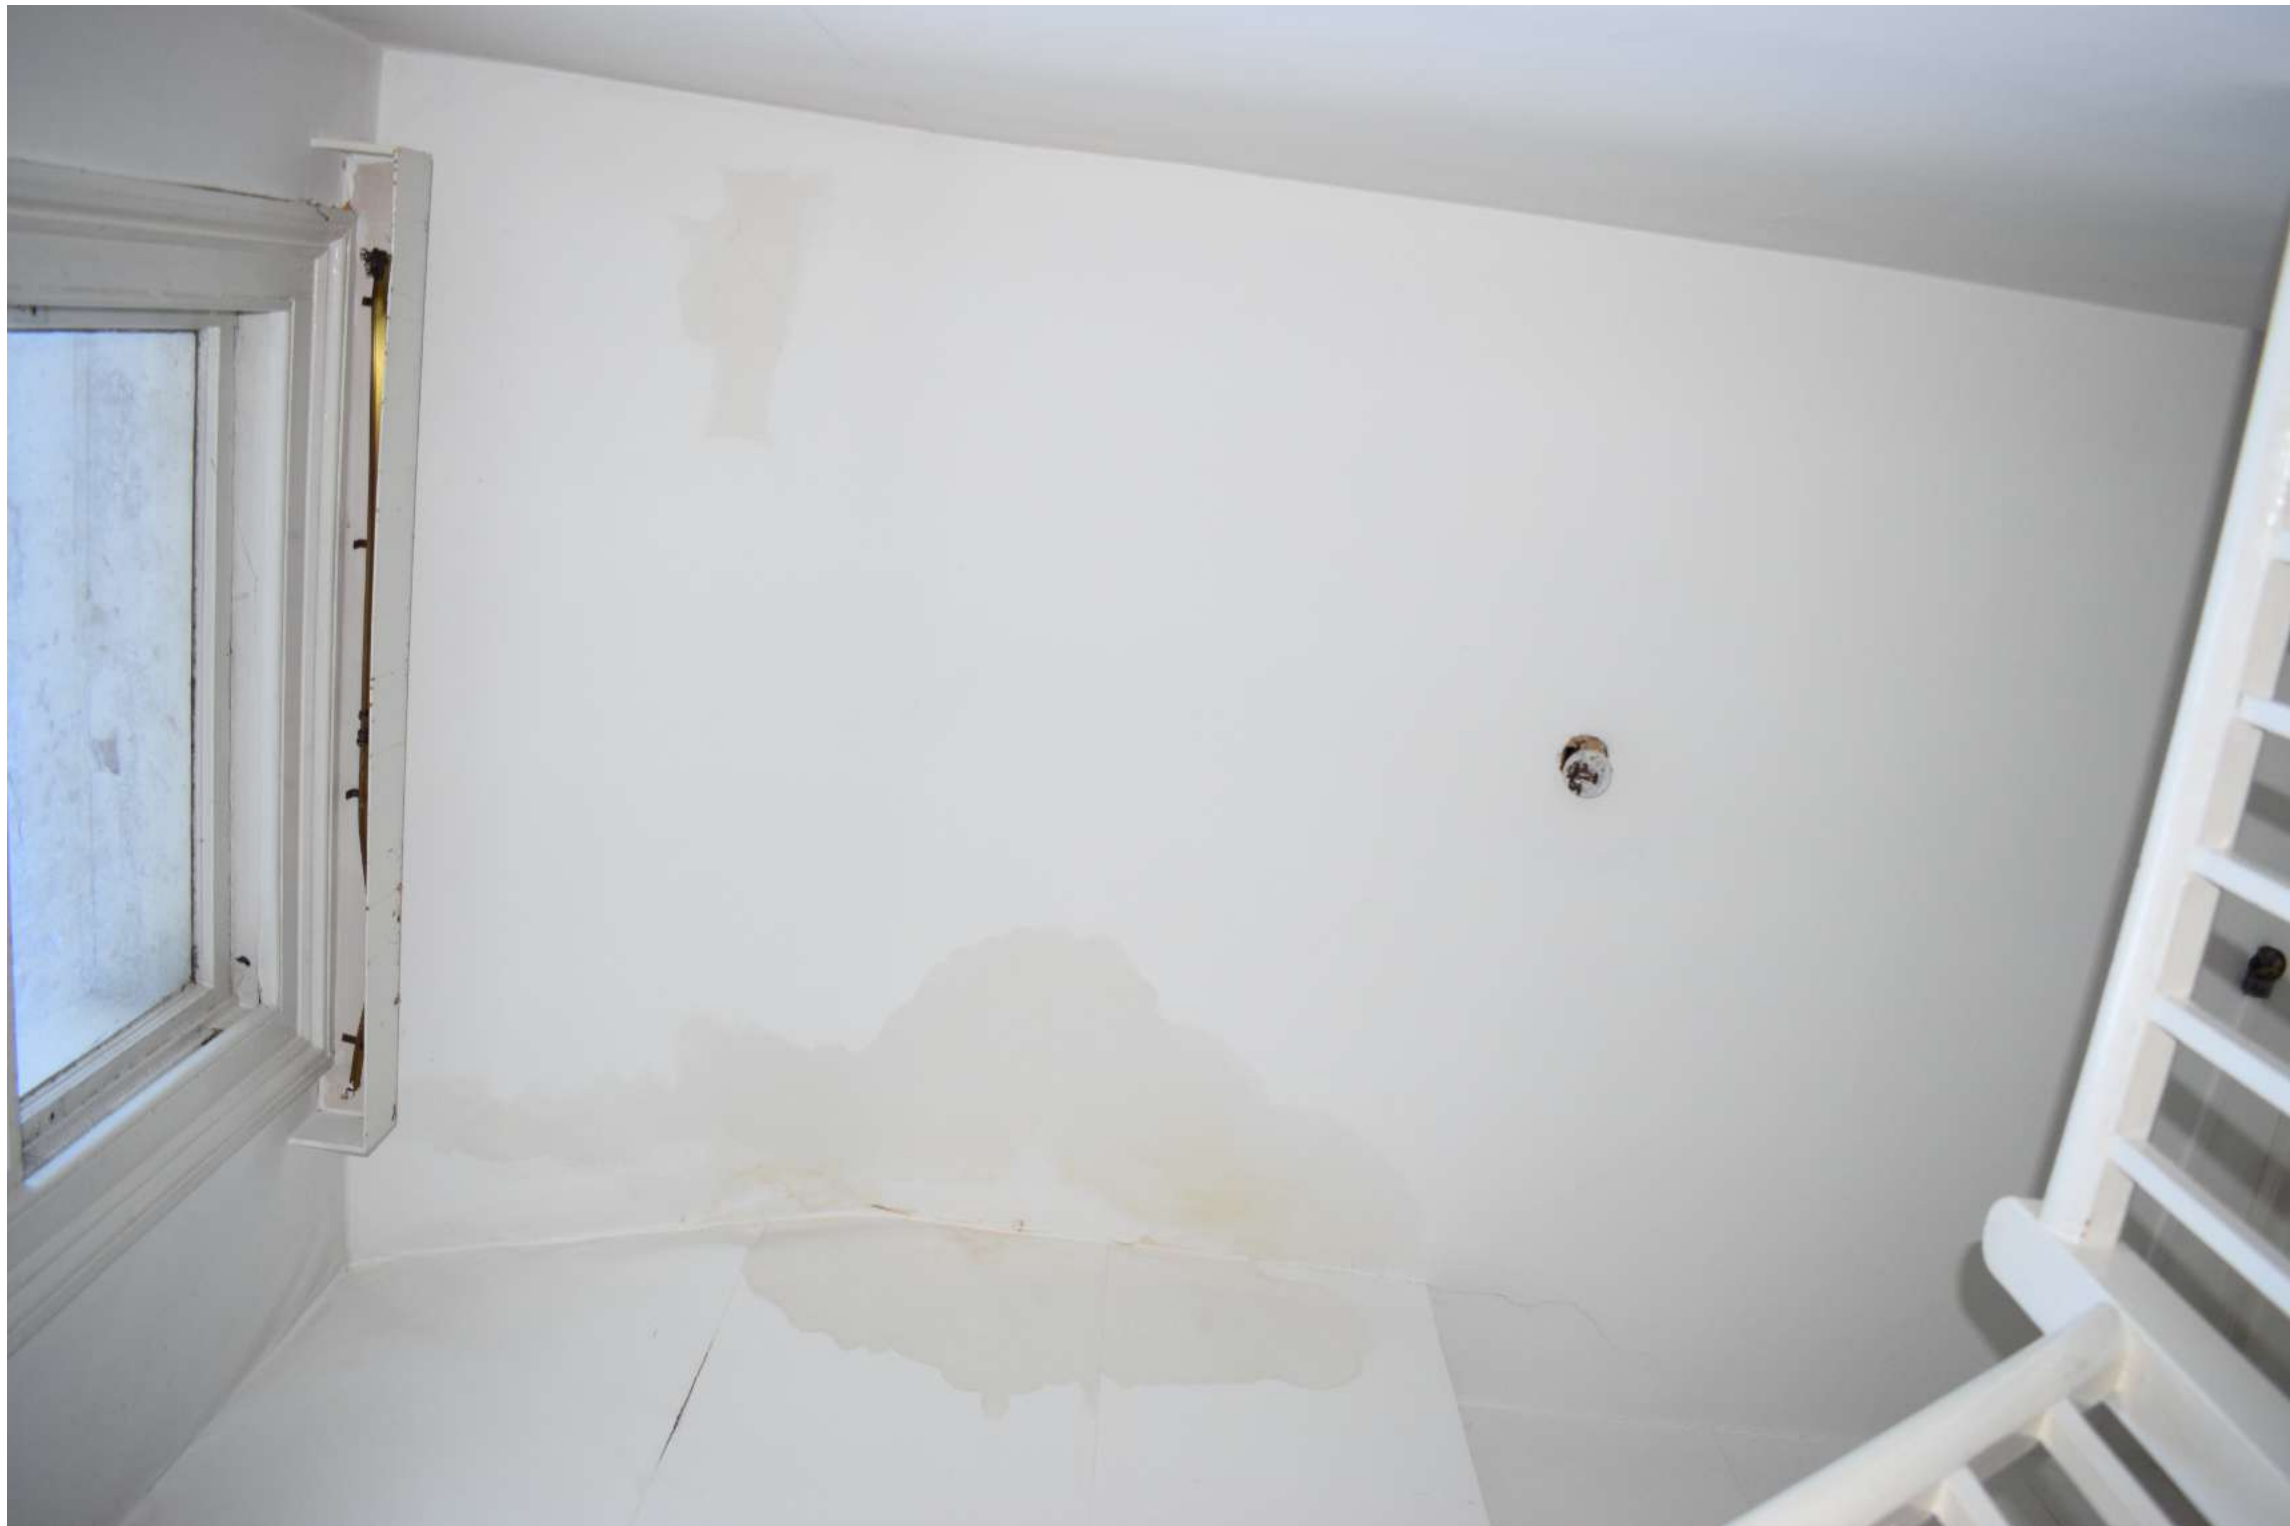
Plate 80

Condition issue: Severe historic damp staining is visible on the opposite corner and adjacent wall of this room, indicating a pervasive moisture issue within the external fabric.

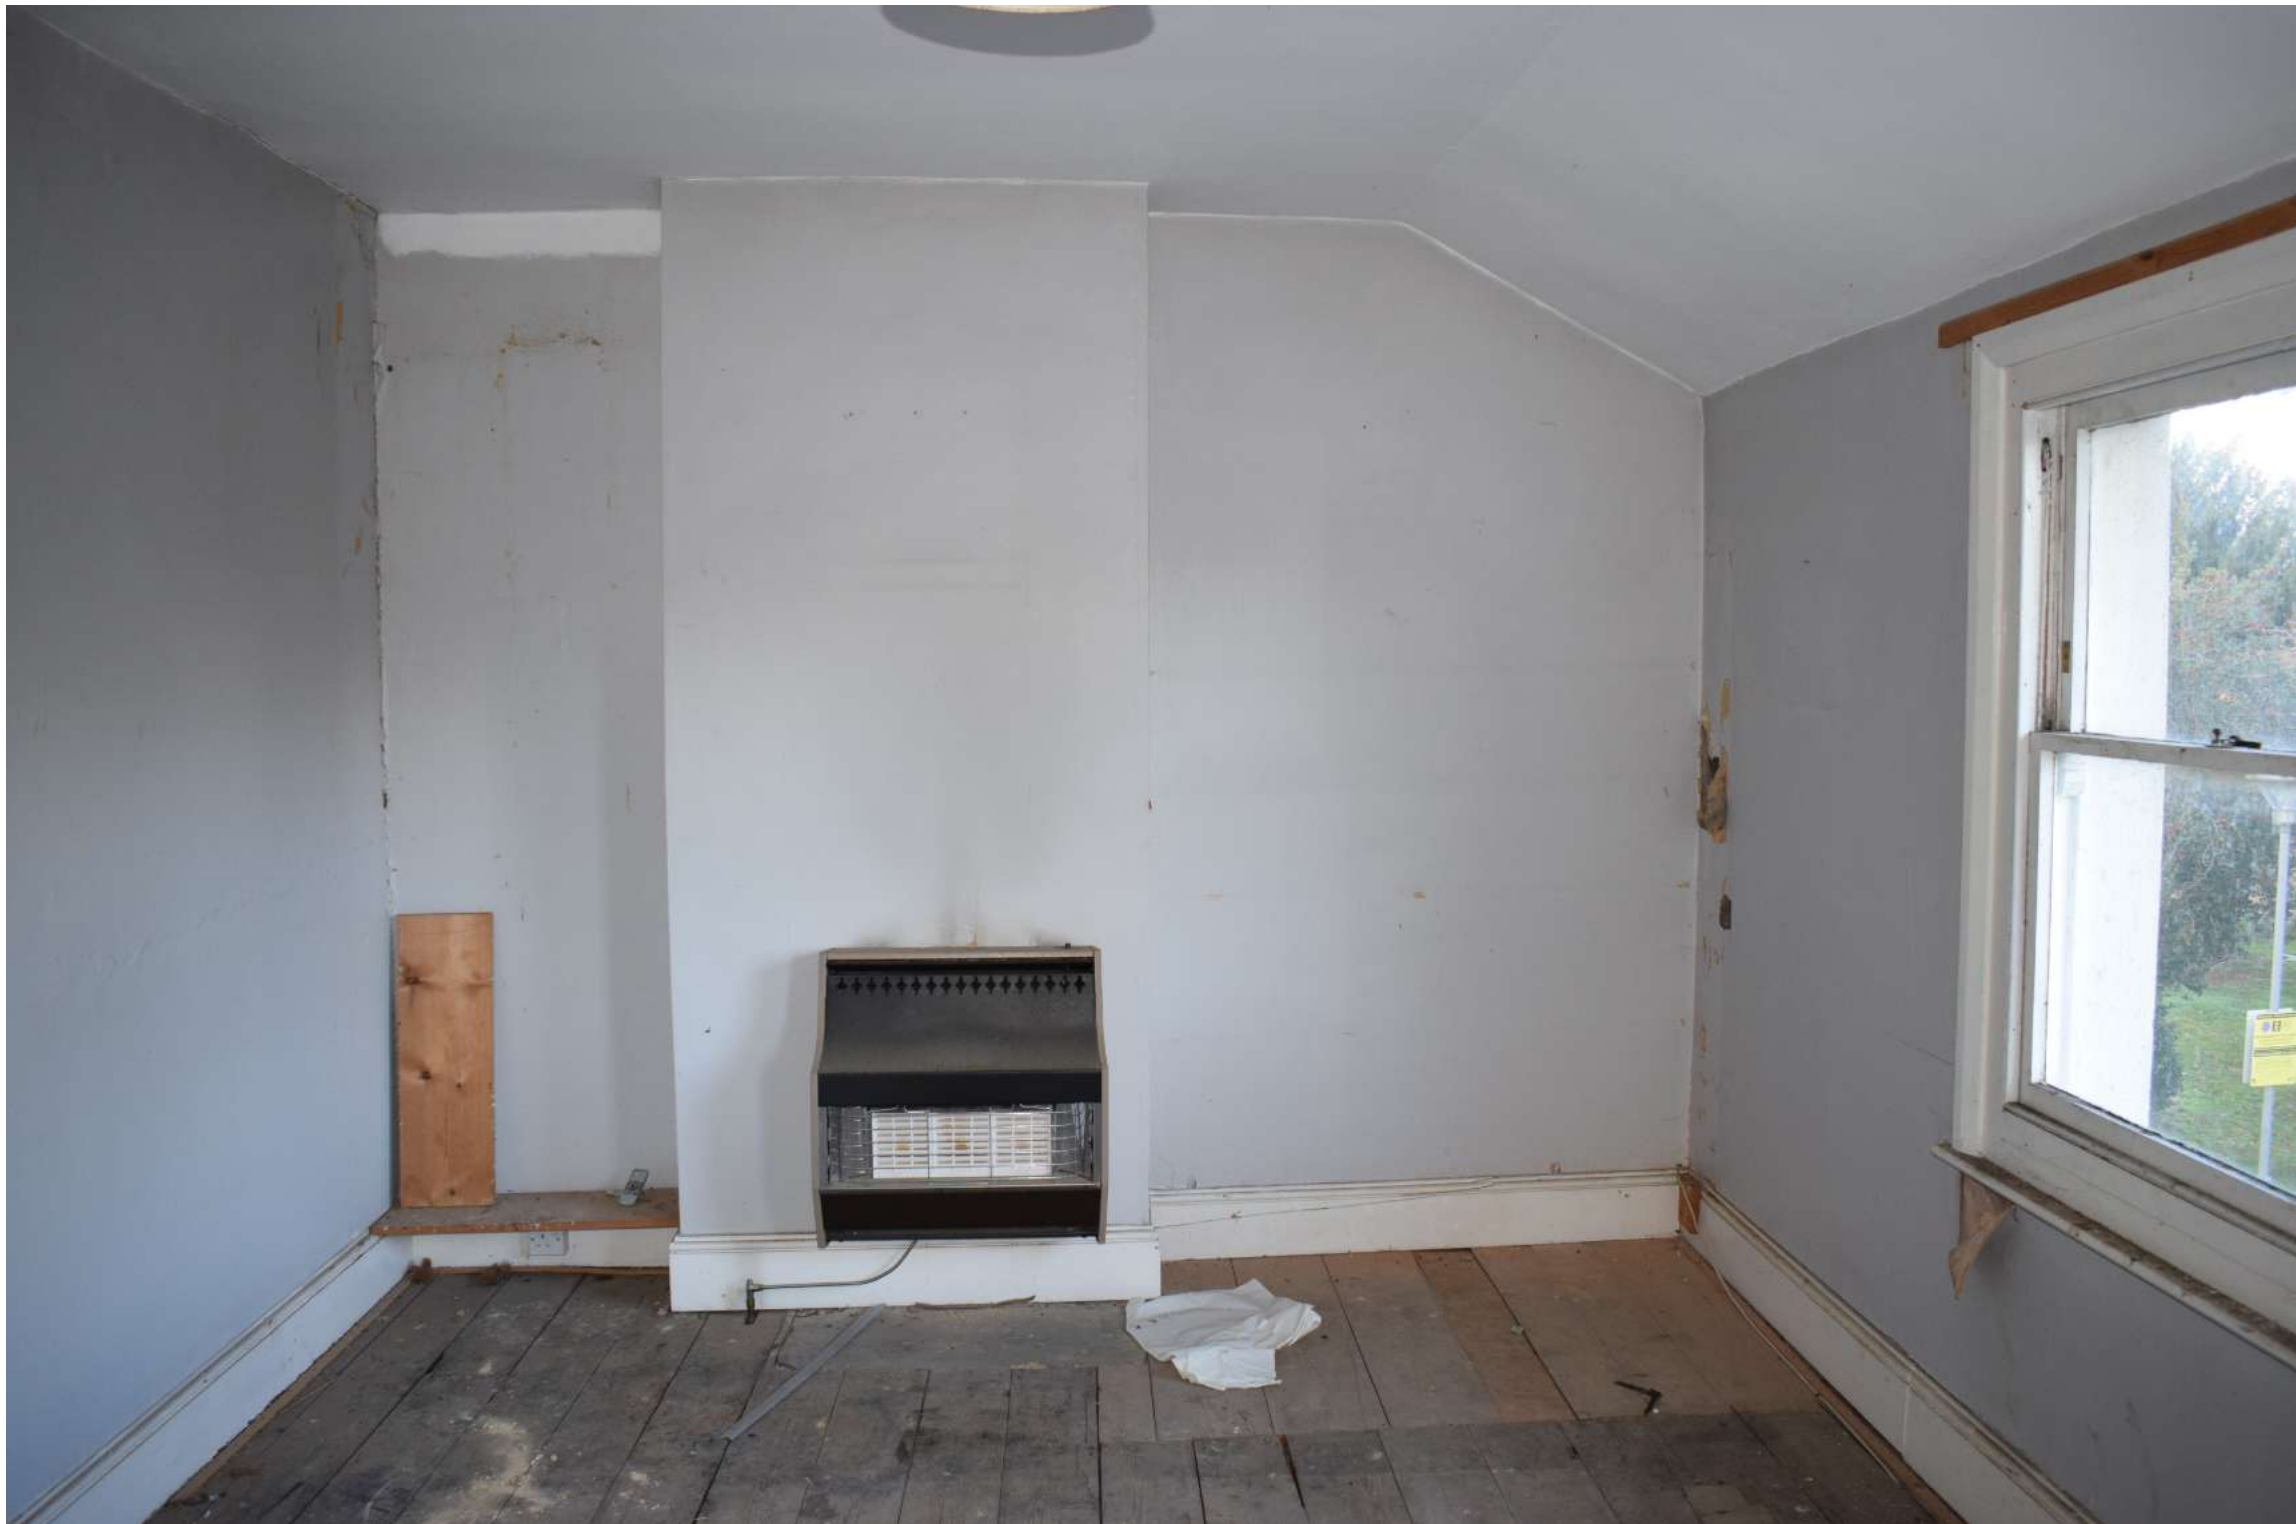
Plate 84

This view shows that the surrounding plaster exhibits general evidence of historic dampness.

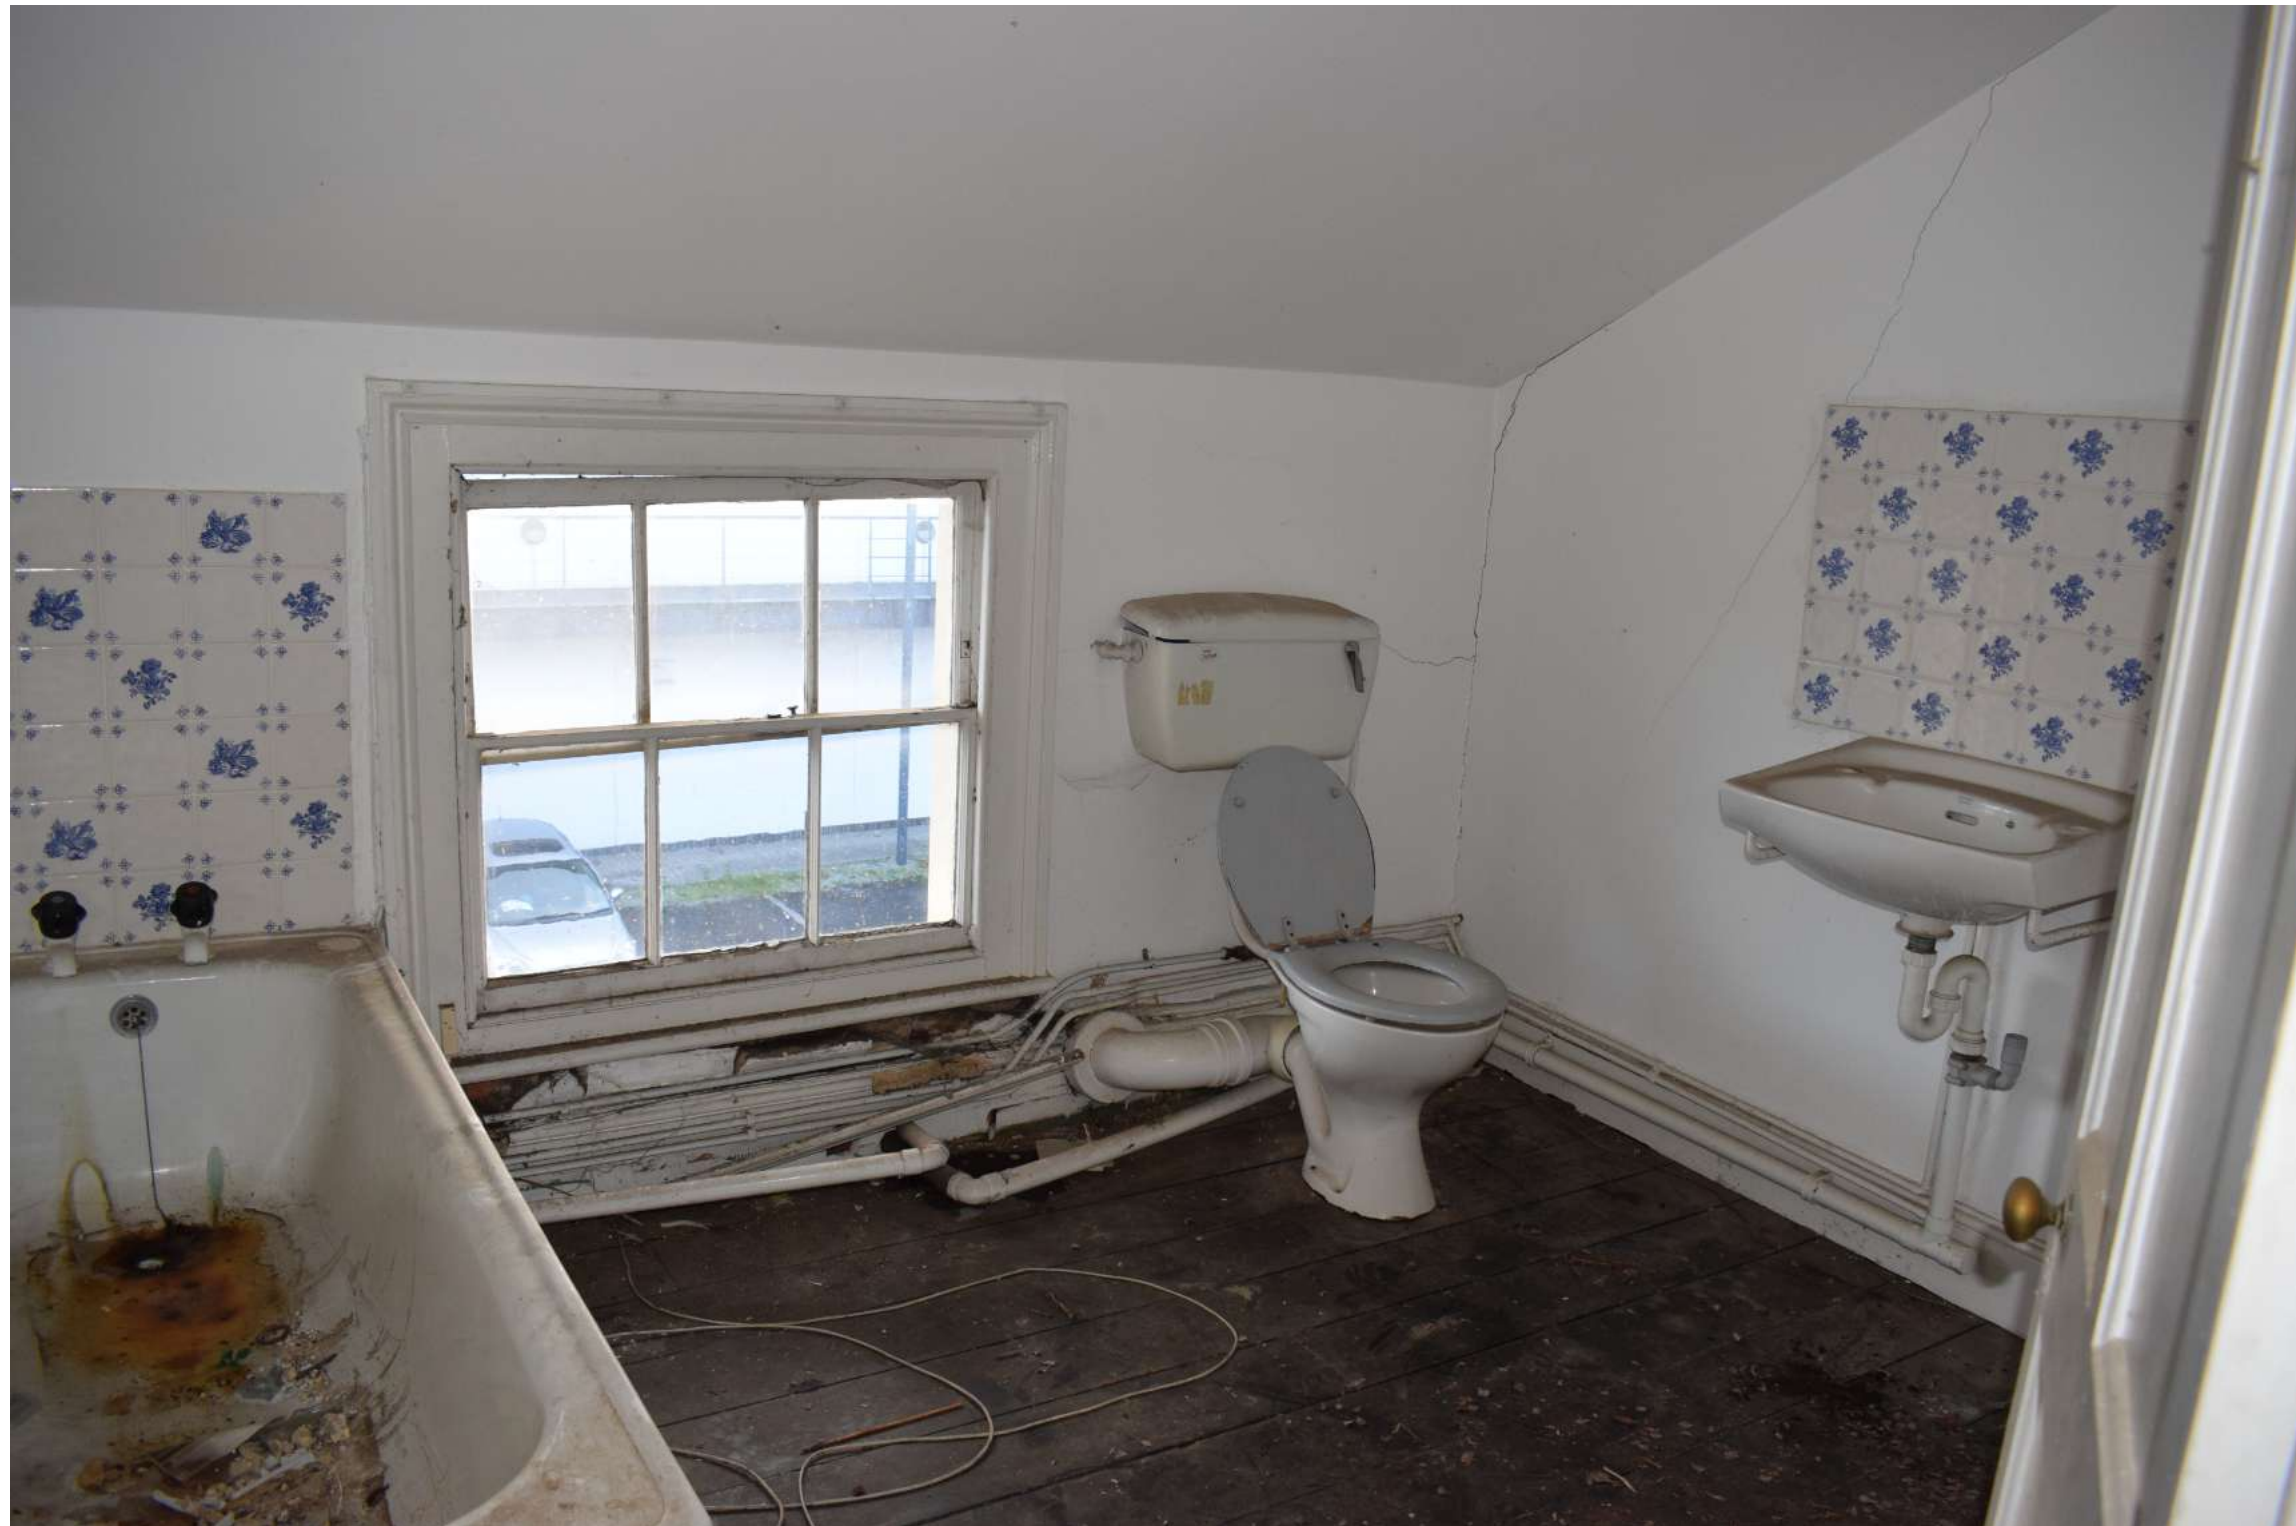
Plate 86

Condition issue: A general view of the severe historic damp actively manifesting below the window.

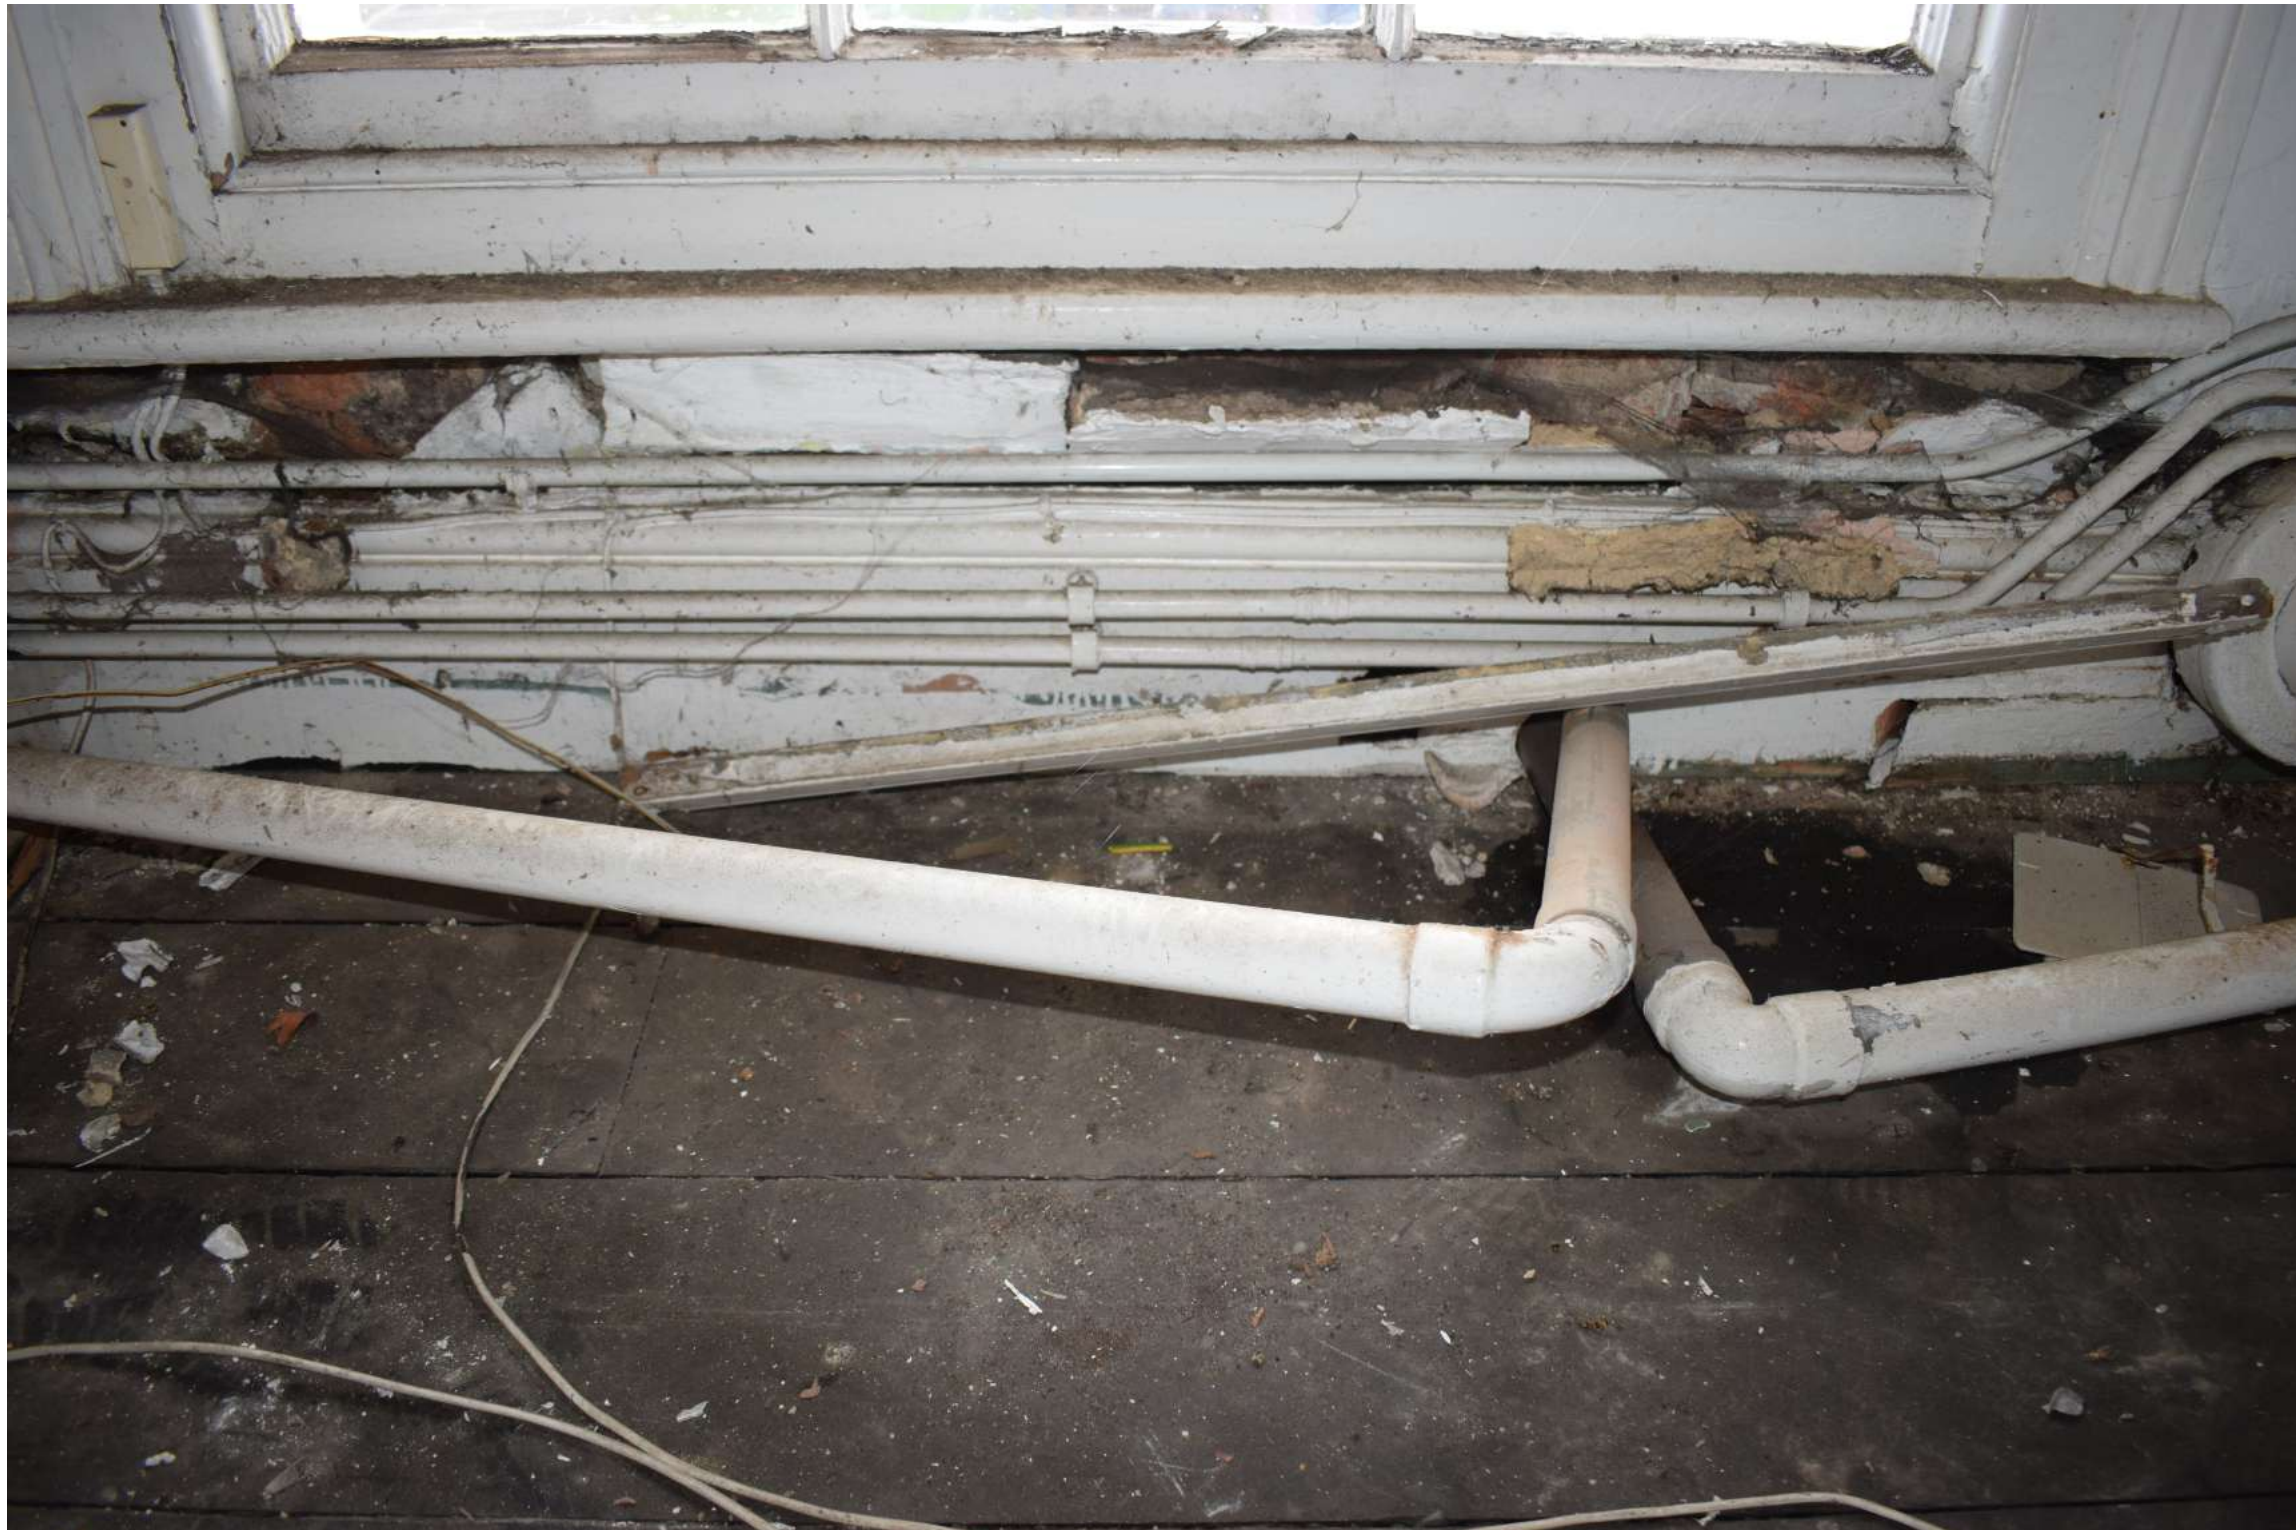
Plate 87

Condition issue: A detailed view of the severe historic damp actively manifesting below the window.

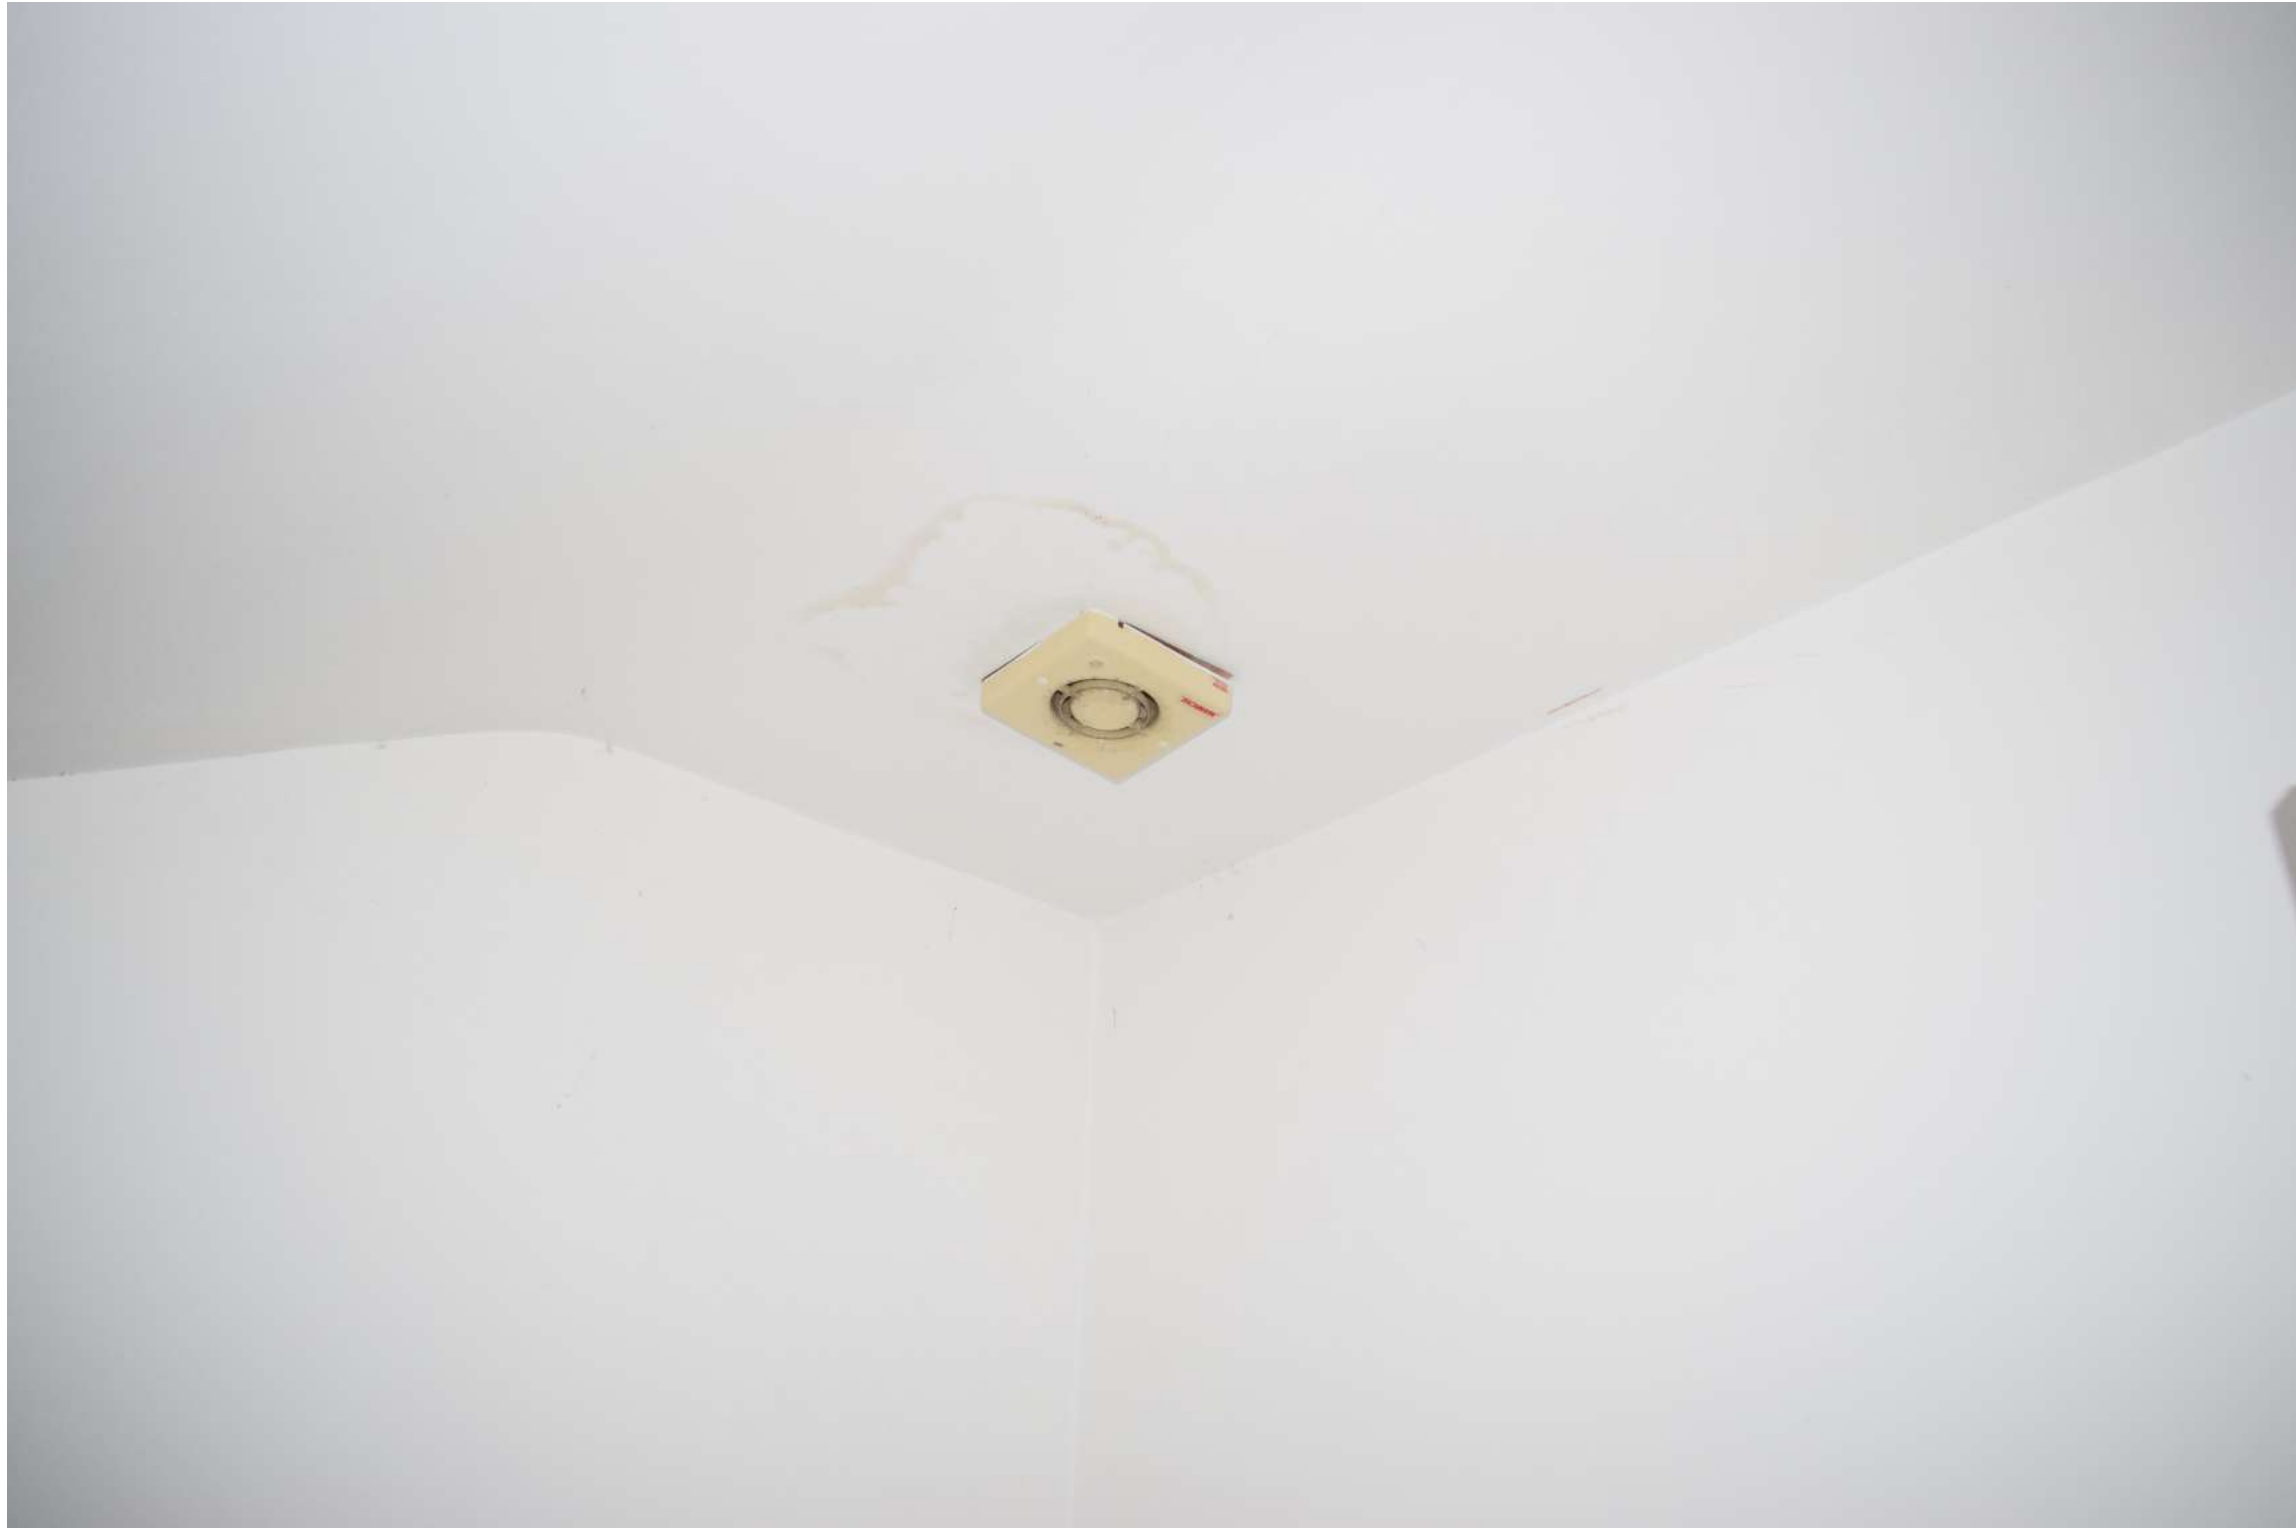
Plate 89

Condition issue: This image, located in the second-floor Bathroom, indicates a condition issue with small areas of historic damp around modern fixtures.

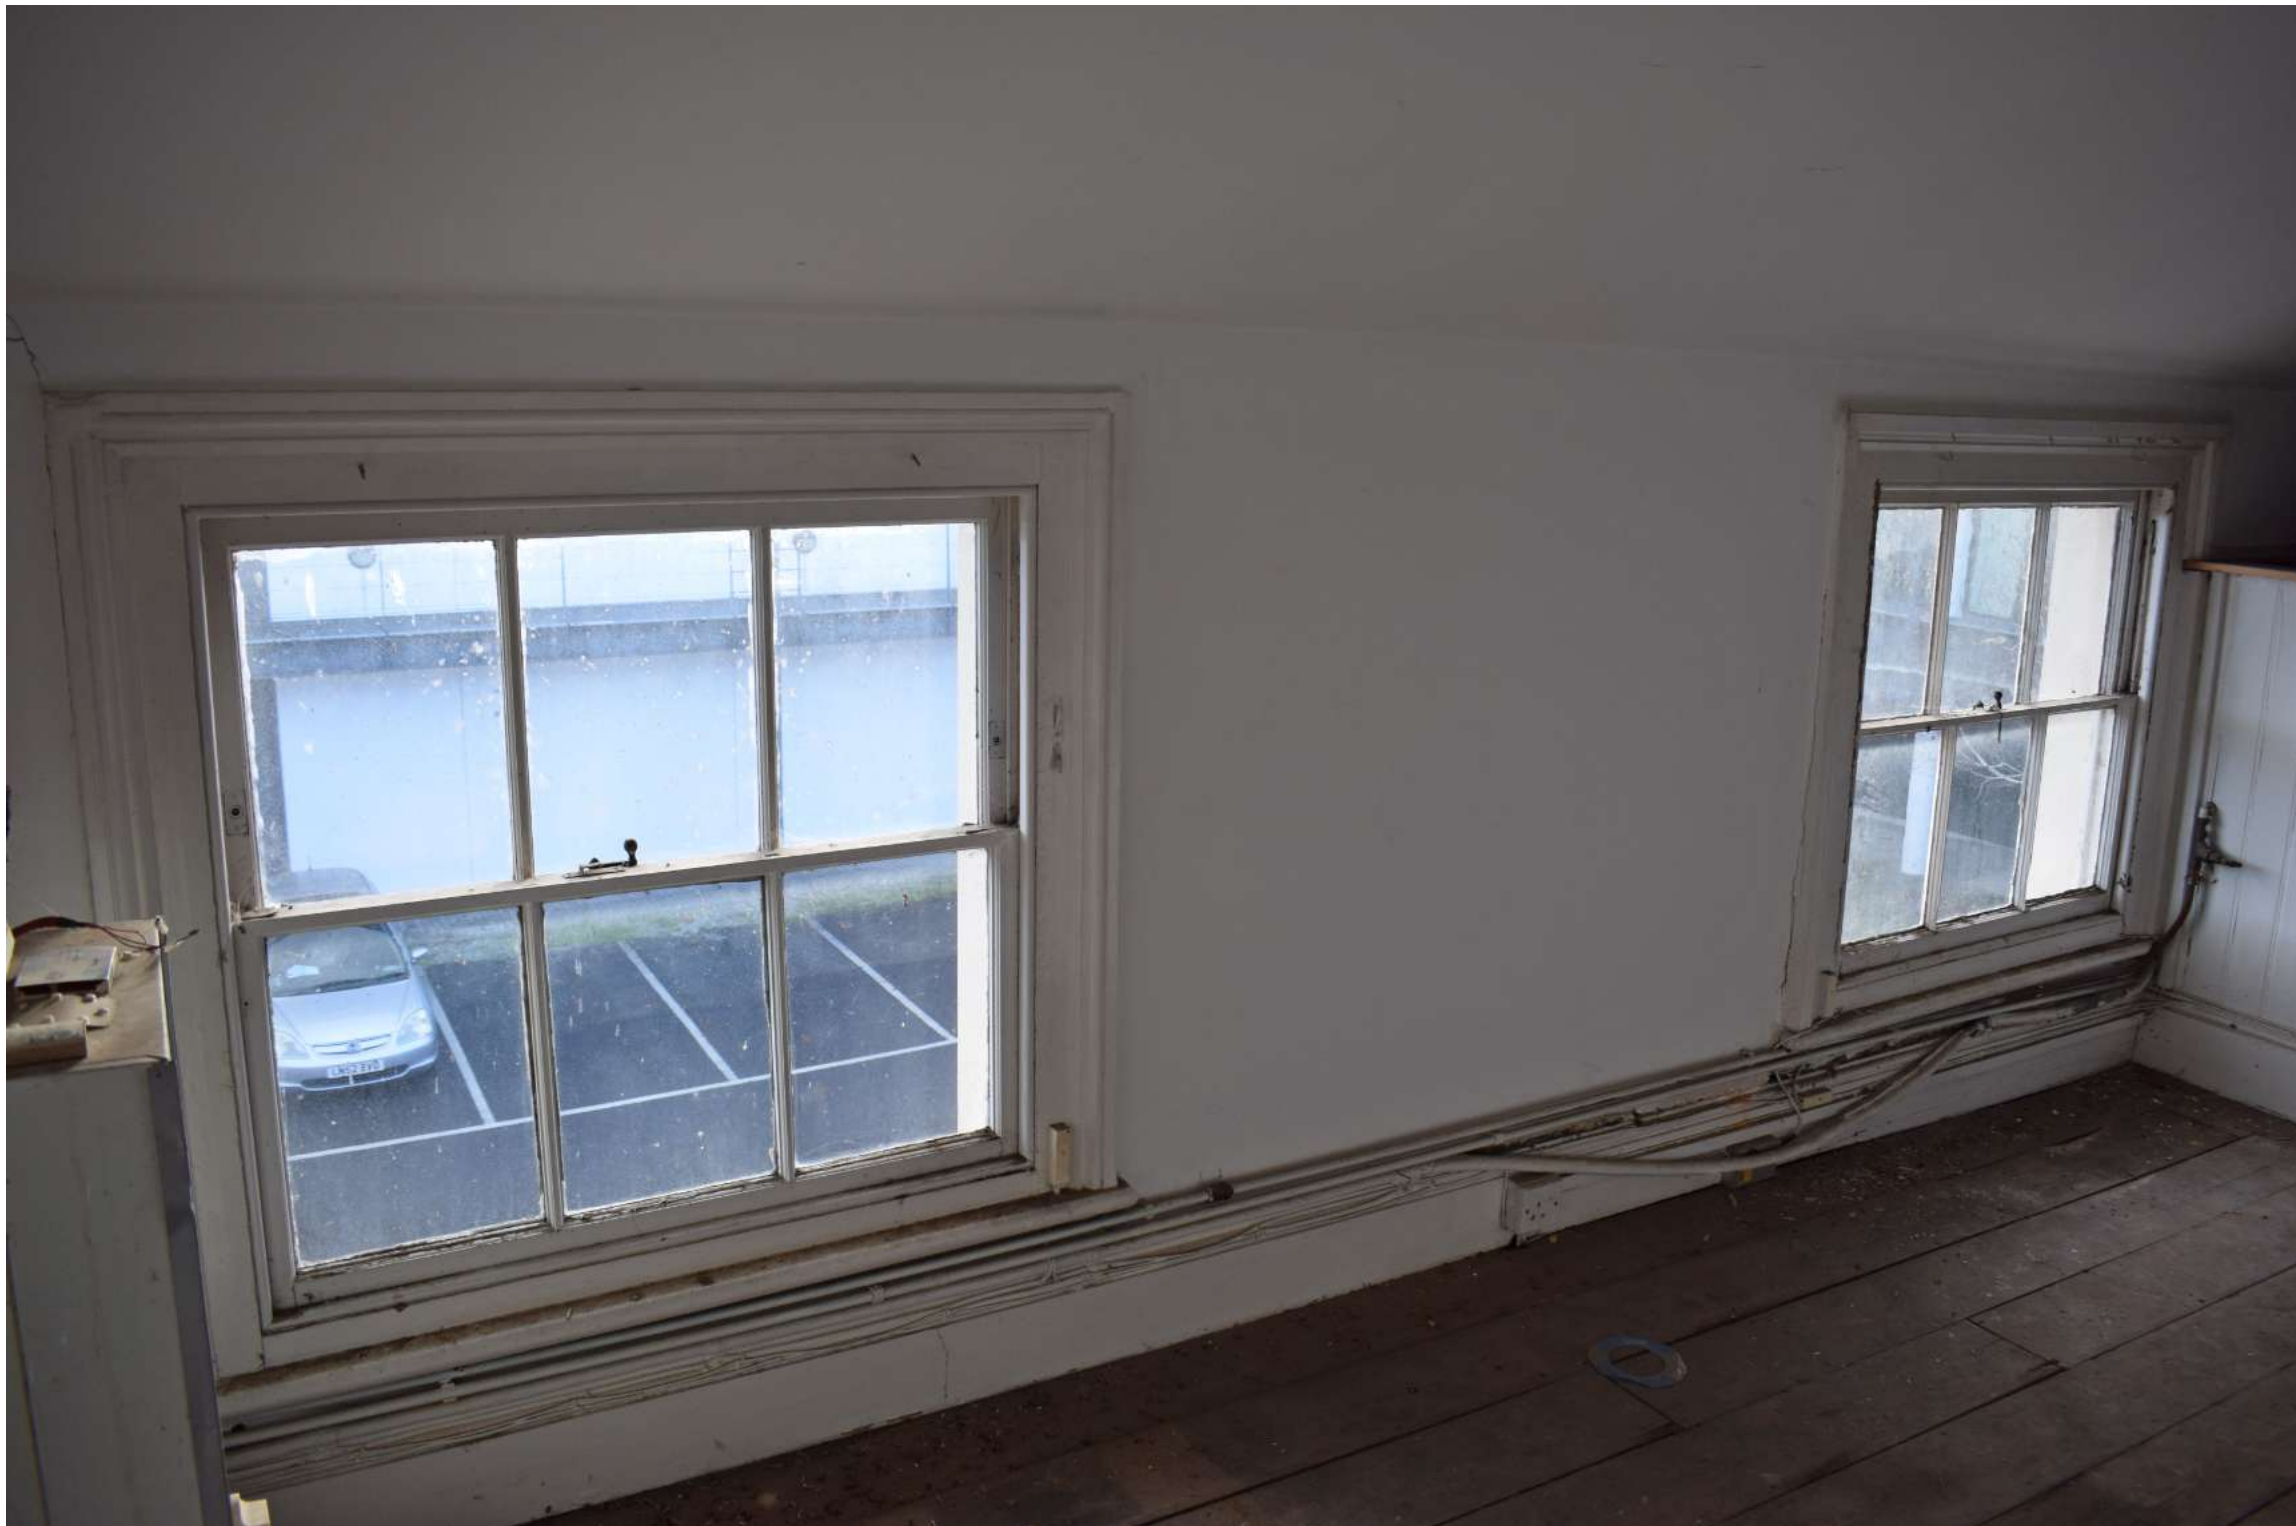
Plate 90

Building regulations will require glazed units in front of these windows and new ventilation fixtures to replace the window ventilation once secured.
