Phases 2a and 2b west wing

## Appendix 11

Yeomanry House

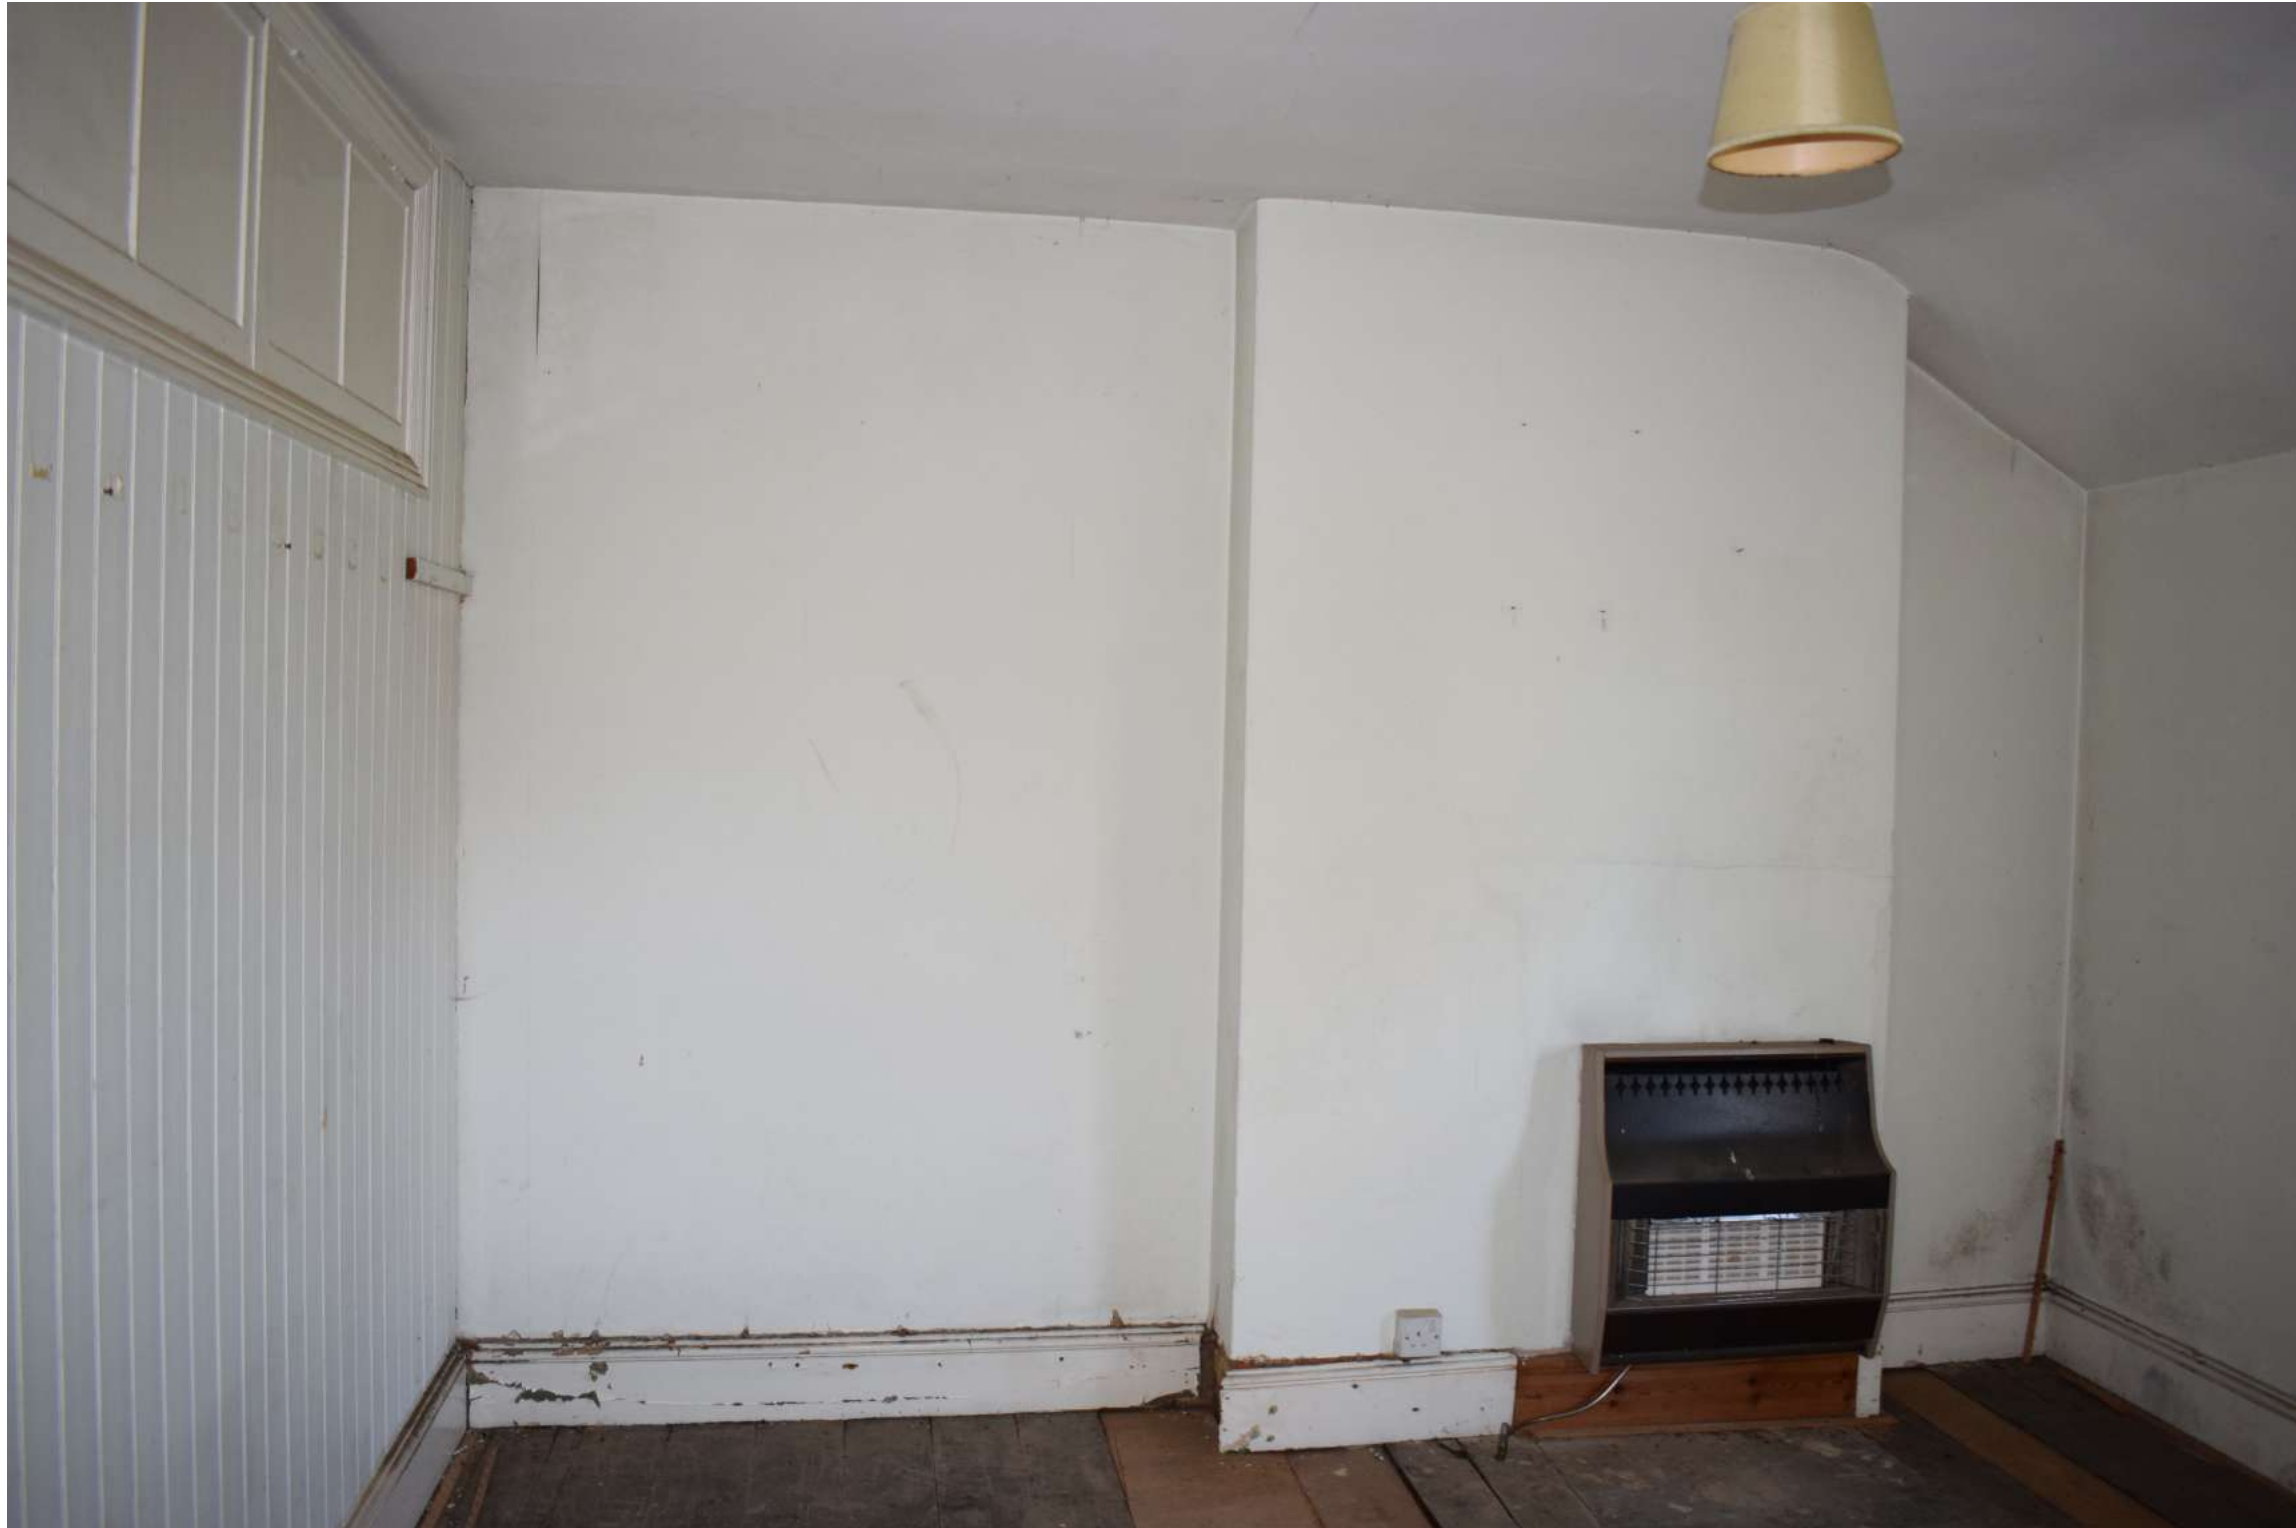
Plate 97

Condition issue: This image provides evidence of historic damp, possibly still actively, manifesting through the wallpaper in the corner.

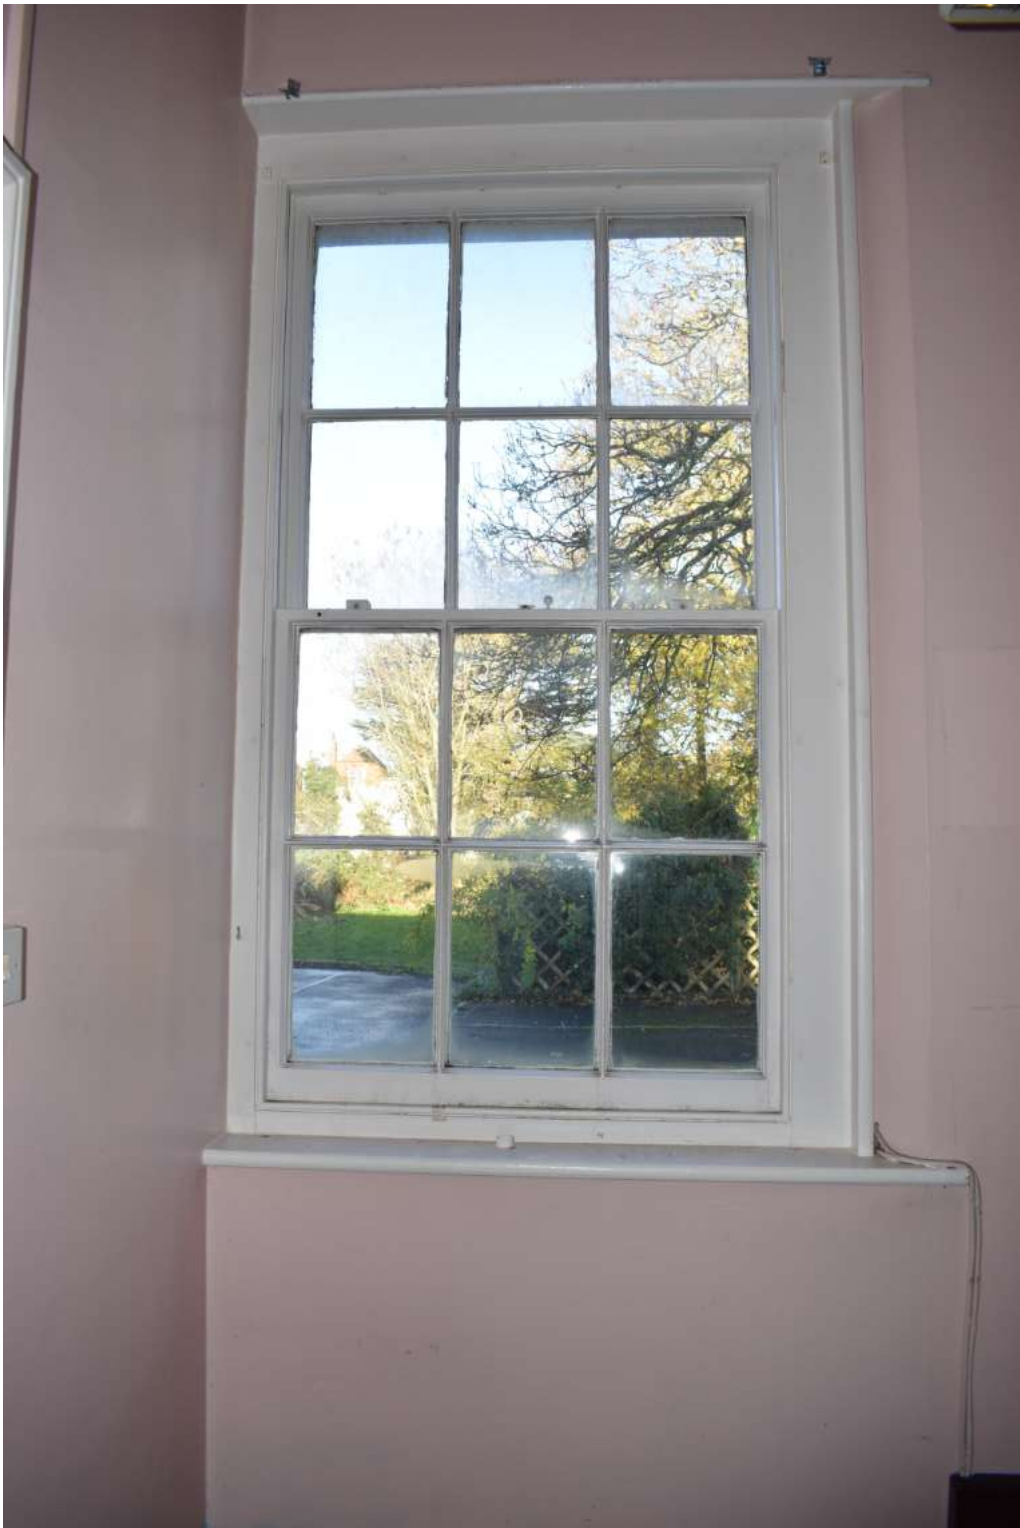
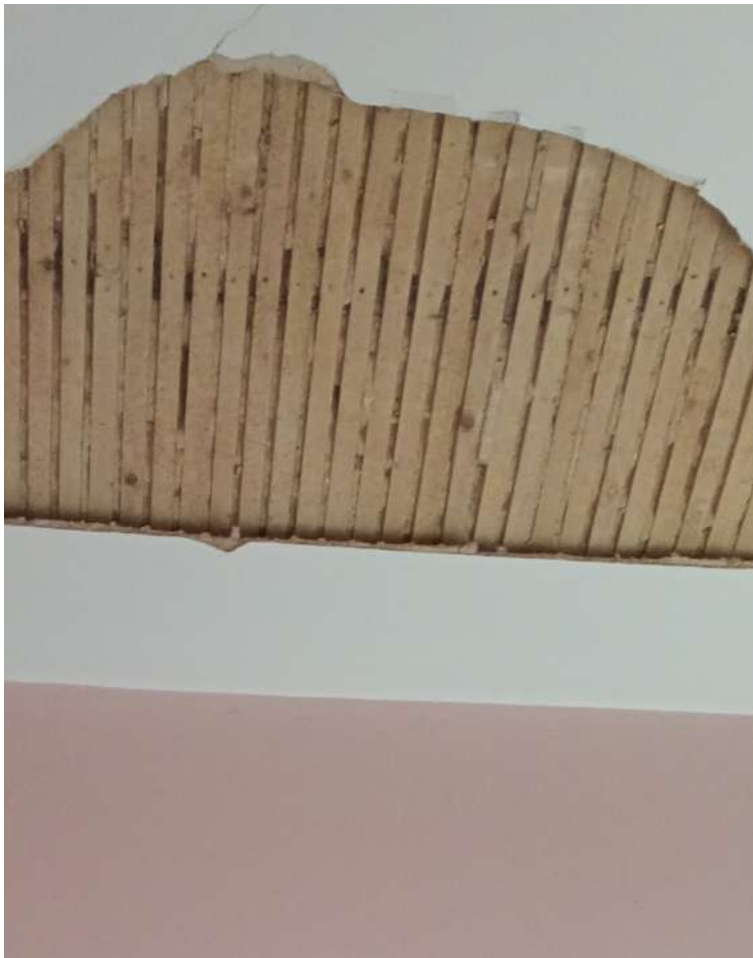
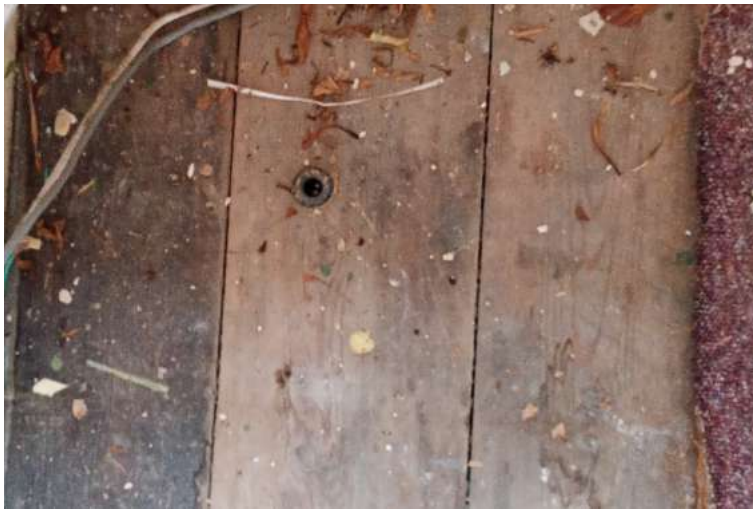
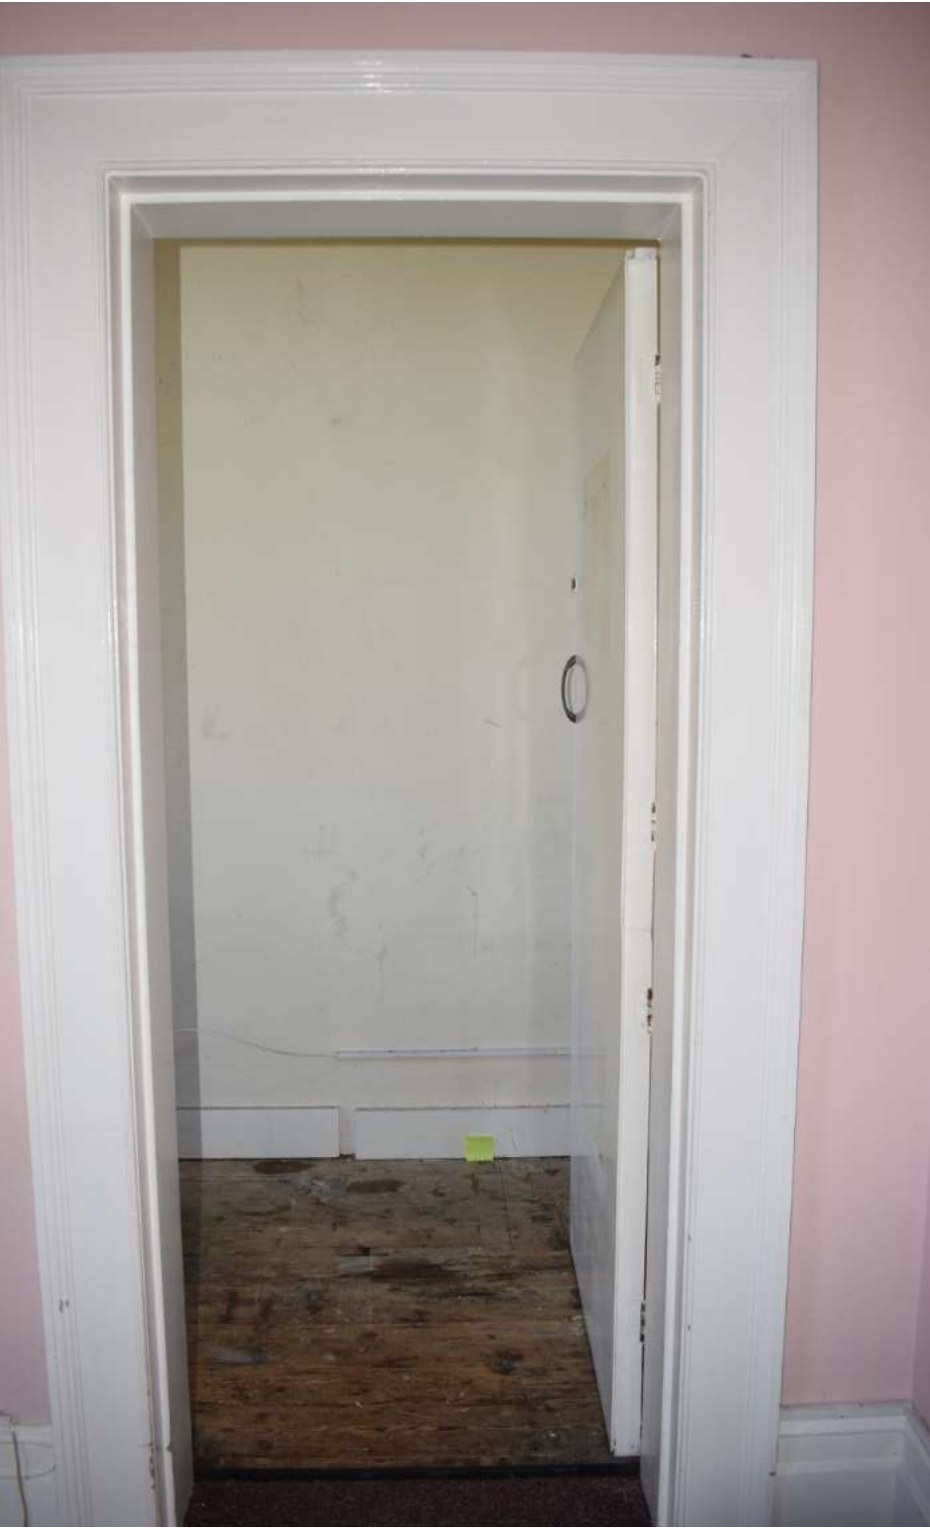
Plate 108

This angled wall that cuts into window architrave. The angled wall cutting into the window architrave is often seen when an original room layout (like a hallway or main reception room) was subdivided later to create a smaller, functional space, such as a butler's pantry or washroom. Insets: a detail of a poorly executed repair that took part of the lath and plaster ceiling with it and the timber flooring.

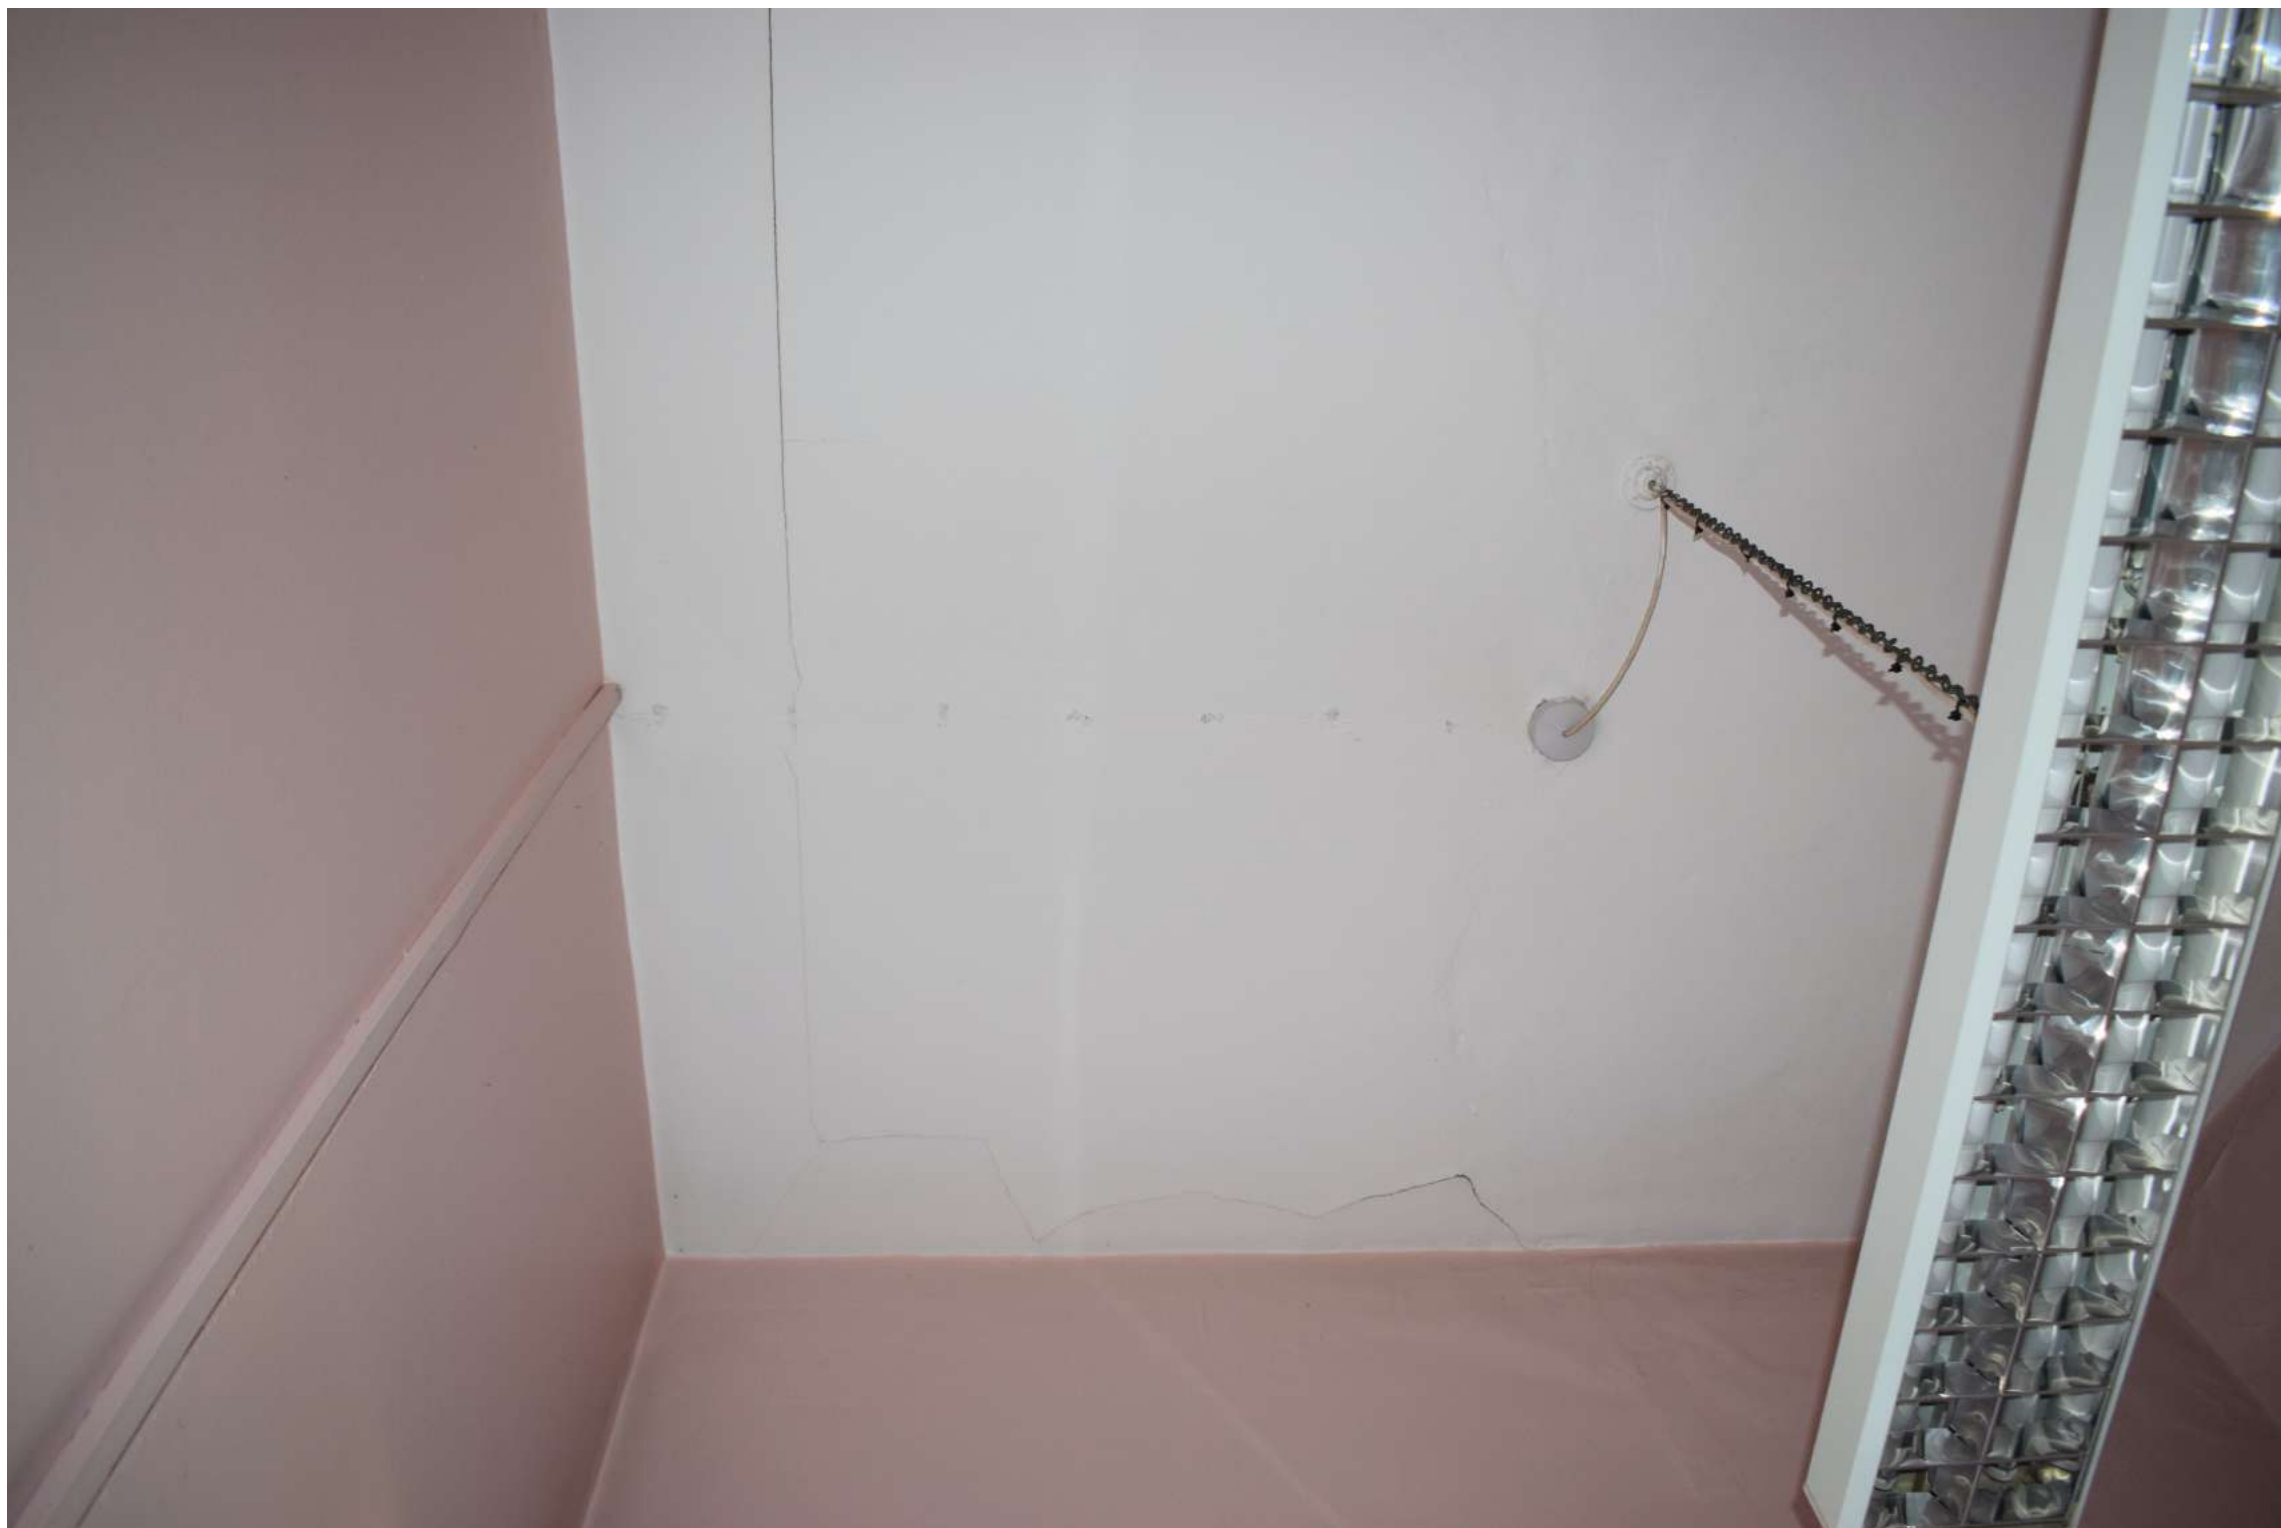
Plate 110

The butler's pantry ceiling shows cracks but is otherwise in good condition.

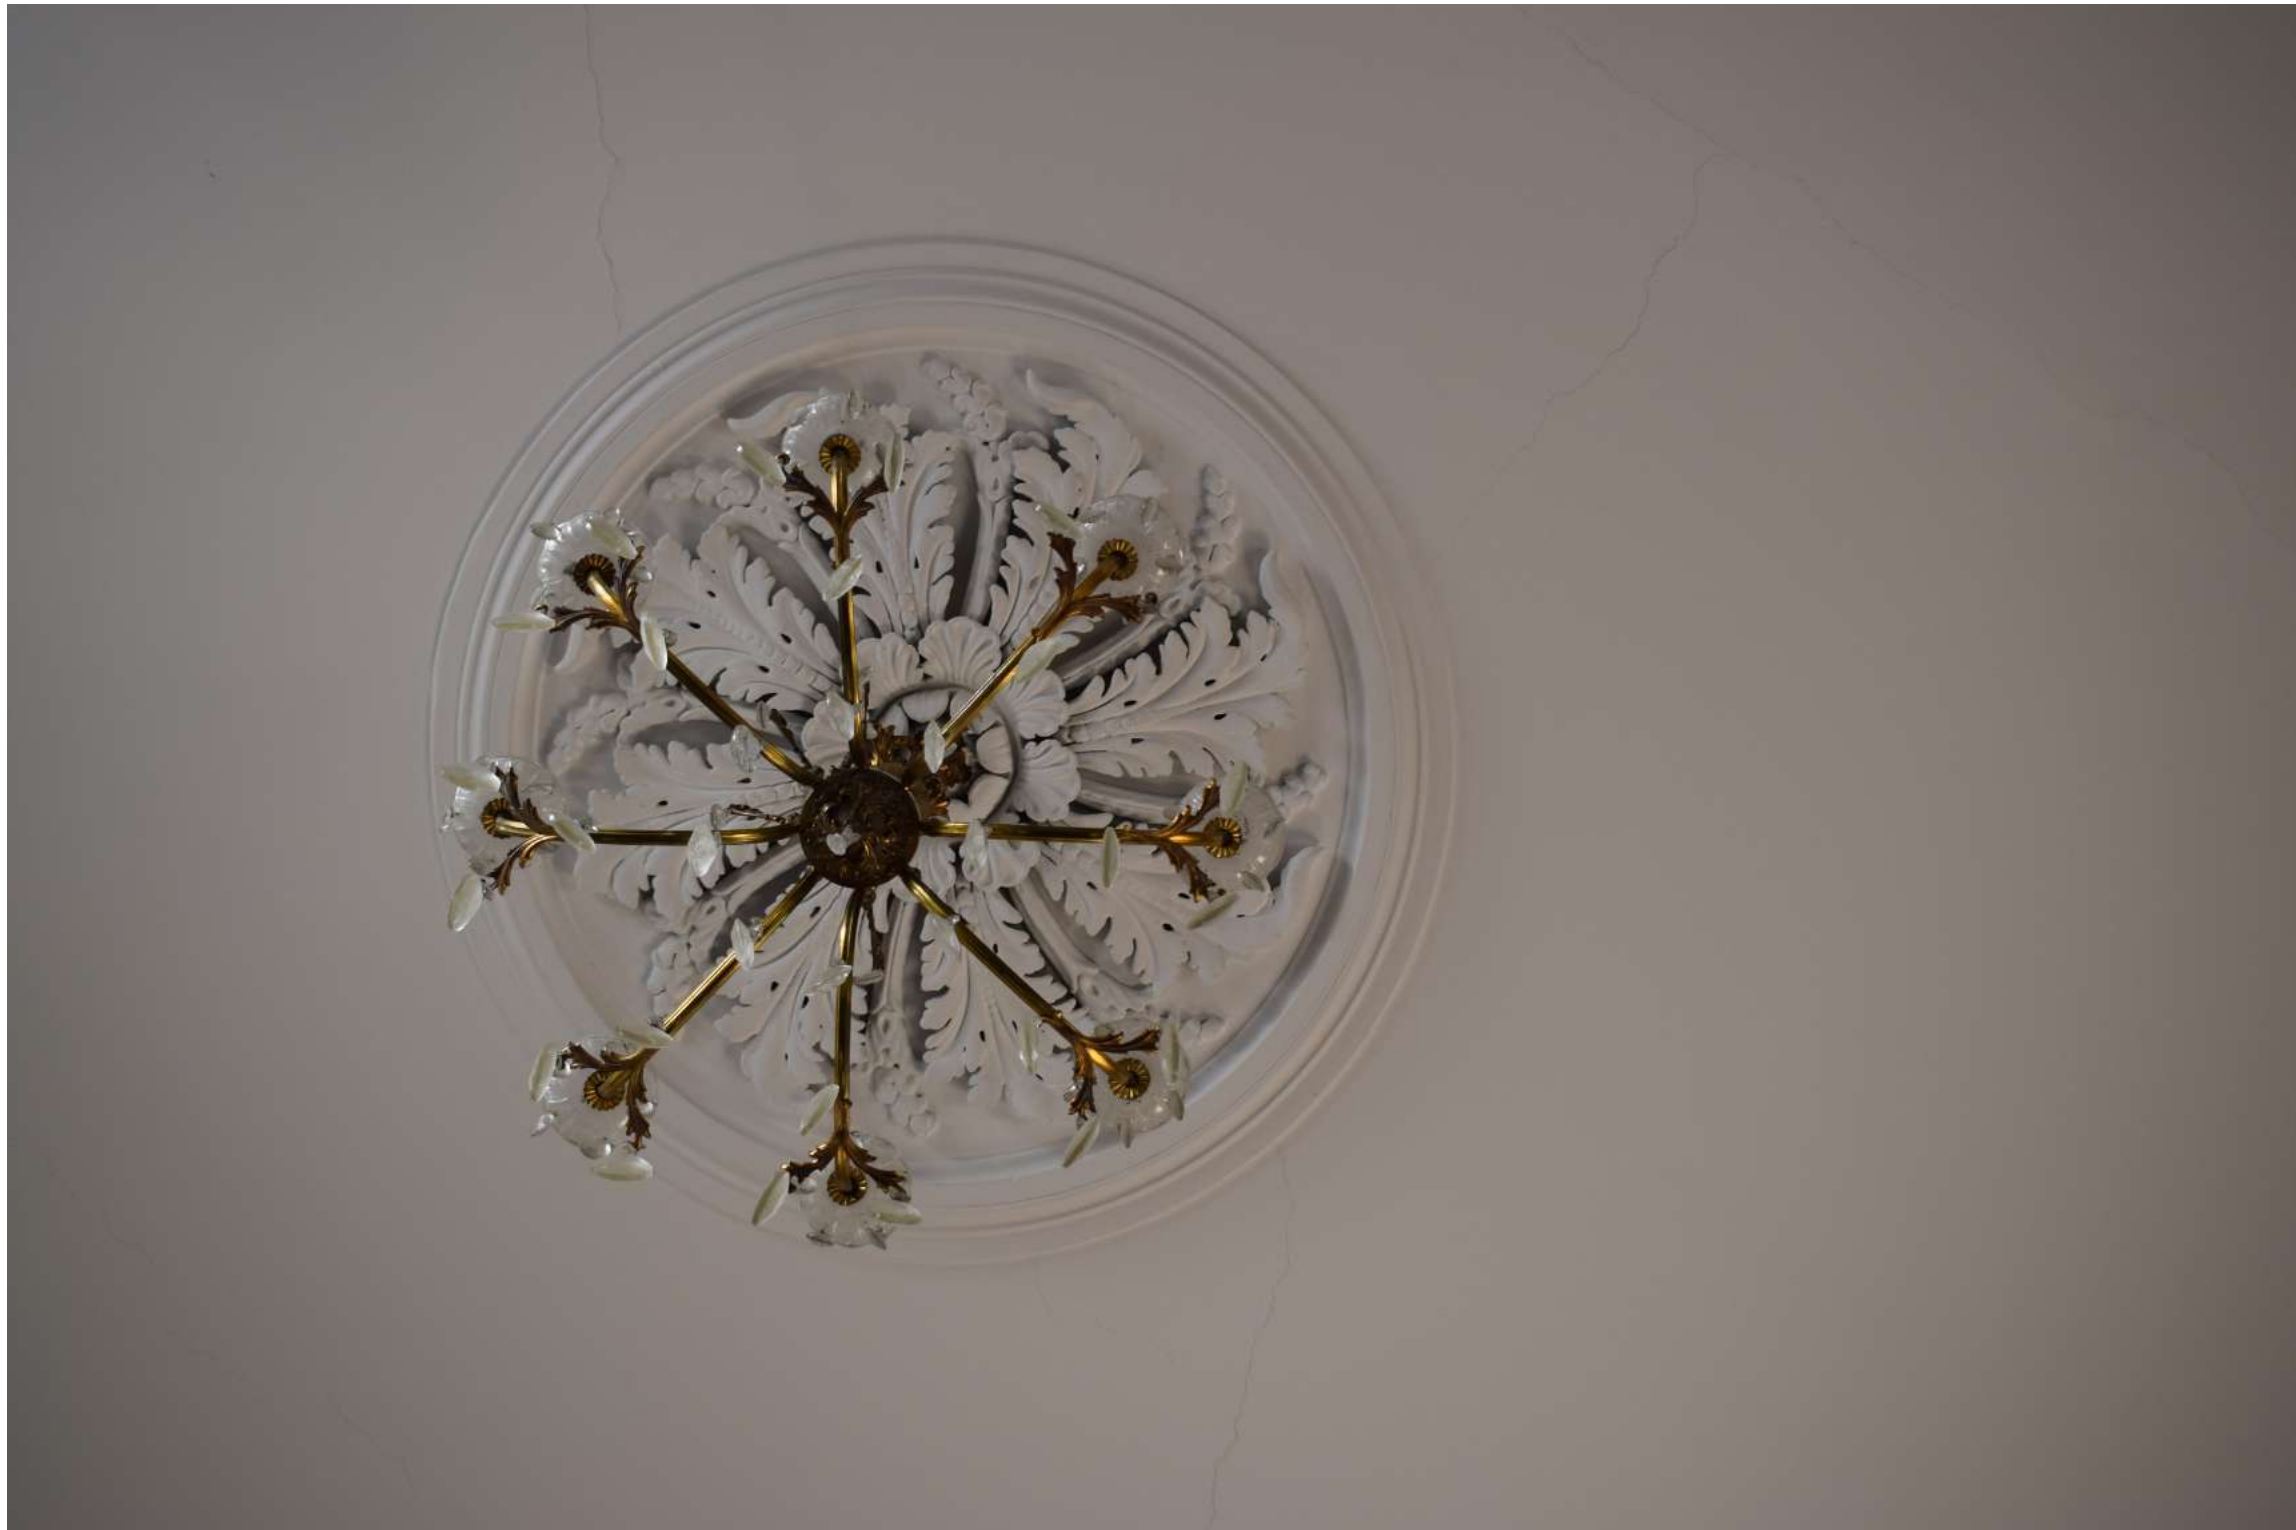
Plate 112

The large ceremony room contains a central decorative ceiling rose. The ceiling is in good condition except in one corner.

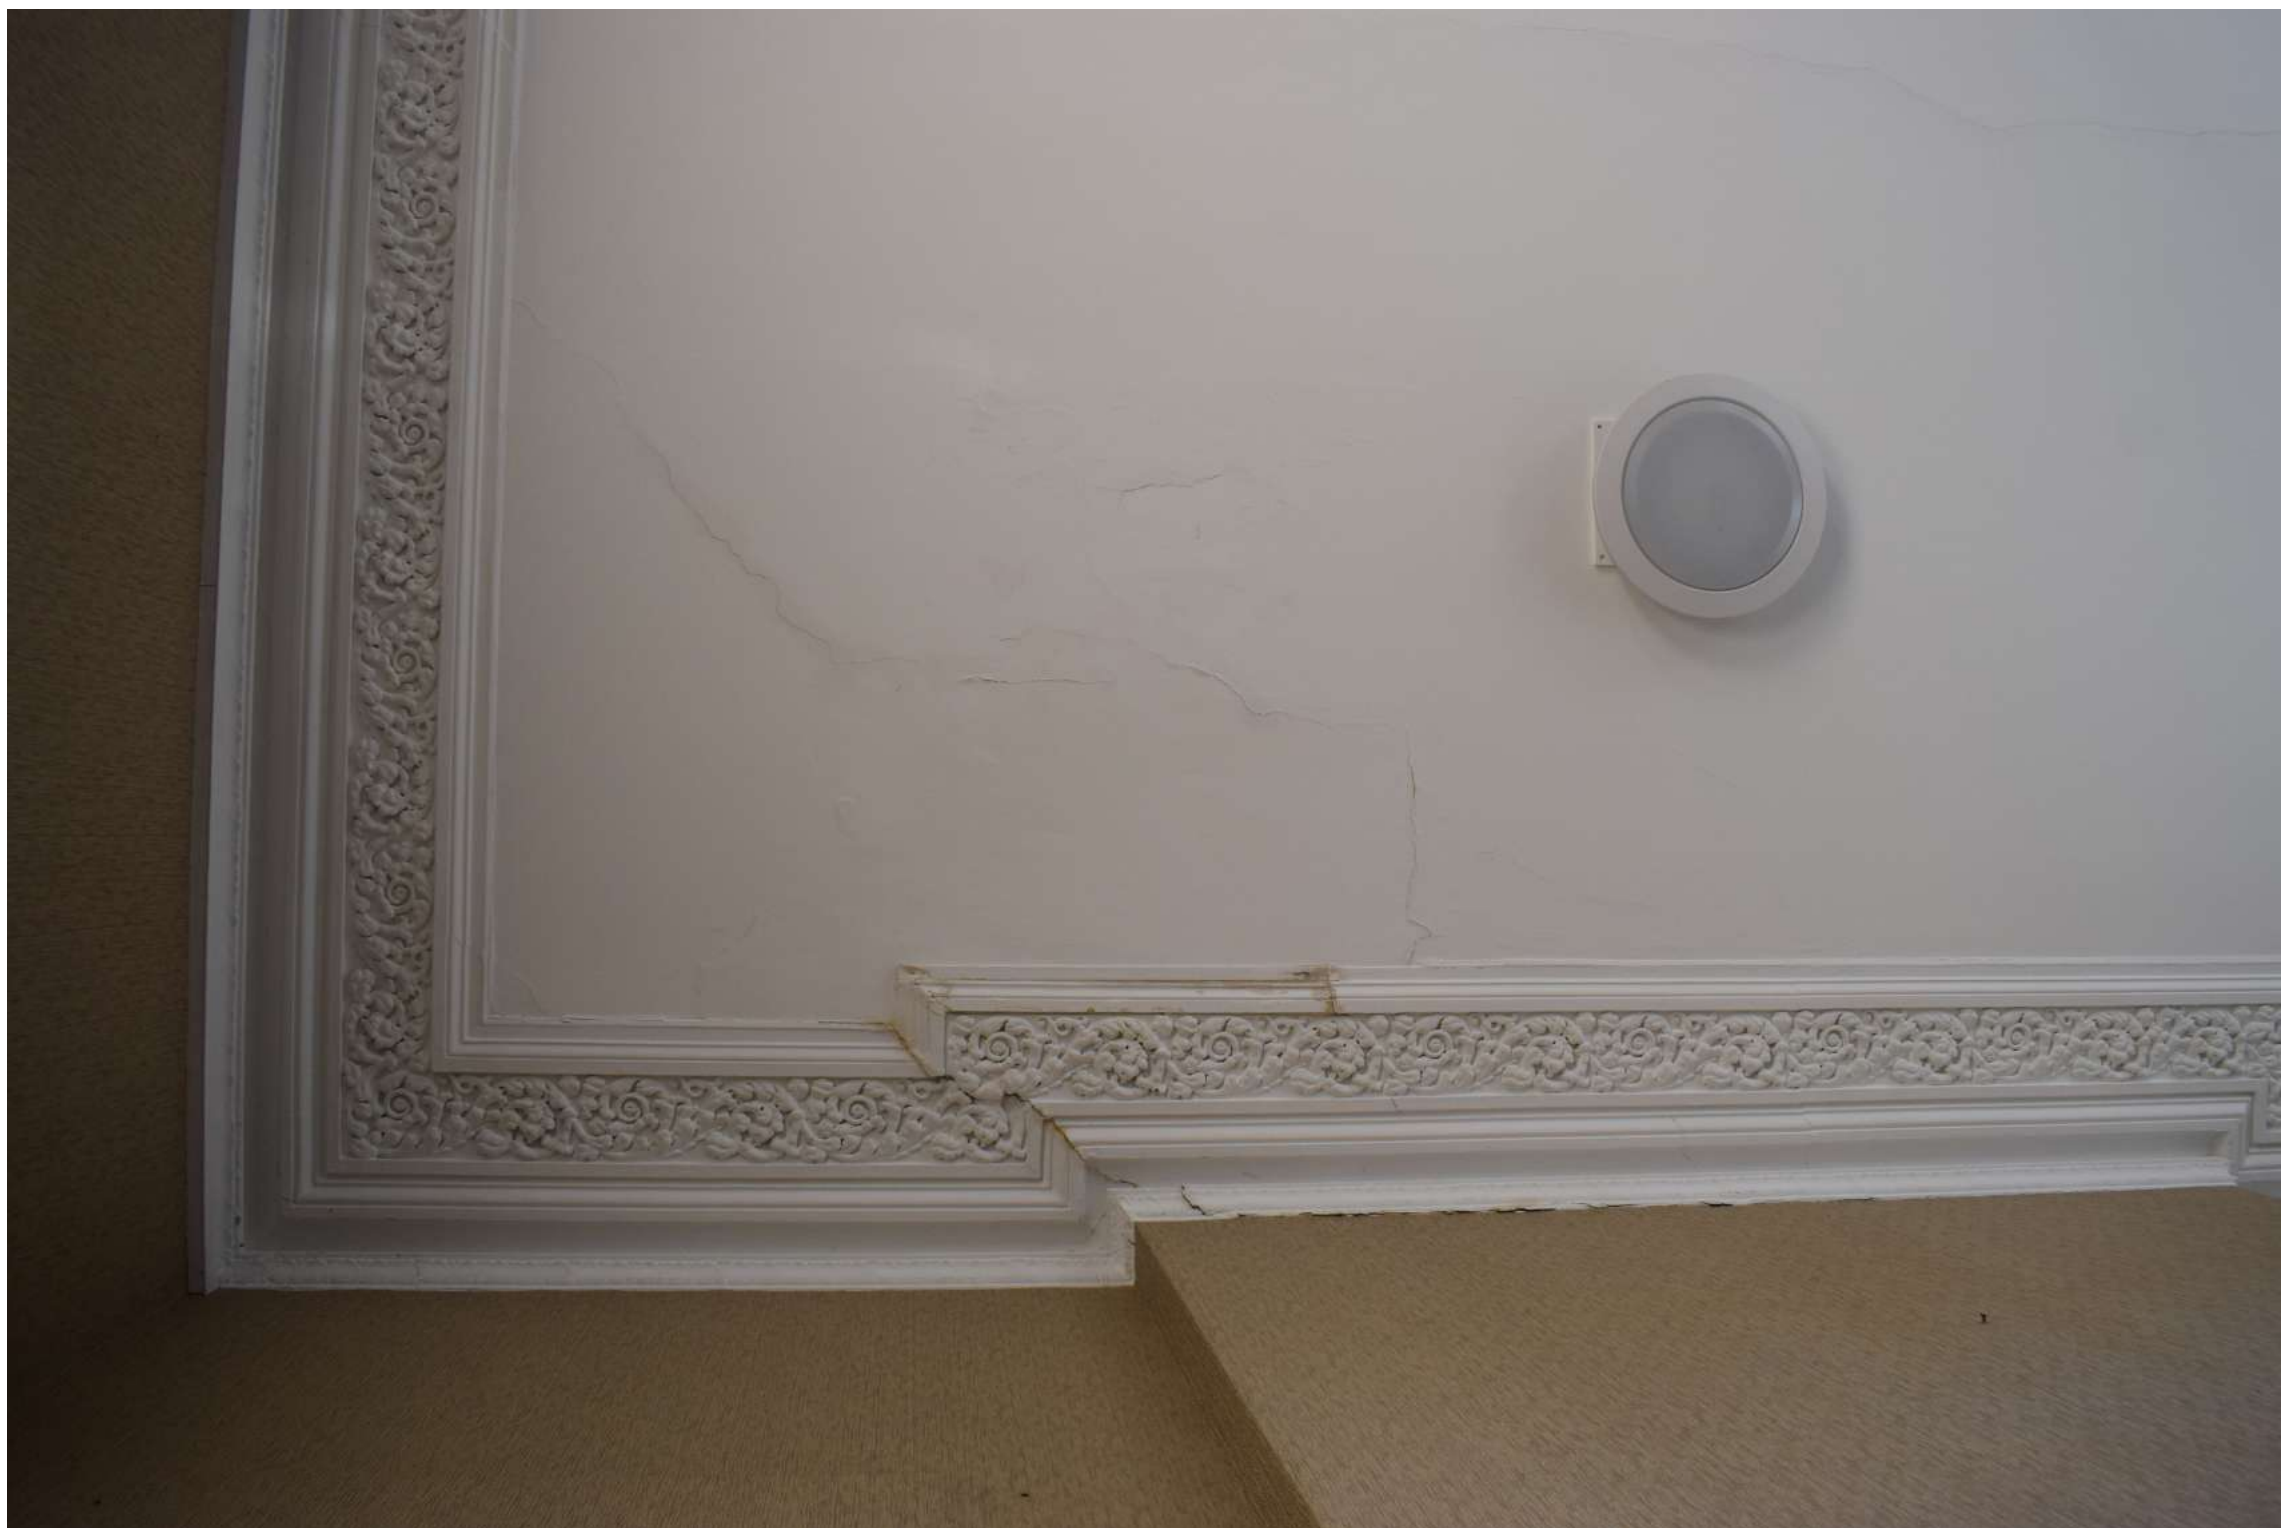
Plate 113

Hairline crack are visible in the ceiling of the large ceremony room require stabilisation and repair.

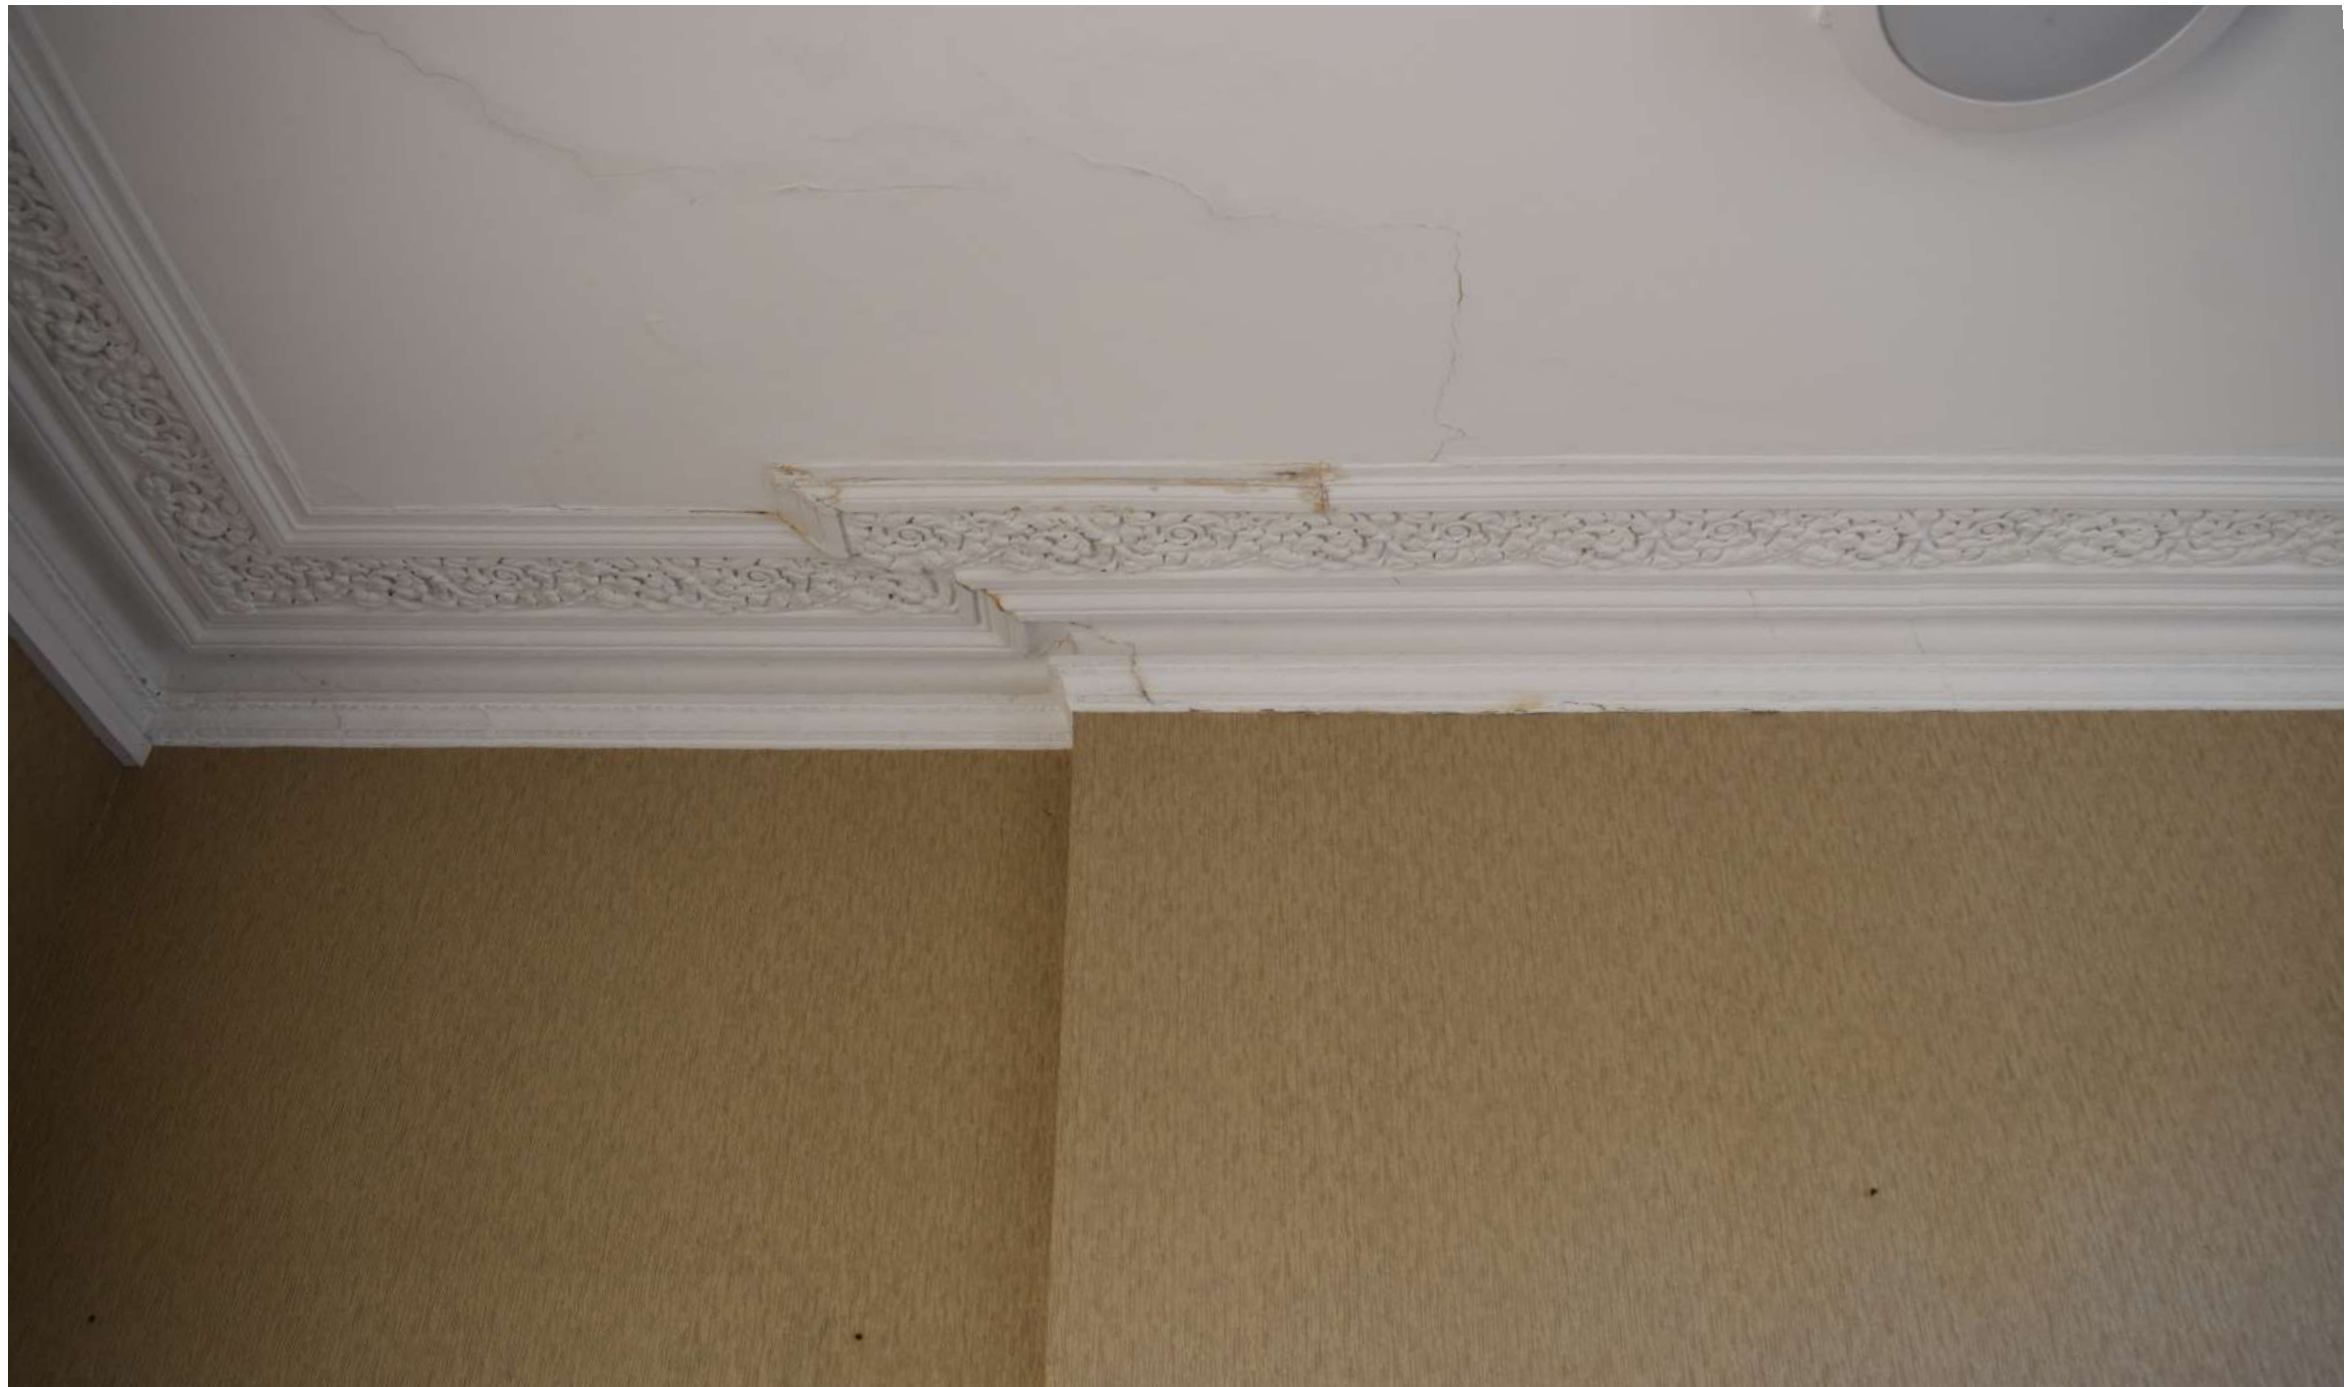
Plate 114

Hairline cracks are also visible in the cornice of the large ceremony room require stabilisation and repair.
