Phases 2a and 2b west wing

## Appendix 11

Yeomanry House

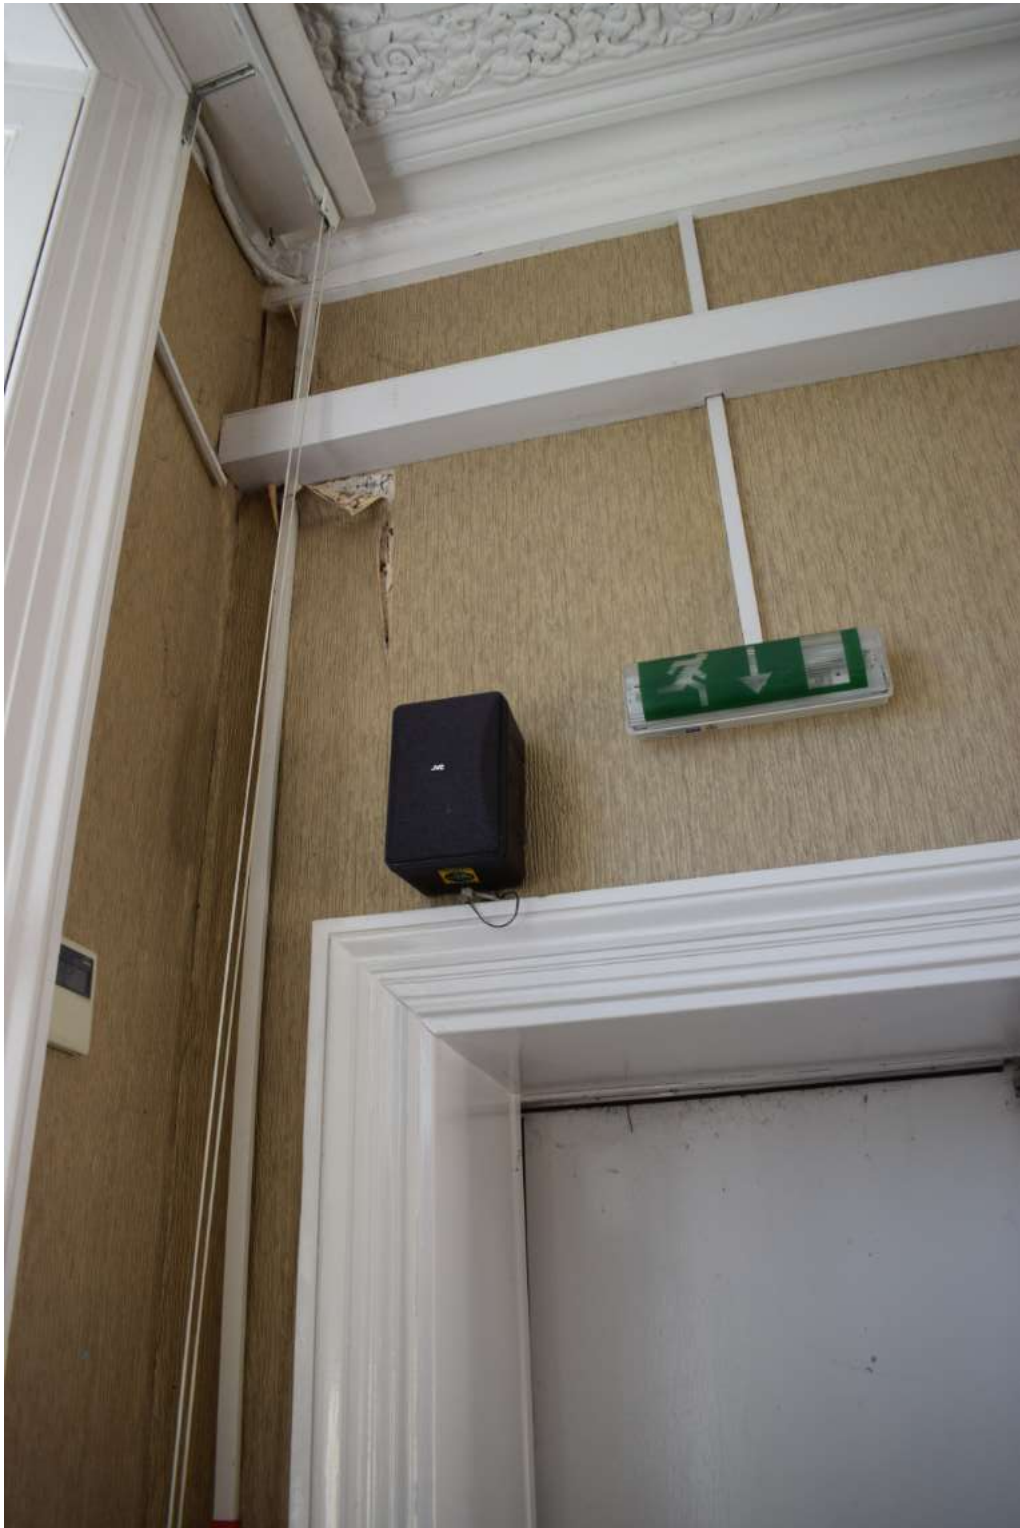
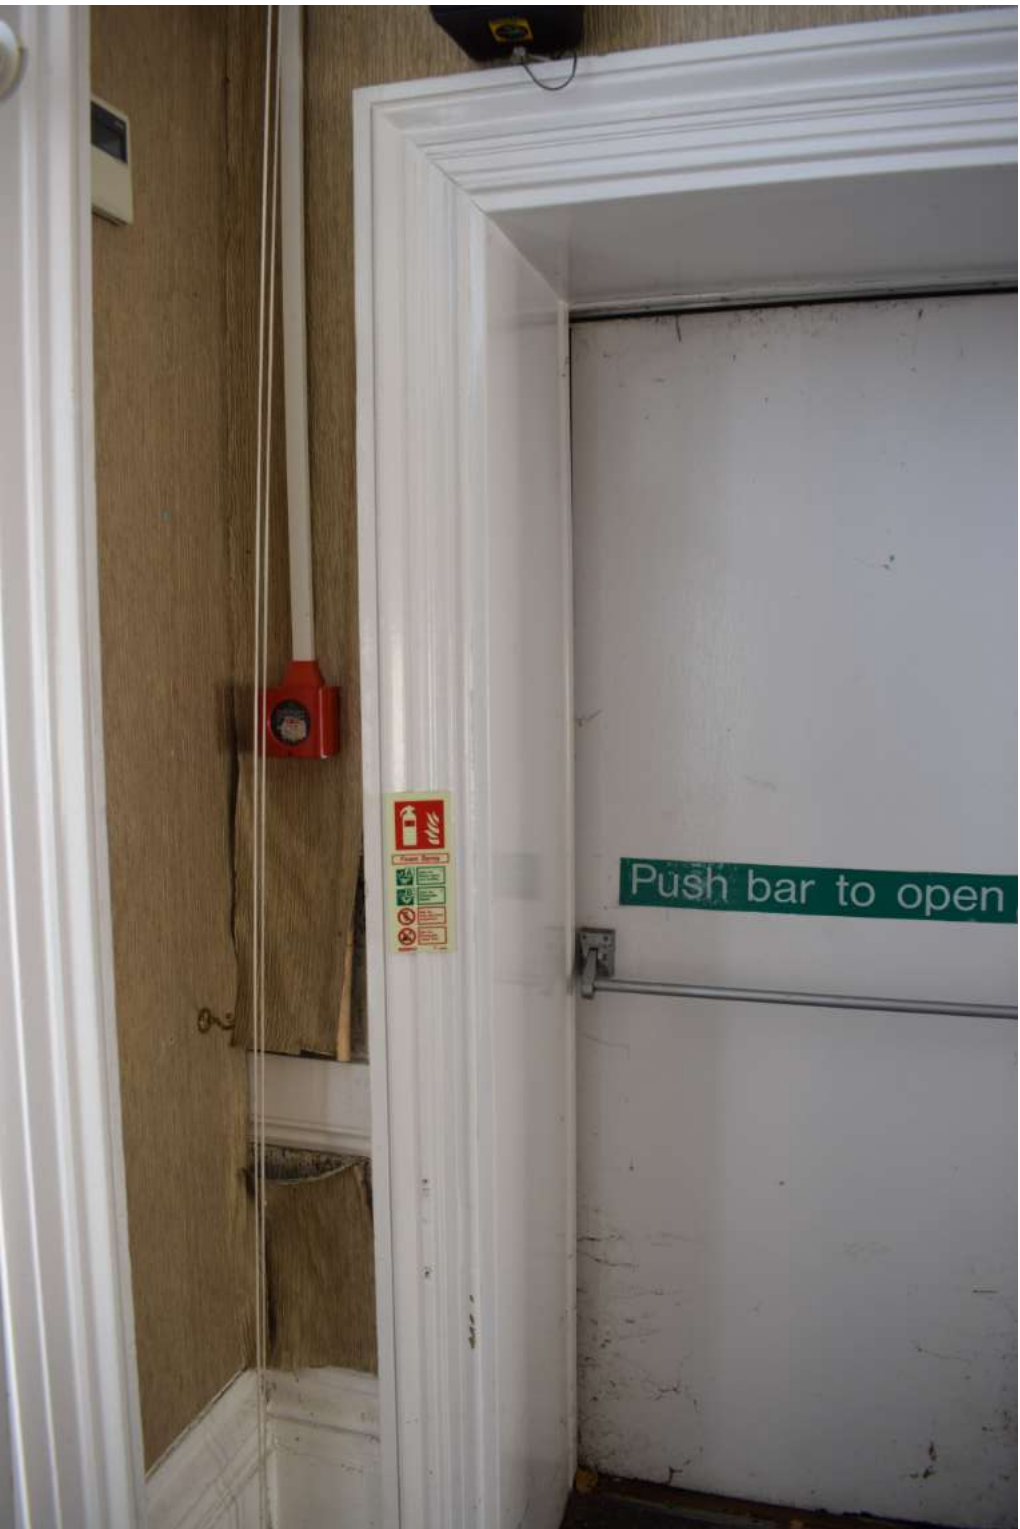
Plate 115

There is damp seen behind very wet wallpaper in the opposite corner. Inset: a detail of the timber flooring.

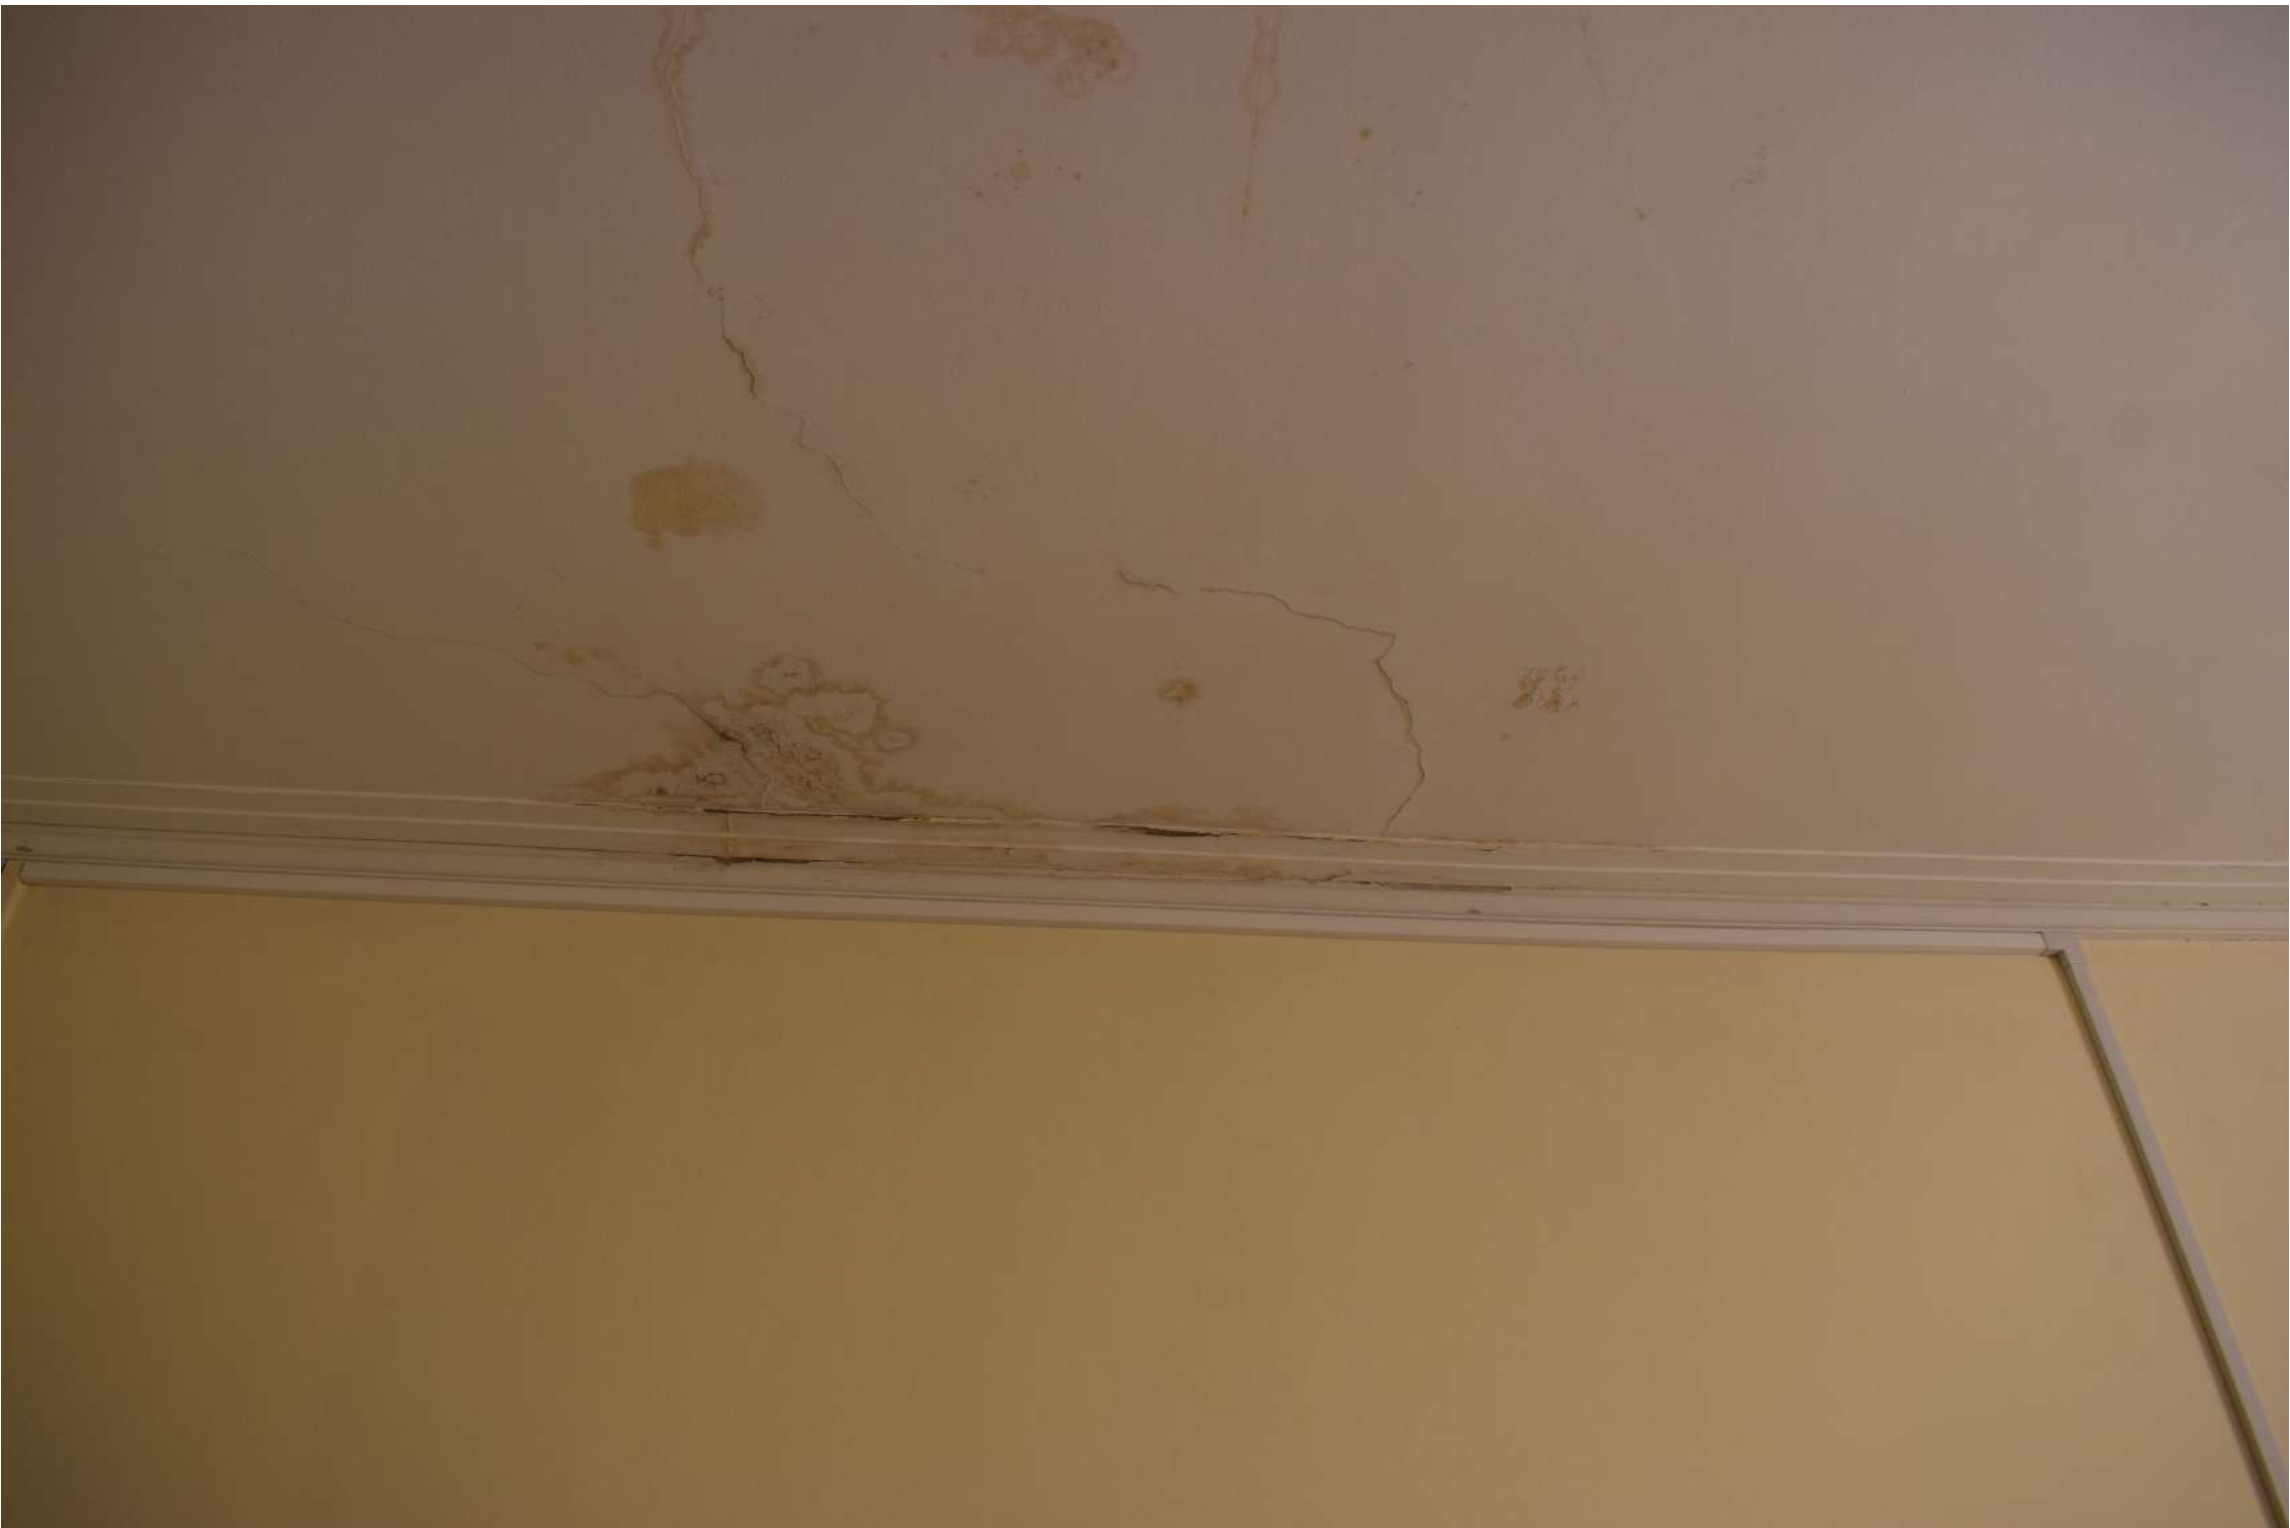
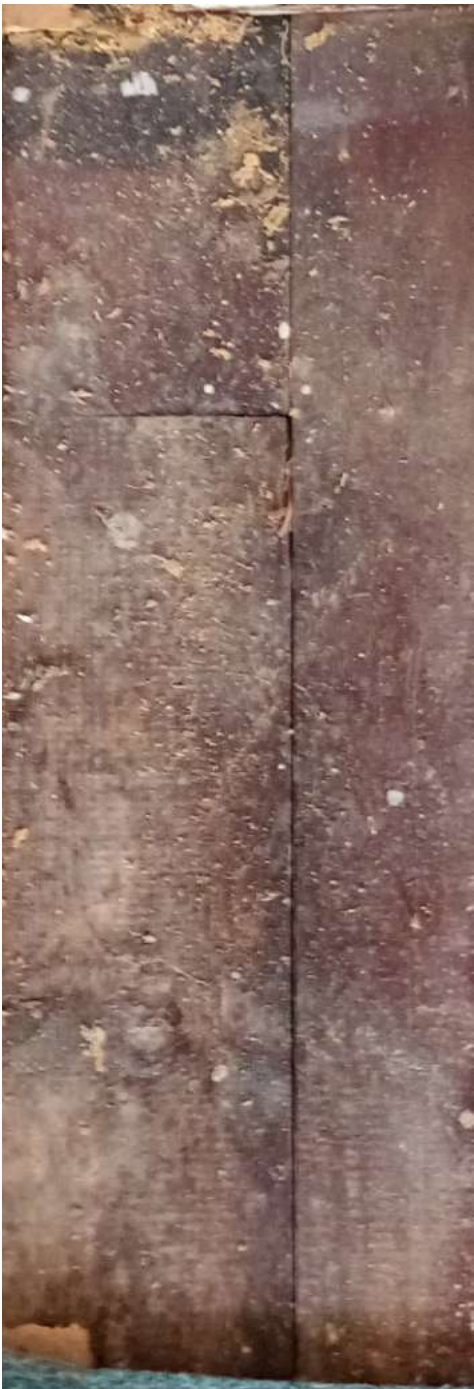
Plate 123  
In Office B, a damp stain caused by water ingress into the ceiling, affecting what appears to be a modern and historic coving. Inset: a detail of the timber flooring.

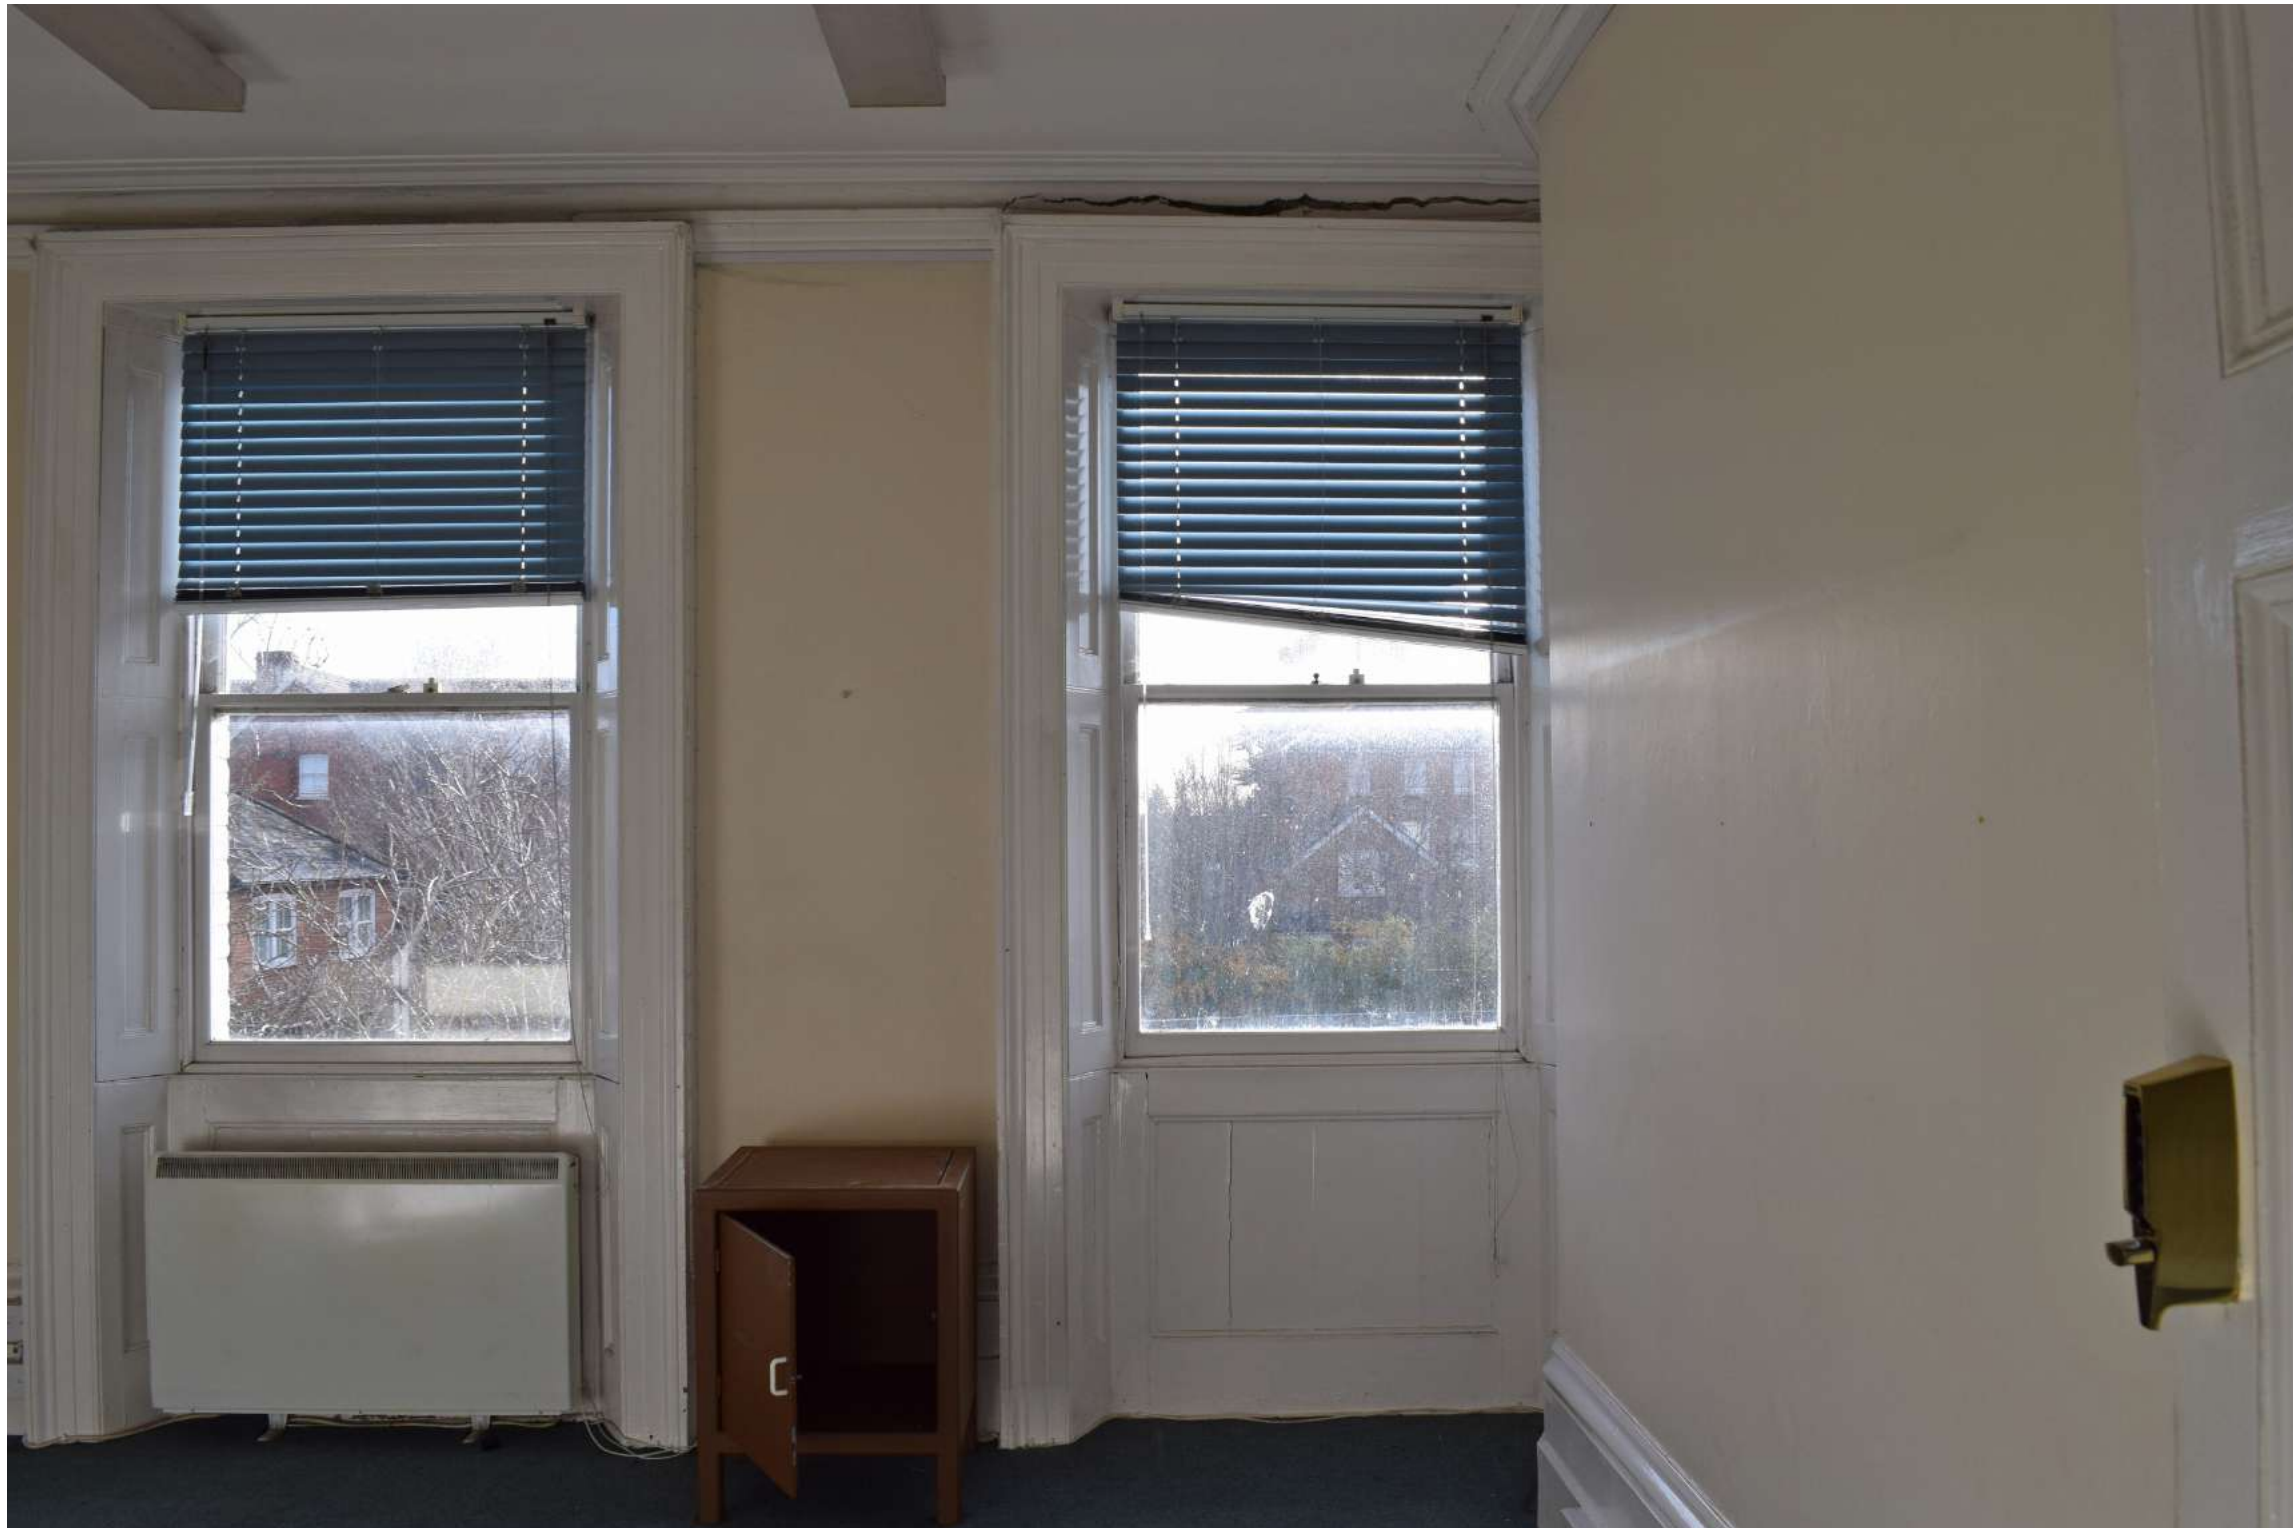
Plate 124

Matching skirtings and covings are seen in Office A, indicating sub-division. Historically lit by three windows, it is now lit by two sash windows. The damage above one of the windows in Office A may need to be checked for structural movement.

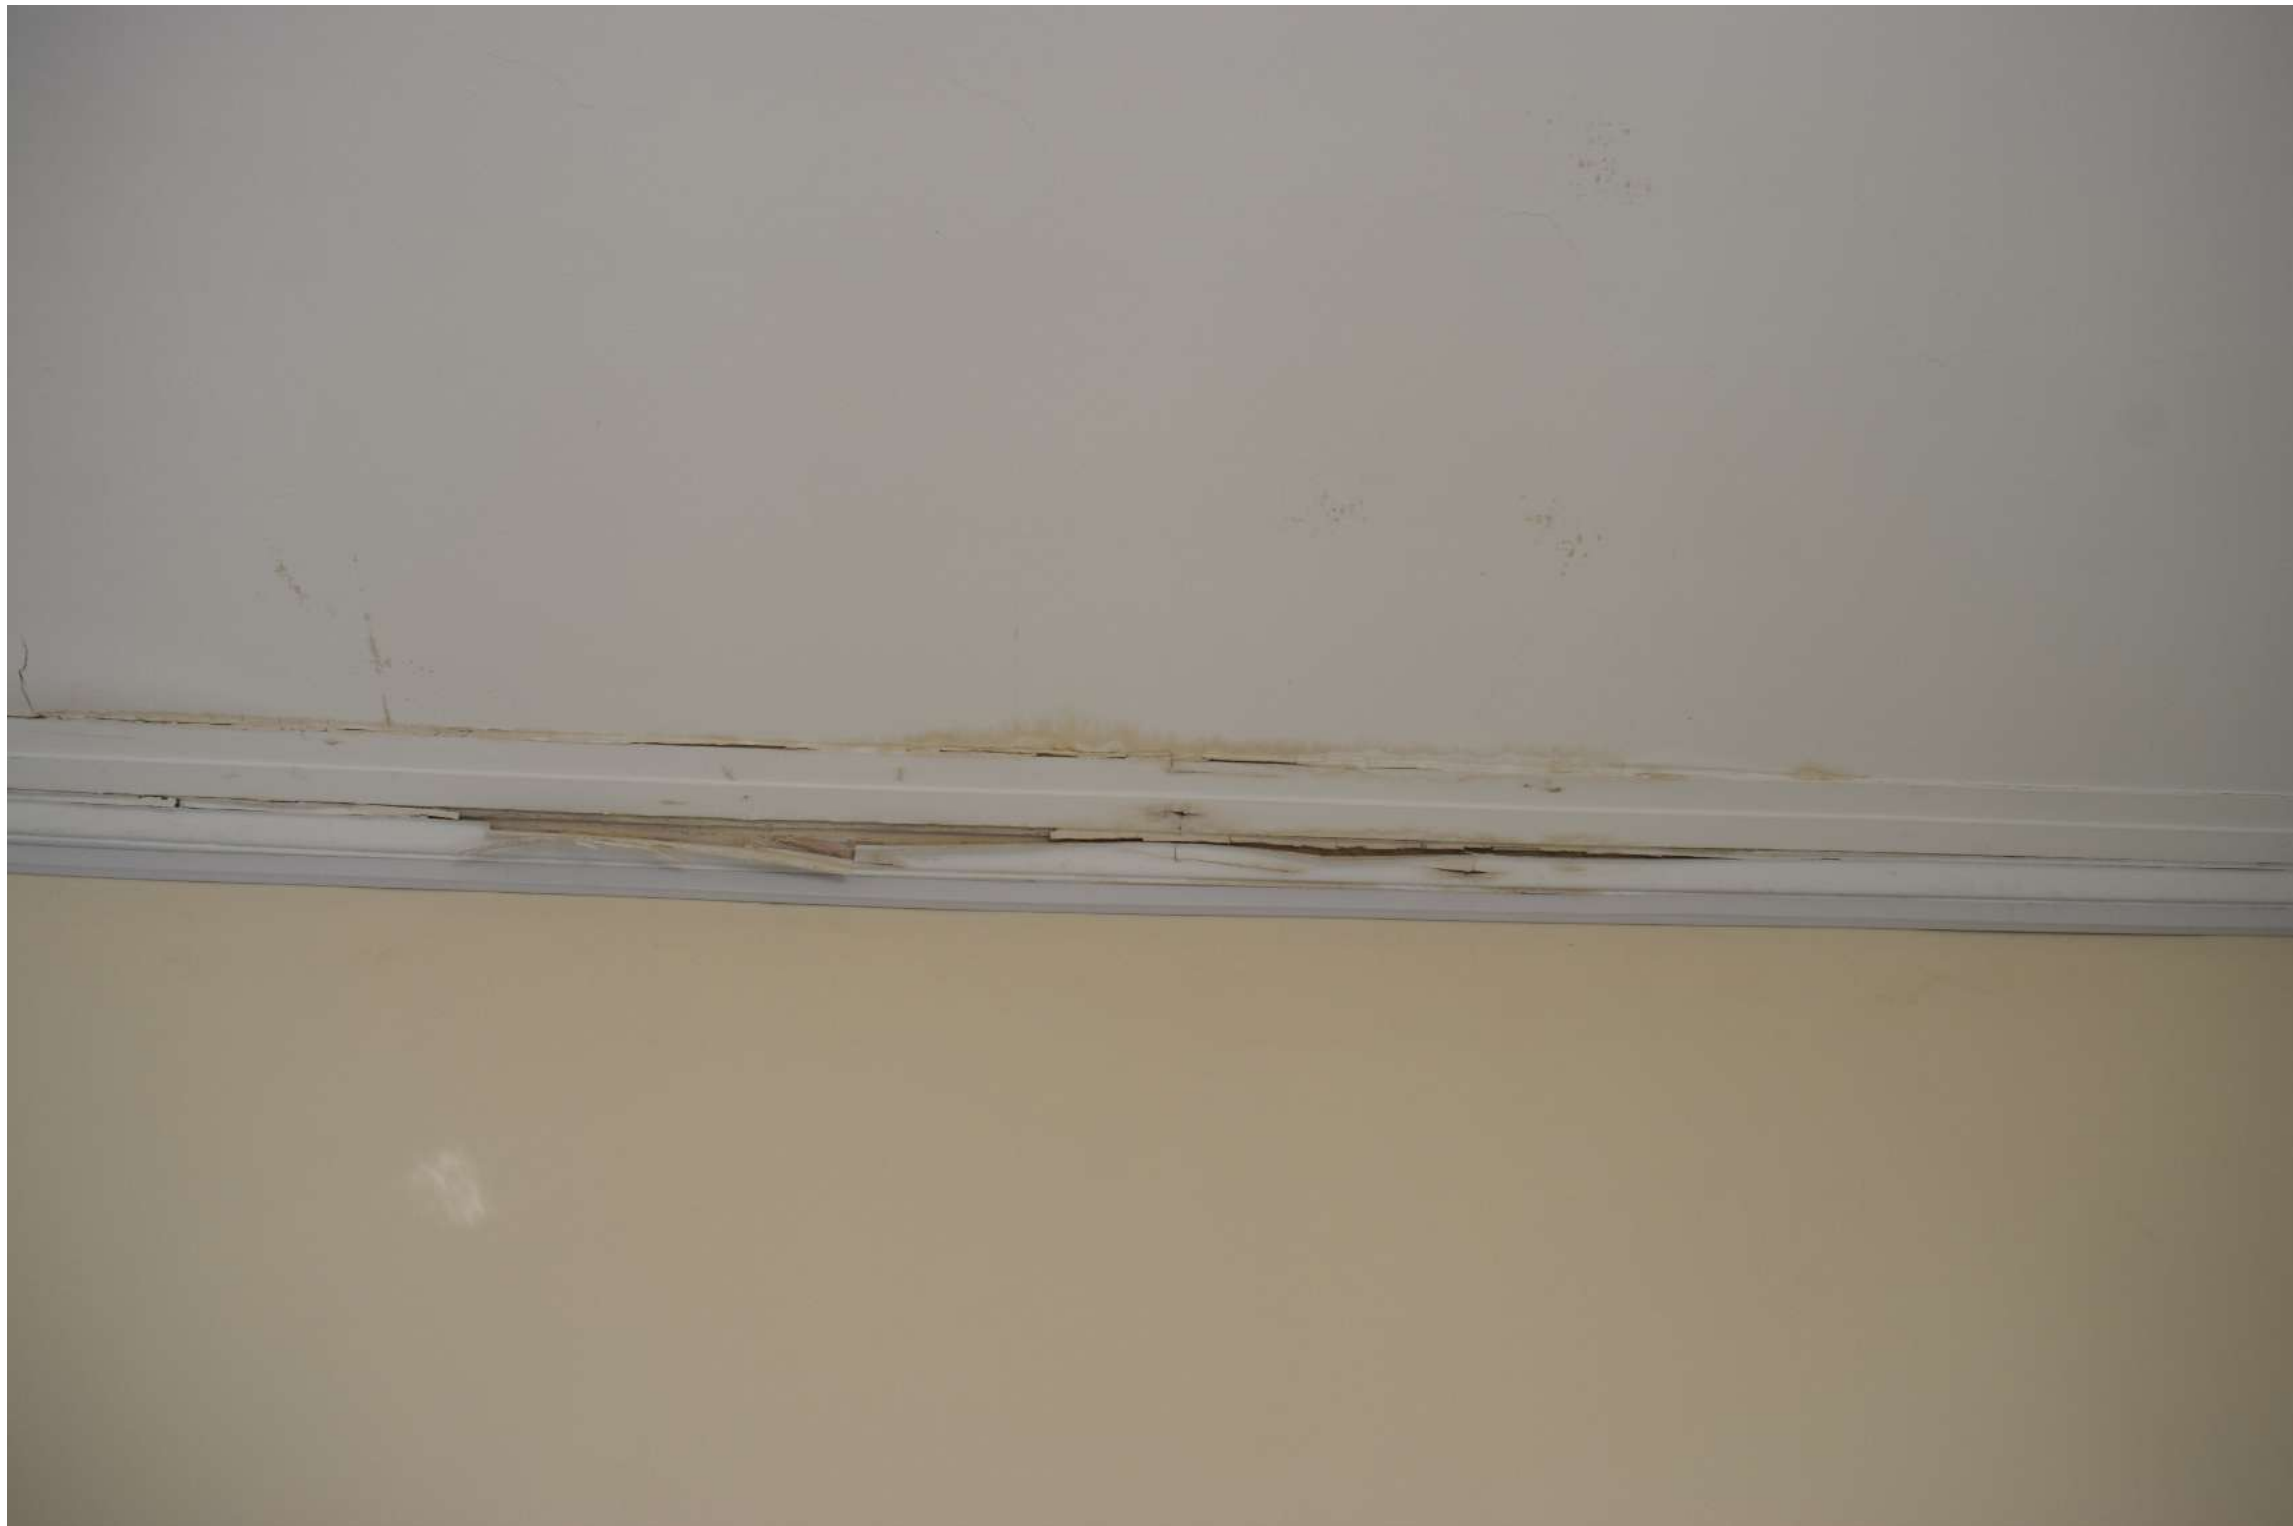
Plate 125

A damp stain caused by water ingress into the ceiling, affecting what appears to be a modern and historic coving.

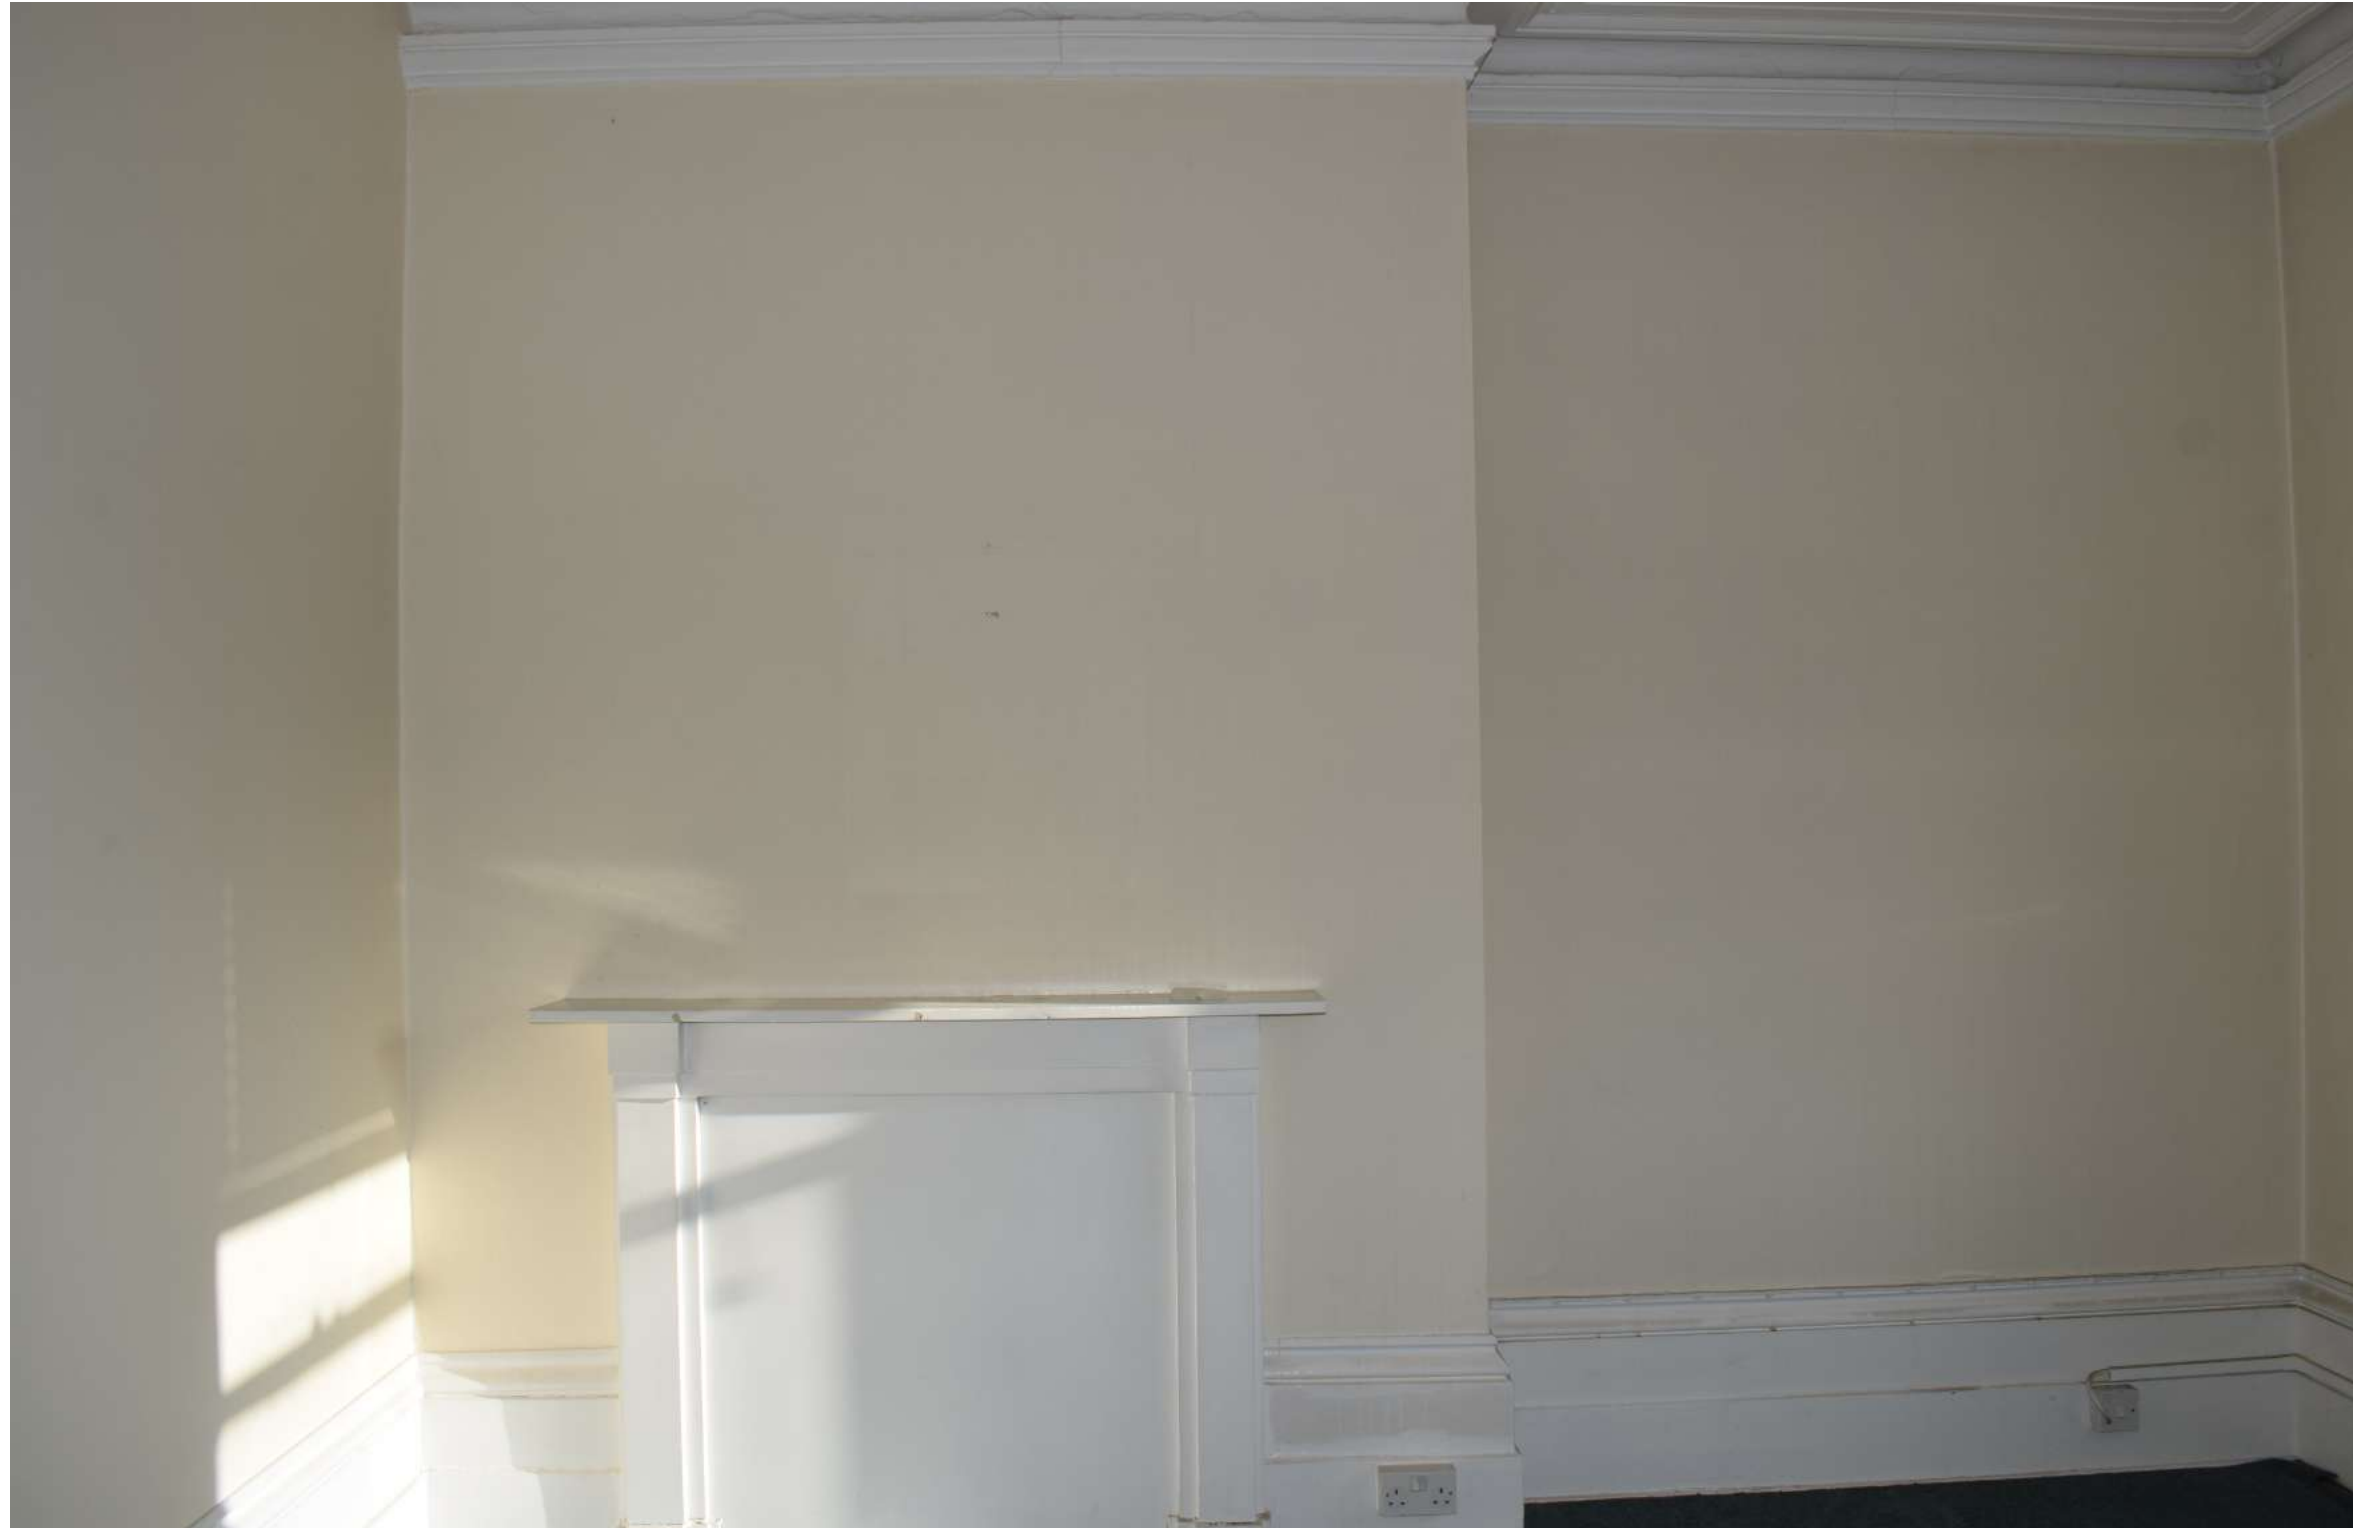
Plate 126

The hairline cracks in the coving seen above the fire place.

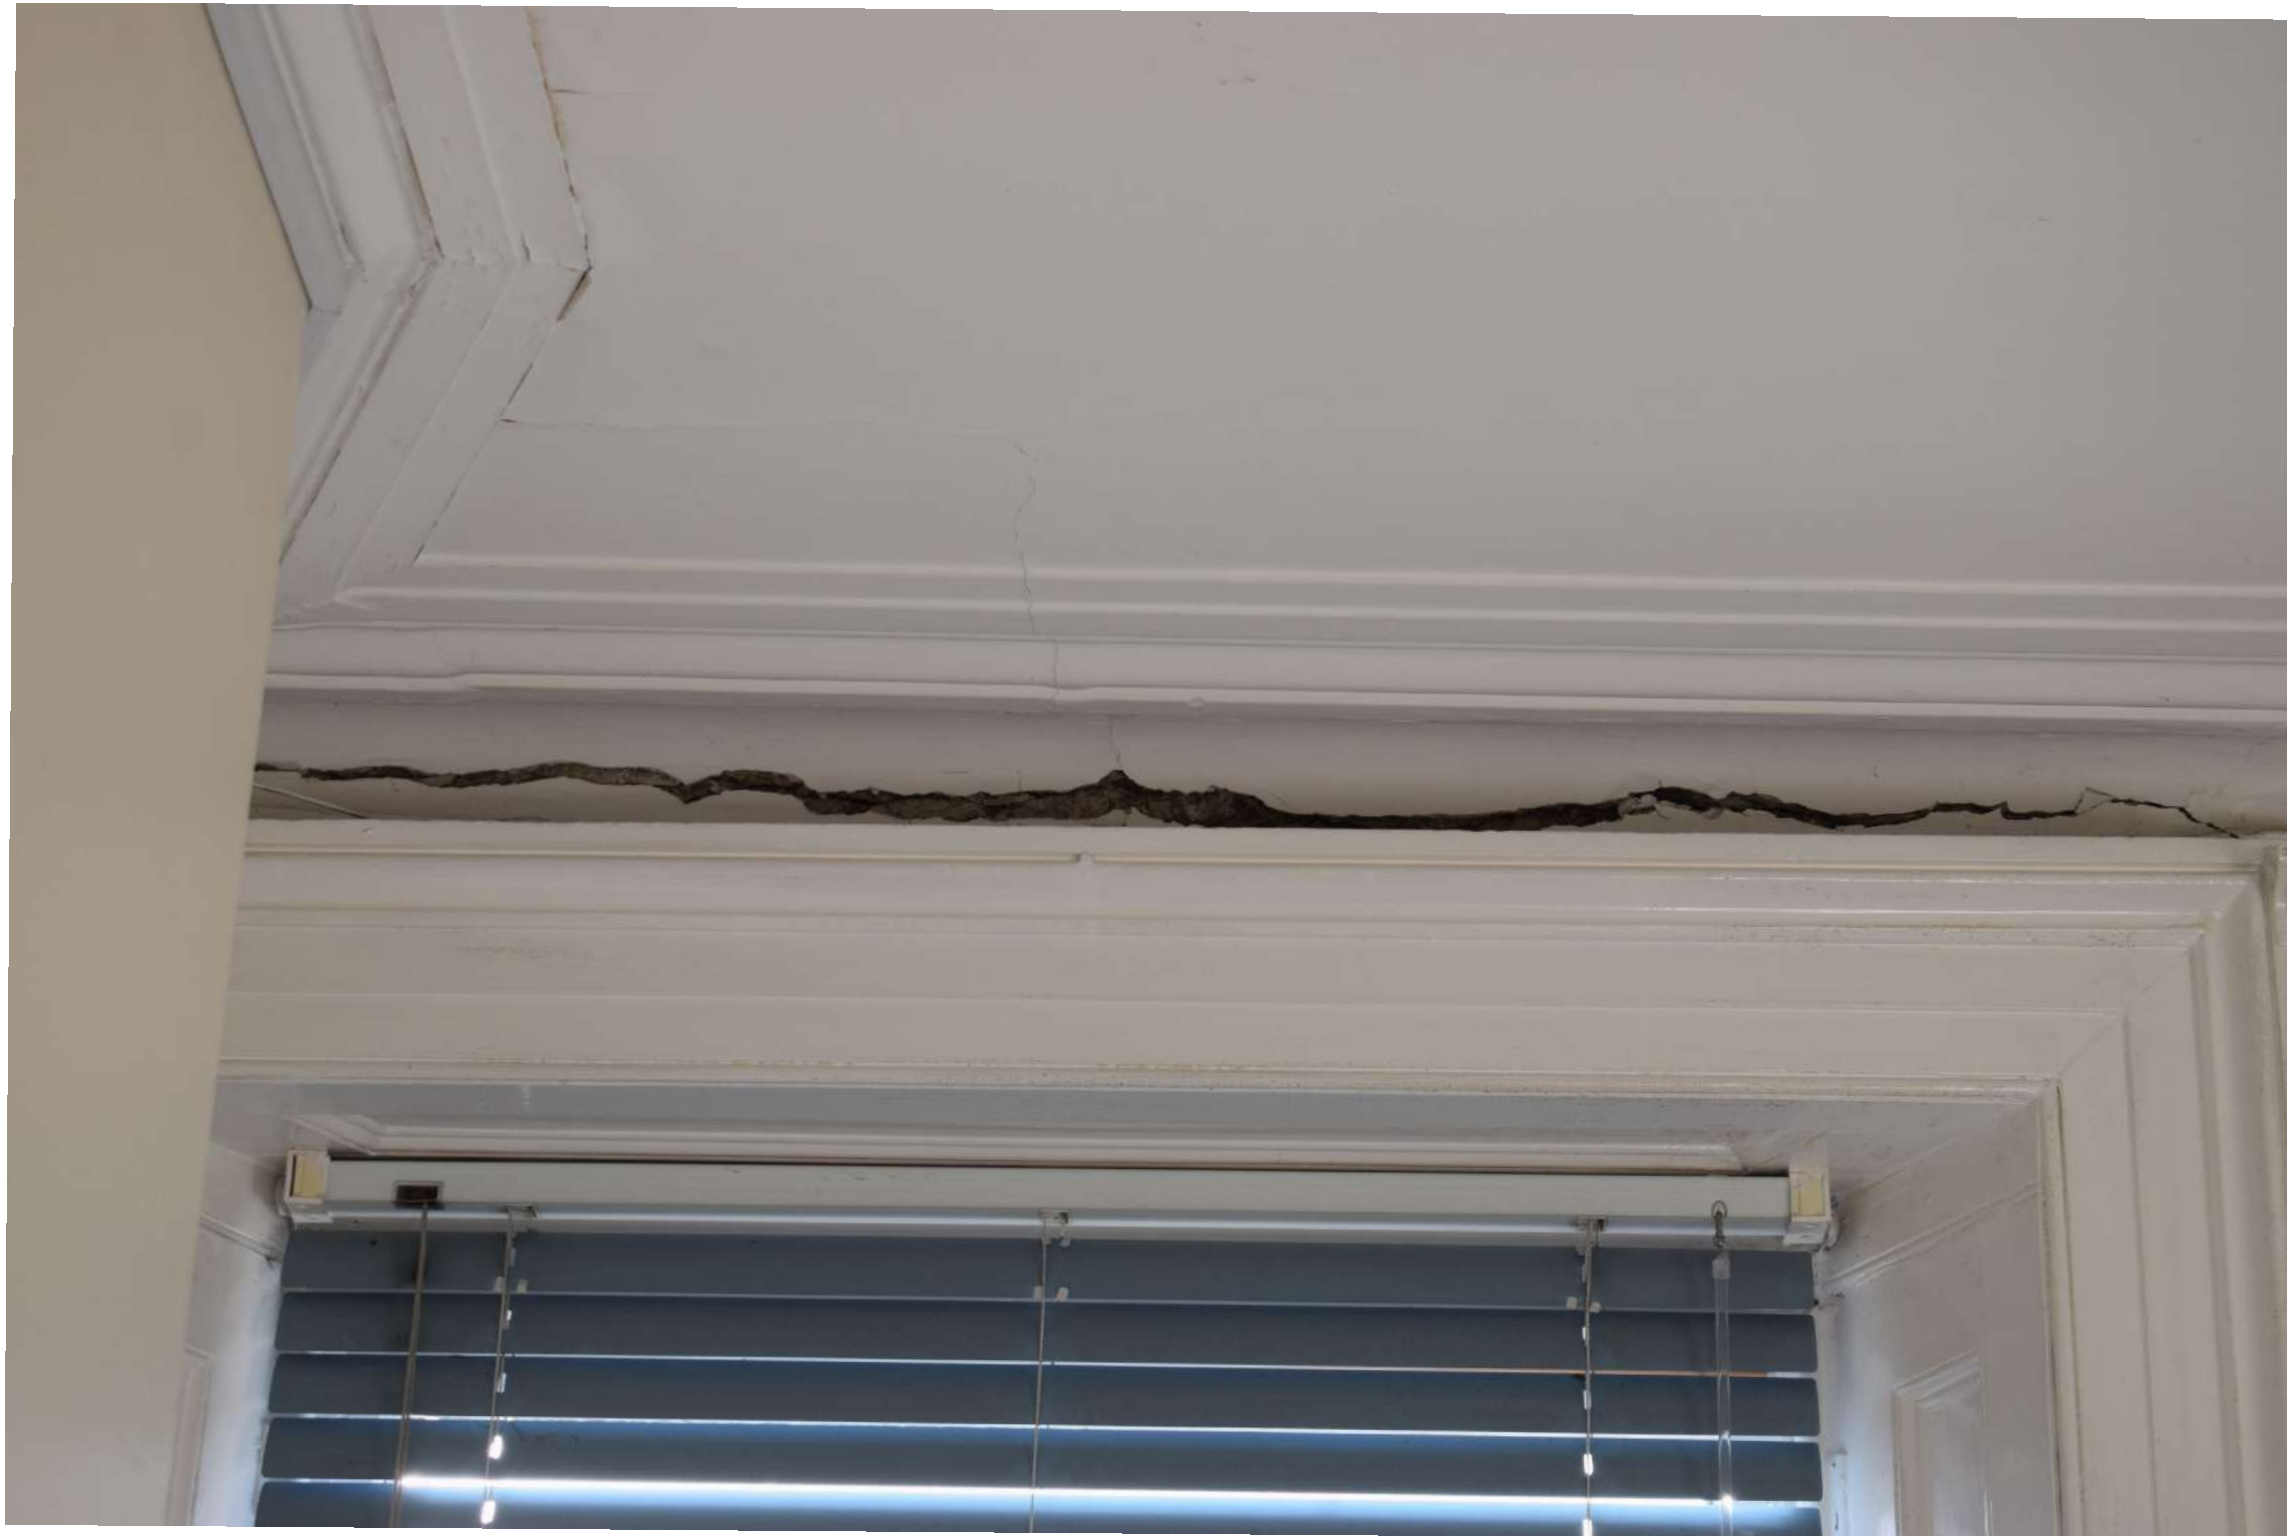
Plate 130

The angled wall sub-divided the front rooms historically. The damage above one of the windows in Office A may need to be checked for structural movement.
