*Figure 1: The frontage of Yeomanry House*

***Report Reference: AH\_YHse-CH\_Final.doc***

**Produced by: Archway Heritage**

- 2.1.1 This assessment was produced by Archway Heritage for Richard McCarthy Homes to inform a planning application and a listed building consent. The Proposed Development seeks a change of use from a Registry Office (Sui Generis) to domestic accommodation, to include repairs. It requires internal alterations to the main Listed Building to facilitate the new use, whilst seeking to preserve the historic fabric. The building is identified as a key positive building within the Russell Street/Castle Hill/Oxford Road Conservation Area (see Figures 1-2). A key consideration is to test for modern materials, particularly asbestos. This work was undertaken 2<sup>nd</sup> March 2026.

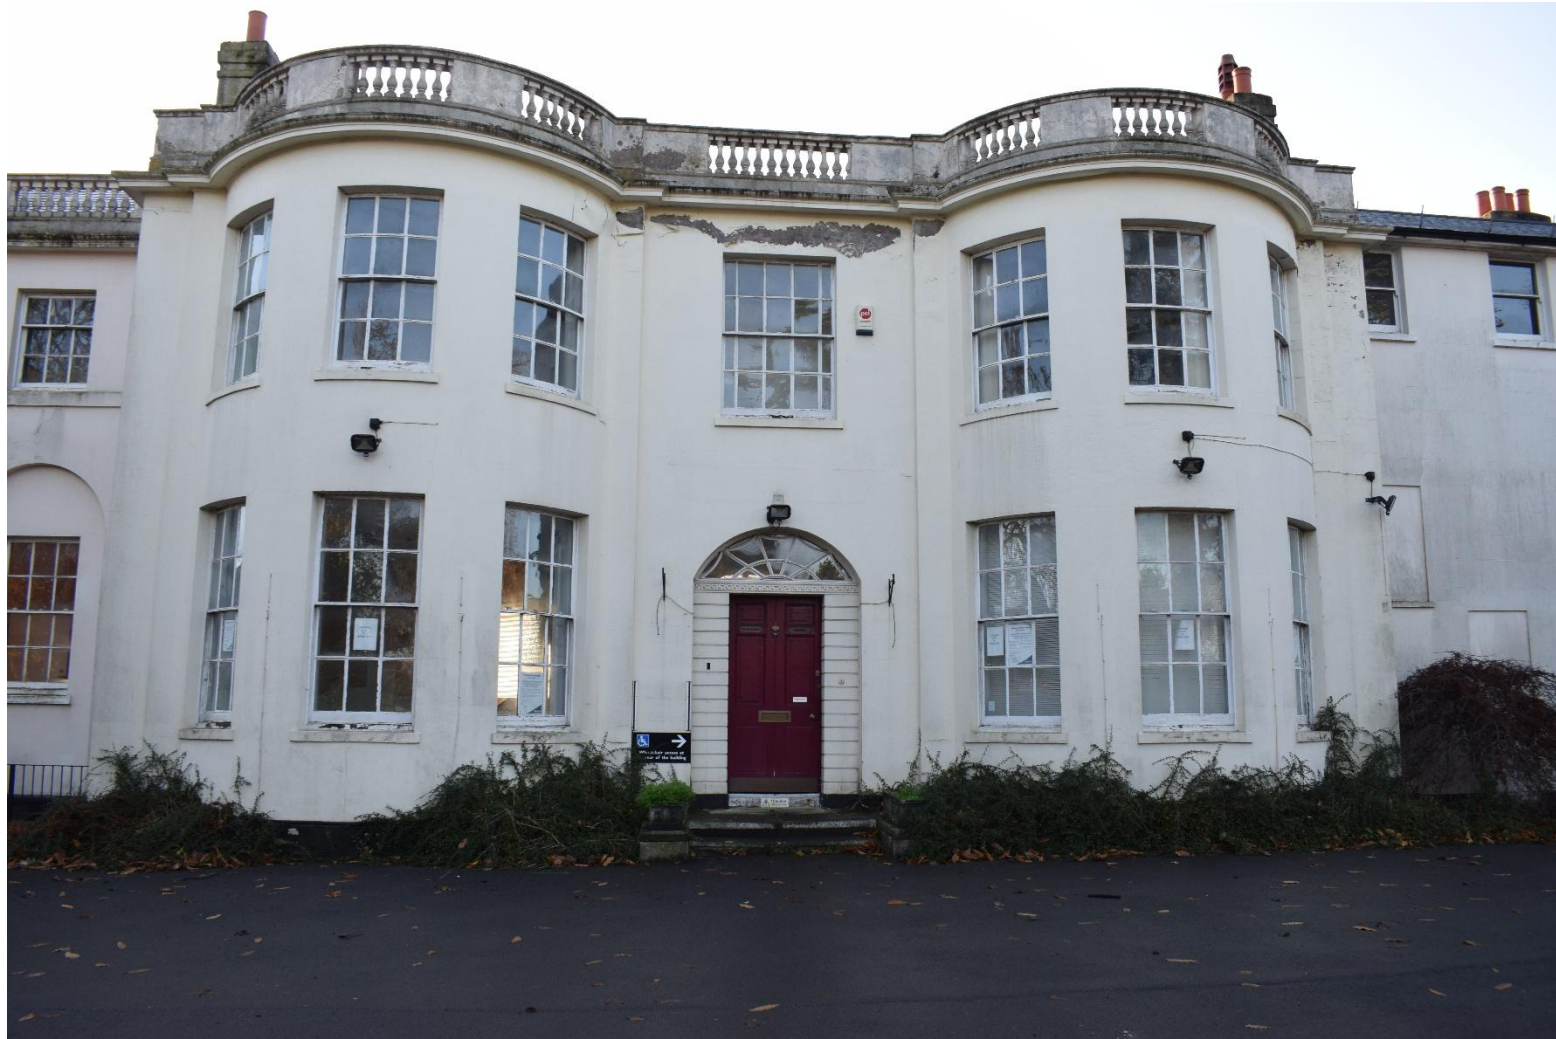
- 4.4.5 The moulded cornice and stone balustrade show significant surface deterioration and may require a structural assessment. Repair or replacement of the defective stonework is recommended to prevent further decay. The weathered window sills and sashes require cleaning, repair, refinishing, and repainting. The bushes encroaching on the lower wall should be cut back and removed to prevent moisture damage.

*Figure 7: The frontage of Phase 1, the original core of Yeomanry House*

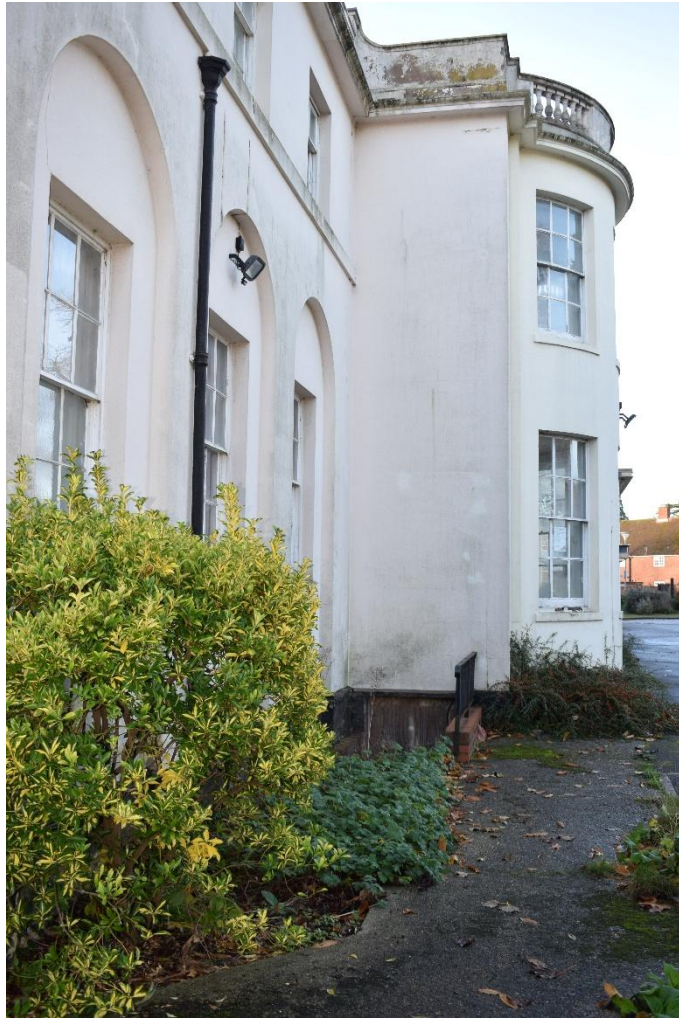
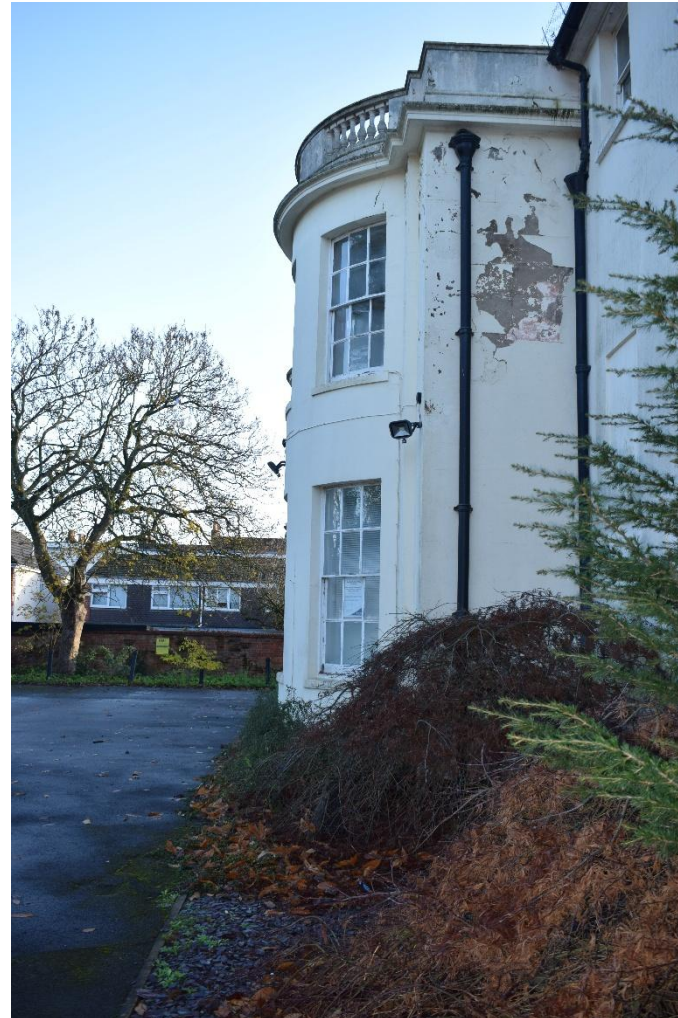
*Figure 8: Side elevations of the projecting bow windows of Phase 1*

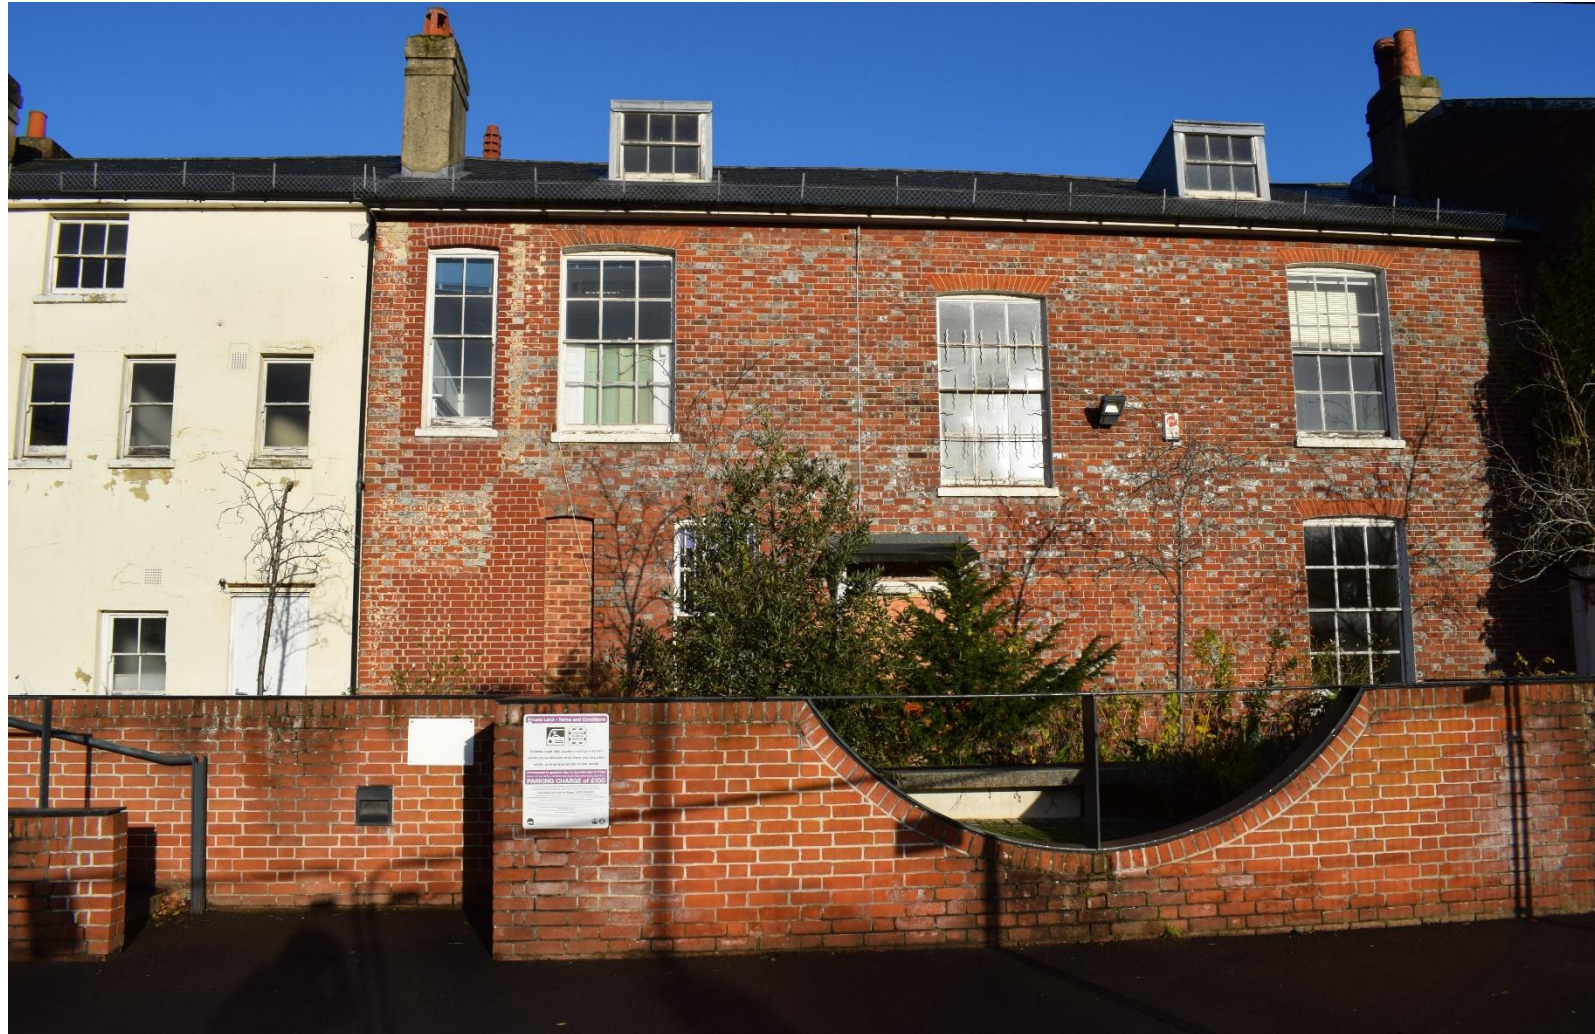
*Figure 9: The rear elevation of Phase 1, the original core of Yeomanry House*

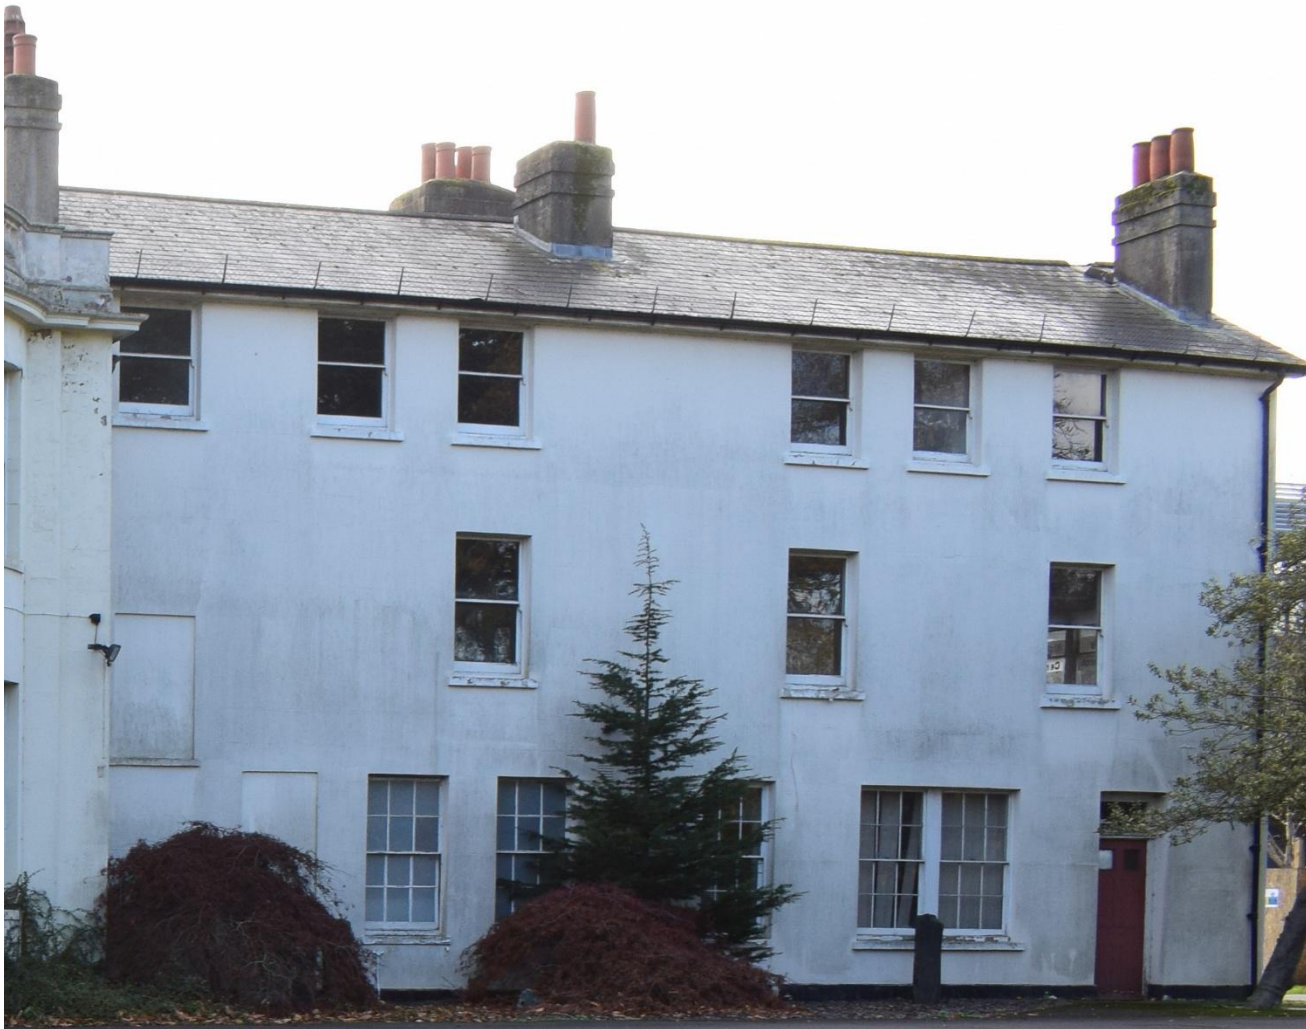
- 4.6.9 The front elevation was originally stucco and appears generally less severely damaged than the original core but still shows dirt and aging.
- 4.6.10 The side elevation is in poor condition with cracks appearing and patch repairs that have attracted moss and other plant growth, which traps water and exasperates damage.

*Figure 10: The frontage of Phases 2a and 2b*

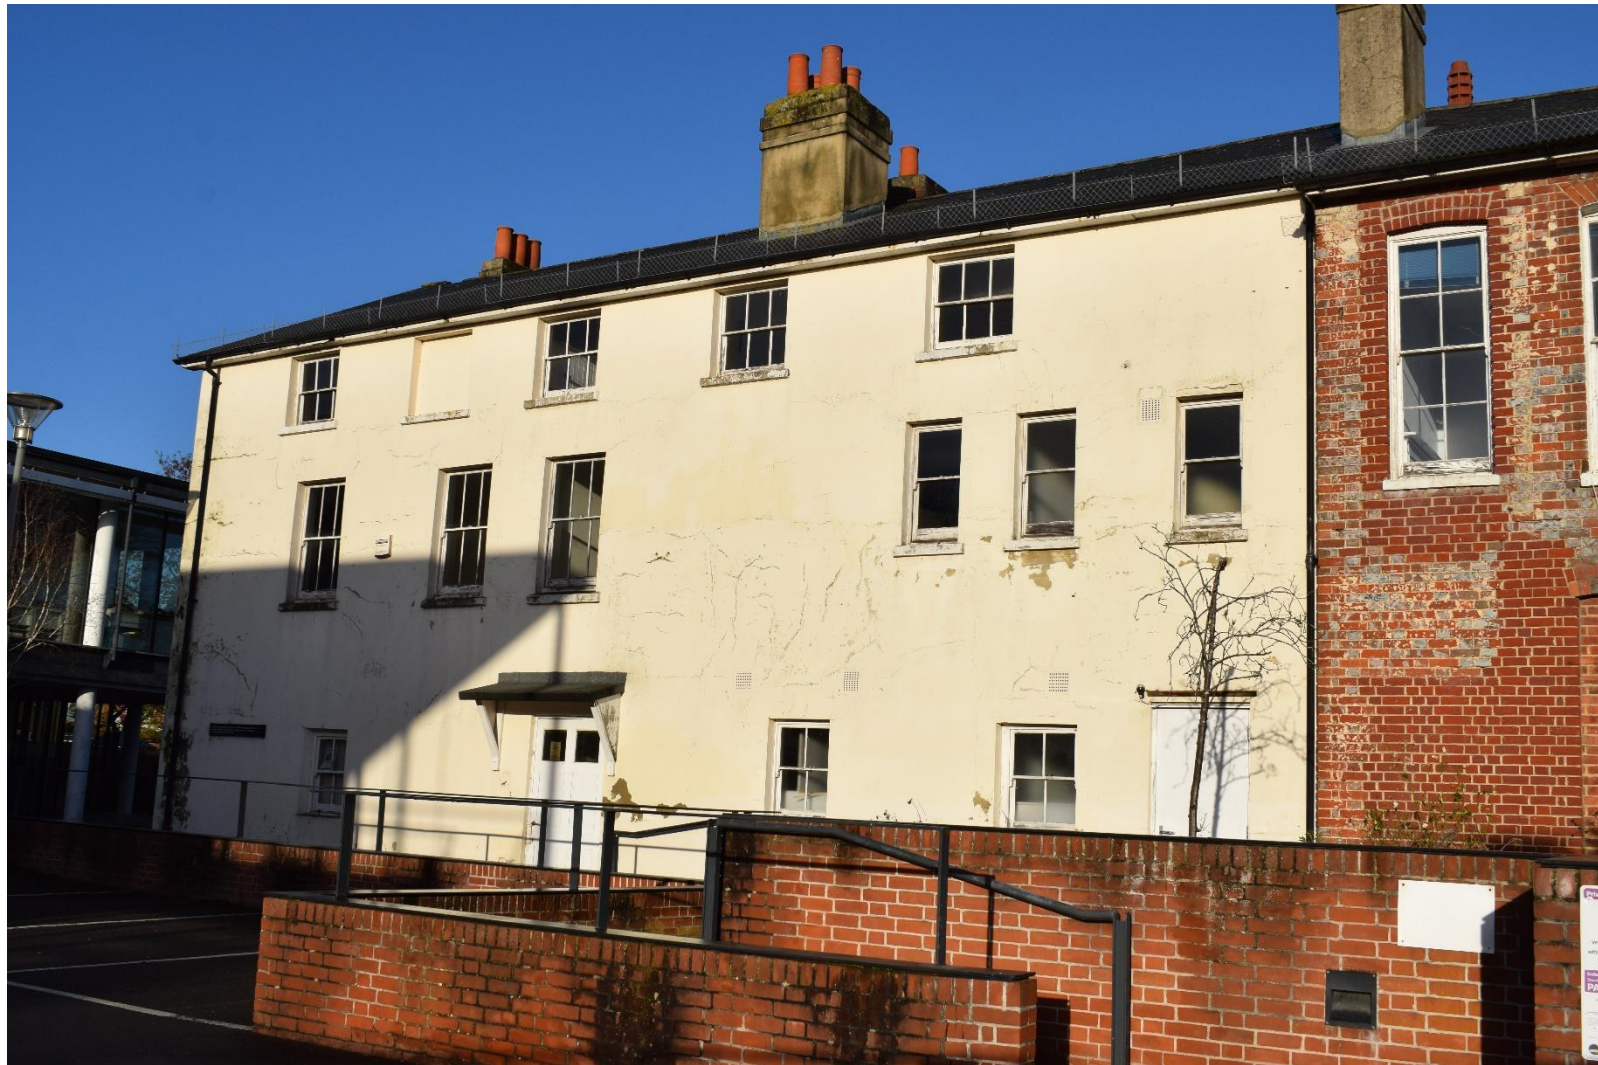
*Figure 11: The rear elevation of Phases 2a and 2b*

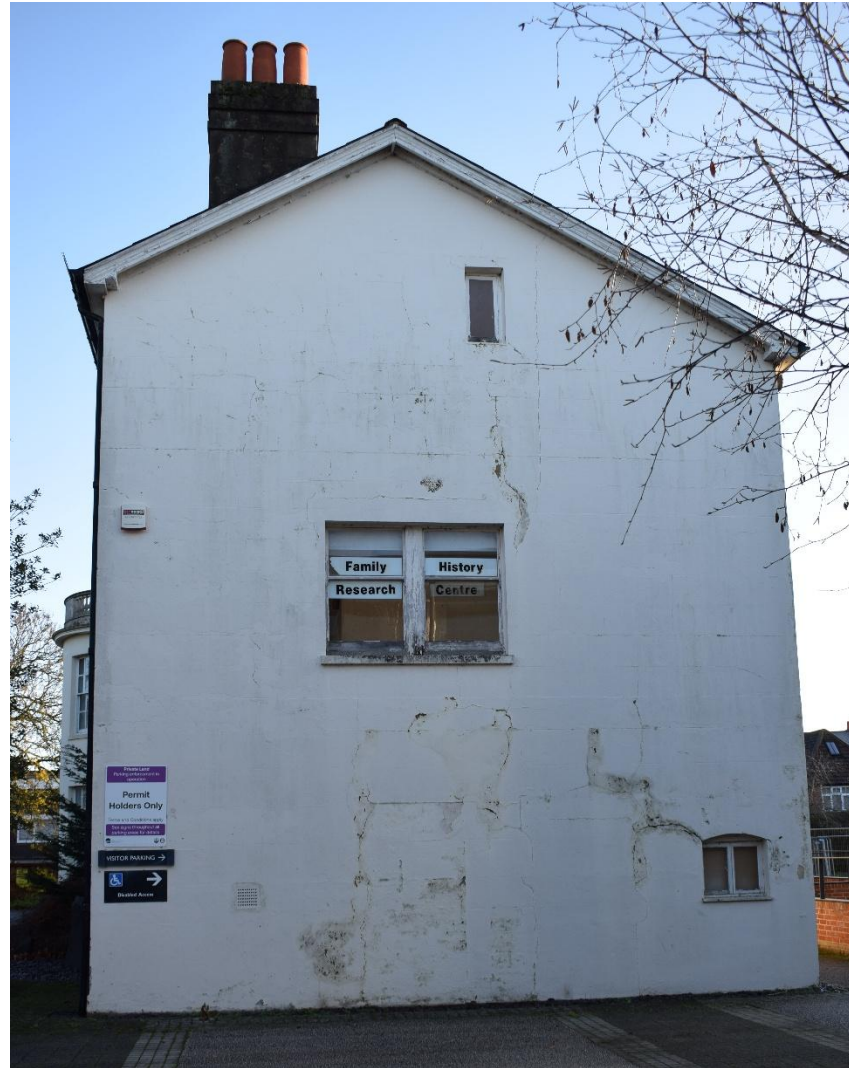
*Figure 12: The gable elevation of Phase 2b*

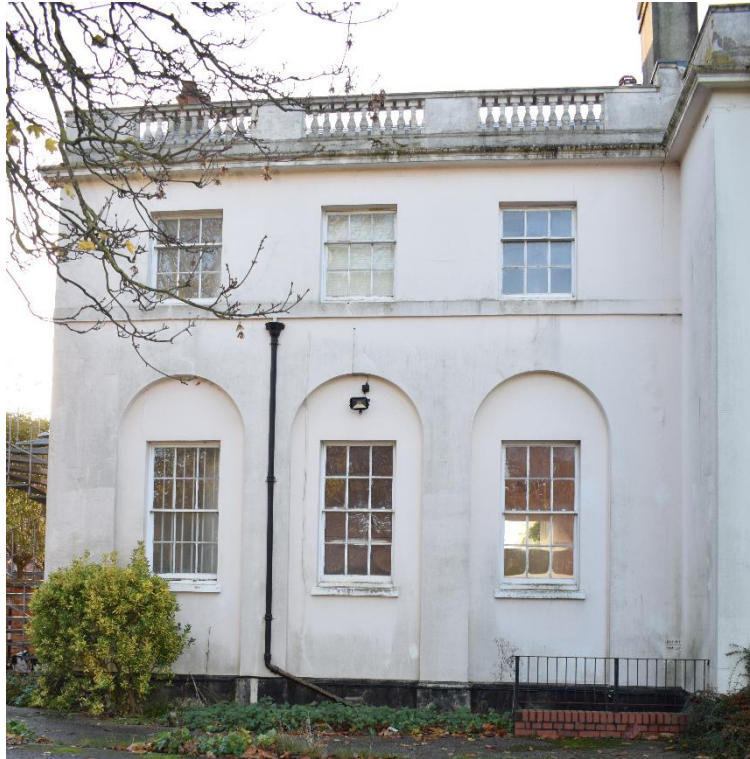
- 4.7.6 The front elevation of this phase is stucco and is generally less severely damaged than the core but still shows dirt and aging. The downpipe is likely to be a soil pipe, which needs to be decommissioned but retained as part of the history of the building.
- 4.7.7 The side elevation has been mortared with cementitious mix raised above the surface of

*Figure 13: The front and side elevation of Phase 3*

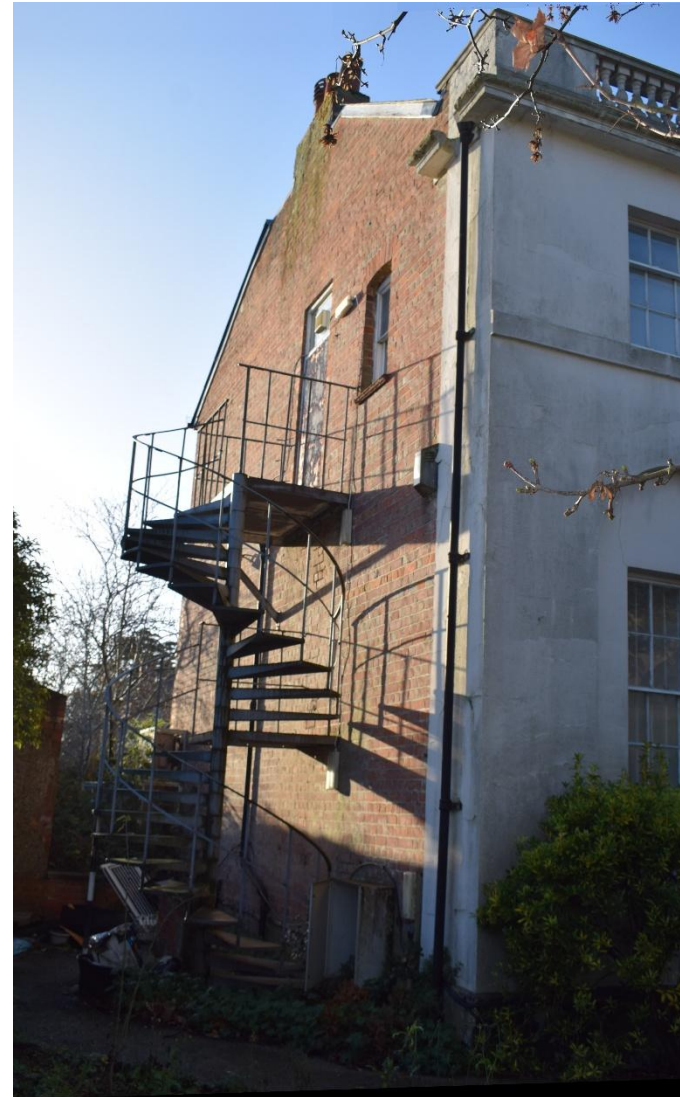
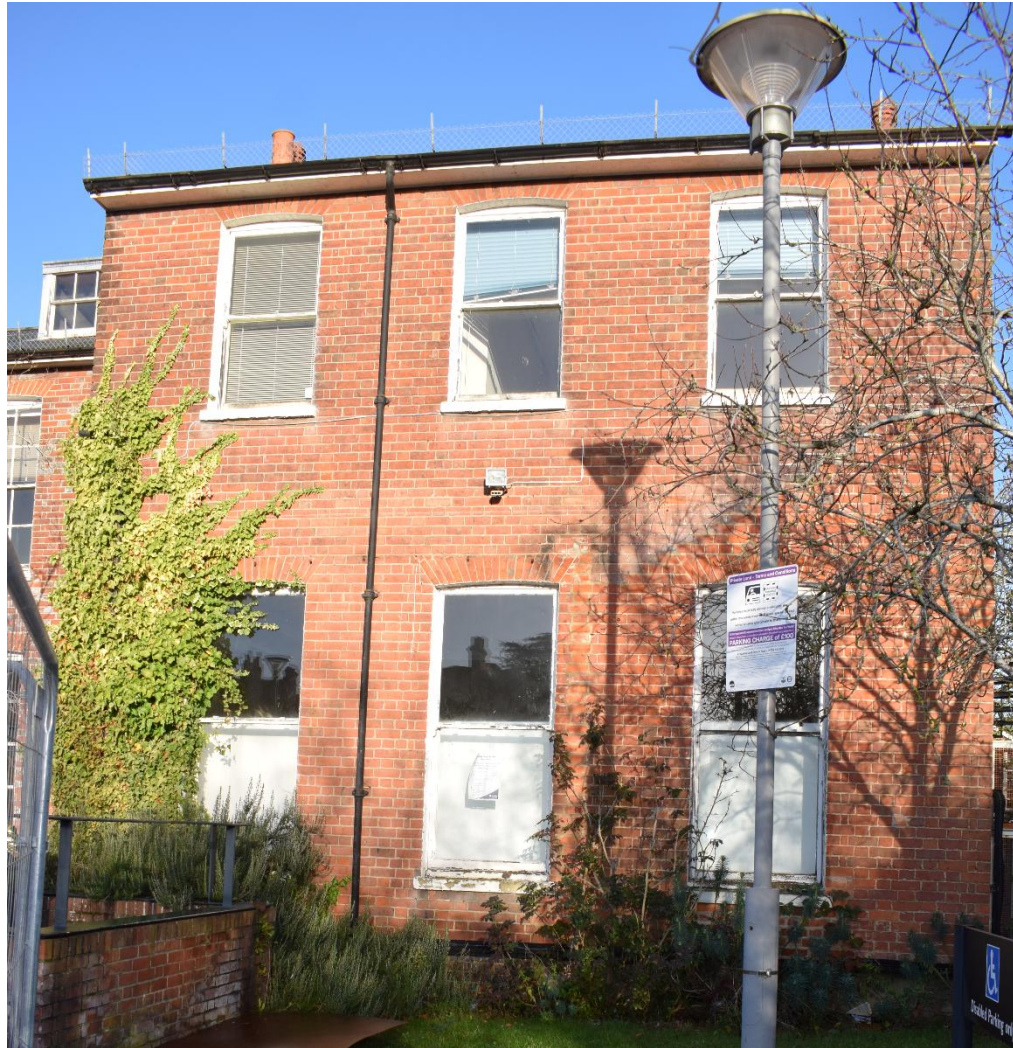
the bricks. Therefore, it is necessary to repoint brickwork where necessary using lime mortar to a **bevelled** profile. The bricks' surfaces on the ground floor corner nearest the rear elevation have been scored. This surface level damage impacts the fire-face and the bricks ability to shed water and allow it to evaporate from the brick's core. The replacement bricks may be the result of repair post-extension or former staircase support removal. The moss growing on the chimney and discolouration indicates a sheltered location by the trees. The moss can hold water, encouraging moisture ingress.

*Figure 14: The rear elevation of Phase 3*
