## READING SCHOOL EXTERNAL REPAIRS PHASE 2

## 3 - MAIN BUILDING / ENGLISH BLOCK

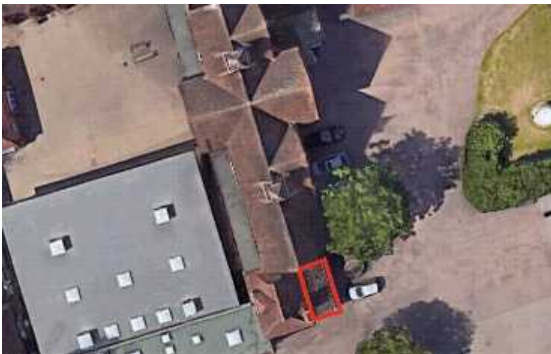
| Ref. | Description | £ |
|---|---|---|
| N.B | <i>The existing mono pitched roof covering is asbestos profiled sheet on insulation (northern half) on (assumed) vapour barrier on plywood boarding. The roof stricture is fixed onto heavy duty EML connected to an alarm system. Works to the roof shall be programmed to provide an 8 week lead-in period to allow client programming for storage re-location and temporary disconnection of the alarm system.</i> | |

| Ref. | Description | £ |
|---|---|---|
| 3.4.1 | Remove existing asbestos roof sheets, insulation and dispose. Include for removal of all existing flashings, fascia boards and rainwater good. All works and disposal to be carried out in full accordance with the Control of Asbestos Regulations 2012. | |
