**DESIGN AND ACCESS STATEMENT**

**READING SCHOOL  
MAIN BUILDING (ENGLISH BLOCK)**

30 March 2026 (Rev 2.0)

**READING SCHOOL – MAIN BUILDING / ENGLISH BLOCK  
EXTERNAL REPAIRS  
DESIGN AND ACCESS STATEMENT**

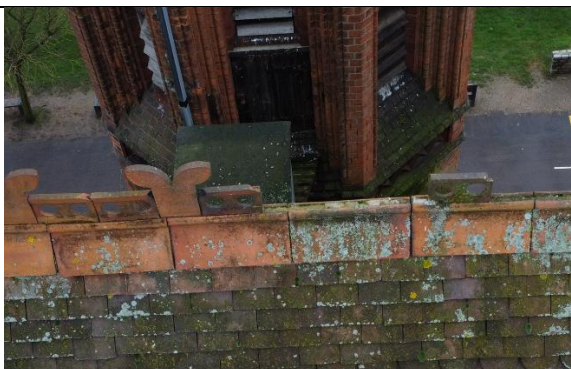
- 2.2.2. The ridge tiles to the roof of the Main Hall, as shown in Fig 1.2 below, comprise clay ridge tiles with a central groove, allowing for individual decorative mortar bedded clay tile inserts. The decorative inserts are missing in areas and they will be replaced with new bespoke handmade inserts to match the existing profiles / pattern. The existing mortar to the ridge tiles will be carefully ground out to allow for bedding in fresh lime mortar. There are areas where the rolled edge to the ridge tiles have spalled as shown in Fig.1.3, this will be repaired using pins and colour matched mortar to rebuild the rolled profile. The same work and methods used were recently successfully carried out on another building at the school, the Chapel.

Fig 1.2 – Bespoke ridge tiles to main hall

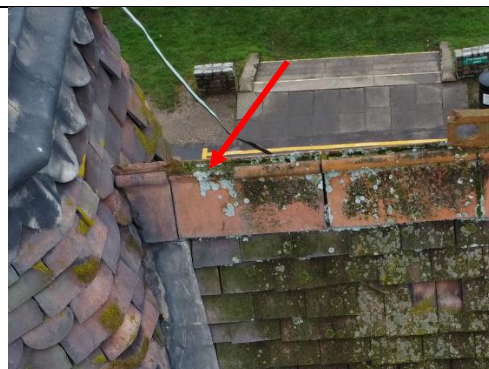
Fig 1.3 – Spalled rolled ridge tile edge

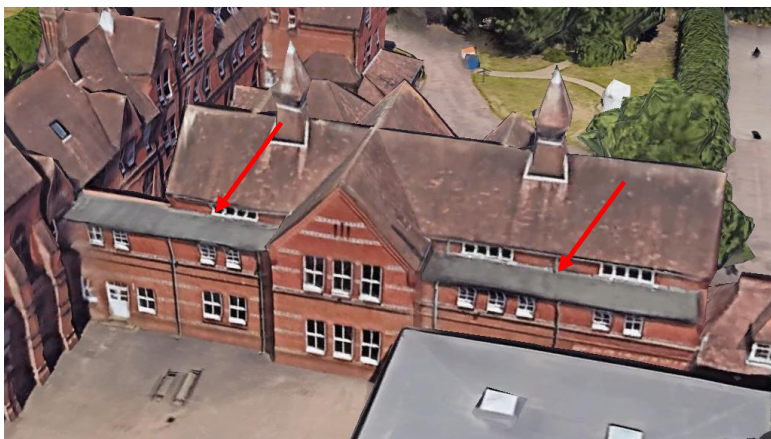
- 2.3.1. The existing high level flat roofs are uninsulated with bitumen felt coverings overlaying a previous asphalt covered roof. The roofs are in a poor condition with an increased risk of water ingress causing damage to the internal finishes which include lath and plaster ceilings. The proposed works include to strip the existing bitumen felt whilst retaining the underlying asphalt to act as a vapour control layer. A new bitumen felt covering will be applied, including a layer of 120mm insulation board providing a u-value of 0.18 in accordance with Approved Document L. The works are proposed to the high-level roofs as shown below.

Fig 1.4 – Flat Roofs to be replaced

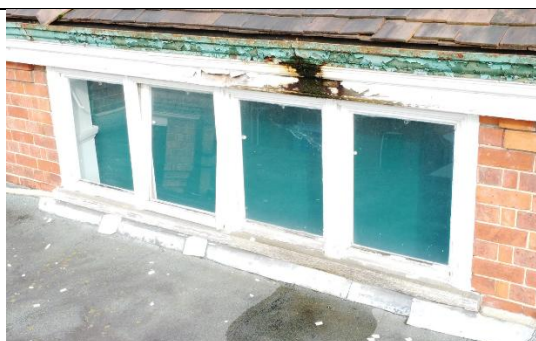
Fig 1.5 - Existing Windows above flat roofs

- 2.3.2. The proposed inclusion of thermal insulation to the flat roof areas will raise the existing flat roof level by circa 100mm. In order for a Guarantee to be provided for the roofing works, a minimum upstand of 150mm is required at abutments / below windows etc. To accommodate the increased roof height and required upstand, the existing windows located above the flat roofs will require replacement with reduced height windows. The existing windows are timber framed with single glazed centrally pivoted casements circa 2700mm wide x 830mm high. The existing windows are currently in a deteriorated condition with large areas of timber decay. The proposed replacement windows would be timber framed with double glazed top hum opening casements circa 2700mm wide x 660mm high. Figures 1.5 and 1.6 below show the existing windows and the proposed replacement. The brickwork wall below the windows will be built up to allow for the new window cill height and weathered with code 4 lead flashings.

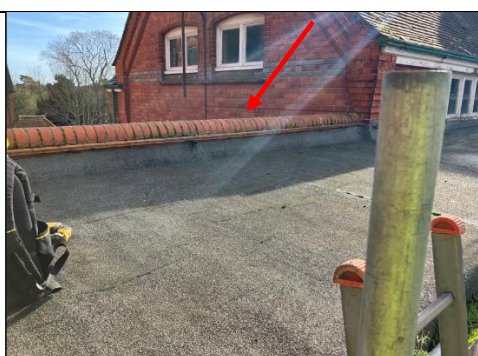
Fig 1.7 – Parapet to the edge of the northern flat roof

- 2.3.3. **Parapet Wall Alterations – Option 1.** As noted in item 2.3.2 above, the inclusion of a new insulation layer will raise the roof level with a further requirement for a 150mm upstand. To accommodate the increased roof height and required upstand, the low-level parapet brickwork walls will require raising by circa 150mm in height. The existing brickwork parapet walls incorporate clay creasing tiles with half round brickwork cappings. The low-level parapet walls requiring raising are shown in Figures 1.7 and 1.8 below. The half round cappings and creasing tiles will be carefully removed and set aside for reinstatement. The brick walls will be raised using bricks to match the existing and bedded in NHL 3.5 lime mortar to match existing. There is a level clash between the new height of the northern parapet wall and the adjacent buildings rainwater goods as shown in fig 1.9. The proposed works include to leave a gap between the brickwork cappings at this junction and form a recessed lead saddle to provide weatherproofing as shown in Figures 1.9 and 1.10.

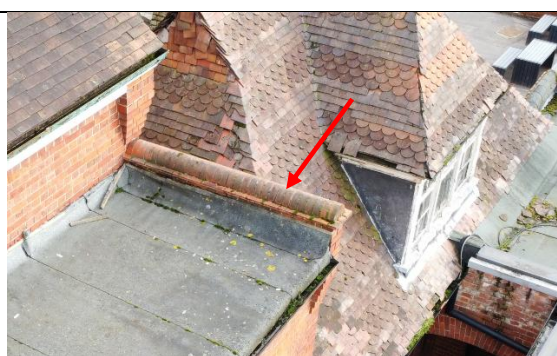
Fig 1.8 – Parapet to the edge of the southern flat roof

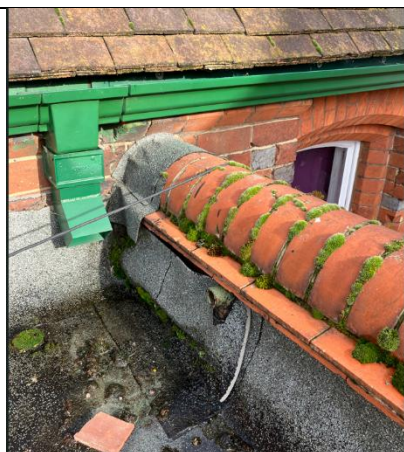
Fig 1.9 – There will be a clash between the increased height of the parapet wall and the adjacent rainwater goods

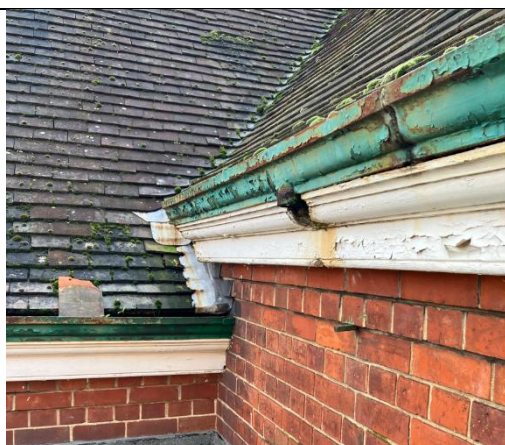
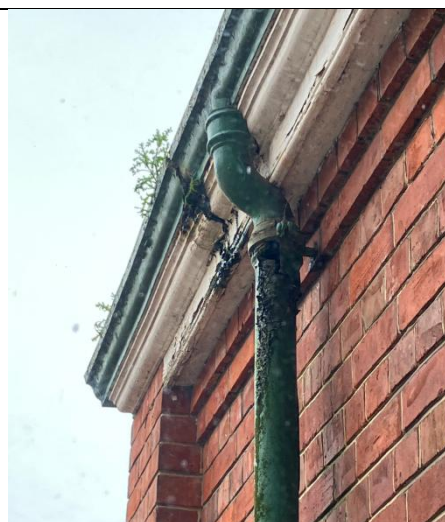
- 2.4.1. The existing rainwater goods comprise cast iron Ogee profile gutters and circular downpipes. The rainwater goods are in a very poor condition with sections missing, cracked, corroded and leaking resulting in deterioration of the surrounding fabric. Vegetation growth is also evident in areas. Example photographs of deteriorated rainwater goods are shown in Fig 1.11 and 1.12 below.

Fig 1.11 – Deteriorated Rainwater Goods

Fig 1.12 – Deteriorated Rainwater Goods

- 2.4.2. It is proposed to replace the existing rainwater goods with new heritage powder coated gutters and downpipes to match the existing profiles and colour.

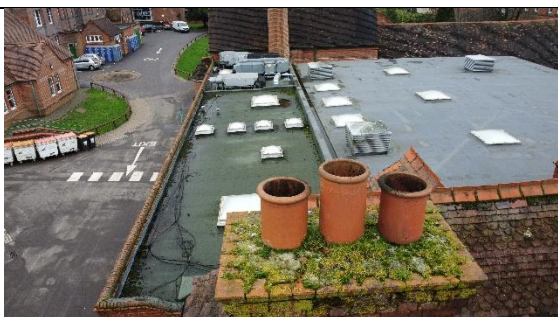
Fig 1.13 – Deteriorated flaunching and pointing to chimney

- To the southern chimney, replace the deteriorated mortar flaunching with new NHL 5 lime mortar flaunching to match existing. Repoint areas of deteriorated existing pointing to the chimney with NHL 3.5 lime mortar to match existing (Fig 1.13),
- Carry out isolated areas of repointing to the main brickwork elevations where the mortar is missing or friable, using NHL 3.5 lime mortar to match existing (Fig. 1.16),
- Replacement of spalled or damaged / missing brickwork, using reclaimed bricks to match existing and bedded in lime mortar to match existing (Fig 1.14 and 1.15). Where possible repairs will be carried out leaving the original brickwork in position and specialist refacing using a lime mortar matched to the brickwork colour,
- Repoint missing / live collar joints around windows as required using a lime mortar,
- Reinstate several loose areas of brickwork and leave secure.

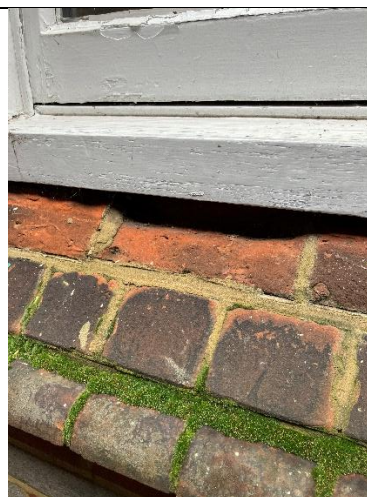
Fig 1.14 – Example of spalled brickwork requiring replacement / repair

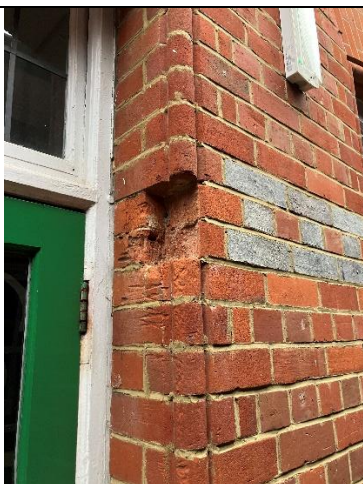
Fig 1.15 – Example of damaged brickwork requiring replacement / repair

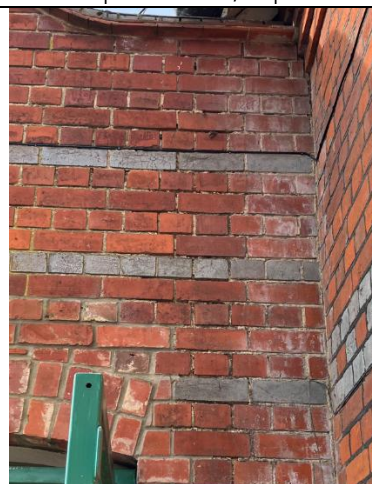
Fig 1.16 – Example of perished mortar pointing to be repointed with lime mortar to match

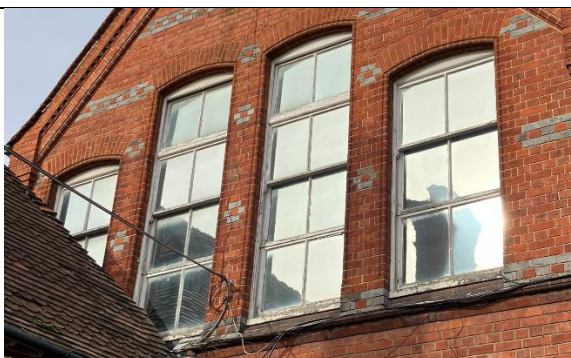
Fig 1.17 – Example of windows in a deteriorating condition

- 2.7.1. It is proposed to carry out repairs to the English Block Corridor windows only ahead of redecorations as noted above. The existing windows are all currently timber framed single glazed comprising a mixture of vertical sliding sash, top hung and bottom hung casements.
- 2.7.2. The decorations have deteriorated resulting in areas of decay to the timber windows. It is proposed to carry out repairs to areas of decay using Repair Care Dry Flex epoxy wood filler and splicing where appropriate. Where new sills are required, they will be replaced with Sapele.
- 2.7.3. The existing glazing putty is in a deteriorating condition with areas notably missing, cracked or "live". Where required, the glazing putty will be replaced with Repair Care Dry Seal MP putty replacement.

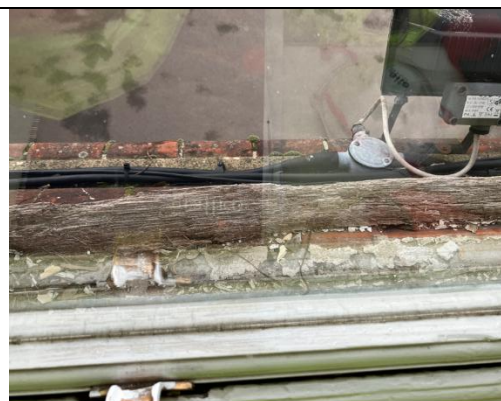
Fig 1.18 – Example of decayed / missing sill requiring replacement

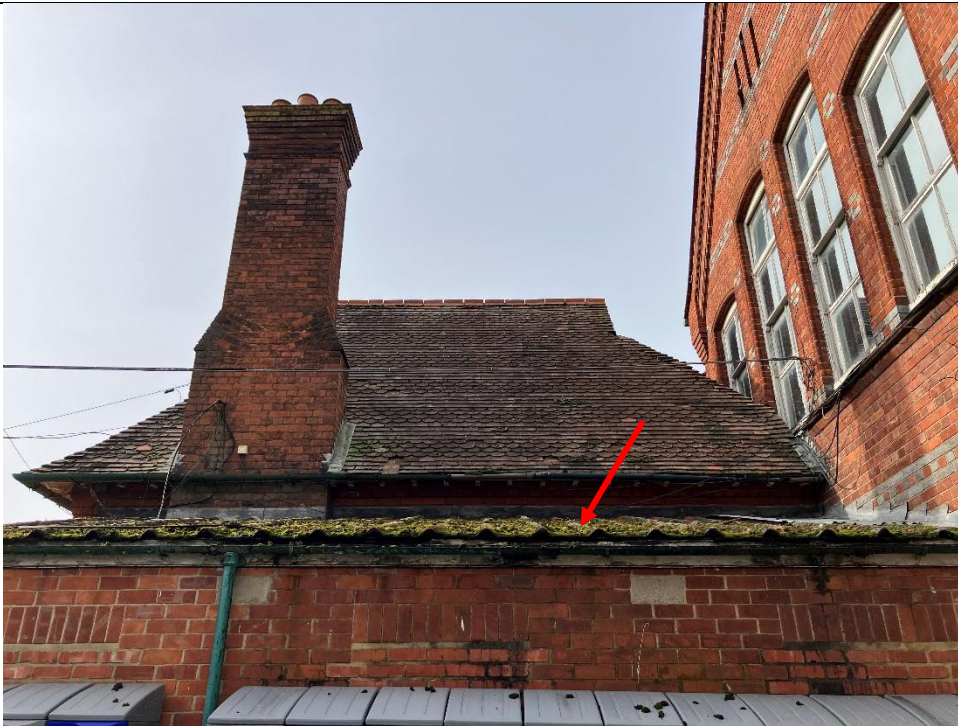
**Photograph 11**

Asbestos cement armory roof to be replaced

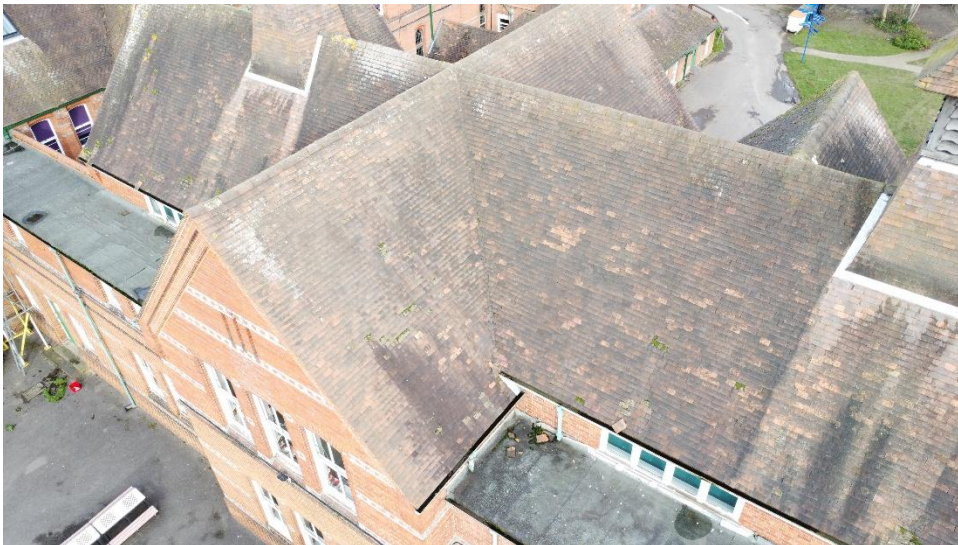
**Photograph 12**

General view showing two flat roofs to be replaced

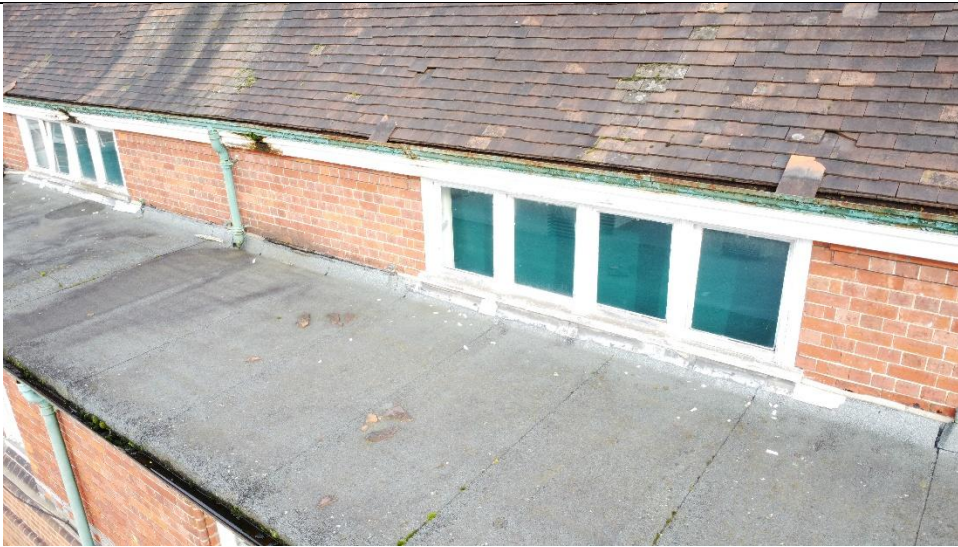
**Photograph 13**

View showing flat roof that requires replacement and windows that require replacing (resizing)
