# Your survey report

122 Kidmore Road, Caversham  
Heights, Reading, Berkshire RG4  
7NB

10th March 2022

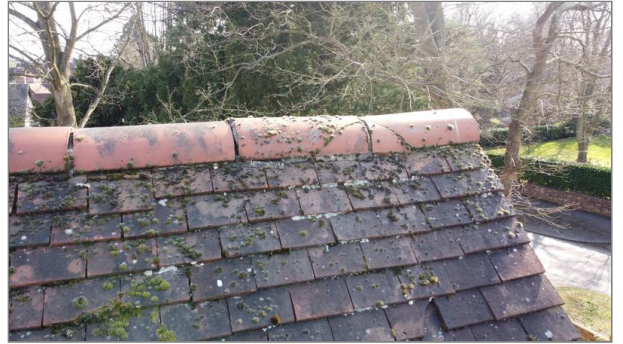
Coupled with this, the ridge tiles are cracked and loose in some areas and require replacement where damaged, but lifting off, cleaning down and resetting on new mortar elsewhere.

*Photo - 3 Cracked ridge*

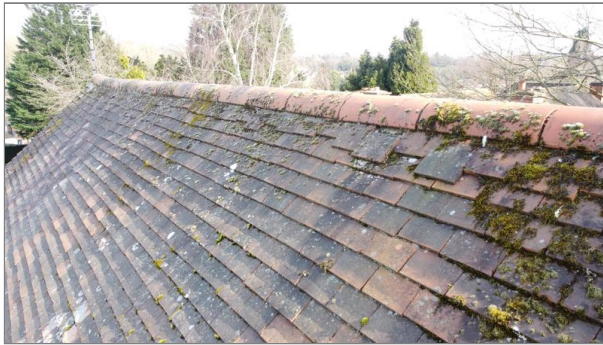
It is likely that the clay tiling of the main house is, for the most part, original. As you might imagine, there are a number of slipped, cracked and missing tiles and a minor overhaul is required.

*Photo - 4 Slipped tiles*

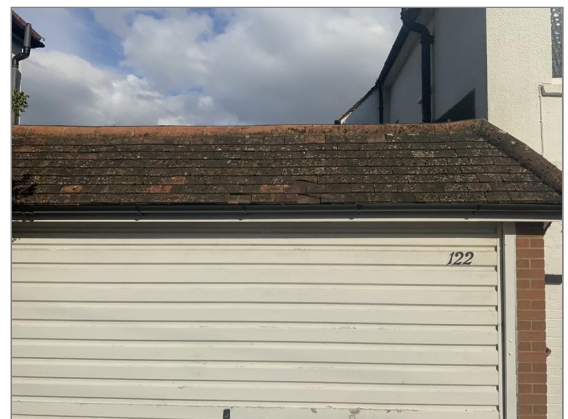
*Photo - 13 Cracked tiles*

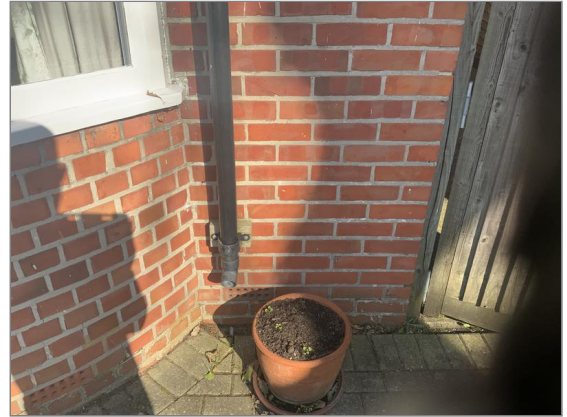
serving the bay. The other is at the rear corner, serving on of the main roof pitches. It is not appropriate for rainwater to simply discharge onto the ground around the base of a property, as this can lead to water saturation in the walls, and in extreme circumstances, ground instability. I would therefore recommend that a rainwater drain is installed, which is a small channel which collects surface water. This can be linked through to the drains, which may be some distance away, without the need for significant excavations.

*Photo - 19 Bay downpipe discharges here*

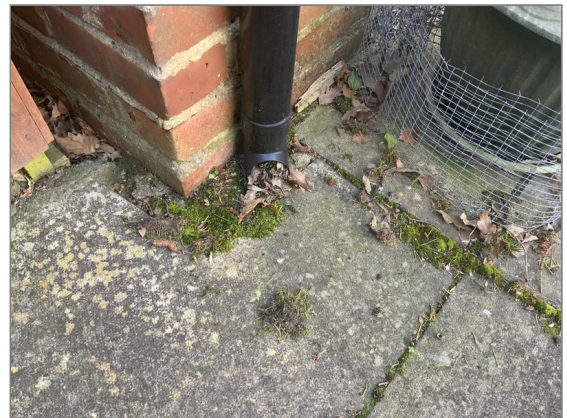
*Photo - 21 Poor condition*

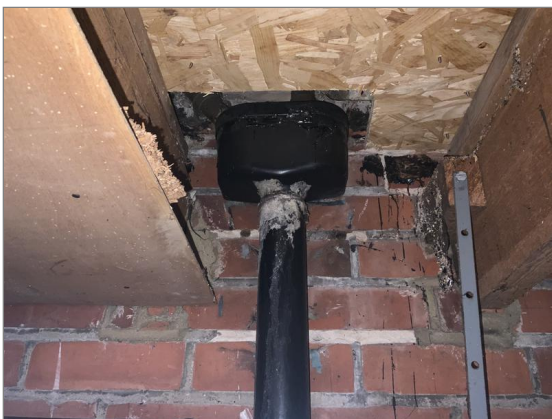
*Photo - 22 Joints leak*

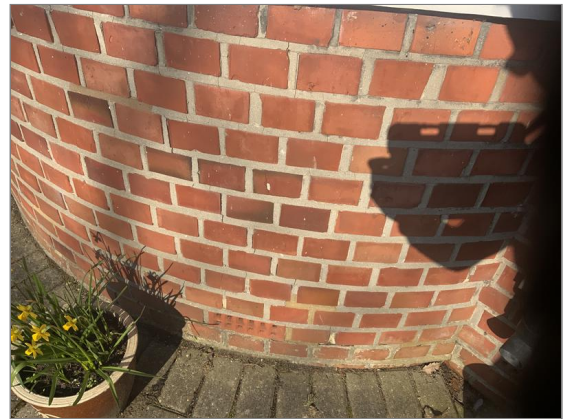
Despite a small crack in the front bay at ground level, the property is not felt to have any significant structural defects.

Bay windows tend to move fairly readily, as they are often formed on more shallow foundations than the rest of the house. The crack should be filled, however, it is likely that the cracking will reopen in the future. Unless the cracking opens to significant widths of around 5mm or more, or is continuously worsening, then no significant action is likely necessary. I cannot of course guarantee that there will be no future structural movement, but as long as the property is maintained in the normal way, I foresee no special problems arising. This means ensuring that the drains are kept free flowing, and do not discharge water into the ground, the downpipes discharge into the below ground drains, and that large trees are not allowed to grow within close proximity. There is of course a fairly large tree nearby, on the front of the property, and I would recommend that all large deciduous trees are pruned, so that they do not reach their full mature height.

*Photo - 24 Slight cracking*

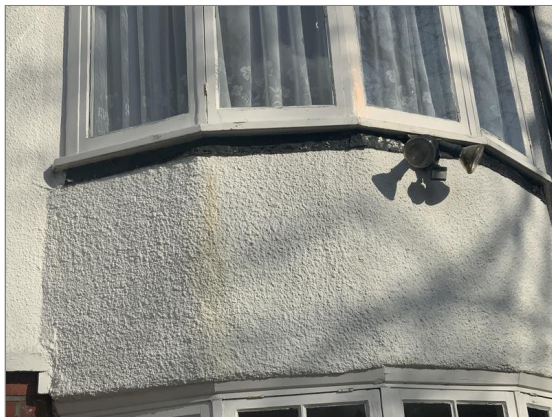
*Photo - 27 Ageing flashing*

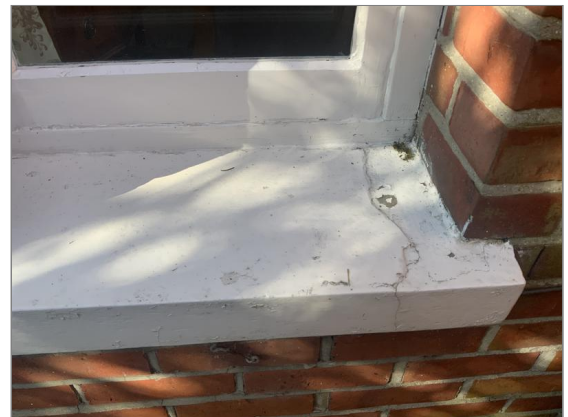
External window sills require redecoration now. Decoration plays an important role in older buildings and can prevent water ingress into the walls below.

*Photo - 28 Ageing decoration*

There is evidence of previous decay and repair, and it is necessary to paint timber windows every 4 - 5 years. I would therefore suggest you budget for redecoration of the windows within the next 1 - 2 years.

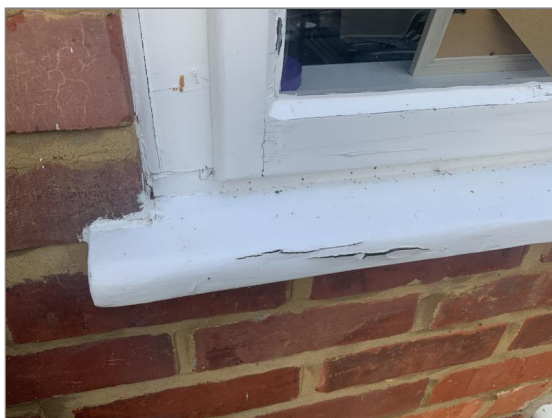
*Photo - 29 Ageing*

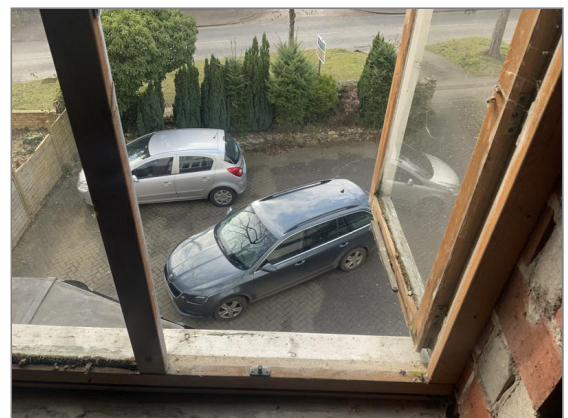
All of the windows represent a fall hazard at first floor level and the window in the loft. If children are to be present within the property, window restrictors should be fitted to limit the opening.

*Photo - 30 Fall hazard*

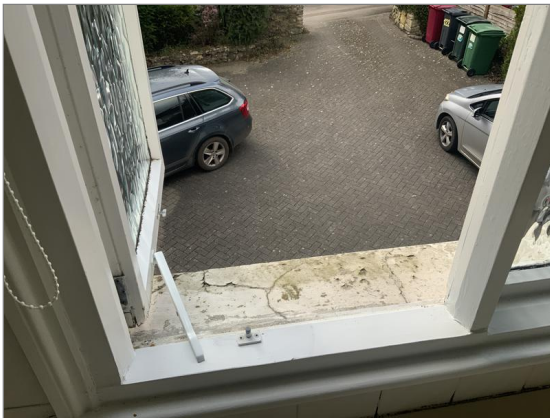
*Photo - 31 Fall hazard*

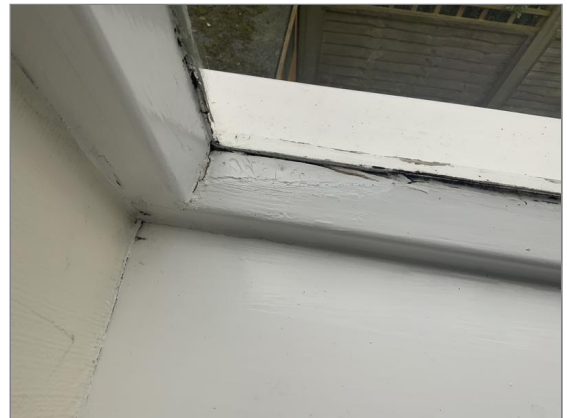
*Photo - 32 Decay repair*

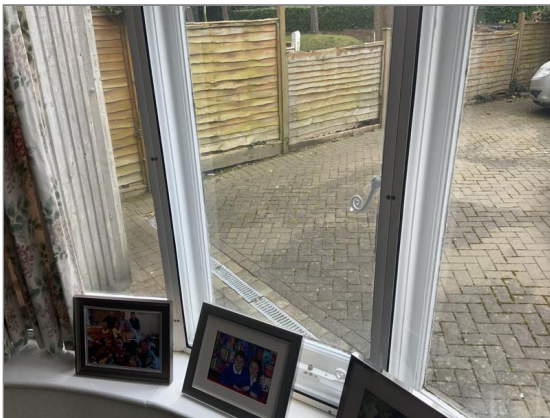
Single glazed windows are less thermally efficient than double glazed equivalents and the vendor has installed secondary glazing into the lower large windows in the forward lounge, but not elsewhere. You could consider further secondary glazing, or the removal of the single glazed window panes and their replacement with slim line double glazing.

*Photo - 33 Secondary glazing*

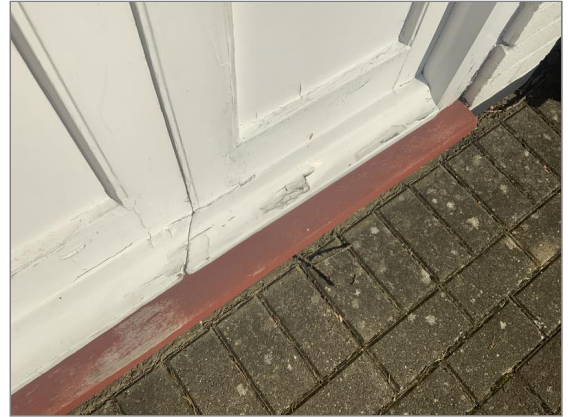
The front doors are a pair of timber glazed doors with a further secondary door inside. These doors operated adequately. They show signs of historic decay on the drip detail at low level, which has been filled and painted, but again is ageing and requires further repair.

*Photo - 35 Ageing*

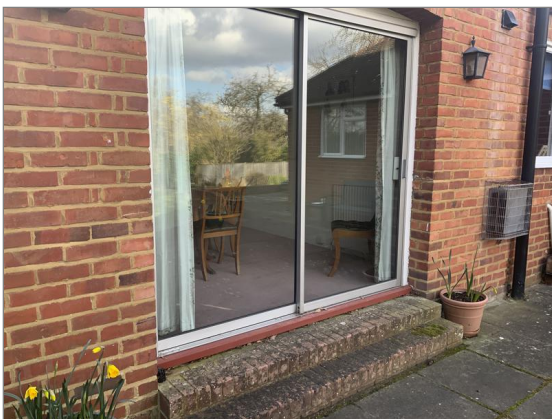
The sliding doors to the rear were stiff and slightly difficult to operate. These doors are somewhat dated, and you may wish to budget for upgrading.

*Photo - 38 Sliding doors*

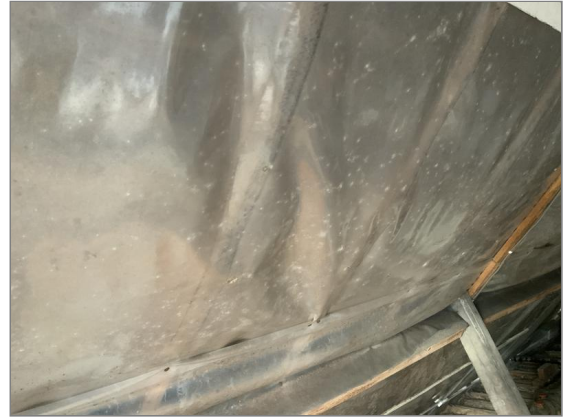
Polythene has been installed on the underside of the roof structure. Unfortunately, I would now recommend that this is removed as this creates an unventilated or at least poorly ventilated void above. You will see that there is mould growth on the upper surface of the polythene and these unvented air pockets can ultimately lead to decay of the timber structure. This is less common where the tiling does not have an underlay or membrane beneath, as is the case here, as this type of tiled roof tends to be somewhat draughty. This membrane however will not prevent secondary water ingress. This is because all that will happen is water ingress does occur is that water will track onto the top side of the polythene and run down it, and ultimately, into the ceilings around the perimeter of the house.

*Photo - 41 Mouldy*

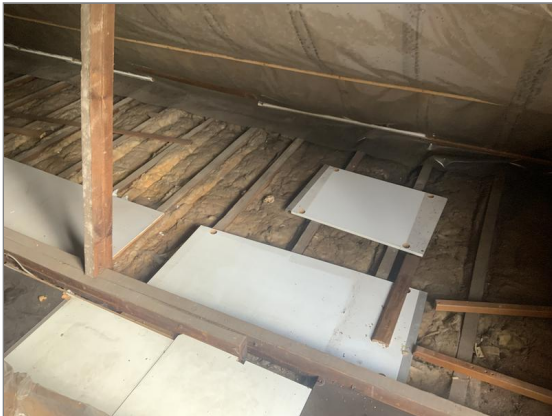
It should be noted that whilst there is a small amount of insulation present within the loft, this is not enough to comply with minimum recommendations. It is currently suggested that a minimum depth of 270mm using glass fibre or mineral fibre insulation is provided for, and you should install this now, taking care not to reduce ventilation.

*Photo - 42 Inadequate insulation*

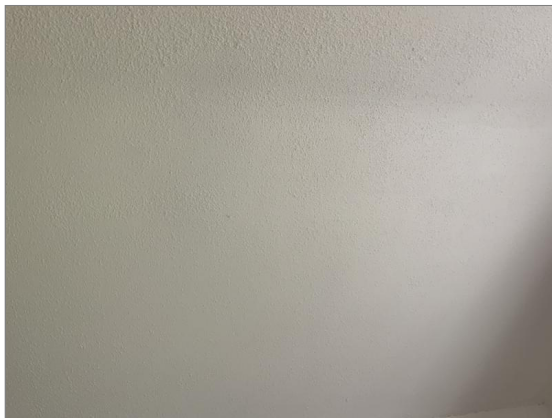
It should be noted that textured coatings were present in some locations. Historically, textured coatings were reinforced with asbestos and were often provided by a company called Artex. Artex is a shortening of the words 'asbestos reinforced textured coating' and whilst the company Artex still exists today, it no longer uses asbestos in its products. In fact, it stopped putting asbestos in the textured coatings around the 1980's, however, it is impossible to date the textured coating, and therefore, it is safer to assume that it does contain asbestos than not. Asbestos is extremely hazardous to health and if small particles are inhaled, it can lead to life threatening lung illnesses and you are advised to review the Health & Safety Executive's website here:

*Photo - 45 Textured coating*

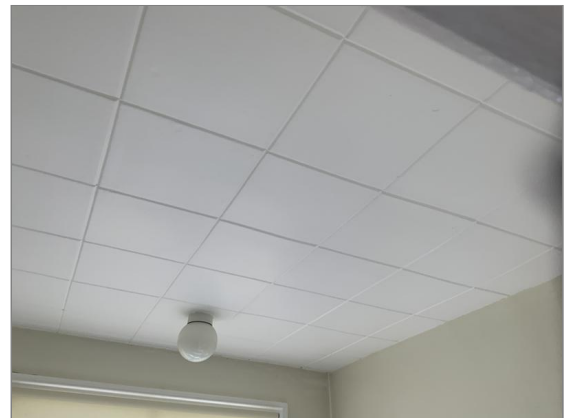
It should be noted that polystyrene ceiling tiles were found in the first floor bathroom. Polystyrene is flammable and if ignited, could release very toxic gases. You are therefore advised to remove the polystyrene ceiling tiles and should expect a significant decorative and plaster repair to be necessary thereafter.

*Photo - 46 Polystyrene tiles*

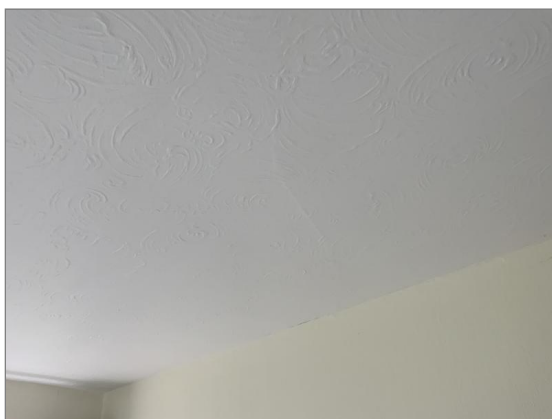
*Photo - 47 Some undulating*

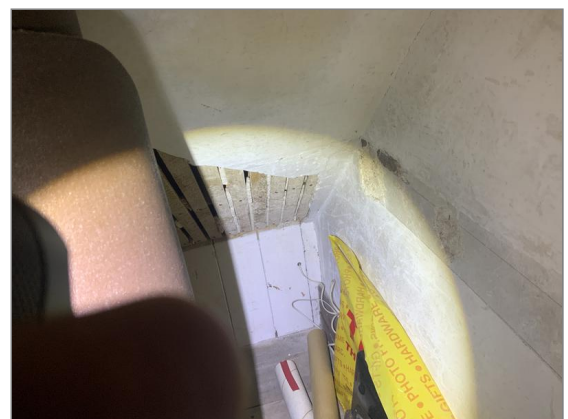
*Photo - 48 Exposed laths*

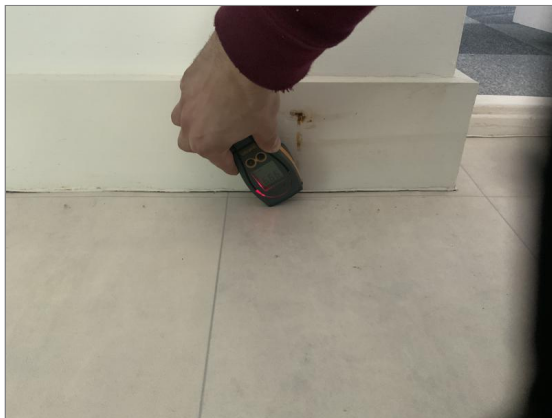
In the utility room, the skirting board had a corroding nail and when tested, full saturation readings were found.

*Photo - 49 Maximum saturation*

The vendor informed me that pipework travels up through the wall here, and clearly there is a leak. This will require opening up work and repair.

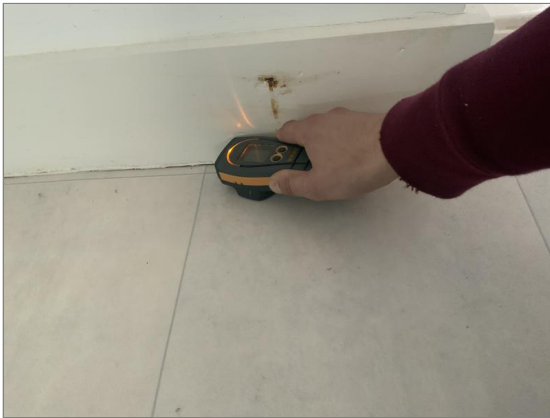
Slightly elevated moisture readings were found around the leak in the wall, and of course, this will be linked. As long as this is repaired soon, this is unlikely to lead to any significant problems.

*Photo - 52 Damp here*

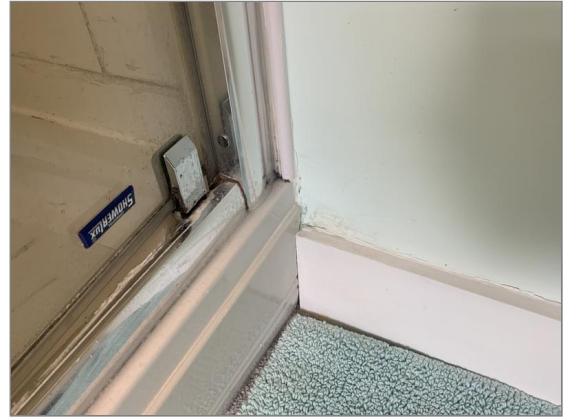
The shower for example requires the mastic to be re-done, as there is a leak. On the whole however, the bathrooms are in adequate and functional condition and free from significant defect.

*Photo - 65 Slight leak*

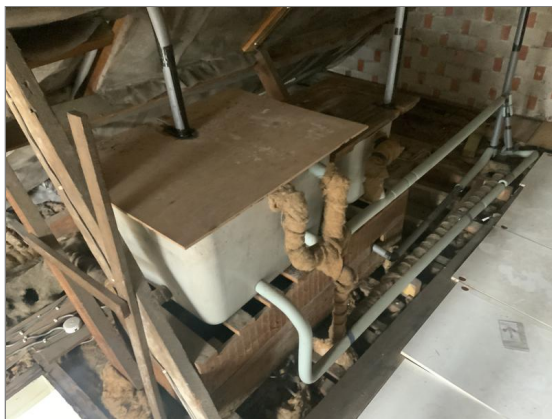
There are plastic header tanks in the loft, and these serve the hot water system. These fill with cold water from the mains and then drop down into the hot water cylinder below, to create a gravity feed. Tanks in the loft should always be insulated to avoid them reaching freezing temperatures. It is also not ideal to have a timber lid, as timber decays. Close fitting plastic lids or similar should be installed now.

*Photo - 69 Tanks*

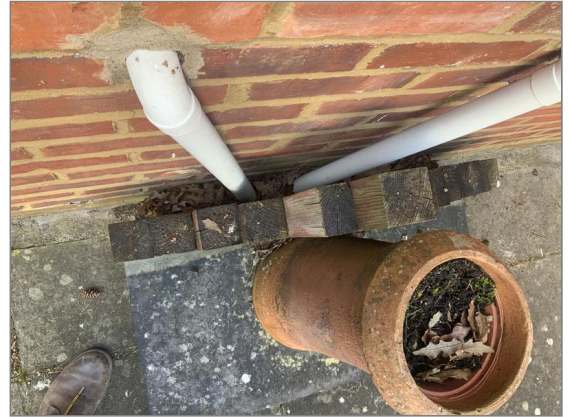
*Photo - 72 Cleaning recommended*

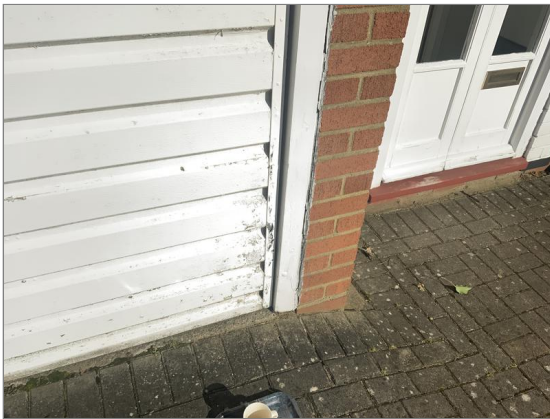
The property has a garage with an electric up and over door. The door was found to be fully functional and the garage was generally in good condition. Decoration is advisable to the front door of the garage, and it should be pointed out that the windows are load bearing. This means that the brickwork has been built up off of the windows, and if you change them, you must bear this in mind.

Photo - 73 Ageing decoration

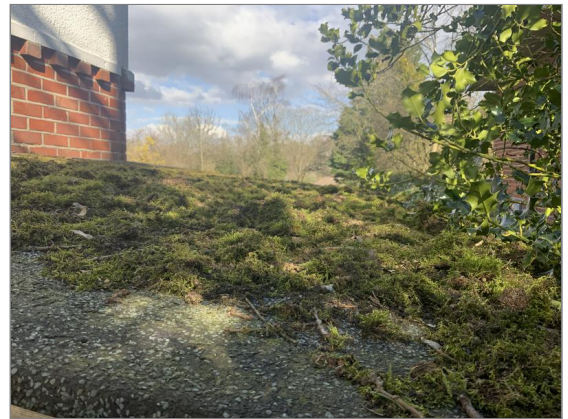
Photo - 78 Moss to roof

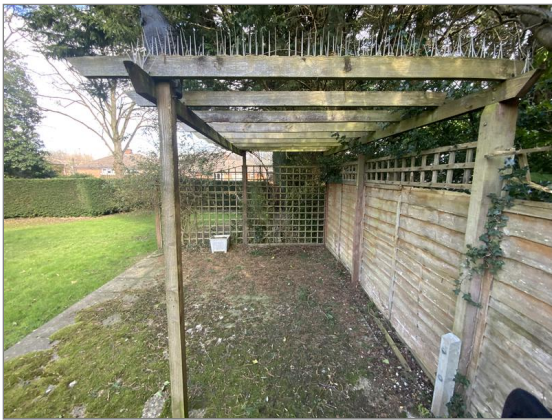
Towards the rear of the garden there is a pergola which I would recommend is removed soon, as the posts are beginning to decay.

*Photo - 81 Ageing*

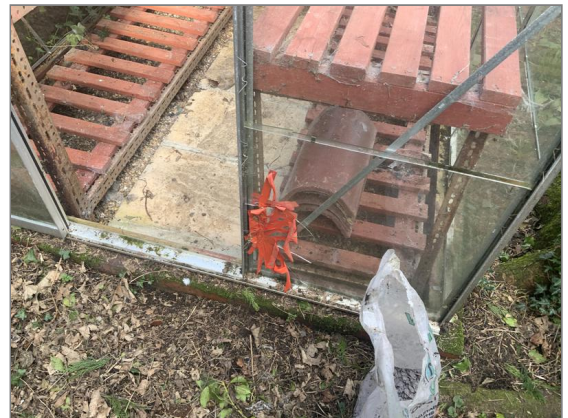
At the very rearmost part of the garden there is a further shed and greenhouse. The shed is in good condition, but the greenhouse has glass in it which will break into shards if impacted upon, and indeed, one element of glass is broken and has been taped up next to the door. Children should be kept away from this structure.

*Photo - 84 Broken*

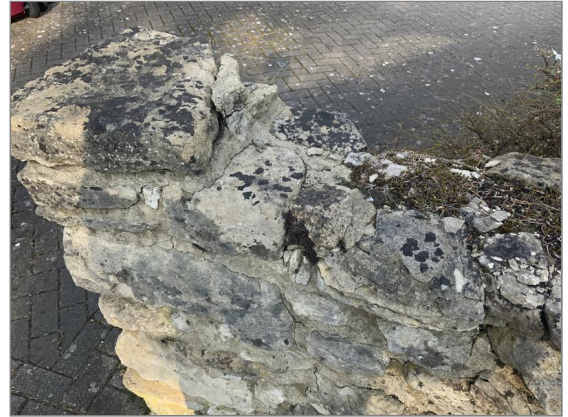
*Photo - 86 Ageing*

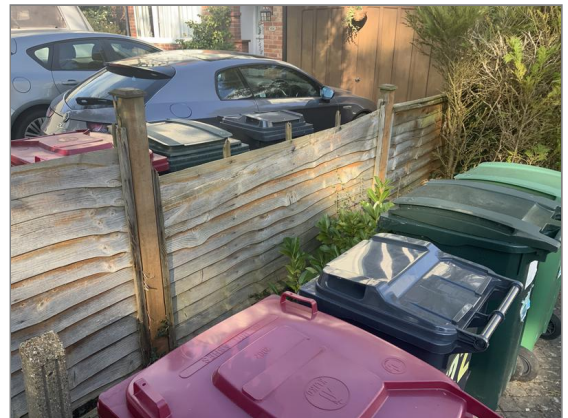
*Photo - 88 Old fences*

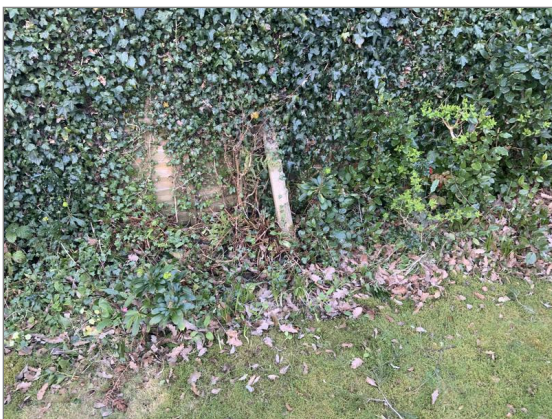
*Photo - 89 Propped*

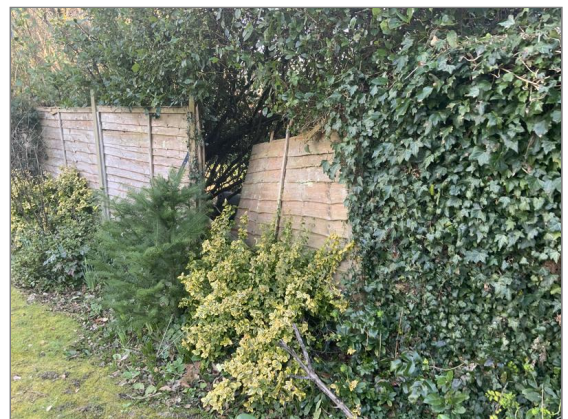
*Photo - 90 Fallen over*

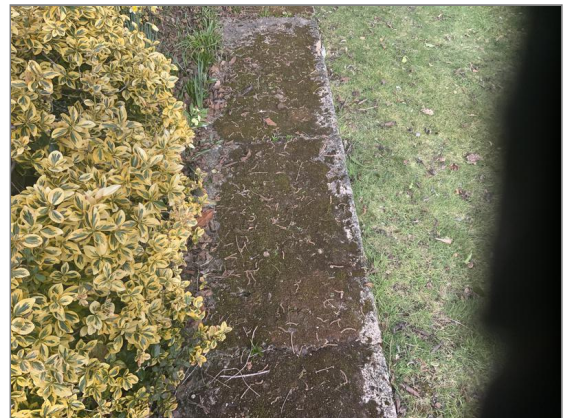
Finally, the pathway in the garden is very old and is cracked and uneven underfoot.

*Photo - 94 Ageing*
