# ASBESTOS REFURBISHMENT SURVEY REPORT

FOR: Reading Borough Council (Corporate)  
AT: Reading Town Hall, Blagrove Street, Reading

J356435  
Issue 1

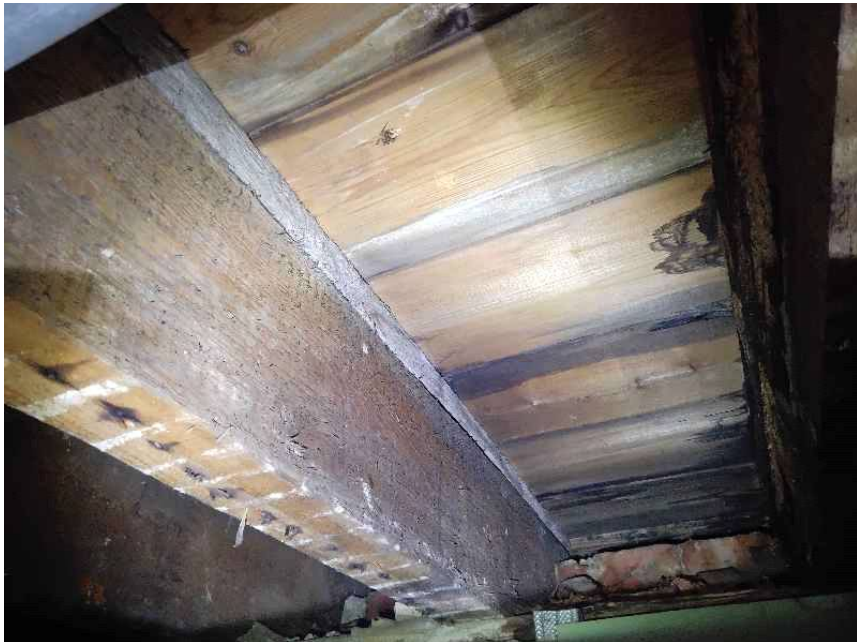
| Sample N° | IS013582 | | |

| Item: | Insulation Residue to Joist | Identification: | Identified |
| Extent of damage: | Low Damage | | 0 |
| Asbestos type: | No Asbestos Detected | | 0 |

| Action: | No Further Action Required | | |

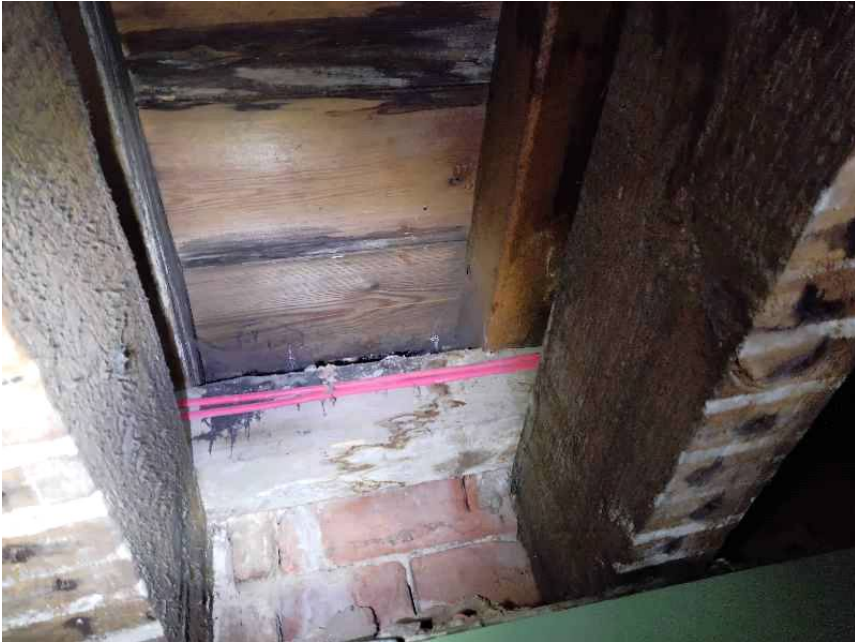
| Sample N° | IS013583 | | |

| Item: | Bituminous Screed to Wall | Identification: | Identified |
| Extent of damage: | Low Damage | | 0 |
| Asbestos type: | No Asbestos Detected | | 0 |

| Action: | No Further Action Required | | |

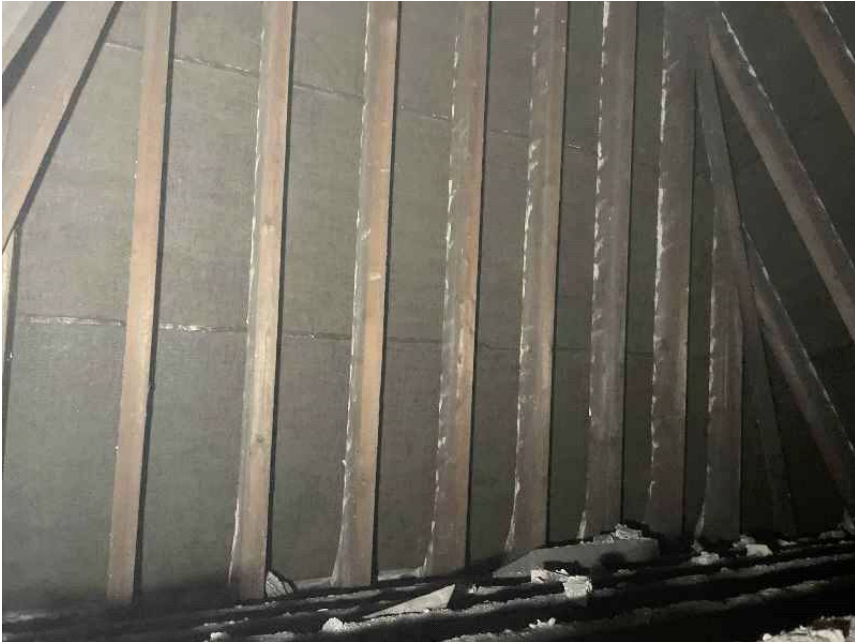
| Sample N° | BW000912 | | |

| Item: | Sarking felt lining to underside of the roof | Identification: | Identified |
| Extent of damage: | Low Damage | | 0 |
| Asbestos type: | No Asbestos Detected | | 0 |

| Action: | No Further Action Required | | |

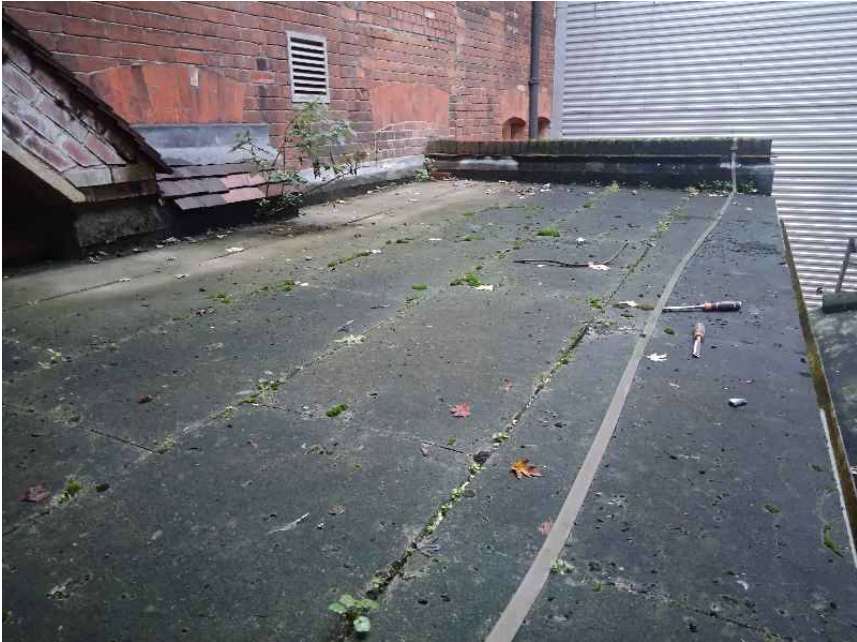
| Sample N° | BW000996 | | |

| Item: | Felt lining | Identification: | Identified |
| Extent of damage: | Low Damage | | 0 |
| Asbestos type: | No Asbestos Detected | | 0 |

| Action: | No Further Action Required | | |

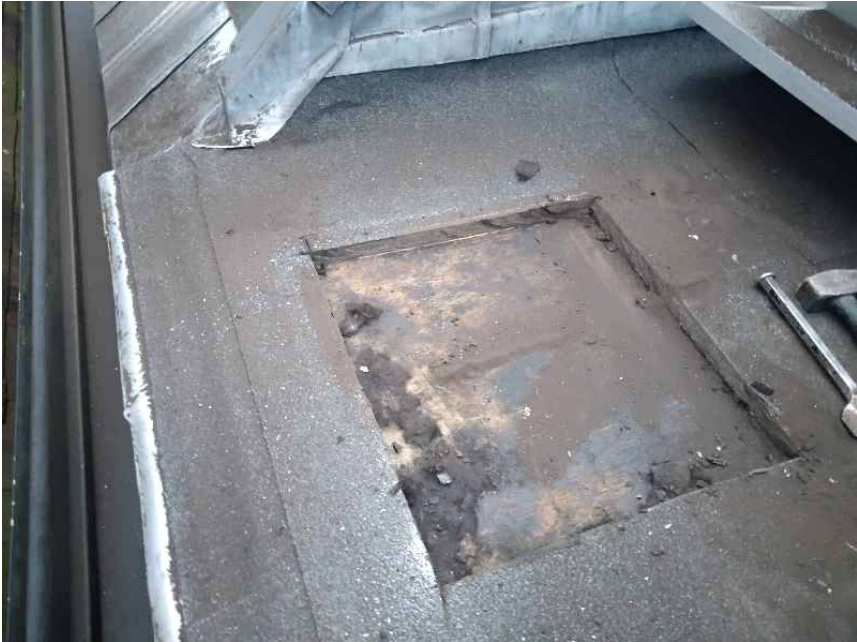
| Sample N° | BW001036 | | |

| Item: | Felt lining adjacent skylight | Identification: | Identified |
| Extent of damage: | Low Damage | | 0 |
| Asbestos type: | No Asbestos Detected | | 0 |

| Action: | No Further Action Required | | |

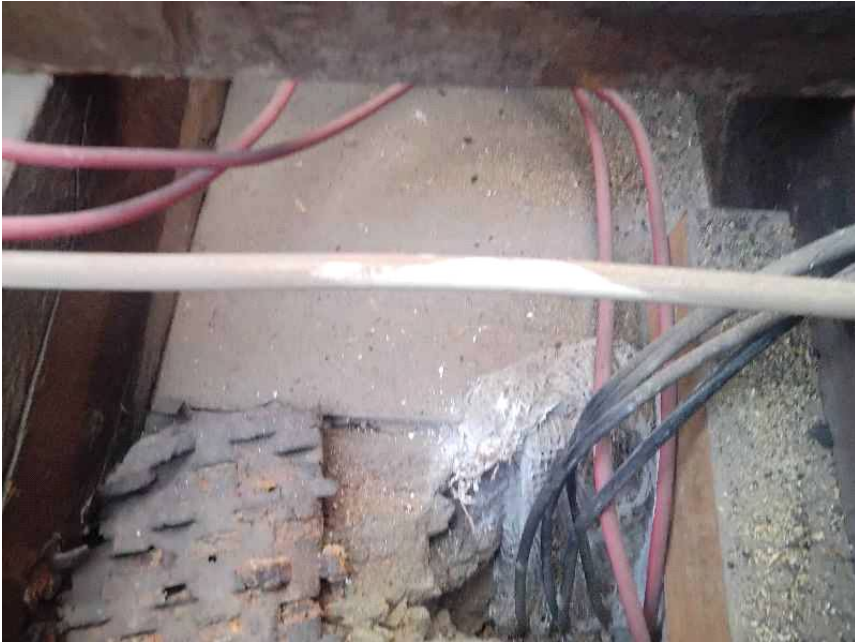
| Sample N° | BW001037 | | |

| Item: | Mesh to ducts | Identification: | Identified |
| Extent of damage: | Low Damage | | 0 |

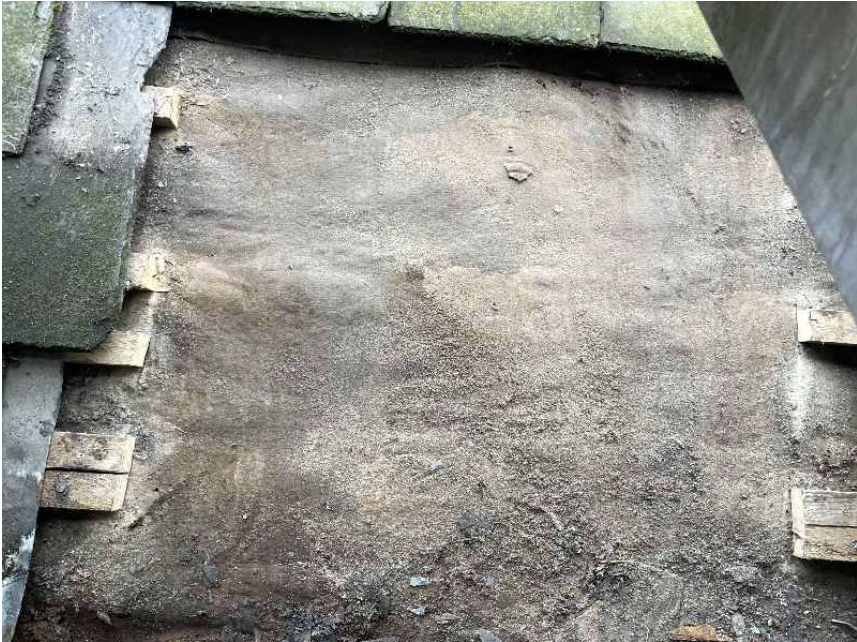
| Sample N° | BW000913 | | |

| Item: | Sarking felt lining to underside of the roof | Identification: | Identified |
| Extent of damage: | Low Damage | | 0 |

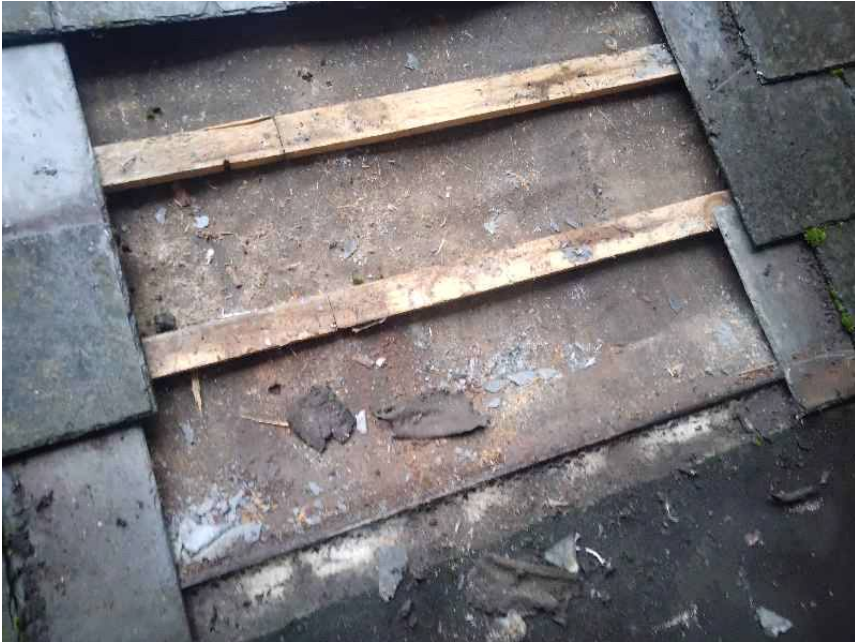
| Sample N° | BW000995 | | |

| Item: | Sarking felt | Identification: | Identified |
| Extent of damage: | Low Damage | | 0 |

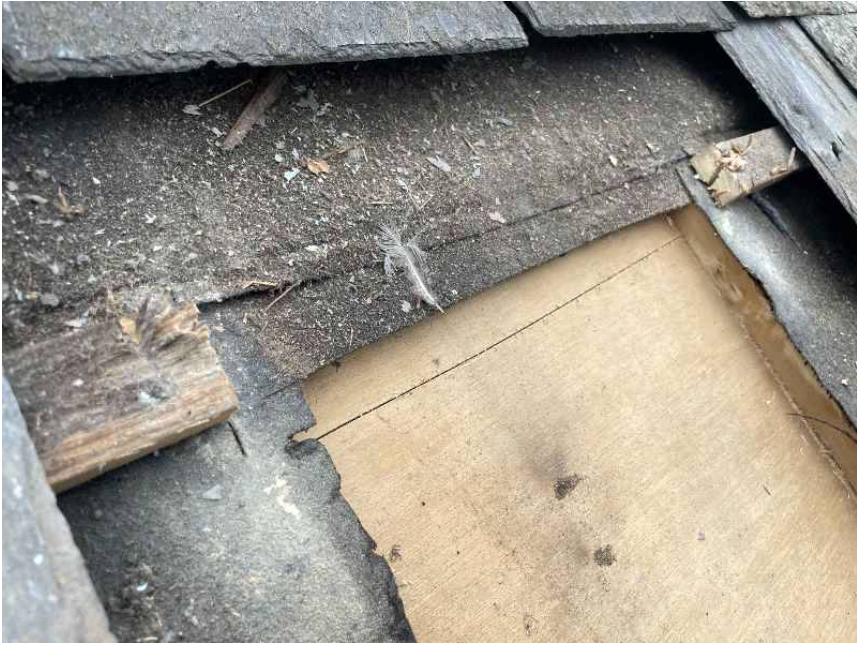
| Sample N° | BW000914 | | |

| Item: | Sarking felt lining to underside of the roof | Identification: | Identified |
| Extent of damage: | Low Damage | | 0 |

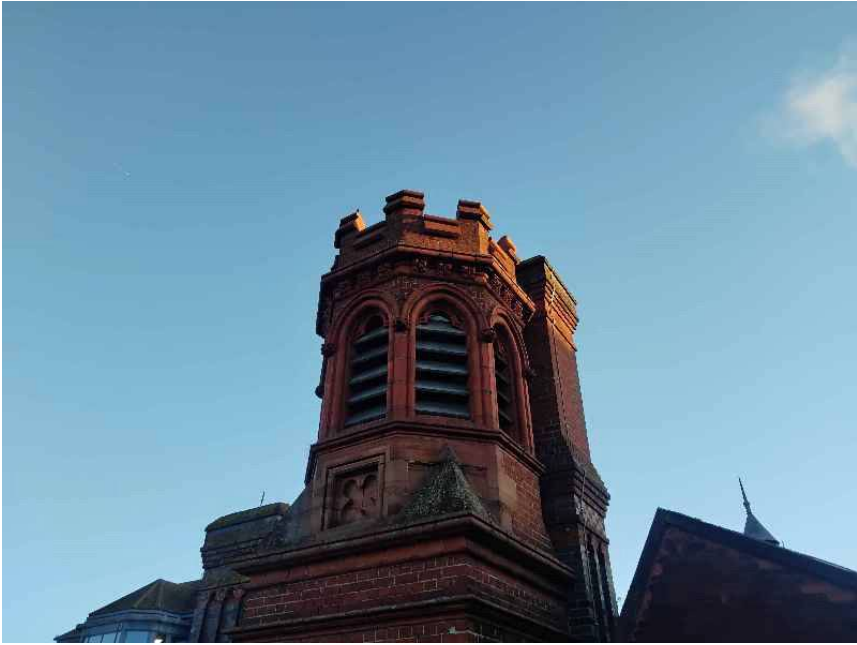
| Sample N° | Presumptive Sample 3 | | |

| Sample number | Location | Item | Product type | Extent of damage | Surface treatment | Asbestos type | Accessibility | Sample type | Material assessment score | Approx quantity | Action |
|---|---|---|---|---|---|---|---|---|---|---|---|
| Presumptive Sample 3 | Reading Town Hall R.03 - Roof 12 | Felt lining to roof | Reinforced Composite | Low Damage | Completely Sealed | Chrysotile | D | P | 3 | 2m <sup>2</sup> | Remove prior to demolition or refurbishment |

| Item: | Felt lining to roof | Identification: | Presumed |
| Extent of damage: | Low Damage | | 1 |

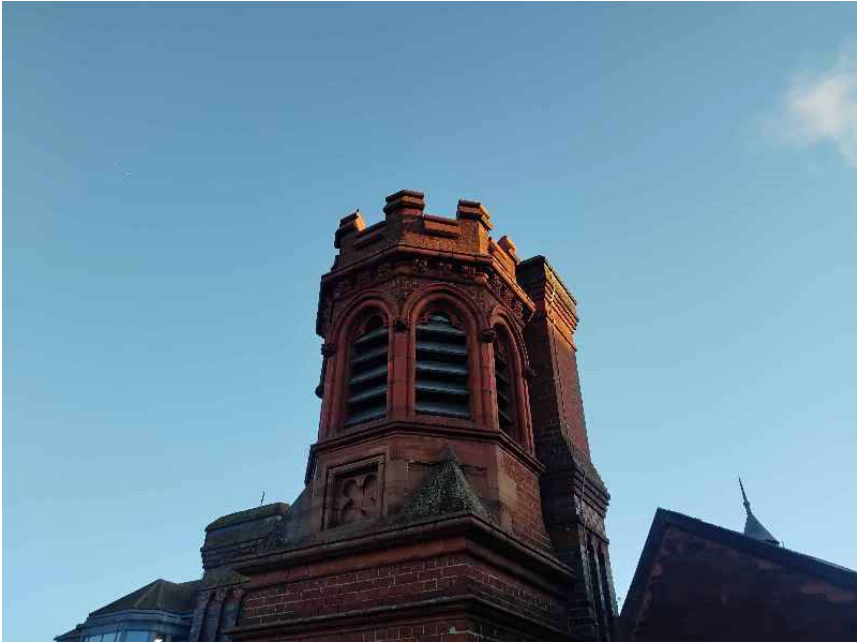
| Location | Reading Town Hall R.03 - Roof 12 | | |

| Item: | Access issues | Identification: | |

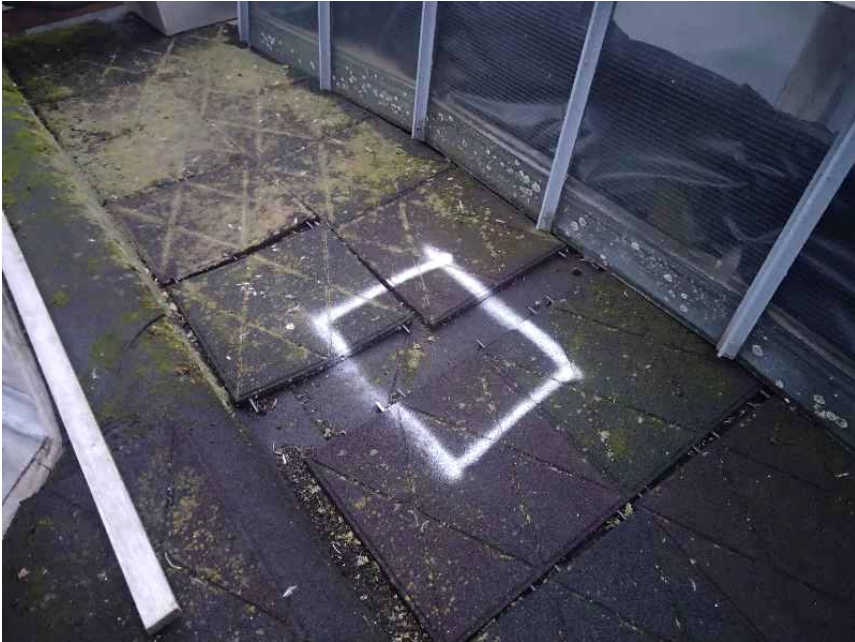
| Sample N° | BW001038 | | |

| Item: | Asphalt | Identification: | Identified |
| Extent of damage: | Low Damage | | 0 |

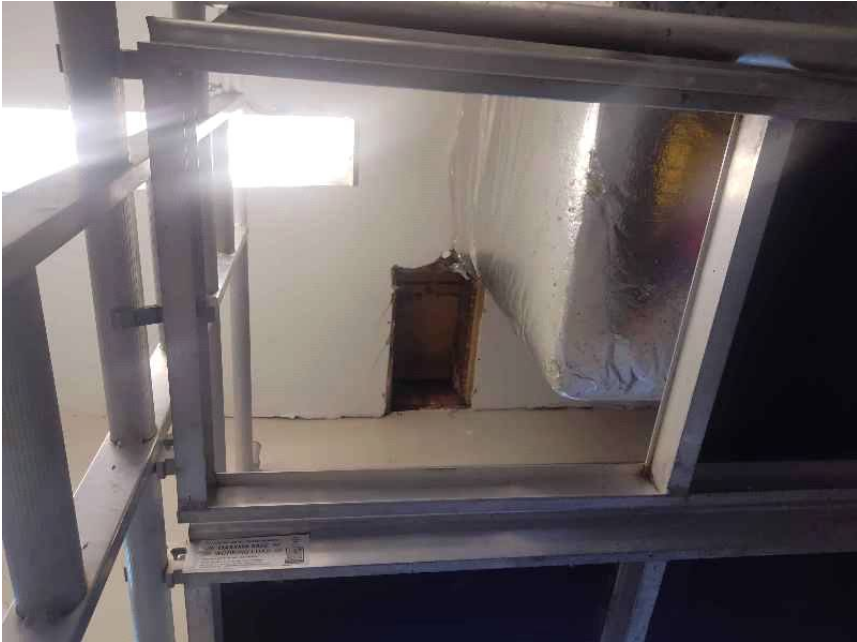
| Location | Reading Town Hall - Roof 14 & 15 R.01 - Roof 14 | | |

| Item: | Access location | Identification: | |

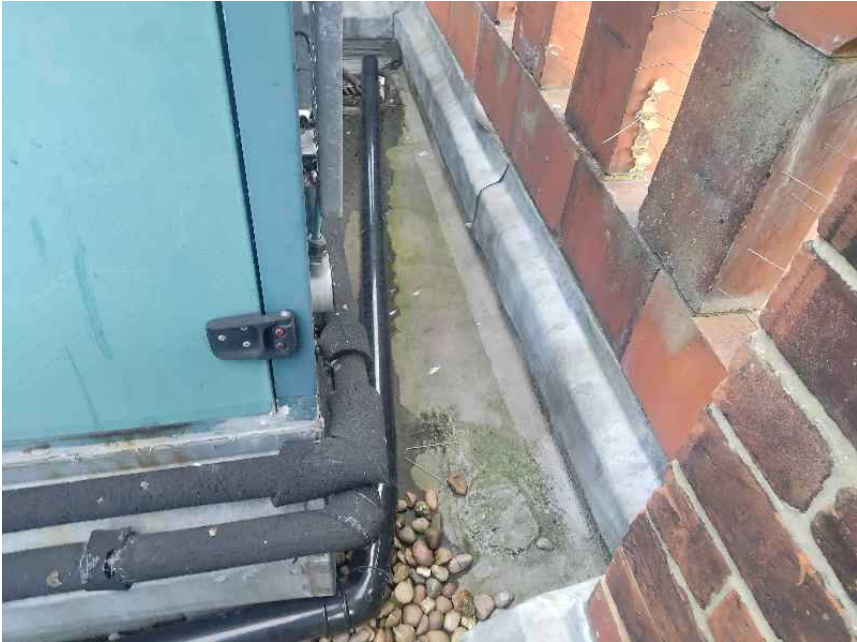
| Sample N° | BW000909 | | |

| Item: | Felt lining to roof above | Identification: | Identified |
| Extent of damage: | Low Damage | | 0 |

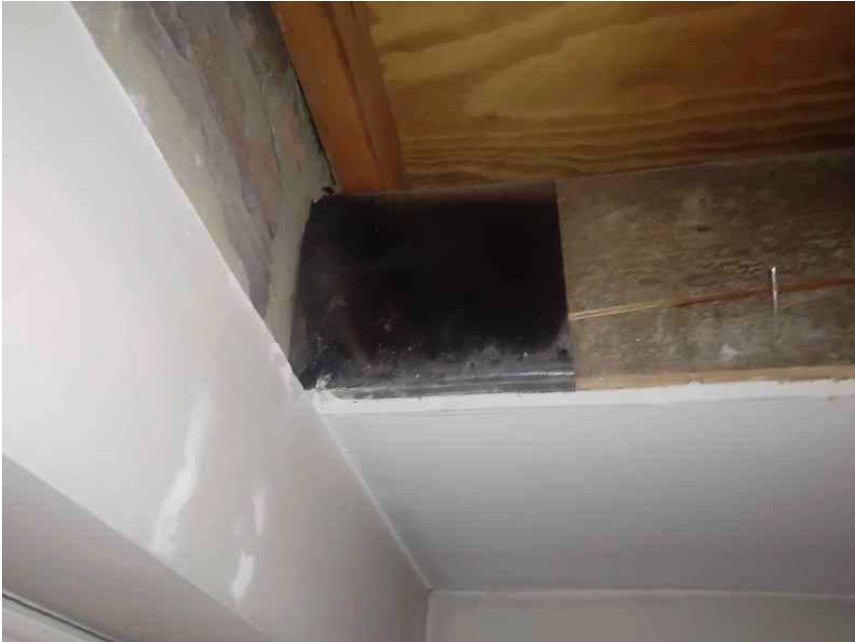
| Sample N° | BW000907 | | |

| Item: | Damp proof membrane around joists | Identification: | Identified |
| Extent of damage: | Low Damage | | 0 |

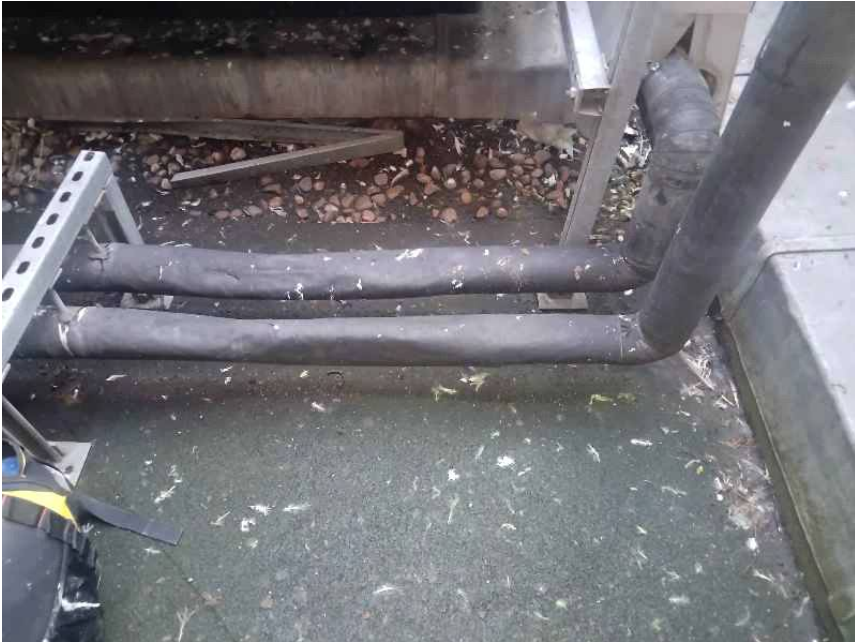
| Sample N° | BW000908 | | |

| Item: | Felt lining above | Identification: | Identified |
| Extent of damage: | Low Damage | | 0 |
