project  
**Reading Town Hall,  
Alterations & Improvements**

title  
**Photosheet Of Existing  
Roof RF21**

| job no.<br><b>997</b> | dwg no.<br><b>121</b> | status/revision<br><b>PL00</b> |

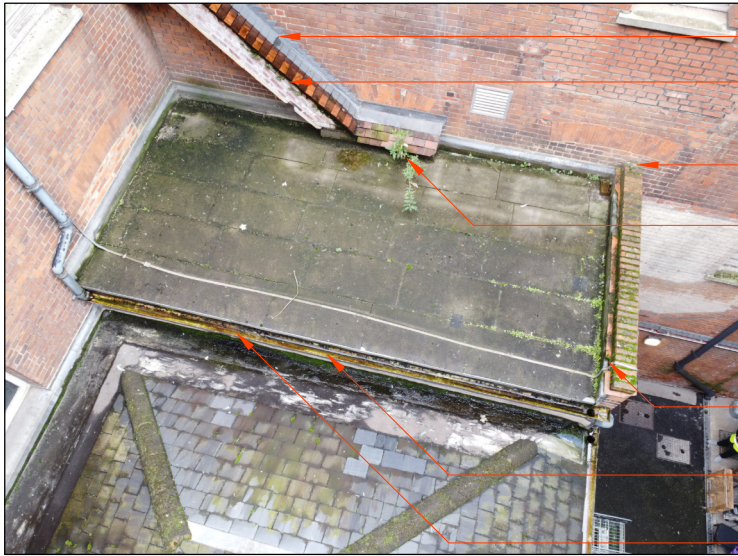
**01** **FLAT ROOF AND PARAPET RF21-PAR.01**  
NTS - Date Taken: 10/10/24

- Lead cover flashings lifting and showing signs of water ingress
- Vegetation growth under tiles
- Lead cover flashings damaged and lifting
- No lead saddle or flashings
- Severe vegetation growth under tile covering
- Slumping and splitting asphalt upstand along external wall
- Localised isolated repairs to flat roof covering
- Isolated cracked/damaged clay tile creasing below brick copings
- Algae growth and staining along the length of eaves gutter
- Standing water along the full length of the eaves gutters

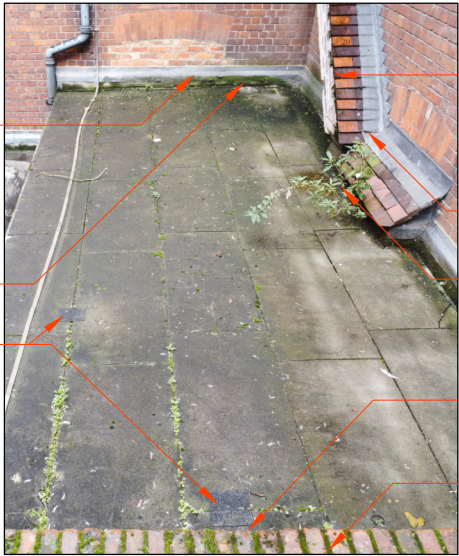
**02** **ROOF COVERING RF21**  
NTS - Date Taken: 10/10/24

- Debris on flat roof covering
- Vegetation growth under tiles
- Isolated cracked/damaged clay tile creasing below brick copings
- Gaps where lead flashings overlap
- Severe vegetation growth under tile covering
- Vegetation growth between paving slab joints and along junction to parapet wall
- Damaged / defective bricks along brickwork soldier course
- Open / defective mortar joints between brick copings with moss in joints
- Damaged roof covering with missing fragments along exposed edge

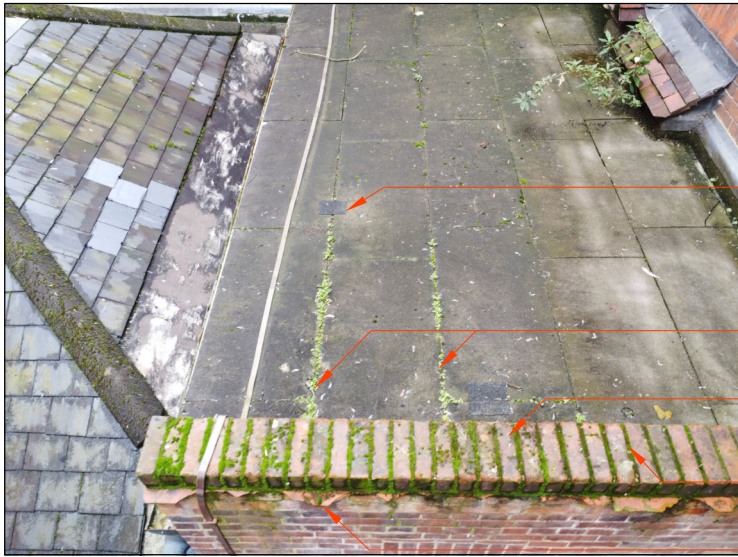
**04** **ROOF COVERING AND PARAPET RF21-PAR.01**  
NTS - Date Taken: 10/10/24

- No flashing detail at junction between tiles and external wall
- Efflorescence and staining to tiles on redundant chimney
- Localised isolated repairs to flat roof covering
- Isolated defective/open mortar joints and damaged/defective bricks in chimney
- Vegetation growth between paving slab joints
- Damaged / defective bricks to brick on edge copings
- Open / defective mortar joints between brickwork copings, moss in joints
- Isolated cracked/damaged clay tile creasing below brick copings

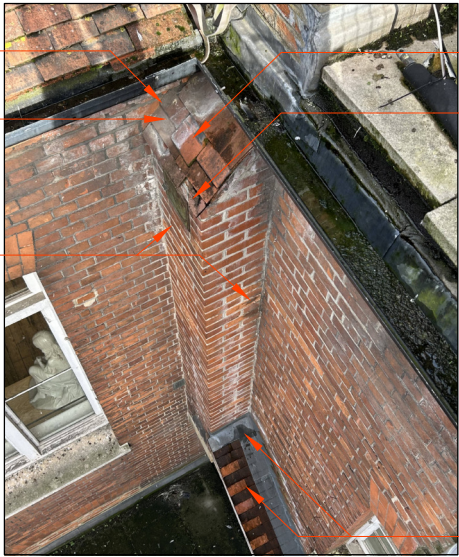
**05** **CHIMNEY RF21-CH.01**  
NTS - Date Taken: 17/10/24

- Slipped/displaced tiles to top of redundant chimney
- Isolated cracked / damaged roof tiles to top of redundant chimney
- Debris, vegetation growth, and standing water along edge of flat roof covering
- Isolated cracked / damaged roof tiles to remains of tiled covering
- Cracked and damaged flat roof covering with open joints
- Gaps where lead flashings overlap
- Open joints between stone paving slab flat roof coverings
- Remains of tiled pitched roof and associated flashing are saturated with water, possible leak in eaves gutter above

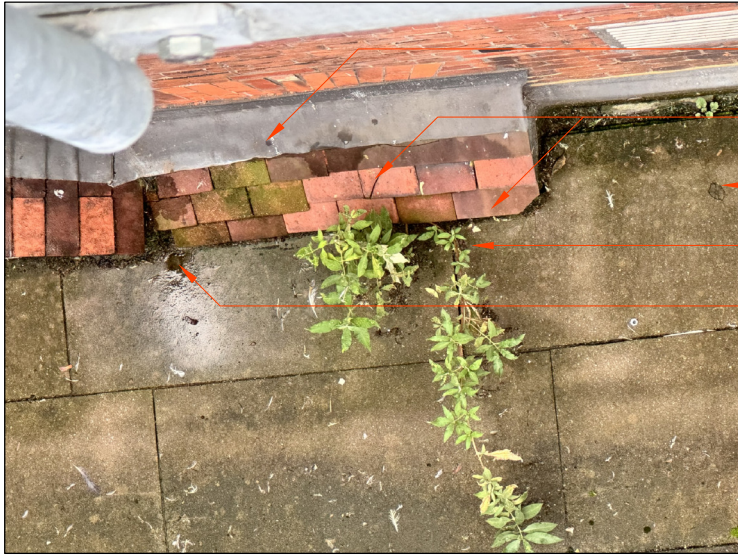
**07** **ROOF COVERING RF21**  
NTS - Date Taken: 10/10/24

- Lead flashings damaged and lifting
- Isolated cracked / damaged roof tiles to remains of tiled covering
- Cracked and damaged flat roof covering
- Severe vegetation growth under tile covering
- Standing water on flat roof covering
- Damaged roof covering with missing fragments along exposed edge
- Algae growth and staining along the length of eaves gutter
- Standing water along the full length of the eaves gutters
- Isolated cracked/damaged clay tile creasing below brick copings
