| Project Title:<br>READING TOWN HALL | | SFK Ref:<br>24173 - 0180 | |
| Dwg Title: ROOF 18 STRUCTURAL<br>DETAILS AS EXISTING | | Dwg No:<br>24173-SFK-18-RF-DR-S-0180 | |

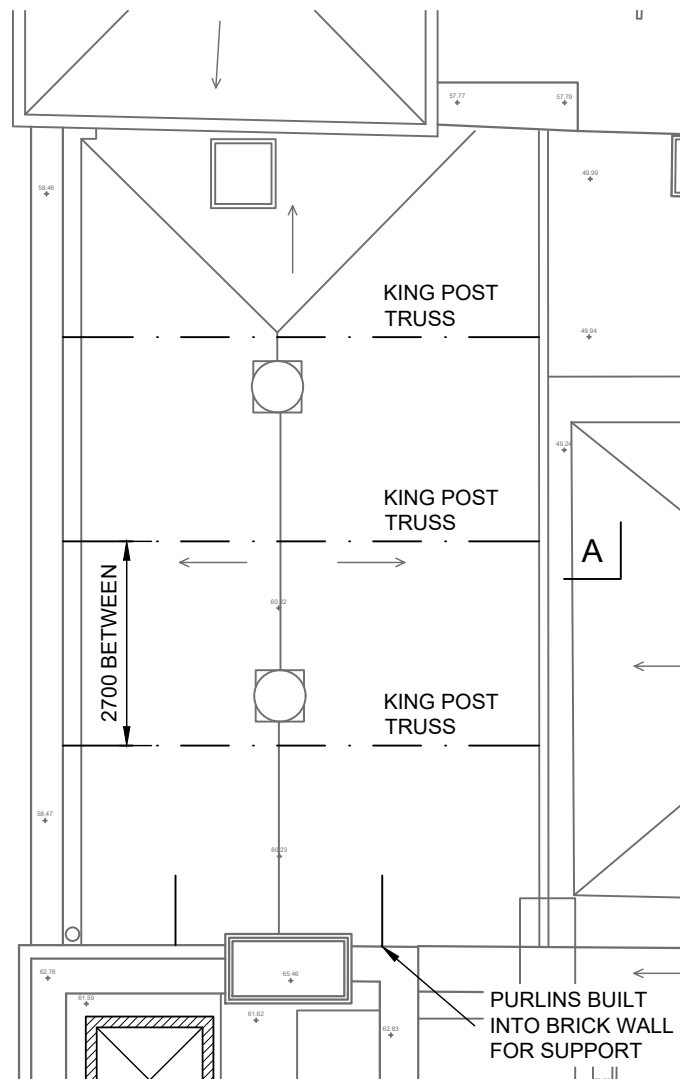
ROOF 18 PLAN

ON NORTH SIDE  
SOME RAFTER ENDS  
HAVE BEEN REPAIRED  
WITH PARTNER TIMBERS  
ADDED TO SIDE AND  
BOLTED TOGETHER.

SOME RAFTER FEET DAMP,  
GUTTER MAY BE LEAKING

WALL PLATE HAS  
BEEN REPLACED  
ON NEW DPC

PURLINS BUILT  
INTO BRICK WALL  
FOR SUPPORT

- ALL TIMBER IS GOOD QUALITY SOFTWOOD.
- TIMBER DRY AT TIME OF INSPECTION AND GENERALLY IN GOOD CONDITION.
- FOR PROPOSED WORKS, ARCHITECT TO ADDRESS POSSIBLE GUTTER LEAK.
- ENDS OF NORTH RAFTER FEET TO BE CHECKED FOR DECAY.
- PROPOSED ADDITION OF NEW INSULATION TO CEILING ASSESSED AS ADEQUATE BY INSPECTION OF CEILING JOIST AND TRUSS SIZES.
