project  
**Reading Town Hall,  
Alterations & Improvements**

title  
**Photosheet Of Existing  
Roof RF13**

| job no.<br><b>997</b> | dwg no.<br><b>113</b> | status/revision<br><b>PL00</b> |

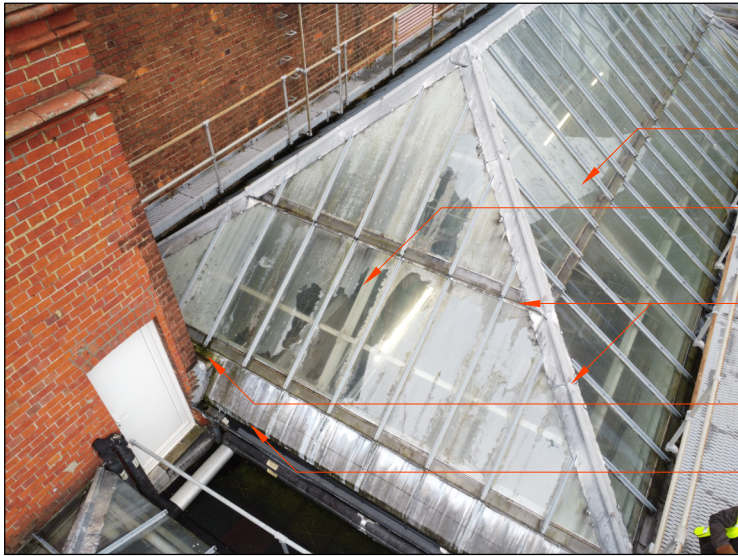
**01** ROOF LANTERN RF13-RFL.01  
NTS - Date Taken: 09/10/24

- Defective sealant between glazed panes and roof lantern structure / frame
- Older double glazed Georgian wired glass to roof lantern offering limited thermal insulation
- Damaged or missing solar film
- Lifting lead flashings over and under glazed panes
- Defective asphalt valley gutter covering and standing water
- Discolouration / algae on base of lead roof lantern covering
- Algae / black mould growth at junctions between glazed panes and lantern frame

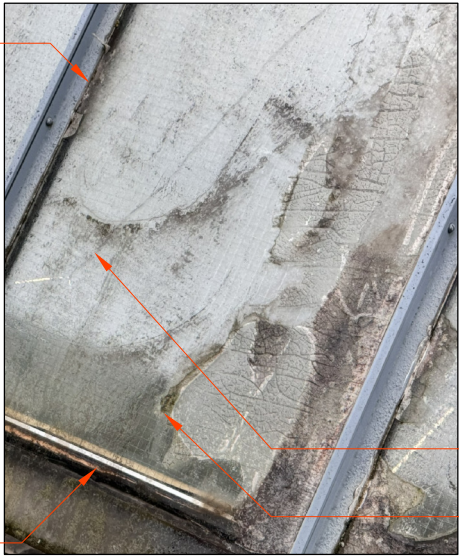
**02** RF13-RFL.01 COVERING  
NTS - Date Taken: 09/10/24

- Lifting lead waterproofing over roof lantern
- Lifting lead flashings at junction where the roof lantern's glazed panes overlap
- Defective sealant between glazed panes and roof lantern structure / frame
- Damaged or missing solar film
- Condition of glazed panes under solar film unknown – cracked panes may be present
- Remaining solar film cracked and discoloured

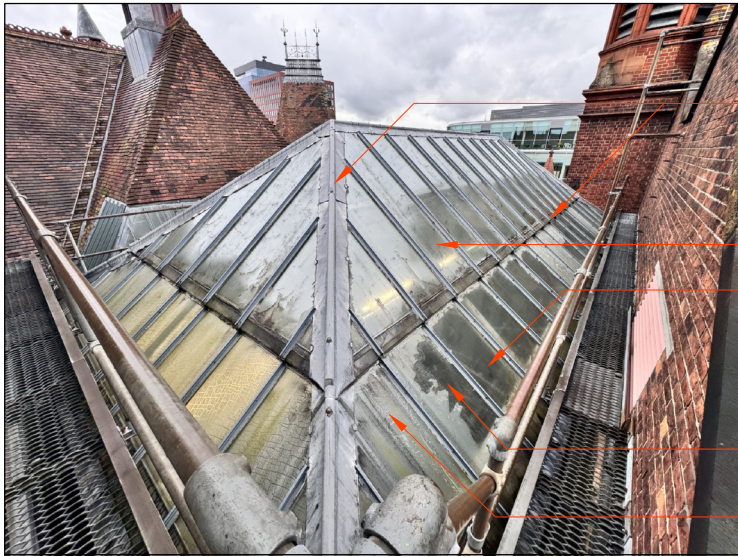
**04** ROOF LANTERN RF13-RFL.01  
NTS - Date Taken: 09/10/24

- Older double glazed Georgian wired glass roof to lantern offering limited thermal insulation
- Lifting lead flashings over and under glazed panes
- Minimal upstand height to roof lantern
- Older double glazed Georgian wired glass to roof lantern offering limited thermal insulation
- Damaged or missing solar film
- Remaining solar film cracked and discoloured
- Condition of glazed panes under solar film unknown – cracked panes may be present
- Remaining solar film cracked and discoloured

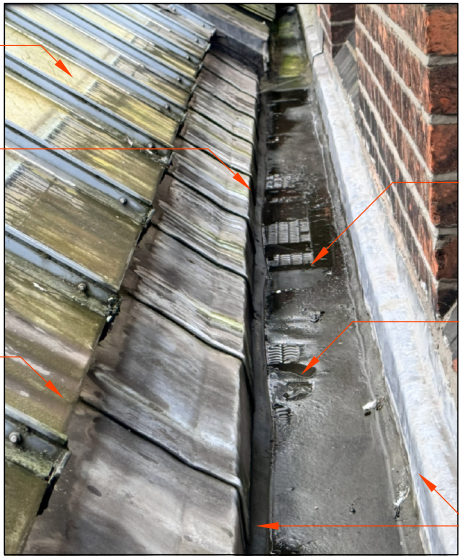
**05** GUTTER RF13-VGUT.03  
NTS - Date Taken: 09/10/24

- Discolouration / algae on base of lead roof lantern covering
- Outlet partially blocked by lead roof lantern covering
- Standing water in valley gutter
- Lifting lead flashings at the base of the roof lantern
- Defective asphalt valley gutter covering
- Debris in eaves gutter
- Outlet from eaves to discharge directly into existing outlet in valley gutter
- Lead cover flashings damaged and lifting

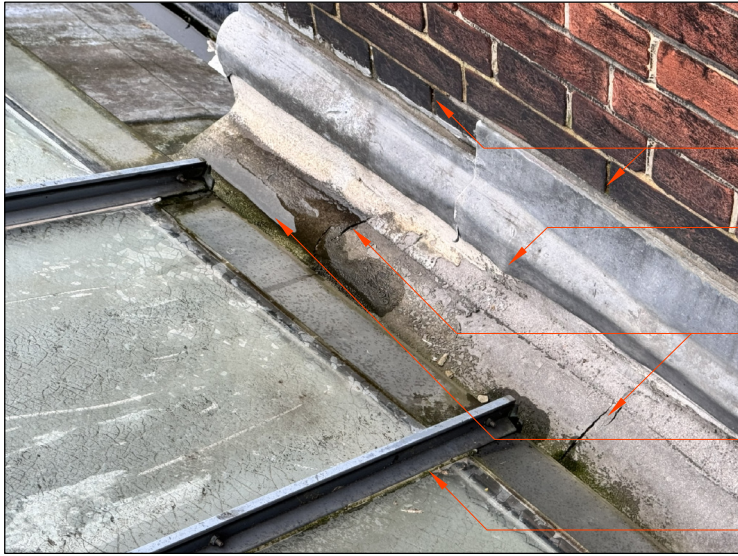
**07** VALLEY GUTTER RF13-VGUT.01  
NTS - Date Taken: 09/10/24

- Discolouration / algae on base of lead roof lantern covering
- Standing water in valley gutter
- Defective mortar joints in wall above lead cover flashings
- Lead cover flashings damaged and lifting
- Defective asphalt valley gutter covering
- Multiple splits in asphalt valley gutter covering
- Remaining solar film cracked and discoloured
- Standing water in valley gutter
- Defective sealant between glazed panes and roof lantern structure / frame
