project  
**Reading Town Hall,  
Alterations & Improvements**

title  
**Photosheet Of Existing  
Roof RF8**

| job no.<br><b>997</b> | dwg no.<br><b>108</b> | status/revision<br><b>PL00</b> |

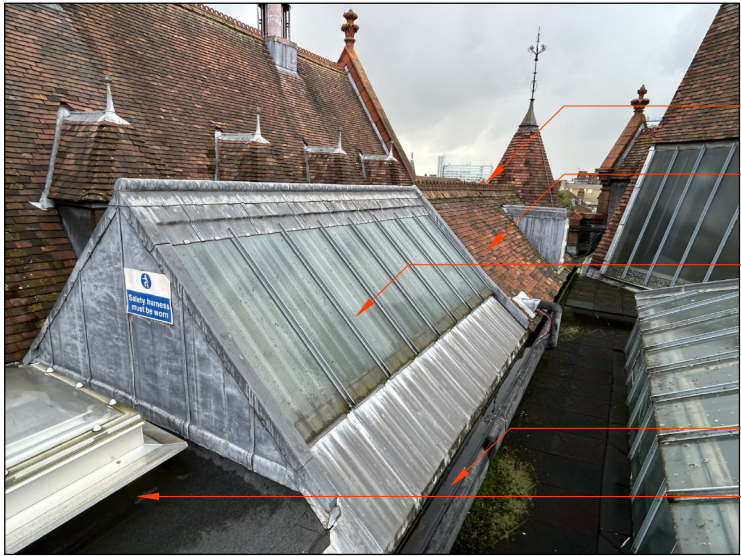
01 ROOF LANTERN RF8-RFL.01  
NTS - Date Taken: 08/10/24

- Defective bricks and mortar around flashing by eaves gutter
- Damaged ridge tiles with open / missing mortar joints / moss
- Slipped / displaced roof tiles in isolated areas
- Single glazed Georgian wired glass to roof lantern offering limited thermal insulation
- Outlet level sits above the internal surface level of the eaves gutter
- Standing water in eaves gutter
- Standing water around upstands on mineral felt flat roof covering

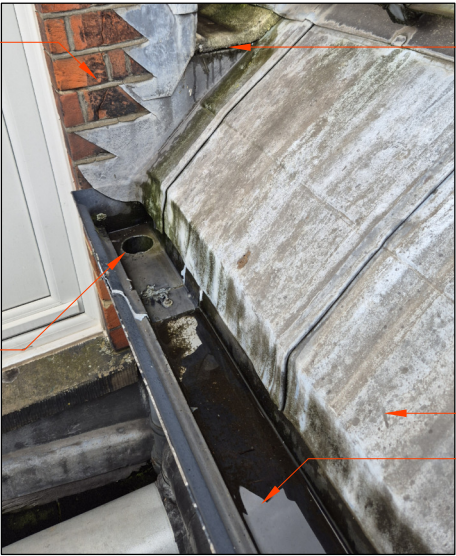
02 OUTLET RF13-OUT.02  
NTS - Date Taken: 08/10/24

- Defective asphalt valley gutter covering to RF13 valley gutter
- Single glazed Georgian wired glass to roof lantern offering limited thermal insulation
- Minimal upstand to roof lantern
- Moss and lichen present on surface of roof tiles
- Slipped / displaced roof tiles
- Discolouration / algae on base of lead roof lantern covering
- Standing water in eaves gutter
- Standing water along the full length of the eaves gutter

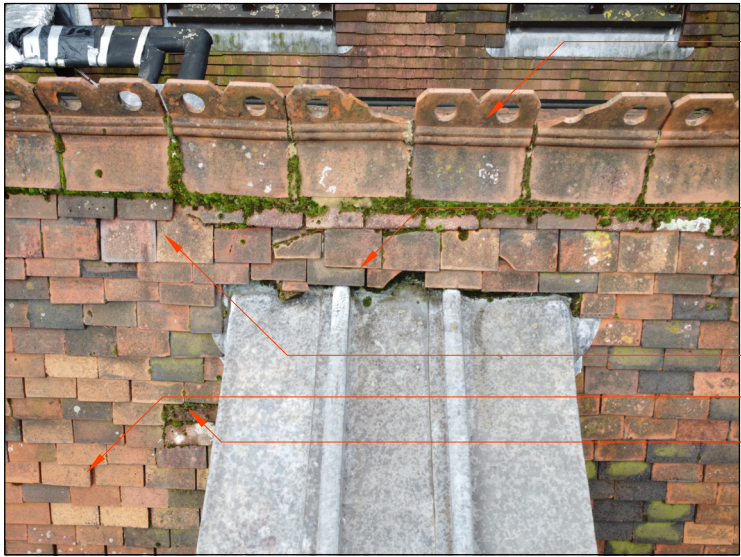
04 EXTERNAL ACCESS SURROUND RF8-HATCH.01  
NTS - Date Taken: 09/10/24

- Damaged crests to ridge tiles with open / missing mortar joints / moss
- Older uPVC external access door offering limited thermal insulation
- Slipped / displaced roof tiles
- Cracked/damaged roof tiles above flat roof to access door hatch
- Moss and algae on roof tiles, lead apron, eaves gutter, and on uPVC access door
- Insufficient lap to tiles below ridge tiles to either side of ridge
- Slipped / displaced roof tiles
- Moss on surface of roof tiles
- Cracked / damaged roof tiles along eaves of northern roof slope

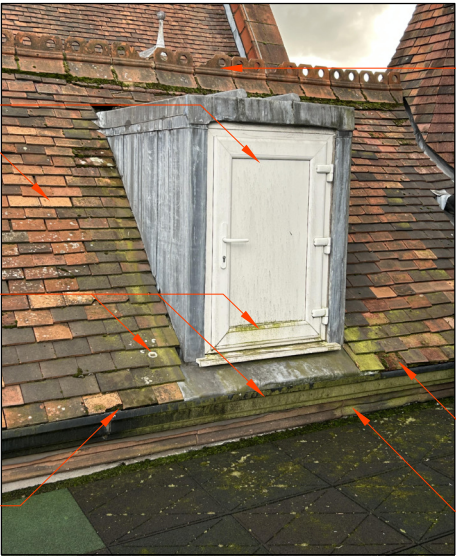
05 ACCESS RF8-HATCH.01  
NTS - Date Taken: 08/10/24

- Damaged crests to ridge tiles with open / missing mortar joints / moss
- Standing water on flat roof covering
- Likely single glazed / older double glazed smoke vent offering limited thermal insulation, water ingress evident
- Roof coverings lifting around upstands
- Multiple cracked single glazed panes in the Georgian wired glass roof lantern
- Outlet level sits above the internal surface level of the eaves gutter
- Slipped / displaced roof tiles along eaves of northern roof slope
- Slumped / cracked /defective asphalt upstands to roof
- Standing water along the full length of the eaves gutter

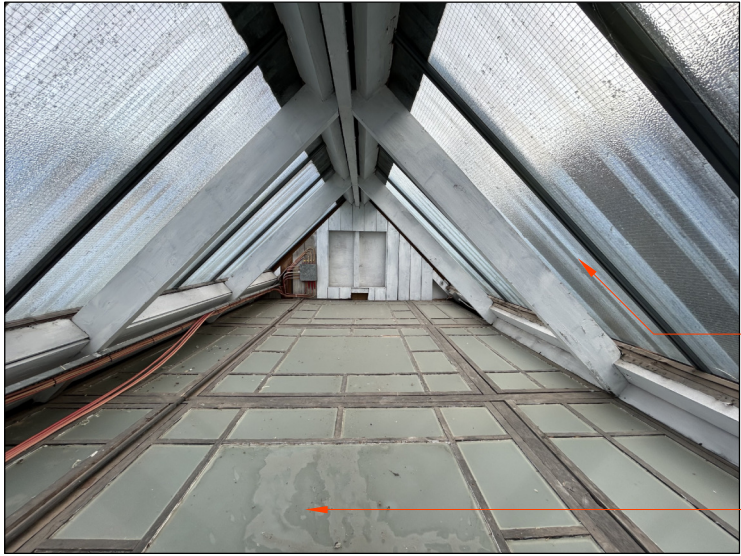
08 CLAY TILED ROOF RF8  
NTS - Date Taken: 09/10/24

- Single glazed Georgian wired glass to roof lantern offering limited thermal insulation
- Standing water along the full length of the eaves gutters
- Previous remedial waterproofing to ducting has become damaged
- Slipped / displaced / damaged roof tiles across both roof slopes
- Single glazed Georgian wired glass to roof lantern offering limited thermal insulation
- Existing plant and ducting restricting access to remedial roof works
- Historic glazed laylight in generally good condition
- Damaged ridge tiles with open / missing mortar joints / moss
