project  
**Reading Town Hall,  
Alterations & Improvements**

title  
**Photosheet Of Existing  
Roof RF17**

| job no.<br><b>997</b> | dwg no.<br><b>117</b> | status/revision<br><b>PL00</b> |

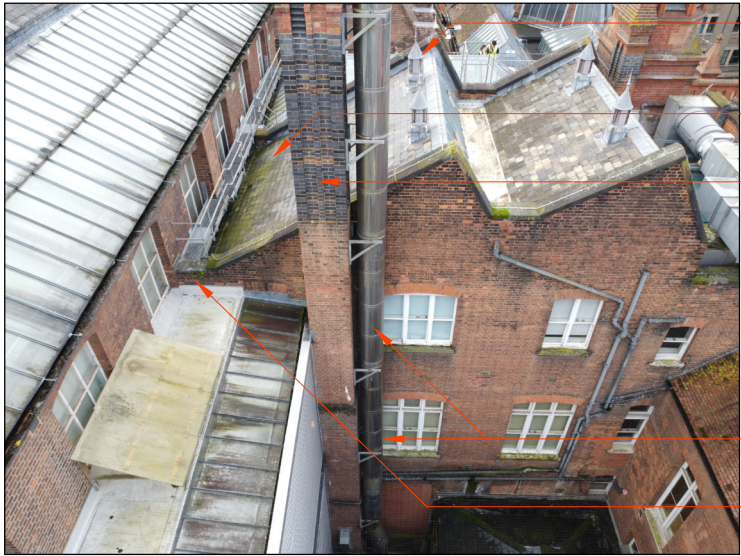
**01 SOUTH SLOPE RF17A AND EAST GABLE END**  
NTS - Date Taken: 09/10/24

- Discolouration/weathering to vents
- Cracked/damaged slates and isolated slipped/displaced slates previously refixed with tingles
- Damaged/defective bricks to chimney
- Dirt present on mortar flaunching to chimney
- Mortar flaunching to chimney has become loose and detached
- Stainless steel gas boiler flue partially obscuring existing windows on floors below
- Vegetation growth along external face of parapet wall
- Open/defective mortar joints to chimney

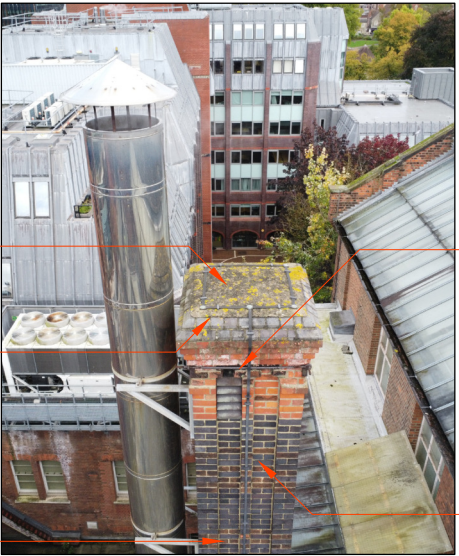
**02 RF17-CH.01 AND RF17-VENT.03**  
NTS - Date Taken: 09/10/24

- Moss, lichen, and dirt present on surface of coping stones
- Loose and lifting lead flashings and upstands
- Single glazed Georgian wired glass patent glazing
- Existing vent function unknown
- Previous water ingress from vents in patent glazing
- Lead cover flashing cracked and fragments missing, staining and algae growth
- Minimal upstand and cover flashing between valley gutter and patent glazing
- Damaged/defective bricks to chimney

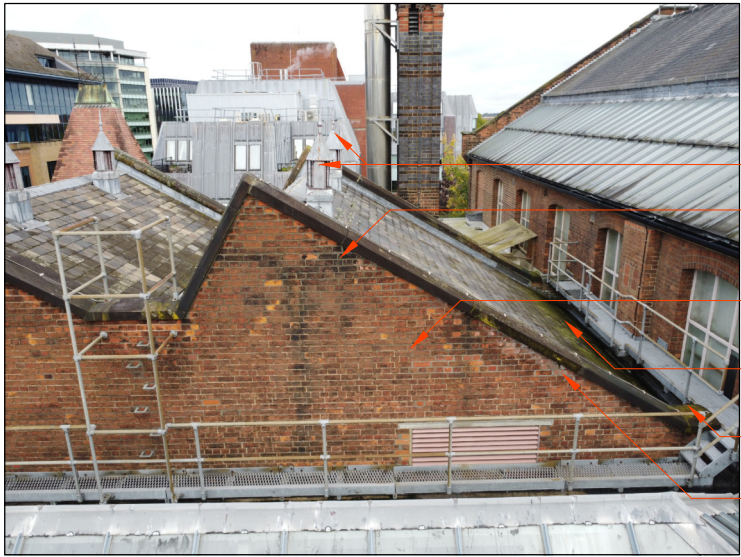
**04 SOUTH SLOPE RF17A AND WEST GABLE END**  
NTS - Date Taken: 09/10/24

- Moss, lichen, and dirt present on surface of coping stones
- Open / defective mortar joints between coping stones along coped gable
- Discolouration/weathering to vents
- Staining/discolouration to bricks
- Isolated defective/open mortar joints in brickwork and damaged/defective bricks
- Algae and lichen present on the bottom courses of slates
- Algae and lichen on coping stones on coped gable and parapet wall
- Efflorescence present on brickwork along coped gable
- Cracked / damaged slates across RF17A

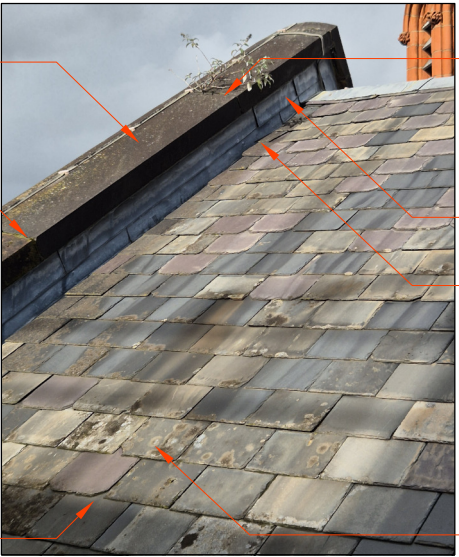
**05 COPED GABLE RF17-CG.04**  
NTS - Date Taken: 08/10/24

- Vegetation growth along coped gable
- Algae and lichen on lead coping on parapet wall and coped gable
- Lead cover flashings damaged and lifting, gaps in flashings to coped gable
- Isolated slipped/displaced slates, previously refixed with tingles
- Defective lead coping surface to parapet wall showing signs of slumping, standing water has been trapped due to uneven surface in coping material
- Loose lead flashing due to previously failed and repaired mortar joint
- Dirt and staining present on surface of slates on RF17A

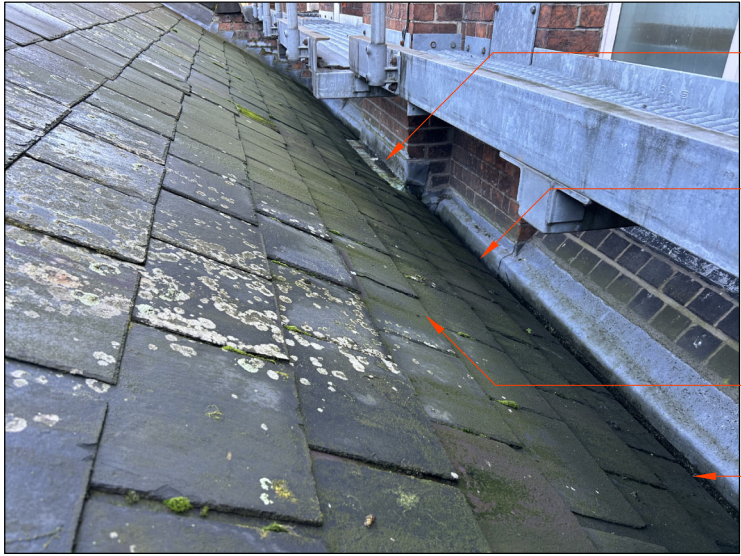
**07 SOUTH SLOPE RF17A AND GUTTER RF17-VGUT.02**  
NTS - Date Taken: 25/11/24

- Algae along lead flashings to roof slope RF17A
- Signs of possible moisture ingress where lead cover flashings overlap/is damaged
- Lead cover flashings are displaced and lifting
- Guard for outlet RF17-OUT.01 surrounded and blocked by debris
- Debris present along valley gutter RF17-VGUT.01
- Algae and lichen present on the bottom courses of slates
- Possible slumping and splitting asphalt upstands along valley gutters to roof slope RF17A
- Algae and lichen present on the bottom courses of slates
