| project<br>Reading Town Hall,<br>Alterations & Improvements | | |
| title<br>Photosheet Of Existing<br>Roof RF9 | | |

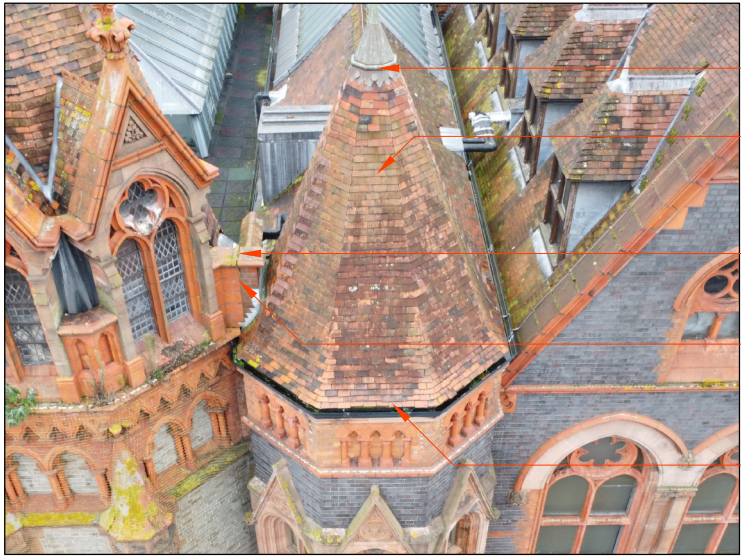
01 WESTERN ROOF SLOPES RF9  
NTS - Date Taken: 09/10/24

- Discolouration/corrosion to finials, copper patination
- Algae and dirt present on upper tiles
- Isolated slipped/displaced roof tiles
- Open/defective mortar joints between copings along parapet wall
- Open/defective mortar joints between brickwork along parapet wall
- Slipped/displaced hip tiles with gaps to lower part of hips
- Slipped/displaced tiles along eaves
- Debris, moss, and vegetation growth along the full length of all eaves gutters

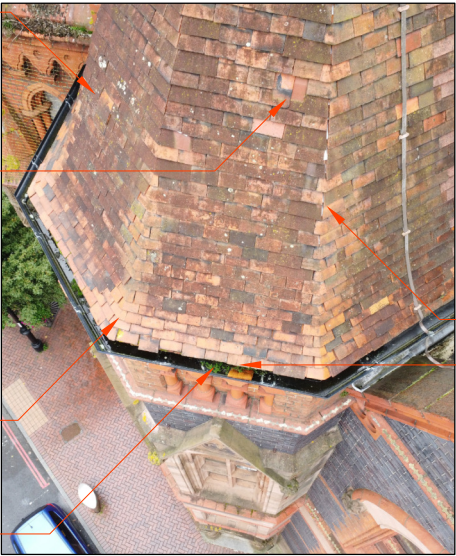
02 GUTTER RF9-EGUT.01  
NTS - Date Taken: 09/10/24

- Open/defective mortar joints between copings along parapet wall
- Open/defective mortar joints between brickwork along parapet wall
- Algae and debris in parapet gutter, signs of standing water
- Gaps under stepped lead flashing and roof tiles, debris below
- Gaps between mitred cut roof tiles at hips
- Slipped/displaced tiles along eaves

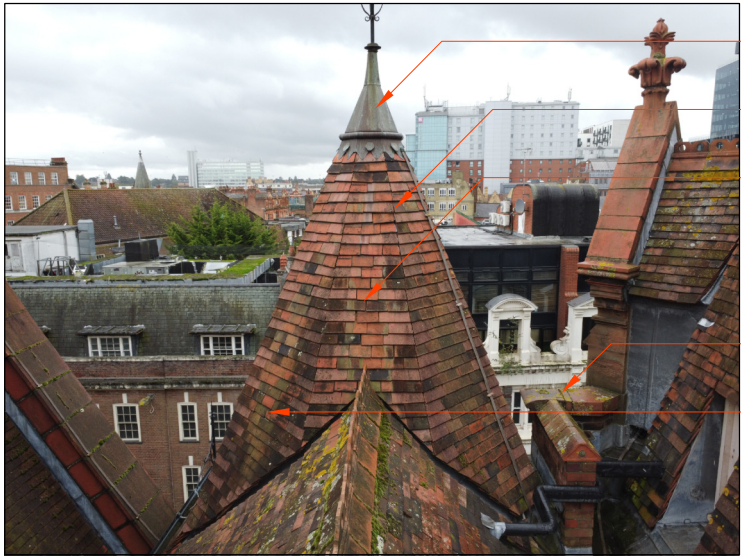
04 EASTERN ROOF SLOPES RF9  
NTS - Date Taken: 09/10/24

- Discolouration/corrosion to finials, copper patination
- Gaps between mitred cut roof tiles at hips
- Isolated slipped/displaced roof tiles, with gaps between tiles
- Staining to leadwork dressings
- Gaps at top of overlapping lead cover flashings from valley gutter
- Algae and moss on coping stones on parapet wall
- Staining along typical drainage routes
- Lead cover flashings lifting and showing signs of high water level in valley gutter
- Damaged and fragmented asphalt covering around edge of valley gutter

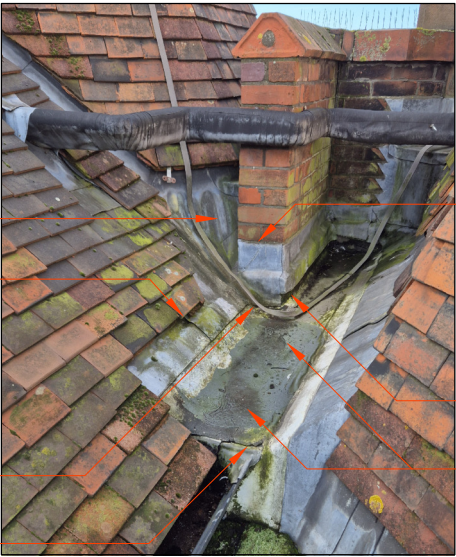
05 GUTTER RF9-VGUT.01  
NTS - Date Taken: 17/10/24

- Algae, moss, and lichen on copings on parapet wall
- Open / defective mortar joints between copings, moss in joints
- Failing mortar joint in parapet wall to lead flashing
- Algae and debris in parapet gutter, signs of standing water
- Isolated defective/open mortar joints in brickwork and damaged/defective bricks
- Defective and splitting asphalt upstand from valley gutter
- Asphalt valley gutter showing signs of creasing and splitting
- Defective and splitting asphalt upstand from valley gutter

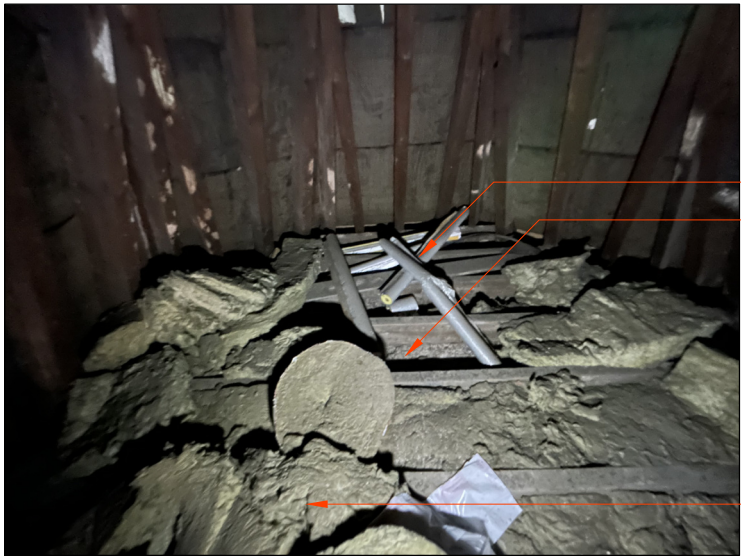
07 INTERNAL SPACE AND INSULATION RF9  
NTS - Date Taken: 17/10/24

- Gaps between mitred cut roof tiles at hips. Ensure soakers are present / in place
- General loose debris located in roof space
- Missing insulation between joists
- Minor defects along intersecting pitched valley gutters
- Isolated slipped/displaced roof tiles
- Moss around typical drainage routes
- Lighting conductor tape has become detached from fixing clip
- Lifted / displaced insulation across floor
- Staining to leadwork dressings
