# ASBESTOS RE-INSPECTION REPORT

FOR: Reading Borough Council (Corporate)  
AT: The Old Town Hall, Blagrove Street (CT03)

J303446  
Issue 2

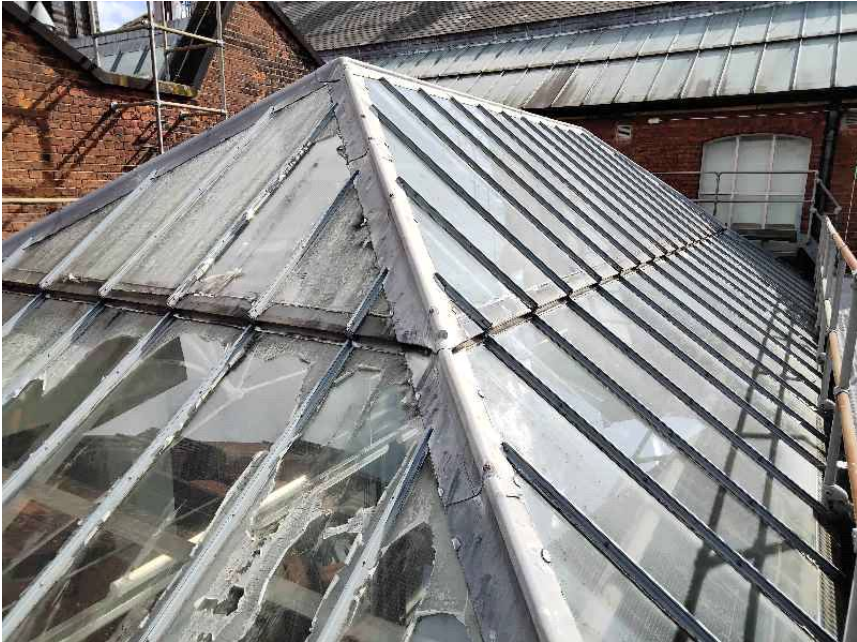
| Sample N° | TP000914 {NT001154}* | | |

| Location | The Old Town Hall E.01 - External | | |
| Item: | Rope packing to skylights | Identification: | Identified |
| Extent of damage: | Low Damage | | 1 |
| | | Material Assessment Score: | 5 |
| Re-inspection Comments:<br>No Change | | | |

| Action: | This material should be incorporated into the asbestos management plan until it has been removed prior to either demolition or refurbishment | | |

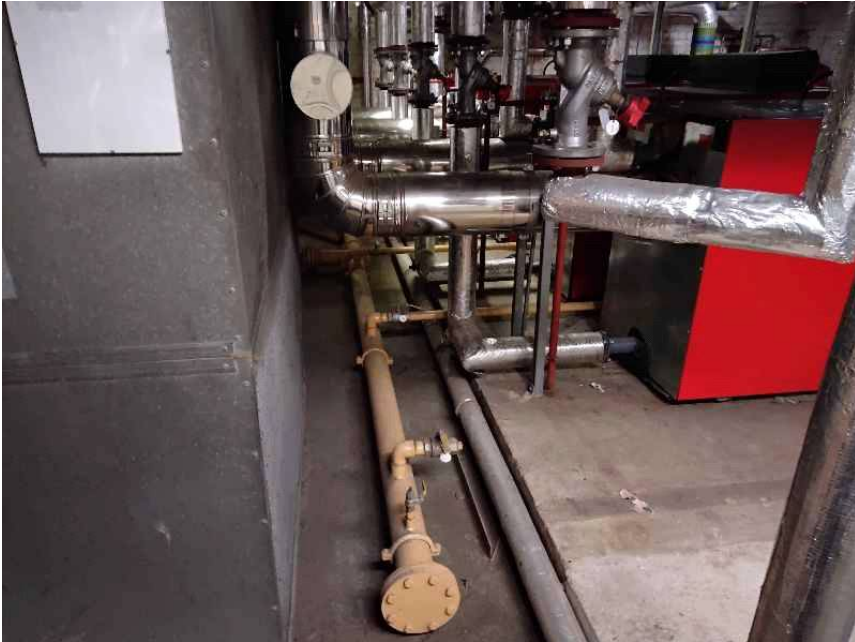
| Sample N° | TPS000917 {NT001157}* | | |

| Location | The Old Town Hall Z1.01 - Basement B.514 | | |
| Item: | Gaskets to pipework | Identification: | Identified |
| Extent of damage: | Low Damage | | 1 |
| | | Material Assessment Score: | 4 |
| Re-inspection Comments:<br>No Change | | | |

| Action: | This material should be incorporated into the asbestos management plan until it has been removed prior to either demolition or refurbishment | | |

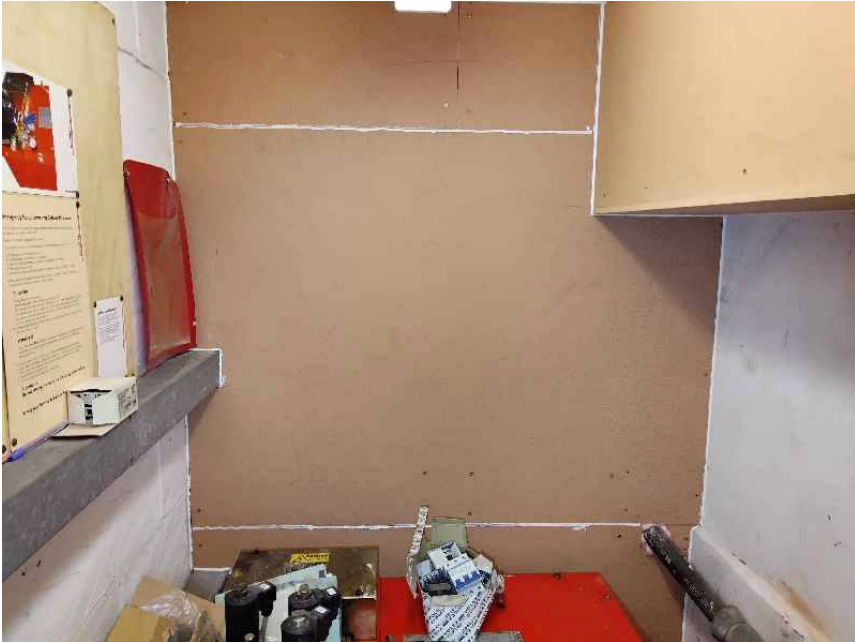
| Sample N° | TPS000922 {NT001158}* | | |

| Location | The Old Town Hall Z1.02 - Basement B.507 | | |
| Item: | Gasket to pipe flange behind plasterboard wall | Identification: | Identified |
| Extent of damage: | Low Damage | | 1 |
| | | Material Assessment Score: | 4 |
| Survey Comments:<br>Is enclosed by MDF timber panels. | | | |
| Re-inspection Comments:<br>Unable to Access | | | |

| Action: | This material should be incorporated into the asbestos management plan until it has been removed prior to either demolition or refurbishment | | |

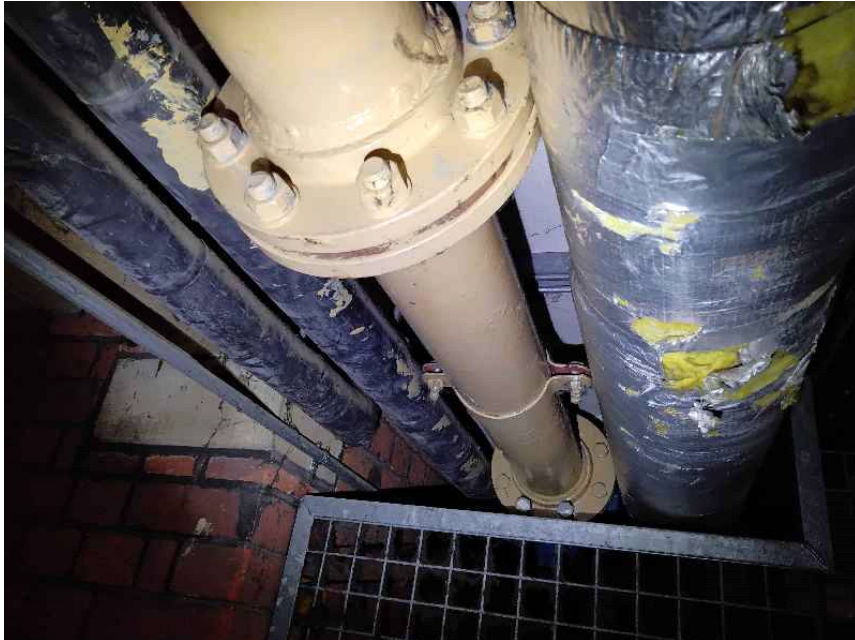
| Sample N° | Presumptive Sample 8 | | |

| Location | The Old Town Hall Z1.03 - Boiler Room Entrance | | |
| Item: | Gasket to Flange | Identification: | Presumed |
| Extent of damage: | Low Damage | | 1 |
| | | Material Assessment Score: | 5 |
| <p>Survey Comments:</p><br><br><br><p>Re-inspection Comments:</p> <p>Additional Entry</p> | | | |

| Action: | This material/area should be treated as containing asbestos until proven otherwise | | |

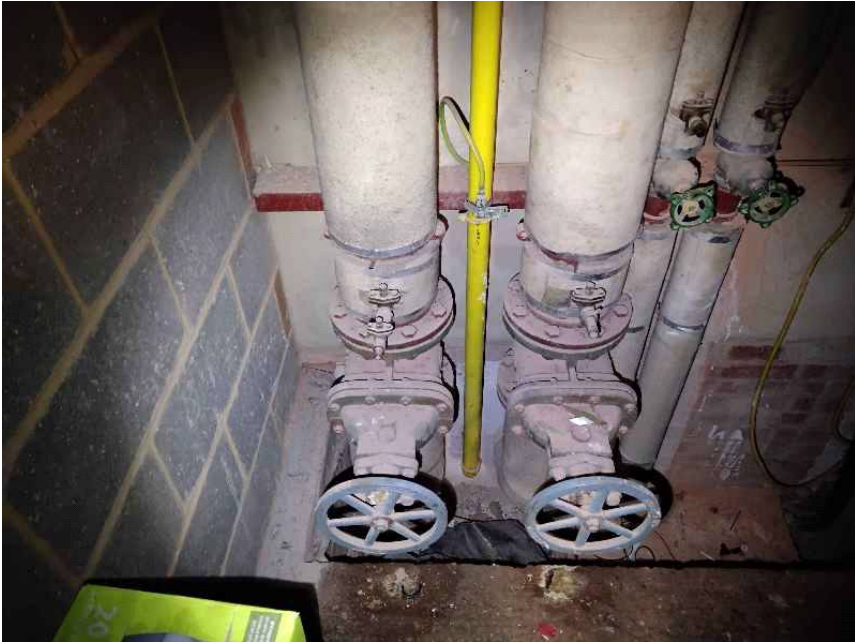
| Sample N° | TPS000919 {NT001152}* | | |

| Location | The Old Town Hall G.01 - Room 024 | | |
| Item: | Gaskets to pipework | Identification: | Identified |
| Extent of damage: | Low Damage | | 1 |
| | | Material Assessment Score: | 4 |
| Re-inspection Comments:<br>No change | | | |

| Action: | This material should be incorporated into the asbestos management plan until it has been removed prior to either demolition or refurbishment | | |

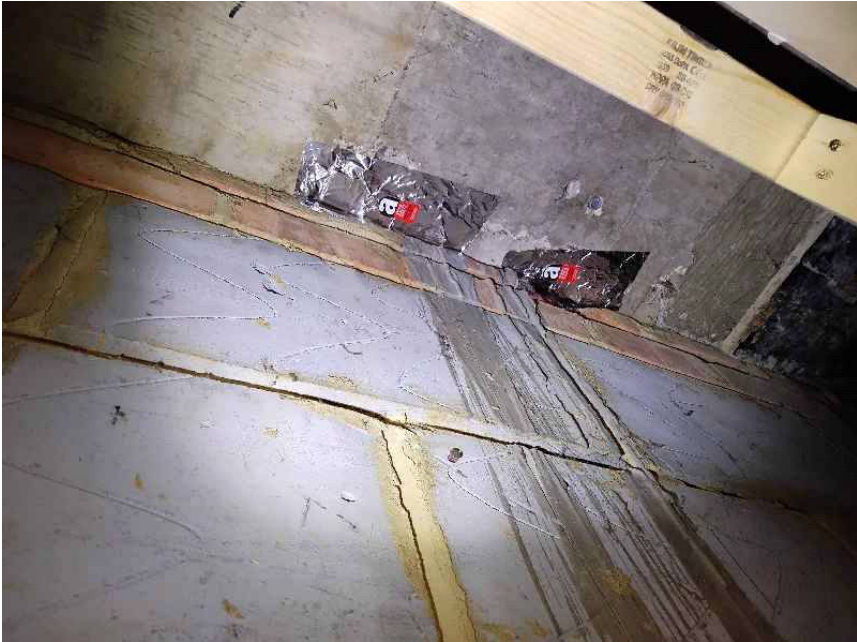
| Sample N° | TPS000918 {NT001153}* | | |

| Location | The Old Town Hall G.02 - Room 003 | | |
| Item: | Cement panel to secondary ceiling | Identification: | Identified |
| Extent of damage: | Low Damage | | 1 |
| | | Material Assessment Score: | 4 |
| Re-inspection Comments:<br>No change | | | |

| Action: | This material should be incorporated into the asbestos management plan until it has been removed prior to either demolition or refurbishment | | |

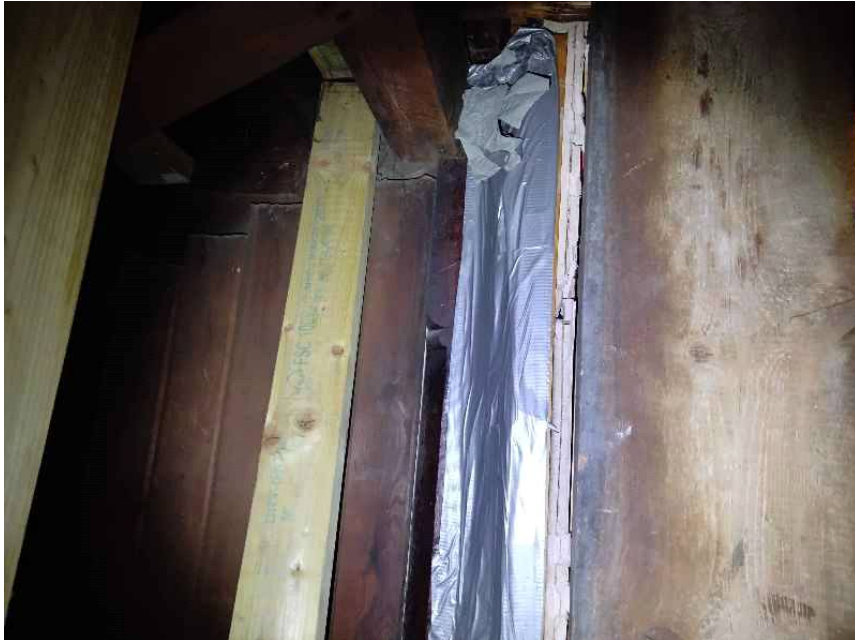
| Sample N <sup>o</sup> | TPS000916 {NT001156}* | | |

| Location | Sample No. | Item | Product | Action |
|---|---|---|---|---|
| The Old Town Hall G.03 - Room 079 | TPS000916 {NT001156}* | Insulation board wall lining to store off museum cupboard sandwiched between timber | Asbestos Insulating Board | Incorporate ACM into management plan until removal |

| Location | The Old Town Hall G.03 - Room 079 | | |
| Item: | Insulation board wall lining to store off museum cupboard sandwiched between timber | Identification: | Identified |
| Extent of damage: | Low Damage | | 1 |
| Asbestos type: | Chrysotile + Amosite | | 2 |
| | | Material Assessment Score: | 6 |
| <p>Survey Comments:<br/>No Comments</p> <p>Re-inspection Comments:<br/>No Change</p> | | | |

| Action: | This material should be incorporated into the asbestos management plan until it has been removed prior to either demolition or refurbishment | | |

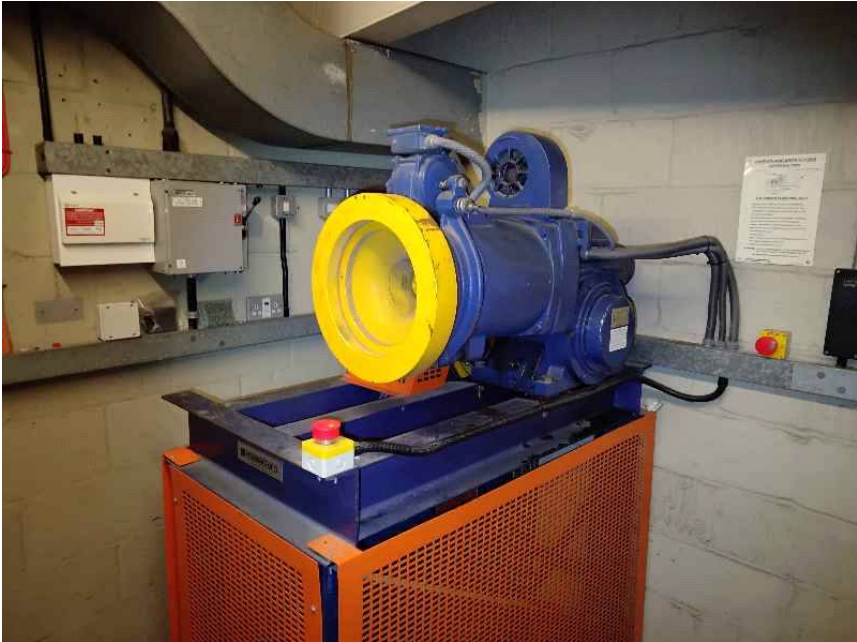
| Sample N° | TPS000915 {NT001155}* | | |

| Location | The Old Town Hall 3.01 - Room 308 | | |
| Item: | Brake shoes on lift motor | Identification: | Identified |
| Extent of damage: | Low Damage | | 1 |
| | | Material Assessment Score: | 3 |
| Re-inspection Comments:<br>No Change | | | |

| Action: | This material should be incorporated into the asbestos management plan until it has been removed prior to either demolition or refurbishment | | |
