project  
**Reading Town Hall,  
Alterations & Improvements**

title  
**Photosheet Of Existing  
Roof RF16**

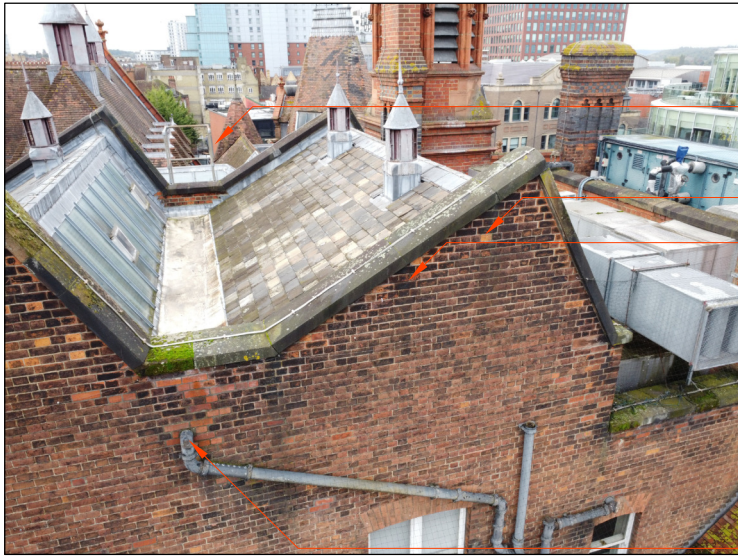
01 SOUTH SLOPE RF16A AND GUTTER RF16-VGUT.01  
NTS - Date Taken: 09/10/24

- Moss, lichen, and dirt present on surface of coping stones
- Metal enclosure for external access ladder
- Isolated defective/open mortar joints in brickwork and damaged/defective bricks
- Staining/discolouration to bricks
- Previous remedial works to coping stone joints has begun to crack and fail
- Lead cover flashings damaged and lifting, gaps in flashings to coped gable
- Detached mortar pointing from junction between lead flashing and coped gable
- Cracked / damaged slates across RF16A
- Rainwater downpipe from outlet RF16-OUT.01 to ground

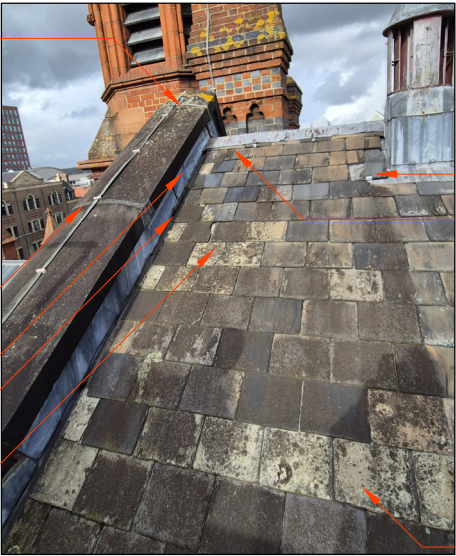
02 SOUTH SLOPE RF16A  
NTS - Date Taken: 08/10/24

- Moss, lichen, and dirt present on surface of coping stones, moss in joints
- Open/defective mortar joints between coping stones
- Isolated slipped/displaced slates, previously refixed with tingles
- Lifting lead flashing along ridge
- Defective bricks in parapet wall, some bricks previously filled using mortar
- Slumping and cracked asphalt upstand to parapet wall
- Defective asphalt valley gutter covering, showing signs of cracking, slumping, blistering, and wrinkling, particularly at junctions and around outlets
- Dirt present on surface of slates on RF16A

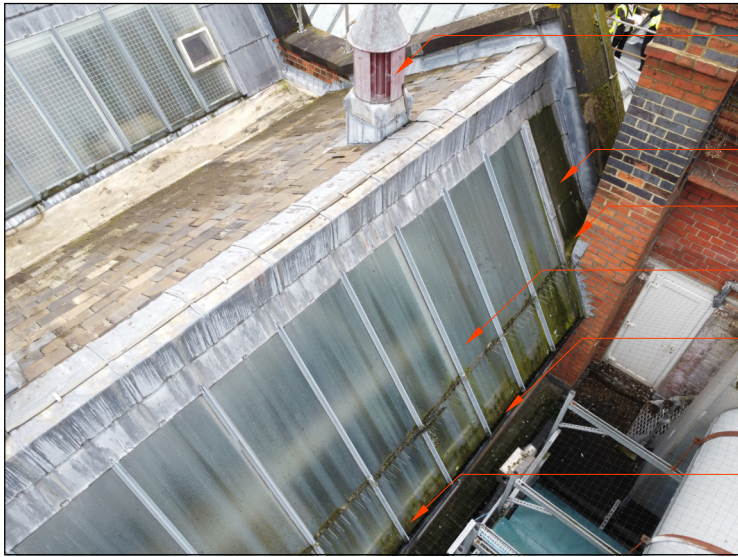
04 PATENT GLAZING RF16-PG.01  
NTS - Date Taken: 09/10/24

- Discolouration/weathering to vents
- Open/defective mortar joints along coped gable
- Severe algae growth to leadwork
- Standing water and debris in lead back gutter to chimney
- Single glazed Georgian wired glass patent glazing
- Debris and standing water along the length of the eaves gutter
- Staining / discolouration and algae growth to brickwork
- Moss and algae growth at the bottom of glazed panes
- Minor localised damage to timber frame finish for north light

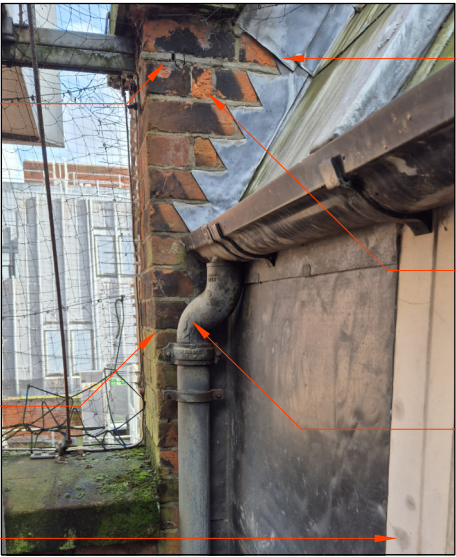
05 CLERESTORY RF16-CL.01  
NTS - Date Taken: 08/10/24

- Loose and lifting lead flashings and upstands
- Stepped lead flashings warped and lifting, gaps in flashings to coped gable
- Moss, algae and lichen at the bottom of glazed panes
- Damaged/defective bricks to coped gable
- Defective sealant between glazed panes and patent glazing structure / frame
- Cracks/damage to eaves gutter and associated rainwater downpipe
- Single glazed north light
- Failing sealant between north light and chimney

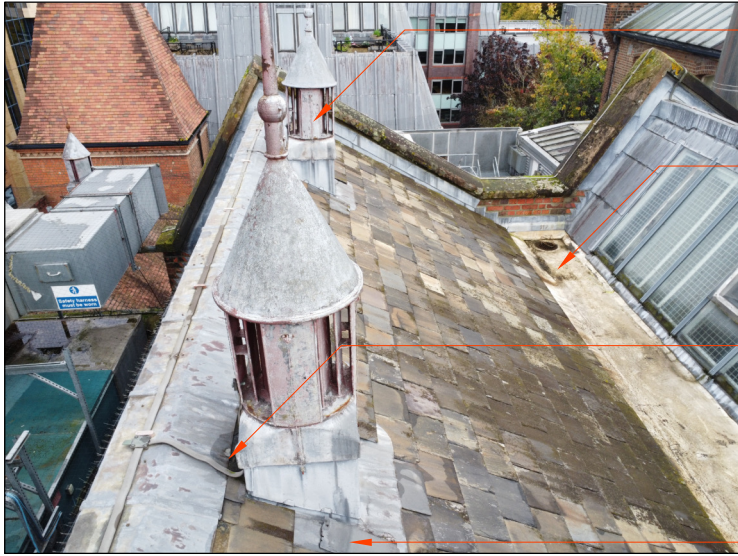
07 SOUTH SLOPE RF16A AND ROOF VENTS  
NTS - Date Taken: 09/10/24

- Insufficient outlet guard to prevent debris from entering the outlet and downpipe
- Discolouration/weathering to vents
- Evidence of friable / degrading surface to the underside of slates in isolation
- Signs of standing water / slowly draining water on flat roof
- Defective asphalt valley gutter covering, showing signs of cracking, slumping, blistering, and wrinkling, particularly at junctions and around outlets
- Insufficient rainwater drainage to back of roof vents
- Algae and dirt present on the bottom courses of slates on RF16A
- Slumping and splitting asphalt upstand and minimal lead cover flashing to RF16A
- Isolated slipped/displaced slates, previously refixed with tingles
