project  
**Reading Town Hall,  
Alterations & Improvements**

title  
**Photosheet Of Existing  
Roof RF23**

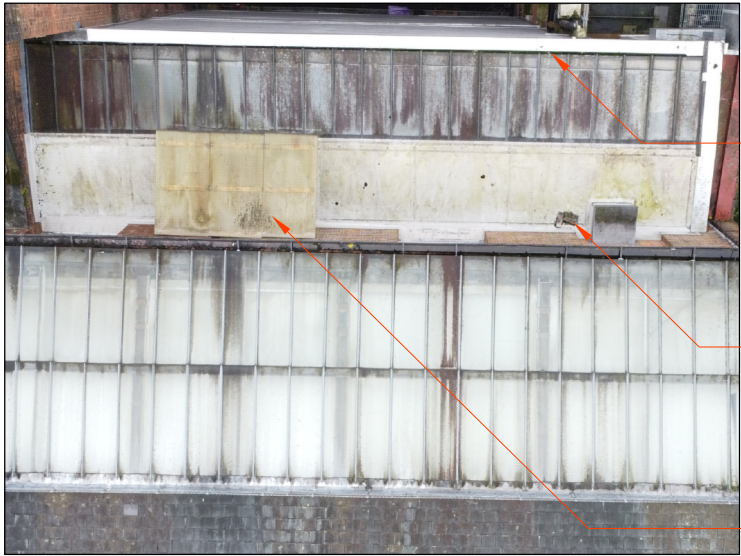
## 01 ROOF COVERING AND PARAPET GUTTER RF23

- Severe debris, moss, and vegetation in the parapet gutter
- Staining to sheet material, no permanent waterproof covering
- Patent glazing offering limited thermal insulation
- Loose debris stored on roof which may impact drainage routes
- Heavily stained patent glazing caused by water runoff, restricting daylight from entering the building
- Lean-to canopy constructed over smoke vent to prevent water ingress

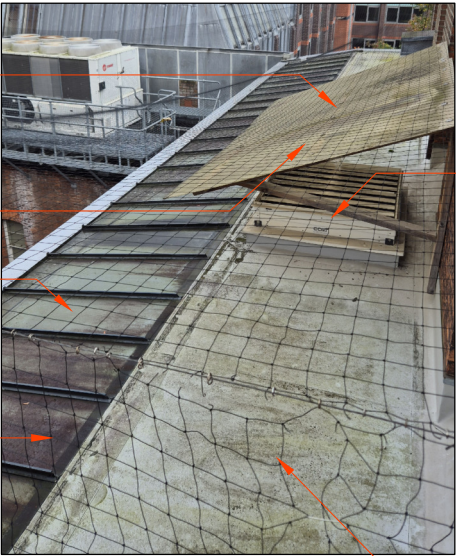
## 02 ROOF COVERING RF23

- Evidence of water on the top edge of the flashing, staining to brickwork
- Standing water on parapet against brickwork chimney
- Smoke vent unit is open and insufficiently waterproofed
- Defective lead surface to parapet wall showing signs of slumping
- Lead cover flashings damaged and lifting, remedial works to mortar joint in wall
- Gaps where lead flashings overlap
- Open/defective mortar joints in brickwork and damaged/defective bricks
- Debris on flat roof from defective adjacent brickwork wall
- Algae growth and staining to flat roof covering

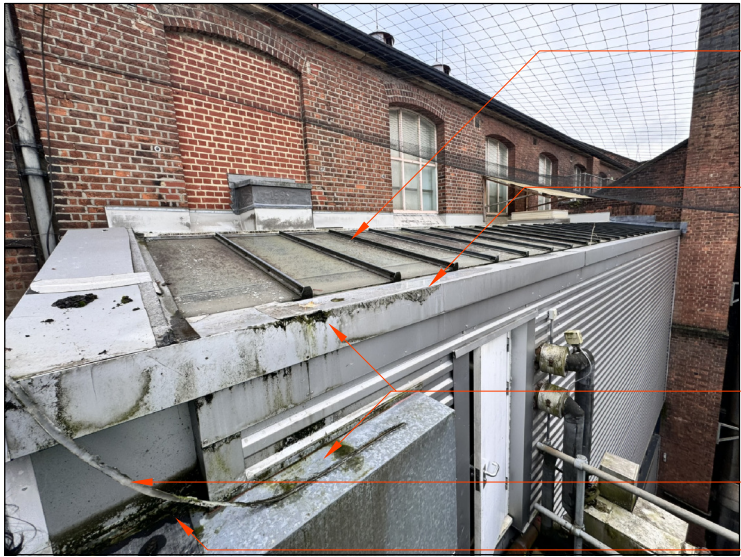
## 04 ROOF COVERING AND PARAPET RF23-PAR.01

- Heavily stained patent glazing caused by water runoff, restricting daylight from entering the building
- Existing remedial repairs to the metal coping along the parapet are lifting
- Failed and peeling surface finish to parapet
- Lifting and defective asphalt upstands, evidence of water ingress
- Standing water along the metal coping of the parapet wall and asphalt upstands
- Algae growth and staining to parapet and adjacent plant
- Algae growth and staining to parapet
- Failed and displaced mastic sealant
- Standing water on adjacent plant, signs of high water level

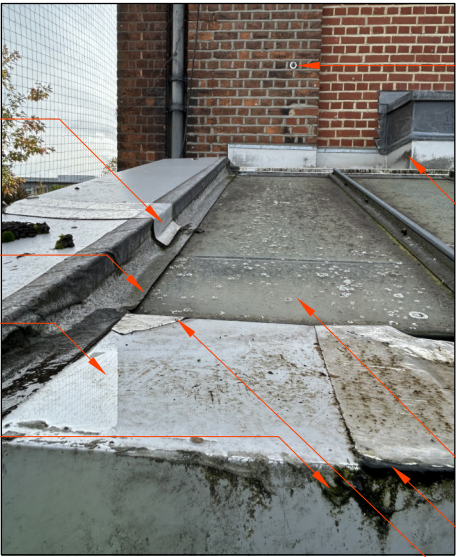
## 05 PARAPET RF23-PAR.02

- Strength of existing fall arrest system bolt eyes is unknown
- Standing water along the metal coping of the parapet
- Staining to upstand, likely high water level
- Severe debris, moss, and vegetation in the parapet gutter
- Existing outlets concealed by vegetation / moss and may be blocked by debris
- Localised remedial repairs to the metal coping along the parapet
- Heavily stained patent glazing caused by water runoff, restricting daylight from entering the building
- Localised remedial repairs to the metal coping along the parapet

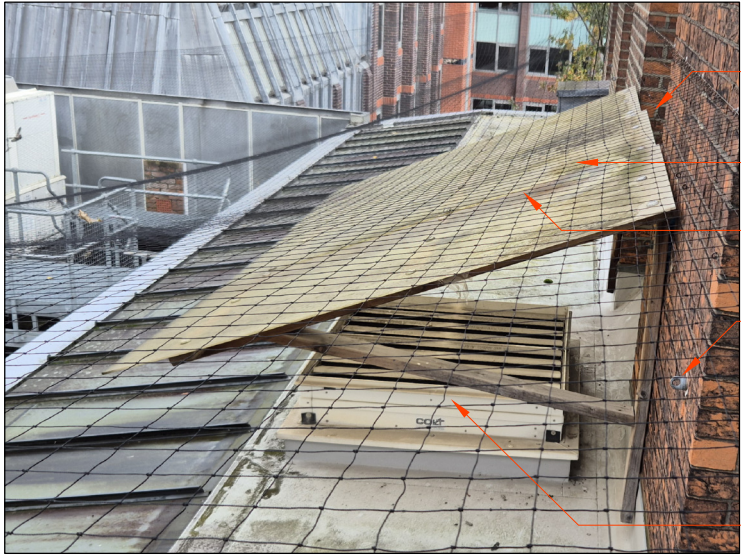
## 07 SMOKE VENT RF23-VENT.01

- Space between lean-to canopy and existing window for water to penetrate
- Lean-to canopy constructed over smoke vent to prevent water ingress
- Staining to sheet material, no permanent waterproof covering
- Strength of existing fall arrest system bolt eyes is unknown
- No sign of water ingress on the underside of the flat roof timber decking
- Split in timber wall plate that continues along the length of the timber
- Smoke vent unit is open and insufficiently waterproofed
