**Reading Town Hall,  
Alterations & Improvements**

**Photosheet Of Existing  
Roof RF10**

**110**

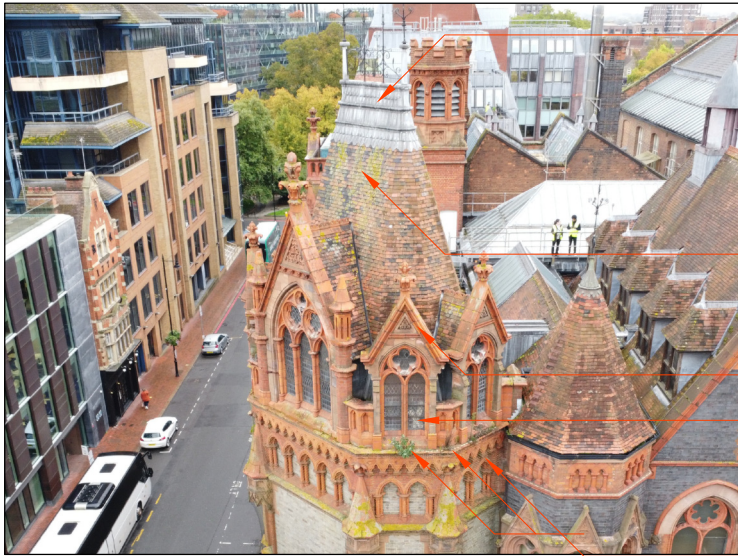
**01 WESTERN ROOF SLOPES RF10**  
NTS - Date Taken: 09/10/24

- Discolouration/corrosion to finials and decorative ridge capping
- Isolated missing roof tiles
- Staining on terracotta copings
- Open / defective mortar joints between copings on coped gable, moss in joints
- Algae growth and staining along typical drainage routes
- Isolated cracked/damaged roof tiles across all roof slopes
- Defective / lifting flashings to inner faces of all coped gables
- Single glazed leaded glass windows
- Gaps where intersecting pitched lead valley gutter sections overlap
- Vegetation growth on terracotta around windows

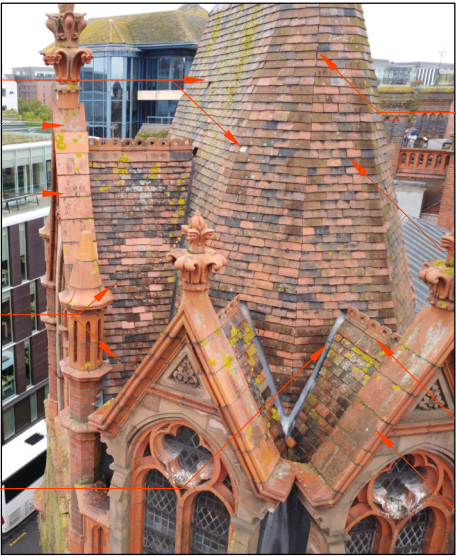
**02 VALLEY GUTTERS RF10**  
NTS - Date Taken: 09/10/24

- Open / defective mortar joints between copings on coped gable, moss in joints
- Gaps between mitred cut roof tiles at hips
- Vegetation growth around windows and terracotta finials
- Isolated slipped/displaced roof tiles
- Algae growth and staining around typical drainage routes on leadwork dressings
- Single glazed leaded glass windows
- Crested ridge tiles with open mortar joints/moss between joints
- Open / defective mortar joints between copings on coped gable, moss in joints

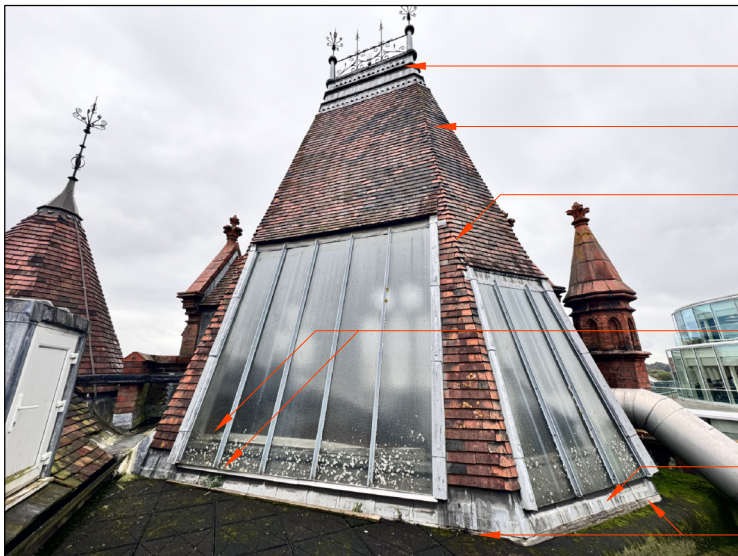
**04 EASTERN ROOF SLOPES RF10**  
NTS - Date Taken: 09/10/24

- Discolouration/corrosion to finials and decorative ridge capping
- Isolated slipped/displaced roof tiles
- Slipped/displaced hip tiles with gaps to lower part of hips
- Splits in rubber matting over flat roof
- Multiple cracked/shattered single glazed Georgian wired panes, some with missing fragments
- Gaps between rubber matting and upstands, evidence of water ingress
- Lead cover flashings damaged and lifting
- Slumping and splitting asphalt upstand below patent glazing

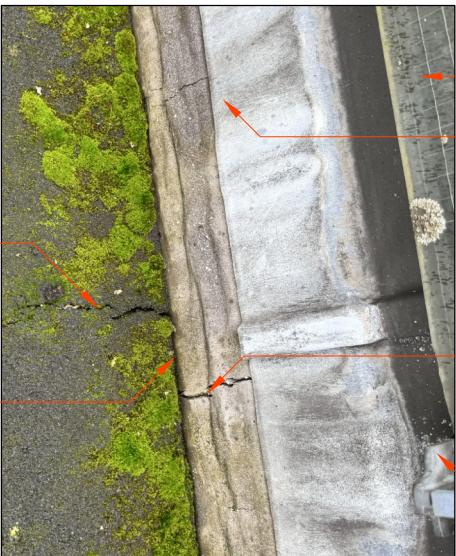
**05 UPSTANDS RF10**  
NTS - Date Taken: 09/10/24

- Single glazed Georgian wired glass patent glazing offering limited thermal insulation
- Lead cover flashings damaged and lifting
- Leadwork rainwater channel with bird prevention spikes, internal condition unknown
- Standing water and debris around rainwater channels, possible water ingress
- Slumping and splitting asphalt upstand below patent glazing
- Defective and lifting lead flashings around rainwater channels
- Missing sealant between glazed panes and structure / frame
- Isolated missing roof tiles, revealing lead flashings below
